**NIST NCSTAR 1-5A
Federal Building and Fire Safety Investigation of
the World Trade Center Disaster**

**Visual Evidence, Damage Estimates,
And Timeline Analysis**

Visual Evidence, Damage Estimates, and Timeline Analysis

September 2005

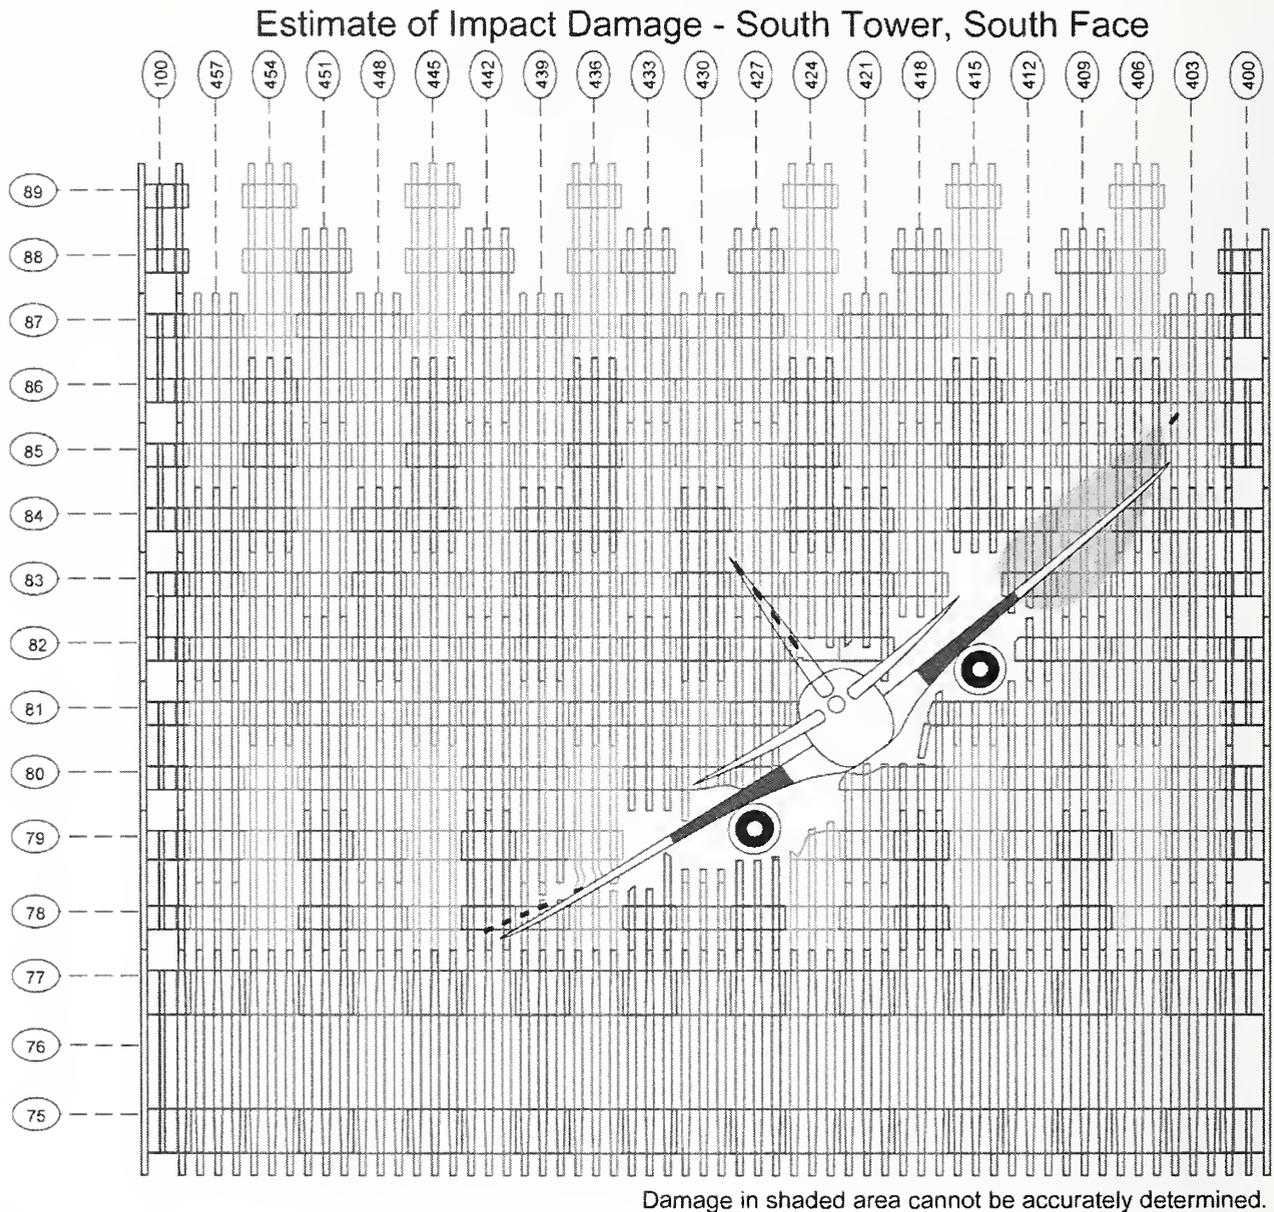
Figure E-3. A scaled outline of a Boeing 767-200ER is superimposed on the damage diagram for the south face of WTC 2. The position of the aircraft has been adjusted to best match the damage pattern and marks showing where the wing tips and vertical stabilizer struck. The red areas correspond to the approximate locations of fuel on the aircraft based on an analysis reported elsewhere (NCSTAR 1-2B).

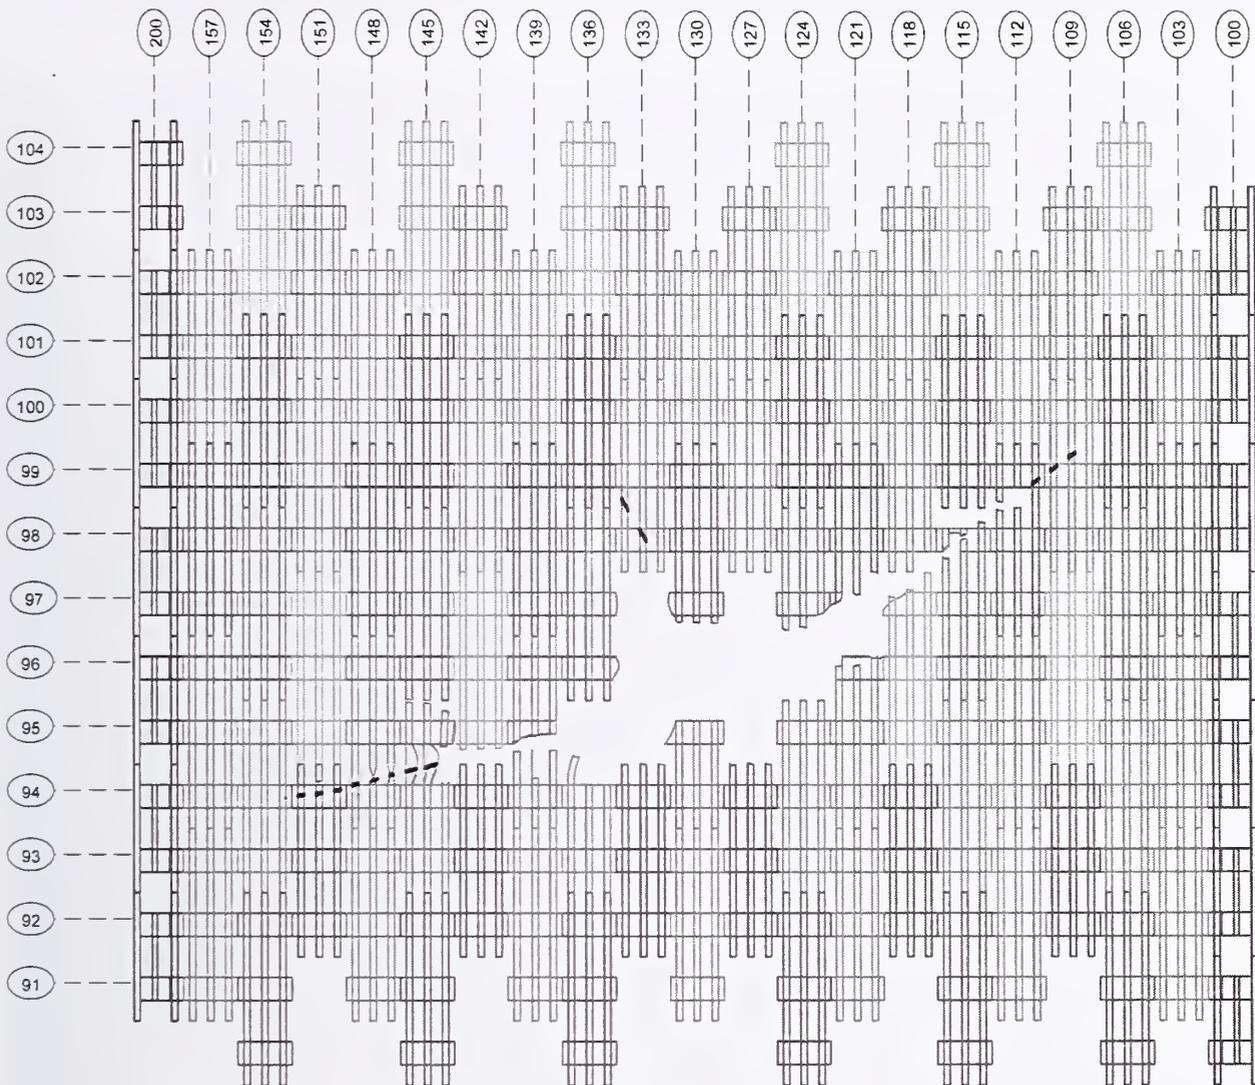
Figure 6-6. A drawing shows the aircraft impact damage to the steel façade of WTC 1. The dark dotted lines indicate locations where the wings and vertical stabilizer of the aircraft marked the aluminum cladding on columns.

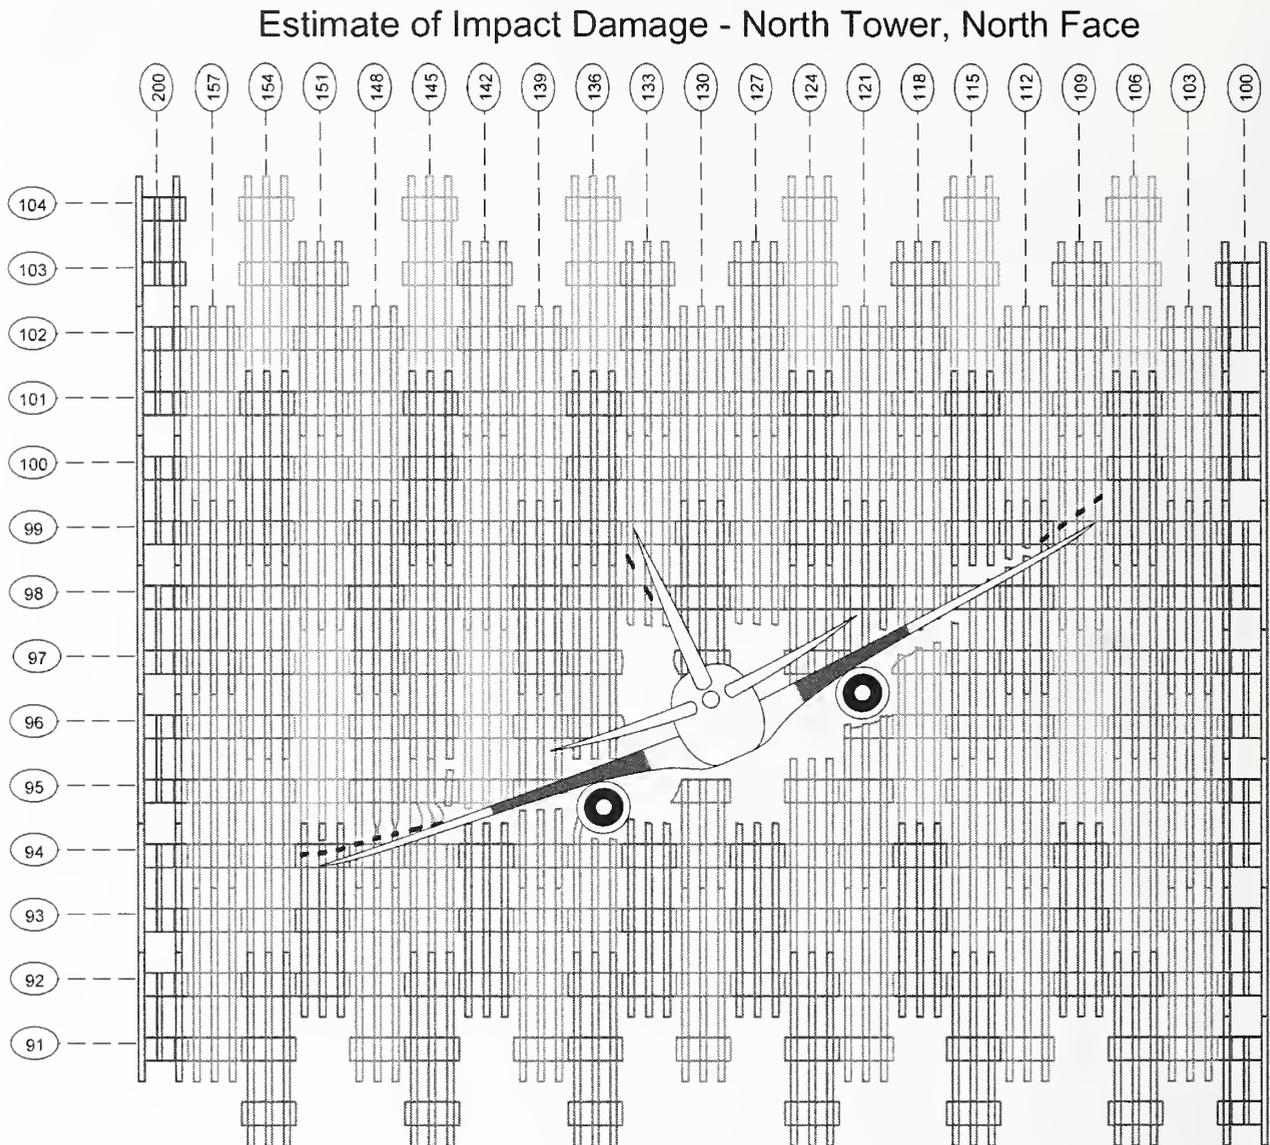
Figure 6-7. A scaled outline of a Boeing 767-200ER is superimposed on the damage diagram shown in Figure 6-6. The position of the aircraft has been adjusted to give the best match with the damage pattern and marks showing where the wing tips and vertical stabilizer struck. The red areas correspond to the approximate locations of fuel on the aircraft based on an analysis reported elsewhere (NIST NCSTAR 1-2B).

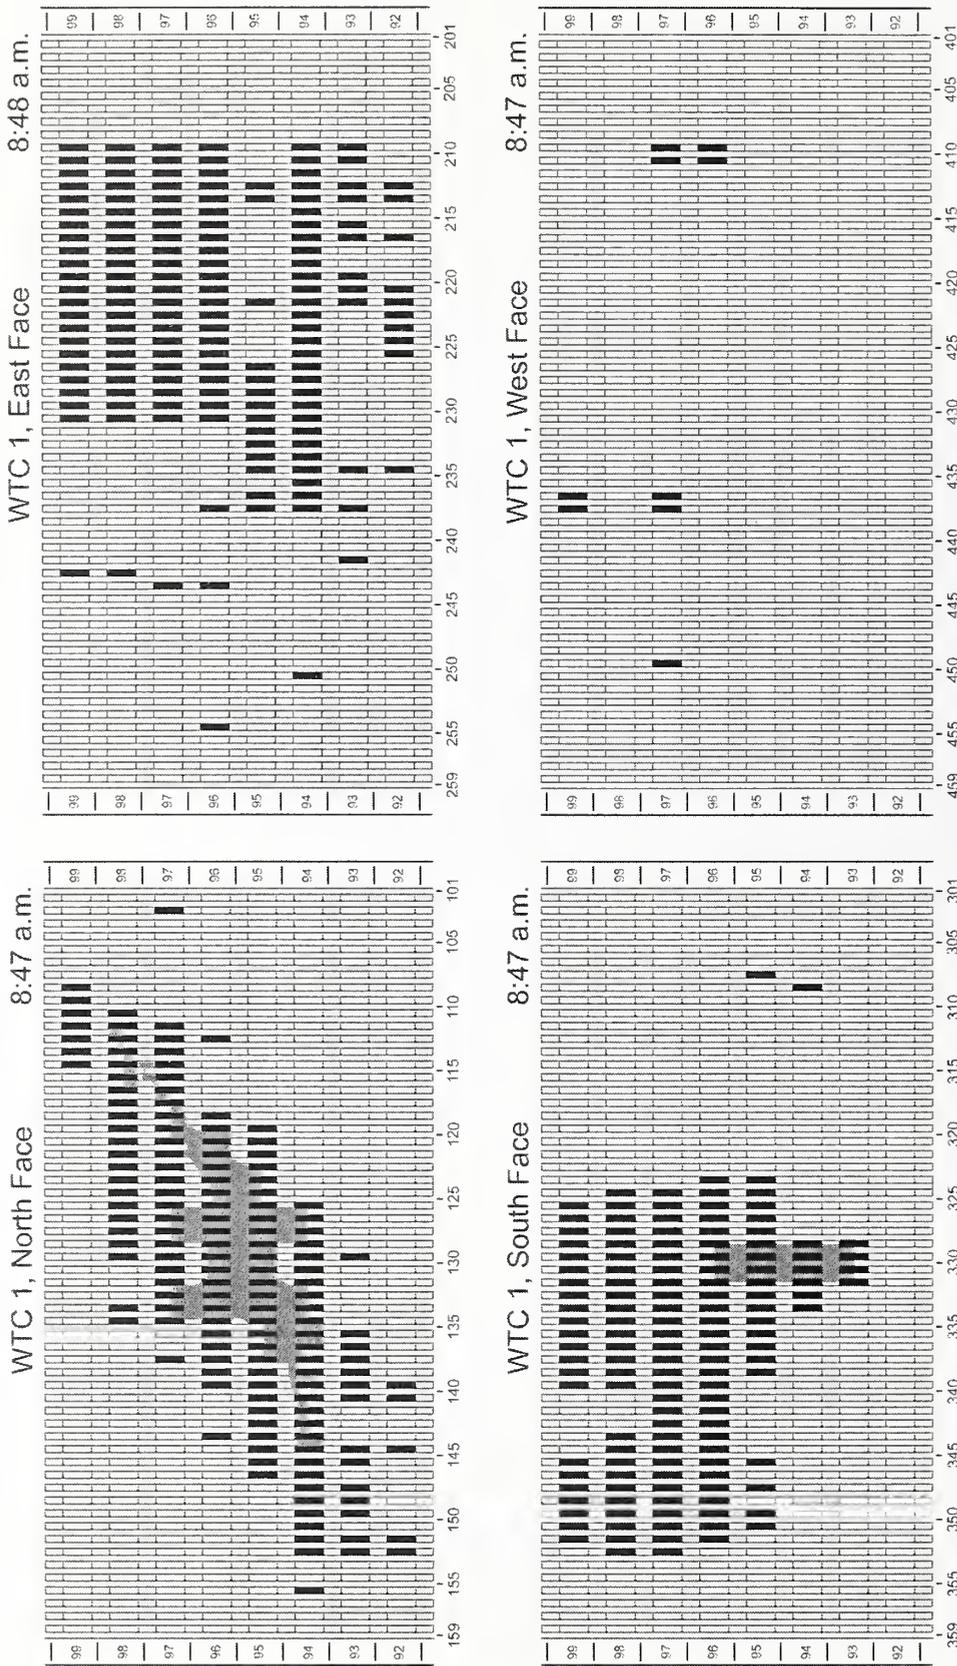
Figure 6-9. The condition of windows is shown for the four faces of WTC 1 around 8:47 a.m. shortly after it was struck by American Airlines Flight 11. The colors represent ■ - window broken open, □ - glass in place, and ▒ - not visible.

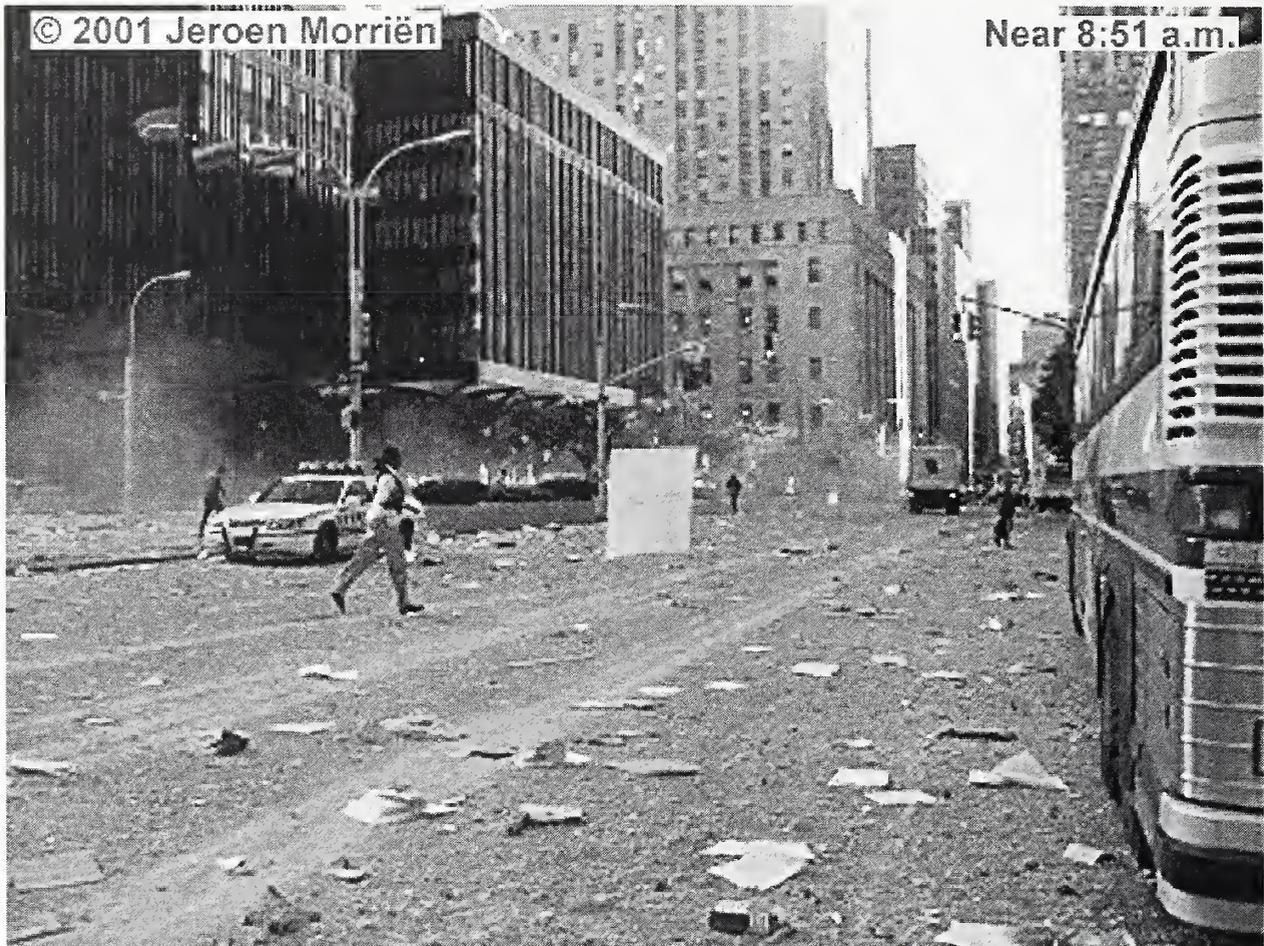
Figure 6-14. A photograph recorded around 8:51 a.m. shows debris present on Church Street, which ran along the east side of the WTC complex. WTC 5 is located on the left-hand side.

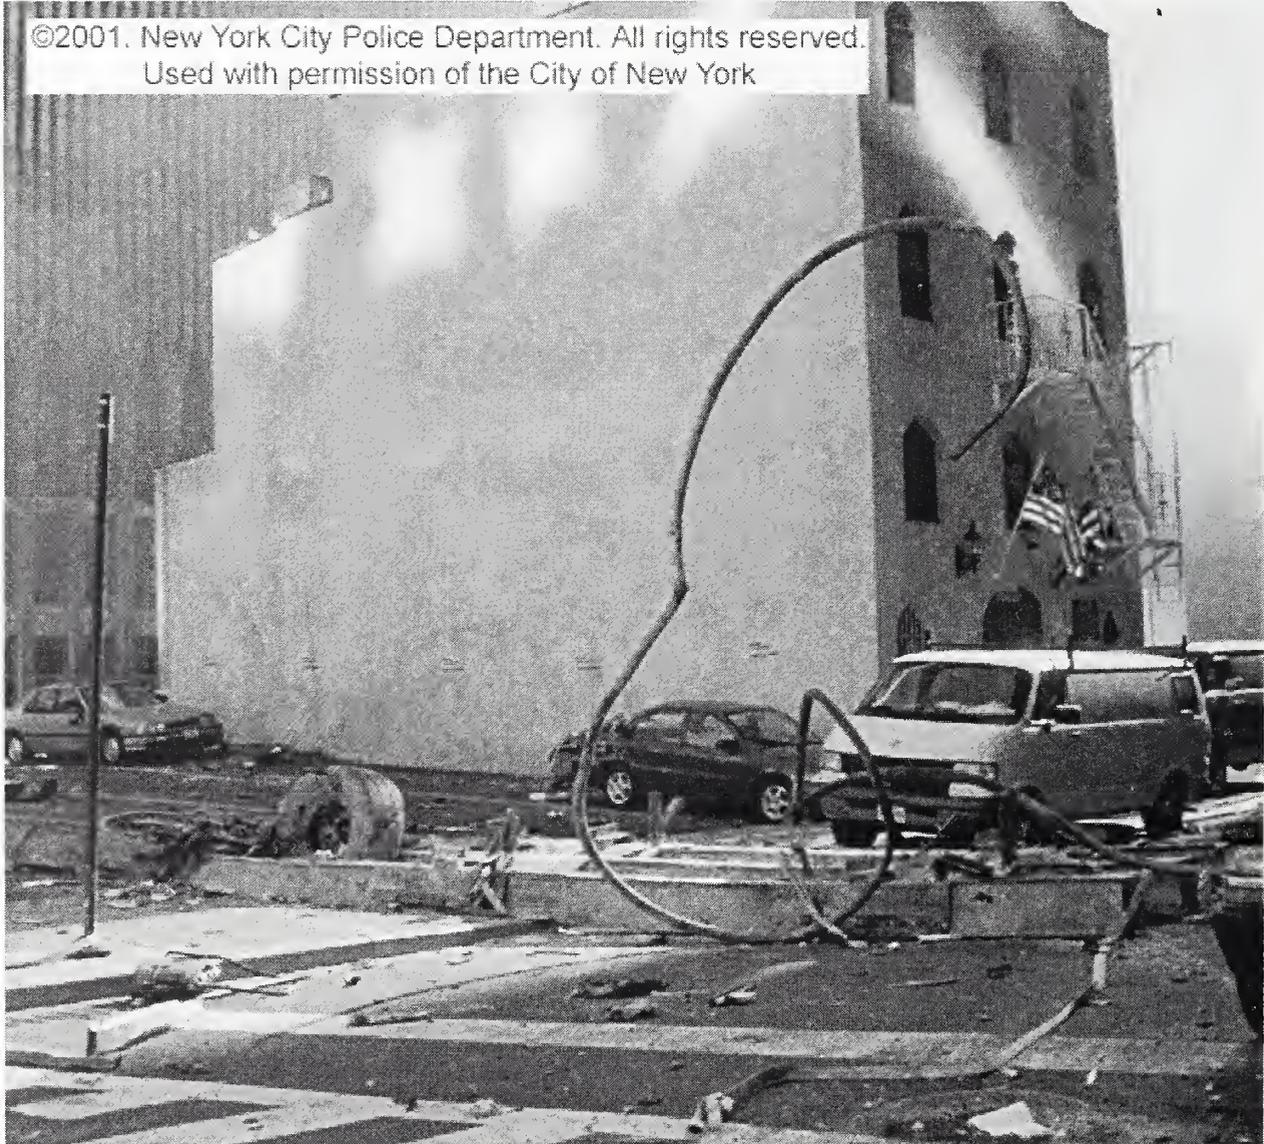
Figure 6-16. Photograph showing a full steel panel section lying in Cedar Street near its intersection with West Street. An aircraft wheel is embedded in one of the windows. The building behind the panel is Saint Nicholas Greek Orthodox Church and the lower section of WTC 2 can be seen across Liberty Street.

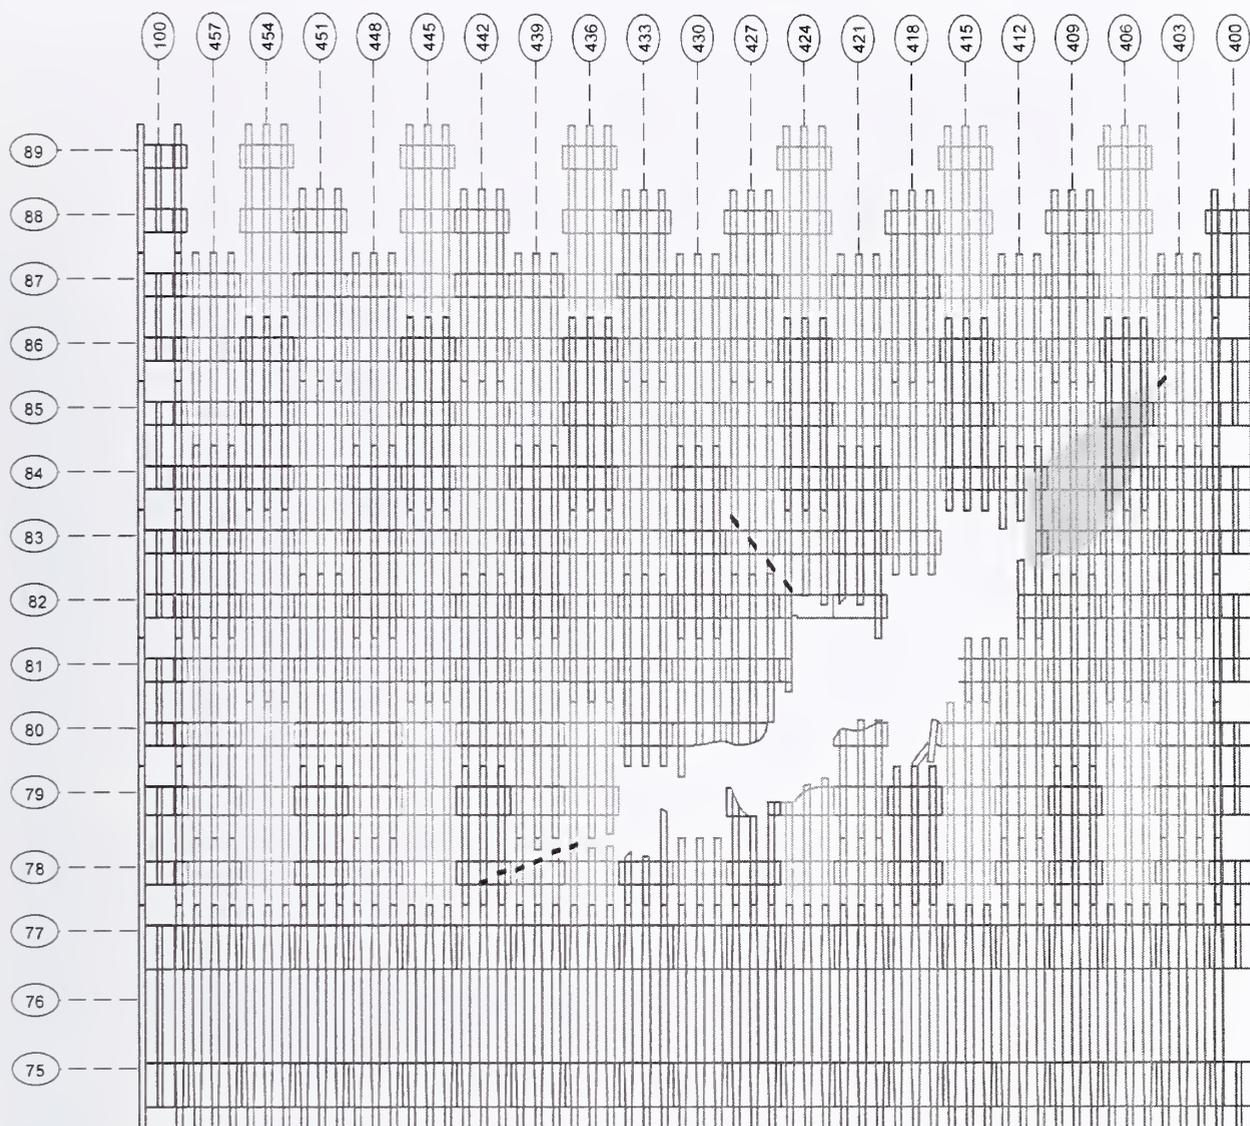
Damage in shaded area cannot be accurately determined.

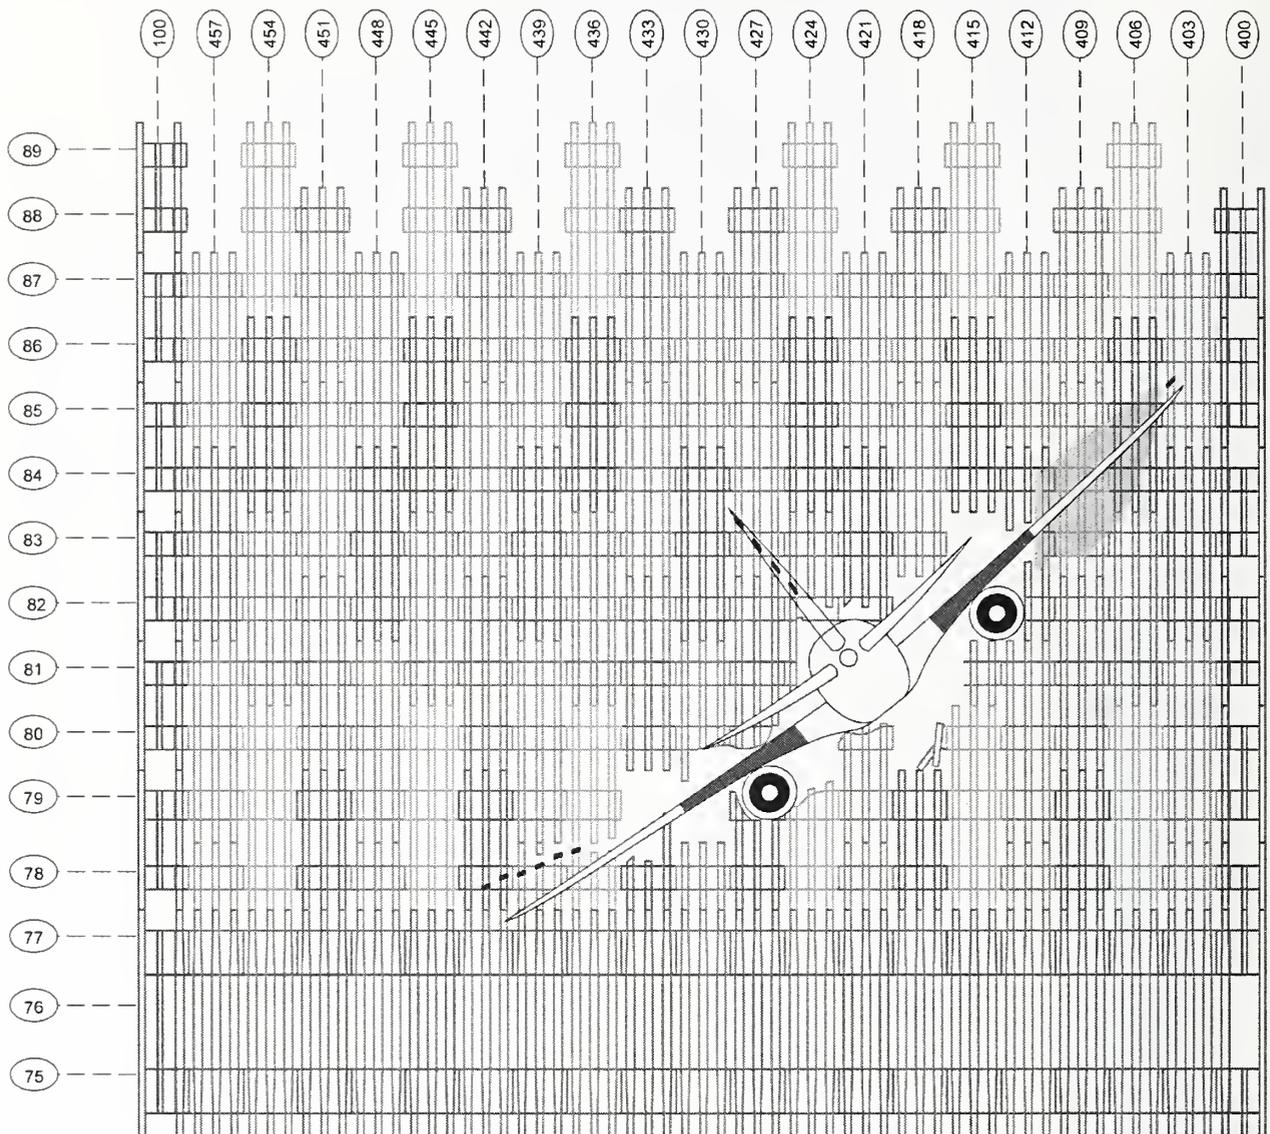
Damage in shaded area cannot be accurately determined.

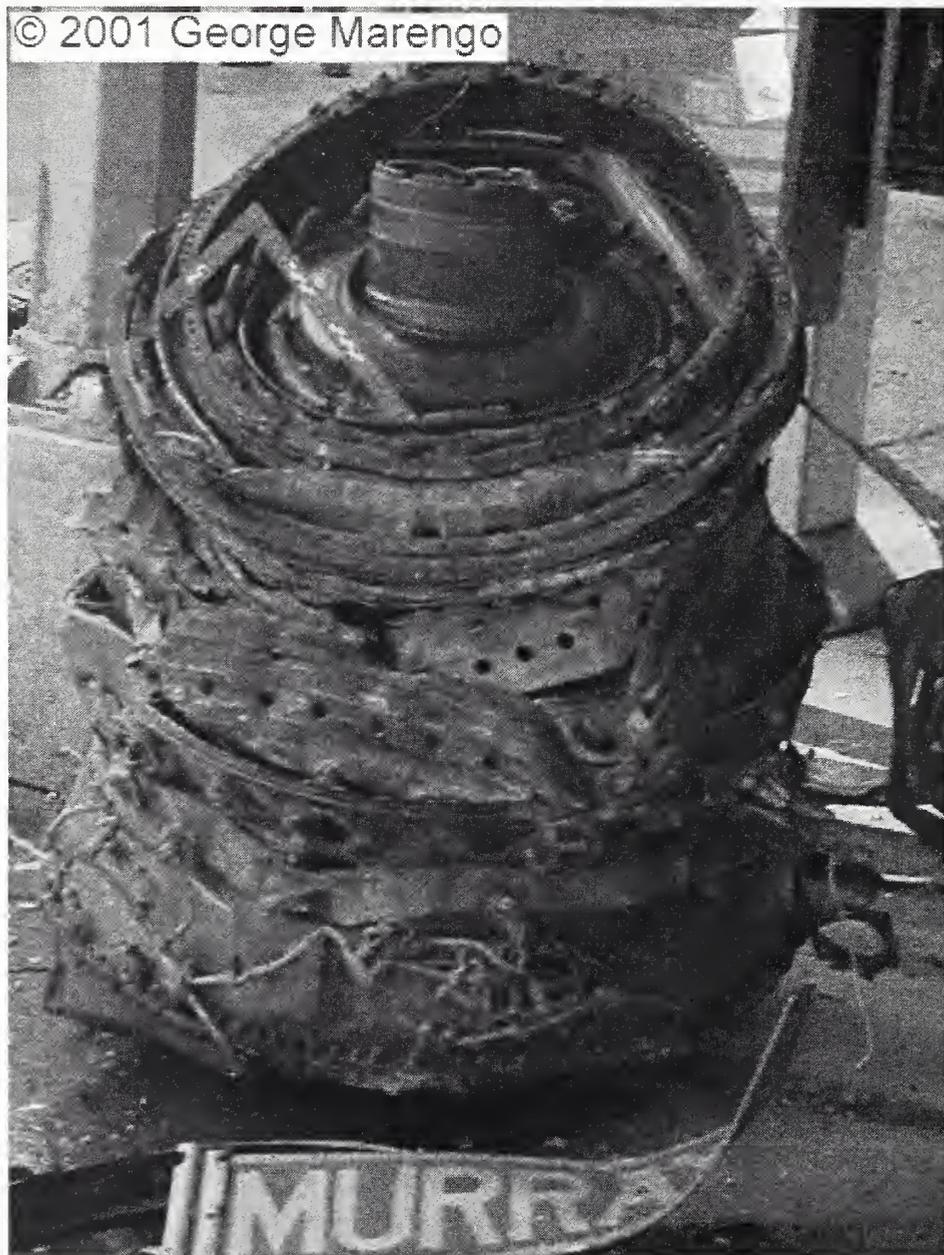
Figure 7-34. This photograph shows what appears to be part of an aircraft engine lying near the northeast corner of the intersection of Church and Murray Streets. The photograph was taken prior to the collapse of WTC 2.

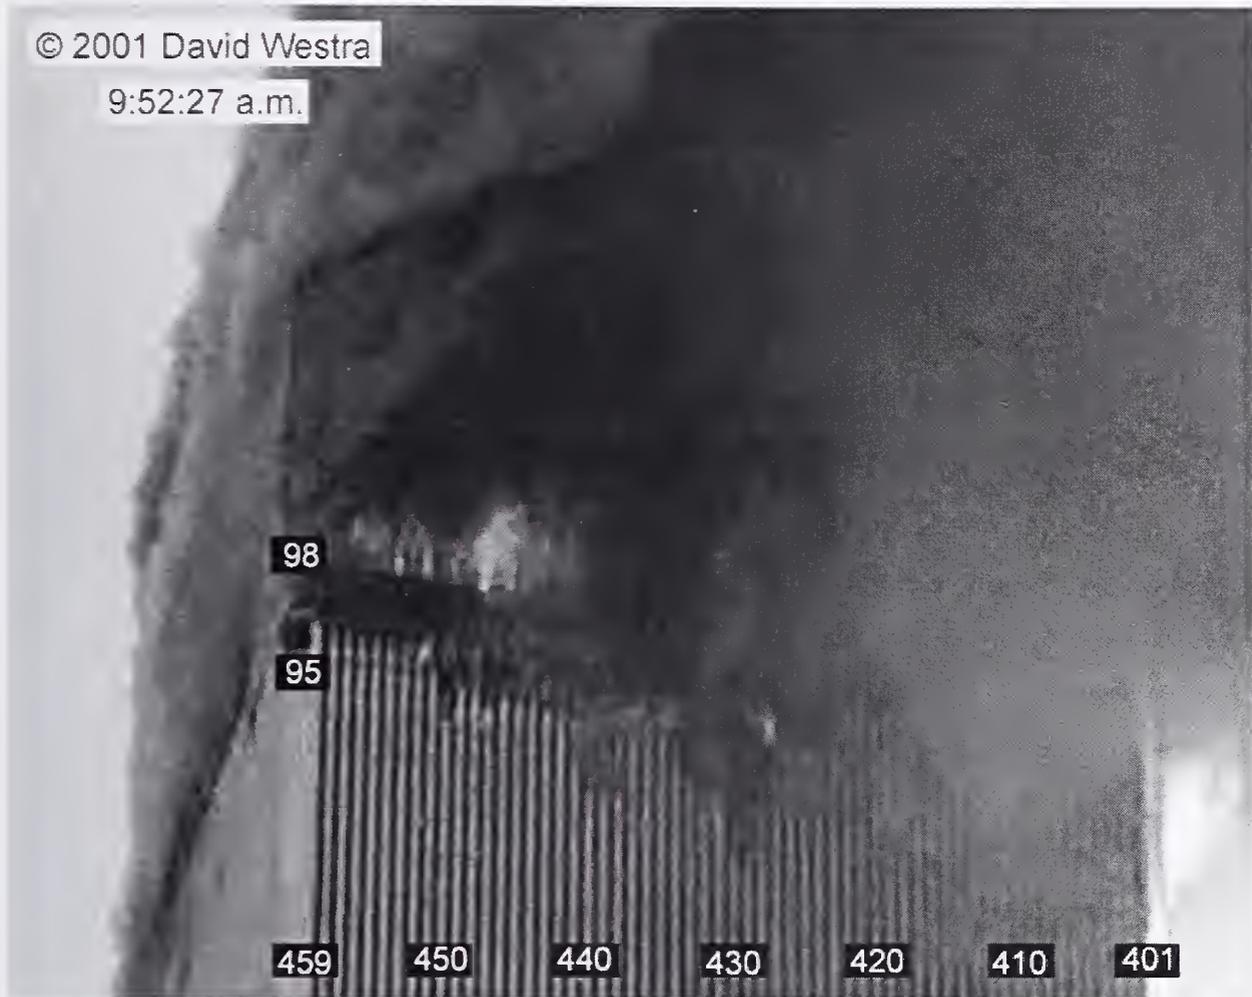
Figure 8-64. This cropped photograph shows the south face of WTC 1 at 9:52:27 a.m. The intensity levels have been adjusted and column and floor numbers have been added. For reference purposes, the missing aluminum panel on the southwest corner of the towers is on the 96th floor, and the heaviest fire is on the 98th floor.
