**NYC Department of Education**  
**Building Condition Assessment Survey 2023 - 2024**

Architectural Inspection

**K010**

**Asset:** P.S. 10 - BROOKLYN, 511 7TH AVENUE, New York, 11215

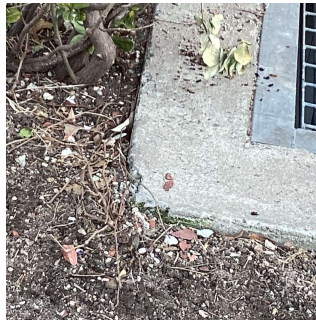
AW6  
No violations recorded.

Question	Response
<b>Architectural</b>	
<b>EXTERIOR</b>	Inspected
<b>AREAWAY</b>	Inspected
Instance on AW3-AW7	Inspected
Instance Condition	2 - Between Good and Fair
Instance Quantity	5
Instance Quantity Uom	EACH
Deficiency	AREAWAY WALLS: CRACKS AND SPALLING

10  
S.F.  
REPAIR  
PRIORITY 3  
LEVEL 2

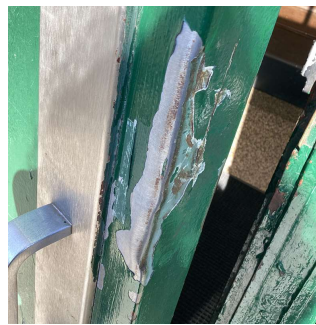
Facade A - Main Entrance

METAL: DETERIORATED DOOR - MAJOR DETERIORATION

1  
EACH  
REPLACE  
PRIORITY 4  
LEVEL 2

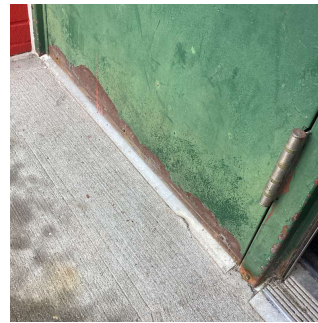
Facade G

**METAL: DETERIORATED DOOR - MINOR DETERIORATION**

4  
EACH  
MAINTENANCE  
PRIORITY 3  
LEVEL 2

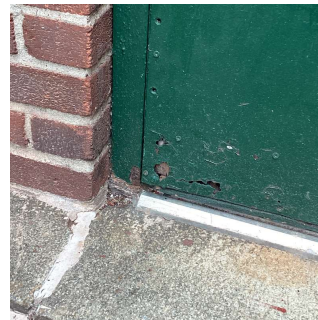
Facade L

**METAL CLAD: DETERIORATED DOOR - MAJOR DETERIORATION**

REPLACE

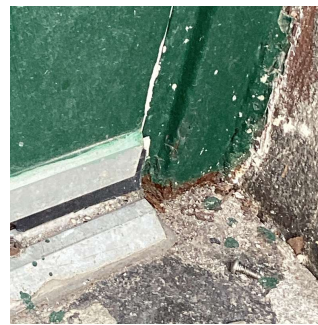
Facade A - East Entrance  
No violations recorded.

**METAL: DETERIORATED DOOR AND FRAME - MINOR DETERIORATION**

2  
EACH  
MAINTENANCE  
PRIORITY 3  
LEVEL 2

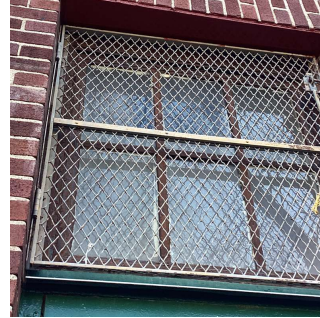
Facade D

METAL: DENTED, MAJOR RUSTING

10  
S.F.  
REPLACE

PRIORITY 4  
 LEVEL 2

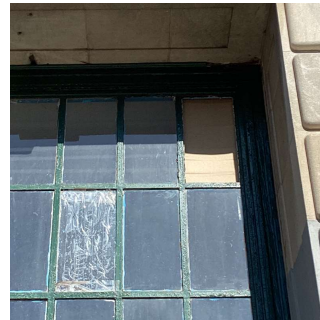
Facade A - East Entrance

**WOOD: BROKEN GLASS**

10  
 S.F.  
 MAINTENANCE  
 PRIORITY 3  
 LEVEL 2

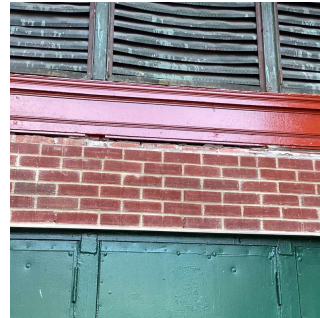
Facade A - Near HC Entrance

BRICK: DETERIORATED JOINTS

PRIORITY 4  
LEVEL 2

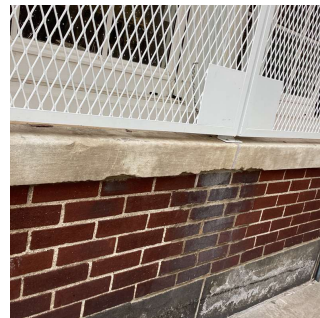
Facade L

**BRICK: DETERIORATED MASONRY SILLS - MAJOR**

REMOVE AND REPLACE

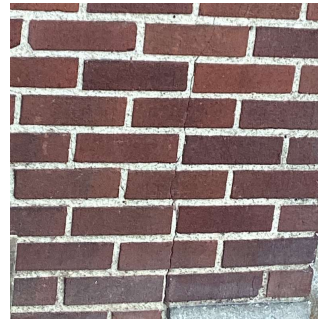
Facade D - North Entrance

CAST IN PLACE / PRE-CAST CONCRETE: MINOR CRACKS/SPALLING

REPAIR

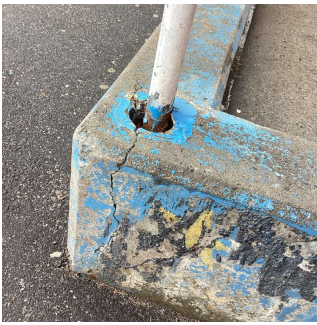
<b>SKYLIGHT/ROOF VENT</b>	
	Inspected
Material Type(s)	Other
Condition	2 - Between Good and Fair
Deficiency	No deficiencies recorded
<b>ROOF/GRAVITY TANK</b>	
	Does not Exist
<b>STAIRS/RAMPS: EXTERIOR</b>	
	Inspected
<b>BUILDING CHEEK/FLANK WALLS</b>	
	Inspected
Condition	4 - Between Fair and Poor
Deficiency	CAST IN PLACE CONCRETE: CRACKS/SPALLING - MAJOR
Roof Plan reference

Deficiency Quantity	20
Quantity Uom	S.F.
Potential Action	REPLACE
Urgency of Action	PRIORITY 4
Purpose of Action	LEVEL 2

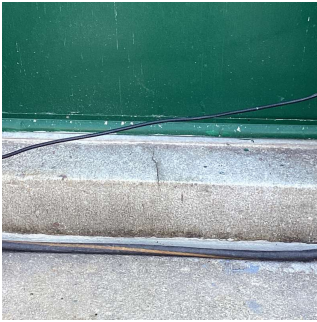
Violations	Facade G No violations recorded.
<b>RAILINGS</b>	
Condition	Inspected 2 - Between Good and Fair
Deficiency	No deficiencies recorded
<b>STAIRS/RAMPS</b>	
Condition	Inspected 4 - Between Fair and Poor
Deficiency	STONE: CRACKS/SPALLING - MINOR
Roof Plan reference

Deficiency Quantity	10
Quantity Uom	S.F.
Potential Action	REPAIR
Urgency of Action	PRIORITY 3
Purpose of Action	LEVEL 2
Deficiency Photo1

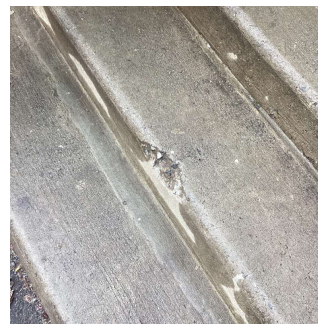
Facade H

Violations	Facade D No violations recorded.
Deficiency	CONCRETE: WORN-OUT TREAD/RISER/NOSING

20  
S.F.  
REPLACE  
PRIORITY 4  
LEVEL 2

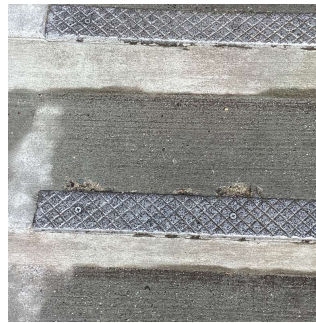
Facade G

**CONCRETE: CRACKS/SPALLING - MINOR**

10  
S.F.  
REPAIR  
PRIORITY 3  
LEVEL 2

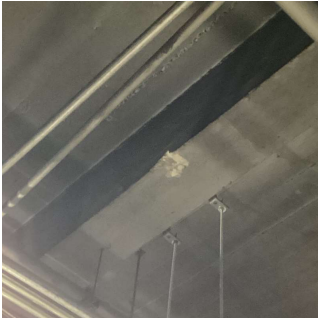
Question	Response
<b>INTERIOR</b>	
<b>STRUCTURAL</b>	
<b>COLUMNS/BEAMS/BEARING WALLS</b>	
Violations	No violations recorded.
Deficiency	STEEL COLUMNS/BEAMS: DETERIORATED CONCRETE FIREPROOFING
Deficiency Location/Instance	Basement - Boiler Room
Deficiency Quantity	30
Quantity Uom	S.F.
Potential Action	REPLACE
Urgency of Action	PRIORITY 3
Purpose of Action	LEVEL 5
Deficiency Photo1

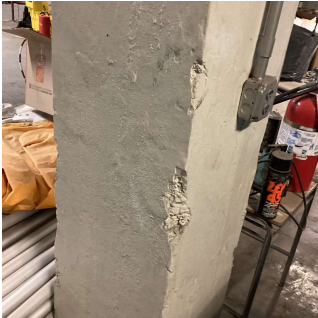
Violations	No violations recorded.
Deficiency	STEEL COLUMNS/BEAMS: DETERIORATED CONCRETE FIREPROOFING
Deficiency Location/Instance	Basement - Boiler Room, Oil Tank
Deficiency Quantity	60
Quantity Uom	S.F.
Potential Action	REPLACE
Urgency of Action	PRIORITY 4
Purpose of Action	LEVEL 5
Deficiency Photo1

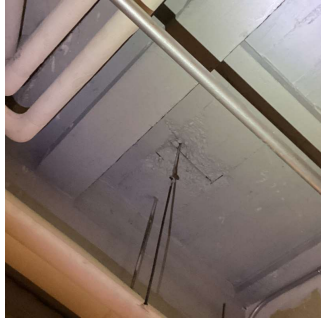
Violations	No violations recorded.
<b>FLOOR STRUCTURE</b>	
Condition	Inspected
Condition	3 - Fair
Deficiency	CONCRETE: CRACKS/SPALLED/REINFORCEMENT EXPOSED
Deficiency Location/Instance	Basement - Oil Tank Room
Deficiency Quantity	10
Quantity Uom	S.F.

Potential Action	REPAIR
Urgency of Action	PRIORITY 4

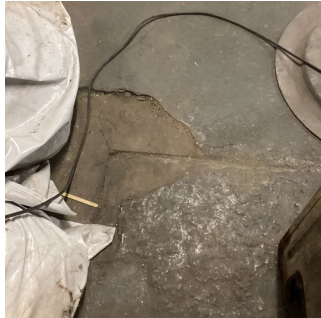
Violations	Basement - Oil Tank Room No violations recorded.
Deficiency	CONCRETE SLAB ON GRADE: THRU CRACKS
Deficiency Location/Instance	Basement - Boiler Room, Electrical Room
Deficiency Quantity	20
Quantity Uom	S.F.
Potential Action	REPAIR
Urgency of Action	PRIORITY 3
Purpose of Action	LEVEL 5
Deficiency Photo1

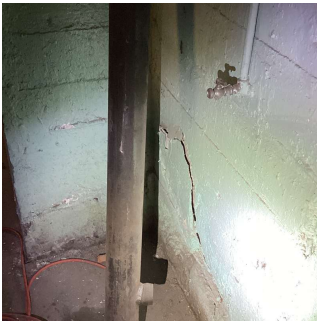
Violations	Basement - Boiler Room No violations recorded.
<b>FOUNDATION WALLS</b>	
Material Type(s)	Inspected Concrete
Condition	4 - Between Fair and Poor
Deficiency	CONCRETE: CRACKED/SPALLED/REINFORCEMENT EXPOSED
Deficiency Location/Instance	Basement - Boiler Room, Oil Tank
Deficiency Quantity	50
Quantity Uom	S.F.
Potential Action	REPAIR
Urgency of Action	PRIORITY 4
Purpose of Action	LEVEL 5

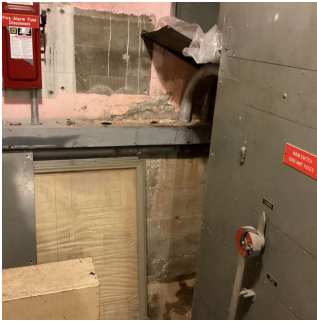
Violations	Basement - Boiler Room No violations recorded.
Deficiency	CONCRETE: WATER INFILTRATION IN ELECTRICAL PANEL ROOM
Deficiency Location/Instance	Basement - Electrical Room
Deficiency Quantity	100
Quantity Uom	S.F.
Potential Action	INSTALL WATERPROOFING
Urgency of Action	PRIORITY 5
Purpose of Action	LEVEL 6
Deficiency Photo1

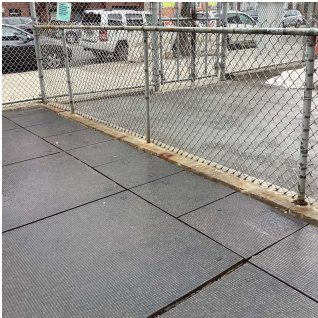
Question	Response
<b>SITE</b>	
<b>PLAYGROUNDS</b>	
<b>Fence</b>	
Instance on Schoolyard	Inspected
Condition	3 - Fair
Deficiency	CHAIN LINK: DAMAGED POST/RAIL
Deficiency Location/Instance	Schoolyard
Deficiency Quantity	40
Quantity Uom	L.F.
Potential Action	REPLACE
Urgency of Action	PRIORITY 3
Purpose of Action	LEVEL 2
Deficiency Photo1

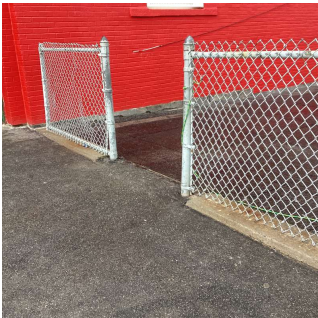
Violations	Schoolyard No violations recorded.
Deficiency	CHAIN LINK: MISSING SECTIONS
Deficiency Location/Instance	Schoolyard
Deficiency Quantity	50
Quantity Uom	S.F.
Potential Action	REPLACE
Urgency of Action	PRIORITY 3
Purpose of Action	LEVEL 2
Deficiency Photo1

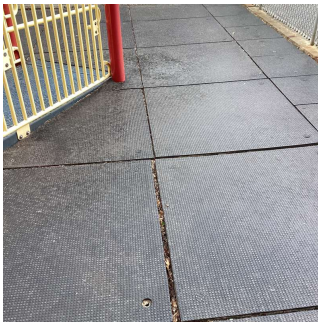
Priority Condition Exist Last Year?	Priority Category	Condition Description	Component Affected	Location Description	Person(s) Notified	Person(s) Title	PhotoImage
No	Tripping Hazard	Displaced safety surfacing is a potential safety hazard.	SITE   PLAYGROUN DS   Safety Surfacing	Schoolyard	David Riches	Fireman
