**NYC Department of Education**  
**Building Condition Assessment Survey 2023 - 2024**

Architectural Inspection

**Asset:**      **P.S. 12 - BROOKLYN, 430 HOWARD AVE, New York, 11233**

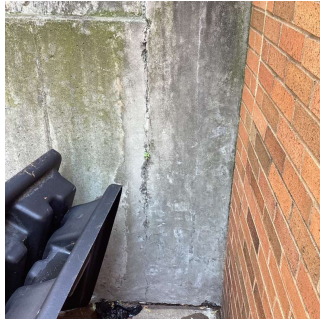
Violations	AW1 No violations recorded.
Deficiency	AREAWAY WALLS: CRACKS AND SPALLING
Roof Plan reference

Deficiency Quantity	10
Quantity Uom	S.F.
Potential Action	REPAIR
Urgency of Action	PRIORITY 3
Purpose of Action	LEVEL 2
Deficiency Photo1

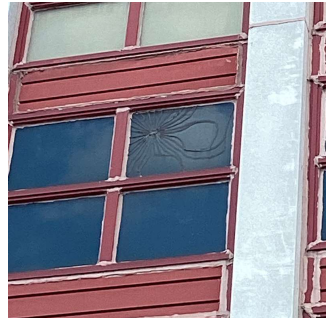
Question	Response
<b>EXTERIOR</b>	
<b>EXTERIOR WALLS</b>	Inspected
Material Type(s)	Concrete, Masonry, Steel
Replacement Quantity	35,000
Replacement Uom	S.F.
Instance on All Facades	Inspected
Instance Condition	3 - Fair
Instance Quantity	35,000
Instance Quantity Uom	S.F.
Deficiency	METAL/GLASS CURT WALL: BROKEN GLASS
Roof Plan reference

Deficiency Quantity	10
Quantity Uom	S.F.
Potential Action	REPLACE
Urgency of Action	PRIORITY 3
Purpose of Action	LEVEL 2
Deficiency Photo1

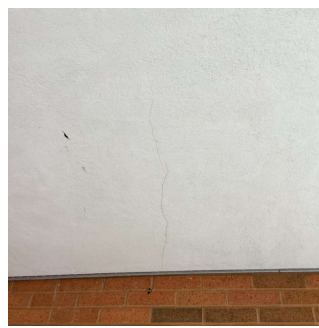
Question	Response
<b>EXTERIOR</b>	
<b>EXTERIOR WALLS</b>	Inspected
Violations	Facade E No violations recorded.
<b>EXTERIOR SOFFITS</b>	Inspected
Condition	2 - Between Good and Fair
Deficiency	STUCCO/PLASTER: MINOR CRACKS/SPALLING
Roof Plan reference

Deficiency Quantity	10
Quantity Uom	S.F.
Potential Action	REPAIR
Urgency of Action	PRIORITY 3
Purpose of Action	LEVEL 2
Deficiency Photo1

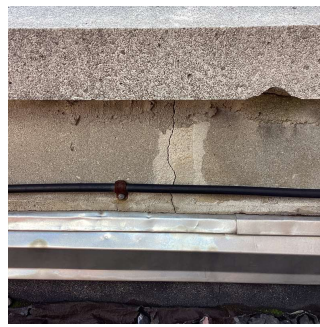
Question	Response
<b>EXTERIOR</b>	
<b>PARAPETS</b>	
Instance on All Facades	Inspected
Instance Condition	2 - Between Good and Fair
Instance Quantity	7,000
Instance Quantity Uom	C.F.
Deficiency	CONCRETE MASONRY UNITS: MINOR CRACKS, SPALLING
Roof Plan reference

Deficiency Quantity	40
Quantity Uom	S.F.
Potential Action	REPAIR
Urgency of Action	PRIORITY 3
Purpose of Action	LEVEL 2
Deficiency Photo1

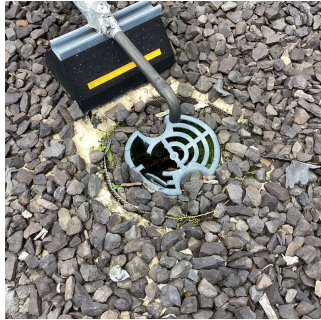
Roof 21
Instance Quantity	400
Instance Quantity Uom	S.F.
Does the roof have major mechanical equipment sitting on Dunnage Steel less than 18" above the Roofing?	No
Does this roof instance have a Sustainable Roof System?	No
Do solar panels exist on these roofs?	No
Is/Are the roof(s) suitable for Solar Panel installation?	No
Installation Year	1993
Source of Installation	Custodial Staff
Deficiency	No deficiencies recorded
<b>ROOFING DRAINS</b>	Inspected
Condition	5 - Poor
Deficiency	DETERIORATED
Roof Plan reference

Deficiency Quantity	3
Quantity Uom	EACH
Potential Action	REPLACE

Question	Response
<b>EXTERIOR</b>	
<b>ROOF</b>	
<b>Roofing</b>	
<b>ROOFING DRAINS</b>	
Urgency of Action	PRIORITY 4
Purpose of Action	LEVEL 2
Deficiency Photo1

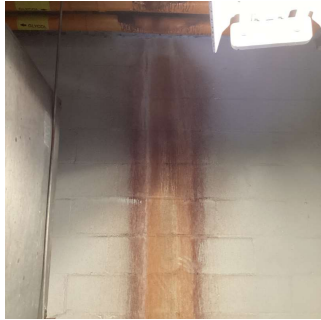
Violations	Roof 17 No violations recorded.
<b>Specialties</b>	Inspected
<b>BULKHEAD/PENTHOUSE</b>	Inspected
Condition	5 - Poor
Deficiency	BULKHEAD/PENTHOUSE WALLS/EXTERIOR: WATER INFILTRATION
Roof Plan reference

Deficiency Quantity	100
Quantity Uom	S.F.
Potential Action	REPAIR
Urgency of Action	PRIORITY 5
Purpose of Action	LEVEL 2
Deficiency Photo1

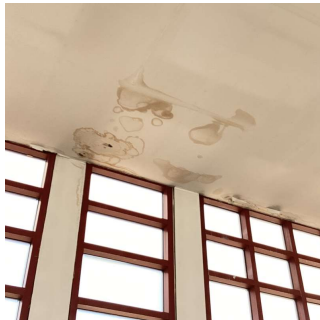
Violations	BH3 No violations recorded.
Deficiency	BULKHEAD/PENTHOUSE ROOF: MAJOR LEAKAGE
Roof Plan reference

Deficiency Quantity	400
Quantity Uom	S.F.
Potential Action	REPLACE
Urgency of Action	PRIORITY 5
Purpose of Action	LEVEL 2
Deficiency Photo1

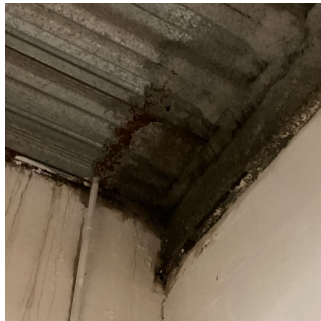
Water and Gas Meter Room
Violations	No violations recorded.
<b>FLOOR STRUCTURE</b>	
	Inspected
Condition	3 - Fair
Deficiency	METAL DECK AND CONCRETE: DETERIORATED
Deficiency Location/Instance	Sub-Basement - Boiler Room
Deficiency Quantity	20
Quantity Uom	S.F.
Potential Action	REPAIR
Urgency of Action	PRIORITY 4
Purpose of Action	LEVEL 5

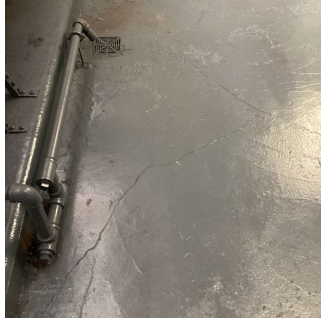
Violations	Boiler Room No violations recorded.
Deficiency	CONCRETE: CRACKS/SPALLED/REINFORCEMENT EXPOSED
Deficiency Location/Instance	2nd Floor - Auditorium Mechanical Equipment Room
Deficiency Quantity	50
Quantity Uom	S.F.
Potential Action	REPAIR
Urgency of Action	PRIORITY 3
Purpose of Action	LEVEL 5
Deficiency Photo1

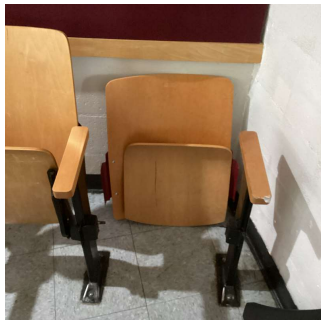
Question	Response
<b>INTERIOR</b>	
<b>AUDITORIUM</b>	
<b>Fixed Seating</b>	
Deficiency	DAMAGED/BROKEN/INOPERABLE
Deficiency Location/Instance	Seat M/19
Deficiency Quantity	1
Quantity Uom	EACH
Potential Action	REPLACE
Urgency of Action	PRIORITY 5
Purpose of Action	LEVEL 6
Deficiency Photo1

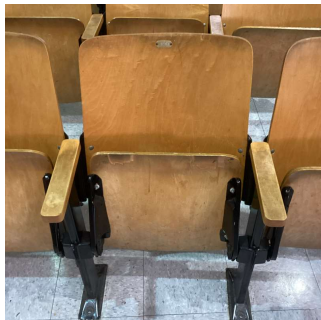
Violations	Seat M/19 No violations recorded.
Deficiency	DAMAGED/BROKEN/INOPERABLE
Deficiency Location/Instance	Seats A/107, 109, B/103, 105, C/102 and others
Deficiency Quantity	15
Quantity Uom	EACH
Potential Action	REPLACE
Urgency of Action	PRIORITY 3
Purpose of Action	LEVEL 2
Deficiency Photo1

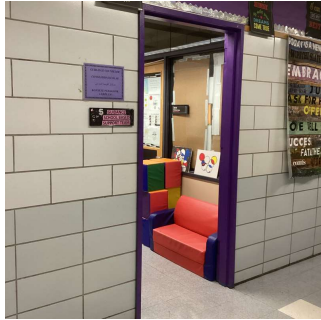
Corridor near Room 306
Violations	No violations recorded.
<b>Door(s)</b>	
Inspected	Inspected
Condition	4 - Between Fair and Poor
Deficiency	METAL: MISSING DOOR
Deficiency Location/Instance	Room 215
Deficiency Quantity	1
Quantity Uom	EACH
Potential Action	MAINTENANCE
Urgency of Action	PRIORITY 3
Purpose of Action	LEVEL 2
Deficiency Photo1

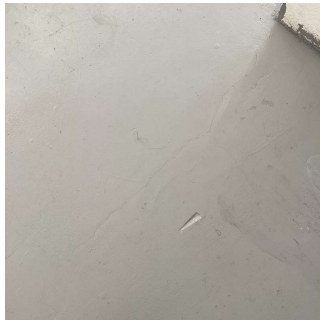
Violations	Stair C/2 No violations recorded.
Deficiency	CONCRETE: CRACKS/SPALLING - MAJOR
Deficiency Location/Instance	Stair C/Bulkhead
Deficiency Quantity	25
Quantity Uom	S.F.
Potential Action	REPLACE
Urgency of Action	PRIORITY 3
Purpose of Action	LEVEL 2
Deficiency Photo1
