**NYC Department of Education**  
**Building Condition Assessment Survey 2023 - 2024**

Architectural Inspection

**Asset:**        **P.S. 13 - BROOKLYN, 557 PENNSYLVANIA AVENUE, New York, 11207**

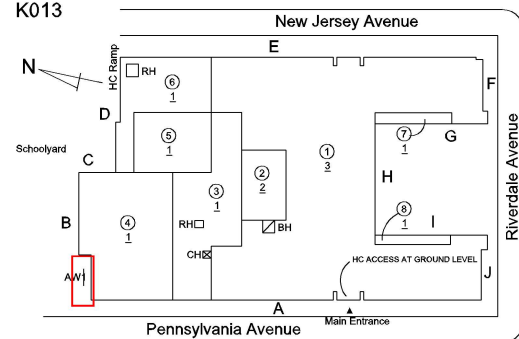
AREAWAY GRATINGS: MAJOR RUSTING AND / OR BROKEN SUPPORTS

REPLACE

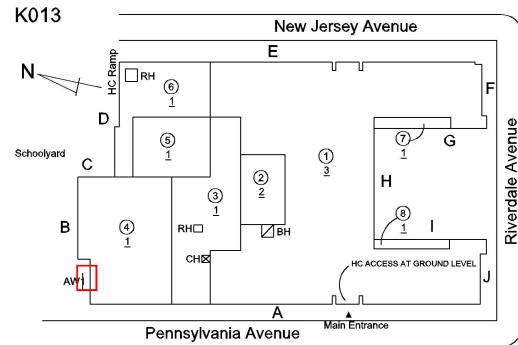
AREAWAY WALLS: CRACKS AND SPALLING

REPLACE

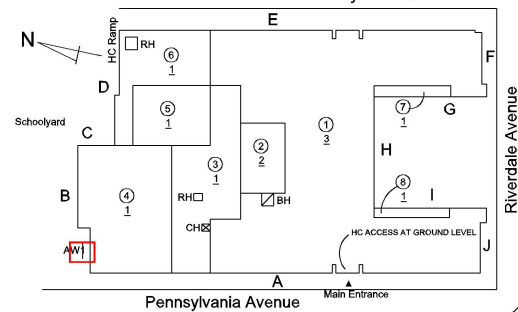
AREAWAY LADDER: DETERIORATED

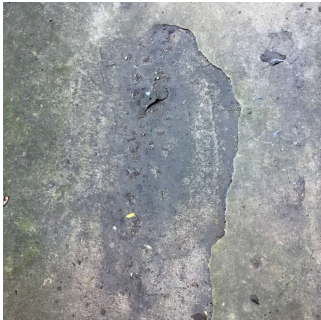
AW1
Violations	No violations recorded.
Deficiency	<b>AREAWAY SLAB: CRACKS AND SPALLING</b>
Roof Plan reference	<b>K013</b>

Deficiency Quantity	20
Quantity Uom	S.F.
Potential Action	REPLACE
Urgency of Action	PRIORITY 4
Purpose of Action	LEVEL 2
Deficiency Photo1

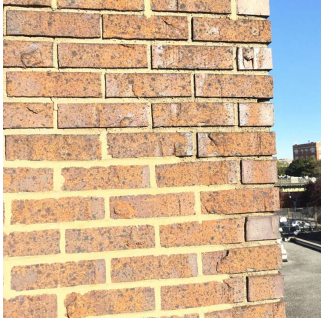
AW1
Violations	No violations recorded.
<b>AWNINGS AND CANOPIES</b>	Does not Exist
<b>CHIMNEY</b>	Inspected
Material Type(s)	Masonry
Condition	3 - Fair
Deficiency	BRICK: DETERIORATED JOINTS

Violations	Chimney No violations recorded.
<b>COPING</b>	Inspected
Condition	3 - Fair
Deficiency	CAST STONE: DETERIORATED TRANSVERSE JOINTS
Roof Plan reference	K013

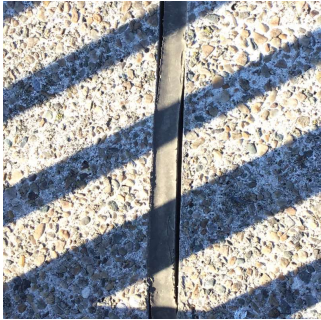
Deficiency Quantity	160
Quantity Uom	L.F.
Potential Action	MAINTENANCE
Urgency of Action	PRIORITY 3
Purpose of Action	LEVEL 2
Deficiency Photo1

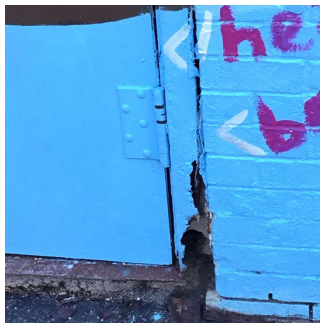
METAL: DETERIORATED DOOR AND FRAME - MAJOR DETERIORATION

Violations	Facade C No violations recorded.
Deficiency	ROLL-UP DOOR: DETERIORATED DOOR AND FRAME - MAJOR DETERIORATION
Roof Plan reference	K013

REPLACE

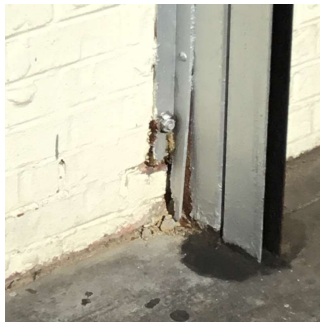
Deficiency Quantity	300
Quantity Uom	S.F.
Potential Action	REPLACE
Urgency of Action	PRIORITY 4
Purpose of Action	LEVEL 2
Deficiency Photo1

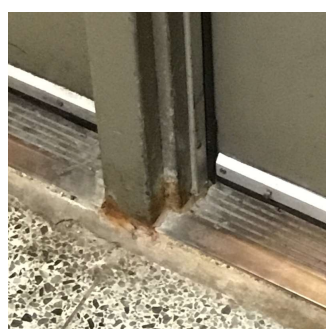
Violations	Facade A No violations recorded.
Deficiency	METAL: DETERIORATED DOOR AND FRAME - MINOR DETERIORATION

Deficiency Quantity	2
Quantity Uom	EACH
Potential Action	MAINTENANCE
Urgency of Action	PRIORITY 3
Purpose of Action	LEVEL 2
Deficiency Photo1

Violations	<p>Facade B</p> <p>No violations recorded.</p>
<b>DOOR HARDWARE</b>	Inspected
Condition	3 - Fair
Deficiency	No deficiencies recorded
<b>LINTELS</b>	Inspected
Condition	2 - Between Good and Fair
Deficiency	No deficiencies recorded
<b>TRANSOM/SIDE LIGHT</b>	Inspected
Condition	2 - Between Good and Fair
Deficiency	No deficiencies recorded
<b>EXTERIOR WALLS</b>	Inspected
Material Type(s)	Concrete, Masonry
Replacement Quantity	24,000
Replacement Uom	S.F.
Instance on All Facades	Inspected
Instance Condition	4 - Between Fair and Poor
Instance Quantity	24,000
Instance Quantity Uom	S.F.
Deficiency	BRICK: DETERIORATED JOINTS

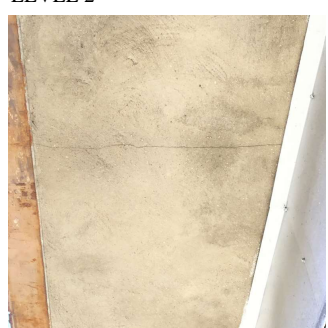
Question	Response
<b>EXTERIOR</b>	
<b>EXTERIOR WALLS</b>	Inspected
Violations	No violations recorded.
<b>EXTERIOR SOFFITS</b>	Inspected
Condition	2 - Between Good and Fair
Deficiency	CONCRETE: MINOR CRACKS/SPALLING
Roof Plan reference	K013

Deficiency Quantity	25
Quantity Uom	S.F.
Potential Action	REPAIR
Urgency of Action	PRIORITY 3
Purpose of Action	LEVEL 2
Deficiency Photo1

Facade A
Violations	No violations recorded.
<b>LOADING DOCK</b>	Does not Exist
<b>LOUVER</b>	Inspected
Condition	3 - Fair
Deficiency	BROKEN/ DENTED BLADES

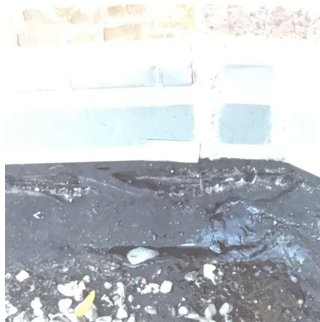
Question	Response
<b>EXTERIOR</b>	
<b>ROOF</b>	
<b>Roofing</b>	
<b>ROOFING</b>	
Instance Photo	 
	Roof 1
Instance Quantity	54,000
Instance Quantity Uom	S.F.
Does the roof have major mechanical equipment sitting on Dunnage Steel less than 18" above the Roofing?	No
Does this roof instance have a Sustainable Roof System?	No
Do solar panels exist on these roofs?	No
Is/Are the roof(s) suitable for Solar Panel installation?	Yes
Installation Year	1974
Source of Installation	Custodial Staff
Deficiency	BUILT-UP: FLASHING: BASE FLASHING DETERIORATED
Roof Plan reference	K013

Deficiency Quantity	10
Quantity Uom	S.F.
Potential Action	REMOVE AND REPLACE
Urgency of Action	PRIORITY 4
Purpose of Action	LEVEL 2
Deficiency Photo1

Roof 1
Violations	No violations recorded.
Deficiency	BUILT-UP: ROOFING: MAJOR ACTIVE ROOF LEAKS IN INSTRUCTIONAL SPACE

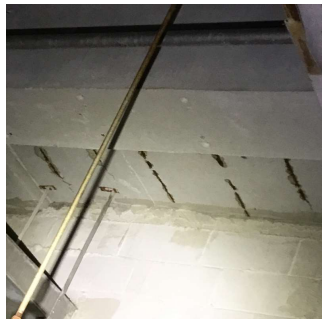
Question	Response
<b>EXTERIOR</b>	
<b>WINDOWS</b>	
<b>LINTELS</b>	Inspected
Condition	2 - Between Good and Fair
Deficiency	No deficiencies recorded
<b>WINDOWS</b>	Inspected
Material Type(s)	Aluminum
Instance on Aluminum - Other: All Facades	Inspected
Instance Condition	2 - Between Good and Fair
Instance Quantity	9,000
Instance Quantity Uom	S.F.
Are these windows insulated	Yes
Installation Year	2010
Source of Installation	Custodial Staff
Deficiency	No deficiencies recorded
<b>INTERIOR</b>	Inspected
<b>POOLS</b>	Does not Exist
<b>STRUCTURAL</b>	Inspected
<b>COLUMNS/BEAMS/BEARING WALLS</b>	Inspected
Condition	2 - Between Good and Fair
Deficiency	No deficiencies recorded
<b>FLOOR STRUCTURE</b>	Inspected
Condition	3 - Fair
Deficiency	CONCRETE: CRACKS/SPALLED/REINFORCEMENT EXPOSED
Deficiency Location/Instance	Basement
Deficiency Quantity	35
Quantity Uom	S.F.
Potential Action	REPAIR
Urgency of Action	PRIORITY 4
Purpose of Action	LEVEL 5

Violations	Room C24A No violations recorded.
Deficiency	CONCRETE SLAB ON GRADE: THRU CRACKS
Deficiency Location/Instance	Basement
Deficiency Quantity	250
Quantity Uom	S.F.
Potential Action	REPAIR
Urgency of Action	PRIORITY 3
Purpose of Action	LEVEL 5

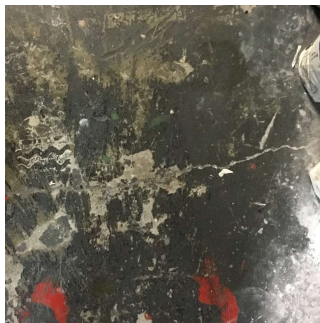
Violations	Room C19 (Boiler Room, Electrical Panel Room, Rooms C1, C5, C14, C24 similar) No violations recorded.
Deficiency	CONCRETE: CRACKS/SPALLED/REINFORCEMENT EXPOSED
Deficiency Location/Instance	3rd Floor
Deficiency Quantity	20
Quantity Uom	S.F.
Potential Action	REPAIR
Urgency of Action	PRIORITY 3
Purpose of Action	LEVEL 5
Deficiency Photo1

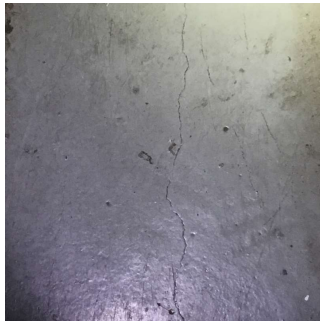
Violations	Room 360 No violations recorded.
<b>FOUNDATION WALLS</b>	Inspected
Material Type(s)	Concrete
Condition	4 - Between Fair and Poor
Deficiency	CONCRETE: WATER INFILTRATION IN NON- INSTRUCTIONAL SPACE
Deficiency Location/Instance	Basement
Deficiency Quantity	100
Quantity Uom	S.F.
Potential Action	INSTALL WATERPROOFING
Urgency of Action	PRIORITY 5
Purpose of Action	LEVEL 5

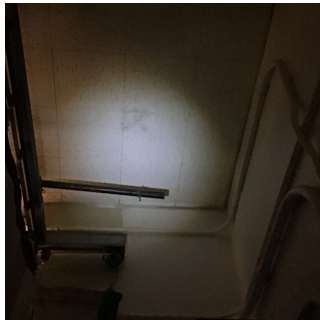
Question	Response
<b>INTERIOR</b>	
<b>STRUCTURAL</b>	
<b>FOUNDATION WALLS</b>	
Deficiency Photo1	 
Violations	Room C14 No violations recorded.
<b>ROOF STRUCTURE</b>	Inspected
Condition	2 - Between Good and Fair
Deficiency	No deficiencies recorded
<b>VAULTS-BUNKERS</b>	Does not Exist
<b>AUDITORIUM</b>	Inspected
Instance on 1st Floor (259 seats)	Inspected
<b>Ceiling</b>	
Instance on 1st Floor (259 seats)	Inspected
Condition	2 - Between Good and Fair
Deficiency	ACOUSTIC TILES ON PLASTER: DAMAGED/MISSING
Deficiency Location/Instance	Stage
Deficiency Quantity	10
Quantity Uom	S.F.
Potential Action	REPLACE
Urgency of Action	PRIORITY 3
Purpose of Action	LEVEL 2
Deficiency Photo1

Violations	Stage No violations recorded.
Deficiency	METAL PAN: DAMAGED/MISSING
Deficiency Location/Instance	Near exit 5
Deficiency Quantity	40
Quantity Uom	S.F.
Potential Action	REPLACE
Urgency of Action	PRIORITY 3
Purpose of Action	LEVEL 2

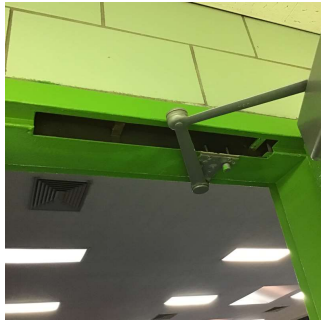
Violations	Near exit 5 No violations recorded.
<b>Door(s)</b>	
Instance on 1st Floor (259 seats)	Inspected
Condition	3 - Fair
Deficiency	METAL: DETERIORATED DOOR AND FRAME
Deficiency Location/Instance	Entrance
Deficiency Quantity	1
Quantity Uom	EACH
Potential Action	MAINTENANCE
Urgency of Action	PRIORITY 3
Purpose of Action	LEVEL 2
Deficiency Photo1

Violations	Entrance No violations recorded.
<b>Fixed H/C Lift</b>	
Instance on 1st Floor (259 seats)	Does not Exist
<b>Fixed Seating</b>	
Instance on 1st Floor (259 seats)	Inspected
Condition	2 - Between Good and Fair
Deficiency	No deficiencies recorded
<b>Floor Finish</b>	
Instance on 1st Floor (259 seats)	Inspected
Condition	2 - Between Good and Fair
Deficiency	VINYL TILES: DETERIORATED SUBSTRATE
Deficiency Location/Instance	Near Entrance, exit, stage, center
Deficiency Quantity	100

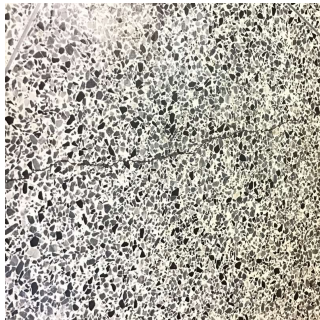
Violations	Exit 5 Vestibule No violations recorded.
Deficiency	VINYL TILES: BROKEN/DETERIORATED/MISSING TILES
Deficiency Location/Instance	Near Windows
Deficiency Quantity	10
Quantity Uom	S.F.
Potential Action	REPLACE
Urgency of Action	PRIORITY 3
Purpose of Action	LEVEL 2
Deficiency Photo1

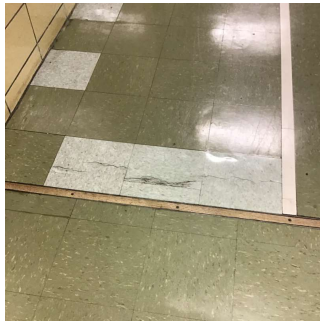
Violations	Corridor near Room 119 No violations recorded.
Deficiency	VINYL TILES: BROKEN/DETERIORATED/MISSING TILES
Deficiency Location/Instance	Rooms 352, 261, 228, 229, 226, and others
Deficiency Quantity	60
Quantity Uom	S.F.
Potential Action	REPLACE
Urgency of Action	PRIORITY 3
Purpose of Action	LEVEL 2
Deficiency Photo1

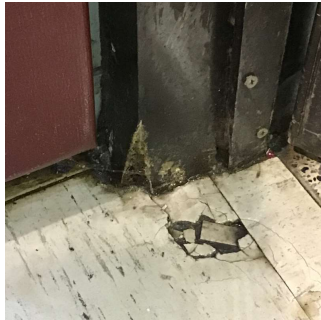
Violations	Near exit 6 No violations recorded.
<b>Fixed Equipment</b>	
Instance on 1st Floor	Inspected
Condition	2 - Between Good and Fair
Deficiency	No deficiencies recorded
<b>Floor Finish</b>	
Instance on 1st Floor	Inspected
Condition	2 - Between Good and Fair
Deficiency	VINYL TILES: BROKEN/DETERIORATED/MISSING TILES
Deficiency Location/Instance	Near Entrance, Near center
Deficiency Quantity	10
Quantity Uom	S.F.
Potential Action	REPLACE
Urgency of Action	PRIORITY 3
Purpose of Action	LEVEL 2
Deficiency Photo1

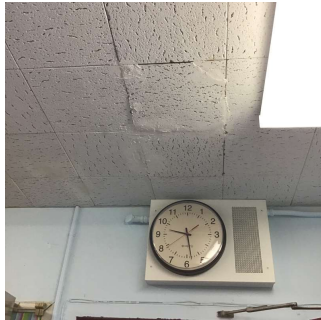
Violations	No violations recorded.
Deficiency	METAL PAN: DAMAGED/MISSING
Deficiency Location/Instance	Near Windows, center
Deficiency Quantity	20
Quantity Uom	S.F.
Potential Action	REPLACE
Urgency of Action	PRIORITY 3
Purpose of Action	LEVEL 2
Deficiency Photo1

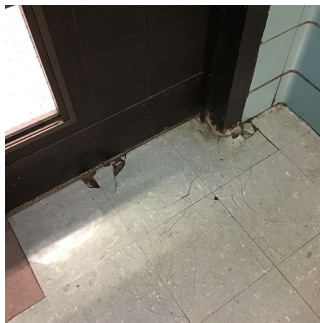
Violations	Stair D/1 No violations recorded.
Deficiency	STONE: BROKEN/MISSING
Deficiency Location/Instance	Stair 1/3, B/2,1, D/3,2, and others
Deficiency Quantity	50
Quantity Uom	S.F.
Potential Action	REPLACE
Urgency of Action	PRIORITY 3
Purpose of Action	LEVEL 2
Deficiency Photo1

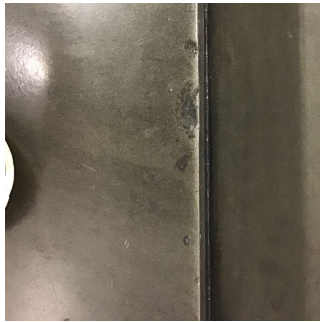
Violations	Stair 1/3 No violations recorded.
<b>Walls</b>	<b>Inspected</b>
Condition	2 - Between Good and Fair
Deficiency	GLAZED BLOCK: CRACKS/SPALLING
Deficiency Location/Instance	Stair 1/3, 1/1, B/3,2, D/2, and others
Deficiency Quantity	40
Quantity Uom	S.F.
Potential Action	REPLACE
Urgency of Action	PRIORITY 3
Purpose of Action	LEVEL 2
Deficiency Photo1

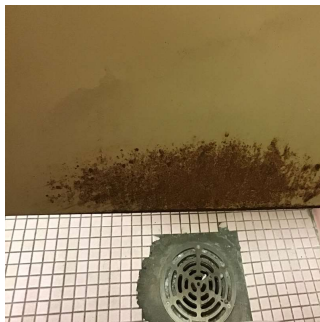
Violations	Kitchen Staff Toilet No violations recorded.
<b>Walls</b>	Inspected
Condition	2 - Between Good and Fair
Deficiency	CERAMIC TILE: BROKEN/ MISSING
Deficiency Location/Instance	Kitchen Staff Toilet
Deficiency Quantity	10
Quantity Uom	S.F.
Potential Action	REPLACE
Urgency of Action	PRIORITY 3
Purpose of Action	LEVEL 2
Deficiency Photo1

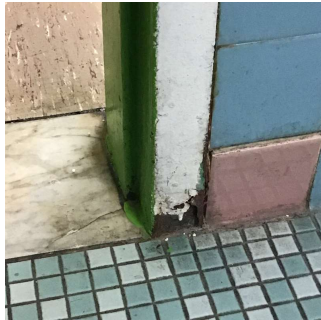
Room 237
Violations	No violations recorded.
<b>Floor Finish</b>	Inspected
Condition	2 - Between Good and Fair
Deficiency	CERAMIC TILE: BROKEN/MISSING TILES
Deficiency Location/Instance	Room 353, 347, 337, 317, 233, and others
Deficiency Quantity	80
Quantity Uom	S.F.
Potential Action	REPLACE
Urgency of Action	PRIORITY 3
Purpose of Action	LEVEL 2

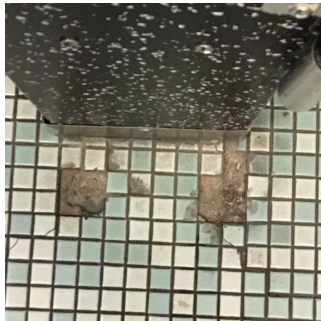
Violations	<p>Room 337</p> <p>No violations recorded.</p>
<b>Stalls</b>	Inspected
Condition	3 - Fair
Deficiency	RUST - MAJOR
Deficiency Location/Instance	Room 317, 217, 113, 114
Deficiency Quantity	6
Quantity Uom	EACH
Potential Action	REPLACE
Urgency of Action	PRIORITY 3
Purpose of Action	LEVEL 2
Deficiency Photo1

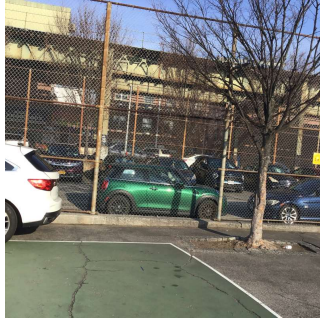
Violations	Schoolyard No violations recorded.
Deficiency	CONCRETE CURB: DAMAGED/DETERIORATED
Deficiency Location/Instance	Schoolyard
Deficiency Quantity	30
Quantity Uom	S.F.
Potential Action	REPLACE
Urgency of Action	PRIORITY 3
Purpose of Action	LEVEL 2
Deficiency Photo1

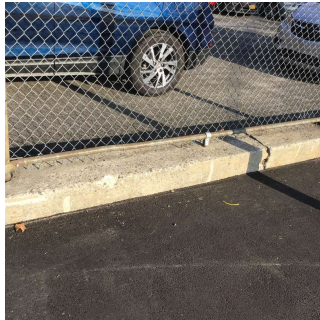
Violations	Schoolyard No violations recorded.
Deficiency	CHAIN LINK: DAMAGED/DETERIORATED
Deficiency Location/Instance	Schoolyard
Deficiency Quantity	10
Quantity Uom	S.F.
Potential Action	REPLACE
Urgency of Action	PRIORITY 5
Purpose of Action	LEVEL 6
Deficiency Photo1

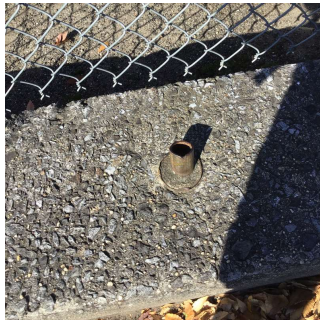
Violations	Schoolyard No violations recorded.
Deficiency	CONCRETE CURB: DAMAGED/DETERIORATED

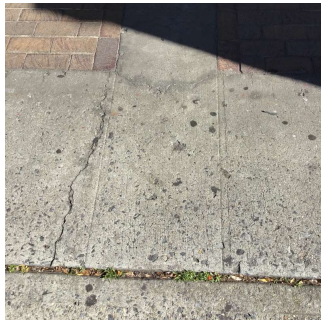
Violations	Along Pennsylvania Avenue No violations recorded.
<b>Pavers</b>	Inspected
Condition	2 - Between Good and Fair
Deficiency	DAMAGED/MISSING
Deficiency Location/Instance	Along Pennsylvania Avenue
Deficiency Quantity	10
Quantity Uom	S.F.
Potential Action	REPLACE
Urgency of Action	PRIORITY 3
Purpose of Action	LEVEL 2
