NYC Department of Education
Building Condition Assessment Survey 2023 - 2024

Architectural Inspection

Asset: I.S. 14 - BROOKLYN, 2424 BATCHELDER STREET, New York, 11235

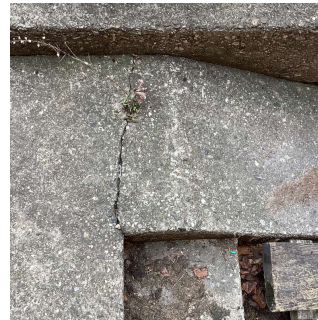
AW4

Question	Response
Architectural	
EXTERIOR	Inspected
AREAWAY	Inspected
Instance on AW1-AW6	Inspected
Instance Condition	4 - Between Fair and Poor
Instance Quantity	6
Instance Quantity Uom	EACH
Deficiency	AREAWAY STAIRS: DETERIORATED MATERIAL SLIDE

REPLACE

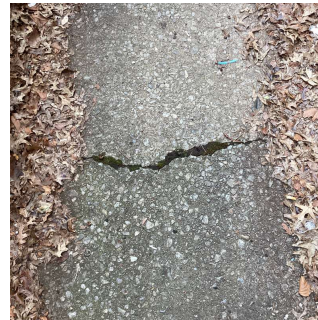
AW1

AREAWAY SLAB: CRACKS AND SPALLING

REPLACE

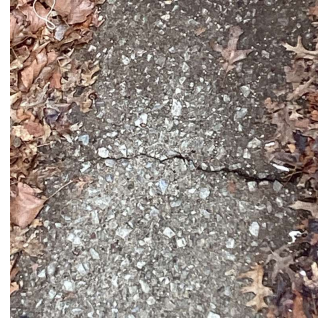
AW1

AREAWAY SLAB: CRACKS AND SPALLING

REPAIR

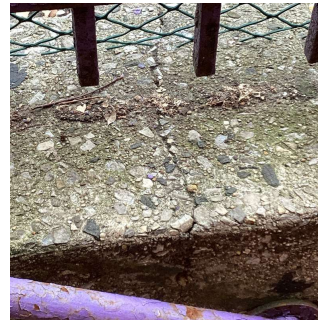
AW6
No violations recorded.

AREAWAY WALLS: CRACKS AND SPALLING

20
S.F.
REPAIR
PRIORITY 3
LEVEL 2

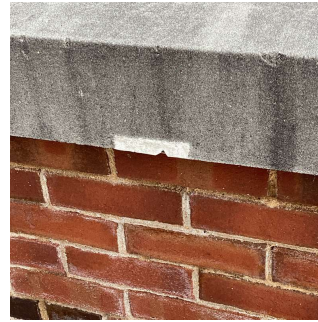
Roof 2

CAST STONE: CRACKED/BROKEN PIECES

10
L.F.
REPLACE-IN-KIND
PRIORITY 4
LEVEL 2

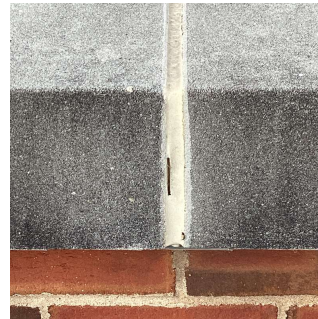
Roof 4

CAST STONE: DETERIORATED TRANSVERSE JOINTS

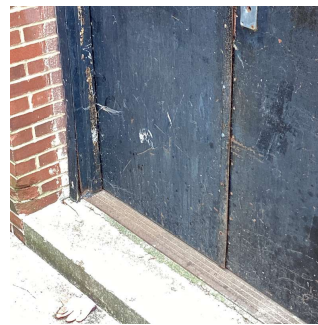
AW4
No violations recorded.

METAL: DETERIORATED DOOR AND FRAME - MAJOR DETERIORATION

2
EACH
REPLACE
PRIORITY 4
LEVEL 2

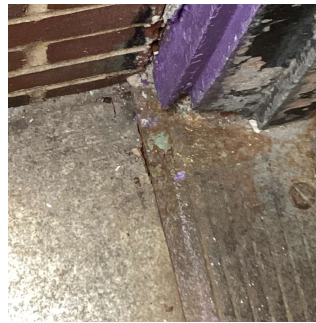
Facade A

METAL CLAD: DETERIORATED DOOR AND FRAME - MAJOR DETERIORATION

12
EACH
REPLACE
PRIORITY 4
LEVEL 2

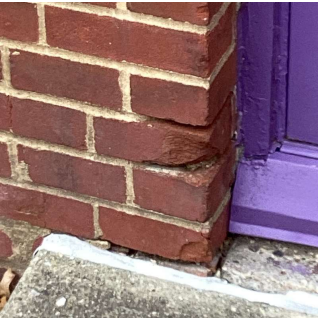
Question	Response
EXTERIOR	
EXTERIOR WALLS	
Material Type(s)	Masonry
Replacement Quantity	51,000
Replacement Uom	S.F.
Instance on All Facades	Inspected
Instance Condition	3 - Fair
Instance Quantity	51,000
Instance Quantity Uom	S.F.
Deficiency	BRICK: DETERIORATED JOINTS
Roof Plan reference	K014

Deficiency Quantity	10
Quantity Uom	S.F.
Potential Action	REPOINT
Urgency of Action	PRIORITY 4
Purpose of Action	LEVEL 2
Deficiency Photo1

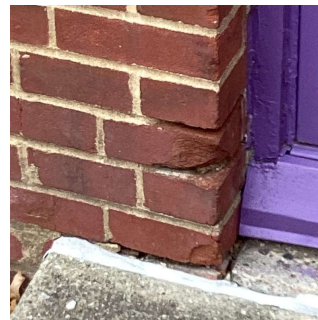
Violations	Facade E No violations recorded.
Deficiency	BRICK: MAJOR / THRU CRACKS

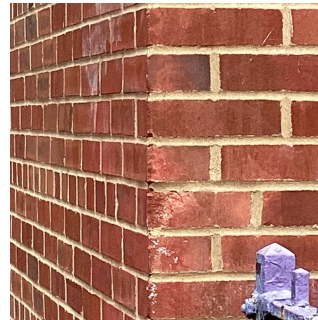
Facade B

BRICK: MINOR CRACKS AND SPALLING

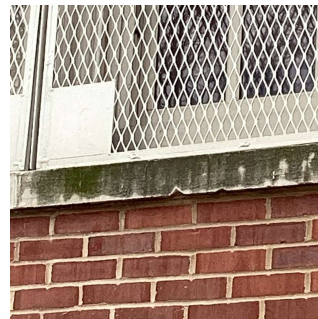
Facade A

BRICK: DETERIORATED MASONRY SILLS - MINOR

REPAIR

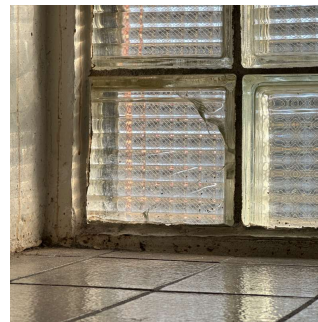
Facade A

GLASS BLOCK: CHIPPED/ BROKEN PIECES

REPLACE-IN-KIND

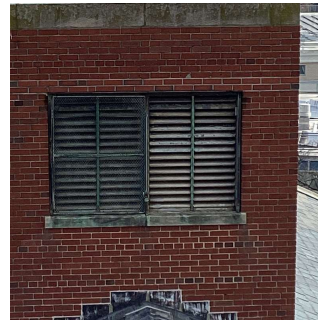
Roof 5

MISSING/DAMAGED SCREEN

REPLACE

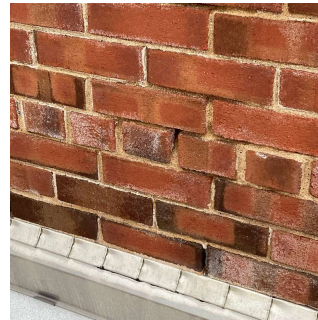
Roof 2

BRICK: DETERIORATED JOINTS

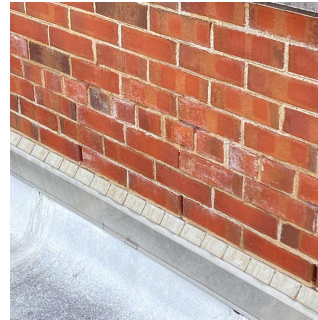
Roof 4

BRICK: DETERIORATED JOINTS

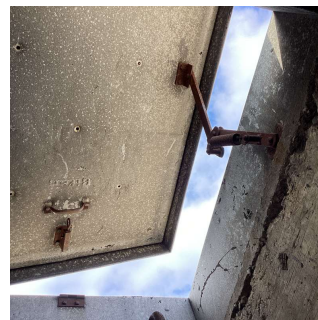
Tower
 No violations recorded.

DETERIORATED

1
 EACH
 REPLACE
 PRIORITY 4
 LEVEL 2

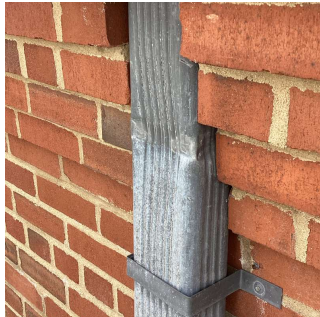
DAMAGED/MISSING

30
 L.F.
 REPLACE
 PRIORITY 4
 LEVEL 2

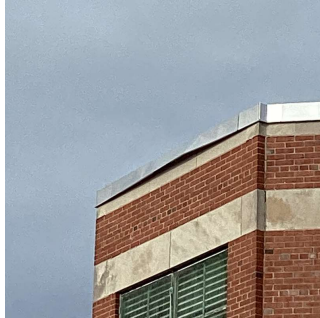
Roof 5
Violations	No violations recorded.
Instance on Built-Up: Roof 8	Inspected
Instance Condition	5 - Poor
Instance Photo	 
	Roof 8
Instance Quantity	200
Instance Quantity Uom	S.F.
Does the roof have major mechanical equipment sitting on Dunnage Steel less than 18" above the Roofing?	No
Does this roof instance have a Sustainable Roof System?	No
Do solar panels exist on these roofs?	No
Is/Are the roof(s) suitable for Solar Panel installation?	No
Installation Year	2013
Source of Installation	Custodial Staff
Deficiency	BUILT-UP: FLASHING: DRIP EDGE/GRAVEL STOP DAMAGED
Roof Plan reference	K014

Deficiency Quantity	10
Quantity Uom	L.F.
Potential Action	REPLACE
Urgency of Action	PRIORITY 4

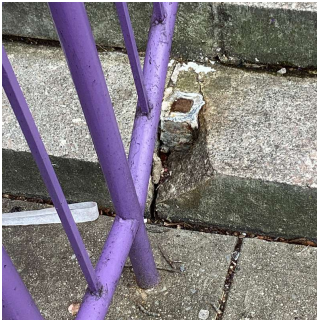
Violations	Facade G No violations recorded.
RAILINGS	Inspected
Condition	2 - Between Good and Fair
Deficiency	No deficiencies recorded
STAIRS/RAMPS	Inspected
Condition	5 - Poor
Deficiency	STONE: CRACKS/SPALLING - MAJOR
Roof Plan reference	K014

Deficiency Quantity	20
Quantity Uom	S.F.
Potential Action	REPLACE
Urgency of Action	PRIORITY 4
Purpose of Action	LEVEL 2
Deficiency Photo1

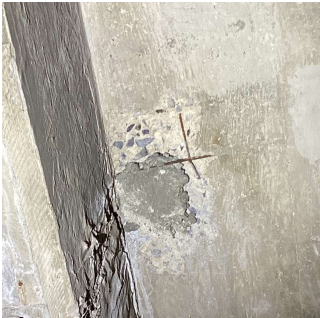
Question	Response
INTERIOR	
STRUCTURAL	
ROOF STRUCTURE	
Deficiency Quantity	20
Quantity Uom	S.F.
Potential Action	REPAIR
Urgency of Action	PRIORITY 4
Purpose of Action	LEVEL 5
Deficiency Photo1

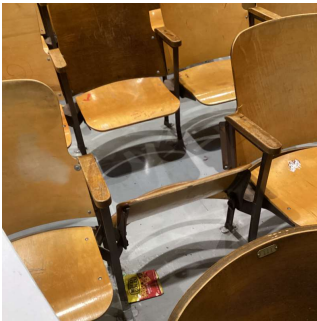
Question	Response
INTERIOR	
AUDITORIUM	
Fixed Seating	
Deficiency Photo1

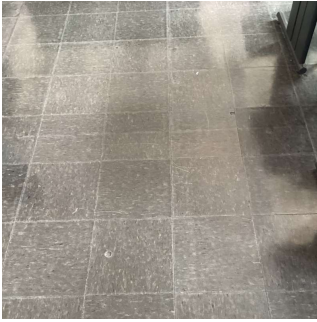
Violations	Corridor near room 332A No violations recorded.
Deficiency	VINYL TILES: BROKEN/DETERIORATED/MISSING TILES
Deficiency Location/Instance	Room 316, 328B,313,226, B28 and others
Deficiency Quantity	2,300
Quantity Uom	S.F.
Potential Action	REPLACE
Urgency of Action	PRIORITY 3
Purpose of Action	LEVEL 2
Deficiency Photo1

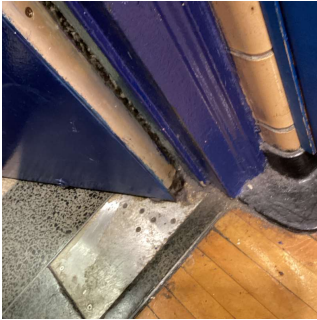
Violations	Center No violations recorded.
Door(s)	
Instance on 1st Floor	Inspected
Condition	5 - Poor
Deficiency	METAL: DETERIORATED DOOR
Deficiency Location/Instance	Entrance (2 Doors)
Deficiency Quantity	2
Quantity Uom	EACH
Potential Action	MAINTENANCE
Urgency of Action	PRIORITY 3
Purpose of Action	LEVEL 2
Deficiency Photo1

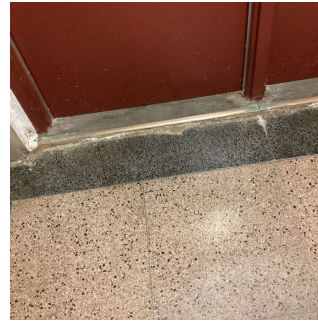
Exit 4

Exit 1/2
Violations	No violations recorded.
Deficiency	
Deficiency	TERRAZZO: CRACKS
Deficiency Location/Instance	Exit/4

Deficiency Quantity	20
Quantity Uom	S.F.
Potential Action	REPLACE
Urgency of Action	PRIORITY 3
Purpose of Action	LEVEL 2
