NYC Department of Education
Building Condition Assessment Survey 2023 - 2024

Architectural Inspection

Asset: **I.S. 62 - BROOKLYN, 700 CORTELYOU ROAD, New York, 11218**

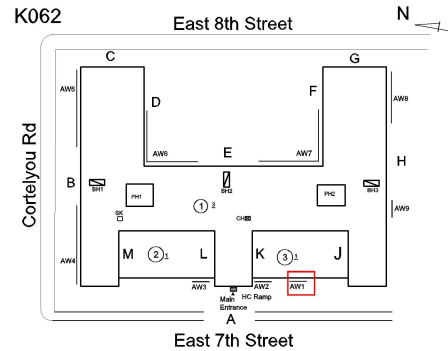
AREAWAY STAIRS: DETERIORATED
TREADS/RISERS/NOSINGS

REPLACE

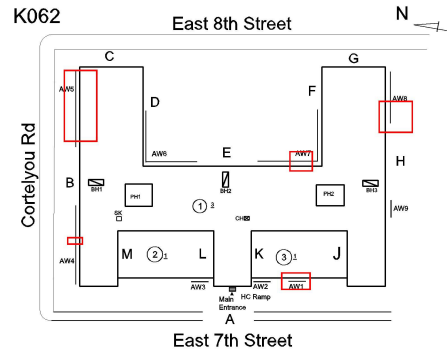
AREAWAY SLAB: CRACKS AND SPALLING

REPLACE

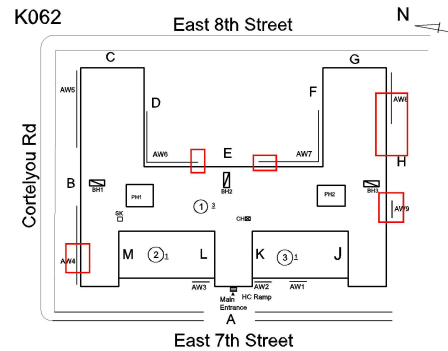
AREAWAY WALLS: DETERIORATED JOINTS

REPAIR

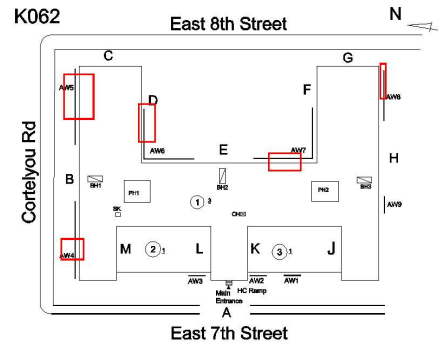
AREAWAY WALLS: CRACKS AND SPALLING

REPLACE

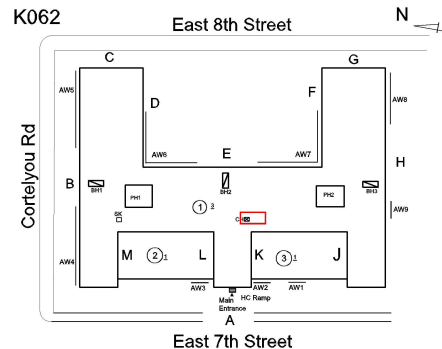
BRICK: DETERIORATED JOINTS

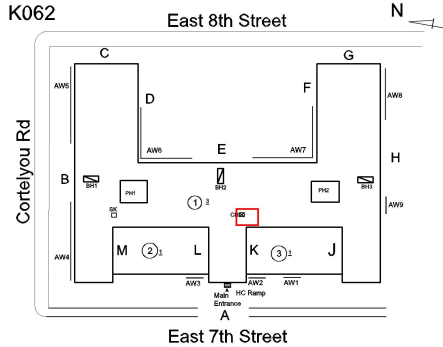
Violations	CH No violations recorded.
Deficiency	BRICK: DETERIORATED JOINTS
Roof Plan reference	K062

Deficiency Quantity	60
Quantity Uom	S.F.
Potential Action	REPOINT
Urgency of Action	PRIORITY 3
Purpose of Action	LEVEL 2
Deficiency Photo1

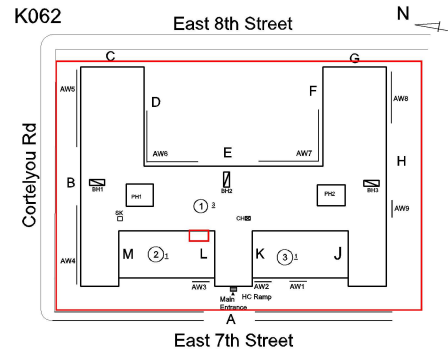
CAST STONE: DETERIORATED TRANSVERSE JOINTS

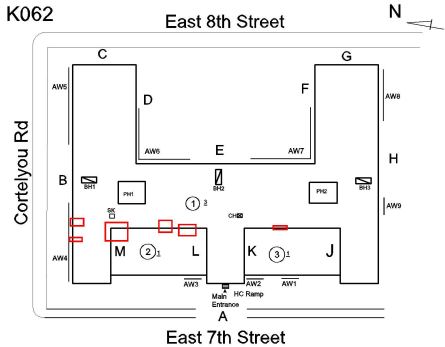
Violations	Roof 1 No violations recorded.
Deficiency	CAST STONE: CRACKED/BROKEN PIECES
Roof Plan reference	K062

Deficiency Quantity	60
Quantity Uom	L.F.
Potential Action	REPLACE-IN-KIND
Urgency of Action	PRIORITY 4
Purpose of Action	LEVEL 2
Deficiency Photo1

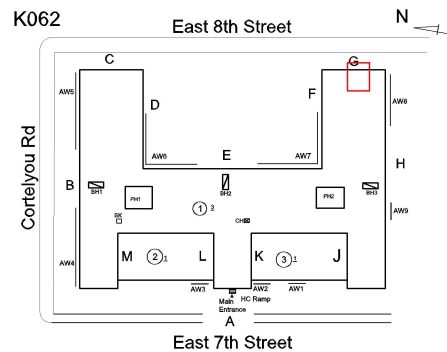
METAL: DETERIORATED DOOR - MAJOR DETERIORATION

REPLACE

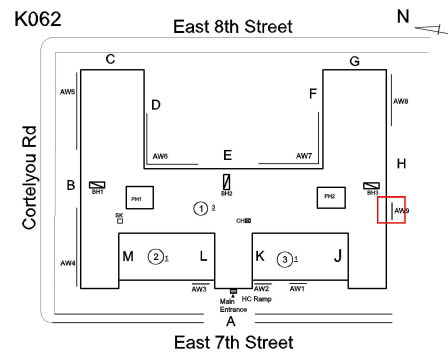
METAL: DETERIORATED DOOR AND FRAME - MAJOR DETERIORATION

REPLACE

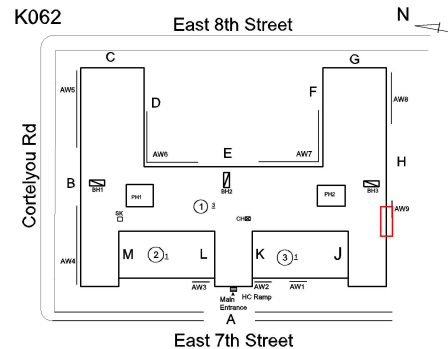
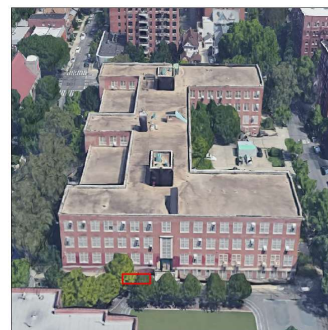
STONE: DETERIORATED JOINTS

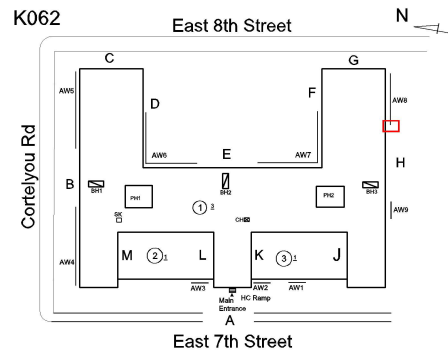
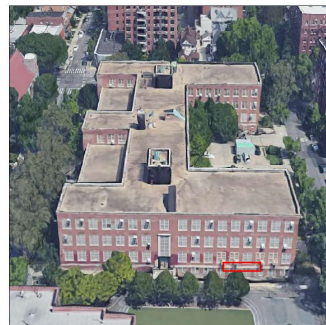
STONE: CHIPPED/SPALLED/BROKEN PIECES - MAJOR

REPLACE

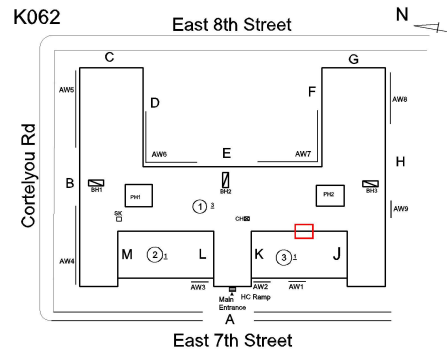
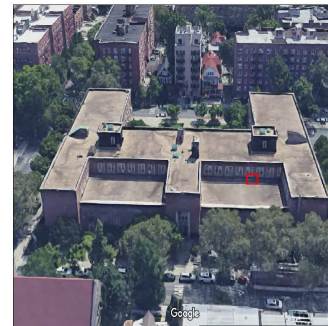
BRICK: MINOR CRACKS AND SPALLING

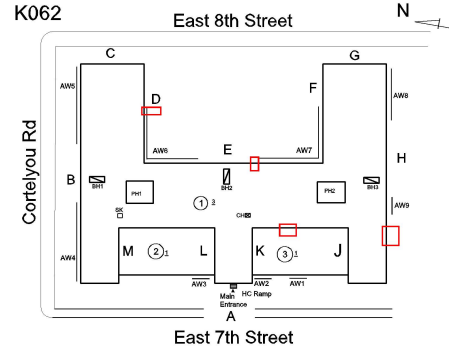
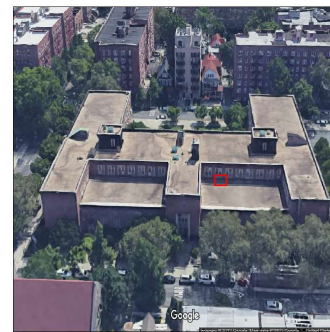
BRICK: DETERIORATED MASONRY SILLS - MAJOR

REMOVE AND REPLACE

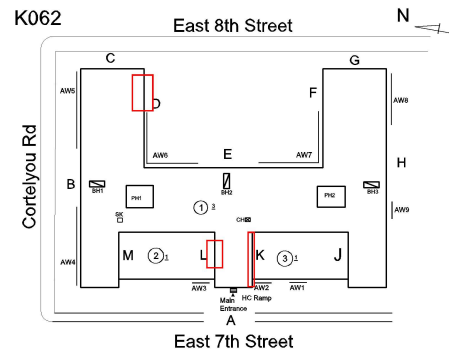
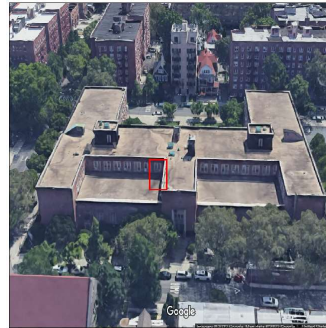
BRICK: EFFLORESCENCE

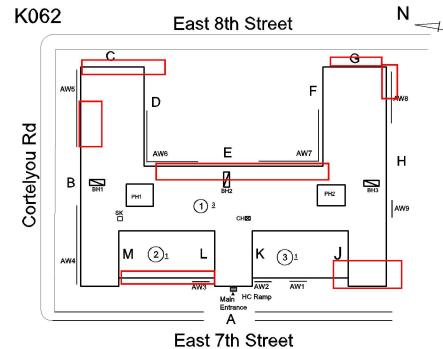
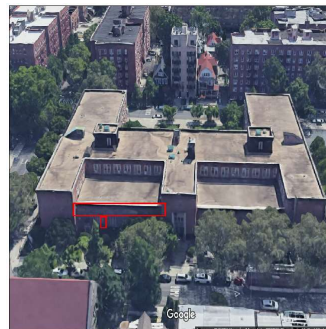
BRICK: DETERIORATED JOINTS

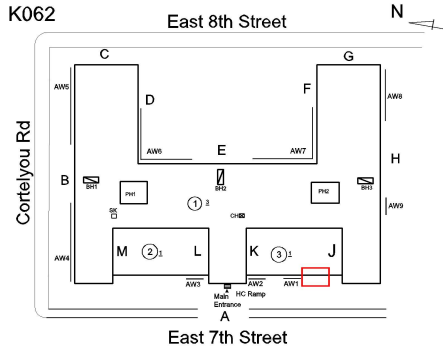
Violations	Roof 1 No violations recorded.
Deficiency	CONCRETE: MAJOR DETERIORATION/CRACKS
Roof Plan reference	<p>K062</p>

Deficiency Quantity	10
Quantity Uom	S.F.
Potential Action	REMOVE AND REBUILD
Urgency of Action	PRIORITY 4
Purpose of Action	LEVEL 2
Deficiency Photo1

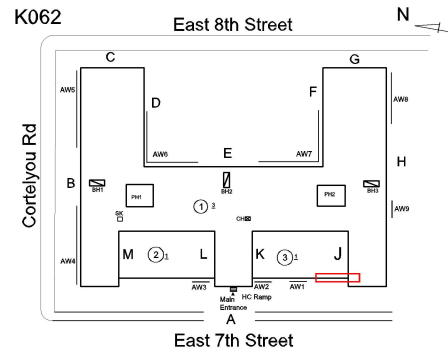
Violations	Roof 3 No violations recorded.
Deficiency	METAL: RAILINGS: RUSTED

REPAIR AND REPAINT

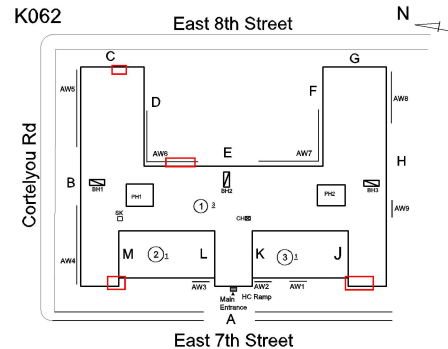
BRICK: MINOR CRACKS, SPALLING

REPAIR

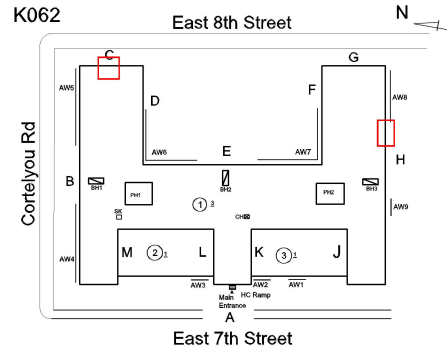
BRICK: MAJOR DETERIORATION/CRACKS

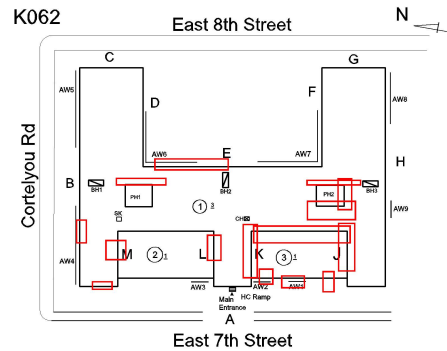
BRICK: DETERIORATED JOINTS

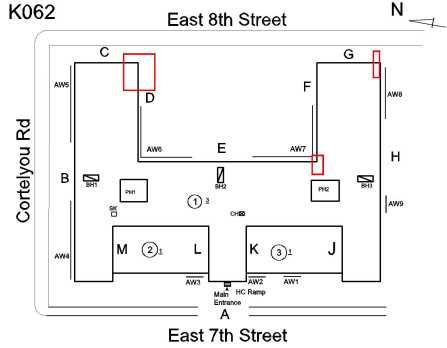
Violations	Roof 1 No violations recorded.
Deficiency	BUILT-UP: FLASHING: CAP FLASHING DAMAGED
Roof Plan reference	<p>K062</p>

Deficiency Quantity	30
Quantity Uom	L.F.
Potential Action	REPLACE
Urgency of Action	PRIORITY 4
Purpose of Action	LEVEL 2
Deficiency Photo1

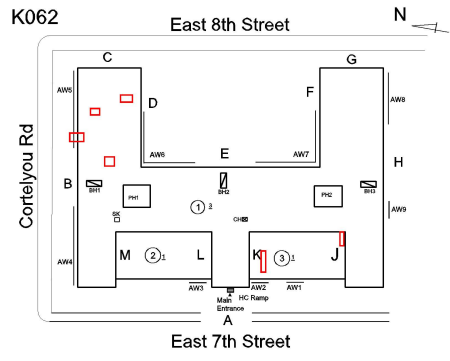
Violations	Roof 1 No violations recorded.
Deficiency	BUILT-UP: ROOFING: LOSS OF GRAVEL

Deficiency Quantity	50
Quantity Uom	S.F.
Potential Action	INSTALL NEW GRAVEL
Urgency of Action	PRIORITY 3
Purpose of Action	LEVEL 2
Deficiency Photo1

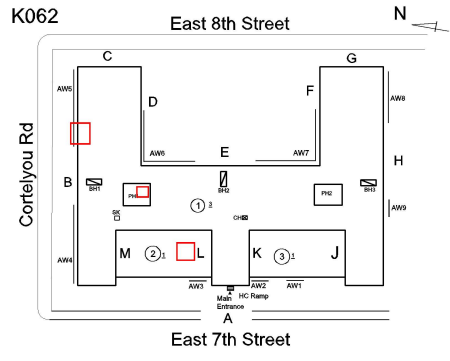
Violations	<p>Roof 1</p> <p>No violations recorded.</p>
ROOFING DRAINS	Inspected
Condition	5 - Poor
Deficiency	DETERIORATED
Roof Plan reference

Deficiency Quantity	3
Quantity Uom	EACH
Potential Action	REPLACE
Urgency of Action	PRIORITY 4
Purpose of Action	LEVEL 2

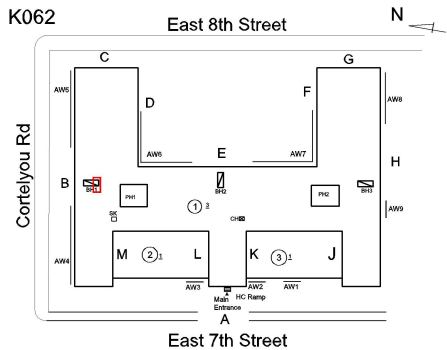
Violations	Roof 1 No violations recorded.
Specialties	Inspected
BULKHEAD/PENTHOUSE	Inspected
Condition	5 - Poor
Deficiency	BULKHEAD/PENTHOUSE DOORS: DETERIORATED DOOR
Roof Plan reference	<p>K062</p>

Deficiency Quantity	1
Quantity Uom	EACH
Potential Action	REPLACE DOOR
Urgency of Action	PRIORITY 4
Purpose of Action	LEVEL 2
Deficiency Photo1

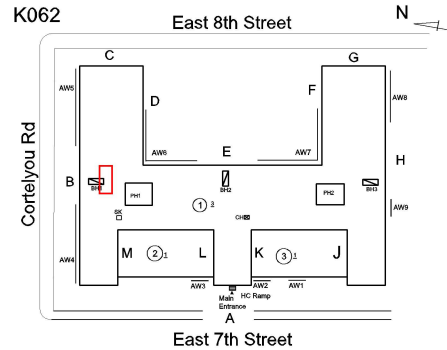
Violations	BH1 No violations recorded.
Deficiency	BULKHEAD/PENTHOUSE ROOF: DETERIORATED

10
S.F.
REPLACE
PRIORITY 4
LEVEL 2

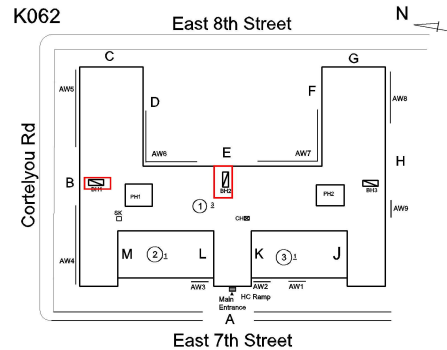
BULKHEAD/PENTHOUSE ROOF: MAJOR LEAKAGE

200
S.F.
REPLACE
PRIORITY 5
LEVEL 2

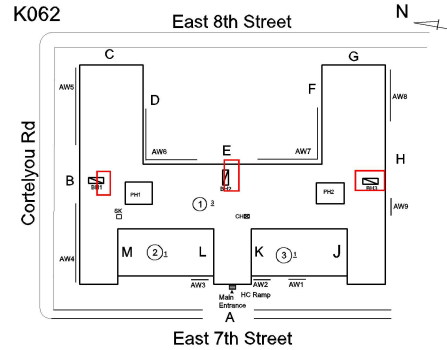
BULKHEAD/PENTHOUSE WALLS/EXTERIOR: DETERIORATED JOINTS

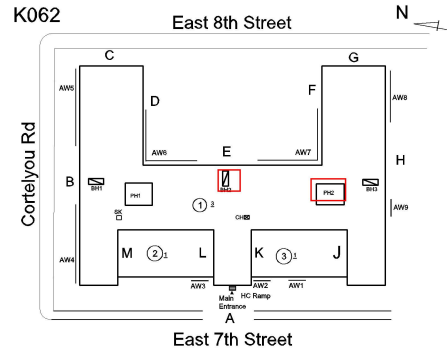
BULKHEAD/PENTHOUSE WALLS/EXTERIOR: DETERIORATED JOINTS

50
S.F.
REPOINT
PRIORITY 3
LEVEL 2

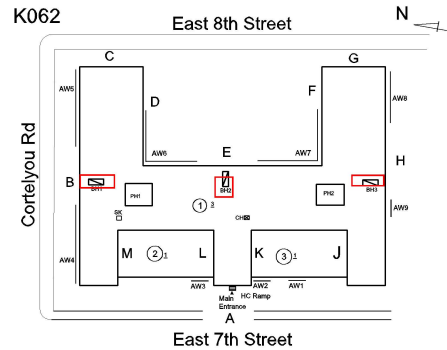
BULKHEAD/PENTHOUSE WINDOWS: AIR/WATER INFILTRATION WITH DAMAGED TRIM OR SILLS

100
L.F.
MAINTENANCE
PRIORITY 3
LEVEL 2

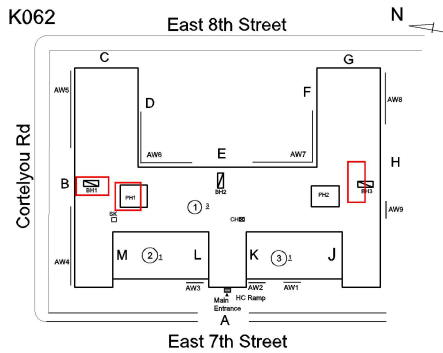
Violations	BH1 No violations recorded.
Deficiency	BULKHEAD/PENTHOUSE WALLS/EXTERIOR: CRACKS/SPALLING - MAJOR
Roof Plan reference	<p>K062</p>

Deficiency Quantity	40
Quantity Uom	S.F.
Potential Action	REPLACE
Urgency of Action	PRIORITY 4
Purpose of Action	LEVEL 2
Deficiency Photo1

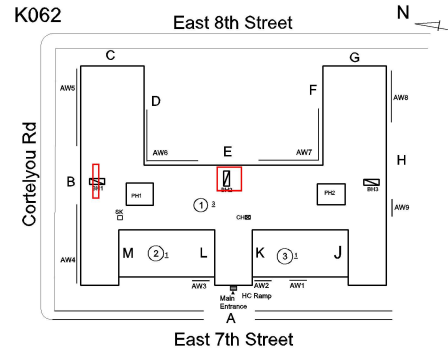
Violations	BH1 No violations recorded.
Deficiency	BULKHEAD/PENTHOUSE CEILING: PLASTER DAMAGED/DETERIORATED

80
S.F.
REPLACE
PRIORITY 3
LEVEL 2

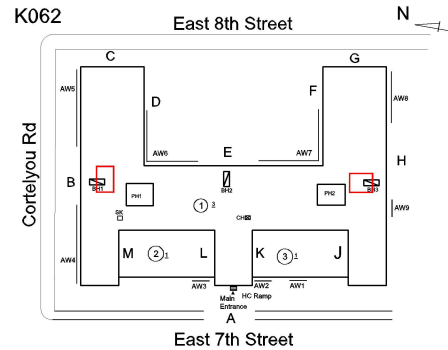
BULKHEAD/PENTHOUSE DOORS: AIR/WATER INFILTRATION WITH DAMAGED CAULKING

20
L.F.
MAINTENANCE
PRIORITY 3
LEVEL 2

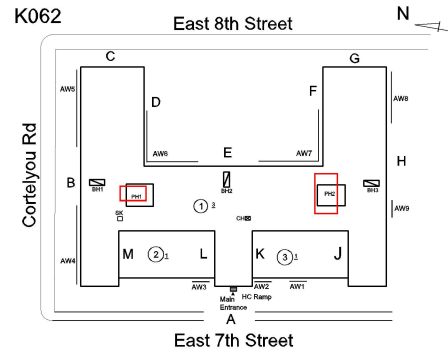
BULKHEAD/PENTHOUSE WALLS/INTERIOR: CMU
 CRACKS/SPALLING

REPLACE

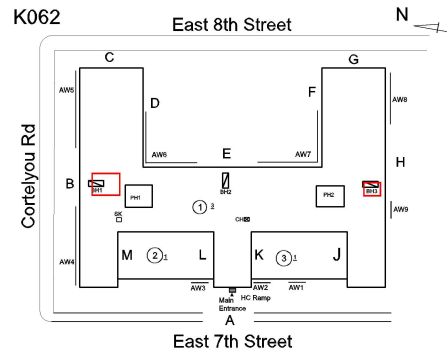
BULKHEAD/PENTHOUSE WALLS/INTERIOR: PLASTER
 CRACKS/SPALLING

100
S.F.
REPLACE
PRIORITY 4
LEVEL 2

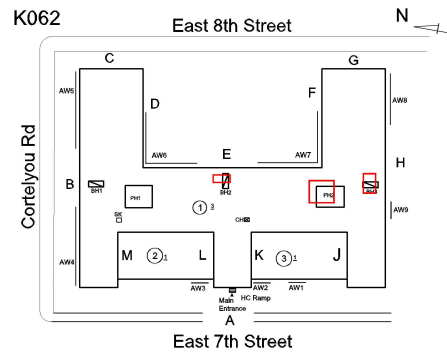
Deficiency	BULKHEAD/PENTHOUSE WALLS/EXTERIOR: CRACKS/SPALLING - MINOR
------------	---

50
S.F.
REPAIR
PRIORITY 3
LEVEL 2

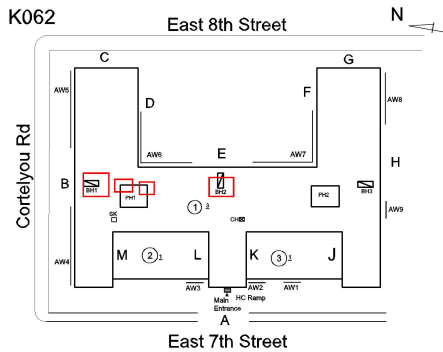
Violations	BH3 No violations recorded.
Deficiency	BULKHEAD/PENTHOUSE WALLS/EXTERIOR: WATER INFILTRATION
Roof Plan reference

Deficiency Quantity	300
Quantity Uom	S.F.
Potential Action	REPAIR
Urgency of Action	PRIORITY 5
Purpose of Action	LEVEL 2
Deficiency Photo1

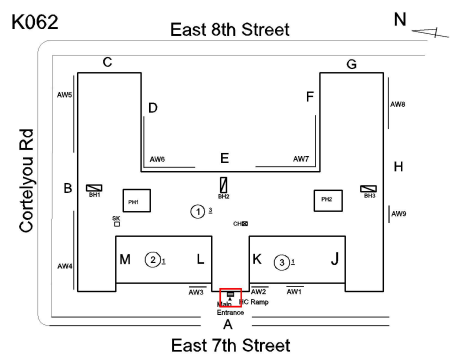
Violations	Roof 1 No violations recorded.
ROOF/GRAVITY TANK	Does not Exist
STAIRS/RAMPS: EXTERIOR	Inspected
BUILDING CHEEK/FLANK WALLS	Inspected
Condition	5 - Poor
Deficiency	STONE: DETERIORATED JOINTS
Roof Plan reference

Deficiency Quantity	20
Quantity Uom	S.F.
Potential Action	REPOINT
Urgency of Action	PRIORITY 3
Purpose of Action	LEVEL 2

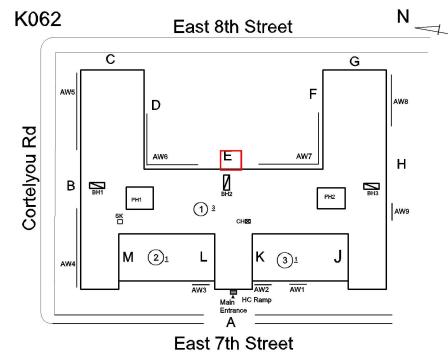
STONE: CRACKS/SPALLING - MINOR

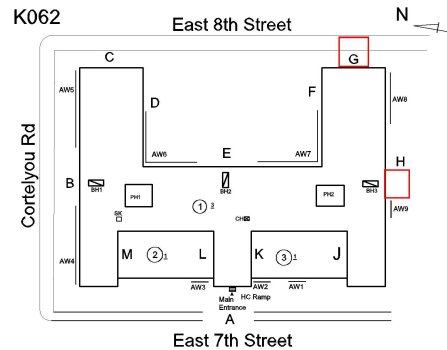
STONE: DETERIORATED JOINTS

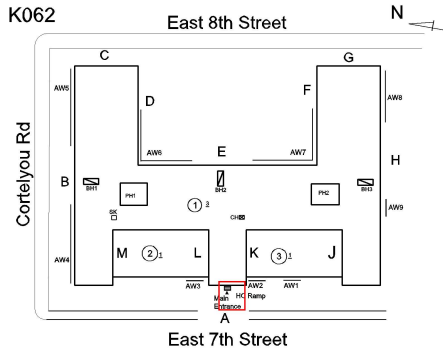
Violations	<p>Facade G</p> <p>No violations recorded.</p>
RAILINGS	Inspected
Condition	2 - Between Good and Fair
Deficiency	No deficiencies recorded
STAIRS/RAMPS	Inspected
Condition	5 - Poor
Deficiency	CONCRETE: CRACKS/SPALLING - MAJOR
Roof Plan reference	<p>K062</p>

Deficiency Quantity	10
Quantity Uom	S.F.
Potential Action	REPLACE
Urgency of Action	PRIORITY 4
Purpose of Action	LEVEL 2
Deficiency Photo1

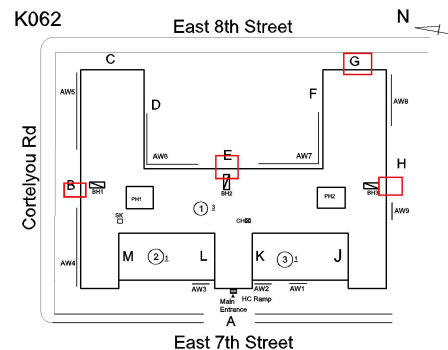
STONE: DETERIORATED JOINTS

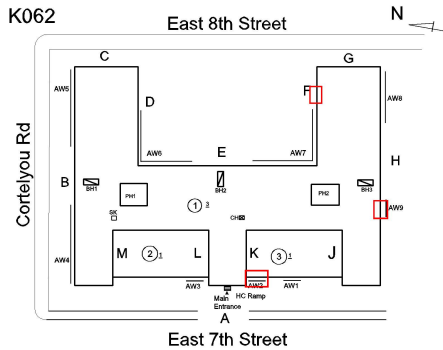
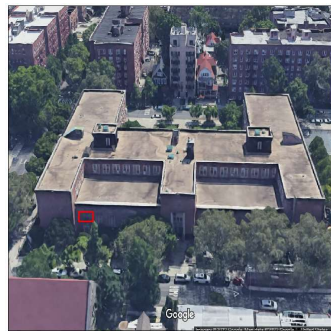
Violations	<p>Facade B</p> <p>No violations recorded.</p>
WINDOWS	Inspected
Replacement Quantity	18,200
Replacement Uom	S.F.
EXTERIOR GUARDS	Inspected
Condition	3 - Fair
Deficiency	DETERIORATED/TORN-OUT/MISSING
Roof Plan reference	<p>K062</p>

Deficiency Quantity	60
Quantity Uom	S.F.
Potential Action	REPLACE
Urgency of Action	PRIORITY 4
Purpose of Action	LEVEL 2

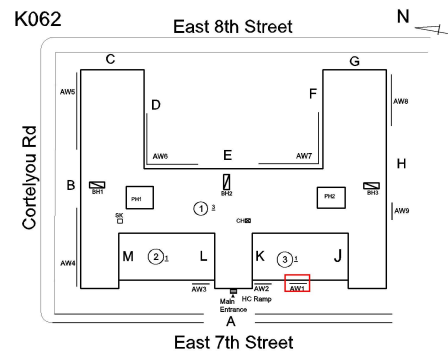
STEEL: BROKEN PANE
