NYC Department of Education
Building Condition Assessment Survey 2023 - 2024

Architectural Inspection

Asset: **P.S. 84 - BROOKLYN, 250 BERRY STREET, New York, 11211**

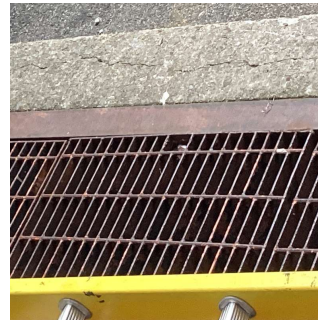
Facade E - AW1

Question	Response
Architectural	
EXTERIOR	Inspected
AREAWAY	Inspected
Instance on AW1-AW3	Inspected
Instance Condition	3 - Fair
Instance Quantity	3
Instance Quantity Uom	EACH
Deficiency	AREAWAY GRATINGS: MAJOR RUSTING / OR BROKEN

REPLACE

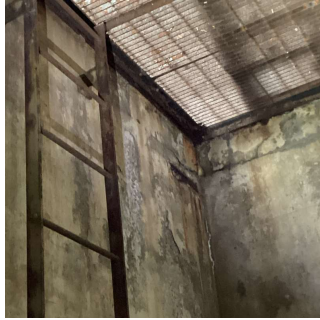
AREAWAY WALLS: CRACKS AND SPALLING

Violations	Facade E - AW1 No violations recorded.
AWNINGS AND CANOPIES	Inspected
Condition	2 - Between Good and Fair
Deficiency	No deficiencies recorded
CHIMNEY	Inspected
Material Type(s)	Masonry
Condition	3 - Fair
Deficiency	BRICK: MINOR CRACKS AND SPALLING
Roof Plan reference	K084

REPAIR

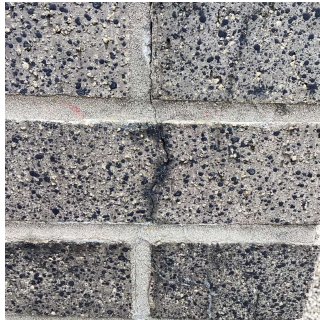
Deficiency Quantity	10
Quantity Uom	S.F.
Potential Action	RESTITCH
Urgency of Action	PRIORITY 3
Purpose of Action	LEVEL 2
Deficiency Photo1

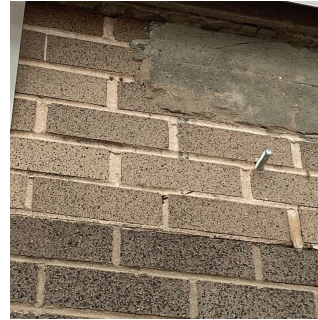
Violations	Roof 1 - CH No violations recorded.
Deficiency	BRICK: DETERIORATED JOINTS

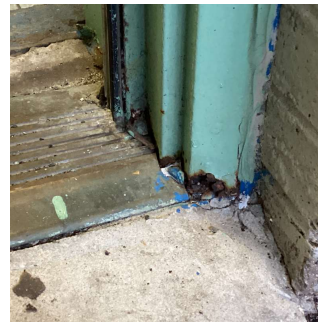
Facade C - Exit 10

Question	Response
EXTERIOR	
DOORS	
DOORS AND FRAMES	
Purpose of Action	LEVEL 2
Deficiency Photo1	 
Violations	Facade F - Exit 9 No violations recorded.
Deficiency	METAL CLAD: DETERIORATED DOOR AND FRAME - MAJOR DETERIORATION
Roof Plan reference	K084  
Deficiency Quantity	6
Quantity Uom	EACH
Potential Action	REPLACE
Urgency of Action	PRIORITY 4
Purpose of Action	LEVEL 2
Deficiency Photo1	 
Violations	Facade H - Exit 4 No violations recorded.
Deficiency	METAL: DETERIORATED DOOR - MAJOR DETERIORATION

REPLACE

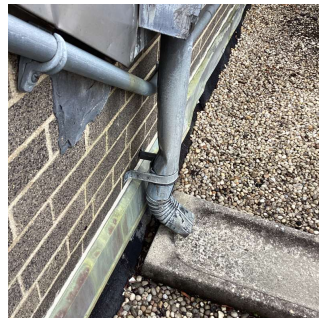
Question	Response
EXTERIOR	
ROOF	
Roofing	
LEADERS, GUTTERS, DOWNSPOUTS, SCUPPERS	
Condition	3 - Fair
Deficiency	DAMAGED/MISSING
Roof Plan reference	K084

Deficiency Quantity	10
Quantity Uom	L.F.
Potential Action	REPLACE
Urgency of Action	PRIORITY 4
Purpose of Action	LEVEL 2
Deficiency Photo1

Roof 1 - Near BH2
Violations	No violations recorded.
ROOF BARRIER/FENCE	Inspected
Condition	2 - Between Good and Fair
Deficiency	No deficiencies recorded
ROOF CAGE	Does not Exist
ROOFING	Inspected
Instance on Built-Up: All Roofs	Under Construction
Instance Photo

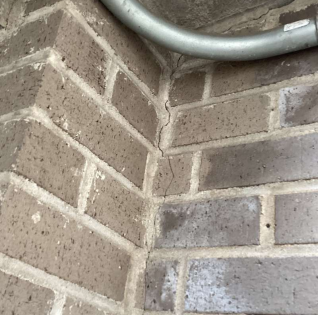
Question	Response
EXTERIOR	
ROOF	
Specialties	
BULKHEAD/PENTHOUSE	
Condition	3 - Fair
Deficiency	BULKHEAD/PENTHOUSE WALLS/EXTERIOR: CRACKS/SPALLING - MINOR
Roof Plan reference	K084

Deficiency Quantity	10
Quantity Uom	S.F.
Potential Action	REPAIR
Urgency of Action	PRIORITY 3
Purpose of Action	LEVEL 2
Deficiency Photo1

Violations	Roof 1 - BH4 No violations recorded.
Deficiency	BULKHEAD/PENTHOUSE CEILING: PLASTER DAMAGED/DETERIORATED
Roof Plan reference	K084

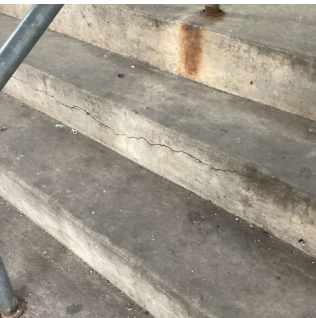
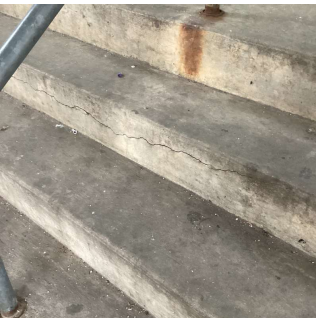
Question	Response
EXTERIOR	
STAIRS/RAMPS: EXTERIOR	
BUILDING CHEEK/FLANK WALLS	Inspected
Condition	2 - Between Good and Fair
Deficiency	No deficiencies recorded
RAILINGS	Inspected
Condition	2 - Between Good and Fair
Deficiency	No deficiencies recorded
STAIRS/RAMPS	Inspected
Condition	5 - Poor
Deficiency	CONCRETE: CRACKS/SPALLING - MAJOR
RooF Plan reference	<p>K084</p>

<p>50 S.F. REPLACE PRIORITY 4 LEVEL 2</p>

<p>Facade A - Exit 2 No violations recorded.</p>
Deficiency Quantity	50
Quantity Uom	S.F.
Potential Action	REPLACE
Urgency of Action	PRIORITY 4
Purpose of Action	LEVEL 2
Deficiency Photo1

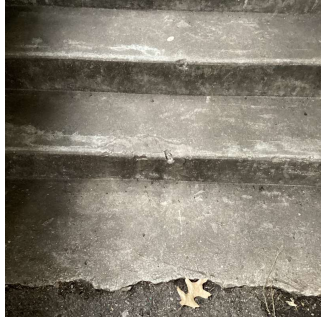
Violations	<p>Facade A - Exit 2 No violations recorded.</p>
Deficiency	CONCRETE: WORN-OUT TREAD/RISER/NOSING
RooF Plan reference	<p>K084</p>

<p>30 S.F. REPLACE</p>
Deficiency Quantity	30
Quantity Uom	S.F.
Potential Action	REPLACE

Question	Response
EXTERIOR	
STAIRS/RAMPS: EXTERIOR	
STAIRS/RAMPS	
Urgency of Action	PRIORITY 4
Purpose of Action	LEVEL 2
Deficiency Photo1

Violations	Facade D No violations recorded.
WINDOWS	Inspected
Replacement Quantity	7,000
Replacement Uom	S.F.
EXTERIOR GUARDS	Inaccessible
LINTELS	Inaccessible
WINDOWS	Inspected
Material Type(s)	Aluminum
Instance on Aluminum - Double Hung: All Facades	Inspected
Instance Condition	3 - Fair
Instance Quantity	6,940
Instance Quantity Uom	S.F.
Are these windows insulated	No
Installation Year	1999
Source of Installation	Custodial Staff
Deficiency	No deficiencies recorded
Instance on Aluminum - Other: Facades C, G	Inspected
Instance Condition	3 - Fair
Instance Quantity	60
Instance Quantity Uom	S.F.
Are these windows insulated	No
Installation Year	1999
Source of Installation	Custodial Staff
Deficiency	No deficiencies recorded
INTERIOR	Inspected
POOLS	Does not Exist
STRUCTURAL	Inspected
COLUMNS/BEAMS/BEARING WALLS	Inspected

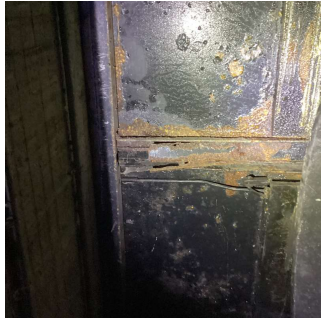
Deficiency	WATER INFILTRATION

Question	Response
INTERIOR	
STRUCTURAL	
VAULTS-BUNKERS	
Vault/Ash Hoist Doors and Framing	
Deficiency Location/Instance	Basement - Ash Hoist Vault
Deficiency Quantity	10
Quantity Uom	S.F.
Potential Action	REPAIR
Urgency of Action	PRIORITY 5
Purpose of Action	LEVEL 2
Deficiency Photo1

Violations	Basement - Ash Hoist Vault No violations recorded.
AUDITORIUM	Inspected
Instance on 1st Floor (324 Seats)	Inspected
Ceiling	
Instance on 1st Floor (324 Seats)	Inspected
Condition	2 - Between Good and Fair
Deficiency	ACOUSTIC TILES: DAMAGED/MISSING
Deficiency Location/Instance	Rear
Deficiency Quantity	10
Quantity Uom	S.F.
Potential Action	REPLACE
Urgency of Action	PRIORITY 3
Purpose of Action	LEVEL 2
Deficiency Photo1

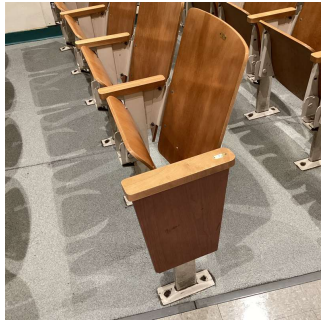
Question	Response
INTERIOR	
AUDITORIUM	
Fixed Seating	
Instance on 1st Floor (324 Seats)	Inspected
Condition	2 - Between Good and Fair
Deficiency	IMPROPERLY ANCHORED
Deficiency Location/Instance	Seat A/2, 6, G/2
Deficiency Quantity	3
Quantity Uom	EACH
Potential Action	MAINTENANCE
Urgency of Action	PRIORITY 3
Purpose of Action	LEVEL 2
Deficiency Photo1

Violations	Seat G/2 No violations recorded.
Floor Finish	
Instance on 1st Floor (324 Seats)	Inspected
Condition	2 - Between Good and Fair
Deficiency	CONCRETE: CRACKS
Deficiency Location/Instance	Near seat H/103, G/103, F/103, E/103, D/103, and others
Deficiency Quantity	100
Quantity Uom	S.F.
Potential Action	REPLACE
Urgency of Action	PRIORITY 3
Purpose of Action	LEVEL 2
Deficiency Photo1

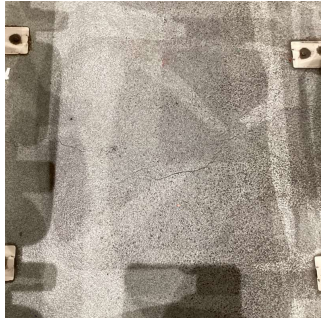
Violations	Near seat H/103 No violations recorded.
Sliding-folding Partition	
Instance on 1st Floor (324 Seats)	Inspected
Condition	2 - Between Good and Fair
Deficiency	No deficiencies recorded

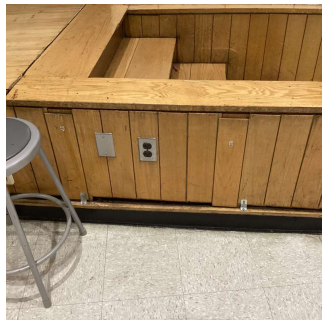
Question	Response
INTERIOR	
AUDITORIUM	
Stage	
Stage	Inspected
Instance on 1st Floor (324 Seats)	Inspected
Condition	3 - Fair
Deficiency	DAMAGED FASCIA
Deficiency Location/Instance	Left Side
Deficiency Quantity	10
Quantity Uom	S.F.
Potential Action	REPLACE
Urgency of Action	PRIORITY 3
Purpose of Action	LEVEL 2
Deficiency Photo1

Left Side
Violations	No violations recorded.
Deficiency	DAMAGED FLOOR
Deficiency Location/Instance	Near center
Deficiency Quantity	10
Quantity Uom	S.F.
Potential Action	REPLACE
Urgency of Action	PRIORITY 3
Purpose of Action	LEVEL 2
Deficiency Photo1

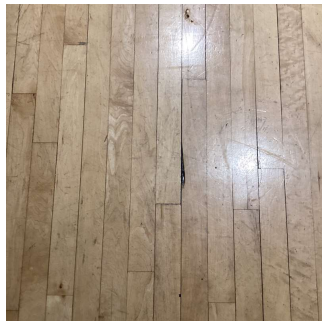
Near center
Violations	No violations recorded.
Deficiency	DAMAGED STEPS
Deficiency Location/Instance	Right side, left side
Deficiency Quantity	20
Quantity Uom	S.F.
Potential Action	REPLACE
Urgency of Action	PRIORITY 3
Purpose of Action	LEVEL 2

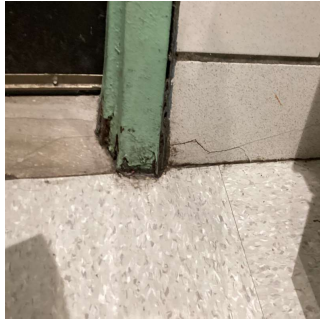
Question	Response
INTERIOR	
CAFETERIA	
Walls	
Condition	2 - Between Good and Fair
Deficiency	GLAZED BLOCK: CRACKS/SPALLING
Deficiency Location/Instance	Near kitchen
Deficiency Quantity	10
Quantity Uom	S.F.
Potential Action	REPLACE
Urgency of Action	PRIORITY 3
Purpose of Action	LEVEL 2
Deficiency Photo1

Violations	Near kitchen No violations recorded.
Window Curtains/Shades/Blinds	
Instance on 1st Floor	Does not Exist
CLASSROOMS/CORRIDORS/ADMIN SPACES	
Ceiling	
Condition	Inspected
Deficiency	2 - Between Good and Fair
Deficiency	No deficiencies recorded
Door(s)	
Condition	Inspected
Condition	5 - Poor
Deficiency	METAL CLAD WOOD: DETERIORATED DOOR
Deficiency Location/Instance	Room 324
Deficiency Quantity	1
Quantity Uom	EACH
Potential Action	MAINTENANCE
Urgency of Action	PRIORITY 3
Purpose of Action	LEVEL 2
Deficiency Photo1	 
Violations	Room 324 No violations recorded.
Deficiency	WOOD: DETERIORATED DOOR
Deficiency Location/Instance	Room 348, 331, 329, 323, 321, and others

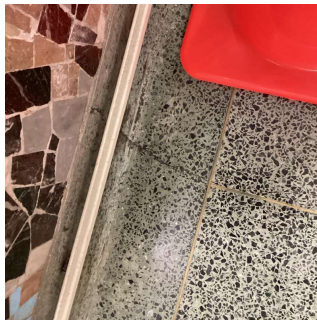
Room 331
Violations	No violations recorded.
Floor Finish	Inspected
Condition	2 - Between Good and Fair
Deficiency	TERRAZZO: CRACKS
Deficiency Location/Instance	Main Entrance Lobby
Deficiency Quantity	10
Quantity Uom	S.F.
Potential Action	REPLACE
Urgency of Action	PRIORITY 3
Purpose of Action	LEVEL 2
Deficiency Photo1

Main Entrance Lobby
Violations	No violations recorded.
Deficiency	VINYL TILES: BROKEN/DETERIORATED/MISSING TILES
Deficiency Location/Instance	Room 334, Corridor near Room 358, 355, 324, 117, and others
Deficiency Quantity	50
Quantity Uom	S.F.
Potential Action	REPLACE
Urgency of Action	PRIORITY 3
Purpose of Action	LEVEL 2

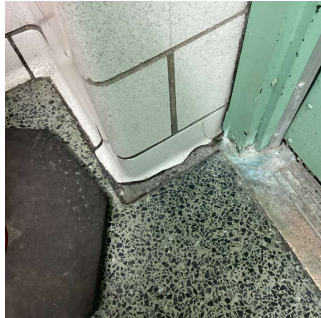
Question	Response
INTERIOR	
CLASSROOMS/CORRIDORS/ADMIN SPACES	
Walls	
Violations	Main Entrance Lobby No violations recorded.
Deficiency	GLAZED BLOCK: CRACKS/SPALLING
Deficiency Location/Instance	Exit 2, Corridor near Room 304, 116
Deficiency Quantity	15
Quantity Uom	S.F.
Potential Action	REPLACE
Urgency of Action	PRIORITY 3
Purpose of Action	LEVEL 2
Deficiency Photo1

Violations	Exit 2 No violations recorded.
Specialties	Inspected
Classroom Locker(s)	Inspected
Condition	2 - Between Good and Fair
Deficiency	No deficiencies recorded
Fixed Seating	Does not Exist
GYMNASIUM	Does not Exist
INTERIOR DOOR HARDWARE	Inspected
Condition	3 - Fair
Deficiency	No deficiencies recorded
INTERIOR GUARDS	Inspected
Condition	2 - Between Good and Fair
Deficiency	No deficiencies recorded
KITCHEN	Inspected
Instance on 1st Floor	Inspected
Ceiling	Inspected
Instance on 1st Floor	Inspected
Condition	2 - Between Good and Fair
Deficiency	METAL PAN: DAMAGED/MISSING

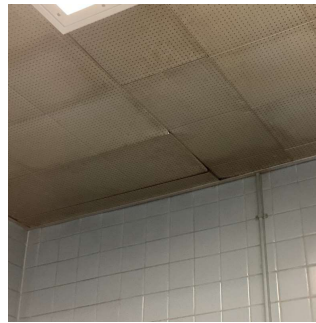
Deficiency Location/Instance	Near Entrance
Deficiency Quantity	10
Quantity Uom	S.F.
Potential Action	REPLACE
Urgency of Action	PRIORITY 3
Purpose of Action	LEVEL 2

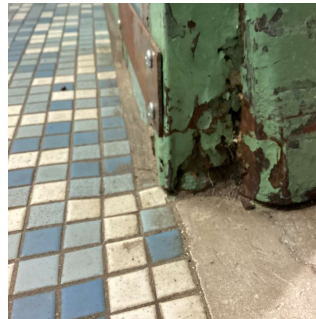
Instance on 1st Floor	Inspected
Condition	5 - Poor
Deficiency	METAL: DETERIORATED DOOR AND FRAME
Deficiency Location/Instance	Entrance
Deficiency Quantity	3
Quantity Uom	EACH
Potential Action	MAINTENANCE
Urgency of Action	PRIORITY 3
Purpose of Action	LEVEL 2
Deficiency Photo1

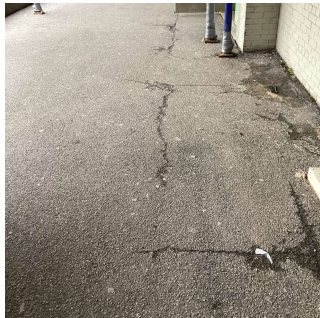
Violations	Near exit 10 No violations recorded.
Deficiency	CRACKS - MAJOR
Deficiency Location/Instance	Near exit 3
Deficiency Quantity	200
Quantity Uom	S.F.
Potential Action	REPLACE
Urgency of Action	PRIORITY 3
Purpose of Action	LEVEL 2
Deficiency Photo1

Violations	Near exit 3 No violations recorded.
Concrete	Inspected
Condition	3 - Fair
Deficiency	DAMAGED/DETERIORATED/MISSING SECTIONS
Deficiency Location/Instance	Near exit 1, Exit 2, Exit 4
Deficiency Quantity	350
Quantity Uom	S.F.
Potential Action	REPLACE
Urgency of Action	PRIORITY 3
Purpose of Action	LEVEL 2
