NYC Department of Education
Building Condition Assessment Survey 2023 - 2024

Architectural Inspection

Asset: P.S. 152 - BROOKLYN, 725 EAST 23RD STREET, New York, 11210

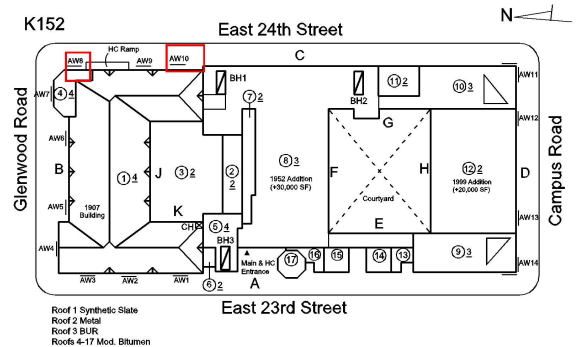
AREAWAY GRATINGS: MAJOR RUSTING / OR BROKEN

REPLACE

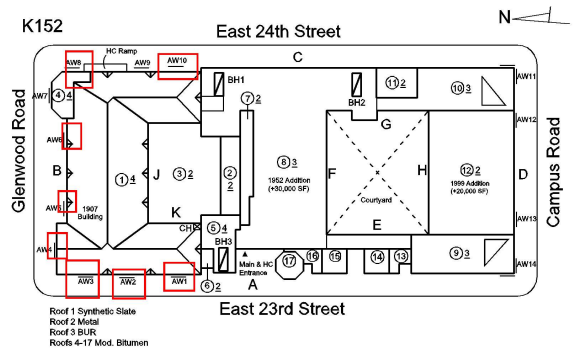
AREAWAY WALLS: DETERIORATED JOINTS AT COPING STONES

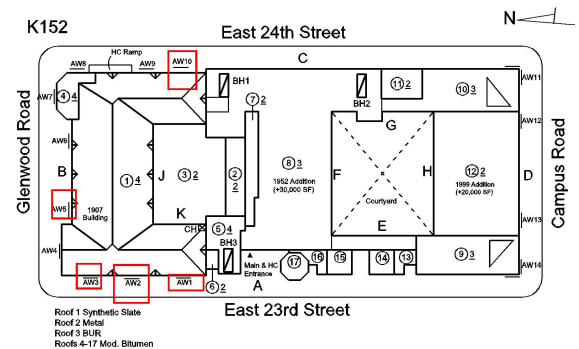
AREAWAY WALLS: DETERIORATED COPING STONE

REPLACE

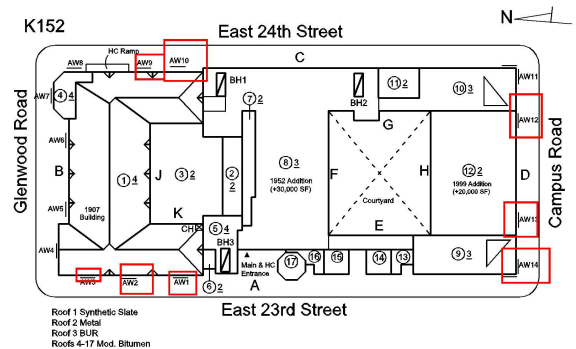
AREAWAY WALLS: CRACKS AND SPALLING

REPLACE

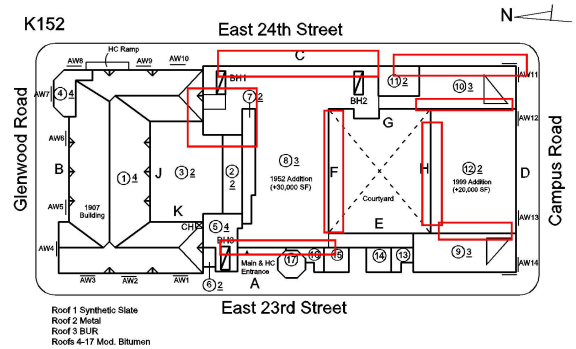
CAST STONE: DETERIORATED TRANSVERSE JOINTS

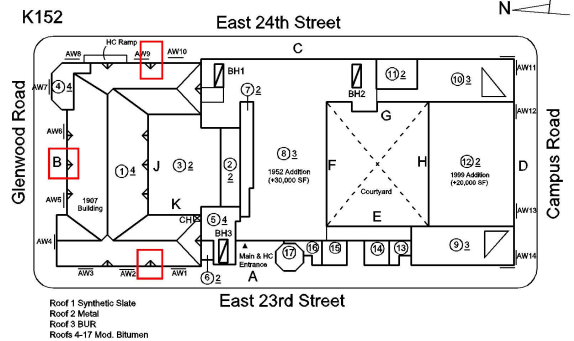
WOOD: DETERIORATED DOOR AND FRAME - MAJOR DETERIORATION

REPLACE

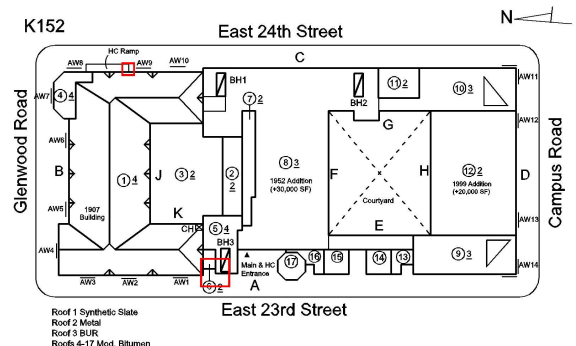
STONE: CHIPPED/SPALLED/BROKEN PIECES - MINOR

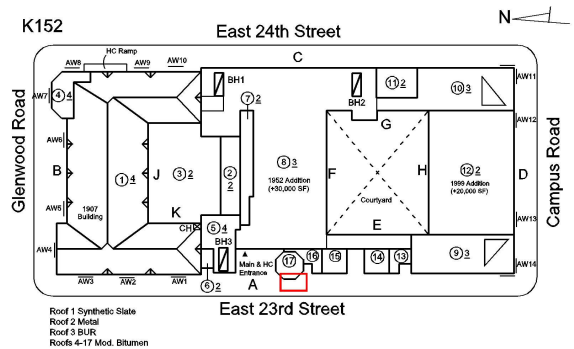
STONE: DETERIORATED MASONRY SILLS - MINOR

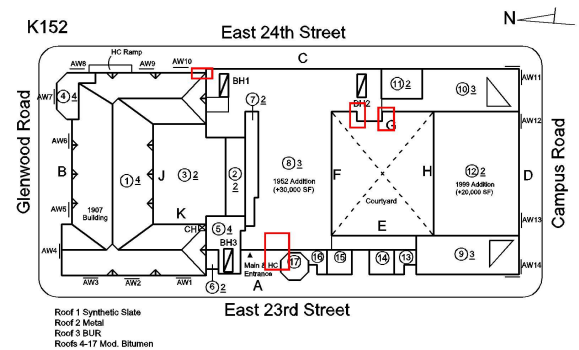
BRICK: MINOR CRACKS AND SPALLING

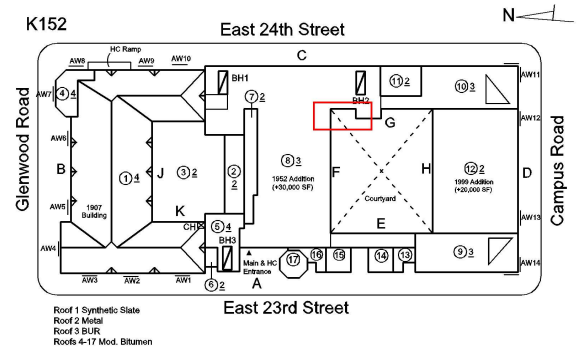
GLASS BLOCK: DETERIORATED JOINTS

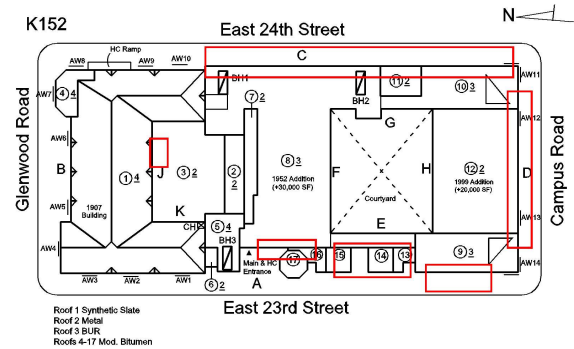
BRICK: DETERIORATED JOINTS

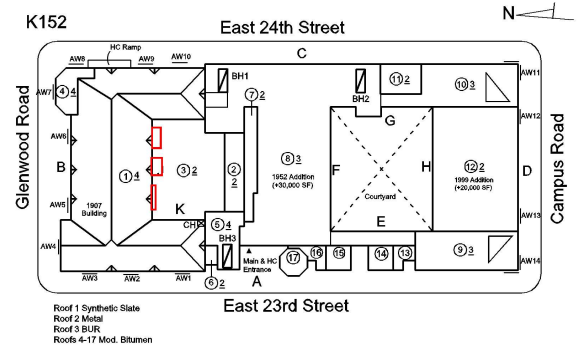
BRICK: MASONRY SILLS - DETERIORATED JOINTS

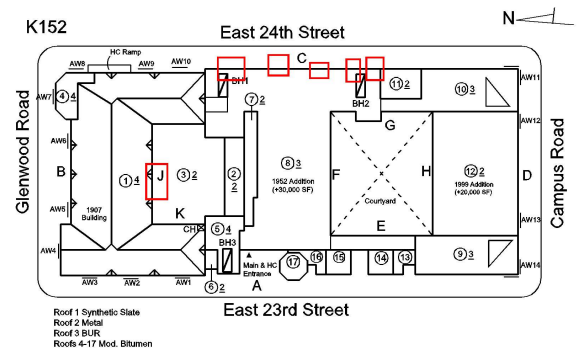
BRICK: DETERIORATED MASONRY SILLS - MAJOR

REMOVE AND REPLACE

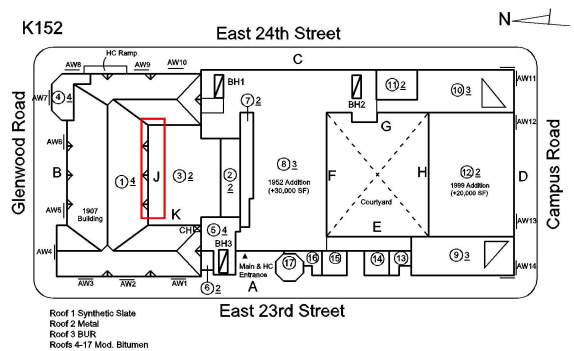
STUCCO CEMENT SURFACE: CRACKS, SPALLING

REPLACE

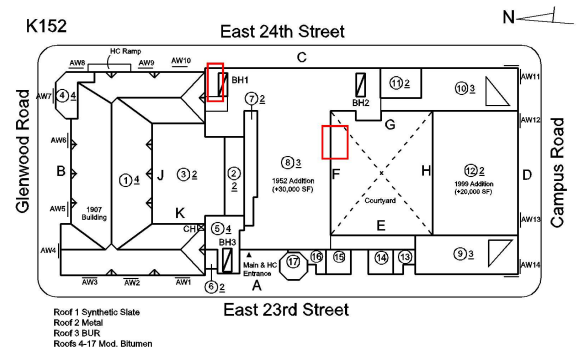
BRICK: MAJOR DETERIORATION/CRACKS

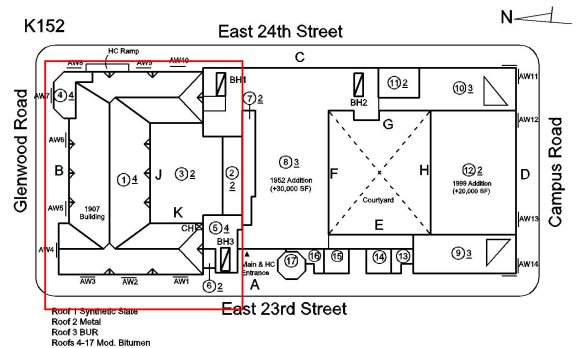
ASPHALT SHINGLE: ROOFING: DAMAGED, WORN-OUT OR MISSING SHINGLES CURLING UP

60
S.F.
REPLACE
PRIORITY 4
LEVEL 2

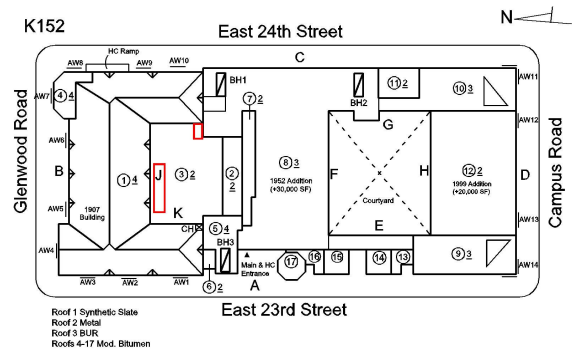
Question	Response
EXTERIOR	
ROOF	
Roofing	
ROOFING	
Source of Installation	Custodial Staff
Deficiency	BUILT-UP: ROOFING: LOSS OF GRAVEL
RooF Plan reference

<p>Roof 1 Synthetic Slate Roof 2 Metal Roof 3 BUR Roofs 4-17 Mod. Bitumen</p>
Deficiency Quantity	20
Quantity Uom	S.F.
Potential Action	INSTALL NEW GRAVEL
Urgency of Action	PRIORITY 3
Purpose of Action	LEVEL 2
Deficiency Photo1

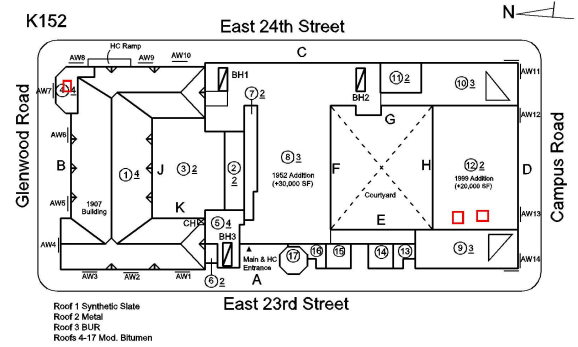
MODIFIED BITUMEN: ROOFING: MAJOR ACTIVE ROOF
LEAKS IN INSTRUCTIONAL SPACE

REPLACE ROOFING WITHOUT MAJOR EQUIPMENT
REMOVAL

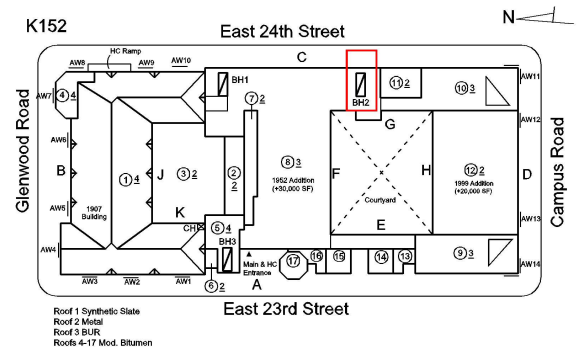
BULKHEAD/PENTHOUSE WALLS/EXTERIOR: WATER INFILTRATION

100
S.F.
REPAIR
PRIORITY 5
LEVEL 2

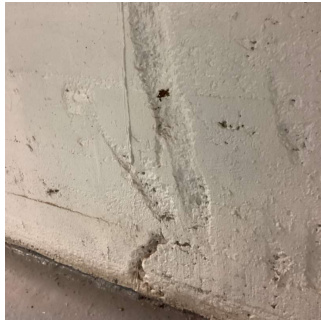
Violations	Basement - Boiler Room No violations recorded.
Deficiency	CONCRETE: WATER INFILTRATION IN ELECTRICAL PANEL ROOM
Deficiency Location/Instance	Basement - Electrical Panel Room
Deficiency Quantity	100
Quantity Uom	S.F.
Potential Action	INSTALL WATERPROOFING
Urgency of Action	PRIORITY 5
Purpose of Action	LEVEL 6
Deficiency Photo1

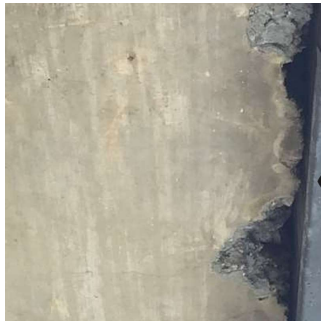
BH2
Violations	No violations recorded.
Deficiency	CLAY/CONCRETE TILES: MISSING/CRACKED/SPALLED
Deficiency Location/Instance	Roof 1 - Attic
Deficiency Quantity	230
Quantity Uom	S.F.
Potential Action	REPLACE
Urgency of Action	PRIORITY 3
Purpose of Action	LEVEL 5
Deficiency Photo1
