NYC Department of Education
Building Condition Assessment Survey 2023 - 2024

Architectural Inspection

Asset: **P.S. 178 - BROOKLYN, 2163 DEAN STREET, New York, 11212**

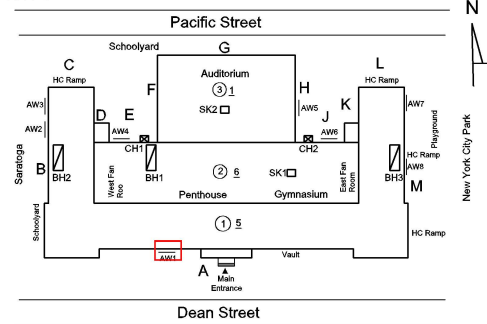
Deficiency	AREAWAY WALLS: DETERIORATED COPING STONE
Roof Plan reference	K178

Deficiency Quantity	15
Quantity Uom	S.F.
Potential Action	REPAIR
Urgency of Action	PRIORITY 3
Purpose of Action	LEVEL 2
Deficiency Photo1

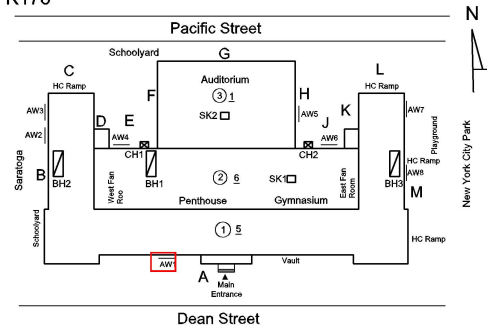
Deficiency	AREAWAY WALLS: DETERIORATED COPING STONE
Roof Plan reference	K178

Deficiency Quantity	20
Quantity Uom	S.F.
Potential Action	REPLACE
Urgency of Action	PRIORITY 4
Purpose of Action	LEVEL 2

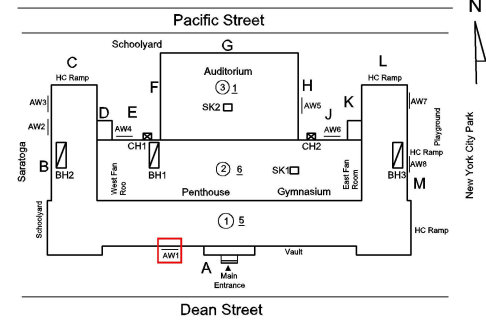
AREAWAY WALLS: DETERIORATED JOINTS

REPAIR

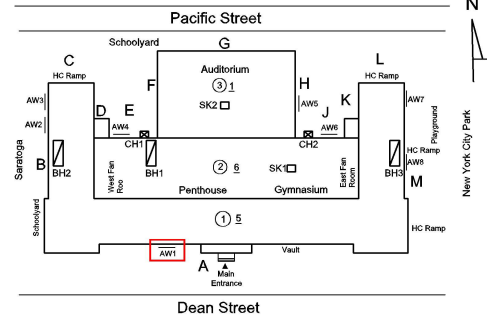
AREAWAY WALLS: CRACKS AND SPALLING

REPLACE

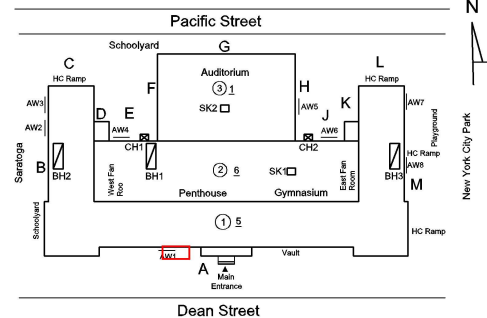
AREAWAY STAIRS: DETERIORATED
TREADS/RISERS/NOSINGS

REPLACE

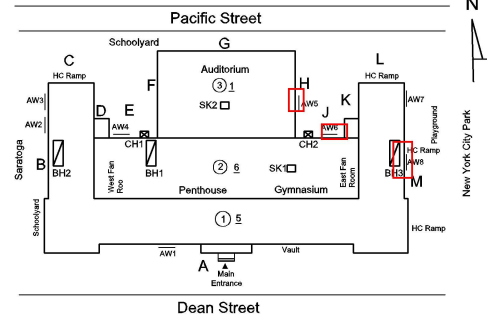
Violations	AW7 No violations recorded.
Deficiency	AREAWAY GRATINGS: MAJOR RUSTING / OR BROKEN

REPLACE

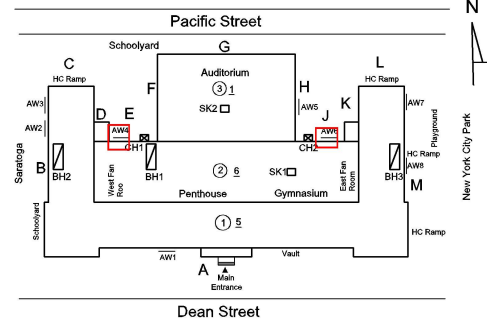
AREAWAY WALLS: DETERIORATED COPING STONE

REPLACE

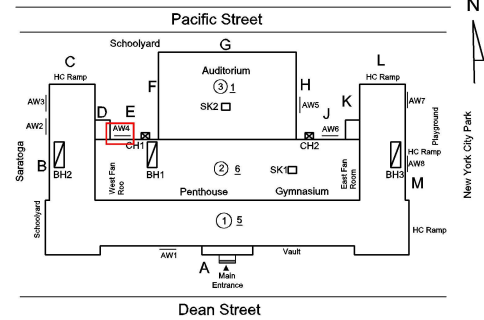
AREAWAY WALLS: DETERIORATED JOINTS AT COPING STONES

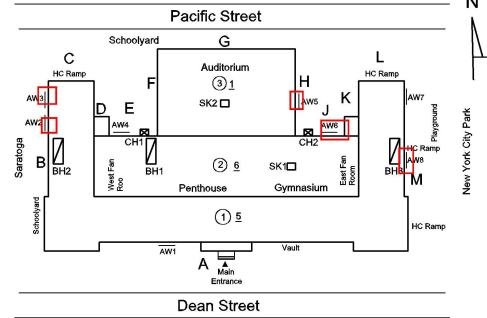
AREAWAY WALLS: CRACKS AND SPALLING

REPLACE

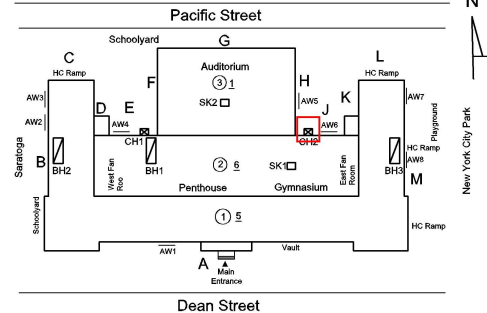
BRICK: DETERIORATED JOINTS

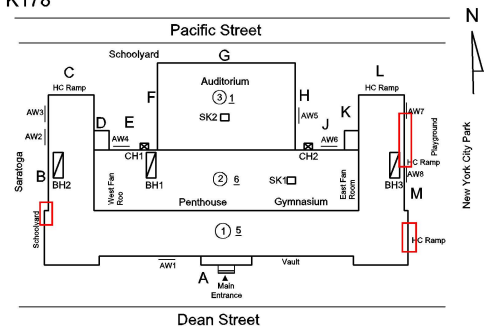
STONE: MAJOR CRACKS, SPALLING

REPLACE

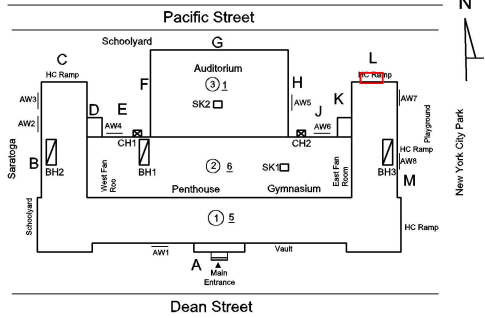
Question	Response
EXTERIOR	
EXTERIOR WALLS	Inspected
Material Type(s)	Masonry
Replacement Quantity	42,500
Replacement Uom	S.F.
Instance on All Facades	Inspected
Instance Condition	4 - Between Fair and Poor
Instance Quantity	42,500
Instance Quantity Uom	S.F.
Deficiency	STONE: DETERIORATED MASONRY SILLS - MAJOR
Roof Plan reference	K178
Elevation

Deficiency Quantity	15
Quantity Uom	L.F.
Potential Action	REMOVE AND REPLACE
Urgency of Action	PRIORITY 4
Purpose of Action	LEVEL 2
Deficiency Photo1

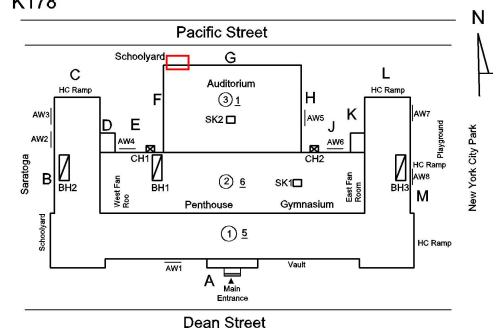
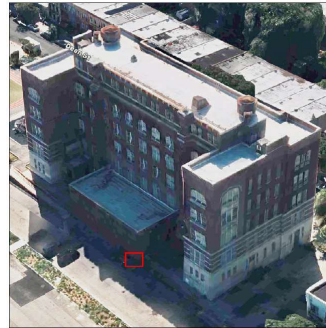
BRICK: MAJOR / THRU CRACKS

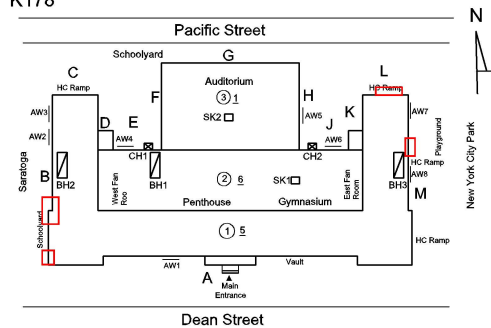
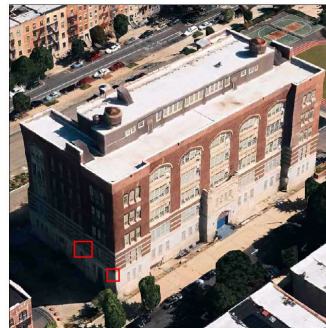
STONE: CHIPPED/SPALLED/BROKEN PIECES - MAJOR
K178

REPLACE

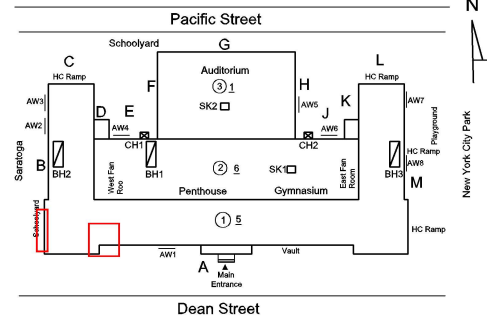
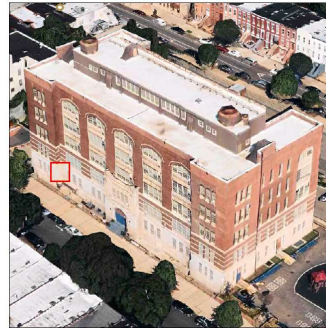
STONE: CHIPPED/SPALLED/BROKEN PIECES - MINOR

REPAIR

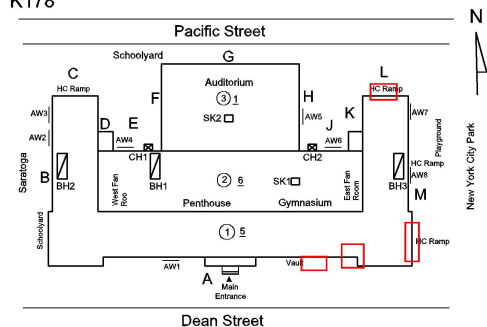
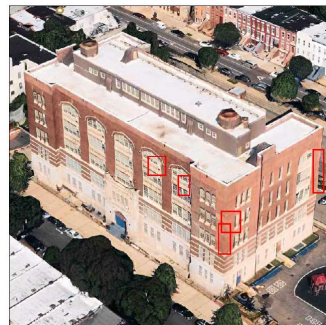
BRICK: WATER INFILTRATION IN INSTRUCTIONAL SPACE
K178

<p>Facade D - Room 302 (Facade A - Rooms 509, 511, Facade L - Rooms 312, 412, 512, Facade M - Rooms 311, 413</p>
Violations	No violations recorded.
EXTERIOR SOFFITS	Inspected
Condition	3 - Fair
Deficiency	CONCRETE: MAJOR CRACKS/SPALLING
Roof Plan reference	K178

REPAIR

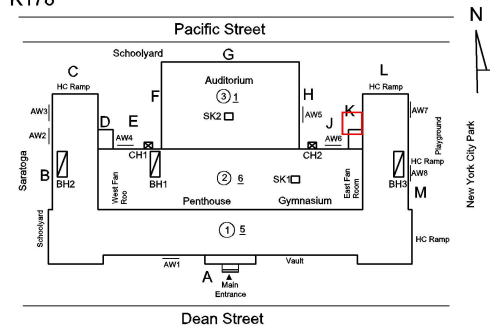
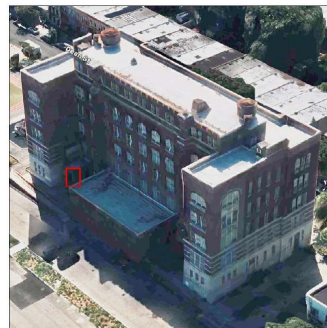
Deficiency Quantity	25
Quantity Uom	S.F.
Potential Action	REPLACE
Urgency of Action	PRIORITY 4
Purpose of Action	LEVEL 2

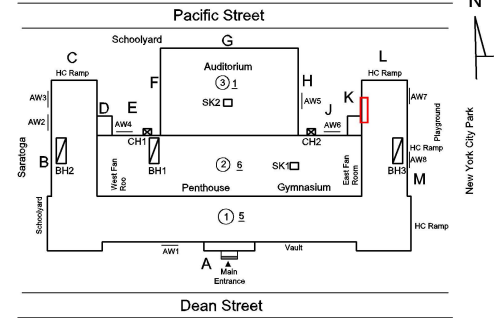
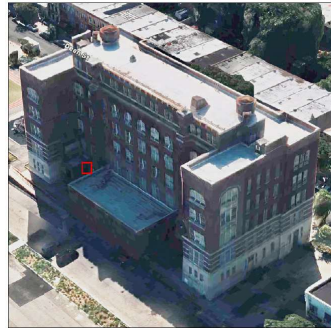
Violations	<p>Facade K</p> <p>No violations recorded.</p>
LOADING DOCK	Does not Exist
LOUVER	Inspected
Condition	3 - Fair
Deficiency	BROKEN/ DENTED BLADES
Roof Plan reference	K178

Deficiency Quantity	10
Quantity Uom	S.F.
Potential Action	REPLACE
Urgency of Action	PRIORITY 4
Purpose of Action	LEVEL 2
Deficiency Photo1

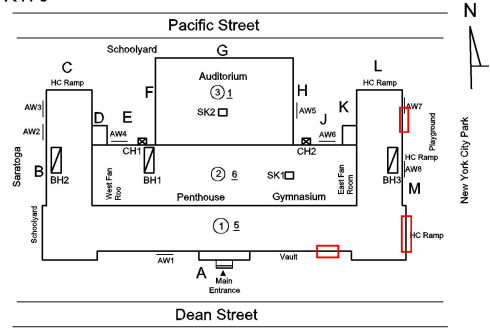
Question	Response
EXTERIOR	
LOUVER	Inspected
	Facade K
Violations	No violations recorded.
PARAPETS	Inspected
Material Type(s)	Masonry
Replacement Quantity	3,000
Replacement Uom	C.F.
Instance on All Roofs	Inspected
Instance Condition	5 - Poor
Instance Quantity	3,000
Instance Quantity Uom	C.F.
Deficiency	BRICK: DETERIORATED JOINTS
Roof Plan reference	K178

Deficiency Quantity	40
Quantity Uom	S.F.
Potential Action	REPOINT
Urgency of Action	PRIORITY 3
Purpose of Action	LEVEL 2
Deficiency Photo1

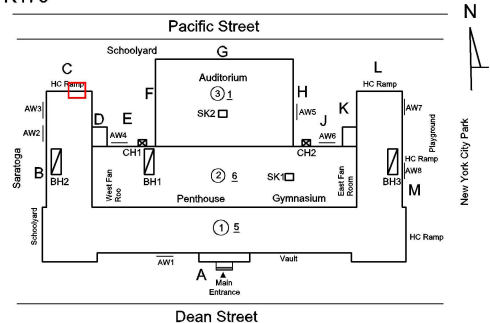
Roof 1
Violations	No violations recorded.
Deficiency	BRICK: MAJOR DETERIORATION/CRACKS
Roof Plan reference	K178

Question	Response
EXTERIOR	
PARAPETS	Inspected
Deficiency Quantity	10
Quantity Uom	S.F.
Potential Action	REMOVE AND REBUILD
Urgency of Action	PRIORITY 4
Purpose of Action	LEVEL 2
Deficiency Photo1

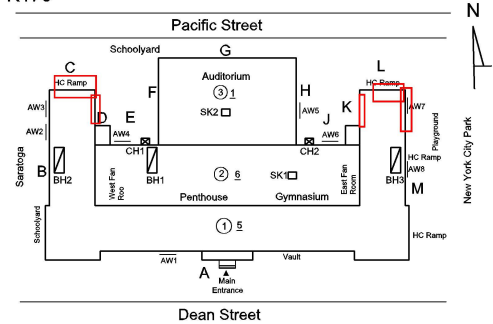
Violations	Roof 1 No violations recorded.
Deficiency	BRICK: EFFLORESCENCE
Roof Plan reference	K178

Deficiency Quantity	80
Quantity Uom	S.F.
Potential Action	MAINTENANCE
Urgency of Action	PRIORITY 1
Purpose of Action	LEVEL 1
Deficiency Photo1

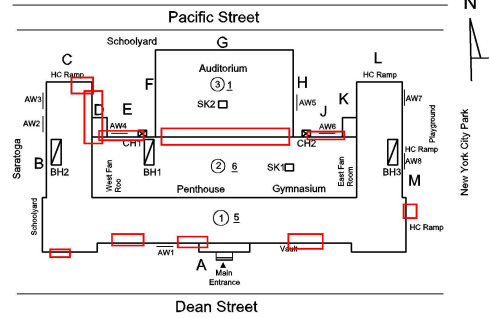
Violations	Roof 1 No violations recorded.
Deficiency	BRICK: DETERIORATED JOINTS

Deficiency Quantity	200
Quantity Uom	S.F.
Potential Action	REPOINT
Urgency of Action	PRIORITY 4
Purpose of Action	LEVEL 2
Deficiency Photo1

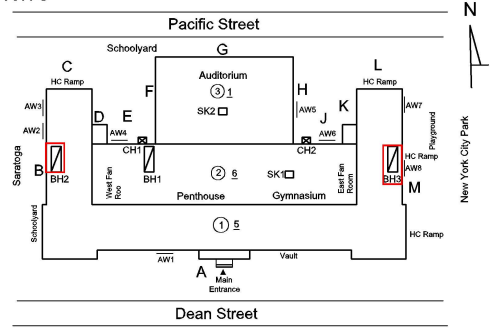
Question	Response
EXTERIOR	
ROOF	
Roofing	
ROOFING	Roof 1
Instance Quantity	15,000
Instance Quantity Uom	S.F.
Does the roof have major mechanical equipment sitting on Dunnage Steel less than 18" above the Roofing?	No
Does this roof instance have a Sustainable Roof System?	Yes
Sustainable Roof Type	White Roof
Sustainable Roof Location (Roof Number)	All Roof
Do solar panels exist on these roofs?	No
Is/Are the roof(s) suitable for Solar Panel installation?	Yes
Installation Year	2019
Source of Installation	Custodial Staff
Deficiency	No deficiencies recorded
ROOFING DRAINS	Inspected
Condition	1 - Good
Deficiency	No deficiencies recorded
Specialties	Inspected
BULKHEAD/PENTHOUSE	Inspected
Condition	5 - Poor
Deficiency	BULKHEAD/PENTHOUSE WALLS/EXTERIOR: WATER INFILTRATION
Roof Plan reference	<p>K178</p>

Deficiency Quantity	250
Quantity Uom	S.F.
Potential Action	REPAIR
Urgency of Action	PRIORITY 5
Purpose of Action	LEVEL 2

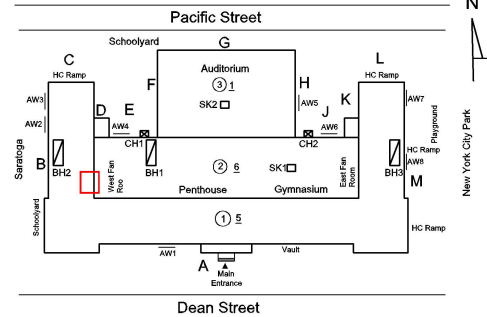
Violations	BH2
Deficiency	No violations recorded.
	BULKHEAD/PENTHOUSE DOORS: DETERIORATED DOOR AND FRAME

1
EACH
REPLACE DOOR AND FRAME
PRIORITY 4
LEVEL 2

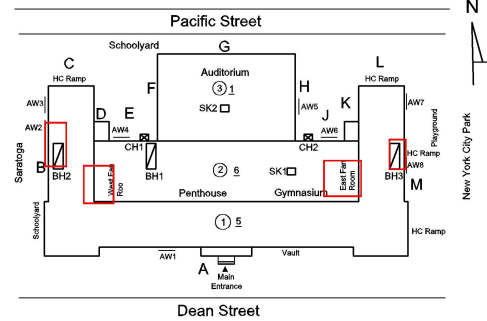
BULKHEAD/PENTHOUSE WALLS/INTERIOR: PLASTER CRACKS/SPALLING

250
S.F.
REPLACE
PRIORITY 4
LEVEL 2

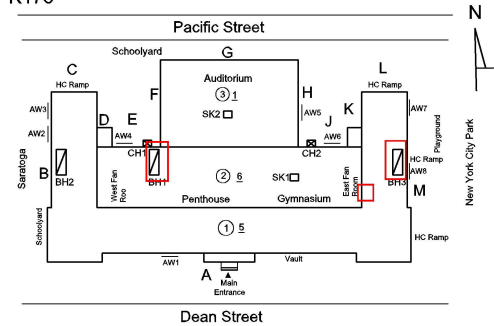
Violations	East Fan Room No violations recorded.
Deficiency	BULKHEAD/PENTHOUSE DOORS: DETERIORATED DOOR
Roof Plan reference	K178

Deficiency Quantity	3
Quantity Uom	EACH
Potential Action	REPLACE DOOR
Urgency of Action	PRIORITY 3
Purpose of Action	LEVEL 2
Deficiency Photo1

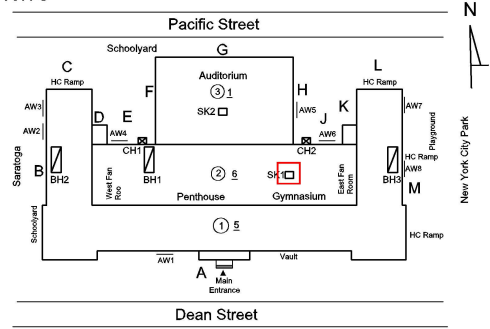
Violations	BH3 No violations recorded.
CUPOLA/ SPIRES/ TOWERS	Does not Exist
DORMER	Does not Exist
DUNNAGE STEEL	Does not Exist
SKYLIGHT/ROOF VENT	Inspected
Material Type(s)	Glass
Condition	3 - Fair
Deficiency	DAMAGED FLASHING

Deficiency Quantity	20
Quantity Uom	L.F.
Potential Action	MAINTENANCE
Urgency of Action	PRIORITY 3
Purpose of Action	LEVEL 2
Deficiency Photo1

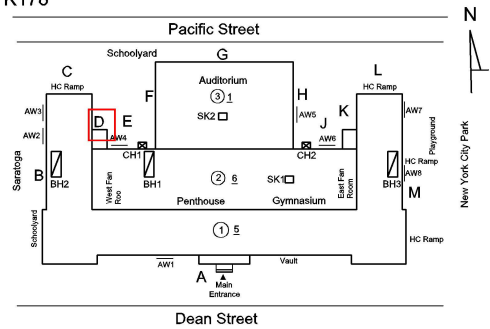
Violations	<p>SK1</p> <p>No violations recorded.</p>
ROOF/GRAVITY TANK	Does not Exist
STAIRS/RAMPS: EXTERIOR	Inspected
BUILDING CHEEK/FLANK WALLS	Inspected
Condition	5 - Poor
Deficiency	STONE: DETERIORATED COPING STONE
Roof Plan reference	<p>K178</p>

Deficiency Quantity	20
Quantity Uom	S.F.
Potential Action	REPLACE
Urgency of Action	PRIORITY 4
Purpose of Action	LEVEL 2

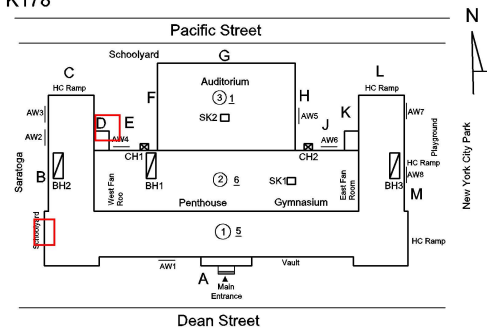
STONE: DETERIORATED JOINTS

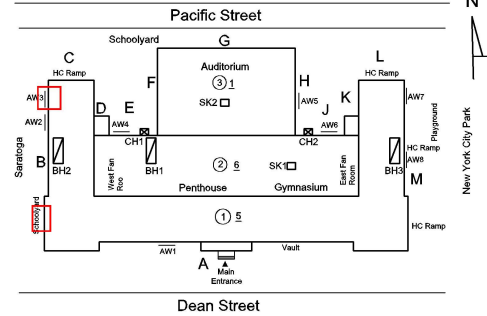
STONE: CRACKS/SPALLING - MINOR

REPAIR

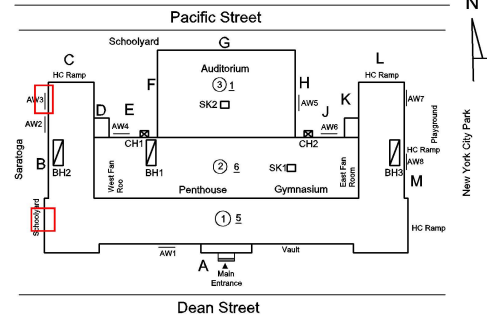
RUST - MAJOR

REPLACE

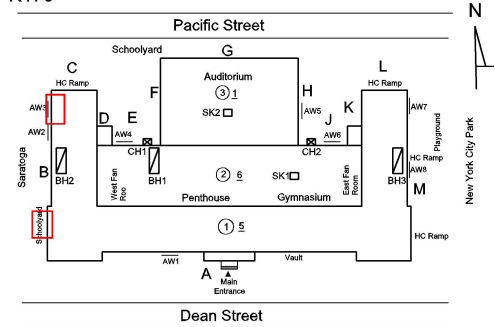
Violations	<p>Facade B</p> <p>No violations recorded.</p>
Deficiency	DAMAGED
Roof Plan reference	<p>K178</p>

Deficiency Quantity	15
Quantity Uom	L.F.
Potential Action	REPLACE
Urgency of Action	PRIORITY 4
Purpose of Action	LEVEL 2
Deficiency Photo1

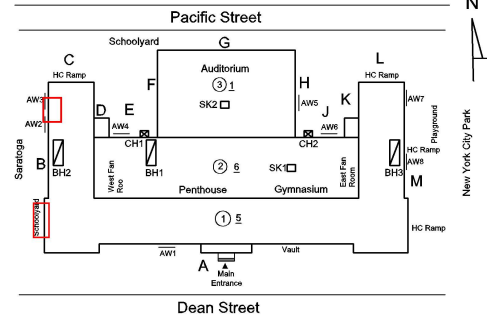
Violations	<p>Facade B</p> <p>No violations recorded.</p>
STAIRS/RAMPS	Inspected
Condition	5 - Poor
Deficiency	STONE: WORN-OUT TREAD/RISER/NOSING

REPLACE

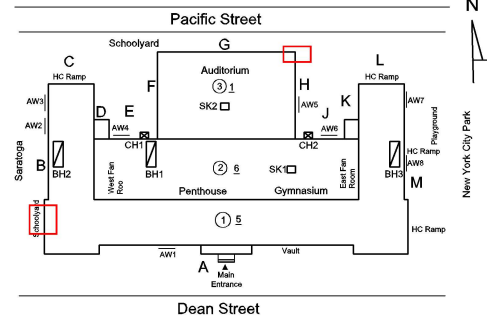
STONE: CRACKS/SPALLING - MAJOR

REPLACE

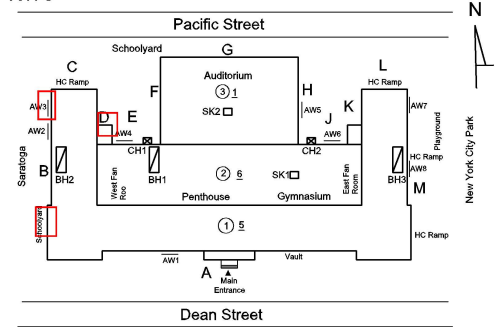
Violations	<p>Facade B</p> <p>No violations recorded.</p>
Deficiency	<p>STONE: DETERIORATED JOINTS</p>
Roof Plan reference	<p>K178</p>

Deficiency Quantity	25
Quantity Uom	L.F.
Potential Action	REPOINT
Urgency of Action	PRIORITY 4
Purpose of Action	LEVEL 2
Deficiency Photo1

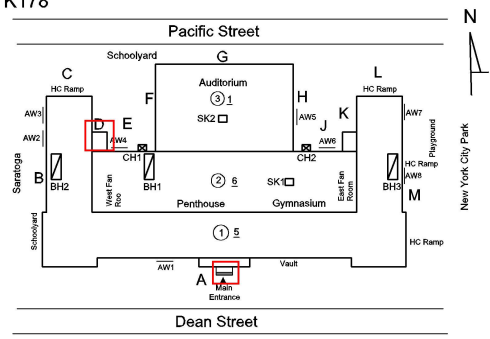
Violations	<p>Facade B</p> <p>No violations recorded.</p>
Deficiency	<p>CONCRETE: CRACKS/SPALLING - MAJOR</p>

Deficiency Quantity	30
Quantity Uom	S.F.
Potential Action	REPLACE
Urgency of Action	PRIORITY 4
Purpose of Action	LEVEL 2
Deficiency Photo1
