NYC Department of Education
Building Condition Assessment Survey 2023 - 2024

Architectural Inspection

Asset: **P.S. 205 - BROOKLYN, 6701 20 AVENUE, New York, 11204**

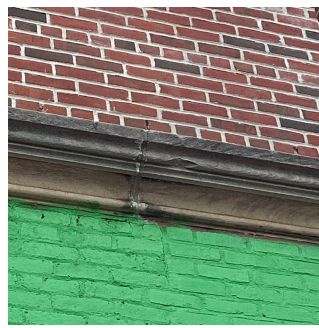
Violations	Facade C - Roof 4 No violations recorded.
DOORS	Inspected
DOORS AND FRAMES	Inspected
Condition	5 - Poor
Deficiency	METAL CLAD: DETERIORATED DOOR AND FRAME - MINOR DETERIORATION
Roof Plan reference

Question	Response
EXTERIOR	
COPING	
Deficiency Photo1	 
Violations	Roof 1 - Near BH2 No violations recorded.
CORNICE	Inspected
Condition	3 - Fair
Deficiency	STONE: MAJOR CRACKS, SPALLING
Roof Plan reference	K205  
Deficiency Quantity	10
Quantity Uom	S.F.
Potential Action	REPLACE
Urgency of Action	PRIORITY 4
Purpose of Action	LEVEL 2
Deficiency Photo1	 
Violations	Facade G No violations recorded.
Deficiency	STONE: MINOR CRACKS, SPALLING

Deficiency Quantity	20
Quantity Uom	S.F.
Potential Action	REPAIR
Urgency of Action	PRIORITY 3
Purpose of Action	LEVEL 2
Deficiency Photo1

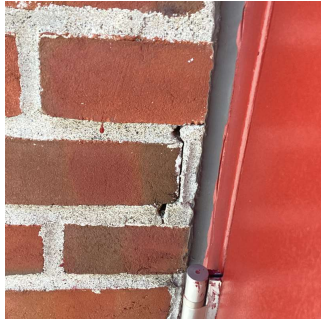
Violations	BH3 No violations recorded.
Deficiency	BULKHEAD/PENTHOUSE CEILING: PLASTER DAMAGED/DETERIORATED
Roof Plan reference	<p>K205</p>

Question	Response
EXTERIOR	
ROOF	
Roofing	Inspected
ROOFING DRAINS	Inspected
Condition	2 - Between Good and Fair
Deficiency	No deficiencies recorded
Specialties	Inspected
BULKHEAD/PENTHOUSE	Inspected
Condition	3 - Fair
Deficiency	BULKHEAD/PENTHOUSE DOORS: DETERIORATED DOOR
RooF Plan reference	<div> <div>K205</div> </div>
Deficiency Quantity	1
Quantity Uom	EACH
Potential Action	REPLACE DOOR
Urgency of Action	PRIORITY 4
Purpose of Action	LEVEL 2
Deficiency Photo1	
	Roof 1 - PH
Violations	No violations recorded.
Deficiency	BULKHEAD/PENTHOUSE WALLS/EXTERIOR: DETERIORATED JOINTS
RooF Plan reference	<div> <div>K205</div> </div>
Deficiency Quantity	10
Quantity Uom	S.F.
Potential Action	REPOINT

Question	Response
EXTERIOR	
ROOF	
Specialties	Inspected
BULKHEAD/PENTHOUSE	Inspected
Urgency of Action	PRIORITY 3
Purpose of Action	LEVEL 2
Deficiency Photo1

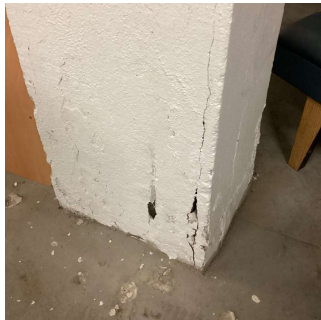
Violations	Basement - Storage Room by Oil Tank No violations recorded.
Deficiency	STEEL COLUMNS/BEAMS: DETERIORATED CONCRETE FIREPROOFING
Deficiency Location/Instance	Basement - Boiler Room, Rooms B01, B12
Deficiency Quantity	80

Question	Response
INTERIOR	
STRUCTURAL	Inspected
COLUMNS/BEAMS/BEARING WALLS	Inspected
Condition	3 - Fair
Deficiency	STEEL COLUMNS/BEAMS: DETERIORATED/MISSING SPRAY-ON FIREPROOFING
Deficiency Location/Instance	Basement - B12
Deficiency Quantity	20
Quantity Uom	S.F.
Potential Action	REPLACE
Urgency of Action	PRIORITY 3
Purpose of Action	LEVEL 5
Deficiency Photo1	 
Violations	Basement - B12 No violations recorded.
Deficiency	STEEL COLUMNS/BEAMS: DETERIORATED CONCRETE FIREPROOFING
Deficiency Location/Instance	Basement - Room B01, Boiler Room, Storage Room by Oil Tank
Deficiency Quantity	30
Quantity Uom	S.F.
Potential Action	REPLACE
Urgency of Action	PRIORITY 4
Purpose of Action	LEVEL 5
Deficiency Photo1

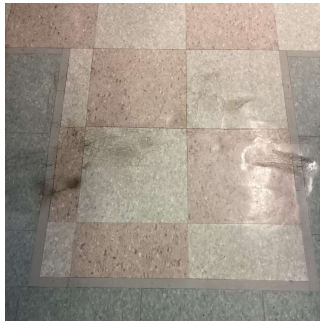
Room 506
Violations	No violations recorded.
Floor Finish	Inspected
Condition	3 - Fair
Deficiency	TERRAZZO: CRACKS
Deficiency Location/Instance	Main Entrance Lobby, Corridor near Rooms 210, 211, 213, by Auditorium and others
Deficiency Quantity	100
Quantity Uom	S.F.
Potential Action	REPLACE
Urgency of Action	PRIORITY 3
Purpose of Action	LEVEL 2
Deficiency Photo1

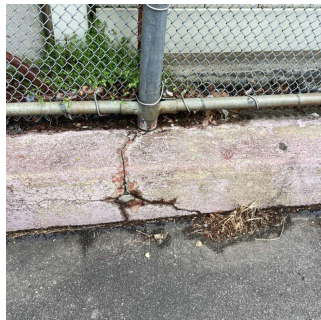
Near Playground
Violations	No violations recorded.
Deficiency	WROUGHT IRON: DAMAGED/DETERIORATED
Deficiency Location/Instance	67th Street, 20th Avenue

67th Street
Violations	No violations recorded.
Deficiency	CONCRETE CURB: DAMAGED/DETERIORATED
Deficiency Location/Instance	Near Playground, 68th Street
Deficiency Quantity	70
Quantity Uom	S.F.
Potential Action	REPLACE
Urgency of Action	PRIORITY 3
Purpose of Action	LEVEL 2
Deficiency Photo1

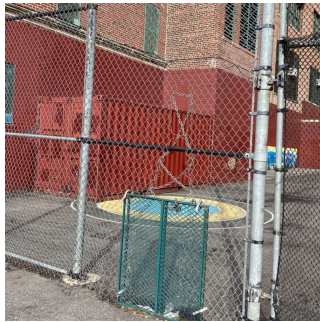
67th Street, Schoolyard
Violations	No violations recorded.
Deficiency	CHAIN LINK: DAMAGED POST/RAIL
Deficiency Location/Instance	67th Street, Schoolyard
Deficiency Quantity	30
Quantity Uom	L.F.
Potential Action	REPLACE
Urgency of Action	PRIORITY 3
Purpose of Action	LEVEL 2
Deficiency Photo1

67th Street
Violations	No violations recorded.
Deficiency	CHAIN LINK: DAMAGED/DETERIORATED
Deficiency Location/Instance	Schoolyard
Deficiency Quantity	600
Quantity Uom	S.F.
Potential Action	REPLACE
Urgency of Action	PRIORITY 3
Purpose of Action	LEVEL 2
Deficiency Photo1
