**NYC Department of Education**  
**Building Condition Assessment Survey 2023 - 2024**

Architectural Inspection

**Asset: I.S. 211 - BROOKLYN, 1001 EAST 100 STREET, New York, 11236**

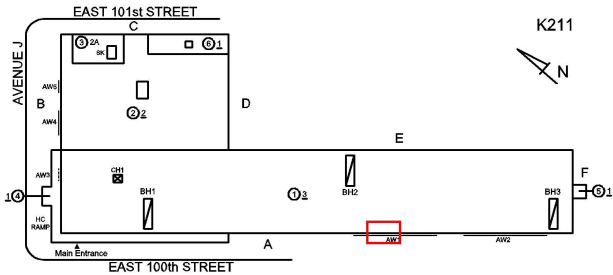
Question	Response
<b>Architectural</b>	
<b>EXTERIOR</b>	Inspected
<b>AREAWAY</b>	Inspected
Instance on AW1-AW5	Inspected
Instance Condition	3 - Fair
Instance Quantity	5
Instance Quantity Uom	EACH
Deficiency	AREAWAY WALLS: CRACKS AND SPALLING
Roof Plan reference

Deficiency Quantity	25
Quantity Uom	S.F.
Potential Action	REPAIR
Urgency of Action	PRIORITY 3
Purpose of Action	LEVEL 2
Deficiency Photo1

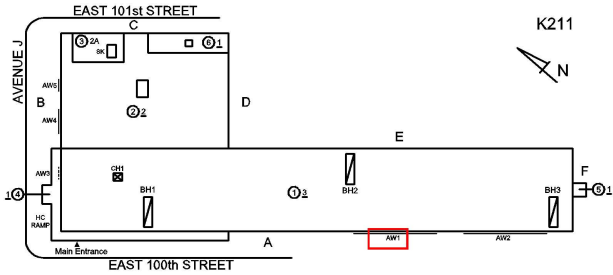
Violations	AW1 No violations recorded.
Deficiency	AREAWAY SLAB: CRACKS AND SPALLING
Roof Plan reference

Deficiency Quantity	40
Quantity Uom	S.F.
Potential Action	REPAIR
Urgency of Action	PRIORITY 3
Purpose of Action	LEVEL 2

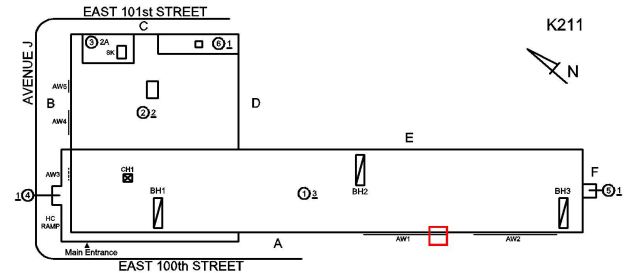
AREAWAY SLAB: CRACKS AND SPALLING

REPLACE

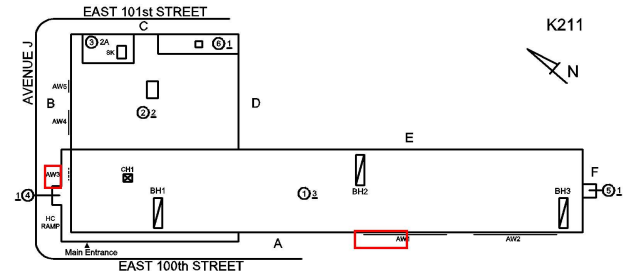
AREAWAY WALLS: CRACKS AND SPALLING

REPLACE

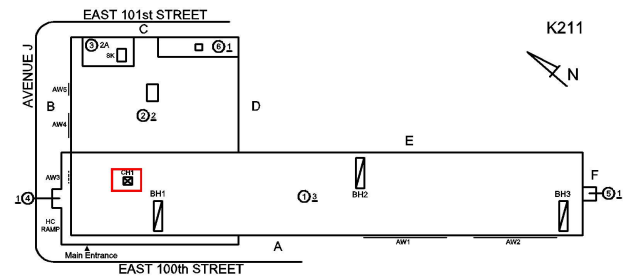
BRICK: DETERIORATED JOINTS

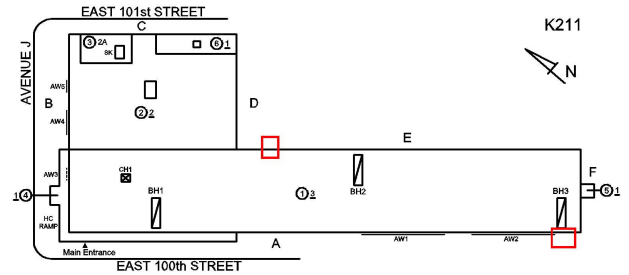
Question	Response
<b>EXTERIOR</b>	
<b>COPING</b>	Inspected
Condition	2 - Between Good and Fair
Deficiency	No deficiencies recorded
<b>CORNICE</b>	Does not Exist
<b>DOORS</b>	Inspected
<b>DOORS AND FRAMES</b>	Inspected
Condition	5 - Poor
Deficiency	WOOD: DETERIORATED DOOR AND FRAME - MAJOR DETERIORATION
Roof Plan reference

Deficiency Quantity	4
Quantity Uom	EACH
Potential Action	REPLACE
Urgency of Action	PRIORITY 4
Purpose of Action	LEVEL 2
Deficiency Photo1

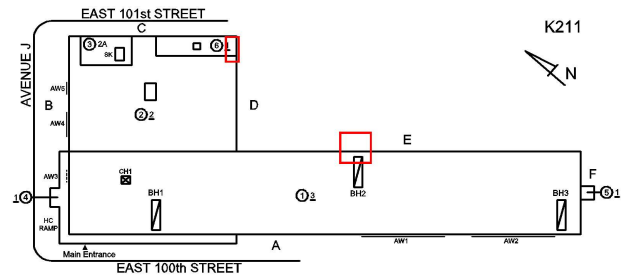
Violations	Facade D No violations recorded.
Deficiency	METAL: DETERIORATED DOOR AND FRAME - MAJOR DETERIORATION
Roof Plan reference

Deficiency Quantity	5
Quantity Uom	EACH
Potential Action	REPLACE
Urgency of Action	PRIORITY 4
Purpose of Action	LEVEL 2

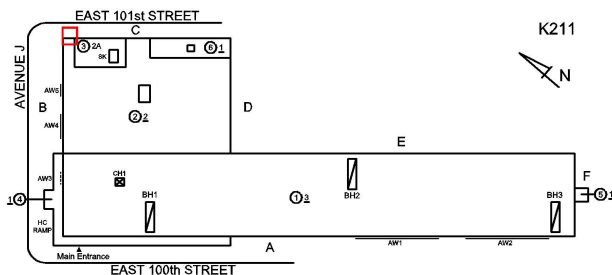
METAL: DETERIORATED DOOR AND FRAME - MINOR  
DETERIORATION

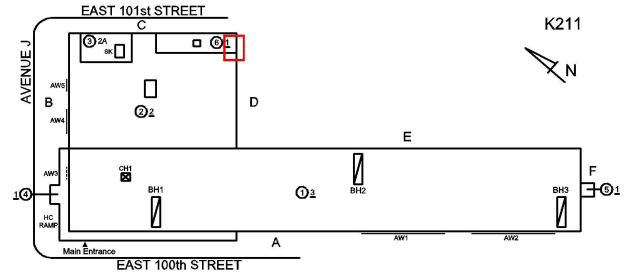
METAL: BROKEN GLASS

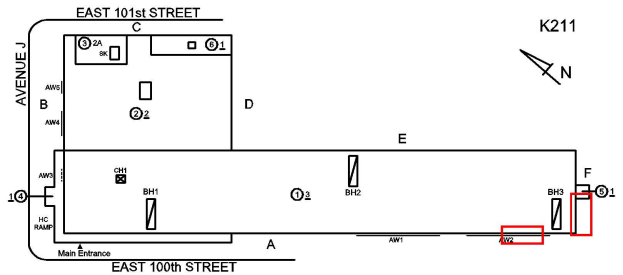
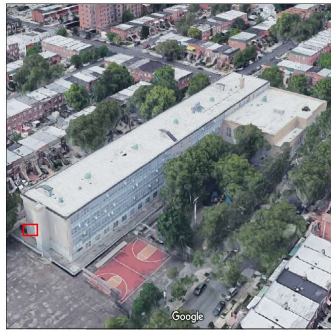
Violations	<p>Facade D</p> <p>No violations recorded.</p>
<b>EXTERIOR WALLS</b>	Inspected
Material Type(s)	Masonry
Replacement Quantity	33,000
Replacement Uom	S.F.
Instance on All Facades	Inspected
Instance Condition	3 - Fair
Instance Quantity	33,000
Instance Quantity Uom	S.F.
Deficiency	BRICK: DETERIORATED JOINTS
Roof Plan reference

Deficiency Quantity	75
Quantity Uom	S.F.
Potential Action	REPOINT
Urgency of Action	PRIORITY 3
Purpose of Action	LEVEL 2

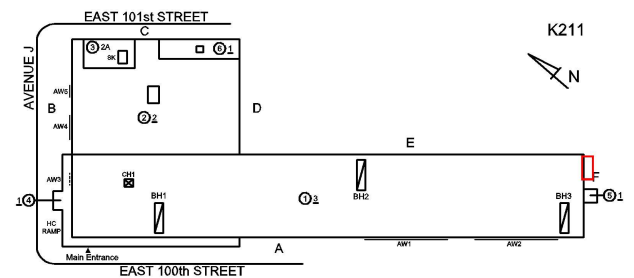
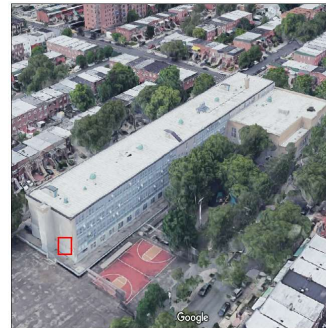
**BRICK: DETERIORATED JOINTS**

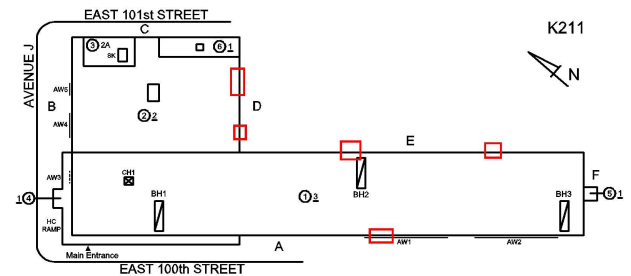
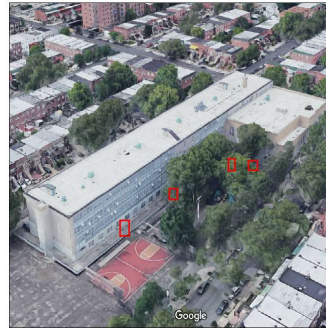
BRICK: DETERIORATED MASONRY SILLS - MAJOR

REMOVE AND REPLACE

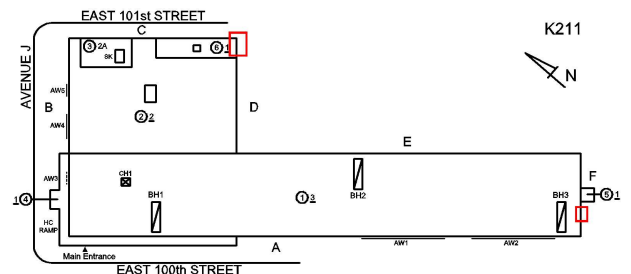
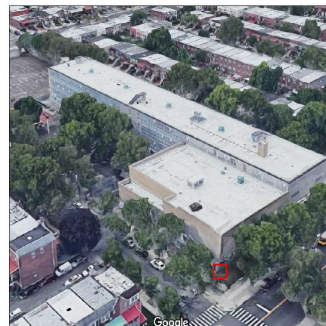
BRICK: MAJOR / THRU CRACKS

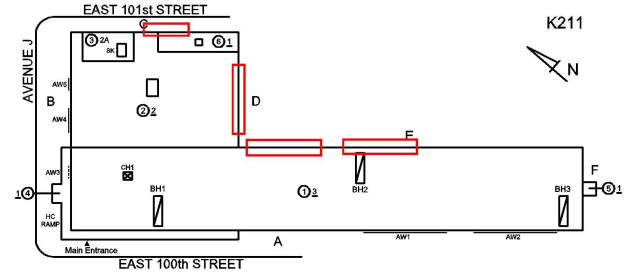
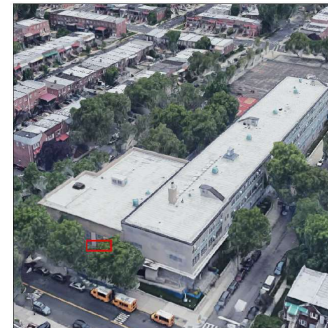
BRICK: DETERIORATED MASONRY SILLS - MINOR

REPAIR

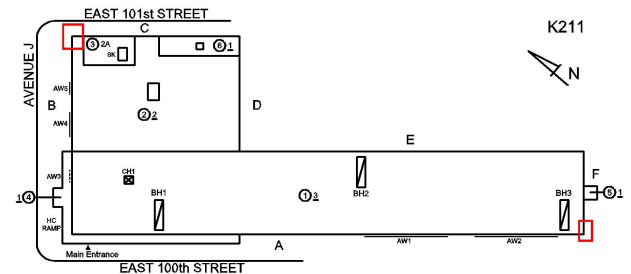
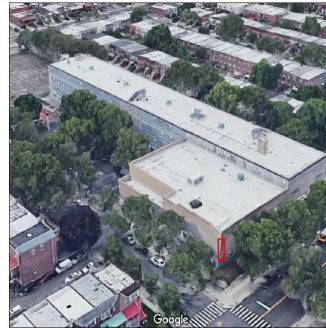
BRICK: CRACKS/DISPLACED/SPALLED BRICK AT BUILDING CORNERS

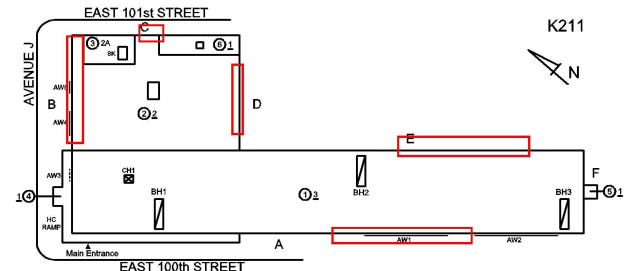
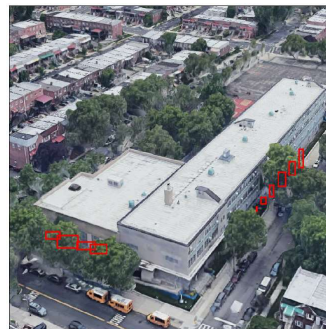
BRICK: MASONRY SILLS - DETERIORATED JOINTS

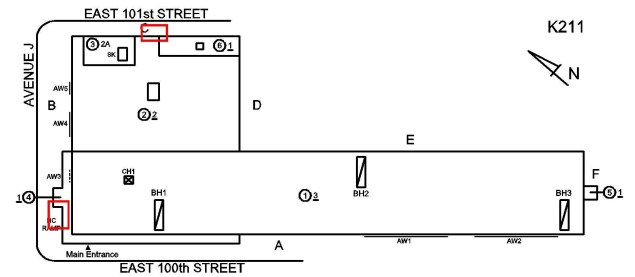
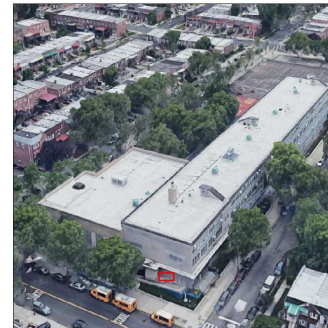
STONE: DETERIORATED JOINTS

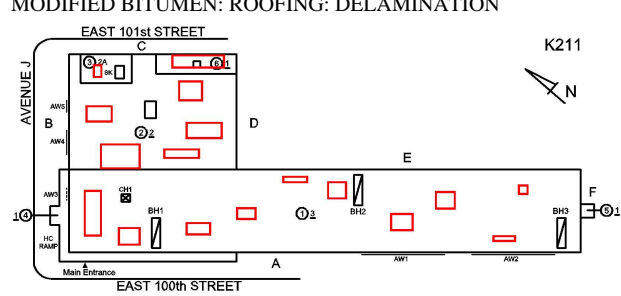
Is/Are the roof(s) suitable for Solar Panel installation?	Yes
Installation Year	2012
Source of Installation	Custodial Staff
Deficiency	MODIFIED BITUMEN: ROOFING: DELAMINATION
Roof Plan reference

Deficiency Quantity	310
Quantity Uom	S.F.
Potential Action	REPLACE ROOFING WITHOUT MAJOR EQUIPMENT REMOVAL
Urgency of Action	PRIORITY 4
Purpose of Action	LEVEL 2

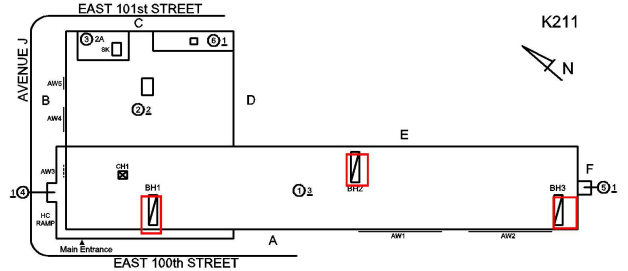
Violations	Roof 1 No violations recorded.
<b>ROOFING DRAINS</b>	Inspected
Condition	2 - Between Good and Fair
Deficiency	No deficiencies recorded
<b>Specialties</b>	Inspected
<b>BULKHEAD/PENTHOUSE</b>	Inspected
Condition	3 - Fair
Deficiency	BULKHEAD/PENTHOUSE WALLS/EXTERIOR: CRACKS/SPALLING - MINOR
Roof Plan reference

Deficiency Quantity	50
Quantity Uom	S.F.
Potential Action	REPAIR
Urgency of Action	PRIORITY 3
Purpose of Action	LEVEL 2
Deficiency Photo1

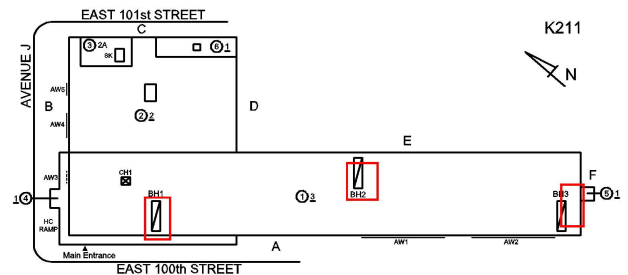
Deficiency	<b>BULKHEAD/PENTHOUSE WALLS/INTERIOR: GLAZED BLOCK CRACKS/SPALLING</b>
Roof Plan reference

40  
S.F.  
REPLACE  
PRIORITY 4  
LEVEL 2

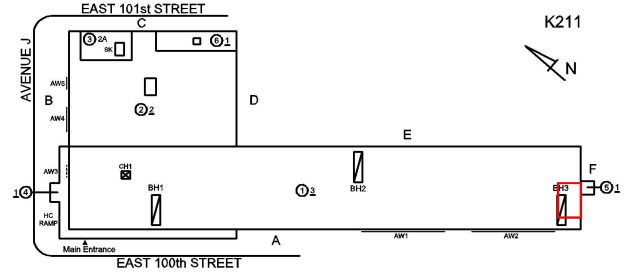
**BULKHEAD/PENTHOUSE WALLS/INTERIOR: GLAZED BLOCK CRACKS/SPALLING**

REPLACE

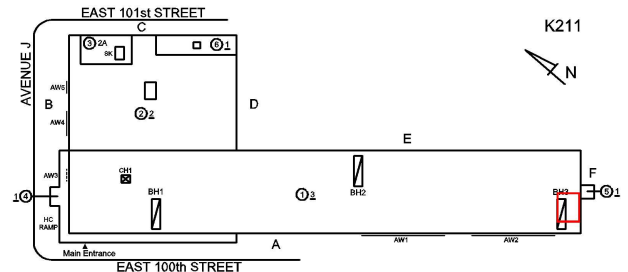
**BULKHEAD/PENTHOUSE CEILING: PLASTER DAMAGED/DETERIORATED**

Question	Response
<b>EXTERIOR</b>	
<b>ROOF</b>	
<b>Specialties</b>	
<b>BULKHEAD/PENTHOUSE</b>	
Deficiency Quantity	10
Quantity Uom	S.F.
Potential Action	REPLACE
Urgency of Action	PRIORITY 3
Purpose of Action	LEVEL 2
Deficiency Photo1

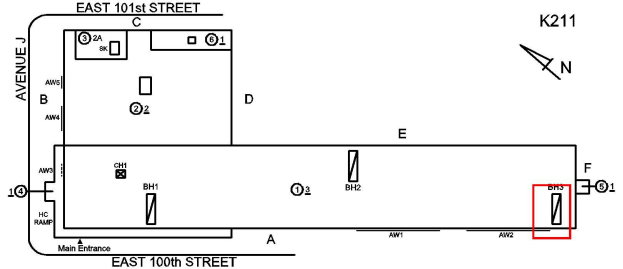
Violations	BH3 No violations recorded.
Deficiency	BULKHEAD/PENTHOUSE ROOF: MINOR LEAKAGE
Roof Plan reference

Deficiency Quantity	50
Quantity Uom	S.F.
Potential Action	MAINTENANCE
Urgency of Action	PRIORITY 3
Purpose of Action	LEVEL 2
Deficiency Photo1

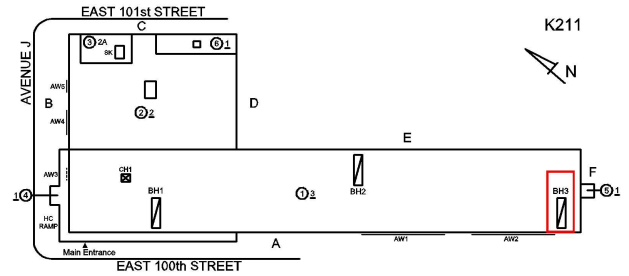
Violations	BH3 No violations recorded.
Deficiency	BULKHEAD/PENTHOUSE WALLS/INTERIOR: PLASTER CRACKS/SPALLING

15  
S.F.  
REPLACE  
PRIORITY 4  
LEVEL 2

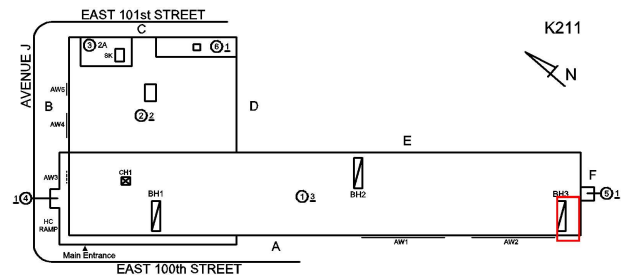
Deficiency	<b>BULKHEAD/PENTHOUSE WALLS/EXTERIOR: WATER INFILTRATION</b>
------------	--

50  
S.F.  
REPAIR  
PRIORITY 5  
LEVEL 2

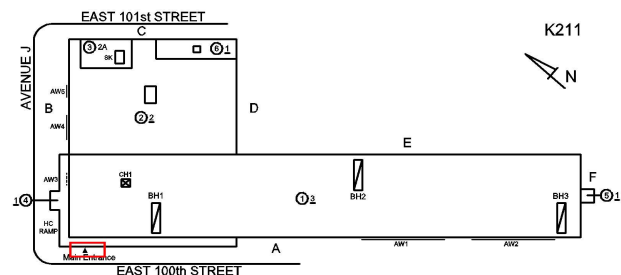
Question	Response
<b>EXTERIOR</b>	
<b>STAIRS/RAMPS: EXTERIOR</b>	
<b>BUILDING CHEEK/FLANK WALLS</b>	Inspected
Condition	4 - Between Fair and Poor
Deficiency	STONE: DETERIORATED JOINTS
Roof Plan reference

Deficiency Quantity	10
Quantity Uom	S.F.
Potential Action	REPOINT
Urgency of Action	PRIORITY 3
Purpose of Action	LEVEL 2
Deficiency Photo1

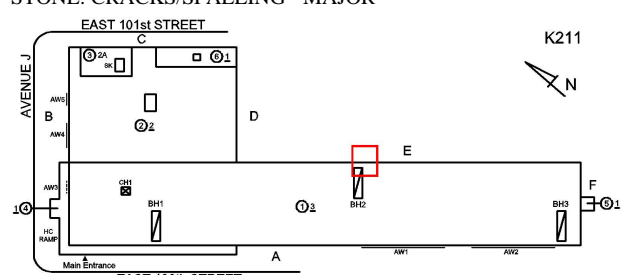
Violations	<p>Facade A</p> <p>No violations recorded.</p>
Deficiency	STONE: CRACKS/SPALLING - MAJOR
Roof Plan reference

Deficiency Quantity	20
Quantity Uom	S.F.
Potential Action	REPLACE
Urgency of Action	PRIORITY 4
Purpose of Action	LEVEL 2

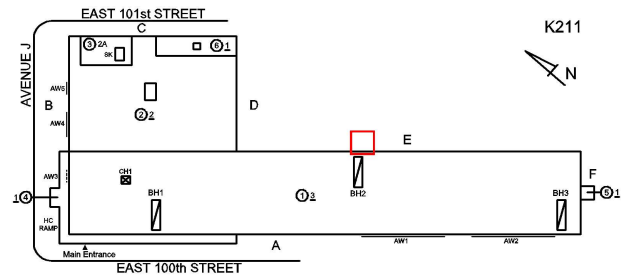
**STONE: CRACKS/SPALLING - MINOR**

REPAIR

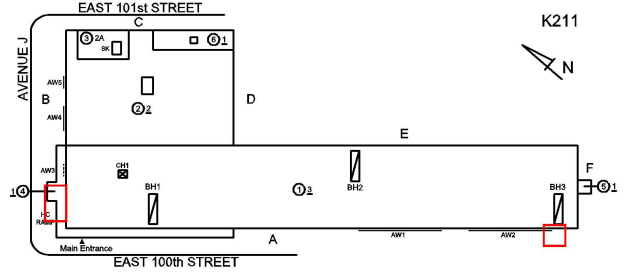
Violations	<p>Facade B</p> <p>No violations recorded.</p>
Deficiency	RUST - MAJOR
Roof Plan reference

Deficiency Quantity	30
Quantity Uom	L.F.
Potential Action	REPLACE
Urgency of Action	PRIORITY 4
Purpose of Action	LEVEL 2
Deficiency Photo1

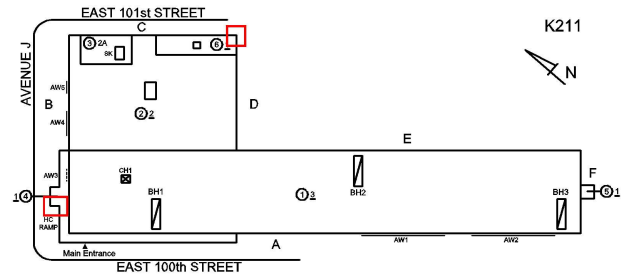
Question	Response
<b>EXTERIOR</b>	
<b>STAIRS/RAMPS: EXTERIOR</b>	
<b>STAIRS/RAMPS</b>	
Violations	No violations recorded.
Deficiency	CONCRETE: CRACKS/SPALLING - MINOR
Roof Plan reference

Deficiency Quantity	20
Quantity Uom	S.F.
Potential Action	REPAIR
Urgency of Action	PRIORITY 3
Purpose of Action	LEVEL 2
Deficiency Photo1

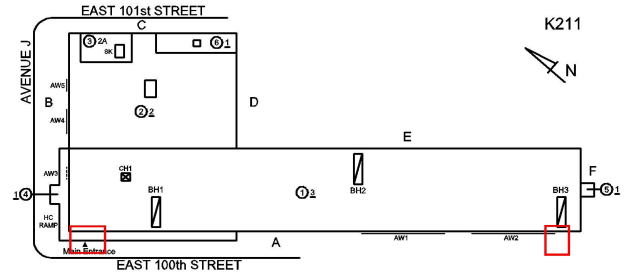
Violations	Facade B
Deficiency	STONE: DETERIORATED JOINTS
Roof Plan reference

Deficiency Quantity	25
Quantity Uom	L.F.
Potential Action	REPOINT
Urgency of Action	PRIORITY 4
Purpose of Action	LEVEL 2

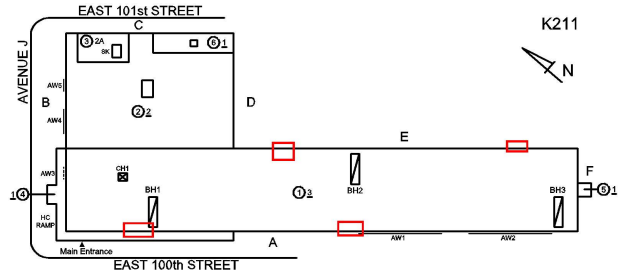
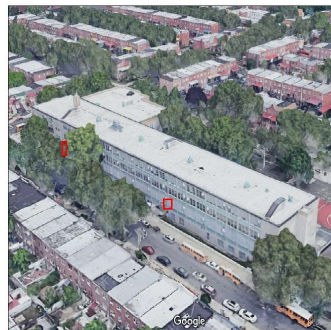
Violations	<p>Facade A</p> <p>No violations recorded.</p>
<b>WINDOWS</b>	Inspected
Replacement Quantity	12,000
Replacement Uom	S.F.
<b>EXTERIOR GUARDS</b>	Inspected
Condition	3 - Fair
Deficiency	DETERIORATED/TORN-OUT/MISSING
Roof Plan reference

Deficiency Quantity	120
Quantity Uom	S.F.
Potential Action	REPLACE
Urgency of Action	PRIORITY 4
Purpose of Action	LEVEL 2

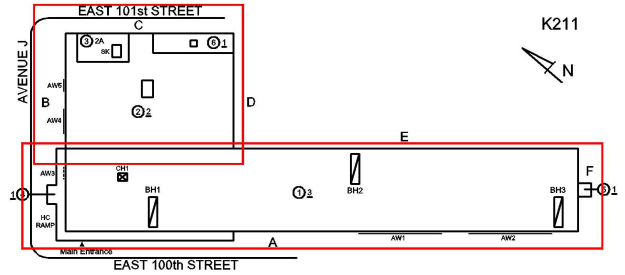
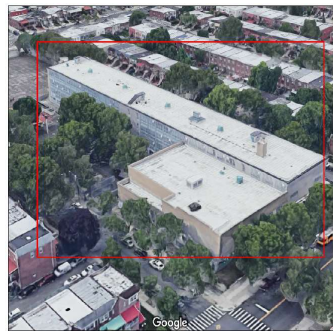
Violations	<p>Facade E</p> <p>No violations recorded.</p>
<b>LINTELS</b>	Inspected
Condition	2 - Between Good and Fair
Deficiency	No deficiencies recorded
<b>WINDOWS</b>	Inspected
Material Type(s)	Aluminum
Instance on Aluminum - Double Hung: All Facades	Inspected
Instance Condition	3 - Fair
Instance Quantity	12,000
Instance Quantity Uom	S.F.
Are these windows insulated	No
Installation Year	1996
Source of Installation	Custodial Staff
Deficiency	ALUMINUM - DOUBLE HUNG: INOPERABLE BALANCE
Roof Plan reference

Deficiency Quantity	120
Quantity Uom	EACH
Potential Action	REPLACE BALANCES
Urgency of Action	PRIORITY 3
Purpose of Action	LEVEL 2
