**NYC Department of Education**  
**Building Condition Assessment Survey 2023 - 2024**

Architectural Inspection

**Asset:** P.S. 226 - BROOKLYN, 6006 23 AVENUE, New York, 11204

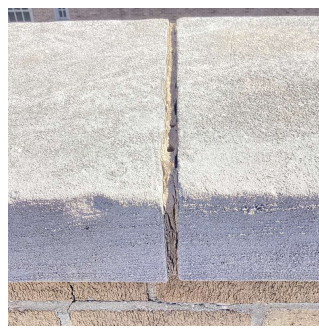
Violations	<p>Roof 3</p> <p>No violations recorded.</p>
Deficiency	<b>CAST STONE: DETERIORATED TRANSVERSE JOINTS</b>

Violations	Roof 3 No violations recorded.
<b>CORNICE</b>	Inspected
Condition	2 - Between Good and Fair
Deficiency	No deficiencies recorded
<b>DOORS</b>	Inspected
<b>DOORS AND FRAMES</b>	Inspected
Condition	5 - Poor
Deficiency	METAL CLAD: DETERIORATED DOOR AND FRAME - MAJOR DETERIORATION
Roof Plan reference

Deficiency Quantity	35
Quantity Uom	L.F.
Potential Action	MAINTENANCE
Urgency of Action	PRIORITY 3
Purpose of Action	LEVEL 2
Deficiency Photo1

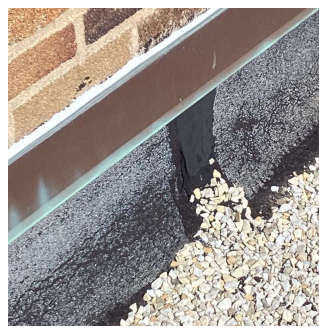
Question	Response
<b>EXTERIOR</b>	
<b>ROOF</b>	
<b>Roofing</b>	
<b>ROOFING</b>	
Does the roof have major mechanical equipment sitting on Dunnage Steel less than 18" above the Roofing?	No
Does this roof instance have a Sustainable Roof System?	No
Do solar panels exist on these roofs?	No
Is/Are the roof(s) suitable for Solar Panel installation?	Yes
Installation Year	1992
Source of Installation	Custodial Staff
Deficiency	BUILT-UP: FLASHING: BASE FLASHING DETERIORATED
Roof Plan reference

Violations	Roof 1 No violations recorded.
Deficiency	BUILT-UP: ROOFING: MAJOR ACTIVE ROOF LEAKS IN NON-INSTRUCTIONAL SPACE
Roof Plan reference

Deficiency Quantity	10
Quantity Uom	S.F.
Potential Action	REPAIR
Urgency of Action	PRIORITY 3
Purpose of Action	LEVEL 2
Deficiency Photo1

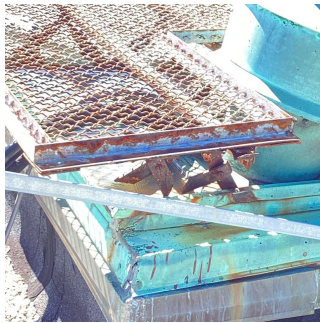
Question	Response
<b>EXTERIOR</b>	
<b>ROOF</b>	
<b>Specialties</b>	
<b>SKYLIGHT/ROOF VENT</b>	
Urgency of Action	PRIORITY 3
Purpose of Action	LEVEL 2
Deficiency Photo1

SK
Violations	No violations recorded.
<b>ROOF/GRAVITY TANK</b>	Does not Exist
<b>STAIRS/RAMPS: EXTERIOR</b>	Inspected
<b>BUILDING CHEEK/FLANK WALLS</b>	Inspected
Condition	5 - Poor
Deficiency	BRICK: CRACKS/SPALLING - MINOR
Roof Plan reference	<p>K226</p>

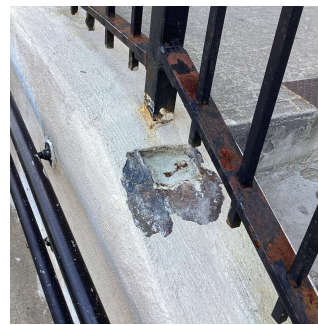
Facade C

CAST IN PLACE CONCRETE: CRACKS/SPALLING - MINOR

REPLACE

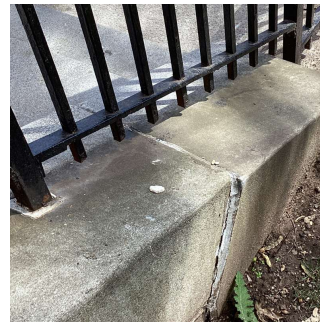
Facade A

RUST - MAJOR

REPLACE

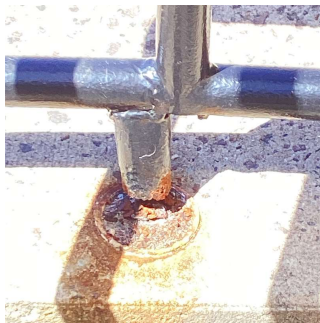
Question	Response
<b>EXTERIOR</b>	
<b>STAIRS/RAMPS: EXTERIOR</b>	
<b>RAILINGS</b>	
Deficiency Photo1

Violations	Facade F No violations recorded.
<b>STAIRS/RAMPS</b>	Inspected
Condition	5 - Poor
Deficiency	STONE: DETERIORATED JOINTS
Roof Plan reference

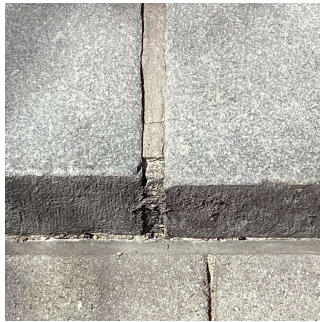
Violations	Facade A No violations recorded.
Deficiency	STONE: DETERIORATED JOINTS

Deficiency Quantity	10
Quantity Uom	L.F.
Potential Action	REPOINT
Urgency of Action	PRIORITY 3
Purpose of Action	LEVEL 2
Deficiency Photo1

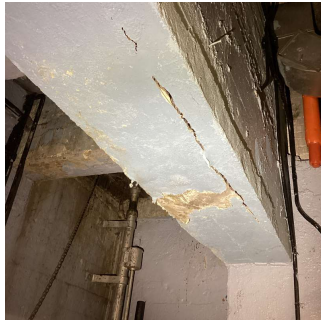
Question	Response
<b>INTERIOR</b>	
<b>STRUCTURAL</b>	
<b>COLUMNS/BEAMS/BEARING WALLS</b>	
Deficiency Photo1

Violations	Ash Hoist Vault No violations recorded.
Deficiency	STEEL COLUMNS/BEAMS: DETERIORATED CONCRETE FIREPROOFING
Deficiency Location/Instance	Basement
Deficiency Quantity	90
Quantity Uom	S.F.
Potential Action	REPLACE
Urgency of Action	PRIORITY 4
Purpose of Action	LEVEL 5
Deficiency Photo1

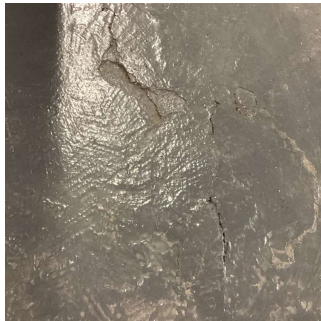
Question	Response
<b>INTERIOR</b>	
<b>STRUCTURAL</b>	
<b>FLOOR STRUCTURE</b>	
Deficiency Photo1

Violations	Boiler Room No violations recorded.
Deficiency	CONCRETE: CRACKS/SPALLED/REINFORCEMENT EXPOSED
Deficiency Location/Instance	Basement
Deficiency Quantity	45
Quantity Uom	S.F.
Potential Action	REPAIR
Urgency of Action	PRIORITY 4
Purpose of Action	LEVEL 5
Deficiency Photo1

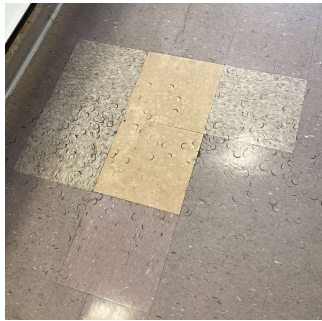
Question	Response
<b>INTERIOR</b>	
<b>CAFETERIA</b>	Inspected
<b>Fixed Equipment</b>	
Instance on 1st Floor	Inspected
Condition	2 - Between Good and Fair
Deficiency	No deficiencies recorded
<b>Floor Finish</b>	
Instance on 1st Floor	Inspected
Condition	5 - Poor
Deficiency	VINYL TILES: BROKEN/DETERIORATED/MISSING TILES
Deficiency Location/Instance	Near Toilet Room 158, Center, Near Windows
Deficiency Quantity	220
Quantity Uom	S.F.
Potential Action	REPLACE
Urgency of Action	PRIORITY 3
Purpose of Action	LEVEL 2
Deficiency Photo1

Near Toilet Room 158
Violations	No violations recorded.
Deficiency	VINYL TILES: DETERIORATED SUBSTRATE
Deficiency Location/Instance	Near Stair C, Near Serving Area, Center
Deficiency Quantity	350
Quantity Uom	S.F.
Potential Action	REPLACE
Urgency of Action	PRIORITY 3
Purpose of Action	LEVEL 2
Deficiency Photo1

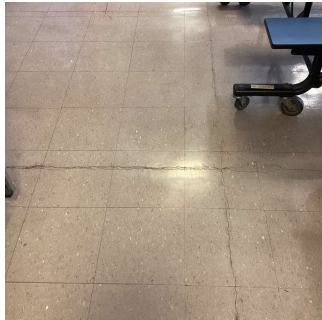
Near Stair C
Violations	No violations recorded.
<b>Sliding-folding Partition</b>

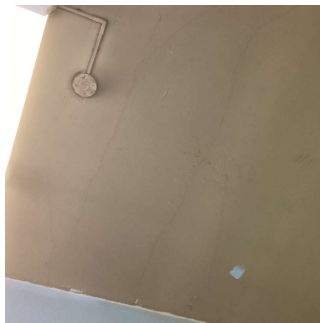
Question	Response
<b>INTERIOR</b>	
<b>STAIRS/RAMPS: INTERIOR</b>	
<b>Ceiling</b>	
Deficiency Photo1

Violations	Stair AB/4 No violations recorded.
<b>Door(s)</b>	Inspected
Condition	5 - Poor
Deficiency	WOOD: DETERIORATED DOOR
Deficiency Location/Instance	Stairs CD/1 Vestibule, G/1
Deficiency Quantity	4
Quantity Uom	EACH
Potential Action	MAINTENANCE
Urgency of Action	PRIORITY 3
Purpose of Action	LEVEL 2
Deficiency Photo1

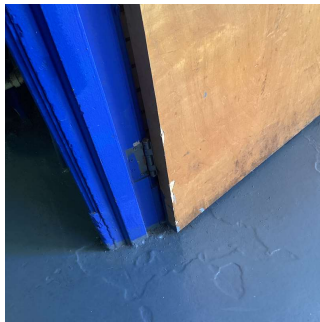
Violations	Stair G/1 No violations recorded.
Deficiency	METAL CLAD WOOD: DETERIORATED DOOR AND FRAME
Deficiency Location/Instance	Stair G/1,3
Deficiency Quantity	2
Quantity Uom	EACH
Potential Action	MAINTENANCE
Urgency of Action	PRIORITY 3
Purpose of Action	LEVEL 2
Deficiency Photo1

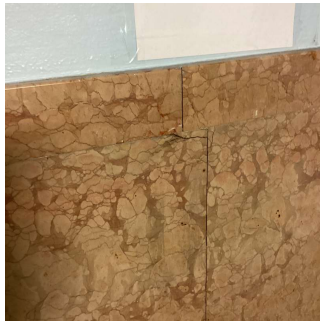
Question	Response
<b>INTERIOR</b>	
<b>STAIRS/RAMPS: INTERIOR</b>	
<b>Walls</b>	
Deficiency Photo1	 
Violations	Stair AB/1 No violations recorded.
Deficiency	STONE: CRACKS/SPALLING
Deficiency Location/Instance	Stair AB/2
Deficiency Quantity	20
Quantity Uom	S.F.
Potential Action	REPLACE
Urgency of Action	PRIORITY 3
Purpose of Action	LEVEL 2
Deficiency Photo1

Violations	Stair AB/2 No violations recorded.
Deficiency	PLASTER: CRACKS/SPALLING
Deficiency Location/Instance	Stairs AB/4, G/2,4
Deficiency Quantity	80
Quantity Uom	S.F.
Potential Action	REPLACE
Urgency of Action	PRIORITY 3
Purpose of Action	LEVEL 2
Deficiency Photo1	 
Violations	Stair G/4 No violations recorded.

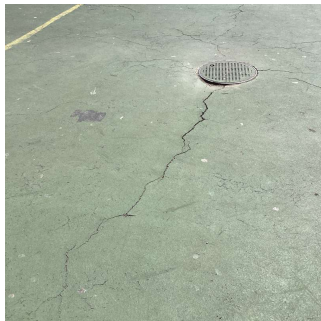
Question	Response
<b>SITE</b>	
<b>PAVING</b>	
<b>Student Use</b>	
<b>Asphalt</b>	
Urgency of Action	PRIORITY 3
Purpose of Action	LEVEL 2
Deficiency Photo1

Violations	Schoolyard No violations recorded.
<b>Concrete</b>	Inspected
Condition	3 - Fair
Deficiency	DAMAGED/DETERIORATED/MISSING SECTIONS
Deficiency Location/Instance	Near Playground
Deficiency Quantity	75
Quantity Uom	S.F.
Potential Action	REPLACE
Urgency of Action	PRIORITY 3
Purpose of Action	LEVEL 2
Deficiency Photo1

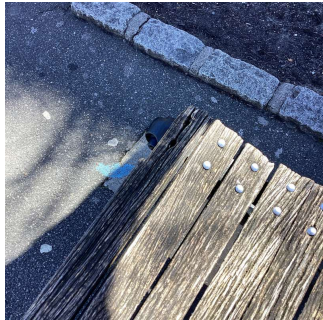
Question	Response
<b>SITE</b>	
<b>SEATING</b>	
<b>Benches</b>	
<b>Metal/Wood/Plastic</b>	
Deficiency	DAMAGED/DETERIORATED
Deficiency Location/Instance	Schoolyard
Deficiency Quantity	4
Quantity Uom	EACH
Potential Action	REPLACE
Urgency of Action	PRIORITY 3
Purpose of Action	LEVEL 2
Deficiency Photo1

Violations	Schoolyard No violations recorded.
Deficiency	DAMAGED/DETERIORATED
Deficiency Location/Instance	Schoolyard
Deficiency Quantity	12
Quantity Uom	EACH
Potential Action	REPLACE
Urgency of Action	PRIORITY 5
Purpose of Action	LEVEL 6
Deficiency Photo1

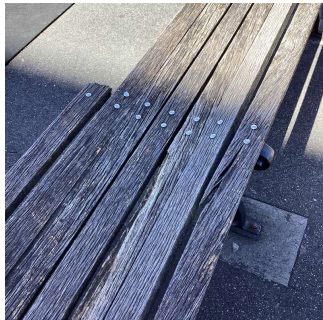
Violations	Schoolyard No violations recorded.
<b>Bleachers</b>	Does not Exist
<b>SITE WALLS (NOT RETAINING WALLS)</b>	Does not Exist
<b>STAIRS/RAMPS: EXTERIOR</b>	Does not Exist
<b>ARTWORK</b>	Does not Exist
