NYC Department of Education
Building Condition Assessment Survey 2023 - 2024

Architectural Inspection

Asset: **P.S. 261 - BROOKLYN, 314 PACIFIC STREET, New York, 11201**

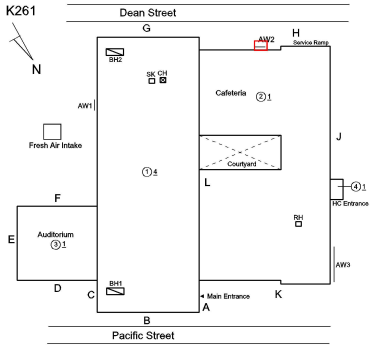
Question	Response
EXTERIOR	
AREAWAY	
Deficiency Photo1	 
Violations	<p>AW1</p> <p>No violations recorded.</p>
Deficiency	AREAWAY SLAB: CRACKS AND SPALLING
Roof Plan reference

Deficiency Quantity	10
Quantity Uom	S.F.
Potential Action	REPAIR
Urgency of Action	PRIORITY 3
Purpose of Action	LEVEL 2
Deficiency Photo1	 
Violations	<p>AW2</p> <p>No violations recorded.</p>
Deficiency	AREAWAY WALLS: CRACKS AND SPALLING

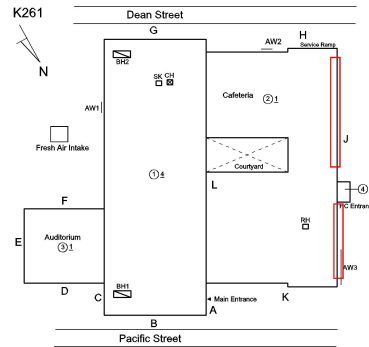
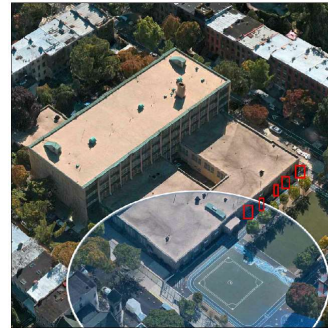
BRICK: DETERIORATED MASONRY SILLS - MAJOR

60
 L.F.
 REMOVE AND REPLACE
 PRIORITY 4
 LEVEL 2

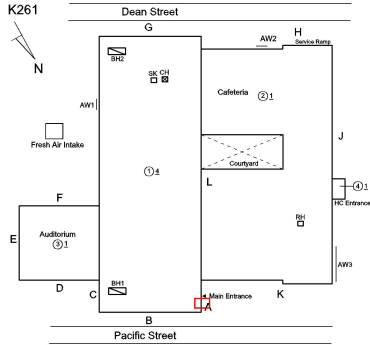
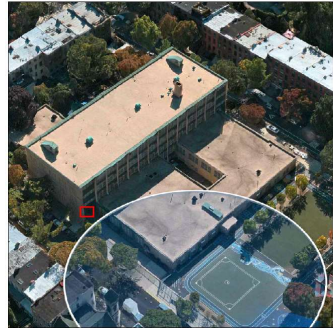
Facade B - Near Main Entrance
Violations	No violations recorded.
EXTERIOR SOFFITS	Inspected
Condition	2 - Between Good and Fair
Deficiency	CONCRETE: MINOR CRACKS/SPALLING
Roof Plan reference

Deficiency Quantity	10
Quantity Uom	S.F.
Potential Action	REPAIR
Urgency of Action	PRIORITY 3
Purpose of Action	LEVEL 2

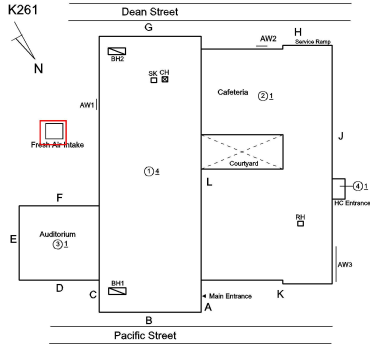
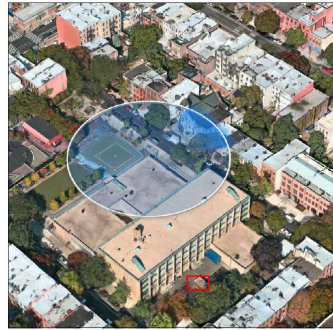
Violations	<p>Facade A - Main Entrance</p> <p>No violations recorded.</p>
LOADING DOCK	Does not Exist
LOUVER	Inspected
Condition	3 - Fair
Deficiency	MISSING/DAMAGED SCREEN
Roof Plan reference	<p>K261</p>

Deficiency Quantity	30
Quantity Uom	S.F.
Potential Action	REPLACE
Urgency of Action	PRIORITY 4
Purpose of Action	LEVEL 2
Deficiency Photo1

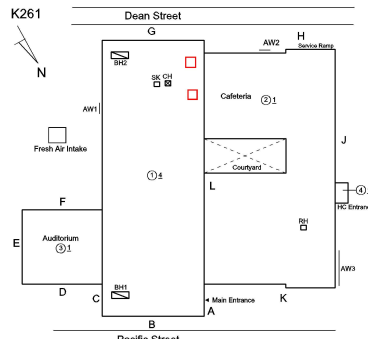
Does the roof have major mechanical equipment sitting on Dunnage Steel less than 18" above the Roofing?	No
Does this roof instance have a Sustainable Roof System?	No
Do solar panels exist on these roofs?	No
Is/Are the roof(s) suitable for Solar Panel installation?	Yes
Installation Year	2006
Source of Installation	Custodial Staff
Deficiency	BUILT-UP: ROOFING: MAJOR ACTIVE ROOF LEAKS IN INSTRUCTIONAL SPACE

Deficiency Quantity	200
Quantity Uom	S.F.
Potential Action	REPLACE ROOFING WITH MAJOR EQUIPMENT REMOVAL
Urgency of Action	PRIORITY 5
Purpose of Action	LEVEL 2
Deficiency Photo1

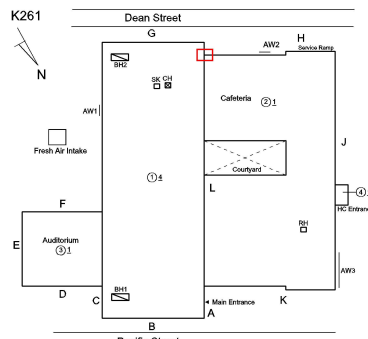
Violations	Roof 1 - Room 430 (shown), Room 416 (similar) No violations recorded.
Deficiency	BUILT-UP: FLASHING: CAP FLASHING DAMAGED
Roof Plan reference

Deficiency Quantity	10
Quantity Uom	L.F.
Potential Action	REPLACE
Urgency of Action	PRIORITY 4
Purpose of Action	LEVEL 2

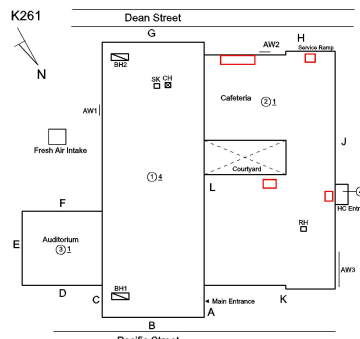
Question	Response
EXTERIOR	
ROOF	
Roofing	
ROOFING	
	Roof 2
Instance Quantity	25,000
Instance Quantity Uom	S.F.
Does the roof have major mechanical equipment sitting on Dunnage Steel less than 18" above the Roofing?	No
Does this roof instance have a Sustainable Roof System?	No
Do solar panels exist on these roofs?	No
Is/Are the roof(s) suitable for Solar Panel installation?	Yes
Installation Year	1997
Source of Installation	Custodial Staff
Deficiency	BUILT-UP: ROOFING: MAJOR ACTIVE ROOF LEAKS IN INSTRUCTIONAL SPACE
Roof Plan reference

Deficiency Quantity	400
Quantity Uom	S.F.
Potential Action	REPLACE ROOFING WITH MAJOR EQUIPMENT REMOVAL
Urgency of Action	PRIORITY 5
Purpose of Action	LEVEL 4
Deficiency Photo1

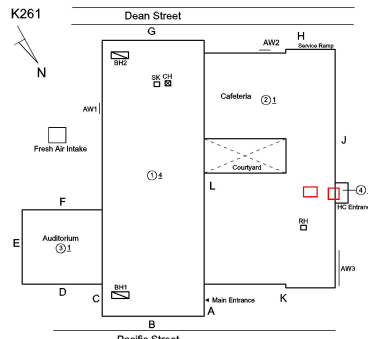
Violations	35495554R, 35650882N
Deficiency	BUILT-UP: ROOFING: MAJOR ACTIVE ROOF LEAKS IN INSTRUCTIONAL SPACE

Deficiency Quantity	300
Quantity Uom	S.F.
Potential Action	REPLACE ROOFING WITHOUT MAJOR EQUIPMENT REMOVAL
Urgency of Action	PRIORITY 5
Purpose of Action	LEVEL 2
Deficiency Photo1

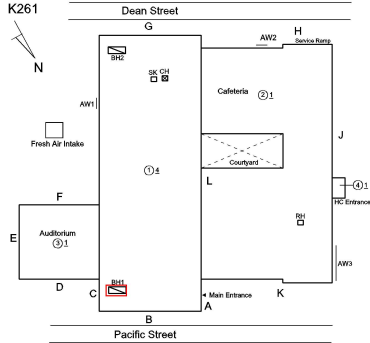
Violations	Roof 2 No violations recorded.
Specialties	Inspected
BULKHEAD/PENTHOUSE	Inspected
Condition	3 - Fair
Deficiency	BULKHEAD/PENTHOUSE WALLS/INTERIOR: GLAZED BLOCK CRACKS/SPALLING
Roof Plan reference

Deficiency Quantity	10
Quantity Uom	S.F.
Potential Action	REPLACE
Urgency of Action	PRIORITY 3
Purpose of Action	LEVEL 2
Deficiency Photo1

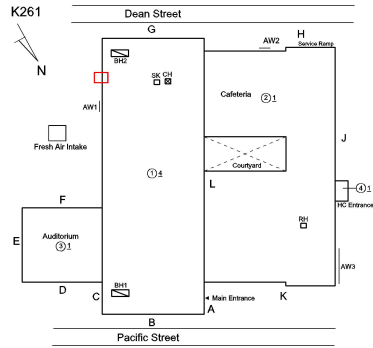
Question	Response
EXTERIOR	
STAIRS/RAMPS: EXTERIOR	
RAILINGS	Inspected
Deficiency	No deficiencies recorded
STAIRS/RAMPS	Inspected
Condition	5 - Poor
Deficiency	STONE: CRACKS/SPALLING - MAJOR
Roof Plan reference

Deficiency Quantity	10
Quantity Uom	S.F.
Potential Action	REPLACE
Urgency of Action	PRIORITY 4
Purpose of Action	LEVEL 2
Deficiency Photo1

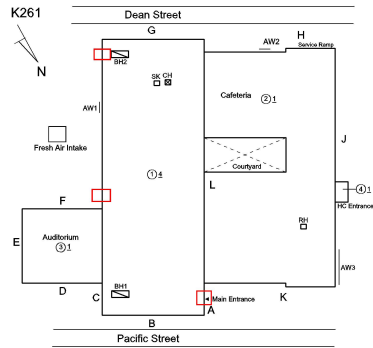
Violations	<p>Facade C - Near Exit 6</p> <p>No violations recorded.</p>
Deficiency	STONE: DETERIORATED JOINTS
Roof Plan reference

Deficiency Quantity	20
Quantity Uom	L.F.
Potential Action	REPOINT
Urgency of Action	PRIORITY 4
Purpose of Action	LEVEL 2

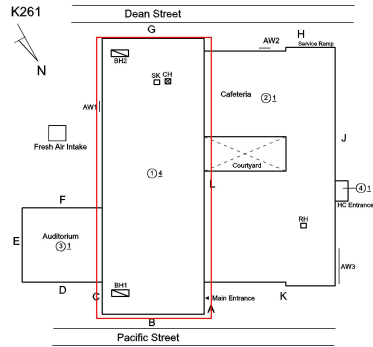
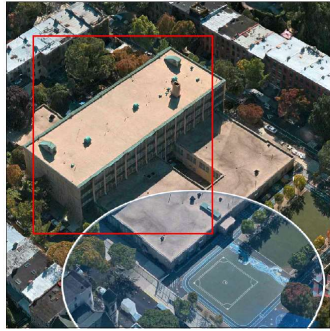
Question	Response
EXTERIOR	
WINDOWS	
WINDOWS	Inspected
Material Type(s)	Aluminum
Instance on Aluminum - Other: All Facades	Inspected
Instance Condition	3 - Fair
Instance Quantity	10,000
Instance Quantity Uom	S.F.
Are these windows insulated	Yes
Installation Year	2006
Source of Installation	Custodial Staff
Deficiency	ALUMINUM - OTHER: BROKEN PANE
Roof Plan reference

Deficiency Quantity	300
Quantity Uom	S.F.
Potential Action	MAINTENANCE
Urgency of Action	PRIORITY 3
Purpose of Action	LEVEL 2
Deficiency Photo1
