NYC Department of Education
Building Condition Assessment Survey 2023 - 2024

Architectural Inspection

Asset: **I.S. 292 - BROOKLYN, 300 WYONA STREET, New York, 11207**

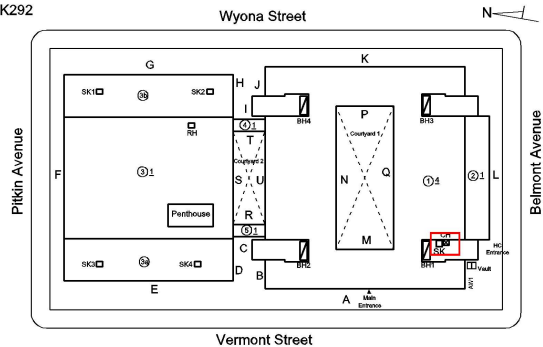
Violations	<p>AW1</p> <p>No violations recorded.</p>
AWNINGS AND CANOPIES	Does not Exist
CHIMNEY	Inspected
Material Type(s)	Masonry
Condition	3 - Fair
Deficiency	BRICK: MINOR CRACKS AND SPALLING
Roof Plan reference	<p>K292</p>

Deficiency Quantity	10
Quantity Uom	S.F.
Potential Action	RESTITCH
Urgency of Action	PRIORITY 3
Purpose of Action	LEVEL 2
Deficiency Photo1

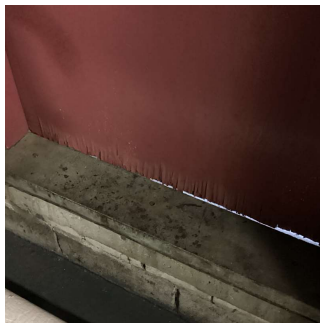
Violations	<p>Facade G - Roof 3B</p> <p>No violations recorded.</p>
Deficiency	<p>METAL CLAD: DETERIORATED DOOR - MINOR DETERIORATION</p>
Roof Plan reference	<p>K292</p>

Deficiency Quantity	4
Quantity Uom	EACH
Potential Action	MAINTENANCE
Urgency of Action	PRIORITY 3
Purpose of Action	LEVEL 2
Deficiency Photo1

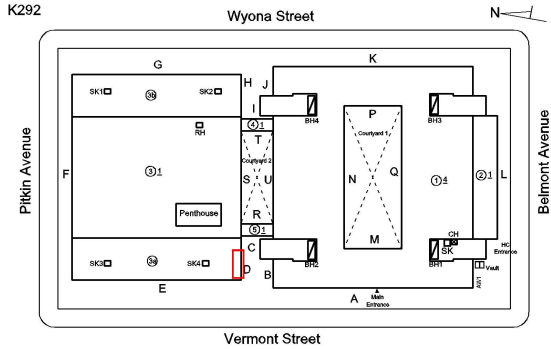
Violations	Roof 3a No violations recorded.
Deficiency	BRICK: MAJOR DETERIORATION/CRACKS
Roof Plan reference	K292

Deficiency Quantity	10
Quantity Uom	S.F.
Potential Action	REMOVE AND REBUILD
Urgency of Action	PRIORITY 4
Purpose of Action	LEVEL 2
Deficiency Photo1

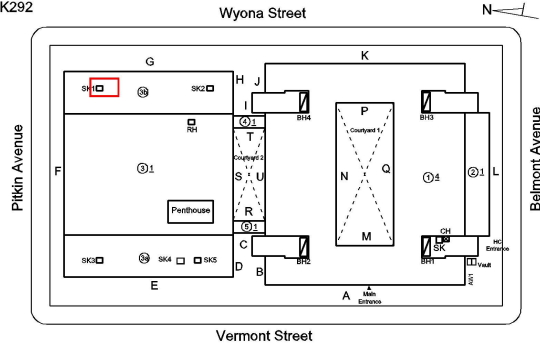
Question	Response
EXTERIOR	
ROOF	
Roofing	
LEADERS, GUTTERS, DOWNSPOUTS, SCUPPERS	
Deficiency Roof Plan reference	DAMAGED/MISSING K292

Deficiency Quantity Quantity Uom Potential Action Urgency of Action Purpose of Action Deficiency Photo1	10 L.F. REPLACE PRIORITY 4 LEVEL 2

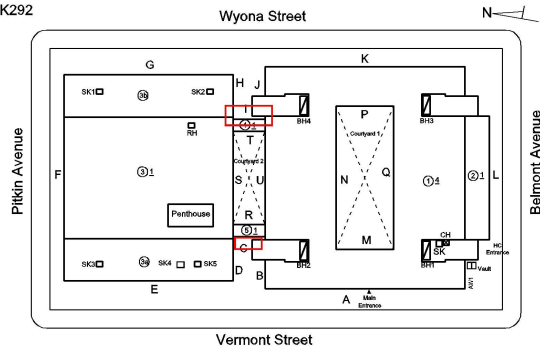
Violations	SK1 No violations recorded.
ROOF BARRIER/FENCE	Inspected
Condition	3 - Fair
Deficiency Roof Plan reference	BEAR CLAW/METAL BAR: DETERIORATED, MAJOR RUSTING K292

Deficiency Quantity Quantity Uom Potential Action Urgency of Action Purpose of Action	30 S.F. REPLACE PRIORITY 4 LEVEL 2

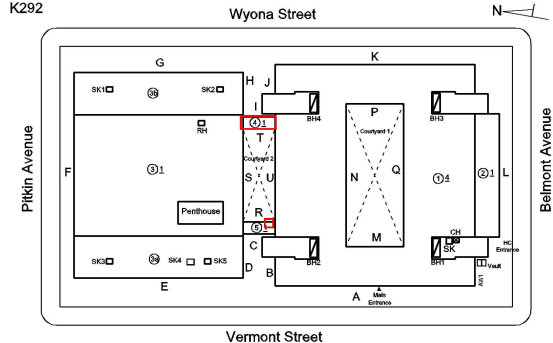
Is/Are the roof(s) suitable for Solar Panel installation?	Yes
Installation Year	2009
Source of Installation	Custodial Staff
Deficiency	BUILT-UP: ROOFING: LOSS OF GRAVEL
Roof Plan reference	<div> <div>K292</div>

Question	Response
EXTERIOR	
ROOF	
Roofing	
ROOFING	
Quantity Uom	S.F.
Potential Action	INSTALL NEW GRAVEL
Urgency of Action	PRIORITY 3
Purpose of Action	LEVEL 2
Deficiency Photo1

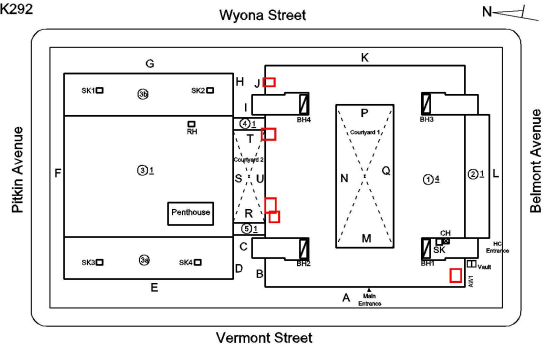
Violations	Roof 4 No violations recorded.
Deficiency	BUILT-UP: FLASHING: PITCH POCKET DETERIORATED - MINOR
Roof Plan reference	K292

Deficiency Quantity	5
Quantity Uom	EACH
Potential Action	REPAIR
Urgency of Action	PRIORITY 3
Purpose of Action	LEVEL 2
Deficiency Photo1

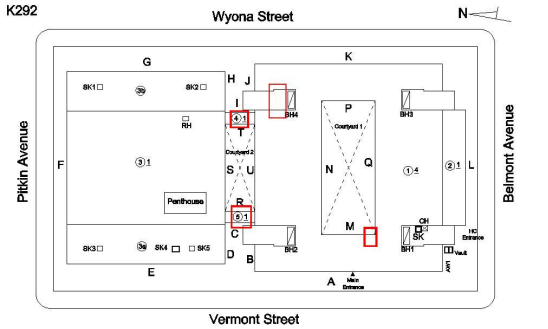
Violations	Roof 1 No violations recorded.
Deficiency	BUILT-UP: ROOFING: MAJOR ACTIVE ROOF LEAKS IN INSTRUCTIONAL SPACE
Roof Plan reference	<p>K292</p>

Deficiency Quantity	700
Quantity Uom	S.F.
Potential Action	REPLACE ROOFING WITHOUT MAJOR EQUIPMENT REMOVAL
Urgency of Action	PRIORITY 5
Purpose of Action	LEVEL 2

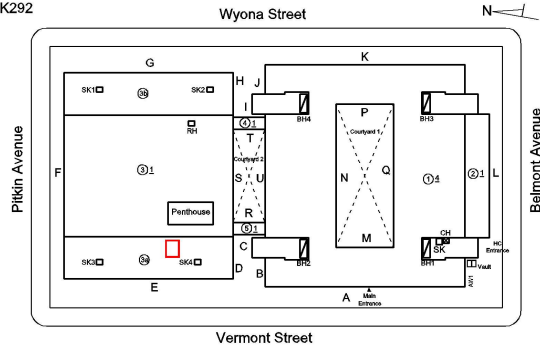
Violations	Roof 3 No violations recorded.
ROOFING DRAINS	Inspected
Condition	3 - Fair
Deficiency	DETERIORATED
Roof Plan reference	K292

Deficiency Quantity	1
Quantity Uom	EACH
Potential Action	REPLACE
Urgency of Action	PRIORITY 4
Purpose of Action	LEVEL 2
Deficiency Photo1

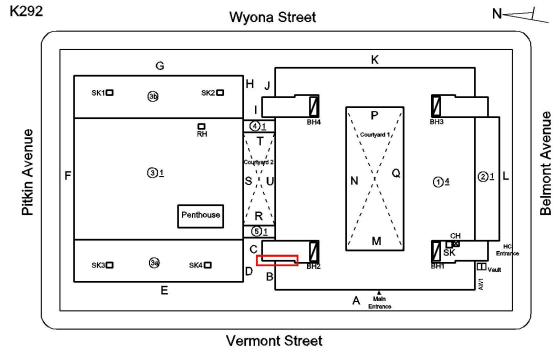
Violations	BH1 No violations recorded.
Deficiency	BULKHEAD/PENTHOUSE WALLS/EXTERIOR: EFFLORESCENCE
Roof Plan reference	K292

Deficiency Quantity	20
Quantity Uom	S.F.
Potential Action	MAINTENANCE
Urgency of Action	PRIORITY 3
Purpose of Action	LEVEL 2
Deficiency Photo1	No photo recorded
Violations	No violations recorded.
Deficiency	BULKHEAD/PENTHOUSE WALLS/EXTERIOR: CRACKS/SPALLING - MINOR
Roof Plan reference	K292

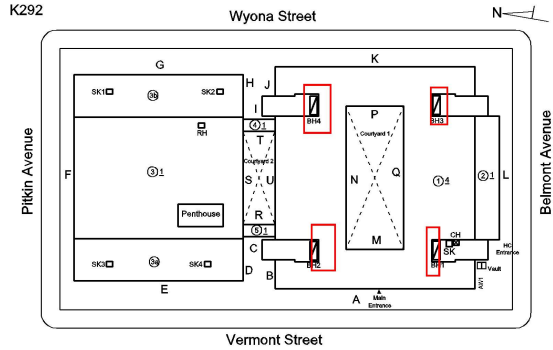
Violations	BH2 No violations recorded.
Deficiency	BULKHEAD/PENTHOUSE WALLS/EXTERIOR: CRACKS/SPALLING - MAJOR
Roof Plan reference	<p>K292</p>

Deficiency Quantity	50
Quantity Uom	S.F.
Potential Action	REPLACE
Urgency of Action	PRIORITY 4
Purpose of Action	LEVEL 2
Deficiency Photo1

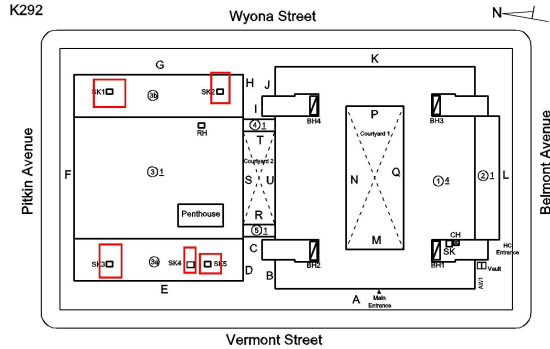
Violations	SK No violations recorded.
Deficiency	WATER INFILTRATION
Roof Plan reference	<p>K292</p>

Deficiency Quantity	500
Quantity Uom	S.F.
Potential Action	MAINTENANCE
Urgency of Action	PRIORITY 3
Purpose of Action	LEVEL 2
Deficiency Photo1

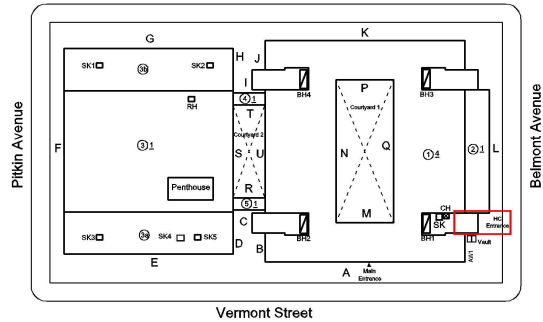
Violations	<p>Facade L</p> <p>No violations recorded.</p>
Deficiency	STONE: CRACKS/SPALLING - MINOR
Roof Plan reference	<p>K292</p>

Deficiency Quantity	10
Quantity Uom	S.F.
Potential Action	REPAIR
Urgency of Action	PRIORITY 3
Purpose of Action	LEVEL 2

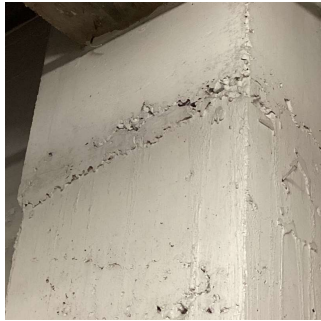
Violations	Basement - Room B2 No violations recorded.
Deficiency	STEEL COLUMNS/BEAMS: DETERIORATED MASONRY FIREPROOFING
Deficiency Location/Instance	BH2
Deficiency Quantity	20
Quantity Uom	S.F.
Potential Action	REPLACE
Urgency of Action	PRIORITY 4
Purpose of Action	LEVEL 5
Deficiency Photo1

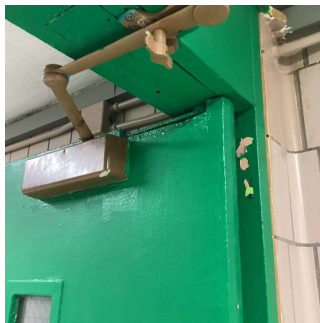
Violations	Corridor near Room 430 No violations recorded.
Deficiency	WOOD: DETERIORATED DOOR
Deficiency Location/Instance	Rooms 419, 430, 433, 434, 435 and others
Deficiency Quantity	7
Quantity Uom	EACH
Potential Action	MAINTENANCE
Urgency of Action	PRIORITY 3
Purpose of Action	LEVEL 2
Deficiency Photo1
