NYC Department of Education
Building Condition Assessment Survey 2023 - 2024

Architectural Inspection

Asset: **P.S. 308 - BROOKLYN, 616 QUINCY STREET, New York, 11221**

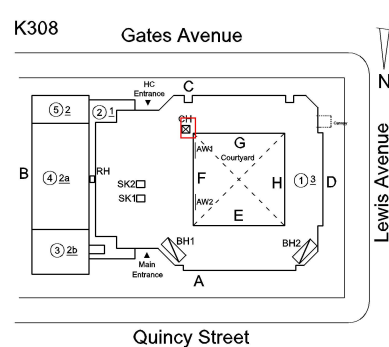
Roof Plan reference

CONCRETE MASONRY UNIT: DETERIORATED JOINTS

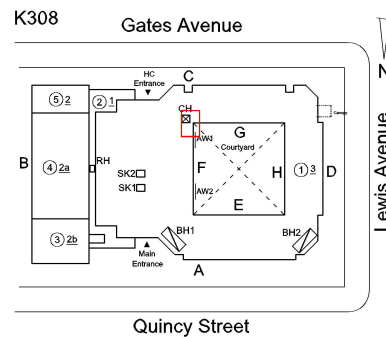
Roof Plan reference

CONCRETE MASONRY UNIT: MINOR CRACKS, SPALLING

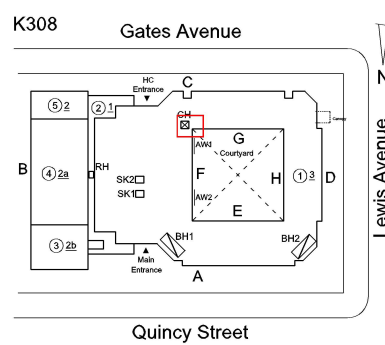
Roof Plan reference

CONCRETE MASONRY UNIT: DETERIORATED LADDER

REPLACE

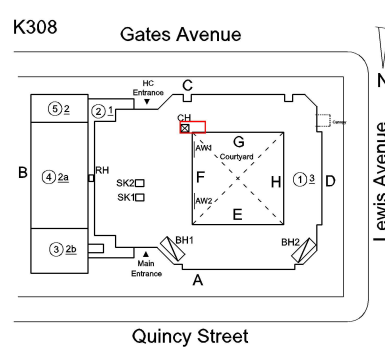
Roof Plan reference

CONCRETE MASONRY UNIT: MAJOR / THRU CRACKS

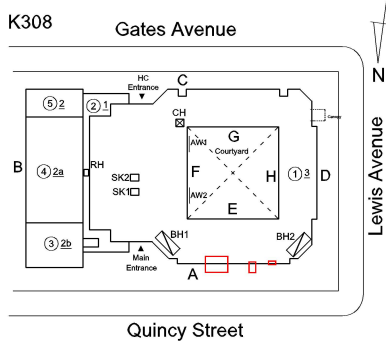
Violations	CH No violations recorded.
COPING	Inspected
Condition	4 - Between Fair and Poor
Deficiency	METAL: DETERIORATED
Roof Plan reference	K308

Deficiency Quantity	10
Quantity Uom	L.F.
Potential Action	REPLACE-IN-KIND
Urgency of Action	PRIORITY 4
Purpose of Action	LEVEL 2
Deficiency Photo1

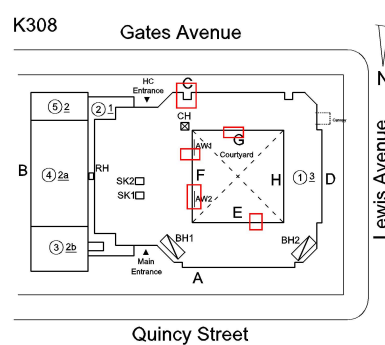
Roof Plan reference

CAST STONE: CRACKED/BROKEN PIECES

REPLACE-IN-KIND

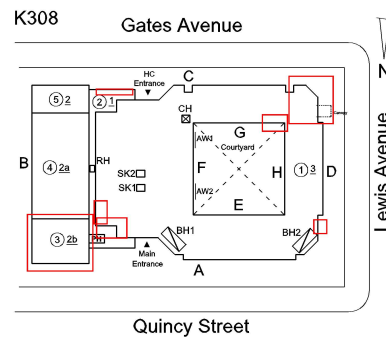
Roof Plan reference

CAST STONE: DETERIORATED TRANSVERSE JOINTS

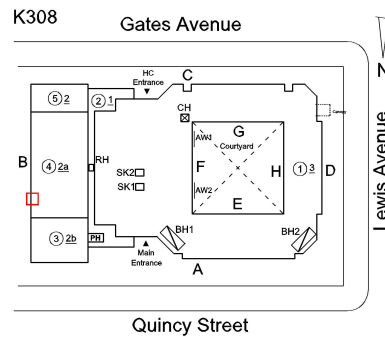
Roof Plan reference

METAL CLAD: DETERIORATED DOOR AND FRAME - MINOR DETERIORATION

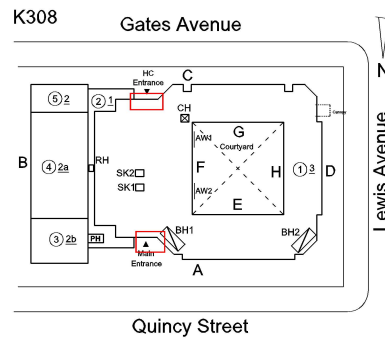
Roof Plan reference

METAL CLAD: DETERIORATED DOOR AND FRAME - MAJOR DETERIORATION

REPLACE

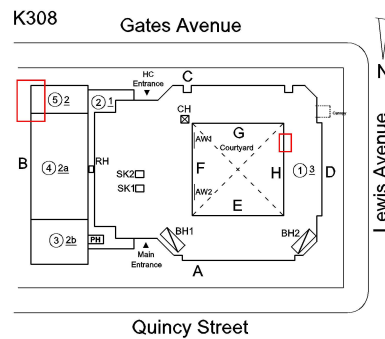
Roof Plan reference

METAL: DETERIORATED DOOR AND FRAME - MAJOR DETERIORATION

REPLACE

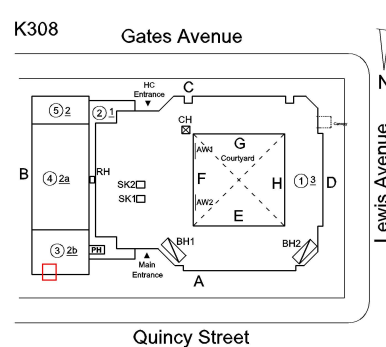
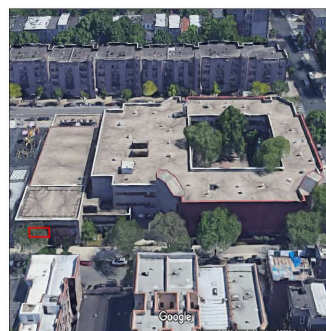
CONCRETE MASONRY UNIT: DETERIORATED
CONTROL/EXPANSION JOINTS

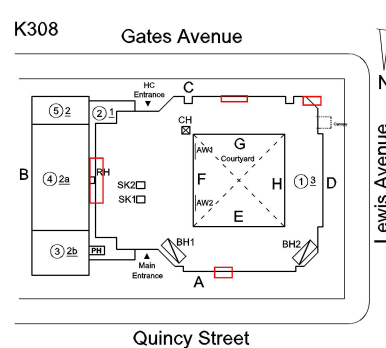
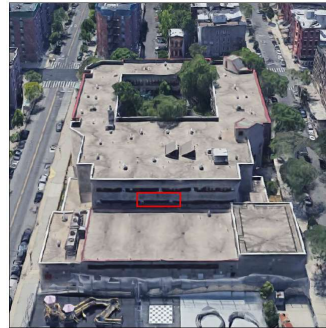
CONCRETE MASONRY UNIT: MINOR CRACKS AND SPALLING

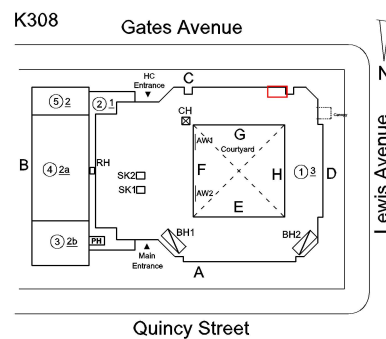
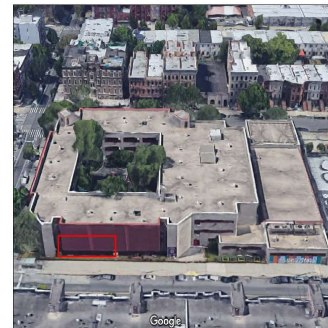
METAL PANEL: DAMAGED TRIM

REPLACE

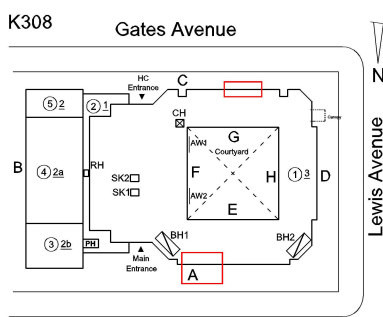
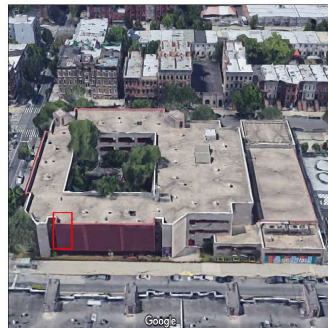
Question	Response
EXTERIOR	
EXTERIOR WALLS	
Violations	No violations recorded.
Deficiency	METAL PANEL: SEVERE DENTS
Roof Plan reference	<p>K308</p>

Deficiency Quantity	20
Quantity Uom	S.F.
Potential Action	REPLACE
Urgency of Action	PRIORITY 4
Purpose of Action	LEVEL 2
Deficiency Photo1

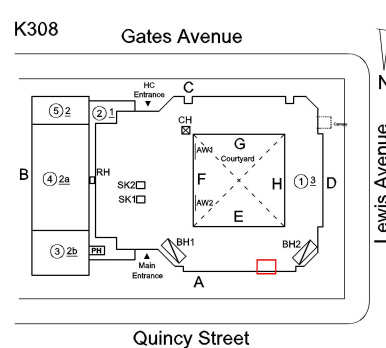
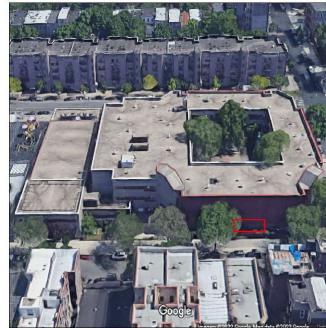
STUCCO/PLASTER: MAJOR CRACKS/SPALLING

REPLACE

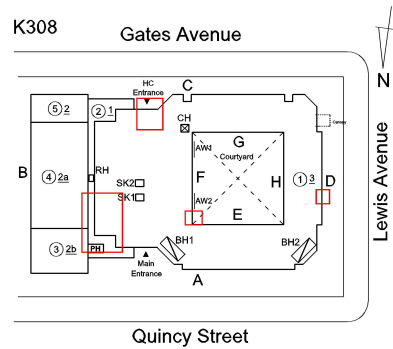
Roof Plan reference

**CONCRETE MASONRY UNITS: MAJOR
 DETERIORATION/CRACKS**

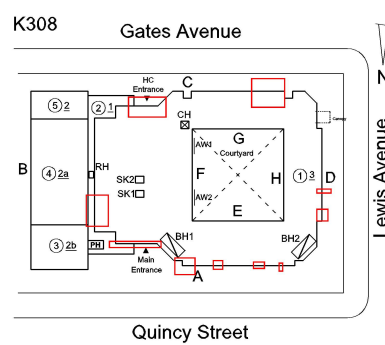
Roof Plan reference

CONCRETE MASONRY UNITS: MINOR CRACKS, SPALLING

REPAIR

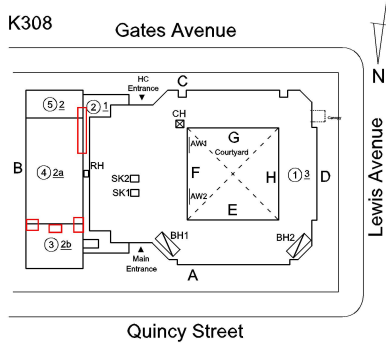
Violations	Roof 1 No violations recorded.
Deficiency	BRICK: EFFLORESCENCE
Roof Plan reference	K308

Deficiency Quantity	300
Quantity Uom	S.F.
Potential Action	MAINTENANCE
Urgency of Action	PRIORITY 3
Purpose of Action	LEVEL 2
Deficiency Photo1	No photo recorded
Violations	No violations recorded.
PLAZA DECK	Does not Exist
ROOF	Inspected
Roofing	Inspected
Replacement Quantity	55,000
Replacement Uom	S.F.
ROOF HATCH/SMOKE HATCH	Inspected
Condition	5 - Poor
Deficiency	DETERIORATED
Roof Plan reference	K308

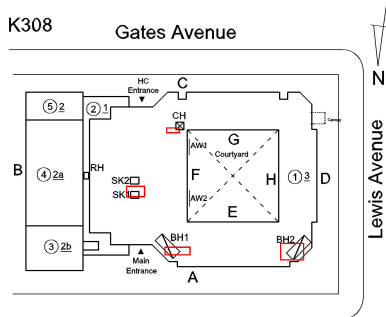
Violations	<p>RH</p> <p>No violations recorded.</p>
LEADERS, GUTTERS, DOWNSPOUTS, SCUPPERS	Inspected
Condition	3 - Fair
Deficiency	DAMAGED/MISSING
Roof Plan reference	<p>K308 Gates Avenue</p>

<p>Quincy Street</p>
Deficiency Quantity	40
Quantity Uom	L.F.
Potential Action	REPLACE
Urgency of Action	PRIORITY 4
Purpose of Action	LEVEL 2
Deficiency Photo1	 
Violations	<p>BH2</p> <p>No violations recorded.</p>
ROOF BARRIER/FENCE	Inspected
Condition	3 - Fair

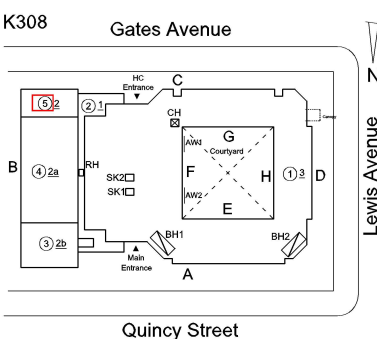
Question	Response
EXTERIOR	
ROOF	
Roofing	
ROOF BARRIER/FENCE	
Deficiency	RAILINGS/PANELS: DETERIORATED, MAJOR RUSTING
Roof Plan reference	<div> <div>K308</div>

</div>
Deficiency Quantity	25
Quantity Uom	S.F.
Potential Action	REPLACE
Urgency of Action	PRIORITY 4
Purpose of Action	LEVEL 2
Deficiency Photo1

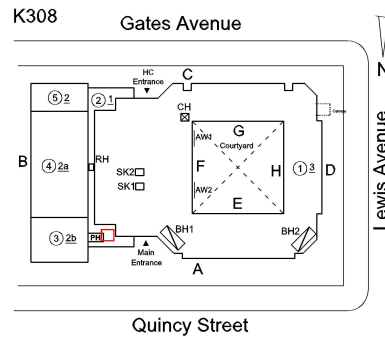
Roof Plan reference

BUILT-UP: ROOFING: MAJOR ACTIVE ROOF LEAKS IN INSTRUCTIONAL SPACE

REPLACE ROOFING WITHOUT MAJOR EQUIPMENT REMOVAL

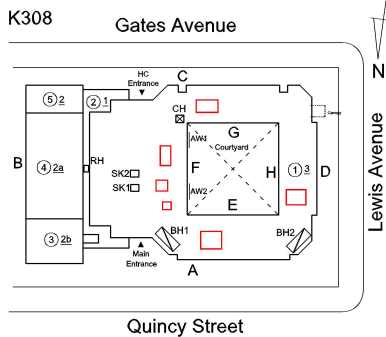
Violations	Roof 1 No violations recorded.
Deficiency	BUILT-UP: ROOFING: LOSS OF GRAVEL
Roof Plan reference	K308

Deficiency Quantity	90
Quantity Uom	S.F.
Potential Action	INSTALL NEW GRAVEL
Urgency of Action	PRIORITY 3
Purpose of Action	LEVEL 2
Deficiency Photo1

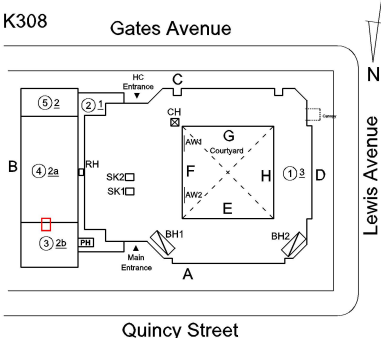
Violations	Roof 1 No violations recorded.
Deficiency	BUILT-UP: FLASHING: PITCH POCKET DETERIORATED - MINOR

Deficiency Quantity	1
Quantity Uom	EACH
Potential Action	REPAIR
Urgency of Action	PRIORITY 3
Purpose of Action	LEVEL 2
Deficiency Photo1

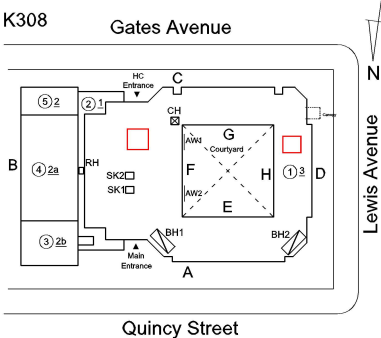
Violations	<p>Roof 3</p> <p>No violations recorded.</p>
ROOFING DRAINS	Inspected
Condition	4 - Between Fair and Poor
Deficiency	DETERIORATED
Roof Plan reference	<p>K308</p>

Deficiency Quantity	2
Quantity Uom	EACH
Potential Action	REPLACE
Urgency of Action	PRIORITY 4
Purpose of Action	LEVEL 2

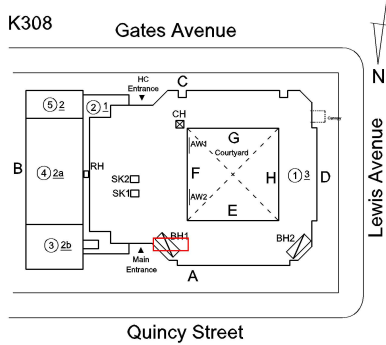
Violations	Roof 1 No violations recorded.
Specialties	Inspected
BULKHEAD/PENTHOUSE	Inspected
Condition	3 - Fair
Deficiency	BULKHEAD/PENTHOUSE WALLS/INTERIOR: CMU DETERIORATED JOINTS
Roof Plan reference	<p>K308</p>

Deficiency Quantity	30
Quantity Uom	S.F.
Potential Action	REPOINT
Urgency of Action	PRIORITY 3
Purpose of Action	LEVEL 2
Deficiency Photo1

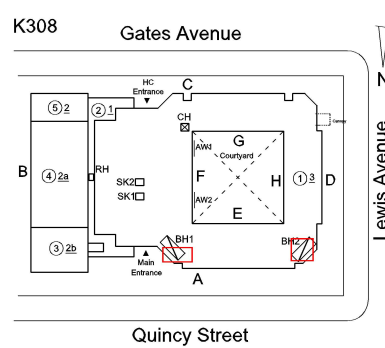
Roof Plan reference

Violations	BH1 No violations recorded.
Deficiency	BULKHEAD/PENTHOUSE WALLS/INTERIOR: CMU CRACKS/SPALLING

20
S.F.
REPLACE
PRIORITY 3
LEVEL 2

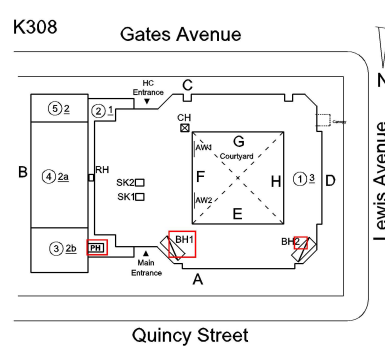
Roof Plan reference

**BULKHEAD/PENTHOUSE WALLS/EXTERIOR:
CRACKS/SPALLING - MINOR**

30
S.F.
REPAIR
PRIORITY 3
LEVEL 2

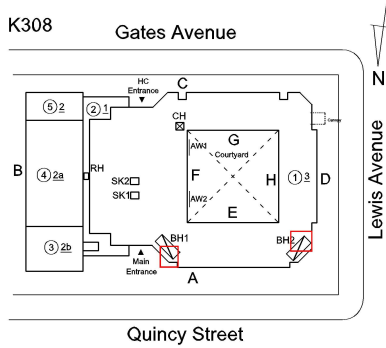
Violations	BH1 No violations recorded.
Deficiency	BULKHEAD/PENTHOUSE WALLS/EXTERIOR: CRACKS/SPALLING - MAJOR
Roof Plan reference	<p>K308 Gates Avenue</p>

<p>Quincy Street</p>
Deficiency Quantity	20
Quantity Uom	S.F.
Potential Action	REPLACE
Urgency of Action	PRIORITY 4
Purpose of Action	LEVEL 2
Deficiency Photo1

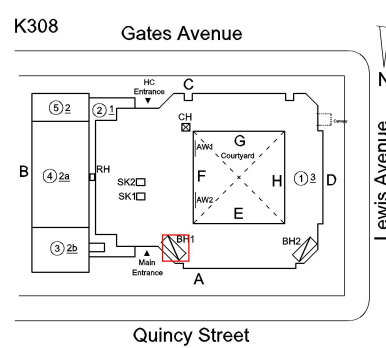
Roof Plan reference

Violations	BH1 No violations recorded.
Deficiency	BULKHEAD/PENTHOUSE WINDOWS: DETERIORATED LINTELS

10
L.F.
REPLACE
PRIORITY 4
LEVEL 2

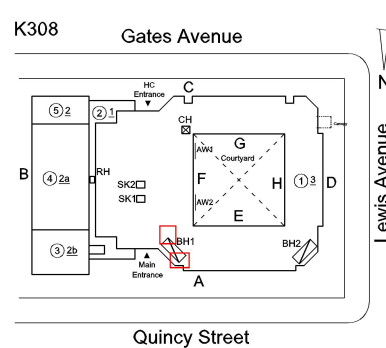
Roof Plan reference

Deficiency **BULKHEAD/PENTHOUSE WALLS/EXTERIOR: DETERIORATED JOINTS**

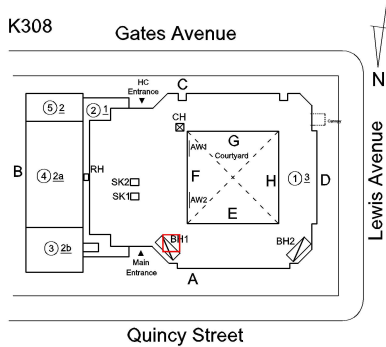
Violations	BH1 No violations recorded.
Deficiency	BULKHEAD/PENTHOUSE WALLS/EXTERIOR: EFFLORESCENCE
Roof Plan reference	K308 Gates Avenue

Deficiency Quantity	10
Quantity Uom	S.F.
Potential Action	MAINTENANCE
Urgency of Action	PRIORITY 3
Purpose of Action	LEVEL 2
Deficiency Photo1	No photo recorded
Violations	No violations recorded.
CUPOLA/ SPIRES/ TOWERS	Does not Exist
DORMER	Does not Exist
DUNNAGE STEEL	Inspected
Condition	3 - Fair
Deficiency	HEIGHT LESS THAN 18"
Roof Plan reference	K308 Gates Avenue

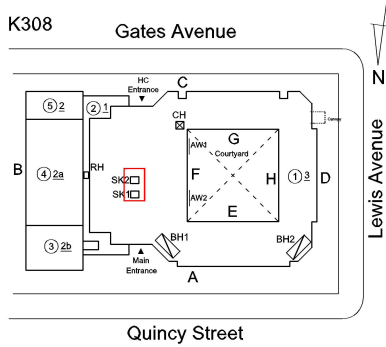
Violations	Roof 5 No violations recorded.
SKYLIGHT/ROOF VENT	Inspected
Material Type(s)	Glass
Condition	3 - Fair
Deficiency	BROKEN FRAMING
Roof Plan reference	<p>K308</p>

Deficiency Quantity	40
Quantity Uom	L.F.
Potential Action	MAINTENANCE
Urgency of Action	PRIORITY 3
Purpose of Action	LEVEL 2
Deficiency Photo1

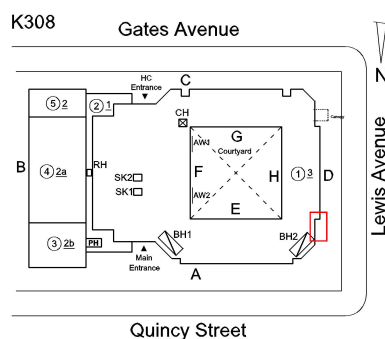
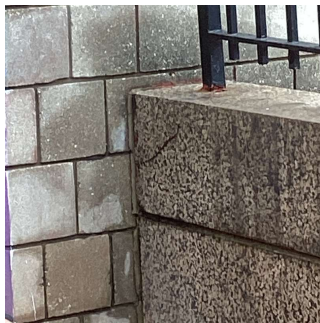
Violations	SK1 No violations recorded.
ROOF/GRAVITY TANK	Does not Exist
STAIRS/RAMPS: EXTERIOR	Inspected
BUILDING CHEEK/FLANK WALLS	Inspected
Condition	5 - Poor
Deficiency	STONE: CRACKS/SPALLING - MAJOR
Roof Plan reference

Deficiency Quantity	20
Quantity Uom	S.F.
Potential Action	REPLACE
Urgency of Action	PRIORITY 4
Purpose of Action	LEVEL 2

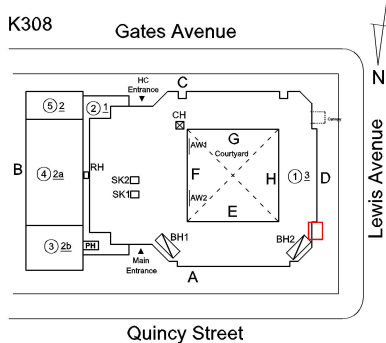
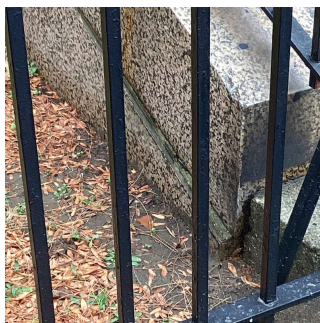
Violations	Facade D No violations recorded.
Deficiency	STONE: BULGING/DISPLACED
Roof Plan reference	K308

Deficiency Quantity	20
Quantity Uom	S.F.
Potential Action	REPLACE
Urgency of Action	PRIORITY 4
Purpose of Action	LEVEL 2
Deficiency Photo1

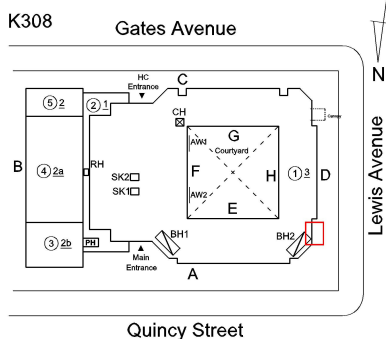
<p>Facade A</p> <p>No violations recorded.</p>
Violations	No violations recorded.
STAIRS/RAMPS	Inspected
Condition	4 - Between Fair and Poor
Deficiency	STONE: DETERIORATED SUBSTRATE
Roof Plan reference	<p>K308</p>

<p>10</p> <p>S.F.</p> <p>REPLACE SUBSTRATE AND RESET</p> <p>PRIORITY 4</p> <p>LEVEL 2</p>

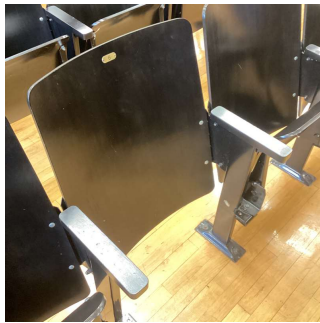
Seat B/6
Violations	No violations recorded.
Deficiency	DAMAGED/BROKEN/INOPERABLE
Deficiency Location/Instance	Seats A/23, 15
Deficiency Quantity	2
Quantity Uom	EACH
Potential Action	REPLACE
Urgency of Action	PRIORITY 3
Purpose of Action	LEVEL 2
Deficiency Photo1	 
	Seat A/23
Violations	No violations recorded.
Floor Finish	
Instance on 1st Floor (275 Seats)	Inspected
Condition	2 - Between Good and Fair
Deficiency	WOOD: DAMAGED/DETERIORATED
Deficiency Location/Instance	Near Main Entrance
Deficiency Quantity	20
Quantity Uom	S.F.
Potential Action	REPLACE
Urgency of Action	PRIORITY 3
Purpose of Action	LEVEL 2

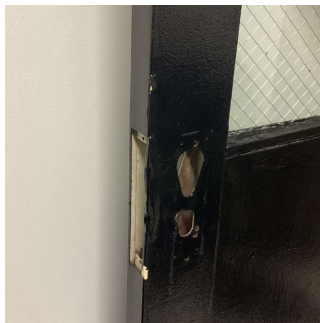
Violations	Room 321 No violations recorded.
Deficiency	WOOD: DETERIORATED DOOR
Deficiency Location/Instance	Rooms 385, 383, 380, 377, 300 and others
Deficiency Quantity	11
Quantity Uom	EACH
Potential Action	MAINTENANCE
Urgency of Action	PRIORITY 3
Purpose of Action	LEVEL 2
Deficiency Photo1
