NYC Department of Education
Building Condition Assessment Survey 2023 - 2024

Architectural Inspection

K335

Asset: P.S. 335 - BROOKLYN, 130 ROCHESTER AVENUE, New York, 11213

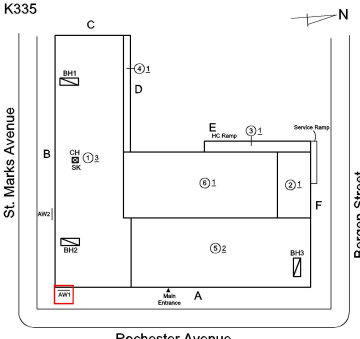
Violations	AW1
	No violations recorded.
Deficiency	AREAWAY DRAINS: DETERIORATED
Roof Plan reference	K335

Deficiency Quantity	1
Quantity Uom	EACH
Potential Action	REPLACE
Urgency of Action	PRIORITY 4
Purpose of Action	LEVEL 2

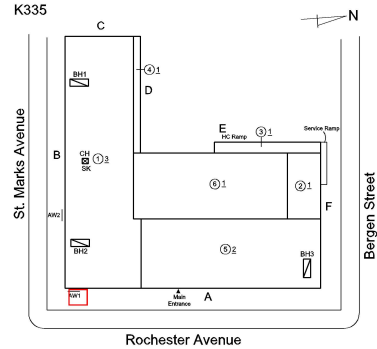
AREAWAY STAIRS: DETERIORATED
TREADS/RISERS/NOSINGS

REPLACE

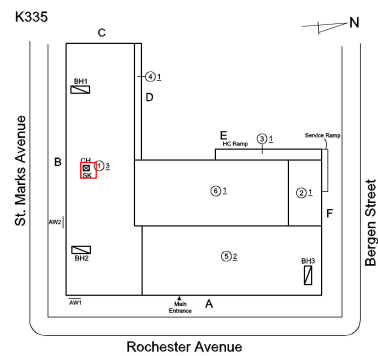
BRICK: DETERIORATED LADDER

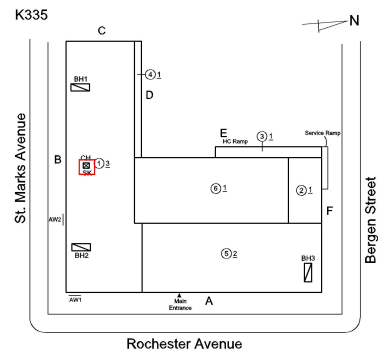
BRICK: MINOR CRACKS AND SPALLING

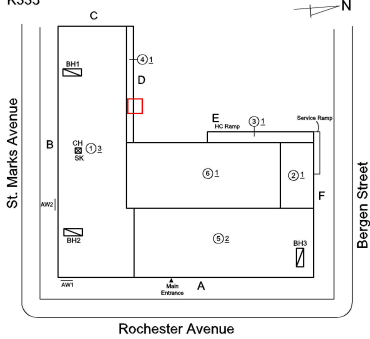
Violations	CH No violations recorded.
COPING	Inspected
Condition	3 - Fair
Deficiency	METAL: DETERIORATED
Roof Plan reference	K335

Deficiency Quantity	20
Quantity Uom	L.F.
Potential Action	REPLACE-IN-KIND
Urgency of Action	PRIORITY 4
Purpose of Action	LEVEL 2
Deficiency Photo1

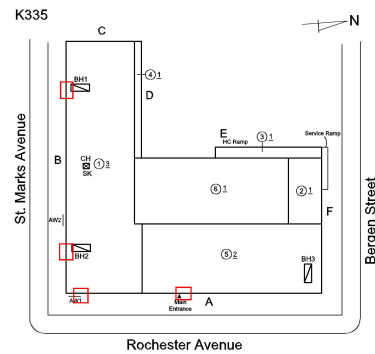
Violations	Roof 4 - Facade D No violations recorded.
CORNICE	Does not Exist
DOORS	Inspected
DOORS AND FRAMES	Inspected
Condition	5 - Poor
Deficiency	METAL CLAD: DETERIORATED DOOR - MAJOR DETERIORATION

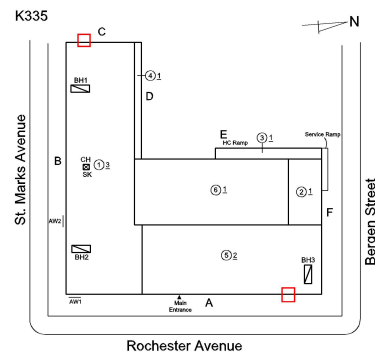
METAL: DETERIORATED DOOR AND FRAME - MAJOR DETERIORATION

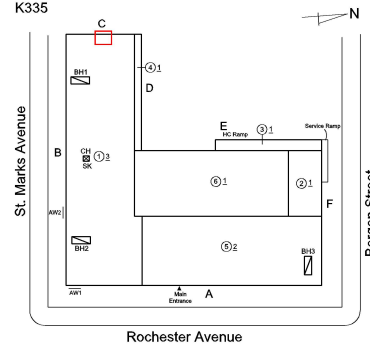
METAL CLAD: DETERIORATED DOOR AND FRAME - MAJOR DETERIORATION

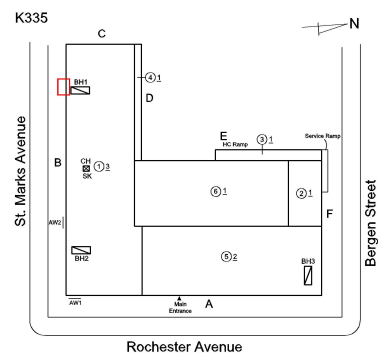
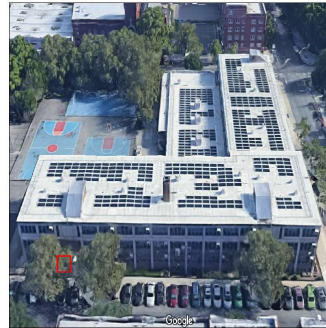
BRICK: CRACKS/DISPLACED/SPALLED BRICK AT BUILDING CORNERS

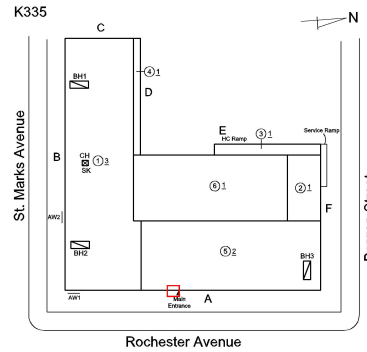
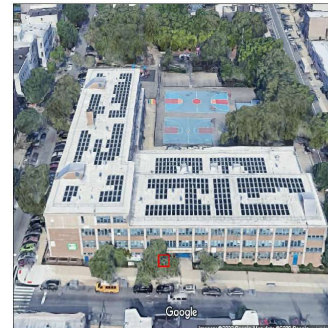
CAST IN PLACE / PRE-CAST CONCRETE: MAJOR CRACKS/SPALLING

10
S.F.
REPLACE
PRIORITY 4
LEVEL 2

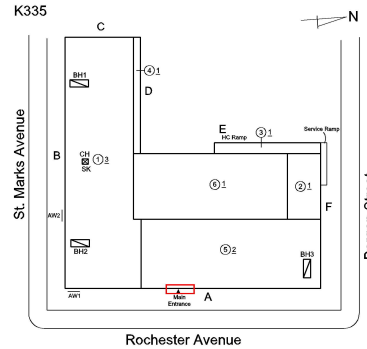
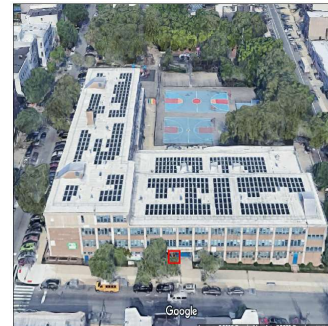
CERAMIC TILE: CHIPPED, SPALLED, BROKEN PIECES

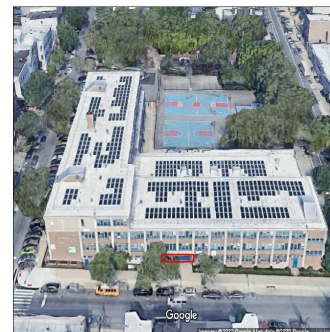
STUCCO/PLASTER: MINOR CRACKS/SPALLING

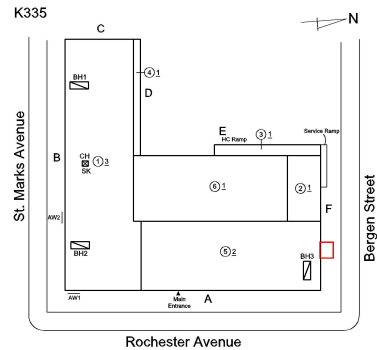
STONE: CRACKS/SPALLING - MAJOR

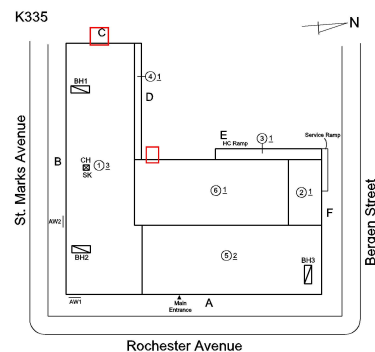
MISSING RAILING

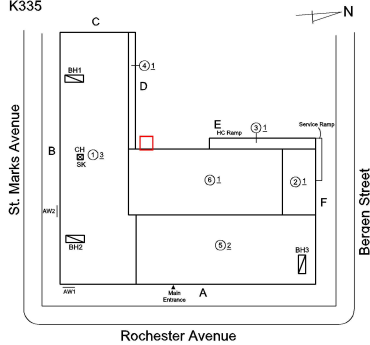
<p>Facade C - Near Exit 6</p> <p>No violations recorded.</p>
Violations	
STAIRS/RAMPS	Inspected
Condition	5 - Poor
Deficiency	STONE: DETERIORATED JOINTS
Roof Plan reference	<p>K335</p>

Deficiency Quantity	10
Quantity Uom	L.F.
Potential Action	REPOINT
Urgency of Action	PRIORITY 3
Purpose of Action	LEVEL 2
Deficiency Photo1

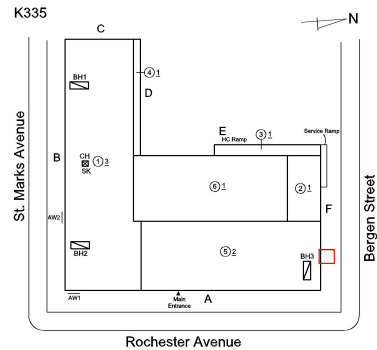
STONE: DETERIORATED SUBSTRATE

REPLACE SUBSTRATE AND RESET

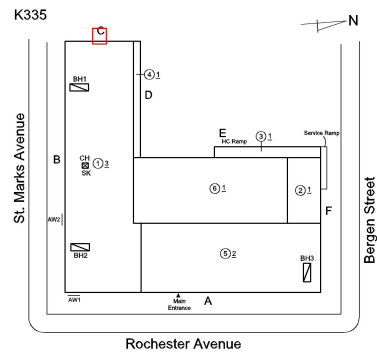
CONCRETE: WORN-OUT TREAD/RISER/NOSING

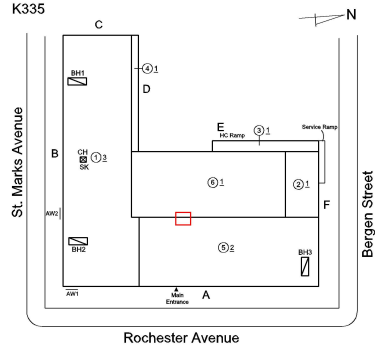
Violations	Facade C - Near Exit 6 No violations recorded.
WINDOWS	Inspected
Replacement Quantity	10,000
Replacement Uom	S.F.
EXTERIOR GUARDS	Inspected
Condition	2 - Between Good and Fair
Deficiency	No deficiencies recorded
LINTELS	Inspected
Condition	2 - Between Good and Fair
Deficiency	No deficiencies recorded
WINDOWS	Inspected
Material Type(s)	Aluminum
Instance on Aluminum - Double Hung: All Facades	Inspected
Instance Condition	3 - Fair
Instance Quantity	10,000
Instance Quantity Uom	S.F.
Are these windows insulated	No
Installation Year	2007
Source of Installation	Custodial Staff
Deficiency	ALUMINUM - DOUBLE HUNG: DETERIORATED
Roof Plan reference	K335
