NYC Department of Education
Building Condition Assessment Survey 2023 - 2024

Architectural Inspection

Asset: TILDEN AF - BROOKLYN, 5800 TILDEN AVENUE, New York, 11203

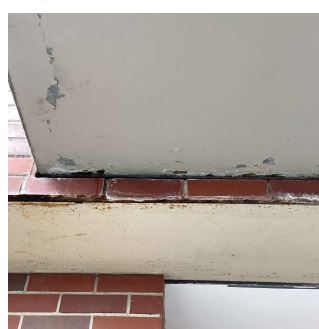
Question	Response
EXTERIOR	
AWNINGS AND CANOPIES	
Deficiency	METAL: WATER PENETRATION
Roof Plan reference

Deficiency Quantity	20
Quantity Uom	S.F.
Potential Action	REPAIR
Urgency of Action	PRIORITY 5
Purpose of Action	LEVEL 2
Deficiency Photo1

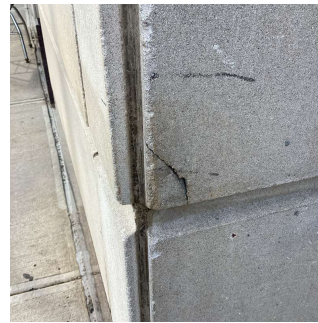
Facade D

Question	Response
EXTERIOR	
COPING	Inspected
Purpose of Action	LEVEL 2
Deficiency Photo1	No photo recorded
Violations	No violations recorded.
CORNICE	Does not Exist
DOORS	Inspected
DOORS AND FRAMES	Inspected
Condition	2 - Between Good and Fair
Deficiency	No deficiencies recorded
DOOR HARDWARE	Inspected
Condition	2 - Between Good and Fair
Deficiency	No deficiencies recorded
LINTELS	Inspected
Condition	2 - Between Good and Fair
Deficiency	No deficiencies recorded
TRANSOM/SIDE LIGHT	Does not Exist
EXTERIOR WALLS	Inspected
Material Type(s)	Concrete, Masonry
Replacement Quantity	4,000
Replacement Uom	S.F.
Instance on All Facades	Inspected
Instance Condition	3 - Fair
Instance Quantity	4,000
Instance Quantity Uom	S.F.
Deficiency	CAST IN PLACE / PRE-CAST CONCRETE: MINOR CRACKS/SPALLING
Roof Plan reference

Deficiency Quantity	10
Quantity Uom	S.F.
Potential Action	REPAIR
Urgency of Action	PRIORITY 3

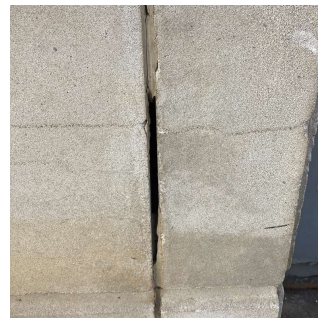
Facade A

CAST IN PLACE / PRE-CAST CONCRETE: DETERIORATED JOINTS

10

REPOINT

PRIORITY 4

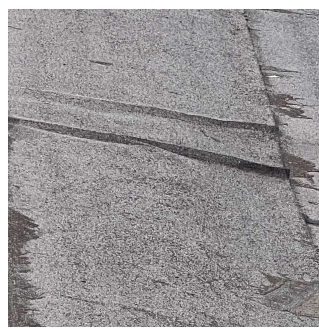
Question	Response
EXTERIOR	
ROOF	
Roofing	
ROOFING	
Roof Plan reference	 
Deficiency Quantity	200
Quantity Uom	S.F.
Potential Action	REPLACE ROOFING WITHOUT MAJOR EQUIPMENT REMOVAL
Urgency of Action	PRIORITY 5
Purpose of Action	LEVEL 2
Deficiency Photo1	 
Violations	Roof 1 - South Shower Room (Roof 2 - Weight Room similar) No violations recorded.
Instance on Modified Bitumen: Roofs 4-6	Inspected
Instance Condition	4 - Between Fair and Poor
Instance Photo	 
	Roof 5
Instance Quantity	1,600
Instance Quantity Uom	S.F.
Does the roof have major mechanical equipment sitting on Dunnage Steel less than 18" above the Roofing?	No
Does this roof instance have a Sustainable Roof System?	No
Do solar panels exist on these roofs?	No
Is/Are the roof(s) suitable for Solar Panel installation?	No
Installation Year	2002
Source of Installation	Custodial Staff
Deficiency	MODIFIED BITUMEN: ROOFING: DELAMINATION

Deficiency Quantity	20
Quantity Uom	S.F.
Potential Action	REPLACE ROOFING WITHOUT MAJOR EQUIPMENT REMOVAL
Urgency of Action	PRIORITY 4
Purpose of Action	LEVEL 2
Deficiency Photo1

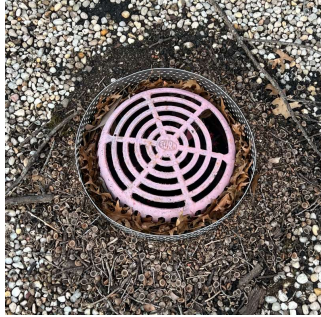
Violations	Roof 6 No violations recorded.
ROOFING DRAINS	Inspected
Condition	5 - Poor
Deficiency	DETERIORATED
Roof Plan reference

Deficiency Quantity	3
Quantity Uom	EACH
Potential Action	REPLACE
Urgency of Action	PRIORITY 4
Purpose of Action	LEVEL 2

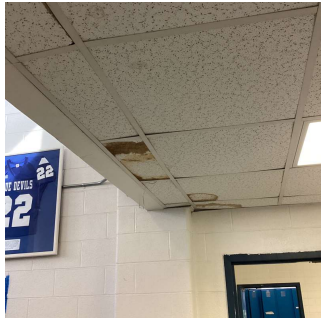
Question	Response
INTERIOR	
STRUCTURAL	Inspected
ROOF STRUCTURE	Inspected
Condition	2 - Between Good and Fair
Deficiency	No deficiencies recorded
VAULTS-BUNKERS	Does not Exist
CLASSROOMS/CORRIDORS/ADMIN SPACES	Inspected
Ceiling	Inspected
Condition	2 - Between Good and Fair
Deficiency	ACOUSTIC TILES: DAMAGED/MISSING - ACTIVE LEAK
Deficiency Location/Instance	Weight Room
Deficiency Quantity	20
Quantity Uom	S.F.
Potential Action	REPLACE
Urgency of Action	PRIORITY 5
Purpose of Action	LEVEL 2
Deficiency Photo1

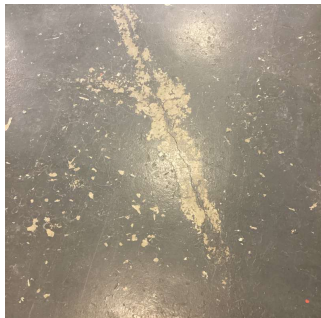
Weight Room
Violations	No violations recorded.
Door(s)	Inspected
Condition	2 - Between Good and Fair
Deficiency	No deficiencies recorded
Floor Finish	Inspected
Condition	2 - Between Good and Fair
Deficiency	CONCRETE: CRACKS
Deficiency Location/Instance	Main Entrance
Deficiency Quantity	25
Quantity Uom	S.F.
Potential Action	REPLACE
Urgency of Action	PRIORITY 3
Purpose of Action	LEVEL 2
Deficiency Photo1

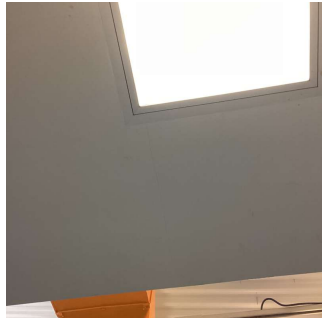
Question	Response
INTERIOR	
CLASSROOMS/CORRIDORS/ADMIN SPACES	Inspected
Walls	Inspected
Condition	2 - Between Good and Fair
Deficiency	No deficiencies recorded
INTERIOR DOOR HARDWARE	Inspected
Condition	3 - Fair
Deficiency	No deficiencies recorded
LOCKER ROOM	Inspected
Instance on 1st Floor - North (43 Lockers)	Inspected
Alternative use	No
Instance on 1st Floor - South (43 Lockers)	Inspected
Alternative use	No
Ceiling	
Instance on 1st Floor - North (43 Lockers)	Inspected
Condition	2 - Between Good and Fair
Deficiency	GYP SUM BOARD: DAMAGED/DETERIORATED
Deficiency Location/Instance	Near Locker 8
Deficiency Quantity	10
Quantity Uom	S.F.
Potential Action	REPLACE
Urgency of Action	PRIORITY 3
Purpose of Action	LEVEL 2
Deficiency Photo1

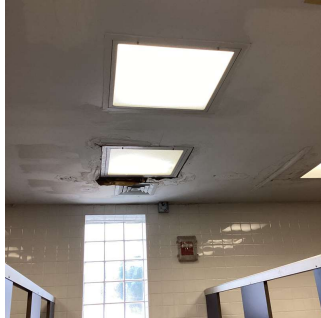
Question	Response
INTERIOR	
LOCKER ROOM	
Locker Room Lockers	
Deficiency Photo1	 
	Locker 13
Violations	No violations recorded.
Walls	
Instance on 1st Floor - South (43 Lockers)	Inspected
Condition	2 - Between Good and Fair
Deficiency	MASONRY: CRACKS/SPALLING
Deficiency Location/Instance	Near Exit, Near Entrance
Deficiency Quantity	20
Quantity Uom	S.F.
Potential Action	REPLACE
Urgency of Action	PRIORITY 3
Purpose of Action	LEVEL 2
Deficiency Photo1	 
	Near Exit
Violations	No violations recorded.
SHOWER ROOM	
	Inspected
Instance on 1st Floor - North	Inspected
Alternative use	Yes
Instance on 1st Floor - South	Inspected
Alternative use	Yes
Ceiling	
Instance on 1st Floor - South	Inspected
Condition	5 - Poor
Deficiency	GYPSUM BOARD: DAMAGED/DETERIORATED - ACTIVE LEAK
Deficiency Location/Instance	Rear Near Window
Deficiency Quantity	40
Quantity Uom	S.F.
Potential Action	REPLACE
Urgency of Action	PRIORITY 5

Question	Response
INTERIOR	
SHOWER ROOM	
Ceiling	
Purpose of Action	LEVEL 2
Deficiency Photo1

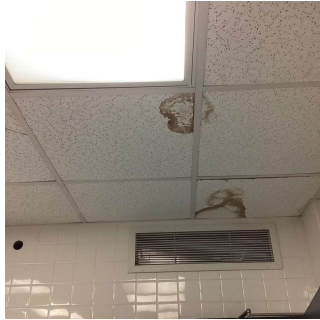
Question	Response
INTERIOR	
TOILET ROOMS - STUDENTS	
Ceiling	Inspected
Condition	2 - Between Good and Fair
Deficiency	ACOUSTIC TILES: DAMAGED/MISSING
Deficiency Location/Instance	Inside South Locker Room
Deficiency Quantity	10
Quantity Uom	S.F.
Potential Action	REPLACE
Urgency of Action	PRIORITY 3
Purpose of Action	LEVEL 2
Deficiency Photo1

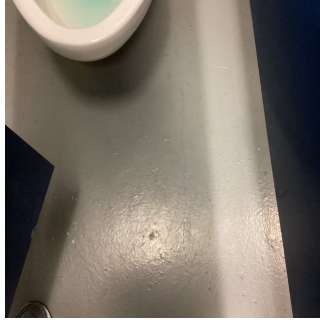
Violations	Inside South Locker Room No violations recorded.
Door(s)	Inspected
Condition	2 - Between Good and Fair
Deficiency	No deficiencies recorded
Floor Finish	Inspected
Condition	3 - Fair
Deficiency	CONCRETE: CRACKS
Deficiency Location/Instance	Inside North, South Locker Rooms
Deficiency Quantity	50
Quantity Uom	S.F.
Potential Action	REPLACE
Urgency of Action	PRIORITY 3
Purpose of Action	LEVEL 2
Deficiency Photo1

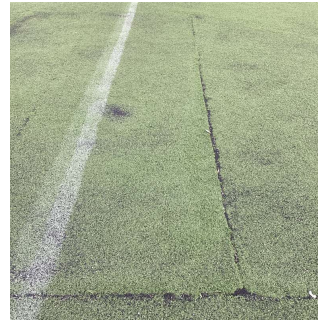
Priority Condition Exist Last Year?	Priority Category	Condition Description	Component Affected	Location Description	Person(s) Notified	Person(s) Title	PhotoImage
Yes	Tripping Hazard	Deteriorated artificial turf with sinkholes is a potential tripping hazard.	ATHLETIC FIELDS PLAYING SURFACE	Northeast side of the Football Field	Saleh Al-Awgari	Fireman

Question	Response
INTERIOR	
TOILET ROOMS - STUDENTS	
Walls	
Deficiency	MASONRY: CRACKS/SPALLING
Deficiency Location/Instance	1st Floor - Girls
Deficiency Quantity	10
Quantity Uom	S.F.
Potential Action	REPLACE
Urgency of Action	PRIORITY 3
Purpose of Action	LEVEL 2
Deficiency Photo1	 
Violations	1st Floor - Girls No violations recorded.
ATHLETIC FIELDS	Inspected
PLAYING SURFACE	Inspected
Synthetic Turf Field exists?	Yes
Year of Installation	2002
Replacement Quantity	81,000
Replacement Uom	S.F.
Instance on Football Field	Inspected
Instance Condition	3 - Fair
Instance Quantity	65,000
Instance Quantity Uom	S.F.
Deficiency	ARTIFICIAL TURF: DAMAGED/WORN OUT
Deficiency Location/Instance	Football Field
Roof Plan reference

Deficiency Quantity	200
Quantity Uom	S.F.
Potential Action	REPLACE
Urgency of Action	PRIORITY 4
Purpose of Action	LEVEL 2

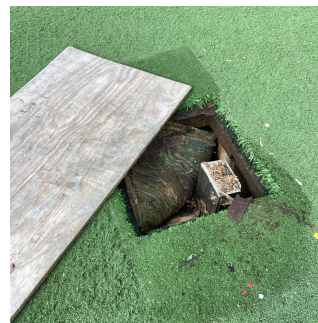
Football Field

ARTIFICIAL TURF: DAMAGED/WORN OUT

40

REPLACE

PRIORITY 5

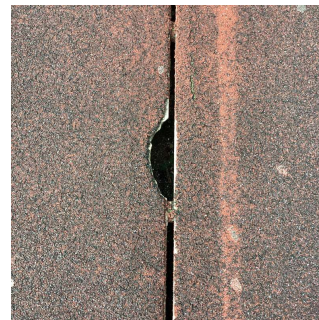
Running Track

Yes	Tripping Hazard	Deteriorated athletic wearing surface is a potential tripping hazard.	ATHLETIC FIELDS PLAYING SURFACE	Northeast and northwest side of the running track	Saleh Al-Awgari	Fireman

ATHLETIC WEARING SURFACE: DAMAGED/DETERIORATED

20

REPLACE

PRIORITY 5

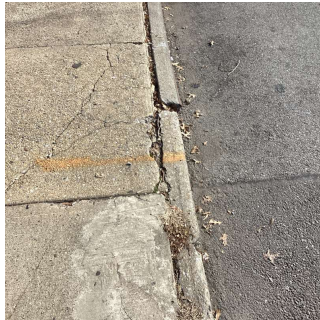
Question	Response
SITE	
PAVING	
Student Use	
Concrete	
Deficiency Photo1	 
Violations	Near Bleachers No violations recorded.
Pavers	Does not Exist
Site Sidewalks & Walkways	Inspected
Asphalt	Does not Exist
Concrete	Inspected
Condition	3 - Fair
Deficiency	CRACKS - MAJOR
Deficiency Location/Instance	Near Field House, Near Entrance, near handball court
Deficiency Quantity	300
Quantity Uom	S.F.
Potential Action	REPLACE
Urgency of Action	PRIORITY 3
Purpose of Action	LEVEL 2
Deficiency Photo1	 
Violations	Near Field House No violations recorded.
Pavers	Does not Exist
DOT Sidewalk	Inspected
Asphalt	Does not Exist
Concrete	Inspected
Condition	4 - Between Fair and Poor
Deficiency	DAMAGED CURBS
Deficiency Location/Instance	Beverley Road, East 57th Street, East 59th Street
Deficiency Quantity	400
Quantity Uom	L.F.
Potential Action	REPLACE
Urgency of Action	PRIORITY 3

Question	Response
SITE	
PAVING	
DOT Sidewalk	
Concrete	
Purpose of Action	LEVEL 2
Deficiency Photo1

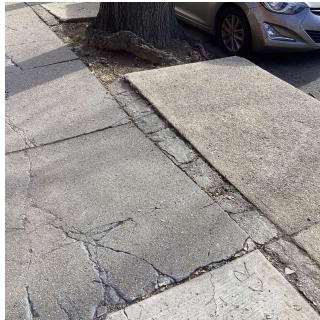
Beverley Road
Violations	No violations recorded.
Deficiency	HEAVING
Deficiency Location/Instance	Beverley Road
Deficiency Quantity	100
Quantity Uom	S.F.
Potential Action	REPLACE
Urgency of Action	PRIORITY 3
Purpose of Action	LEVEL 2
Deficiency Photo1

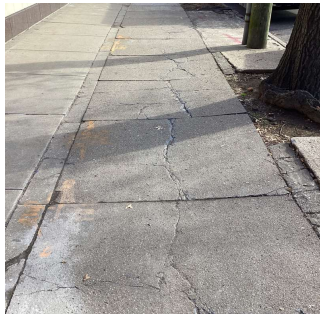
Beverley Road
Violations	No violations recorded.
Deficiency	DAMAGED/DETERIORATED/MISSING SECTIONS
Deficiency Location/Instance	Beverley Road, East 57th Street, East 59th Street
Deficiency Quantity	1,300
Quantity Uom	S.F.
Potential Action	REPLACE
Urgency of Action	PRIORITY 3
Purpose of Action	LEVEL 2
Deficiency Photo1

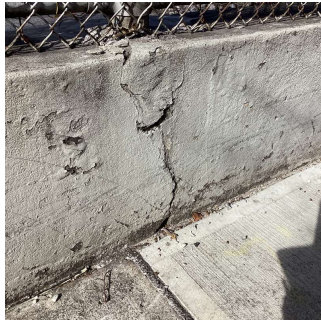
Question	Response
SITE	
PAVING	Inspected
DOT Sidewalk	
Concrete	Inspected
	Beverley Road
Violations	No violations recorded.
Pavers	Does not Exist
PLAYGROUNDS	Does not Exist
RETAINING WALLS	Inspected
Are there any Retaining Walls 6' OR higher facing public street/sidewalk?	No
Condition	3 - Fair
Deficiency	CAST IN PLACE CONCRETE: CRACKS/SPALLING - MAJOR
Deficiency Location/Instance	East 59th Street
Deficiency Quantity	80
Quantity Uom	S.F.
Potential Action	REPLACE
Urgency of Action	PRIORITY 3
Purpose of Action	LEVEL 2
Deficiency Photo1
