NYC Department of Education
Building Condition Assessment Survey 2023 - 2024

Architectural Inspection

K874

Asset: I.S. 340 (OLD 249 AX) - BROOKLYN, 227 STERLING PLACE, New York, 11238

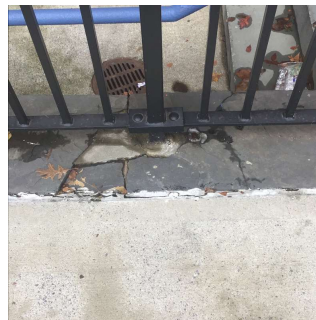
AW7

AREAWAY WALLS: DETERIORATED COPING STONE

20
S.F.
REPLACE
PRIORITY 4
LEVEL 4

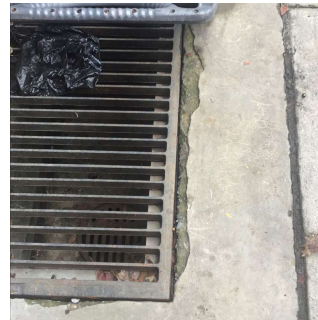
AW8

AREAWAY WALLS: CRACKS AND SPALLING

40
S.F.
REPAIR
PRIORITY 3
LEVEL 2

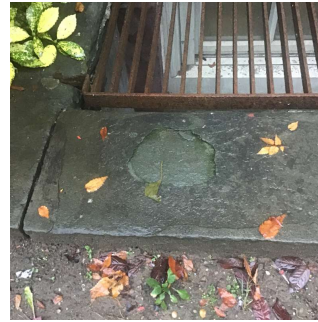
AW1

AREAWAY WALLS: DETERIORATED COPING STONE

40
S.F.
REPAIR
PRIORITY 3
LEVEL 2

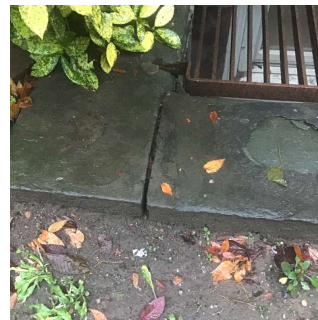
AW1

AREAWAY WALLS: DETERIORATED JOINTS AT COPING STONES

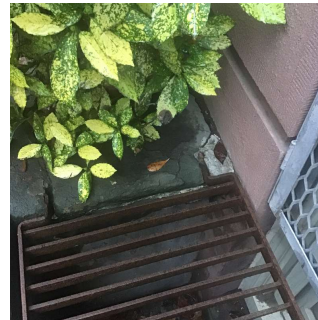
AW1
No violations recorded.

AREAWAY WALLS: DETERIORATED COPING STONE

60
S.F.
REPLACE
PRIORITY 4
LEVEL 2

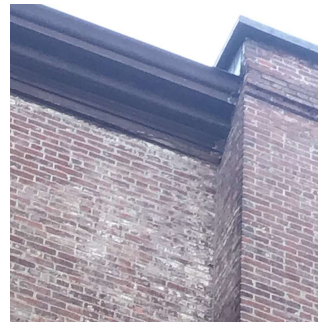
Facade H

WOOD: DETERIORATED

10
S.F.
REPLACE
PRIORITY 4

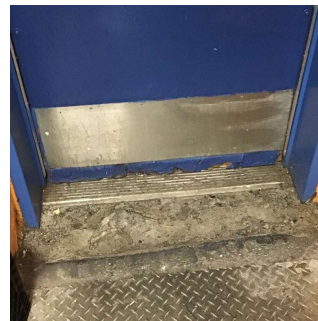
Facade J - Kitchen Exit

METAL CLAD: DETERIORATED DOOR - MAJOR DETERIORATION

3
EACH
REPLACE
PRIORITY 4
LEVEL 2

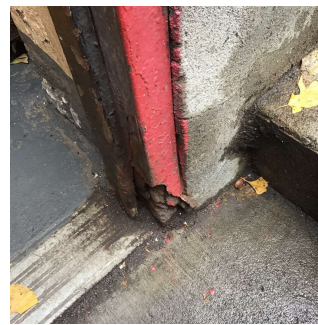
Facade M - Boiler Room Exit at AW5
35636275K

METAL: DETERIORATED DOOR AND FRAME - MAJOR DETERIORATION

1
EACH
REPLACE
PRIORITY 4
LEVEL 4

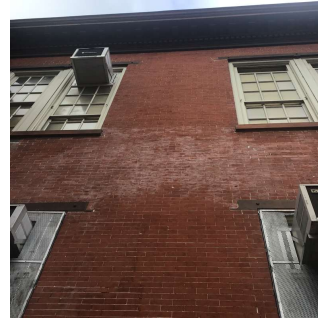
Facade P

Facade A - Main Entrance
Violations	No violations recorded.
EXTERIOR WALLS	
Material Type(s)	Inspected Masonry
Replacement Quantity	18,000
Replacement Uom	S.F.
Instance on All Facades	Inspected
Instance Condition	4 - Between Fair and Poor
Instance Quantity	18,000
Instance Quantity Uom	S.F.
Deficiency	BRICK: EFFLORESCENCE
Roof Plan reference

Deficiency Quantity	500
Quantity Uom	S.F.
Potential Action	MAINTENANCE
Urgency of Action	PRIORITY 1
Purpose of Action	LEVEL 1

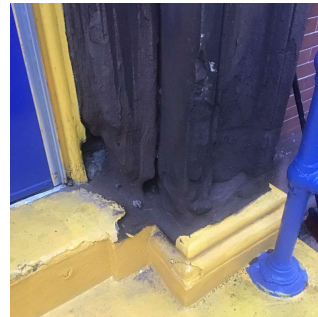
Facade A

STONE: CHIPPED/SPALLED/BROKEN PIECES - MAJOR

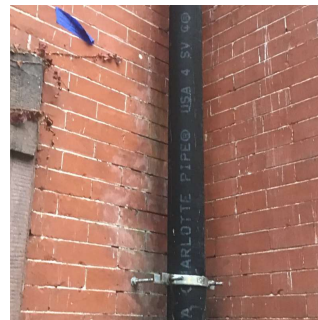
Facade A

BRICK: DETERIORATED JOINTS

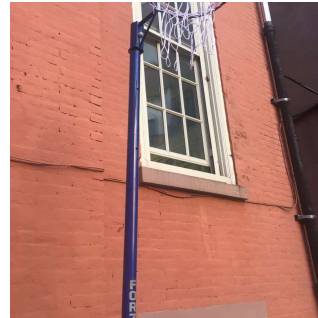
Facade C

BRICK: DETERIORATED JOINTS

PRIORITY 4
LEVEL 2

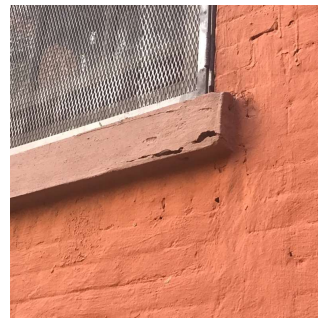
Facade D

BRICK: DETERIORATED MASONRY SILLS - MAJOR

REMOVE AND REPLACE

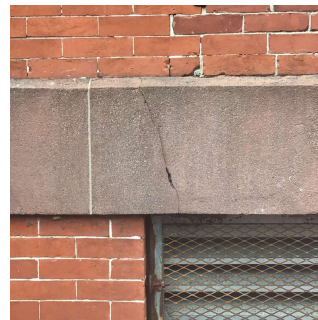
Facade M

STONE: CHIPPED/SPALLED/BROKEN PIECES - MINOR

REPAIR

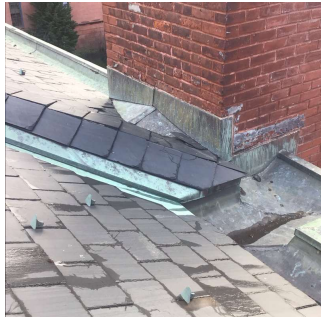
Roof 1
Instance Quantity	13,500
Instance Quantity Uom	S.F.
Does the roof have major mechanical equipment sitting on Dunnage Steel less than 18" above the Roofing?	No
Does this roof instance have a Sustainable Roof System?	No
Do solar panels exist on these roofs?	No
Is/Are the roof(s) suitable for Solar Panel installation?	No
Installation Year	2003
Source of Installation	Custodial Staff
Deficiency	SLATE ROOF: ROOFING: DAMAGED OR MISSING TILES
Roof Plan reference

Quantity Uom	S.F.
Potential Action	REPLACE
Urgency of Action	PRIORITY 4
Purpose of Action	LEVEL 2

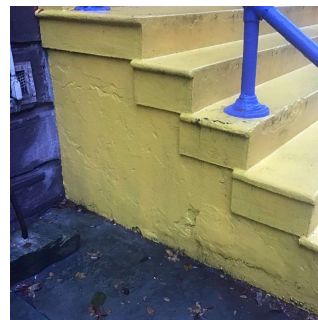
Facade A - Main Entrance

CAST IN PLACE CONCRETE: CRACKS/SPALLING - MINOR

30
S.F.
REPAIR
PRIORITY 3
LEVEL 2

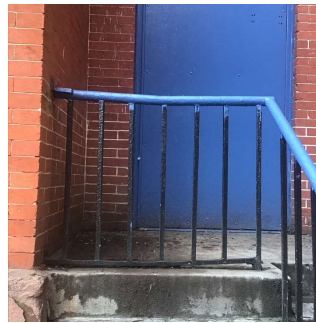
Facade Q

DAMAGED

10
L.F.
REPLACE
PRIORITY 4
LEVEL 2

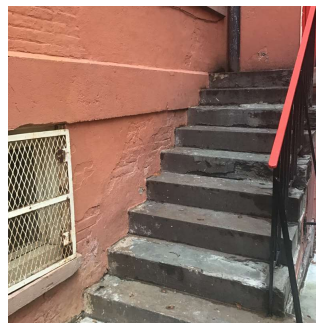
Facade C - Exit 2

MISSING RAILING

REPLACE

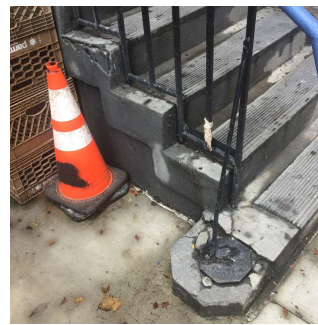
Facade Q
No violations recorded.

CONCRETE: CRACKS/SPALLING - MAJOR

10
S.F.
REPLACE
PRIORITY 4
LEVEL 2

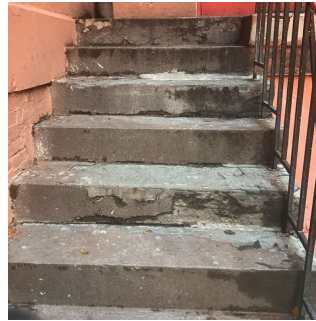
Facade C - Exit 2

STONE: WORN-OUT TREAD/RISER/NOSING

20
S.F.
REPLACE
PRIORITY 4
LEVEL 2

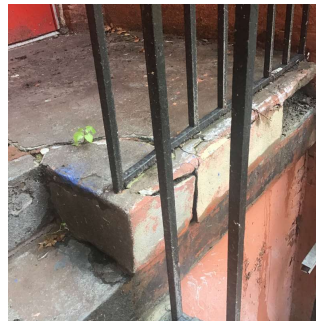
Facade C - Exit 2

STONE: CRACKS/SPALLING - MAJOR

REPLACE

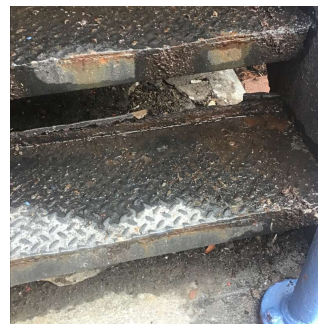
Facade N

METAL: RUST - MAJOR

20
S.F.
REPLACE
PRIORITY 4
LEVEL 2

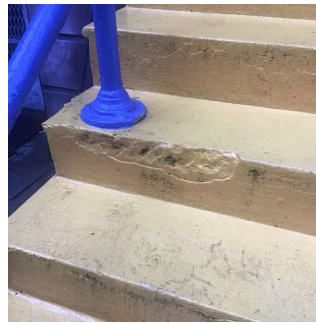
Facade A - Main Entrance

STONE: CRACKS/SPALLING - MINOR

20
S.F.
REPAIR
PRIORITY 3
LEVEL 2

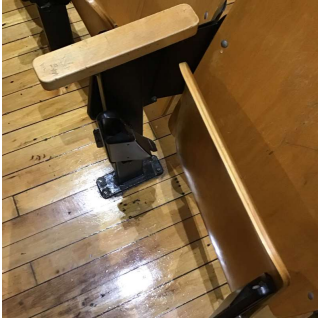
Violations	Seat D/105 No violations recorded.
Deficiency	DAMAGED/BROKEN/INOPERABLE
Deficiency Location/Instance	Seats A/107,D/102,103,104,O/102, and others
Deficiency Quantity	11
Quantity Uom	EACH
Potential Action	REPLACE
Urgency of Action	PRIORITY 3
Purpose of Action	LEVEL 2

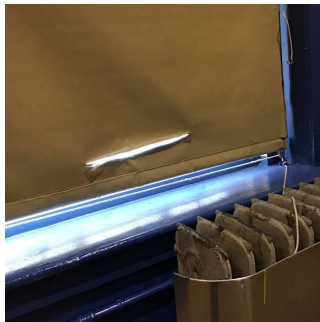
Violations	Near Entrance No violations recorded.
Window Curtains/Shades/Blinds	
Instance on 2nd Floor (180 seats)	Inspected
Condition	3 - Fair
Deficiency	DAMAGED SHADES
Deficiency Location/Instance	Windows
Deficiency Quantity	60
Quantity Uom	S.F.
Potential Action	MAINTENANCE
Urgency of Action	PRIORITY 3
Purpose of Action	LEVEL 2
Deficiency Photo1

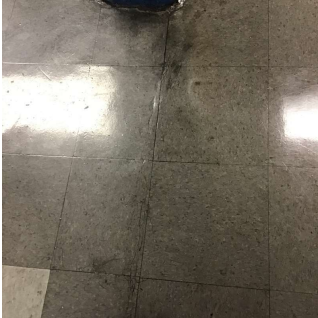
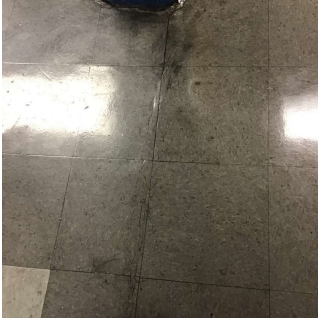
Deficiency	VINYL TILES: DETERIORATED SUBSTRATE
Deficiency Location/Instance	Near Entrance, Servery, center, windows
Deficiency Quantity	400
Quantity Uom	S.F.
Potential Action	REPLACE
Urgency of Action	PRIORITY 3
Purpose of Action	LEVEL 2
Deficiency Photo1

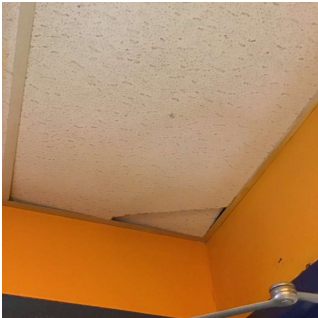
Condition	2 - Between Good and Fair
Deficiency	ACOUSTIC TILES: DAMAGED/MISSING
Deficiency Location/Instance	Corridor near Auditorium entrance
Deficiency Quantity	10
Quantity Uom	S.F.
Potential Action	REPLACE
Urgency of Action	PRIORITY 3
Purpose of Action	LEVEL 2
Deficiency Photo1

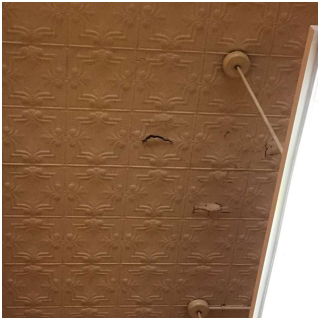
Question	Response
INTERIOR	
CLASSROOMS/CORRIDORS/ADMIN SPACES	
Ceiling	
Violations	Corridor near Auditorium Entrance No violations recorded.
Deficiency	METAL PAN: DAMAGED/MISSING
Deficiency Location/Instance	Corridor near Room 213,115,106
Deficiency Quantity	30
Quantity Uom	S.F.
Potential Action	REPLACE
Urgency of Action	PRIORITY 3
Purpose of Action	LEVEL 2
Deficiency Photo1

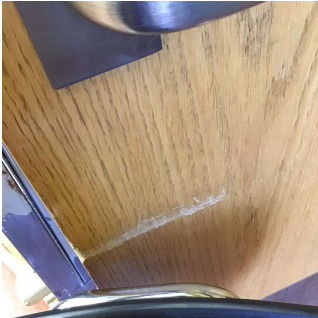
Violations	Corridor near Room 115 No violations recorded.
Door(s)	Inspected
Condition	5 - Poor
Deficiency	WOOD: DETERIORATED DOOR
Deficiency Location/Instance	Room 214,213,202,201,106, and others
Deficiency Quantity	6
Quantity Uom	EACH
Potential Action	MAINTENANCE
Urgency of Action	PRIORITY 3
Purpose of Action	LEVEL 2
Deficiency Photo1

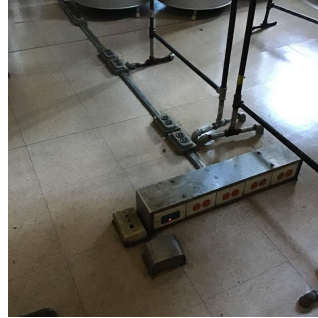
Violations	Room 214 No violations recorded.
Floor Finish	Inspected
Condition	3 - Fair
Deficiency	VINYL TILES: TRIPPING HAZARD - ELECTRICAL OUTLET
Deficiency Location/Instance	Room 210
Deficiency Quantity	20

Quantity Uom	S.F.
Potential Action	REMOVE

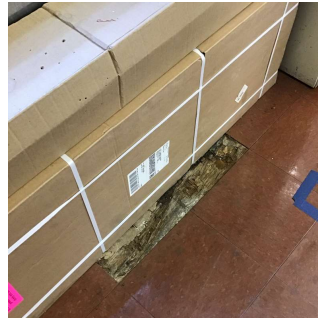
Room 214

VINYL TILES: BROKEN/DETERIORATED/MISSING TILES
Room 218,214, 212,210,208, and others
500
S.F.
REPLACE
PRIORITY 3
LEVEL 2

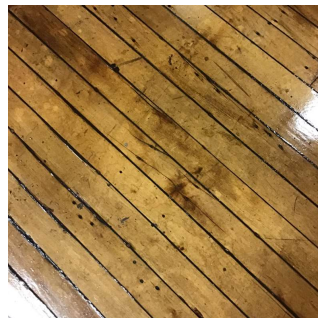
WOOD: DAMAGED/DETERIORATED
Corridor near Room 210,209,207,115, 105, and others
500
S.F.
REPLACE
PRIORITY 3
LEVEL 2

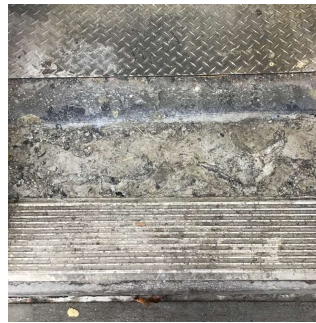
No	Tripping Hazard	Severely damaged concrete floor is a potential tripping hazard.	INTERIOR KITCHEN Floor Finish	Near kitchen exit	Scott Allison	Cleaner

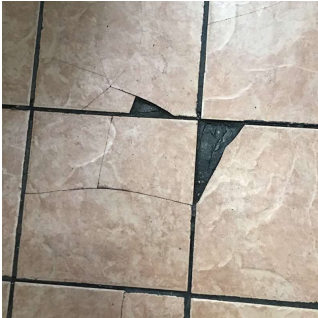
Question	Response
INTERIOR	
TOILET ROOMS - STAFF	
Floor Finish	
Deficiency	CERAMIC TILE: BROKEN/MISSING TILES
Deficiency Location/Instance	2nd Floor Womens, Mens
Deficiency Quantity	20
Quantity Uom	S.F.
Potential Action	REPLACE
Urgency of Action	PRIORITY 3
Purpose of Action	LEVEL 2
Deficiency Photo1

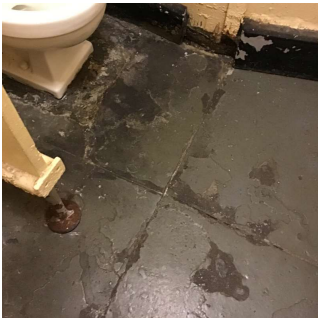
Violations	2nd Floor - Women No violations recorded.
Deficiency	CONCRETE: CRACKS
Deficiency Location/Instance	Kitchen staff
Deficiency Quantity	10
Quantity Uom	S.F.
Potential Action	REPLACE
Urgency of Action	PRIORITY 3
Purpose of Action	LEVEL 2
Deficiency Photo1
