NYC Department of Education
Building Condition Assessment Survey 2023-2024

Architectural Inspection

M075

Asset: P.S. 75 - MANHATTAN, 735 WEST END AVENUE, MANHATTAN, NY, 10025

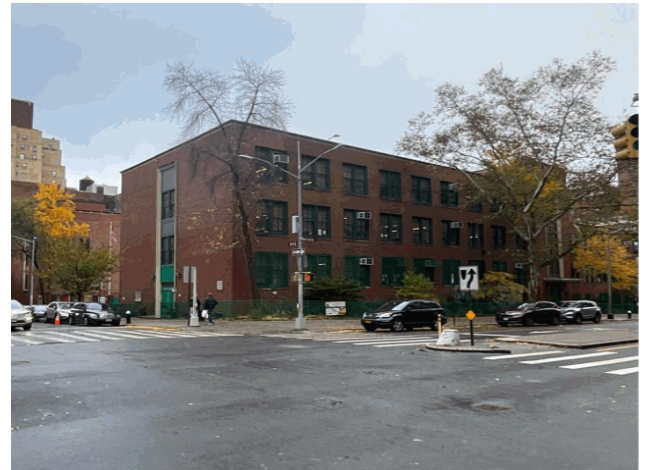
Corner of West 95th Street and West End Avenue - North View

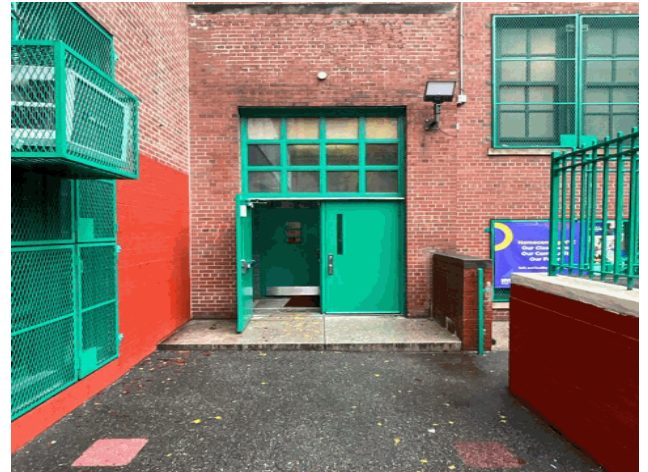
Main Entrance Photo

Facade D - West 95th Street

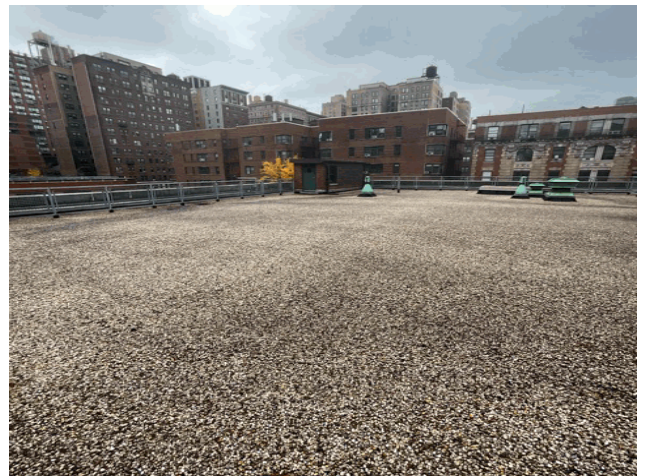
Roof Photo

Roof 2 - South View
