NYC Department of Education
Building Condition Assessment Survey 2023-2024

Architectural Inspection

M116

Asset: P.S. 116 - MANHATTAN, 210 EAST 33 STREET, MANHATTAN, NY, 10016

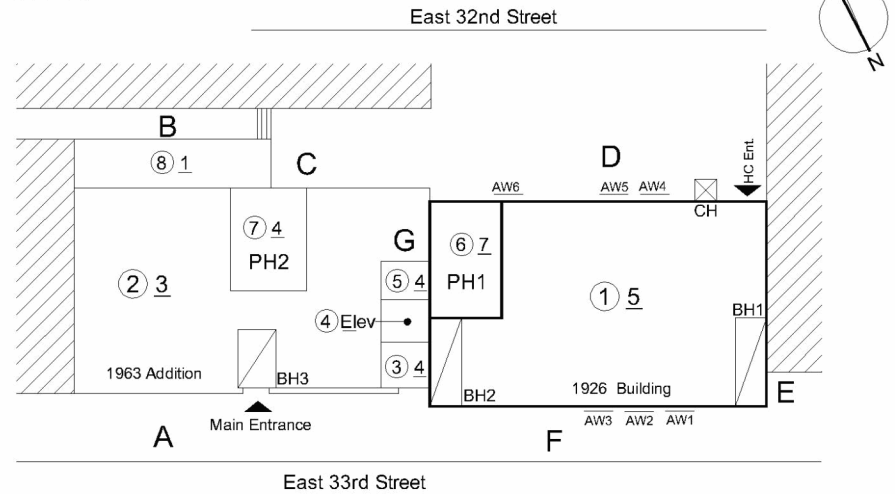
Question	Response
Architectural	
EXTERIOR	Inspected
AREAWAY	Inspected
Instance on AW1-AW6	Inspected
Instance Condition	5- Poor
Instance Quantity	6
Instance Quantity Uom	EACH
Deficiency	AREAWAY WALLS:CRACKS AND SPALLING
