**NYC Department of Education**  
**Building Condition Assessment Survey 2023-2024**

**Architectural Inspection**

**M142**

**Asset:** P.S. 142 - MANHATTAN, 100 ATTORNEY STREET, MANHATTAN, NY, 10002

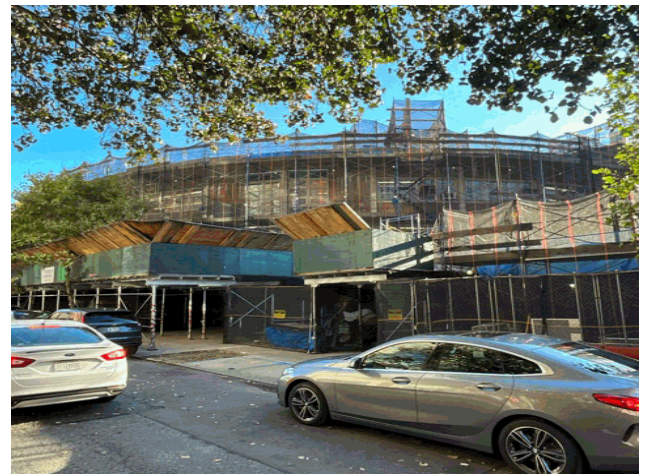
Attorney Street - Northeast View

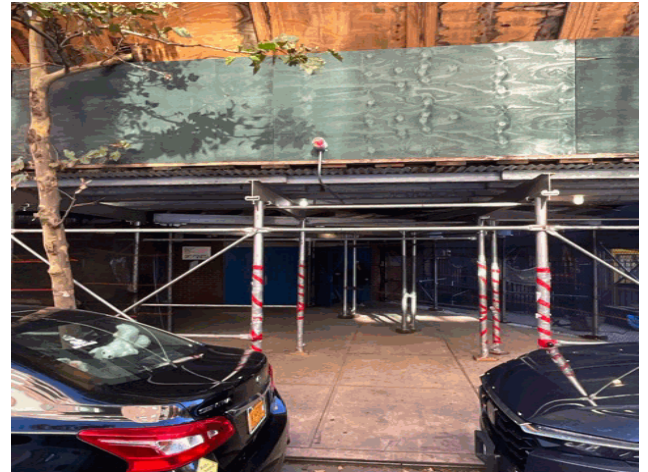
Facade A - Attorney Street

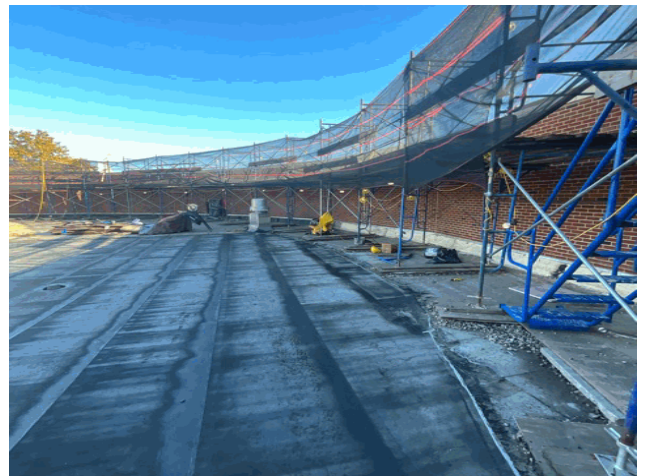
Roof 2 - West View
