**NYC Department of Education**  
**Building Condition Assessment Survey 2023 - 2024**

Architectural Inspection

**Asset:** P.S. 20 - QUEENS, 142-30 BARCLAY AVENUE, New York, 11355

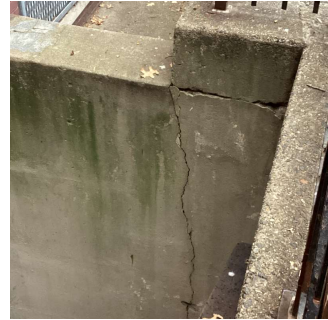
Facade D - AW6

**AREAWAY WALLS: CRACKS AND SPALLING**

REPAIR

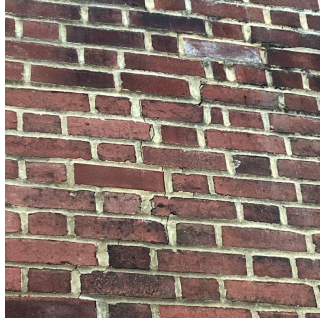
Violations	Facade F - AW8 No violations recorded.
<b>AWNINGS AND CANOPIES</b>	Inspected
Condition	2 - Between Good and Fair
Deficiency	No deficiencies recorded
<b>CHIMNEY</b>	Inspected
Material Type(s)	Masonry
Condition	3 - Fair
Deficiency	BRICK: MINOR CRACKS AND SPALLING
Roof Plan reference

Deficiency Quantity	10
Quantity Uom	S.F.
Potential Action	RESTITCH
Urgency of Action	PRIORITY 3
Purpose of Action	LEVEL 2
Deficiency Photo1

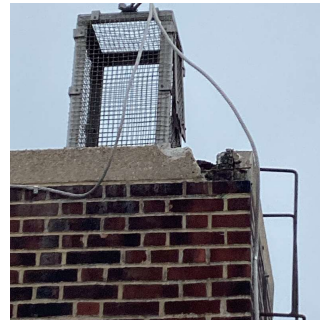
Violations	Roof 1 No violations recorded.
Deficiency	BRICK: DETERIORATED CAP

REPLACE

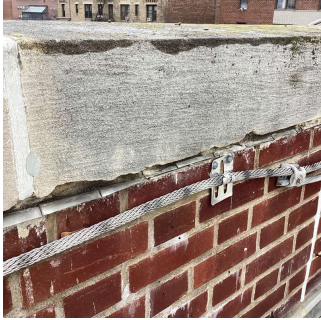
CAST STONE: CRACKED/BROKEN PIECES

Violations	Roof 1 No violations recorded.
Deficiency	CAST STONE: DETERIORATED TRANSVERSE JOINTS
Roof Plan reference

REPLACE-IN-KIND

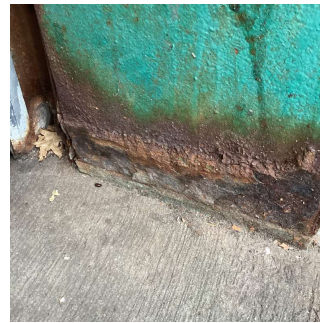
Facade B

Violations	Roof 1 No violations recorded.
<b>CORNICE</b>	Inspected
Condition	2 - Between Good and Fair
Deficiency	No deficiencies recorded
<b>DOORS</b>	Inspected
<b>DOORS AND FRAMES</b>	Inspected
Condition	5 - Poor
Deficiency	ROLL-UP DOOR: DETERIORATED DOOR AND FRAME - MAJOR DETERIORATION

REPLACE

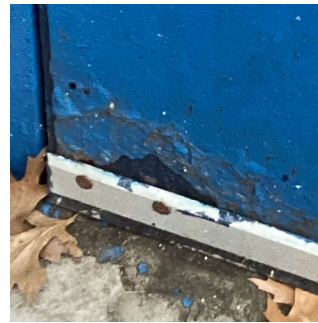
Facade D

**METAL CLAD: DETERIORATED DOOR AND FRAME - MAJOR DETERIORATION**

REPLACE

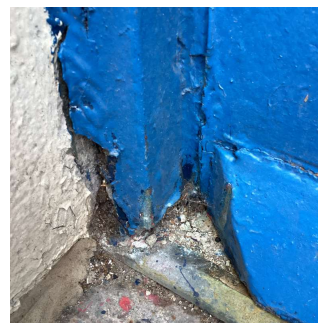
Facade A

**METAL: DETERIORATED DOOR AND FRAME - MAJOR DETERIORATION**

REPLACE

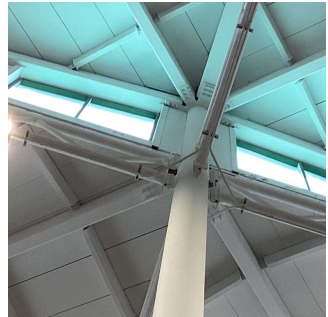
Question	Response
<b>EXTERIOR</b>	
<b>ROOF</b>	
<b>Roofing</b>	
<b>ROOFING</b>	
Instance Quantity	3,000
Instance Quantity Uom	S.F.
Does the roof have major mechanical equipment sitting on Dunnage Steel less than 18" above the Roofing?	No
Does this roof instance have a Sustainable Roof System?	No
Do solar panels exist on these roofs?	No
Is/Are the roof(s) suitable for Solar Panel installation?	No
Installation Year	2020
Source of Installation	Custodial Staff
Deficiency	METAL: ROOFING: MAJOR ACTIVE ROOF LEAKS IN INSTRUCTIONAL SPACE
Roof Plan reference	<p>Q020</p>

Deficiency Quantity	100
Quantity Uom	S.F.
Potential Action	REPLACE
Urgency of Action	PRIORITY 5
Purpose of Action	LEVEL 2
Deficiency Photo1

Violations	Roof 10 - Atrium No violations recorded.
<b>ROOFING DRAINS</b>	Inspected
Condition	3 - Fair
Deficiency	DETERIORATED

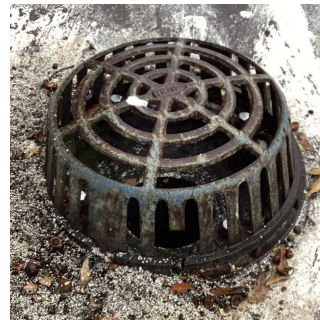
Roof 1  
No violations recorded.

1  
EACH  
REPLACE  
PRIORITY 4  
LEVEL 2

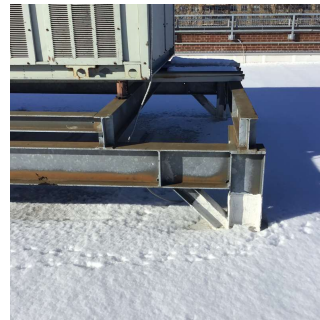
Roof 1  
No violations recorded.

100  
L.F.  
REPLACE  
PRIORITY 3  
LEVEL 2

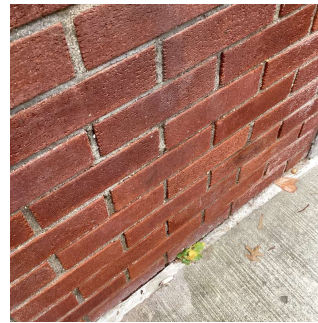
Facade A

Question	Response
<b>EXTERIOR</b>	
<b>ROOF</b>	
Specialties	
<b>SKYLIGHT/ROOF VENT</b>	
Deficiency Photo1	 
Violations	Roof 1 No violations recorded.
<b>ROOF/GRAVITY TANK</b>	Does not Exist
<b>STAIRS/RAMPS: EXTERIOR</b>	Inspected
<b>BUILDING CHEEK/FLANK WALLS</b>	Inspected
Condition	5 - Poor
Deficiency	BRICK: DETERIORATED JOINTS
Roof Plan reference	<p>Q020</p>  
Deficiency Quantity	20
Quantity Uom	S.F.
Potential Action	REPOINT
Urgency of Action	PRIORITY 4
Purpose of Action	LEVEL 2
Deficiency Photo1	 
Violations	Facade B No violations recorded.
Deficiency	CAST IN PLACE CONCRETE: CRACKS/SPALLING - MAJOR

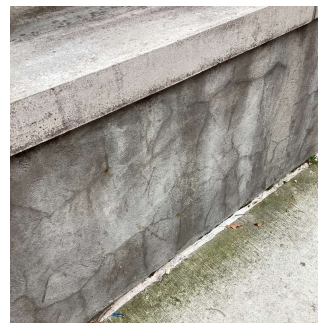
Facade A

STUCCO CEMENT SURFACE: CRACKS/SPALLING - MINOR

REPAIR

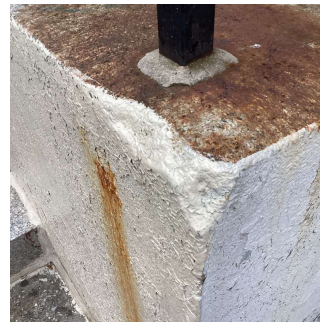
Facade A

STONE: CRACKS/SPALLING - MINOR

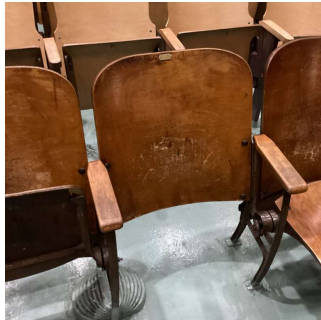
Question	Response
<b>INTERIOR</b>	
<b>AUDITORIUM</b>	
<b>Fixed Seating</b>	
Instance on 1st Floor (466 Seats)	Inspected
Condition	5 - Poor
Deficiency	IMPROPERLY ANCHORED
Deficiency Location/Instance	Seat A/114, J/2
Deficiency Quantity	2
Quantity Uom	EACH
Potential Action	MAINTENANCE
Urgency of Action	PRIORITY 3
Purpose of Action	LEVEL 2
Deficiency Photo1	No photo recorded
Violations	No violations recorded.
Deficiency	DAMAGED/BROKEN/INOPERABLE
Deficiency Location/Instance	Seats A/103, B/111, D/2, F/101, G/10, 12, H/12, K/101, 104, M/12, P/2, Q/2, 106
Deficiency Quantity	13
Quantity Uom	EACH
Potential Action	REPLACE
Urgency of Action	PRIORITY 5
Purpose of Action	LEVEL 6
Deficiency Photo1

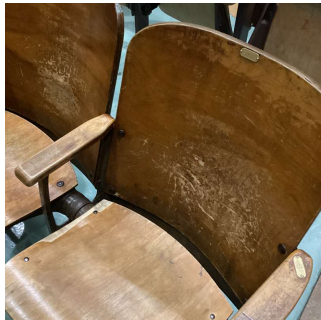
Seat B/114

Violations	No violations recorded.
Deficiency	DAMAGED/BROKEN/INOPERABLE
Deficiency Location/Instance	Seat A/102, 113, B/114, D/4, L/6, and others.
Deficiency Quantity	100
Quantity Uom	EACH
Potential Action	REPLACE
Urgency of Action	PRIORITY 3

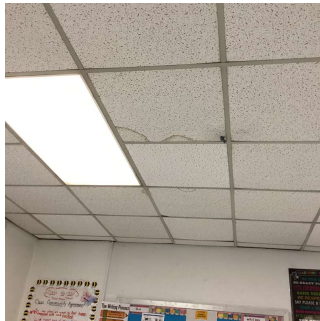
Room 320
Violations	No violations recorded.
Deficiency	ACOUSTIC TILES ON PLASTER: DAMAGED/MISSING
Deficiency Location/Instance	Room 259, Corridor near Rooms 241, 261, 263A, Near Exit 5
Deficiency Quantity	40
Quantity Uom	S.F.
Potential Action	REPLACE
Urgency of Action	PRIORITY 3
Purpose of Action	LEVEL 2
Deficiency Photo1

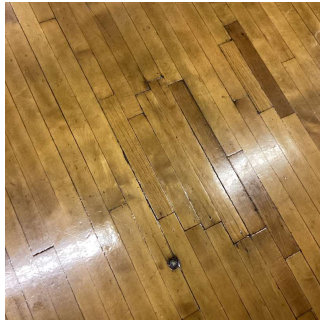
Violations	Room 318 No violations recorded.
<b>Floor Finish</b>	Inspected
Condition	5 - Poor
Deficiency	WOOD: DAMAGED/DETERIORATED
Deficiency Location/Instance	Room 306
Deficiency Quantity	40
Quantity Uom	S.F.
Potential Action	REPLACE
Urgency of Action	PRIORITY 3
Purpose of Action	LEVEL 2
Deficiency Photo1

Violations	Room 306 No violations recorded.
Deficiency	VINYL TILES: DETERIORATED SUBSTRATE
Deficiency Location/Instance	Rooms 104, 166, 310, 320, Corridor near Room 241, and others.
Deficiency Quantity	2,000
Quantity Uom	S.F.
Potential Action	REPLACE
Urgency of Action	PRIORITY 3
Purpose of Action	LEVEL 2
Deficiency Photo1

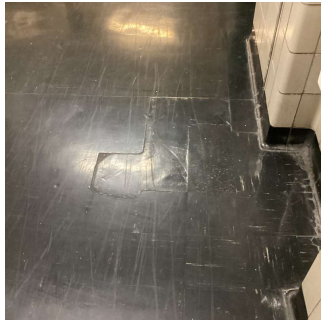
Question	Response
<b>INTERIOR</b>	
<b>CLASSROOMS/CORRIDORS/ADMIN SPACES</b>	
<b>Floor Finish</b>	
Violations	Room 320 No violations recorded.
Deficiency	VINYL TILES: BROKEN/DETERIORATED/MISSING TILES
Deficiency Location/Instance	Room 207, 229, 318, 330, Corridor near Room 318, and others.
Deficiency Quantity	6,000
Quantity Uom	S.F.
Potential Action	REPLACE
Urgency of Action	PRIORITY 3
Purpose of Action	LEVEL 2
Deficiency Photo1

Violations	Corridor near Room 209 No violations recorded.
<b>Walls</b>	Inspected
Condition	2 - Between Good and Fair
Deficiency	GYPSUM BOARD: DETERIORATED
Deficiency Location/Instance	Rooms 151, 249
Deficiency Quantity	20
Quantity Uom	S.F.
Potential Action	REPLACE
Urgency of Action	PRIORITY 3
Purpose of Action	LEVEL 2
Deficiency Photo1

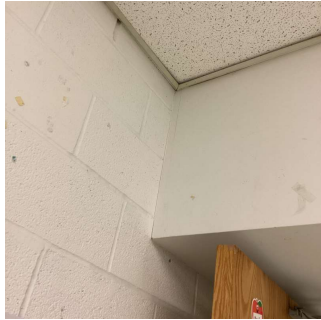
Violations	Room 249 No violations recorded.
Deficiency	MASONRY: CRACKS/SPALLING
Deficiency Location/Instance	Rooms 132, 133, 241, Corridor near Room 033

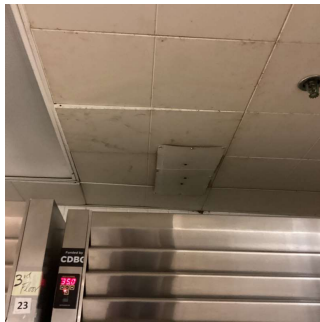
Question	Response
<b>INTERIOR</b>	
<b>INTERIOR GUARDS</b>	Inspected
Deficiency	No deficiencies recorded
<b>KITCHEN</b>	Inspected
Instance on Basement	Inspected
<b>Ceiling</b>	
Instance on Basement	Inspected
Condition	2 - Between Good and Fair
Deficiency	METAL PAN: DAMAGED/MISSING
Deficiency Location/Instance	Fridge Area
Deficiency Quantity	10
Quantity Uom	S.F.
Potential Action	REPLACE
Urgency of Action	PRIORITY 3
Purpose of Action	LEVEL 2
Deficiency Photo1

Violations	Fridge Area No violations recorded.
Deficiency	ACOUSTIC TILES ON PLASTER: DAMAGED/MISSING
Deficiency Location/Instance	Serving Area
Deficiency Quantity	10
Quantity Uom	S.F.
Potential Action	REPLACE
Urgency of Action	PRIORITY 3
Purpose of Action	LEVEL 2
Deficiency Photo1

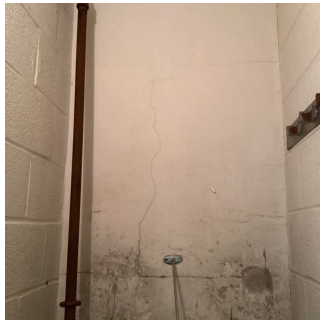
Violations	Serving Area No violations recorded.
Deficiency	GLAZED BLOCK: CRACKS/SPALLING
Deficiency Location/Instance	Serving Area
Deficiency Quantity	10
Quantity Uom	S.F.
Potential Action	REPLACE
Urgency of Action	PRIORITY 3
Purpose of Action	LEVEL 2
Deficiency Photo1	 
Violations	Serving Area No violations recorded.
Deficiency	PLASTER: CRACKS/SPALLING
Deficiency Location/Instance	Mop Room
Deficiency Quantity	10
Quantity Uom	S.F.
Potential Action	REPLACE
Urgency of Action	PRIORITY 3
Purpose of Action	LEVEL 2
Deficiency Photo1

Violations	Mop Room No violations recorded.

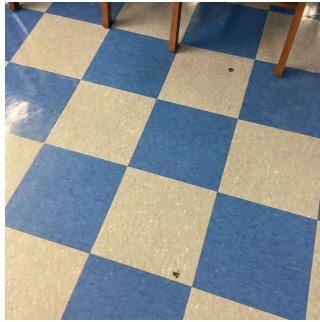
Near Windows
Violations	No violations recorded.
<b>Door(s)</b>	
Instance on Room 220	Inspected
Condition	2 - Between Good and Fair
Deficiency	No deficiencies recorded
<b>Floor Finish</b>	
Instance on Room 220	Inspected
Condition	2 - Between Good and Fair
Deficiency	VINYL TILES: BROKEN/DETERIORATED/MISSING TILES
Deficiency Location/Instance	Room 207C, Near center
Deficiency Quantity	10
Quantity Uom	S.F.
Potential Action	REPLACE
Urgency of Action	PRIORITY 3
Purpose of Action	LEVEL 2
Deficiency Photo1

Near center
Violations	No violations recorded.
Deficiency	CONCRETE: CRACKS
Deficiency Location/Instance	Room 220A
Deficiency Quantity	20
Quantity Uom	S.F.
Potential Action	REPLACE
Urgency of Action	PRIORITY 3

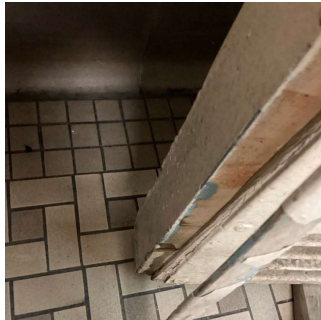
Question	Response
<b>INTERIOR</b>	
<b>TOILET ROOMS - STAFF</b>	
Door(s)	Inspected
Condition	5 - Poor
Deficiency	WOOD: DETERIORATED DOOR
Deficiency Location/Instance	Rooms 107A, 224, 310, 318, Women- Main Entrance, and others.
Deficiency Quantity	6
Quantity Uom	EACH
Potential Action	MAINTENANCE
Urgency of Action	PRIORITY 3
Purpose of Action	LEVEL 2
Deficiency Photo1

Violations	Women- Main Entrance No violations recorded.
<b>Floor Finish</b>	
Condition	Inspected
Condition	2 - Between Good and Fair
Deficiency	CERAMIC TILE: BROKEN/MISSING TILES
Deficiency Location/Instance	Room 107A
Deficiency Quantity	10
Quantity Uom	S.F.
Potential Action	REPLACE
Urgency of Action	PRIORITY 3
Purpose of Action	LEVEL 2
Deficiency Photo1

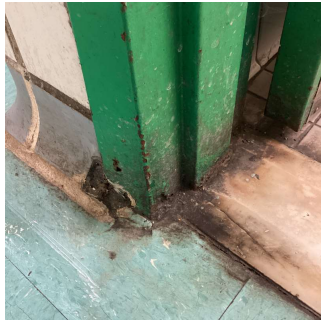
Violations	Room 025 No violations recorded.
<b>Door(s)</b>	Inspected
Condition	5 - Poor
Deficiency	METAL: DETERIORATED DOOR AND FRAME
Deficiency Location/Instance	Room 025
Deficiency Quantity	1
Quantity Uom	EACH
Potential Action	MAINTENANCE
Urgency of Action	PRIORITY 3
Purpose of Action	LEVEL 2
Deficiency Photo1

Violations	Room 025 No violations recorded.
Deficiency	WOOD: DETERIORATED DOOR
Deficiency Location/Instance	Rooms 125, 212, 225, 312, 323, and others.
Deficiency Quantity	7
Quantity Uom	EACH
Potential Action	MAINTENANCE
Urgency of Action	PRIORITY 3
Purpose of Action	LEVEL 2
Deficiency Photo1

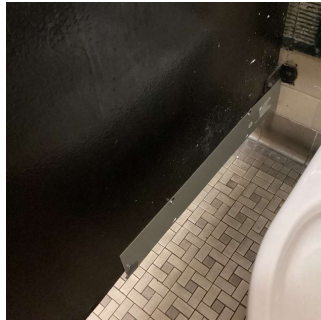
Room 312
Violations	No violations recorded.
<b>Stalls</b>	Inspected
Condition	5 - Poor
Deficiency	RUST - MAJOR
Deficiency Location/Instance	Rooms 225, 323
Deficiency Quantity	8
Quantity Uom	EACH
Potential Action	REPLACE
Urgency of Action	PRIORITY 3
Purpose of Action	LEVEL 2
Deficiency Photo1

Room 323
Violations	No violations recorded.
<b>Walls</b>	Inspected
Condition	2 - Between Good and Fair
Deficiency	MASONRY: CRACKS/SPALLING
Deficiency Location/Instance	Rooms 024, 025, 143/151

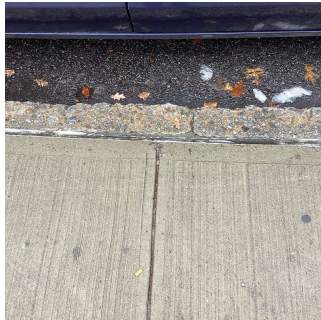
Question	Response
<b>SITE</b>	
<b>PAVING</b>	
<b>DOT Sidewalk</b>	
<b>Concrete</b>	
Deficiency	DAMAGED CURBS
Deficiency Location/Instance	Barclay Avenue, Browne Street, Sanford Avenue.
Deficiency Quantity	200
Quantity Uom	L.F.
Potential Action	REPLACE
Urgency of Action	PRIORITY 3
Purpose of Action	LEVEL 2
Deficiency Photo1

Violations	Barclay Avenue No violations recorded.
<b>Pavers</b>	Does not Exist
<b>PLAYGROUNDS</b>	Inspected
Instance on Interior Courtyard	Inspected
<b>Benches</b>	
Instance on Interior Courtyard	Inspected
Condition	2 - Between Good and Fair
Deficiency	No deficiencies recorded
<b>Fence</b>	
Instance on Interior Courtyard	Does not Exist
<b>Pavement</b>	
Instance on Interior Courtyard	Inspected
Condition	2 - Between Good and Fair
Deficiency	No deficiencies recorded
<b>Play Equipment</b>	
Instance on Interior Courtyard	Inspected
Condition	2 - Between Good and Fair
Deficiency	No deficiencies recorded
