NYC Department of Education
Building Condition Assessment Survey 2023 - 2024

Architectural Inspection

Asset: P.S. 22 - QUEENS, 153-33 SANFORD AVENUE, New York, 11355

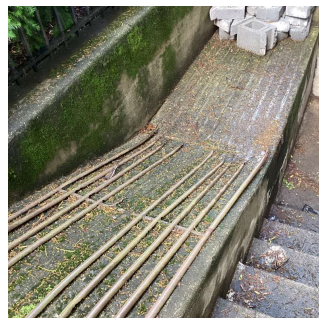
Question	Response
Architectural	
EXTERIOR	Inspected
AREAWAY	Inspected
Instance on AW1, AW2	Inspected
Instance Condition	3 - Fair
Instance Quantity	2
Instance Quantity Uom	EACH
Deficiency	AREAWAY STAIRS: DETERIORATED MATERIAL SLIDE
Roof Plan reference	<p>Q022</p>

Violations	<p>Facade A - AW2</p> <p>No violations recorded.</p>
AWNINGS AND CANOPIES	Inspected
Condition	2 - Between Good and Fair
Deficiency	No deficiencies recorded
CHIMNEY	Inspected
Material Type(s)	Masonry
Condition	2 - Between Good and Fair
Deficiency	No deficiencies recorded
COPING	Inspected
Condition	3 - Fair
Deficiency	CAST STONE: DETERIORATED TRANSVERSE JOINTS

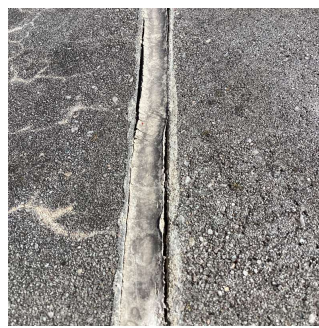
Question	Response
EXTERIOR	
COPING	
Roof Plan reference

Deficiency Quantity	50
Quantity Uom	L.F.
Potential Action	MAINTENANCE
Urgency of Action	PRIORITY 3
Purpose of Action	LEVEL 2
Deficiency Photo1

Violations	Roof 1 No violations recorded.
CORNICE	Does not Exist
DOORS	Inspected
DOORS AND FRAMES	Inspected
Condition	4 - Between Fair and Poor
Deficiency	METAL: DETERIORATED DOOR AND FRAME - MINOR DETERIORATION
Roof Plan reference

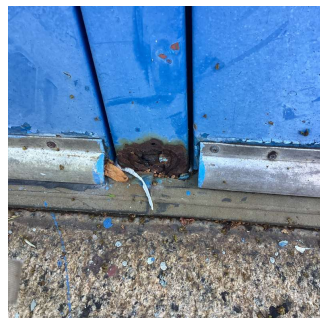
Question	Response
EXTERIOR	
DOORS	
DOORS AND FRAMES	
Violations	No violations recorded.
Deficiency	METAL: DETERIORATED DOOR AND FRAME - MAJOR DETERIORATION
Roof Plan reference	<p>Q022</p>

Deficiency Quantity	4
Quantity Uom	EACH
Potential Action	REPLACE
Urgency of Action	PRIORITY 4
Purpose of Action	LEVEL 2
Deficiency Photo1

Violations	Facade A No violations recorded.
DOOR HARDWARE	Inspected
Condition	3 - Fair
Deficiency	No deficiencies recorded
LINTELS	Inspected
Condition	2 - Between Good and Fair
Deficiency	No deficiencies recorded
TRANSOM/SIDE LIGHT	Inspected
Condition	2 - Between Good and Fair
Deficiency	No deficiencies recorded
EXTERIOR WALLS	Inspected
Material Type(s)	Concrete, Masonry
Replacement Quantity	25,300
Replacement Uom	S.F.
Instance on All Facades	Inspected
Instance Condition	3 - Fair
Instance Quantity	25,300
Instance Quantity Uom	S.F.
Deficiency	BRICK: DETERIORATED JOINTS

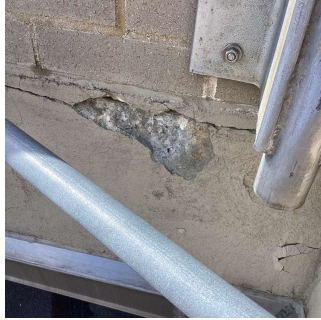
Deficiency

Question	Response
EXTERIOR	
PARAPETS	
Deficiency Photo1

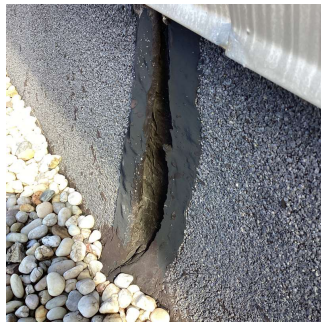
Roof 1
Instance Quantity	28,300
Instance Quantity Uom	S.F.
Does the roof have major mechanical equipment sitting on Dunnage Steel less than 18" above the Roofing?	No
Does this roof instance have a Sustainable Roof System?	No
Do solar panels exist on these roofs?	No
Is/Are the roof(s) suitable for Solar Panel installation?	Yes
Installation Year	2000
Source of Installation	Custodial Staff
Deficiency	BUILT-UP: FLASHING: BASE FLASHING DETERIORATED
Roof Plan reference

Deficiency Quantity	100
Quantity Uom	S.F.
Potential Action	REPAIR
Urgency of Action	PRIORITY 3
Purpose of Action	LEVEL 2
Deficiency Photo1

Roof 1
Violations	No violations recorded.
ROOFING DRAINS	Inspected
Condition	2 - Between Good and Fair
Deficiency	No deficiencies recorded
Specialties	Inspected

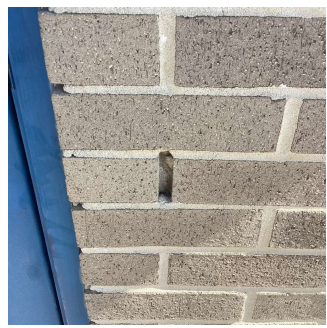
Question	Response
EXTERIOR	
ROOF	
Specialties	
BULKHEAD/PENTHOUSE	Inspected
Condition	3 - Fair
Deficiency	BULKHEAD/PENTHOUSE WALLS/EXTERIOR: DETERIORATED JOINTS
Roof Plan reference

Deficiency Quantity	10
Quantity Uom	S.F.
Potential Action	REPOINT
Urgency of Action	PRIORITY 4
Purpose of Action	LEVEL 2
Deficiency Photo1

Violations	Roof 1 - Bulkhead 2 No violations recorded.
Deficiency	BULKHEAD/PENTHOUSE ROOF: MINOR LEAKAGE
Roof Plan reference

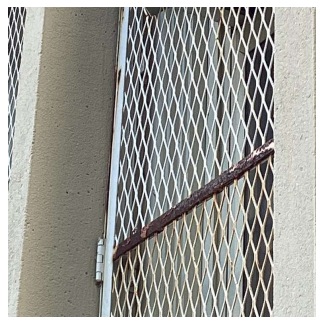
Question	Response
EXTERIOR	
STAIRS/RAMPS: EXTERIOR	
BUILDING CHEEK/FLANK WALLS	Does not Exist
RAILINGS	Inspected
Condition	2 - Between Good and Fair
Deficiency	No deficiencies recorded
STAIRS/RAMPS	Inspected
Condition	2 - Between Good and Fair
Deficiency	No deficiencies recorded
WINDOWS	Inspected
Replacement Quantity	7,000
Replacement Uom	S.F.
EXTERIOR GUARDS	Inspected
Condition	4 - Between Fair and Poor
Deficiency	RUST - MAJOR
Roof Plan reference

300
S.F.
REPLACE
PRIORITY 4
LEVEL 2

Facade A
No violations recorded.

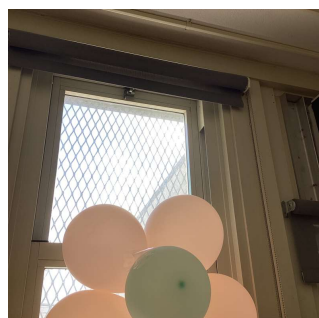
Question	Response
EXTERIOR	
WINDOWS	
LINTELS	Inspected
Condition	2 - Between Good and Fair
Deficiency	No deficiencies recorded
WINDOWS	Inspected
Material Type(s)	Aluminum, Steel
Instance on Aluminum - Double Hung: All Facades	Inspected
Instance Condition	3 - Fair
Instance Quantity	6,700
Instance Quantity Uom	S.F.
Are these windows insulated	No
Installation Year	2000
Source of Installation	Custodial Staff
Deficiency	ALUMINUM - DOUBLE HUNG: AIR/WATER INFILTRATION
Roof Plan reference	<p>Q022</p>

Deficiency Quantity	90
Quantity Uom	L.F.
Potential Action	REPLACE TRIM, SILLS OR WEATHERSTRIPPING
Urgency of Action	PRIORITY 5
Purpose of Action	LEVEL 2
Deficiency Photo1

Violations	<p>Facade C - Room 123, also Room 125</p> <p>No violations recorded.</p>

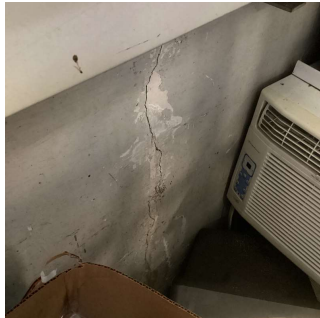
Question	Response
INTERIOR	
STRUCTURAL	
FOUNDATION WALLS	
Deficiency	CONCRETE: CRACKED/SPALLED/REINFORCEMENT EXPOSED
Deficiency Location/Instance	Basement - Fan Room
Deficiency Quantity	10
Quantity Uom	S.F.
Potential Action	REPAIR
Urgency of Action	PRIORITY 3
Purpose of Action	LEVEL 5
Deficiency Photo1

Basement - Fan Room
Violations	No violations recorded.
Deficiency	CONCRETE: WATER INFILTRATION IN NON- INSTRUCTIONAL SPACE
Deficiency Location/Instance	Basement - Fan Room, Oil Tank Room, Workshop, Boiler Room
Deficiency Quantity	300
Quantity Uom	S.F.
Potential Action	INSTALL WATERPROOFING
Urgency of Action	PRIORITY 5
Purpose of Action	LEVEL 5
Deficiency Photo1

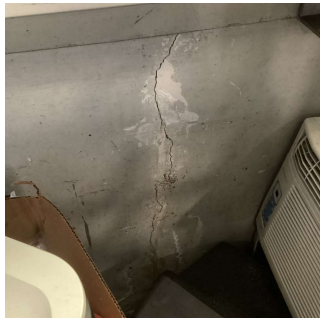
Basement - Fan Room
Violations	No violations recorded.
ROOF STRUCTURE	Inspected
Condition	2 - Between Good and Fair
Deficiency	No deficiencies recorded
VAULTS-BUNKERS	Does not Exist
AUDITORIUM	Inspected
Instance on 1st Floor (218 Seats)	Inspected
Ceiling

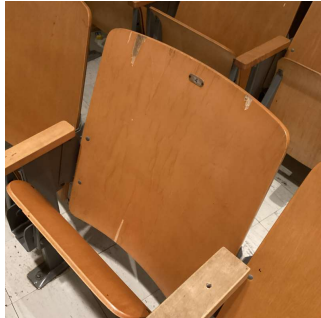
Violations	Seat A/2 No violations recorded.
Deficiency	DAMAGED/BROKEN/INOPERABLE
Deficiency Location/Instance	Seats C/7, D/5, J/4, L/4, M/2, and others
Deficiency Quantity	15
Quantity Uom	EACH
Potential Action	REPLACE
Urgency of Action	PRIORITY 3
Purpose of Action	LEVEL 2
Deficiency Photo1

Violations	Seat L/4 No violations recorded.
Floor Finish

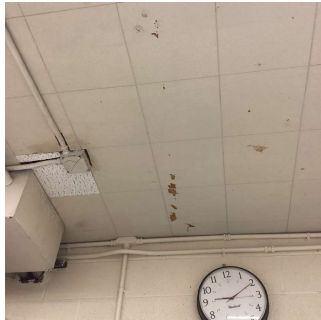
Question	Response
INTERIOR	
CAFETERIA	
Ceiling	
Instance on 1st Floor	Inspected
Condition	2 - Between Good and Fair
Deficiency	ACOUSTIC TILES ON PLASTER: DAMAGED/MISSING
Deficiency Location/Instance	Near Entrance, Center
Deficiency Quantity	20
Quantity Uom	S.F.
Potential Action	REPLACE
Urgency of Action	PRIORITY 3
Purpose of Action	LEVEL 2
Deficiency Photo1

Violations	Near Entrance No violations recorded.
Door(s)	
Instance on 1st Floor	Inspected
Condition	4 - Between Fair and Poor
Deficiency	WOOD: DETERIORATED DOOR
Deficiency Location/Instance	Gymnasium Entrance
Deficiency Quantity	2
Quantity Uom	EACH
Potential Action	MAINTENANCE
Urgency of Action	PRIORITY 3
Purpose of Action	LEVEL 2
Deficiency Photo1

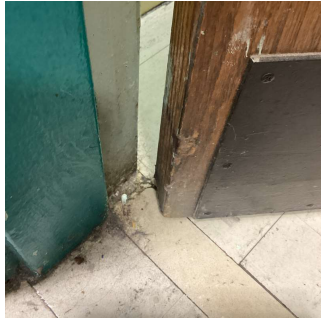
Violations	Gymnasium Entrance No violations recorded.
Fixed Equipment	
Instance on 1st Floor	Does not Exist
Floor Finish	
Instance on 1st Floor	Inspected
Condition	2 - Between Good and Fair
Deficiency	No deficiencies recorded

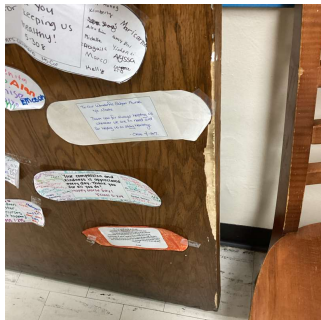
Question	Response
INTERIOR	
CLASSROOMS/CORRIDORS/ADMIN SPACES	
Ceiling	
Deficiency	PLASTER: CRACKS/SPALLING
Deficiency Location/Instance	Room 114
Deficiency Quantity	10
Quantity Uom	S.F.
Potential Action	REPLACE
Urgency of Action	PRIORITY 3
Purpose of Action	LEVEL 2
Deficiency Photo1	 
Violations	Room 114 No violations recorded.
Door(s)	
Condition	Inspected
Deficiency	5 - Poor
Deficiency	WOOD: DETERIORATED DOOR
Deficiency Location/Instance	Rooms 117, 204, 212, 312, 323, and others
Deficiency Quantity	16
Quantity Uom	EACH
Potential Action	MAINTENANCE
Urgency of Action	PRIORITY 3
Purpose of Action	LEVEL 2
Deficiency Photo1

Violations	Room 117 No violations recorded.
Floor Finish	
Condition	Inspected
Condition	2 - Between Good and Fair
Deficiency	No deficiencies recorded
Walls	
Condition	Inspected
Condition	2 - Between Good and Fair
Deficiency	GLAZED BLOCK: CRACKS/SPALLING
Deficiency Location/Instance	Corridor near Rooms 116, 323, Auditorium, Cafeteria, Exit 2, and others

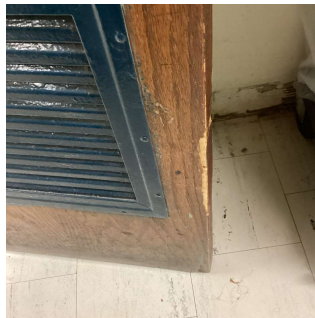
Question	Response
INTERIOR	
KITCHEN	
Ceiling	
Instance on 1st Floor	Inspected
Condition	2 - Between Good and Fair
Deficiency	No deficiencies recorded
Door(s)	
Instance on 1st Floor	Inspected
Condition	3 - Fair
Deficiency	WOOD: DETERIORATED DOOR
Deficiency Location/Instance	Women Toilet Room
Deficiency Quantity	1
Quantity Uom	EACH
Potential Action	MAINTENANCE
Urgency of Action	PRIORITY 3
Purpose of Action	LEVEL 2
Deficiency Photo1

Women Toilet Room
Violations	No violations recorded.
Floor Finish	
Instance on 1st Floor	Inspected
Condition	2 - Between Good and Fair
Deficiency	CONCRETE: CRACKS
Deficiency Location/Instance	Mop Room
Deficiency Quantity	10
Quantity Uom	S.F.
Potential Action	REPLACE
Urgency of Action	PRIORITY 3
Purpose of Action	LEVEL 2
Deficiency Photo1

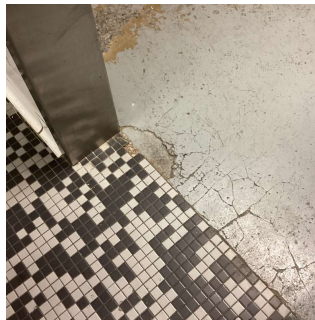
Mop Room
Violations	No violations recorded.
Deficiency	CERAMIC TILE: BROKEN/MISSING TILES
Deficiency Location/Instance	Near Mop Room, Prep Area

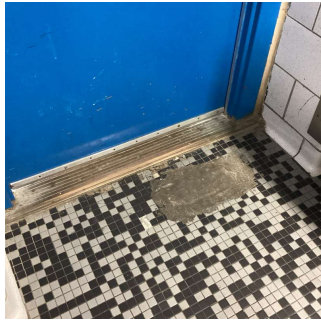
Question	Response
INTERIOR	
KITCHEN	
Floor Finish	
Deficiency Quantity	10
Quantity Uom	S.F.
Potential Action	REPLACE
Urgency of Action	PRIORITY 3
Purpose of Action	LEVEL 2
Deficiency Photo1

Near Mop Room
Violations	No violations recorded.
Walls	
Instance on 1st Floor	Inspected
Condition	2 - Between Good and Fair
Deficiency	CERAMIC TILE: BROKEN/ MISSING
Deficiency Location/Instance	Near Entrance, Emergency Exit, Windows
Deficiency Quantity	20
Quantity Uom	S.F.
Potential Action	REPLACE
Urgency of Action	PRIORITY 3
Purpose of Action	LEVEL 2
Deficiency Photo1

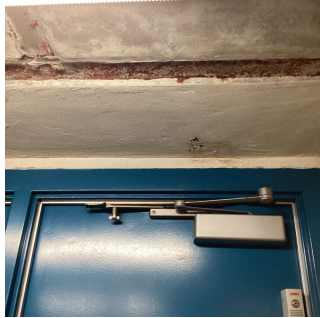
Question	Response
INTERIOR	
STAIRS/RAMPS: INTERIOR	
Ceiling	Inspected
Condition	2 - Between Good and Fair
Deficiency	PLASTER: CRACKS/SPALLING
Deficiency Location/Instance	Stair B/Vestibule
Deficiency Quantity	10
Quantity Uom	S.F.
Potential Action	REPLACE
Urgency of Action	PRIORITY 3
Purpose of Action	LEVEL 2
Deficiency Photo1

Violations	Stair B/Vestibule No violations recorded.
Door(s)	Inspected
Condition	2 - Between Good and Fair
Deficiency	No deficiencies recorded
Partition	Does not Exist
Railings	Inspected
Condition	2 - Between Good and Fair
Deficiency	No deficiencies recorded
Stairs and Landings	Inspected
Condition	5 - Poor
Deficiency	STONE: BROKEN/MISSING
Deficiency Location/Instance	Stairs A/1, B/1, 2, C/1, 2, and others
Deficiency Quantity	300
Quantity Uom	S.F.
Potential Action	REPLACE
Urgency of Action	PRIORITY 3
Purpose of Action	LEVEL 2
Deficiency Photo1

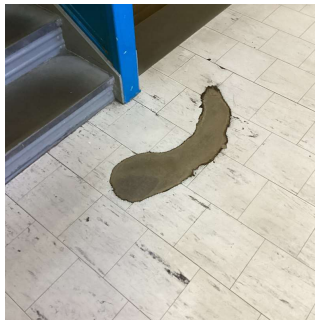
Violations	Stair C/1 No violations recorded.
Deficiency	VINYL TILES: BROKEN/DETERIORATED/MISSING TILES

Question	Response
INTERIOR	
STAIRS/RAMPS: INTERIOR	
Stairs and Landings	
Deficiency Location/Instance	Stairs B/1, 2, C/Vestibule, 1, 2
Deficiency Quantity	20
Quantity Uom	S.F.
Potential Action	REPLACE
Urgency of Action	PRIORITY 3
Purpose of Action	LEVEL 2
Deficiency Photo1

Stair B/1
Violations	No violations recorded.
Walls	
Condition	Inspected
	2 - Between Good and Fair
Deficiency	PLASTER: CRACKS/SPALLING
Deficiency Location/Instance	Stair B/3
Deficiency Quantity	10
Quantity Uom	S.F.
Potential Action	REPLACE
Urgency of Action	PRIORITY 3
Purpose of Action	LEVEL 2
Deficiency Photo1

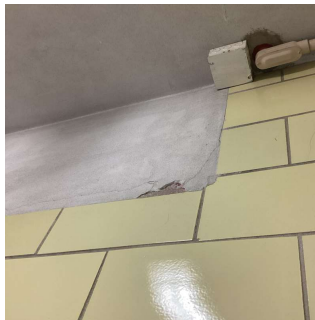
Stair B/3
Violations	No violations recorded.
Deficiency	GLAZED BLOCK: CRACKS/SPALLING
Deficiency Location/Instance	Stairs A/Vestibule, B/1, 2, C/Vestibule, 2, and others
Deficiency Quantity	30
Quantity Uom	S.F.
Potential Action	REPLACE
Urgency of Action	PRIORITY 3
Purpose of Action	LEVEL 2

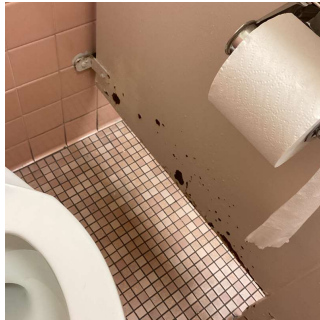
Room 104
Violations	No violations recorded.
Stalls	Inspected
Condition	5 - Poor
Deficiency	RUST - MAJOR
Deficiency Location/Instance	Rooms 107, 213, 315, 317, Kitchen
Deficiency Quantity	5
Quantity Uom	EACH
Potential Action	REPLACE
Urgency of Action	PRIORITY 3
Purpose of Action	LEVEL 2
Deficiency Photo1

Room 317
Violations	No violations recorded.
Walls	Inspected
Condition	2 - Between Good and Fair
Deficiency	PLASTER: CRACKS/SPALLING
Deficiency Location/Instance	Room 213
Deficiency Quantity	10
Quantity Uom	S.F.
Potential Action	REPLACE
Urgency of Action	PRIORITY 3
Purpose of Action	LEVEL 2

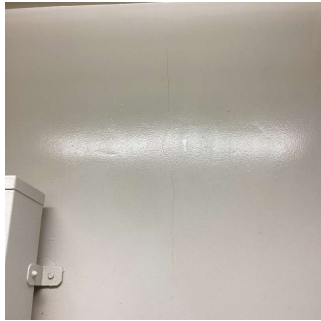
Violations	Room 213 No violations recorded.
Deficiency	CERAMIC TILE: BROKEN/ MISSING
Deficiency Location/Instance	Room 107
Deficiency Quantity	10
Quantity Uom	S.F.
Potential Action	REPLACE
Urgency of Action	PRIORITY 3
Purpose of Action	LEVEL 2
Deficiency Photo1	 
Violations	Room 107 No violations recorded.
TOILET ROOMS - STUDENTS	
Ceiling	Inspected
Condition	2 - Between Good and Fair
Deficiency	PLASTER: CRACKS/SPALLING - ACTIVE LEAK
Deficiency Location/Instance	Room 211
Deficiency Quantity	30
Quantity Uom	S.F.
Potential Action	REPLACE
Urgency of Action	PRIORITY 5
Purpose of Action	LEVEL 2
