NYC Department of Education
Building Condition Assessment Survey 2023 - 2024

Architectural Inspection

Asset: I.S. 53 - QUEENS, 10-45 NAMEOKE STREET, New York, 11691

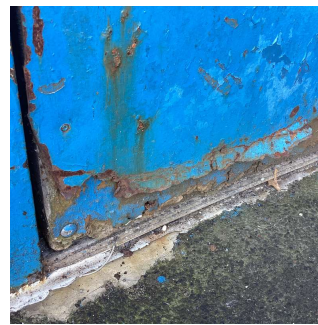
Facade F

Question	Response
Architectural	
EXTERIOR	Inspected
AREAWAY	Inspected
Instance on AW1	Inspected
Instance Condition	2 - Between Good and Fair
Instance Quantity	1
Instance Quantity Uom	EACH
Deficiency	No deficiencies recorded
AWNINGS AND CANOPIES	Does not Exist
CHIMNEY	Inspected
Material Type(s)	Masonry
Condition	1 - Good
Deficiency	No deficiencies recorded
COPING	Inspected
Condition	1 - Good
Deficiency	No deficiencies recorded
CORNICE	Does not Exist
DOORS	Inspected
DOORS AND FRAMES	Inspected
Condition	5 - Poor
Deficiency	METAL CLAD: DETERIORATED DOOR AND FRAME - MAJOR DETERIORATION

2
EACH
REPLACE
PRIORITY 4
LEVEL 2

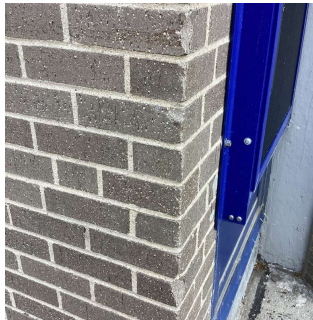
Facade E

BRICK: CRACKS/DISPLACED/SPALLED BRICK AT BUILDING CORNERS

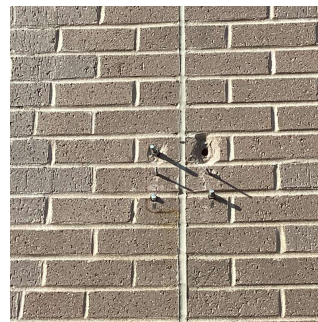
Facade F
No violations recorded.

BRICK: MAJOR / THRU CRACKS

10
S.F.
REMOVE AND REBUILD
PRIORITY 4
LEVEL 2

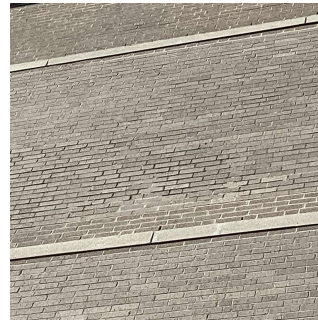
Facade F
No violations recorded.

BRICK: DETERIORATED JOINTS

1,000
S.F.
REPOINT
PRIORITY 3
LEVEL 2

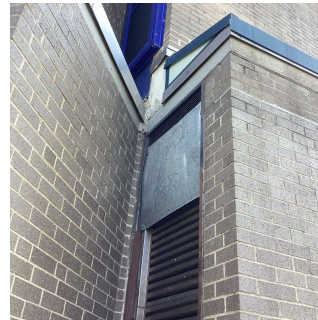
Facade D
No violations recorded.

MAJOR RUSTING

10
S.F.
REPLACE
PRIORITY 4
LEVEL 2

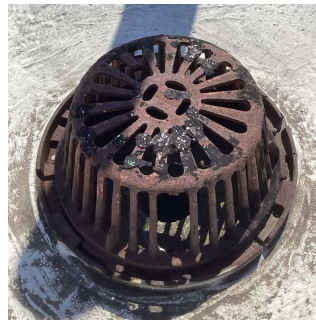
Roof 1
No violations recorded.

Is/Are the roof(s) suitable for Solar Panel installation?	Yes
Installation Year	2021
Source of Installation	Custodial Staff
Deficiency	No deficiencies recorded
ROOFING DRAINS	Inspected
Condition	3 - Fair
Deficiency	DETERIORATED

1
EACH
REPLACE
PRIORITY 4
LEVEL 2

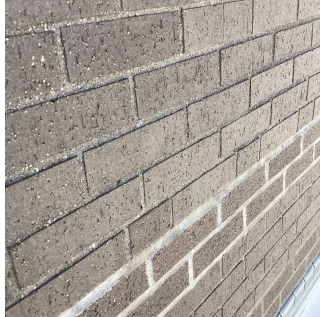
BULKHEAD/PENTHOUSE WALLS/EXTERIOR: DETERIORATED JOINTS

100
S.F.
REPOINT
PRIORITY 3
LEVEL 2

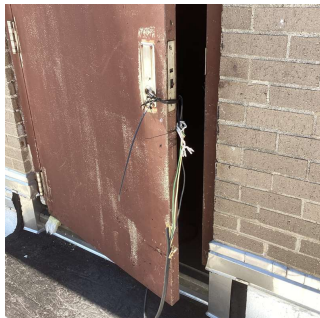
Violations	Roof 1 - Bulkhead No violations recorded.
Deficiency	BULKHEAD/PENTHOUSE DOORS: DETERIORATED DOOR
Roof Plan reference	Q053
Deficiency Quantity	1
Quantity Uom	EACH
Potential Action	REPLACE DOOR
Urgency of Action	PRIORITY 3
Purpose of Action	LEVEL 2
Deficiency Photo1

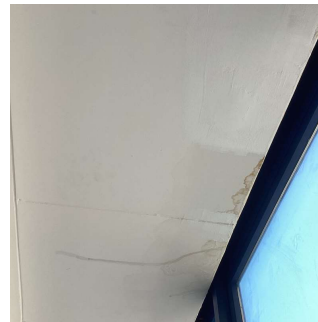
Facade K - Skylight at Corridor near Room 381, also Skylight Room 301

WATER INFILTRATION

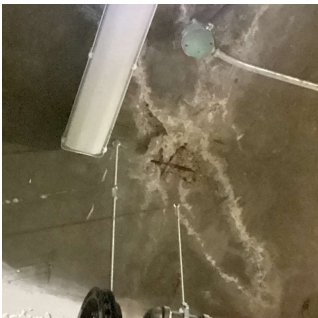
Question	Response
INTERIOR	
STRUCTURAL	
FLOOR STRUCTURE	
Deficiency Quantity	10
Quantity Uom	S.F.
Potential Action	REPAIR
Urgency of Action	PRIORITY 3
Purpose of Action	LEVEL 5
Deficiency Photo1	 
	Basement - Electrical Panel Room
Violations	No violations recorded.
Deficiency	CONCRETE: CRACKS/SPALLED/REINFORCEMENT EXPOSED
Deficiency Location/Instance	Basement - Pump Room
Deficiency Quantity	30
Quantity Uom	S.F.
Potential Action	REPAIR
Urgency of Action	PRIORITY 3
Purpose of Action	LEVEL 5
Deficiency Photo1

Basement - Pump Room
Violations	No violations recorded.
FOUNDATION WALLS	
	Inspected
Material Type(s)	Concrete
Condition	2 - Between Good and Fair
Deficiency	No deficiencies recorded
ROOF STRUCTURE	
	Inspected
Condition	2 - Between Good and Fair
Deficiency	No deficiencies recorded
VAULTS-BUNKERS	
	Does not Exist
AUDITORIUM	
	Inspected
Instance on 3rd Floor (695 Seats)	Under Construction
CAFETERIA	
	Inspected
Instance on 1st Floor	Inspected

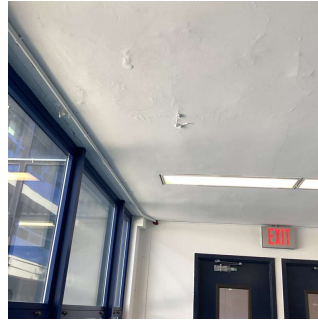
Near Room 170
No violations recorded.

Instance on 1st Floor	Inspected
Condition	2 - Between Good and Fair
Deficiency	PLASTER: CRACKS/SPALLING
Deficiency Location/Instance	Near Room 170
Deficiency Quantity	20
Quantity Uom	S.F.
Potential Action	REPLACE
Urgency of Action	PRIORITY 3
Purpose of Action	LEVEL 2
Deficiency Photo1

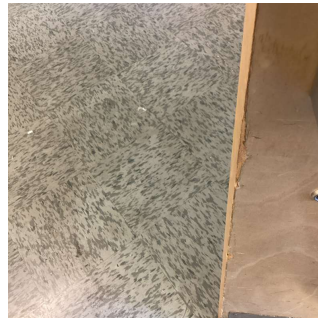
Entrance
No violations recorded.

Instance on 1st Floor	Inspected
Condition	4 - Between Fair and Poor
Deficiency	WOOD: DETERIORATED DOOR
Deficiency Location/Instance	Entrances
Deficiency Quantity	2
Quantity Uom	EACH
Potential Action	MAINTENANCE
Urgency of Action	PRIORITY 3
Purpose of Action	LEVEL 2
Deficiency Photo1

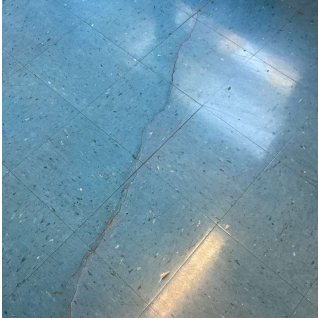
Question	Response
INTERIOR	
CAFETERIA	
Floor Finish	
Deficiency Location/Instance	Near Entrance, Serving Area, Windows
Deficiency Quantity	40
Quantity Uom	S.F.
Potential Action	REPLACE
Urgency of Action	PRIORITY 3
Purpose of Action	LEVEL 2
Deficiency Photo1

Violations	Near Entrance No violations recorded.
Sliding-folding Partition	
Instance on 1st Floor	Does not Exist
Stage	
Instance on 1st Floor	Does not Exist
Walls	
Instance on 1st Floor	Inspected
Condition	2 - Between Good and Fair
Deficiency	WOOD PANELING: DETERIORATED
Deficiency Location/Instance	Near center
Deficiency Quantity	10
Quantity Uom	S.F.
Potential Action	REPLACE
Urgency of Action	PRIORITY 3
Purpose of Action	LEVEL 2
Deficiency Photo1	 
Violations	Near center No violations recorded.
Deficiency	PLASTER: CRACKS/SPALLING
Deficiency Location/Instance	Columns, Near Room 170
Deficiency Quantity	20
Quantity Uom	S.F.
Potential Action	REPLACE

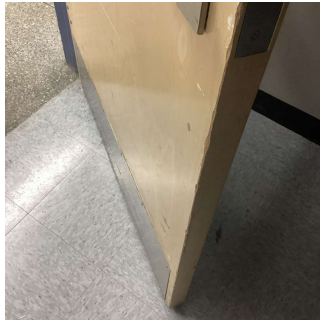
Room 353
Violations	No violations recorded.
Door(s)	
Condition	Inspected
	5 - Poor
Deficiency	WOOD: DETERIORATED DOOR
Deficiency Location/Instance	Rooms 109, 110, 357, 423, 477, and others
Deficiency Quantity	25
Quantity Uom	EACH
Potential Action	MAINTENANCE
Urgency of Action	PRIORITY 3
Purpose of Action	LEVEL 2
Deficiency Photo1

Room 110
Violations	No violations recorded.
Floor Finish	
Condition	Inspected
	2 - Between Good and Fair
Deficiency	TERRAZZO: CRACKS
Deficiency Location/Instance	Main Entrance Lobby, Corridor near Rooms 187, 239, Cafeteria, Gymnasium, and others
Deficiency Quantity	330
Quantity Uom	S.F.
Potential Action	REPLACE
Urgency of Action	PRIORITY 3
Purpose of Action	LEVEL 2

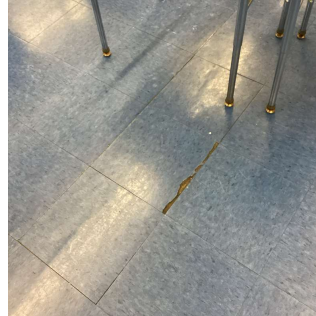
Room 368

VINYL TILES: BROKEN/DETERIORATED/MISSING TILES

REPLACE

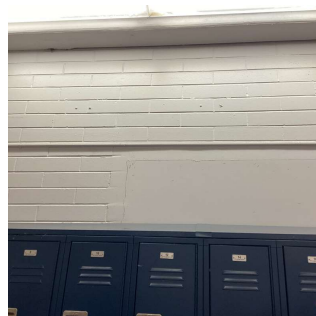
PLASTER: CRACKS/SPALLING

REPLACE

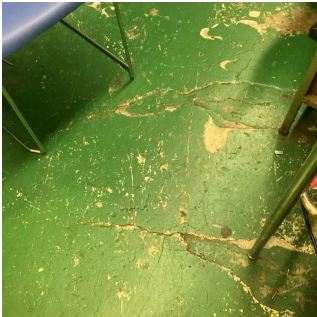
Condition	2 - Between Good and Fair
Deficiency	CONCRETE: CRACKS
Deficiency Location/Instance	Office/Storage
Deficiency Quantity	30
Quantity Uom	S.F.
Potential Action	REPLACE
Urgency of Action	PRIORITY 3

Violations	Office/Storage No violations recorded.
Seating	
Instance on 1st Floor	Does not Exist
Sliding-folding Partition	
Instance on 1st Floor	Inspected
Condition	2 - Between Good and Fair
Deficiency	No deficiencies recorded
Stage	
Instance on 1st Floor	Does not Exist
Walls	
Instance on 1st Floor	Inspected
Condition	2 - Between Good and Fair
Deficiency	WALL PADDING: DETERIORATED
Deficiency Location/Instance	Near Center
Deficiency Quantity	100
Quantity Uom	S.F.
Potential Action	REPLACE
Urgency of Action	PRIORITY 3
Purpose of Action	LEVEL 2
Deficiency Photo1

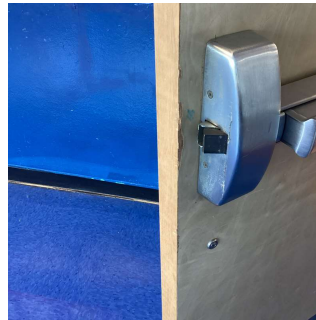
Entrance

Question	Response
INTERIOR	
KITCHEN	
Floor Finish	
Deficiency Photo1	 
Violations	Room 128 No violations recorded.
Walls	
Instance on 1st Floor	Inspected
Condition	2 - Between Good and Fair
Deficiency	BRICK: CRACKS/SPALLING
Deficiency Location/Instance	Near Room 124
Deficiency Quantity	10
Quantity Uom	S.F.
Potential Action	REPLACE
Urgency of Action	PRIORITY 3
Purpose of Action	LEVEL 2
Deficiency Photo1	 
Violations	Near Room 124 No violations recorded.
LIBRARY	
Instance on Room 347	Inspected
Built-in Furnishing	
Instance on Room 347	Inspected
Condition	2 - Between Good and Fair
Deficiency	No deficiencies recorded
Ceiling	
Instance on Room 347	Inspected
Condition	2 - Between Good and Fair
Deficiency	No deficiencies recorded
Door(s)	
Instance on Room 347	Inspected
Condition	4 - Between Fair and Poor
Deficiency	WOOD: DETERIORATED DOOR
Deficiency Location/Instance	Entrances

Deficiency Quantity	2
Quantity Uom	EACH
Potential Action	MAINTENANCE
Urgency of Action	PRIORITY 3
Purpose of Action	LEVEL 2
Deficiency Photo1

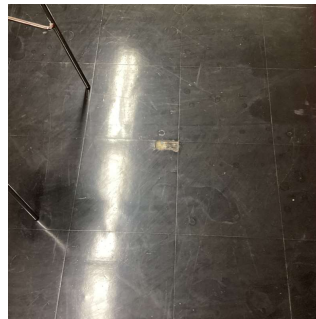
Instance on Room 347	Inspected
Condition	2 - Between Good and Fair
Deficiency	VINYL TILES: BROKEN/DETERIORATED/MISSING TILES
Deficiency Location/Instance	Computer Room
Deficiency Quantity	10
Quantity Uom	S.F.
Potential Action	REPLACE
Urgency of Action	PRIORITY 3
Purpose of Action	LEVEL 2
Deficiency Photo1

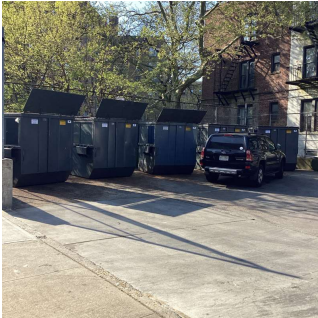
Question	Response
SITE	
CONTAINERIZATION	
Condition	5 - Poor
Deficiency	CONTAINER DAMAGED
Deficiency Location/Instance	Near Exit 2
Deficiency Quantity	4
Quantity Uom	EACH
Potential Action	REPLACE
Urgency of Action	PRIORITY 3
Purpose of Action	LEVEL 2
Deficiency Photo1

Violations	Near Exit 2 No violations recorded.
Drainage System for Asphalt	Inspected
Catch Basins/Manhole - Surrounded by asphalt	Inspected
Condition	2 - Between Good and Fair
Deficiency	No deficiencies recorded
Culverts - Asphalt Covering	Does not Exist
Drainage System for Concrete	Inspected
Catch Basins/Manhole - Surrounded by concrete	Inspected
Condition	4 - Between Fair and Poor
Deficiency	DAMAGED COVER
Deficiency Location/Instance	Near Main Entrance
Deficiency Quantity	2
Quantity Uom	EACH
Potential Action	REPLACE
Urgency of Action	PRIORITY 3
Purpose of Action	LEVEL 2
Deficiency Photo1

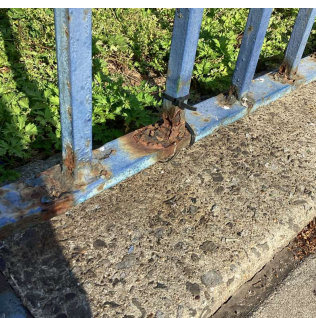
Bayport Place
Violations	No violations recorded.
Deficiency	WROUGHT IRON: RUST - MAJOR
Deficiency Location/Instance	Nameoke Street
Deficiency Quantity	80
Quantity Uom	S.F.
Potential Action	REPLACE
Urgency of Action	PRIORITY 3
Purpose of Action	LEVEL 2
Deficiency Photo1	 
	Nameoke Street
Violations	No violations recorded.
Deficiency	WROUGHT IRON: DAMAGED/DETERIORATED
Deficiency Location/Instance	Nameoke Street, Beach 18th Street
Deficiency Quantity	760
Quantity Uom	S.F.
Potential Action	REPLACE
Urgency of Action	PRIORITY 3
Purpose of Action	LEVEL 2
Deficiency Photo1

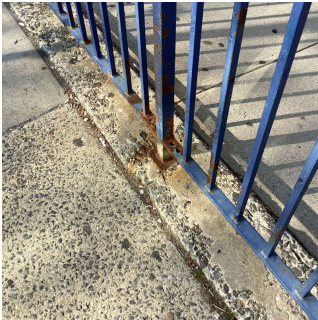
Question	Response
SITE	
FENCES	
Violations	No violations recorded.
Deficiency	CONCRETE CURB: DAMAGED/DETERIORATED
Deficiency Location/Instance	Nameoke Street, Beach 18th Street, Bayport Place
Deficiency Quantity	190
Quantity Uom	S.F.
Potential Action	REPLACE
Urgency of Action	PRIORITY 3
Purpose of Action	LEVEL 2
Deficiency Photo1

Violations	Nameoke Street No violations recorded.
Deficiency	CHAIN LINK: DAMAGED/DETERIORATED
Deficiency Location/Instance	Nameoke Street, Bayport Place
Deficiency Quantity	150
Quantity Uom	S.F.
Potential Action	REPLACE
Urgency of Action	PRIORITY 3
Purpose of Action	LEVEL 2
Deficiency Photo1

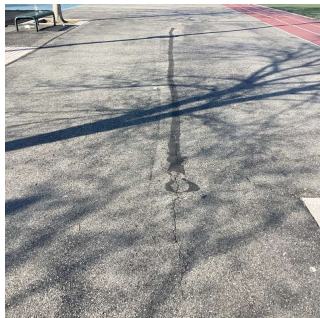
Violations	Near Playground No violations recorded.
Deficiency	CRACKS - MAJOR
Deficiency Location/Instance	Near Playground, Playing Field, basketball Court, School Entrance, Exit 5, Center, and others
Deficiency Quantity	2,500
Quantity Uom	S.F.
Potential Action	REPLACE
Urgency of Action	PRIORITY 3
Purpose of Action	LEVEL 2
Deficiency Photo1

Violations	Near Playground No violations recorded.
Concrete	Inspected
Condition	3 - Fair
Deficiency	DAMAGED/DETERIORATED/MISSING SECTIONS
Deficiency Location/Instance	Courtyard
Deficiency Quantity	200
Quantity Uom	S.F.
Potential Action	REPLACE
Urgency of Action	PRIORITY 3
Purpose of Action	LEVEL 2

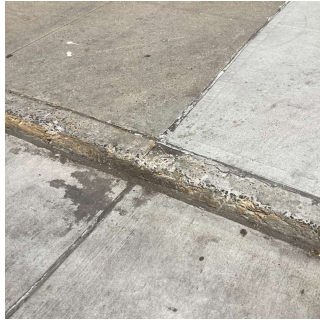
Violations	Near Beach 18th Street No violations recorded.
Concrete	Inspected
Condition	4 - Between Fair and Poor
Deficiency	DAMAGED CURBS
Deficiency Location/Instance	Containerization Area
Deficiency Quantity	50
Quantity Uom	L.F.
Potential Action	REPLACE
Urgency of Action	PRIORITY 3
Purpose of Action	LEVEL 2
Deficiency Photo1

Violations	Containerization Area No violations recorded.
Deficiency	DAMAGED/DETERIORATED/MISSING SECTIONS
Deficiency Location/Instance	Near Exit 6, Garden Area, Containerization Area
Deficiency Quantity	1,300
Quantity Uom	S.F.
Potential Action	REPLACE
Urgency of Action	PRIORITY 3
Purpose of Action	LEVEL 2

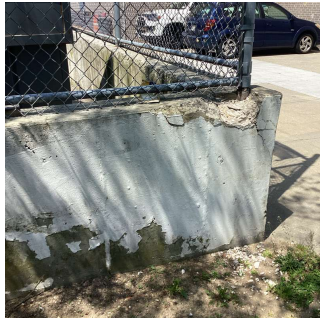
Question	Response
SITE	
RETAINING WALLS	
Condition	3 - Fair
Deficiency	CAST IN PLACE CONCRETE: CRACKS/SPALLING - MAJOR
Deficiency Location/Instance	Containerization Area
Deficiency Quantity	40
Quantity Uom	S.F.
Potential Action	REPLACE
Urgency of Action	PRIORITY 3
Purpose of Action	LEVEL 2
Deficiency Photo1

Violations	Containerization Area No violations recorded.
SEATING	
	Inspected
Benches	
	Inspected
Concrete	
Condition	5 - Poor
Deficiency	CRACKS/SPALLING - MAJOR
Deficiency Location/Instance	Courtyard
Deficiency Quantity	3
Quantity Uom	EACH
Potential Action	REPLACE
Urgency of Action	PRIORITY 3
Purpose of Action	LEVEL 2
Deficiency Photo1	 
Violations	Courtyard No violations recorded.
Metal/Wood/Plastic	
Condition	2 - Between Good and Fair
Deficiency	No deficiencies recorded
Bleachers	
	Does not Exist
SITE WALLS (NOT RETAINING WALLS)	
	Inspected
Condition	2 - Between Good and Fair
Deficiency	CAST IN PLACE CONCRETE: CRACKS/SPALLING - MAJOR

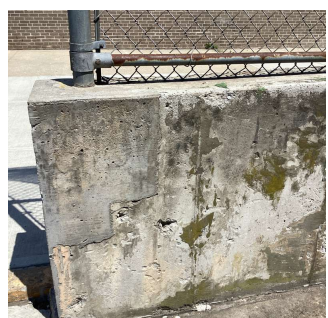
Question	Response
SITE	
SITE WALLS (NOT RETAINING WALLS)	
Deficiency Location/Instance	Office/Storage
Deficiency Quantity	20
Quantity Uom	S.F.
Potential Action	REPLACE
Urgency of Action	PRIORITY 3
Purpose of Action	LEVEL 2
Deficiency Photo1

Containerization Area
Violations	No violations recorded.
STAIRS/RAMPS: EXTERIOR	
	Does not Exist
ARTWORK	
Instance	Inspected
Instance Photo	Exterior - Courtyard - 11132
