NYC Department of Education
Building Condition Assessment Survey 2023 - 2024

Architectural Inspection

Asset: P.S. 69 - QUEENS, 77-02 37 AVENUE, New York, 11372

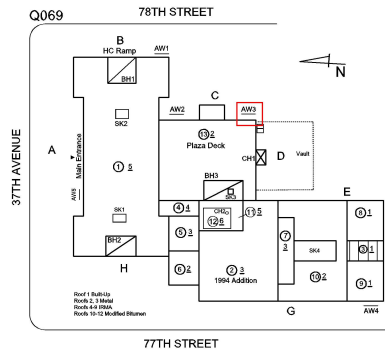
Question	Response
EXTERIOR	
AREAWAY	
Instance Quantity	4
Instance Quantity Uom	EACH
Deficiency	AREAWAY SLAB: CRACKS AND SPALLING
Roof Plan reference

Deficiency Quantity	80
Quantity Uom	S.F.
Potential Action	REPAIR
Urgency of Action	PRIORITY 3
Purpose of Action	LEVEL 2
Deficiency Photo1

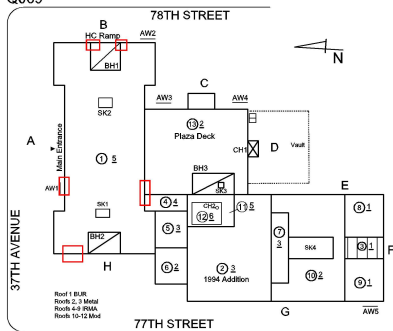
Violations	AW4 No violations recorded.
AWNINGS AND CANOPIES	Does not Exist
CHIMNEY	Inspected
Material Type(s)	Masonry, Metal
Condition	2 - Between Good and Fair
Deficiency	No deficiencies recorded
COPING	Inspected
Condition	3 - Fair
Deficiency	TERRA COTTA: CRACKED/BROKEN PIECES
Roof Plan reference	Q069

Deficiency Quantity	50
Quantity Uom	L.F.
Potential Action	REPLACE-IN-KIND
Urgency of Action	PRIORITY 4
Purpose of Action	LEVEL 2
Deficiency Photo1

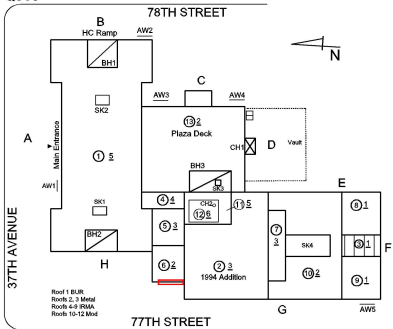
Question	Response
EXTERIOR	
DOORS	Inspected
DOORS AND FRAMES	Inspected
Condition	3 - Fair
Deficiency	METAL: DETERIORATED DOOR AND FRAME - MINOR DETERIORATION
Roof Plan reference	Q069

Deficiency Quantity	3
Quantity Uom	EACH
Potential Action	MAINTENANCE
Urgency of Action	PRIORITY 3
Purpose of Action	LEVEL 2
Deficiency Photo1

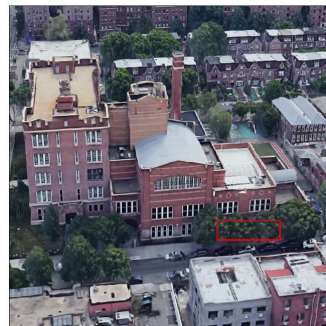
CAST IN PLACE / PRE-CAST CONCRETE: DETERIORATED JOINTS

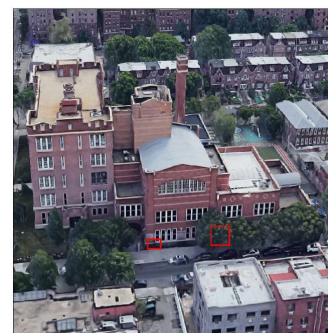
CAST IN PLACE / PRE-CAST CONCRETE: MAJOR CRACKS/SPALLING

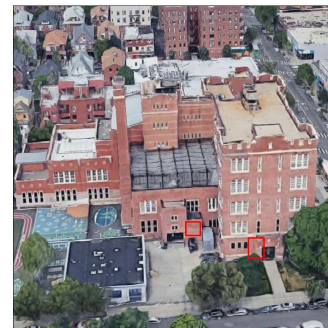
BRICK: MINOR CRACKS AND SPALLING

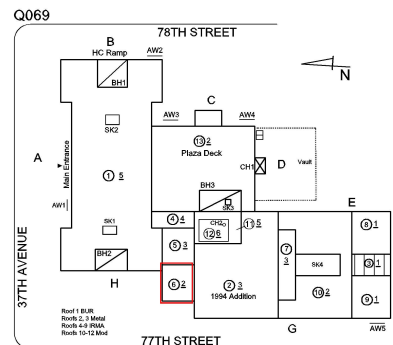
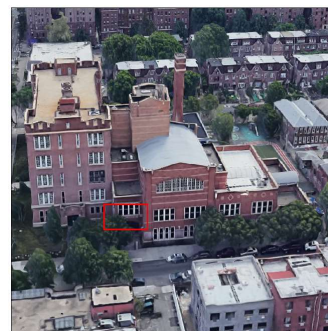
CONCRETE: DETERIORATED

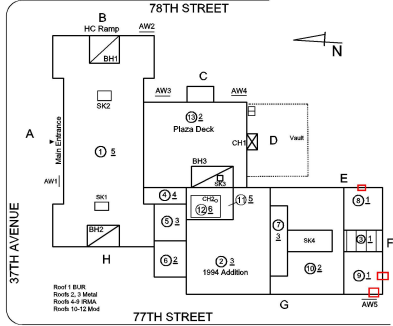
Violations	<p>Facade H</p> <p>No violations recorded.</p>
LOADING DOCK	Does not Exist
LOUVER	Inspected
Condition	2 - Between Good and Fair
Deficiency	No deficiencies recorded
PARAPETS	Inspected
Material Type(s)	Masonry
Replacement Quantity	7,000
Replacement Uom	C.F.
Instance on All Facades	Inspected
Instance Condition	3 - Fair
Instance Quantity	7,000
Instance Quantity Uom	C.F.
Deficiency	BRICK: DETERIORATED CONTROL/EXPANSION JOINT
Roof Plan reference	<p>Q069</p>

Deficiency Quantity	30
Quantity Uom	L.F.
Potential Action	MAINTENANCE
Urgency of Action	PRIORITY 3
Purpose of Action	LEVEL 2

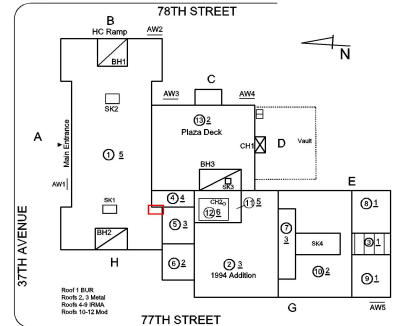
BRICK: DETERIORATED JOINTS

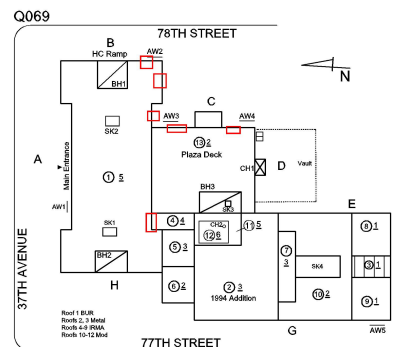
BRICK: MAJOR DETERIORATION/CRACKS

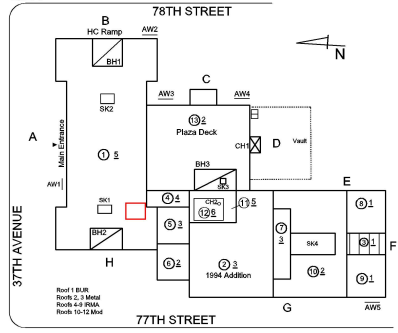
Roof 1
Instance Quantity	9,300
Instance Quantity Uom	S.F.
Does the roof have major mechanical equipment sitting on Dunnage Steel less than 18" above the Roofing?	No
Does this roof instance have a Sustainable Roof System?	No
Do solar panels exist on these roofs?	No
Is/Are the roof(s) suitable for Solar Panel installation?	No
Installation Year	2005
Source of Installation	Custodial Staff
Deficiency	BUILT-UP: ROOFING: LOSS OF GRAVEL

Deficiency Quantity	20
Quantity Uom	S.F.
Potential Action	INSTALL NEW GRAVEL
Urgency of Action	PRIORITY 3
Purpose of Action	LEVEL 2

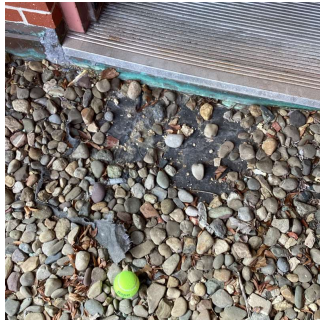
Question	Response
EXTERIOR	
ROOF	
Roofing	
ROOFING	
Source of Installation	Custodial Staff
Deficiency	IRMA: ROOFING: LOSS OF GRAVEL
Roof Plan reference	Q069
Deficiency Quantity	10
Quantity Uom	S.F.
Potential Action	MAINTENANCE
Urgency of Action	PRIORITY 3
Purpose of Action	LEVEL 2
Deficiency Photo1

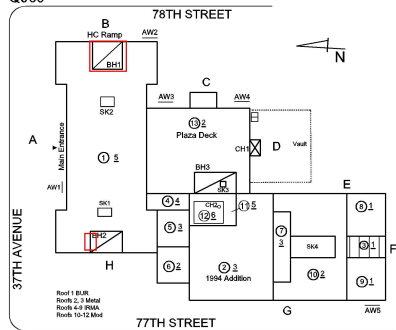
Violations	BH1 No violations recorded.
Deficiency	BULKHEAD/PENTHOUSE WALLS/EXTERIOR: EFFLORESCENCE
Roof Plan reference	<p>Q069</p>

Deficiency Quantity	20
Quantity Uom	S.F.
Potential Action	MAINTENANCE
Urgency of Action	PRIORITY 1
Purpose of Action	LEVEL 1
Deficiency Photo1	No photo recorded
Violations	No violations recorded.
Deficiency	BULKHEAD/PENTHOUSE WALLS/INTERIOR: CMU CRACKS/SPALLING
Roof Plan reference	<p>Q069</p>

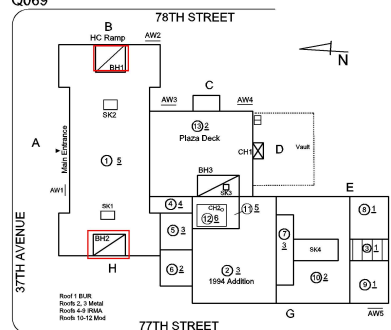
BULKHEAD/PENTHOUSE WALLS/INTERIOR: PLASTER
CRACKS/SPALLING

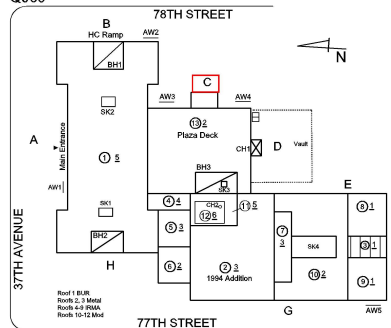
Question	Response
EXTERIOR	
STAIRS/RAMPS: EXTERIOR	
RAILINGS	Inspected
Condition	2 - Between Good and Fair
Deficiency	No deficiencies recorded
STAIRS/RAMPS	Inspected
Condition	4 - Between Fair and Poor
Deficiency	STONE: CRACKS/SPALLING - MAJOR
Roof Plan reference	<p>Q069</p>

<p>10 S.F. REPLACE PRIORITY 4 LEVEL 2</p>

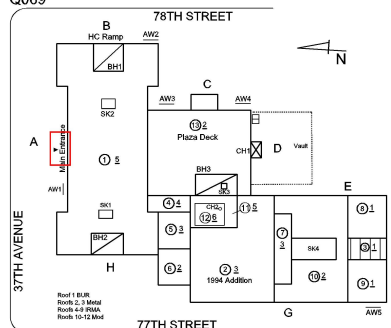
<p>Facade C - Exit 5 No violations recorded.</p>
Deficiency Quantity	
Quantity Uom	
Potential Action	
Urgency of Action	
Purpose of Action	
Deficiency Photo1	
Violations	
Deficiency	STONE: CRACKS/SPALLING - MINOR
Roof Plan reference	<p>Q069</p>

<p>10 S.F. REPAIR PRIORITY 3 LEVEL 2</p>
Deficiency Quantity	
Quantity Uom	
Potential Action	
Urgency of Action	
Purpose of Action

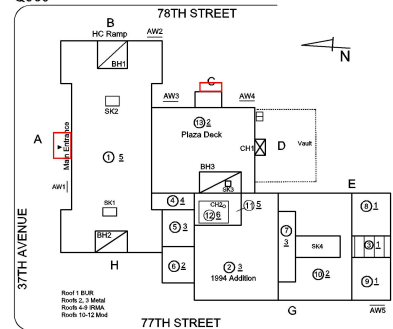
STONE: DETERIORATED JOINTS

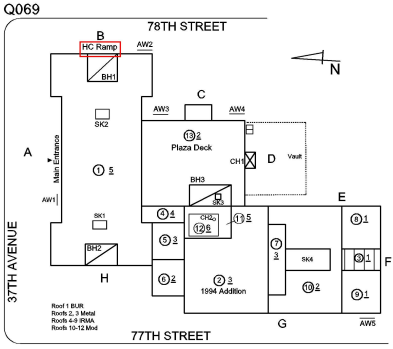
CONCRETE: CRACKS/SPALLING - MINOR

Deficiency Quantity	20
Quantity Uom	S.F.
Potential Action	REPAIR
Urgency of Action	PRIORITY 3
Purpose of Action	LEVEL 2
Deficiency Photo1

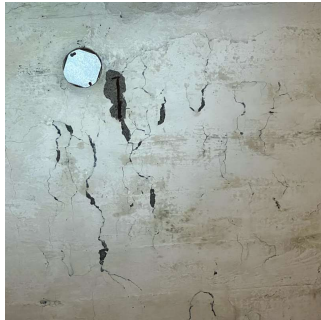
Question	Response
INTERIOR	
STRUCTURAL	
COLUMNS/BEAMS/BEARING WALLS	Inspected
	Basement - Fan Room
Violations	No violations recorded.
FLOOR STRUCTURE	Inspected
Condition	3 - Fair
Deficiency	CINDER CONCRETE FLAT SLAB: CRACKED/SPALLED/REINFORCEMENT EXPOSED
Deficiency Location/Instance	Basement - Room C022C, Fan Room
Deficiency Quantity	40
Quantity Uom	S.F.
Potential Action	REPAIR
Urgency of Action	PRIORITY 3
Purpose of Action	LEVEL 5
Deficiency Photo1

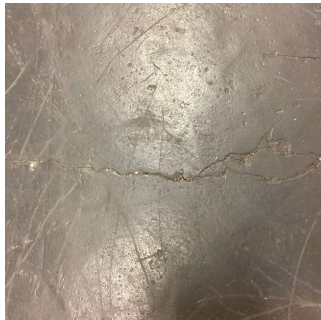
Basement - Room C022C
Violations	No violations recorded.
Deficiency	CONCRETE SLAB ON GRADE: THRU CRACKS
Deficiency Location/Instance	Basement - Fan Room, Storage Room, Boiler Room
Deficiency Quantity	200
Quantity Uom	S.F.
Potential Action	REPAIR
Urgency of Action	PRIORITY 3
Purpose of Action	LEVEL 5
Deficiency Photo1

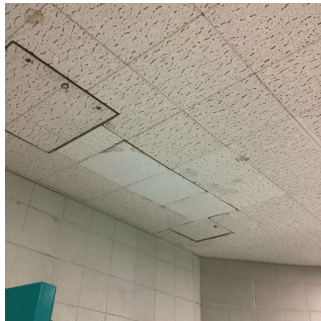
Question	Response
INTERIOR	
CLASSROOMS/CORRIDORS/ADMIN SPACES	
Ceiling	
Deficiency Photo1

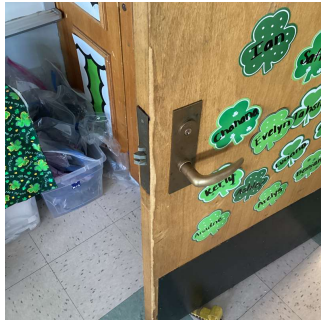
Violations	Corridor near Cafeteria No violations recorded.
Door(s)	Inspected
Condition	5 - Poor
Deficiency	WOOD: DETERIORATED DOOR
Deficiency Location/Instance	Rooms 509, 508, 506, 503, 413 and others
Deficiency Quantity	15
Quantity Uom	EACH
Potential Action	MAINTENANCE
Urgency of Action	PRIORITY 3
Purpose of Action	LEVEL 2
Deficiency Photo1

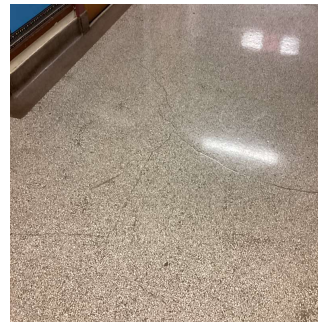
Violations	Room 509 No violations recorded.
Floor Finish	Inspected
Condition	3 - Fair
Deficiency	TERRAZZO: CRACKS
Deficiency Location/Instance	Corridor near Auditorium
Deficiency Quantity	200
Quantity Uom	S.F.
Potential Action	REPLACE
Urgency of Action	PRIORITY 3
Purpose of Action	LEVEL 2

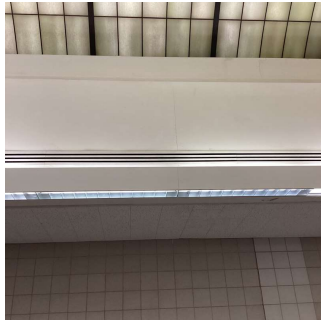
Violations	2nd Floor Atrium No violations recorded.
Deficiency	GYPSUM BOARD: DETERIORATED
Deficiency Location/Instance	2nd Floor Atrium
Deficiency Quantity	20
Quantity Uom	S.F.
Potential Action	REPLACE
Urgency of Action	PRIORITY 3
Purpose of Action	LEVEL 2
Deficiency Photo1

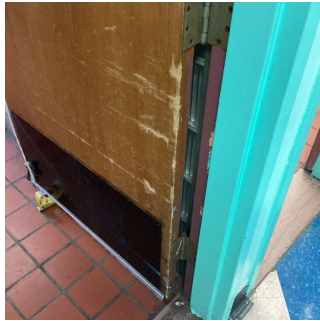
Office
Violations	No violations recorded.
Deficiency	WOOD: DETERIORATED DOOR
Deficiency Location/Instance	Main Entrance, Storage Room, Serving area, large Storage Room
Deficiency Quantity	5
Quantity Uom	EACH
Potential Action	MAINTENANCE
Urgency of Action	PRIORITY 3
Purpose of Action	LEVEL 2

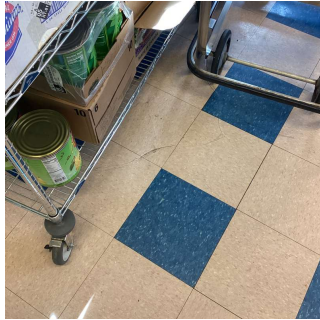
Violations	Main Entrance No violations recorded.
Floor Finish	
Instance on 1st Floor	Inspected
Condition	3 - Fair
Deficiency	VINYL TILES: DETERIORATED SUBSTRATE
Deficiency Location/Instance	Large Storage Room
Deficiency Quantity	10
Quantity Uom	S.F.
Potential Action	REPLACE
Urgency of Action	PRIORITY 3
Purpose of Action	LEVEL 2
Deficiency Photo1

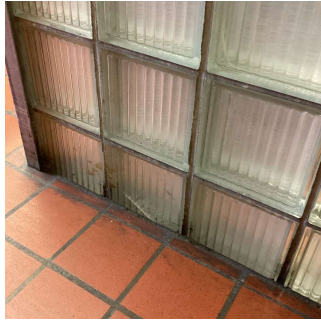
Near Entrance
Violations	No violations recorded.
Walls	
Instance on 1st Floor	Inspected
Condition	2 - Between Good and Fair
Deficiency	GLASS BLOCK: DAMAGED/MISSING
Deficiency Location/Instance	Near Entrance
Deficiency Quantity	10
Quantity Uom	S.F.
Potential Action	REPLACE
Urgency of Action	PRIORITY 3
Purpose of Action	LEVEL 2
Deficiency Photo1

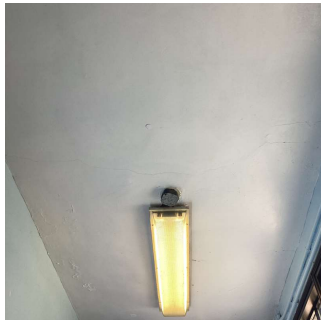
Violations	Stair D/5 No violations recorded.
Deficiency	PLASTER: CRACKS/SPALLING
Deficiency Location/Instance	Stairs AB/1 Vestibule, GH/1 Vestibule
Deficiency Quantity	20
Quantity Uom	S.F.
Potential Action	REPLACE
Urgency of Action	PRIORITY 3
Purpose of Action	LEVEL 2
Deficiency Photo1

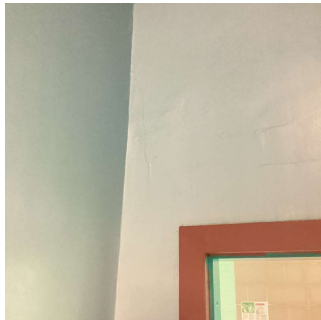
Violations	Stair AB/1 Vestibule No violations recorded.
Deficiency	PLASTER: CRACKS/SPALLING
Deficiency Location/Instance	Stairs AB/1 Vestibule, GH/1 Vestibule
Deficiency Quantity	20
Quantity Uom	S.F.
Potential Action	REPLACE
Urgency of Action	PRIORITY 3
Purpose of Action	LEVEL 2
Deficiency Photo1

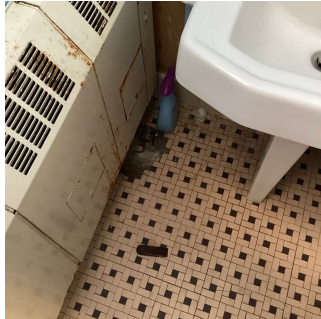
1st Floor - Men
Violations	No violations recorded.
Floor Finish	Inspected
Condition	2 - Between Good and Fair
Deficiency	CERAMIC TILE: BROKEN/MISSING TILES
Deficiency Location/Instance	Inside Kitchen, 1st Floor - Men
Deficiency Quantity	20
Quantity Uom	S.F.
Potential Action	REPLACE
Urgency of Action	PRIORITY 3
Purpose of Action	LEVEL 2
Deficiency Photo1

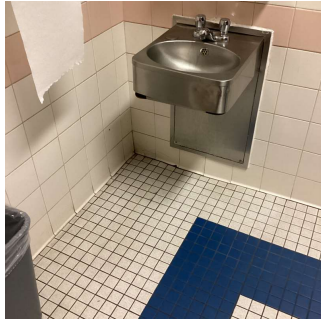
Violations	Room 513 No violations recorded.
Deficiency	CERAMIC TILE: BROKEN/ MISSING
Deficiency Location/Instance	1st Floor - Men, Women, Room 521
Deficiency Quantity	30
Quantity Uom	S.F.
Potential Action	REPLACE
Urgency of Action	PRIORITY 3
Purpose of Action	LEVEL 2
Deficiency Photo1

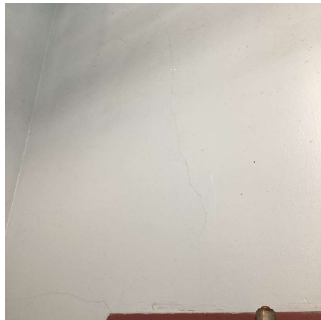
Violations	1st Floor - Men No violations recorded.
Deficiency	PLASTER: CRACKS/SPALLING
Deficiency Location/Instance	Inside Kitchen
Deficiency Quantity	10
Quantity Uom	S.F.
Potential Action	REPLACE
Urgency of Action	PRIORITY 3
Purpose of Action	LEVEL 2
Deficiency Photo1

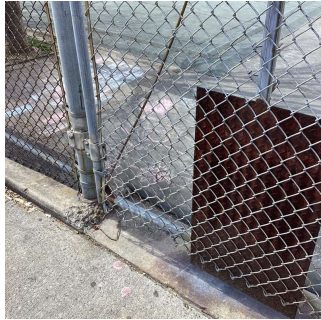
Violations	78th Street No violations recorded.
Deficiency	CHAIN LINK: DAMAGED/DETERIORATED
Deficiency Location/Instance	78th Street
Deficiency Quantity	100
Quantity Uom	S.F.
Potential Action	REPLACE
Urgency of Action	PRIORITY 3
Purpose of Action	LEVEL 2
