**NYC Department of Education**  
**Building Condition Assessment Survey 2023 - 2024**

Architectural Inspection

**Asset:**        **P.S. 70 - QUEENS, 30-45 42 STREET, New York, 11103**

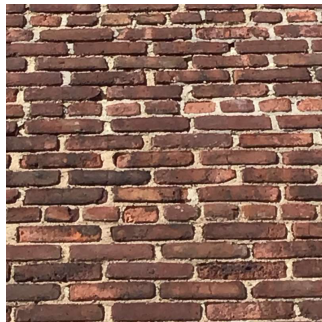
Question	Response
<b>EXTERIOR</b>	
<b>AREAWAY</b>	
Deficiency	No deficiencies recorded
<b>AWNINGS AND CANOPIES</b>	Does not Exist
<b>CHIMNEY</b>	Inspected
Material Type(s)	Masonry
Condition	3 - Fair
Deficiency	BRICK: DETERIORATED JOINTS
Roof Plan reference

Deficiency Quantity	40
Quantity Uom	S.F.
Potential Action	REPOINT
Urgency of Action	PRIORITY 4
Purpose of Action	LEVEL 2
Deficiency Photo1

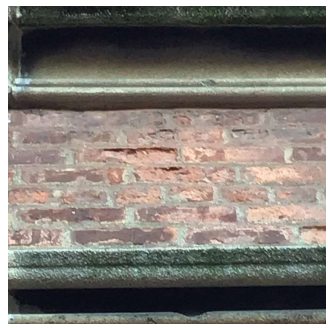
Question	Response
<b>EXTERIOR</b>	
<b>EXTERIOR WALLS</b>	
Violations	No violations recorded.
Deficiency	BRICK: DETERIORATED JOINTS
Roof Plan reference

Deficiency Quantity	180
Quantity Uom	S.F.
Potential Action	REPOINT
Urgency of Action	PRIORITY 4
Purpose of Action	LEVEL 2
Deficiency Photo1

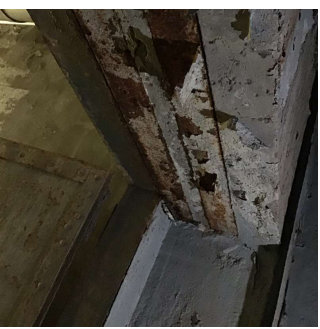
Is/Are the roof(s) suitable for Solar Panel installation?	No
Installation Year	1998
Source of Installation	Custodial Staff
Deficiency	SINGLE PLY, FULLY ADHERED ROOF: ROOFING: MAJOR ACTIVE ROOF LEAKS IN NON-INSTRUCTIONAL SPACE

Deficiency Quantity	100
Quantity Uom	S.F.
Potential Action	REPLACE ROOFING WITHOUT MAJOR EQUIPMENT REMOVAL
Urgency of Action	PRIORITY 5
Purpose of Action	LEVEL 2
Deficiency Photo1

<p>Basement - Heating Chambers</p>
Violations	No violations recorded.
Instance on Built-Up: Roofs 1 - 4	Inspected
Instance Condition	5 - Poor
Instance Photo

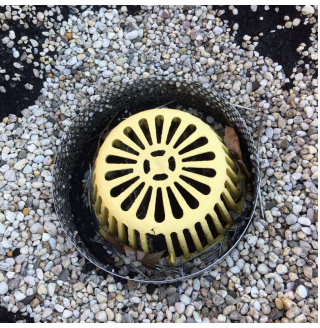
Question	Response
<b>EXTERIOR</b>	
<b>ROOF</b>	
<b>Roofing</b>	
<b>ROOFING DRAINS</b>	
Condition	4 - Between Fair and Poor
Deficiency	DETERIORATED
Roof Plan reference

Deficiency Quantity	2
Quantity Uom	EACH
Potential Action	REPLACE
Urgency of Action	PRIORITY 4
Purpose of Action	LEVEL 2
Deficiency Photo1

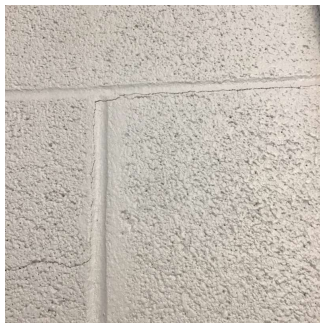
Violations	PH1
Deficiency	35671978K
Roof Plan reference	<p><b>BULKHEAD/PENTHOUSE WALLS/INTERIOR: CMU CRACKS/SPALLING</b></p>

Deficiency Quantity	10
Quantity Uom	S.F.
Potential Action	REPLACE
Urgency of Action	PRIORITY 3
Purpose of Action	LEVEL 2
Deficiency Photo1

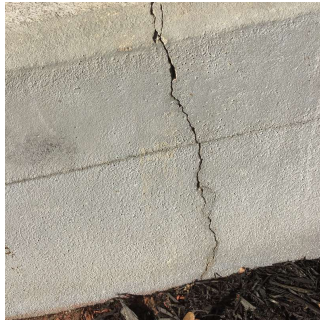
Question	Response
<b>EXTERIOR</b>	
<b>STAIRS/RAMPS: EXTERIOR</b>	
<b>BUILDING CHEEK/FLANK WALLS</b>	
Deficiency Photo1

Violations	<p>Facade A</p> <p>No violations recorded.</p>
<b>RAILINGS</b>	Inspected
Condition	2 - Between Good and Fair
Deficiency	No deficiencies recorded
<b>STAIRS/RAMPS</b>	Inspected
Condition	4 - Between Fair and Poor
Deficiency	STONE: DETERIORATED JOINTS
Roof Plan reference

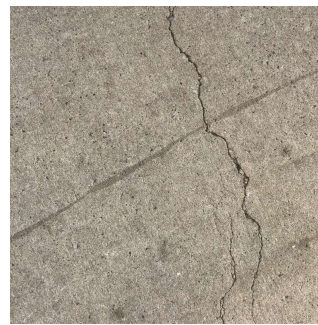
Facade A

Violations	<p>Facade H</p> <p>No violations recorded.</p>
Deficiency	CONCRETE: CRACKS/SPALLING - MAJOR

REPLACE

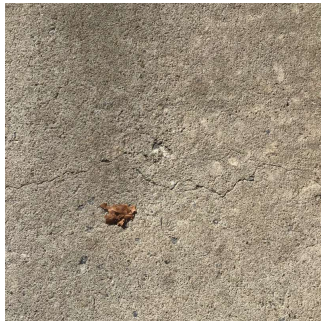
Violations	<p>Facade A</p> <p>No violations recorded.</p>
<b>WINDOWS</b>	Inspected
Replacement Quantity	17,000
Replacement Uom	S.F.
<b>EXTERIOR GUARDS</b>	Inspected
Condition	3 - Fair
Deficiency	DETERIORATED/TORN-OUT/MISSING
Roof Plan reference

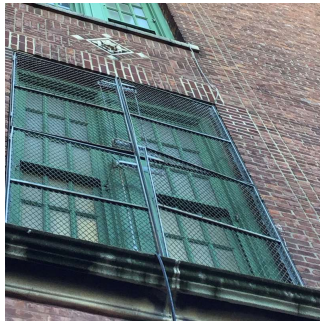
Deficiency Quantity	60
Quantity Uom	S.F.
Potential Action	REPLACE
Urgency of Action	PRIORITY 4
Purpose of Action	LEVEL 2

Violations	Facade K No violations recorded.
<b>LINTELS</b>	Inspected
Condition	2 - Between Good and Fair
Deficiency	No deficiencies recorded
<b>WINDOWS</b>	Inspected
Material Type(s)	Aluminum
Instance on Aluminum - Other: All Facades at 2014 Addition	Inspected
Instance Condition	2 - Between Good and Fair
Instance Quantity	4,000
Instance Quantity Uom	S.F.
Are these windows insulated	Yes
Installation Year	2014
Source of Installation	Custodial Staff
Deficiency	ALUMINUM - OTHER: BROKEN PANE
Roof Plan reference

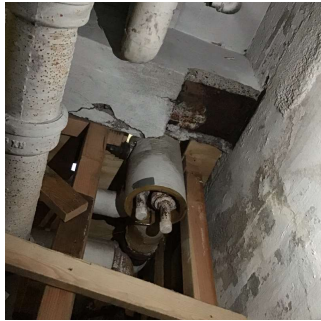
<b>FLOOR STRUCTURE</b>	Inspected
Condition	3 - Fair
Deficiency	CONCRETE: CRACKS/SPALLED/REINFORCEMENT EXPOSED

Violations	Basement- Boiler Room No violations recorded.
Deficiency	CONCRETE: CRACKED/SPALLED/REINFORCEMENT EXPOSED
Deficiency Location/Instance	Basement - Electrical Room, Boiler Room, Fan Room
Deficiency Quantity	60
Quantity Uom	S.F.
Potential Action	REPAIR
Urgency of Action	PRIORITY 3
Purpose of Action	LEVEL 5
Deficiency Photo1

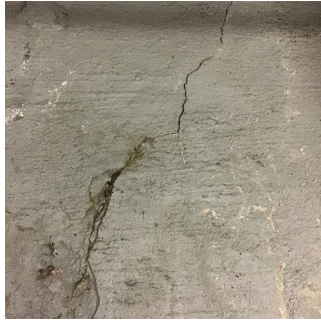
Violations	Basement - Electrical Room No violations recorded.
<b>ROOF STRUCTURE</b>	
Condition	Inspected 3 - Fair
Deficiency	STEEL COLUMNS/BEAMS: DETERIORATED CONCRETE FIREPROOFING
Deficiency Location/Instance	PH1
Deficiency Quantity	20
Quantity Uom	S.F.
Potential Action	REPLACE
Urgency of Action	PRIORITY 4
Purpose of Action	LEVEL 5

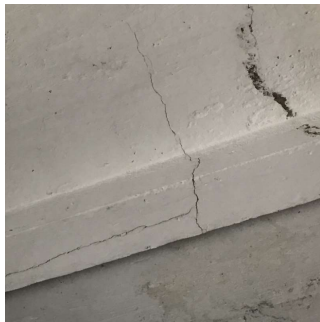
Question	Response
<b>INTERIOR</b>	
<b>STRUCTURAL</b>	
<b>ROOF STRUCTURE</b>	
Deficiency Photo1	 
Violations	PH1 No violations recorded.
Deficiency	STEEL COLUMNS/BEAMS: DETERIORATED CONCRETE FIREPROOFING
Deficiency Location/Instance	PH1, BH2
Deficiency Quantity	25
Quantity Uom	S.F.
Potential Action	REPLACE
Urgency of Action	PRIORITY 3
Purpose of Action	LEVEL 5
Deficiency Photo1

Violations	BH1 No violations recorded.
Deficiency	CINDER CONCRETE, FLAT SLAB: CRACKED/SPALLED/REINFORCEMENT EXPOSED
Deficiency Location/Instance	PH1
Deficiency Quantity	30
Quantity Uom	S.F.
Potential Action	REPAIR
Urgency of Action	PRIORITY 4
Purpose of Action	LEVEL 5
Deficiency Photo1

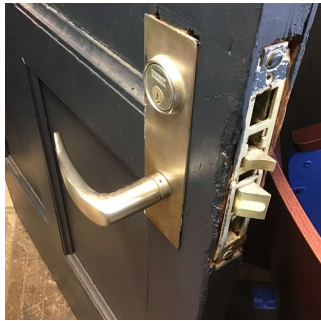
Question	Response
<b>INTERIOR</b>	
<b>AUDITORIUM</b>	
<b>Ceiling</b>	
Instance on 2nd Floor (540 Seats)	Inspected
Condition	2 - Between Good and Fair
Deficiency	No deficiencies recorded
<b>Door(s)</b>	
Instance on 2nd Floor (540 Seats)	Inspected
Condition	2 - Between Good and Fair
Deficiency	WOOD: DETERIORATED DOOR
Deficiency Location/Instance	Rooms Right and Left Side Stage
Deficiency Quantity	2
Quantity Uom	EACH
Potential Action	MAINTENANCE
Urgency of Action	PRIORITY 3
Purpose of Action	LEVEL 2
Deficiency Photo1

Violations	Room Left Side Stage No violations recorded.
<b>Fixed H/C Lift</b>	
Instance on 2nd Floor (540 Seats)	Does not Exist
<b>Fixed Seating</b>	
Instance on 2nd Floor (540 Seats)	Inspected
Condition	1 - Good
Deficiency	No deficiencies recorded
<b>Floor Finish</b>	
Instance on 2nd Floor (540 Seats)	Inspected
Condition	2 - Between Good and Fair
Deficiency	WOOD: DAMAGED/DETERIORATED
Deficiency Location/Instance	Room Left Side Stage

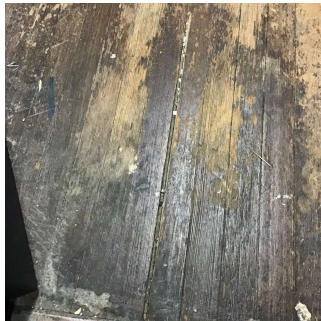
Question	Response
<b>INTERIOR</b>	
<b>AUDITORIUM</b>	
<b>Floor Finish</b>	
Deficiency Photo1

Violations	Room Left Side Stage No violations recorded.
<b>Sliding-folding Partition</b>	
Instance on 2nd Floor (540 Seats)	Does not Exist
<b>Stage</b>	
Instance on 2nd Floor (540 Seats)	Inspected
<b>Stage</b>	Inspected
Instance on 2nd Floor (540 Seats)	Inspected
Condition	2 - Between Good and Fair
Deficiency	DAMAGED STEPS
Deficiency Location/Instance	Left and Right Side
Deficiency Quantity	20
Quantity Uom	S.F.
Potential Action	REPLACE
Urgency of Action	PRIORITY 3
Purpose of Action	LEVEL 2
Deficiency Photo1

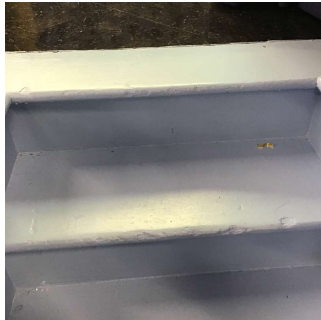
Violations	Left Side No violations recorded.
<b>Stage Curtain Rigging</b>	
Instance on 2nd Floor (540 Seats)	Inspected
Condition	1 - Good
Deficiency	No deficiencies recorded
<b>Stage Curtains</b>	
Instance on 2nd Floor (540 Seats)	Inspected
Condition	1 - Good
Deficiency	No deficiencies recorded
<b>Walls</b>	
Instance on 2nd Floor (540 Seats)	Inspected

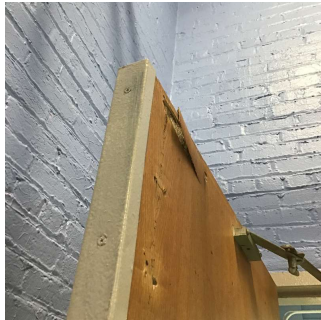
Question	Response
<b>INTERIOR</b>	
<b>CAFETERIA</b>	
<b>Door(s)</b>	
Condition	5 - Poor
Deficiency	METAL: MISSING DOOR
Deficiency Location/Instance	Entrance from Multi-Purpose Room South
Deficiency Quantity	1
Quantity Uom	EACH
Potential Action	MAINTENANCE
Urgency of Action	PRIORITY 3
Purpose of Action	LEVEL 2
Deficiency Photo1	 
Violations	Entrance No violations recorded.
Deficiency	WOOD: DETERIORATED DOOR
Deficiency Location/Instance	Entrances - From Multi-Purpose Room North and south
Deficiency Quantity	5
Quantity Uom	EACH
Potential Action	MAINTENANCE
Urgency of Action	PRIORITY 3
Purpose of Action	LEVEL 2
Deficiency Photo1

Violations	Entrance - From Multi-Purpose Room North No violations recorded.
<b>Fixed Equipment</b>	
Instance on 1st Floor	Does not Exist
<b>Floor Finish</b>	
Instance on 1st Floor	Inspected
Condition	2 - Between Good and Fair
Deficiency	VINYL TILES: BROKEN/DETERIORATED/MISSING TILES
Deficiency Location/Instance	Near center, Entrances , Serving Area.

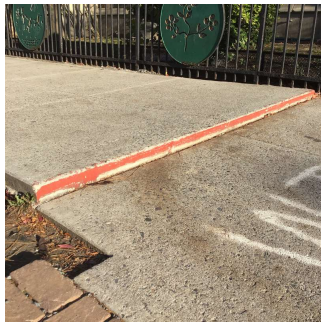
Violations	42nd Street No violations recorded.
Deficiency	DAMAGED/DETERIORATED/MISSING SECTIONS
Deficiency Location/Instance	42nd Street, 43rd Street
Deficiency Quantity	100
Quantity Uom	S.F.
Potential Action	REPLACE
Urgency of Action	PRIORITY 3
Purpose of Action	LEVEL 2
Deficiency Photo1
