**NYC Department of Education**  
**Building Condition Assessment Survey 2023 - 2024**

Architectural Inspection

**Asset:** P.S. 151 - QUEENS, 50-05 31 AVENUE, New York, 11377

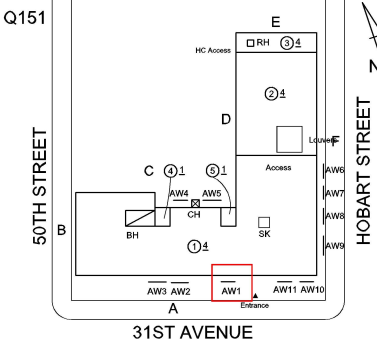
Violations	<p>Facade F</p> <p>No violations recorded.</p>
Deficiency	AREAWAY SLAB: CRACKS AND SPALLING
Roof Plan reference	<p>Q151</p>

Deficiency Quantity	10
Quantity Uom	S.F.
Potential Action	REPAIR
Urgency of Action	PRIORITY 3
Purpose of Action	LEVEL 2

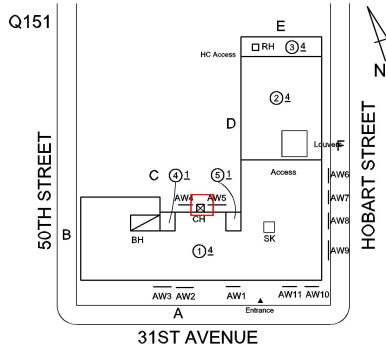
Violations	<p>Facade A</p> <p>No violations recorded.</p>
<b>AWNINGS AND CANOPIES</b>	Does not Exist
<b>CHIMNEY</b>	Inspected
Material Type(s)	Masonry
Condition	3 - Fair
Deficiency	BRICK: DETERIORATED JOINTS
Roof Plan reference	<p>Q151</p>

Deficiency Quantity	300
Quantity Uom	S.F.
Potential Action	REPOINT
Urgency of Action	PRIORITY 3
Purpose of Action	LEVEL 2
Deficiency Photo1

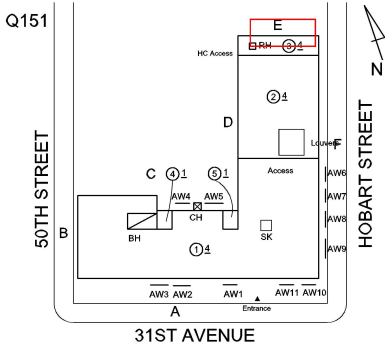
Violations	<p>Roof 2</p> <p>No violations recorded.</p>
Deficiency	CAST STONE: CRACKED/BROKEN PIECES
Roof Plan reference	<p>Q151</p>

Deficiency Quantity	50
Quantity Uom	L.F.
Potential Action	REPLACE-IN-KIND
Urgency of Action	PRIORITY 4
Purpose of Action	LEVEL 2
Deficiency Photo1

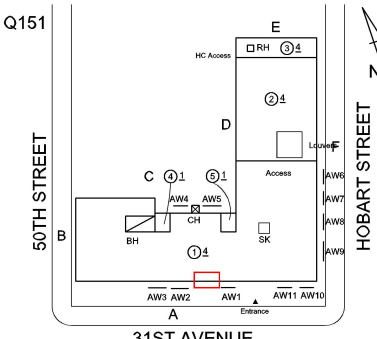
Question	Response
<b>EXTERIOR</b>	
<b>DOORS</b>	
<b>DOORS AND FRAMES</b>	Inspected
Violations	No violations recorded.
<b>DOOR HARDWARE</b>	Inspected
Condition	3 - Fair
Deficiency	No deficiencies recorded
<b>LINTELS</b>	Inspected
Condition	2 - Between Good and Fair
Deficiency	No deficiencies recorded
<b>TRANSOM/SIDE LIGHT</b>	Inspected
Condition	3 - Fair
Deficiency	METAL: BROKEN GLASS
Roof Plan reference	<p>Q151</p>

<p>50TH STREET</p> <p>31ST AVENUE</p> <p>HOBART STREET</p>
Deficiency Quantity	40
Quantity Uom	S.F.
Potential Action	MAINTENANCE
Urgency of Action	PRIORITY 3
Purpose of Action	LEVEL 2
Deficiency Photo1

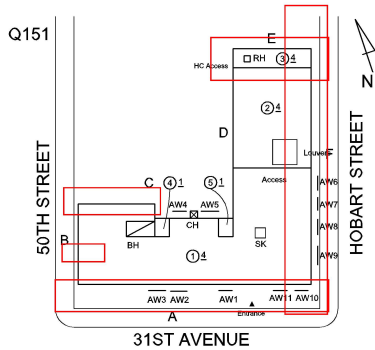
Violations	Roof 2 No violations recorded.
Deficiency	BRICK: DETERIORATED JOINTS
Roof Plan reference	<p>Q151</p>

Deficiency Quantity	500
Quantity Uom	S.F.
Potential Action	REPOINT
Urgency of Action	PRIORITY 3
Purpose of Action	LEVEL 2
Deficiency Photo1

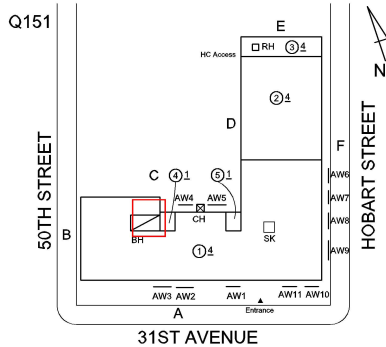
Roof 1
Instance Quantity	18,000
Instance Quantity Uom	S.F.
Does the roof have major mechanical equipment sitting on Dunnage Steel less than 18" above the Roofing?	No
Does this roof instance have a Sustainable Roof System?	Yes
Sustainable Roof Type	White Roof
Sustainable Roof Location (Roof Number)	Roof 1
Do solar panels exist on these roofs?	No
Is/Are the roof(s) suitable for Solar Panel installation?	Yes
Installation Year	2018
Source of Installation	Custodial Staff
Deficiency	No deficiencies recorded
<b>ROOFING DRAINS</b>	Inspected
Condition	1 - Good
Deficiency	No deficiencies recorded
<b>Specialties</b>	Inspected
<b>BULKHEAD/PENTHOUSE</b>	Inspected
Condition	2 - Between Good and Fair
Deficiency	BULKHEAD/PENTHOUSE WALLS/INTERIOR: BRICK CRACKS/SPALLING
Roof Plan reference	<div> <div>Q151</div>

</div>
Deficiency Quantity	20

Quantity Uom	S.F.
Potential Action	REPLACE
Urgency of Action	PRIORITY 3
Purpose of Action	LEVEL 2

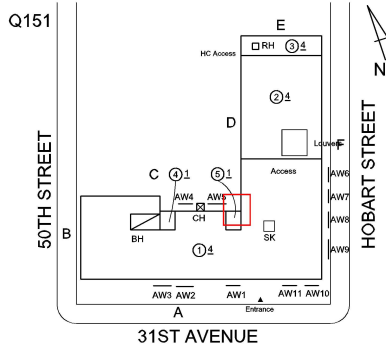
Violations	<p>BH</p> <p>No violations recorded.</p>
<b>CUPOLA/ SPIRES/ TOWERS</b>	Does not Exist
<b>DORMER</b>	Does not Exist
<b>DUNNAGE STEEL</b>	Does not Exist
<b>SKYLIGHT/ROOF VENT</b>	Inspected
Material Type(s)	Other
Condition	2 - Between Good and Fair
Deficiency	No deficiencies recorded
<b>ROOF/GRAVITY TANK</b>	Does not Exist
<b>STAIRS/RAMPS: EXTERIOR</b>	Inspected
<b>BUILDING CHEEK/FLANK WALLS</b>	Inspected
Condition	3 - Fair
Deficiency	BRICK: CRACKS/SPALLING - MINOR
Roof Plan reference	<p>Q151</p>

Deficiency Quantity	15
Quantity Uom	S.F.
Potential Action	REPAIR
Urgency of Action	PRIORITY 3
Purpose of Action	LEVEL 2

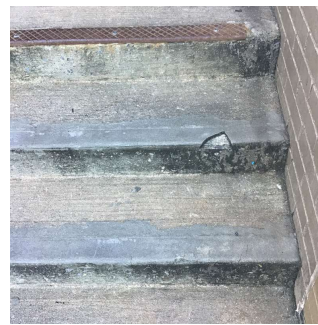
Facade C

Violations	Facade A No violations recorded.
<b>STAIRS/RAMPS</b>	Inspected
Condition	5 - Poor
Deficiency	CONCRETE: WORN-OUT TREAD/RISER/NOSING

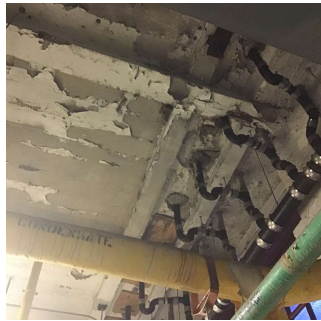
Question	Response
<b>EXTERIOR</b>	
<b>WINDOWS</b>	
<b>WINDOWS</b>	Inspected
Material Type(s)	Aluminum
Instance on Aluminum - Double Hung: All Facades	Inspected
Instance Condition	3 - Fair
Instance Quantity	11,960
Instance Quantity Uom	S.F.
Are these windows insulated	No
Installation Year	2000
Source of Installation	Custodial Staff
Deficiency	No deficiencies recorded
Instance on Aluminum - Other: Facades B	Inspected
Instance Condition	3 - Fair
Instance Quantity	40
Instance Quantity Uom	S.F.
Are these windows insulated	No
Installation Year	2000
Source of Installation	Custodial Staff
Deficiency	No deficiencies recorded
<b>INTERIOR</b>	Inspected
<b>POOLS</b>	Does not Exist
<b>STRUCTURAL</b>	Inspected
<b>COLUMNS/BEAMS/BEARING WALLS</b>	Inspected
Condition	3 - Fair
Deficiency	STEEL COLUMNS/BEAMS: DETERIORATED CONCRETE FIREPROOFING
Deficiency Location/Instance	Basement - Boiler Room
Deficiency Quantity	80
Quantity Uom	S.F.
Potential Action	REPLACE

Urgency of Action	PRIORITY 3
Purpose of Action	LEVEL 5
Deficiency Photo1

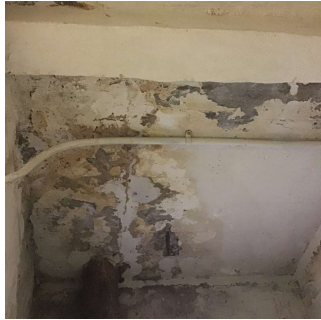
Violations	Basement - Boiler Room No violations recorded.
<b>FLOOR STRUCTURE</b>	Inspected
Condition	3 - Fair
Deficiency	CONCRETE: CRACKS/SPALLED/REINFORCEMENT EXPOSED
Deficiency Location/Instance	Basement - Storage Room
Deficiency Quantity	180
Quantity Uom	S.F.

Question	Response
<b>INTERIOR</b>	
<b>STRUCTURAL</b>	
<b>FLOOR STRUCTURE</b>	
Potential Action	REPAIR
Urgency of Action	PRIORITY 3
Purpose of Action	LEVEL 5
Deficiency Photo1

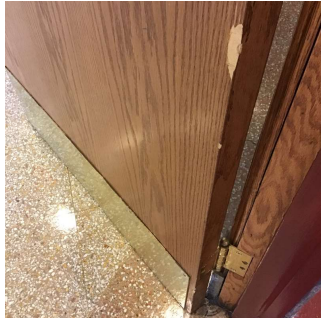
Question	Response
<b>INTERIOR</b>	
<b>AUDITORIUM</b>	
<b>Door(s)</b>	
Deficiency	WOOD: DETERIORATED DOOR
Deficiency Location/Instance	Entrance
Deficiency Quantity	2
Quantity Uom	EACH
Potential Action	MAINTENANCE
Urgency of Action	PRIORITY 3
Purpose of Action	LEVEL 2
Deficiency Photo1

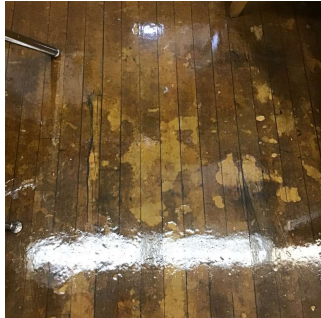
Room 417
Violations	No violations recorded.
<b>Floor Finish</b>	Inspected
Condition	2 - Between Good and Fair
Deficiency	WOOD: DAMAGED/DETERIORATED
Deficiency Location/Instance	Rooms 205, 217, 401, 403, Corridor near Room 427, and others.
Deficiency Quantity	100
Quantity Uom	S.F.
Potential Action	REPLACE
Urgency of Action	PRIORITY 3
Purpose of Action	LEVEL 2
Deficiency Photo1

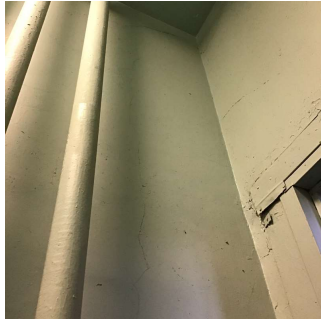
Near Desk Area
Violations	No violations recorded.
Deficiency	PLASTER: CRACKS/SPALLING
Deficiency Location/Instance	Inside Room 159
Deficiency Quantity	10

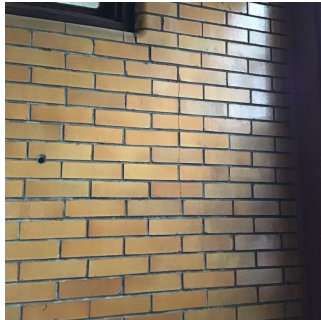
Inside Room 159
Violations	No violations recorded.
Deficiency	SALT GLAZED BRICK: CRACKS/SPALLING
Deficiency Location/Instance	Near Room 159
Deficiency Quantity	10
Quantity Uom	S.F.
Potential Action	REPLACE
Urgency of Action	PRIORITY 3
Purpose of Action	LEVEL 2
Deficiency Photo1

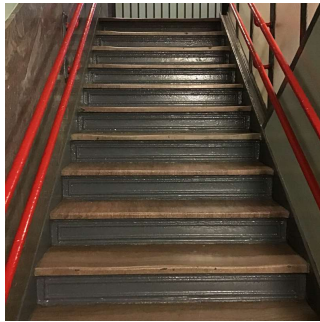
Violations	Main Entrance No violations recorded.
Deficiency	STONE: WORN-OUT TREAD/NOSINGS
Deficiency Location/Instance	Stair CD/1
Deficiency Quantity	260
Quantity Uom	S.F.
Potential Action	REPLACE
Urgency of Action	PRIORITY 3
Purpose of Action	LEVEL 2
Deficiency Photo1

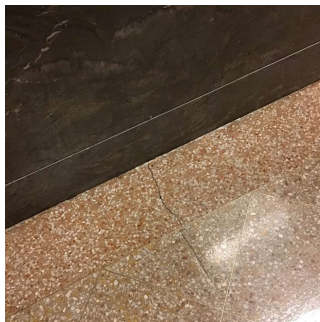
Violations	Stair CD/1 No violations recorded.
Deficiency	TERRAZZO: CRACKS
Deficiency Location/Instance	Stair CD/1
Deficiency Quantity	10
Quantity Uom	S.F.
Potential Action	REPLACE
Urgency of Action	PRIORITY 3
Purpose of Action	LEVEL 2
Deficiency Photo1

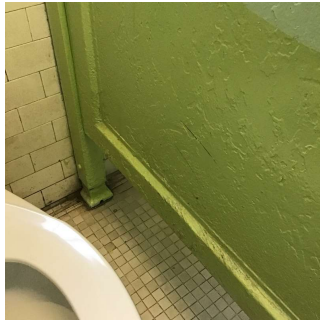
Violations	Room 351 No violations recorded.
<b>Stalls</b>	Inspected
Condition	5 - Poor
Deficiency	RUST - MAJOR
Deficiency Location/Instance	Rooms 351
Deficiency Quantity	1
Quantity Uom	EACH
Potential Action	REPLACE
Urgency of Action	PRIORITY 3
Purpose of Action	LEVEL 2
Deficiency Photo1

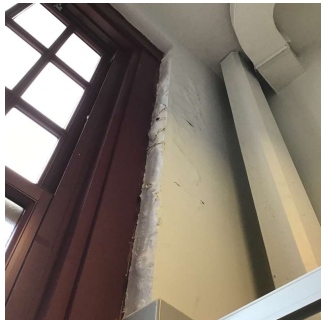
Violations	Room 351 No violations recorded.
Deficiency	PLASTER: CRACKS/SPALLING
Deficiency Location/Instance	Room 356
Deficiency Quantity	10
Quantity Uom	S.F.
Potential Action	REPLACE
Urgency of Action	PRIORITY 3
Purpose of Action	LEVEL 2
Deficiency Photo1
