NYC Department of Education
Building Condition Assessment Survey 2023 - 2024

Architectural Inspection

Asset: P.S. 173 - QUEENS, 174-10 67TH AVENUE, New York, 11365

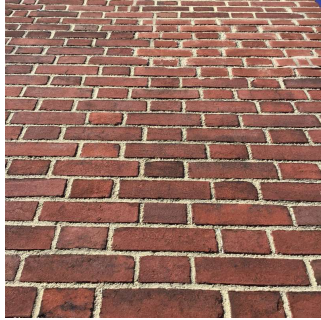
Question	Response
EXTERIOR	
CHIMNEY	
Deficiency Photo1

Violations	<p>CH</p> <p>No violations recorded.</p>
COPING	Inspected
Condition	3 - Fair
Deficiency	CAST STONE: CRACKED/BROKEN PIECES
Roof Plan reference	<p>Q173</p>

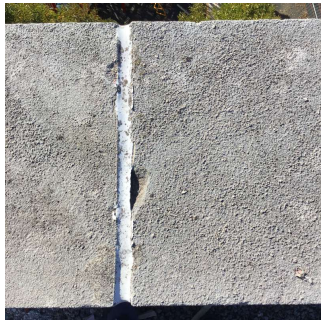
Deficiency Quantity	20
Quantity Uom	L.F.
Potential Action	REPLACE-IN-KIND
Urgency of Action	PRIORITY 4
Purpose of Action	LEVEL 2
Deficiency Photo1

Violations	<p>Roof 1</p> <p>No violations recorded.</p>
Deficiency	CAST STONE: DETERIORATED TRANSVERSE JOINTS

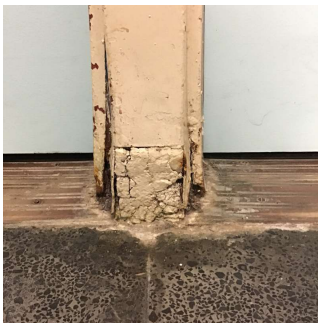
METAL: DETERIORATED DOOR AND FRAME - MAJOR DETERIORATION

<p>Facade J - Exit 9</p>
Violations	No violations recorded.
DOOR HARDWARE	Inspected
Condition	3 - Fair
Deficiency	No deficiencies recorded
LINTELS	Inspected
Condition	2 - Between Good and Fair
Deficiency	No deficiencies recorded
TRANSOM/SIDE LIGHT	Inspected
Condition	3 - Fair
Deficiency	METAL: DENTED, MAJOR RUSTING
Roof Plan reference	<p>Q173</p>

REPLACE

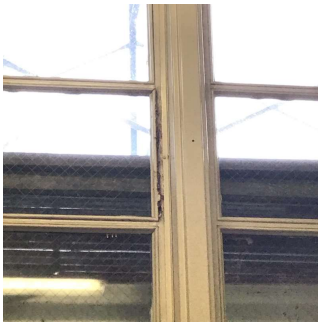
Deficiency Quantity	10
Quantity Uom	S.F.
Potential Action	REPLACE
Urgency of Action	PRIORITY 4
Purpose of Action	LEVEL 2
Deficiency Photo1

<p>Facade A - Main Entrance</p>
Violations	No violations recorded.
Deficiency	METAL: BROKEN GLASS

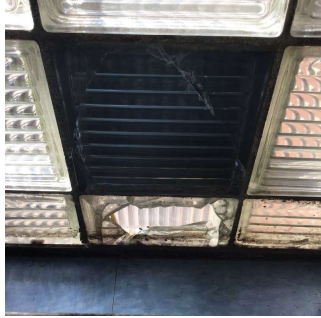
Question	Response
EXTERIOR	
EXTERIOR WALLS	
Urgency of Action	PRIORITY 5
Purpose of Action	LEVEL 6
Deficiency Photo1

Violations	Facade A No violations recorded.
EXTERIOR SOFFITS	Inspected
Condition	2 - Between Good and Fair
Deficiency	No deficiencies recorded
LOADING DOCK	Does not Exist
LOUVER	Inspected
Condition	2 - Between Good and Fair
Deficiency	No deficiencies recorded
PARAPETS	Inspected
Material Type(s)	Masonry
Replacement Quantity	7,500
Replacement Uom	C.F.
Instance on All Facades	Under Construction
Instance Quantity	7,500
Instance Quantity Uom	C.F.
PLAZA DECK	Does not Exist
ROOF	Inspected
Roofing	Inspected
Replacement Quantity	32,000
Replacement Uom	S.F.
ROOF HATCH/SMOKE HATCH	Does not Exist
LEADERS, GUTTERS, DOWNSPOUTS, SCUPPERS	Inspected
Condition	3 - Fair
Deficiency	DAMAGED/MISSING
Roof Plan reference	<p>Q173</p>

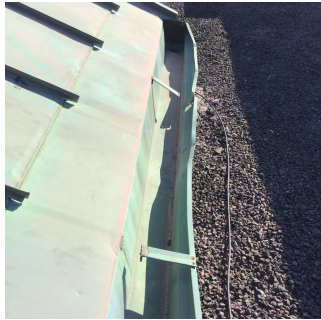
Question	Response
EXTERIOR	
ROOF	
Roofing	
LEADERS, GUTTERS, DOWNSPOUTS, SCUPPERS	
Quantity Uom	L.F.
Potential Action	REPLACE
Urgency of Action	PRIORITY 4
Purpose of Action	LEVEL 2
Deficiency Photo1

Violations	<p>BH1</p> <p>No violations recorded.</p>
ROOF BARRIER/FENCE	Does not Exist
ROOF CAGE	Does not Exist
ROOFING	Inspected
Instance on Built-Up: All Roofs	Under Construction
Instance Quantity	32,000
Instance Quantity Uom	S.F.
ROOFING DRAINS	Under Construction
Specialties	Inspected
BULKHEAD/PENTHOUSE	Under Construction
CUPOLA/ SPIRES/ TOWERS	Does not Exist
DORMER	Does not Exist
DUNNAGE STEEL	Does not Exist
SKYLIGHT/ROOF VENT	Inspected
Material Type(s)	Glass, Plastic
Condition	3 - Fair
Deficiency	DAMAGED GUARDS
Roof Plan reference	<p>Q173</p>

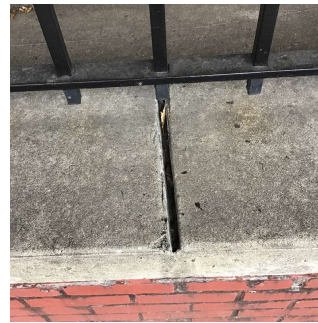
Facade J

Violations	SK2 No violations recorded.
ROOF/GRAVITY TANK	Does not Exist
STAIRS/RAMPS: EXTERIOR	Inspected
BUILDING CHEEK/FLANK WALLS	Inspected
Condition	3 - Fair
Deficiency	BRICK: DETERIORATED JOINTS AT COPING STONES

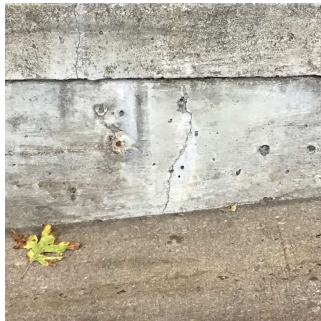
CAST IN PLACE CONCRETE: CRACKS/SPALLING - MINOR

Question	Response
EXTERIOR	
STAIRS/RAMPS: EXTERIOR	
BUILDING CHEEK/FLANK WALLS	
Deficiency Photo1

Violations	<p>Facade J</p> <p>No violations recorded.</p>
Deficiency	BRICK: DETERIORATED JOINTS
Roof Plan reference	<p>Q173</p>

REPAIR

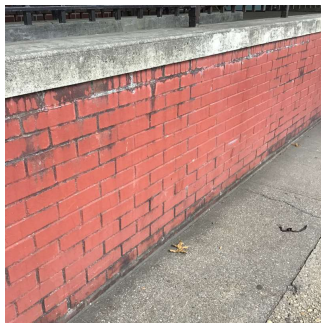
Deficiency Quantity	20
Quantity Uom	S.F.
Potential Action	REPOINT
Urgency of Action	PRIORITY 3
Purpose of Action	LEVEL 2
Deficiency Photo1

Violations	<p>Facade J</p> <p>No violations recorded.</p>
RAILINGS	Inspected
Condition	3 - Fair
Deficiency	DAMAGED

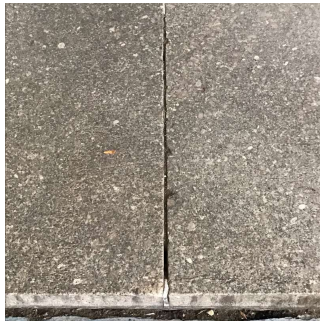
STONE: DETERIORATED JOINTS

Question	Response
EXTERIOR	
STAIRS/RAMPS: EXTERIOR	
STAIRS/RAMPS	
Deficiency Photo1

Violations	Facade F - Exit 7/8 No violations recorded.
Deficiency	CONCRETE: CRACKS/SPALLING - MINOR
Roof Plan reference	Q173

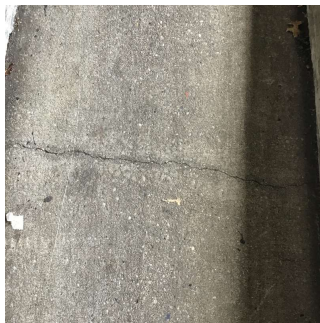
Deficiency Quantity	20
Quantity Uom	S.F.
Potential Action	REPAIR
Urgency of Action	PRIORITY 3
Purpose of Action	LEVEL 2
Deficiency Photo1

Violations	Facade J No violations recorded.
WINDOWS	Inspected
Replacement Quantity	12,000
Replacement Uom	S.F.
EXTERIOR GUARDS	Inspected
Condition	2 - Between Good and Fair
Deficiency	No deficiencies recorded
LINTELS	Inspected
Condition	2 - Between Good and Fair
Deficiency	No deficiencies recorded

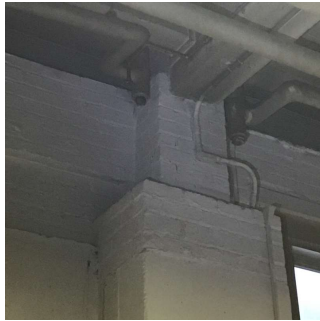
Question	Response
INTERIOR	
STRUCTURAL	
COLUMNS/BEAMS/BEARING WALLS	
Deficiency Photo1

Violations	Boiler Room No violations recorded.
Deficiency	STEEL COLUMNS/BEAMS: DETERIORATED CONCRETE FIREPROOFING
Deficiency Location/Instance	Basement - Boiler Room
Deficiency Quantity	20
Quantity Uom	S.F.
Potential Action	REPLACE
Urgency of Action	PRIORITY 5
Purpose of Action	LEVEL 6
Deficiency Photo1	 
Violations	Basement - Boiler Room No violations recorded.
FLOOR STRUCTURE	Inspected
Condition	3 - Fair
Deficiency	CONCRETE SLAB ON GRADE: THRU CRACKS
Deficiency Location/Instance	Boiler Room - Storage Room
Deficiency Quantity	20
Quantity Uom	S.F.
Potential Action	REPLACE
Urgency of Action	PRIORITY 4
Purpose of Action	LEVEL 5

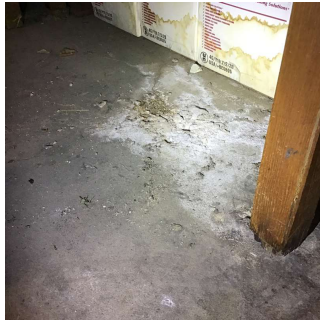
Question	Response
INTERIOR	
STRUCTURAL	
FLOOR STRUCTURE	
Deficiency Photo1

Violations	Boiler Room - Storage Room No violations recorded.
Deficiency	CONCRETE SLAB ON GRADE: THRU CRACKS
Deficiency Location/Instance	Boiler Room
Deficiency Quantity	20
Quantity Uom	S.F.
Potential Action	REPAIR
Urgency of Action	PRIORITY 3
Purpose of Action	LEVEL 5
Deficiency Photo1

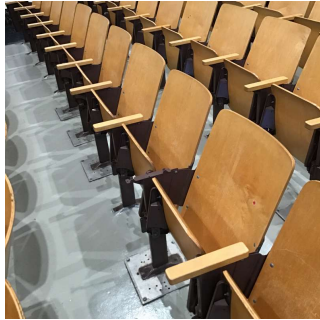
Question	Response
INTERIOR	
STRUCTURAL	Inspected
VAULTS-BUNKERS	
Vault/Ash Hoist Doors and Framing	
Violations	Ash Hoist Vault No violations recorded.
AUDITORIUM	Inspected
Instance on 1st Floor (426 Seats)	Inspected
Ceiling	
Instance on 1st Floor (426 Seats)	Inspected
Condition	2 - Between Good and Fair
Deficiency	No deficiencies recorded
Door(s)	
Instance on 1st Floor (426 Seats)	Inspected
Condition	2 - Between Good and Fair
Deficiency	No deficiencies recorded
Fixed H/C Lift	
Instance on 1st Floor (426 Seats)	Does not Exist
Fixed Seating	
Instance on 1st Floor (426 Seats)	Inspected
Condition	5 - Poor
Deficiency	DAMAGED/BROKEN/INOPERABLE
Deficiency Location/Instance	Seat N/6
Deficiency Quantity	1
Quantity Uom	EACH
Potential Action	REPLACE
Urgency of Action	PRIORITY 5
Purpose of Action	LEVEL 6
Deficiency Photo1

Violations	Seat N/6 No violations recorded.
Deficiency	DAMAGED/BROKEN/INOPERABLE
Deficiency Location/Instance	Seat E/19, F/3, 5, 9, 19 and others

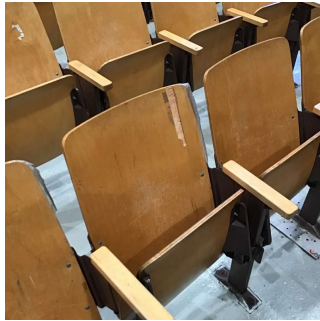
Deficiency Quantity	43
Quantity Uom	EACH
Potential Action	REPLACE
Urgency of Action	PRIORITY 3
Purpose of Action	LEVEL 2

Question	Response
INTERIOR	
AUDITORIUM	Inspected
Fixed Seating	
Deficiency Photo1

Violations	<p>Seat F/3</p> <p>No violations recorded.</p>
Floor Finish	
Instance on 1st Floor (426 Seats)	Inspected
Condition	2 - Between Good and Fair
Deficiency	CONCRETE: CRACKS
Deficiency Location/Instance	Along Row L
Deficiency Quantity	40
Quantity Uom	S.F.
Potential Action	REPLACE
Urgency of Action	PRIORITY 3
Purpose of Action	LEVEL 2
Deficiency Photo1

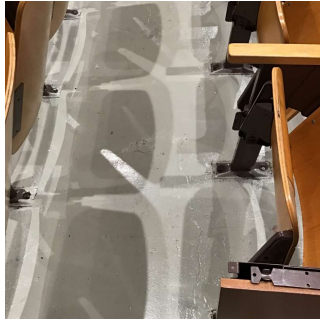
Violations	<p>Along Row L</p> <p>No violations recorded.</p>
Deficiency	VINYL TILES: BROKEN/DETERIORATED/MISSING TILES
Deficiency Location/Instance	Right Side Stage Office
Deficiency Quantity	10
Quantity Uom	S.F.
Potential Action	REPLACE
Urgency of Action	PRIORITY 3
Purpose of Action	LEVEL 2

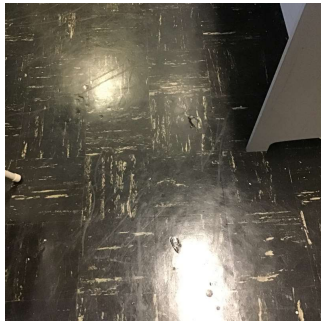
Question	Response
INTERIOR	
AUDITORIUM	
Floor Finish	
Deficiency Photo1

Right Side Stage Office
Violations	No violations recorded.
Sliding-folding Partition	
Instance on 1st Floor (426 Seats)	Does not Exist
Stage	
Instance on 1st Floor (426 Seats)	Inspected
Stage	Inspected
Instance on 1st Floor (426 Seats)	Inspected
Condition	2 - Between Good and Fair
Deficiency	DAMAGED STEPS
Deficiency Location/Instance	Left Side
Deficiency Quantity	10
Quantity Uom	S.F.
Potential Action	REPLACE
Urgency of Action	PRIORITY 3
Purpose of Action	LEVEL 2
Deficiency Photo1

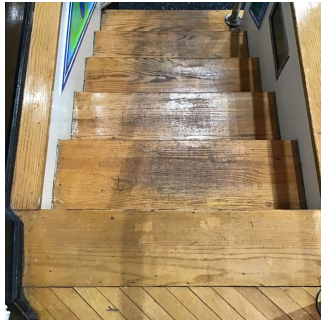
Left Side
Violations	No violations recorded.
Stage Curtain Rigging	Inspected
Instance on 1st Floor (426 Seats)	Inspected
Condition	2 - Between Good and Fair
Deficiency	No deficiencies recorded
Stage Curtains	Inspected
Instance on 1st Floor (426 Seats)	Inspected
Condition	2 - Between Good and Fair
Deficiency	No deficiencies recorded
Walls	
Instance on 1st Floor (426 Seats)	Inspected

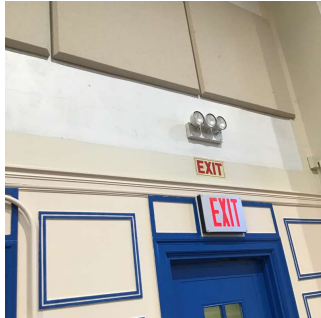
Question	Response
INTERIOR	
AUDITORIUM	
Walls	
Deficiency	PLASTER: CRACKS/SPALLING
Deficiency Location/Instance	Near Entrance, Near Windows
Deficiency Quantity	40
Quantity Uom	S.F.
Potential Action	REPLACE
Urgency of Action	PRIORITY 3
Purpose of Action	LEVEL 2
Deficiency Photo1

Near Entrance
Violations	No violations recorded.
Deficiency	BRICK: CRACKS/SPALLING
Deficiency Location/Instance	Right Side of Stage, Rear of Stage
Deficiency Quantity	60
Quantity Uom	S.F.
Potential Action	REPLACE
Urgency of Action	PRIORITY 3
Purpose of Action	LEVEL 2
Deficiency Photo1

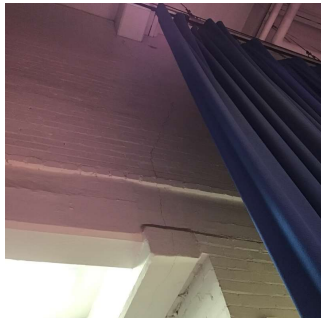
Rear of Stage
Violations	No violations recorded.
Window Curtains/Shades/Blinds	
Instance on 1st Floor (426 Seats)	Inspected
Condition	2 - Between Good and Fair
Deficiency	No deficiencies recorded
CAFETERIA	
Instance on 1st Floor	Inspected
Ceiling	
Instance on 1st Floor	Inspected
Condition	2 - Between Good and Fair
Deficiency	TECTUM: DAMAGED/MISSING
Deficiency Location/Instance	Rear Near Windows, Near Serving area

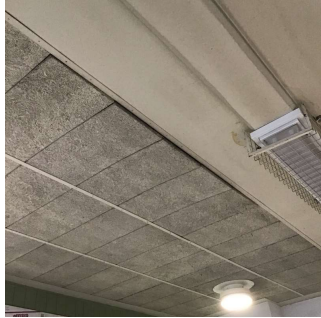
Question	Response
INTERIOR	
CAFETERIA	
Ceiling	
Deficiency Quantity	40
Quantity Uom	S.F.
Potential Action	REPLACE
Urgency of Action	PRIORITY 3
Purpose of Action	LEVEL 2
Deficiency Photo1

Near Serving area
Violations	No violations recorded.
Door(s)	
Instance on 1st Floor	Inspected
Condition	4 - Between Fair and Poor
Deficiency	METAL: DETERIORATED DOOR
Deficiency Location/Instance	Main Entrance
Deficiency Quantity	2
Quantity Uom	EACH
Potential Action	MAINTENANCE
Urgency of Action	PRIORITY 3
Purpose of Action	LEVEL 2
Deficiency Photo1

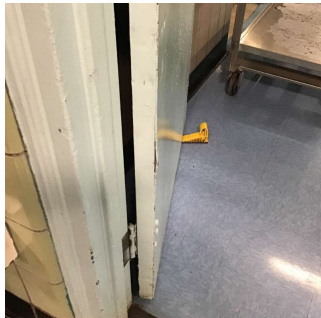
Main Entrance
Violations	No violations recorded.
Fixed Equipment	
Instance on 1st Floor	Does not Exist
Floor Finish	
Instance on 1st Floor	Inspected
Condition	2 - Between Good and Fair
Deficiency	VINYL TILES: BROKEN/DETERIORATED/MISSING TILES
Deficiency Location/Instance	Rear
Deficiency Quantity	20
Quantity Uom	S.F.
Potential Action	REPLACE

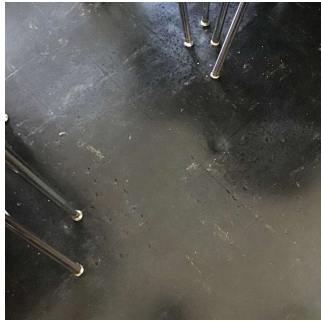
Question	Response
INTERIOR	
CAFETERIA	
Floor Finish	
Urgency of Action	PRIORITY 3
Purpose of Action	LEVEL 2
Deficiency Photo1	 
	Rear
Violations	No violations recorded.
Sliding-folding Partition	
Instance on 1st Floor	Does not Exist
Stage	
Instance on 1st Floor	Does not Exist
Walls	
Instance on 1st Floor	Inspected
Condition	2 - Between Good and Fair
Deficiency	GLAZED BLOCK: CRACKS/SPALLING
Deficiency Location/Instance	Near Stair D/1
Deficiency Quantity	10
Quantity Uom	S.F.
Potential Action	REPLACE
Urgency of Action	PRIORITY 3
Purpose of Action	LEVEL 2
Deficiency Photo1	 
	Near Stair D/1
Violations	No violations recorded.
Window Curtains/Shades/Blinds	
Instance on 1st Floor	Does not Exist
CLASSROOMS/CORRIDORS/ADMIN SPACES	
Ceiling	
Condition	2 - Between Good and Fair
Deficiency	PLASTER: CRACKS/SPALLING
Deficiency Location/Instance	Rooms 329, 325, 316, 312, 215 and others
Deficiency Quantity	80
Quantity Uom	S.F.

Violations	Room 327 No violations recorded.
Walls	Inspected
Condition	2 - Between Good and Fair
Deficiency	PLASTER: CRACKS/SPALLING
Deficiency Location/Instance	Room 305, Corridor near Room 219, Main Entrance
Deficiency Quantity	30
Quantity Uom	S.F.
Potential Action	REPLACE
Urgency of Action	PRIORITY 3
Purpose of Action	LEVEL 2
Deficiency Photo1

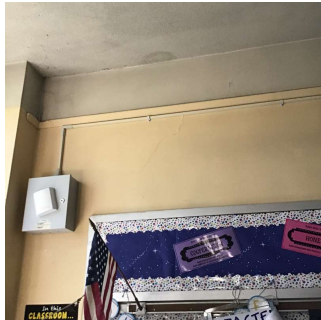
Violations	Room 305 No violations recorded.
Specialties	Does not Exist
GYMNASIUM	Inspected
Instance on 1st Floor	Inspected
Ceiling	
Instance on 1st Floor	Inspected
Condition	2 - Between Good and Fair
Deficiency	TECTUM: DAMAGED/MISSING
Deficiency Location/Instance	Right Side Near Windows, Center
Deficiency Quantity	40
Quantity Uom	S.F.
Potential Action	REPLACE
Urgency of Action	PRIORITY 3
Purpose of Action	LEVEL 2

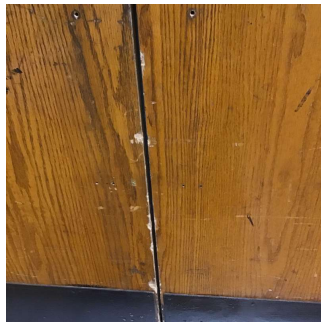
Main Entrance
Violations	No violations recorded.
Fixed Equipment	
Instance on 1st Floor	Inspected
Condition	2 - Between Good and Fair
Deficiency	No deficiencies recorded
Floor Finish	
Instance on 1st Floor	Inspected
Condition	2 - Between Good and Fair
Deficiency	No deficiencies recorded
Seating	
Instance on 1st Floor	Inspected
Condition	3 - Fair
Deficiency	DAMAGED FIXED SEATING
Deficiency Location/Instance	Right Side Near Windows
Deficiency Quantity	1
Quantity Uom	EACH
Potential Action	REPLACE
Urgency of Action	PRIORITY 3
Purpose of Action	LEVEL 2
Deficiency Photo1

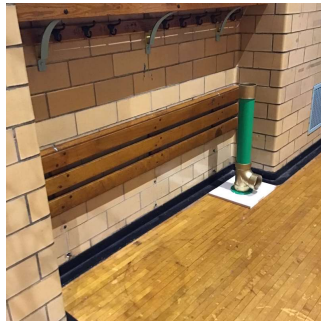
Right Side Near Windows
Violations	No violations recorded.
Sliding-folding Partition	
Instance on 1st Floor	Does not Exist
Stage	
Instance on 1st Floor	Does not Exist
Walls	
Instance on 1st Floor	Inspected
Condition	2 - Between Good and Fair

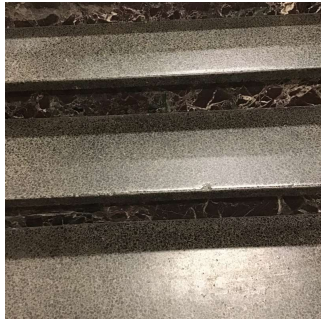
Vestibule Exit 3
Violations	No violations recorded.
Walls	Inspected
Condition	2 - Between Good and Fair
Deficiency	GLAZED BLOCK: CRACKS/SPALLING
Deficiency Location/Instance	Stair D/1 Vestibule
Deficiency Quantity	10
Quantity Uom	S.F.
Potential Action	REPLACE
Urgency of Action	PRIORITY 3
Purpose of Action	LEVEL 2
Deficiency Photo1

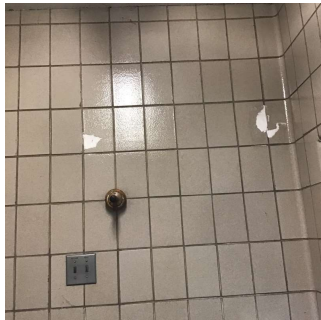
Stair D/1 Vestibule
Violations	No violations recorded.
Deficiency	CERAMIC TILE: BROKEN/ MISSING
Deficiency Location/Instance	Stair D/3
Deficiency Quantity	10
Quantity Uom	S.F.
Potential Action	REPLACE
Urgency of Action	PRIORITY 3
Purpose of Action	LEVEL 2

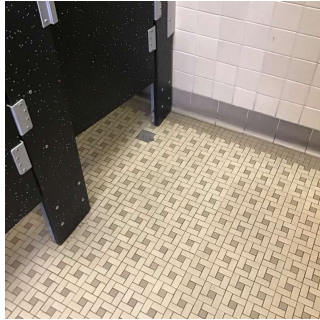
Room 326
Violations	No violations recorded.
Floor Finish	Inspected
Condition	2 - Between Good and Fair
Deficiency	CERAMIC TILE: BROKEN/MISSING TILES
Deficiency Location/Instance	Rooms 206, 226
Deficiency Quantity	20
Quantity Uom	S.F.
Potential Action	REPLACE
Urgency of Action	PRIORITY 3
Purpose of Action	LEVEL 2
Deficiency Photo1

Room 206
Violations	No violations recorded.
Stalls	Inspected
Condition	2 - Between Good and Fair
Deficiency	No deficiencies recorded
Walls	Inspected
Condition	2 - Between Good and Fair
Deficiency	CERAMIC TILE: BROKEN/ MISSING
Deficiency Location/Instance	Rooms 326, 306, 226
Deficiency Quantity	30
Quantity Uom	S.F.
Potential Action	REPLACE
Urgency of Action	PRIORITY 3
Purpose of Action	LEVEL 2

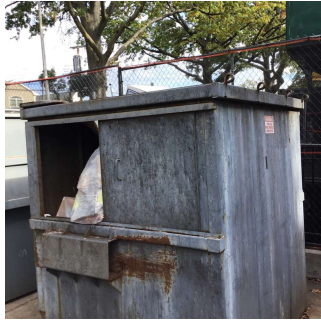
Question	Response
SITE	
CONTAINERIZATION	
Deficiency Photo1

Violations	67th Avenue No violations recorded.
Drainage System for Asphalt	Inspected
Catch Basins/Manhole - Surrounded by asphalt	Inspected
Condition	2 - Between Good and Fair
Deficiency	No deficiencies recorded
Culverts - Asphalt Covering	Does not Exist
Drainage System for Concrete	Inspected
Catch Basins/Manhole - Surrounded by concrete	Inspected
Condition	2 - Between Good and Fair
Deficiency	No deficiencies recorded
Culverts - Concrete Covering	Does not Exist
Drainage System for Soil	Inspected
Catch Basins/Manhole - Surrounded by Soil	Inspected
Condition	2 - Between Good and Fair
Deficiency	No deficiencies recorded
Culverts - Soil Covering	Does not Exist
DRINKING FOUNTAINS	Does not Exist
FENCES	Inspected
Condition	2 - Between Good and Fair
Deficiency	CONCRETE CURB: DAMAGED/DETERIORATED
Deficiency Location/Instance	Along New York City Park
Deficiency Quantity	20

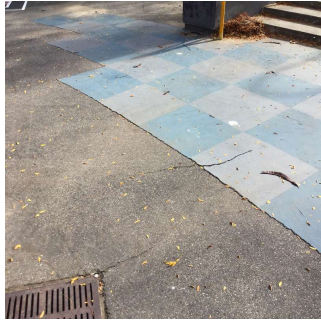
Violations	Schoolyard No violations recorded.
Concrete	Inspected
Condition	2 - Between Good and Fair
Deficiency	No deficiencies recorded
Pavers	Does not Exist
Site Sidewalks & Walkways	Inspected
Asphalt	Does not Exist
Concrete	Inspected
Condition	4 - Between Fair and Poor
Deficiency	CRACKS - MAJOR
Deficiency Location/Instance	Near New York City Park, Near Main Entrance
Deficiency Quantity	700

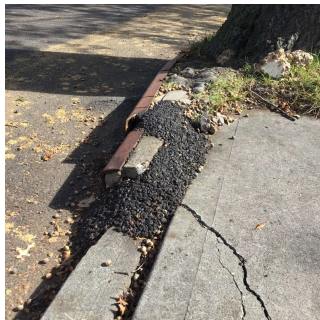
Violations	67th Avenue No violations recorded.
Deficiency	DAMAGED CURBS
Deficiency Location/Instance	67th Avenue,Fresh Meadows Lane, 68th Avenue
Deficiency Quantity	160
Quantity Uom	L.F.
Potential Action	REPLACE
Urgency of Action	PRIORITY 3
Purpose of Action	LEVEL 2

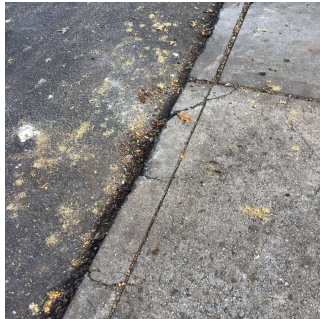
Violations	67th Avenue No violations recorded.
Deficiency	HEAVING
Deficiency Location/Instance	67th Avenue, Fresh Meadow Lane
Deficiency Quantity	200
Quantity Uom	S.F.
Potential Action	REPLACE
Urgency of Action	PRIORITY 3
Purpose of Action	LEVEL 2
Deficiency Photo1
