**NYC Department of Education**  
**Building Condition Assessment Survey 2023 - 2024**

Architectural Inspection

Q430

**Asset:** FRANCIS LEWIS HS - Q, 58-20 UTOPIA PKWY, New York, 11365

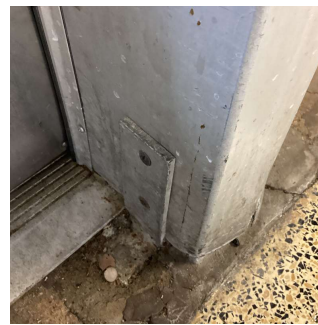
Deficiency

No deficiencies recorded

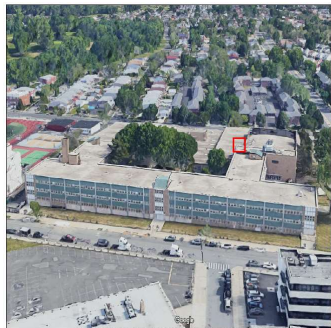
Elevation

Violations	<p>Facade A</p> <p>No violations recorded.</p>
<b>EXTERIOR WALLS</b>	Inspected
Material Type(s)	Masonry, Steel
Replacement Quantity	58,000
Replacement Uom	S.F.
Instance on All Facades	Inspected
Instance Condition	3 - Fair
Instance Quantity	58,000
Instance Quantity Uom	S.F.
Deficiency	BRICK: MINOR CRACKS AND SPALLING
Roof Plan reference

Deficiency Quantity	50
Quantity Uom	S.F.
Potential Action	RESTITCH
Urgency of Action	PRIORITY 3
Purpose of Action	LEVEL 2

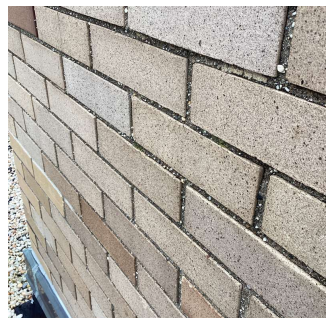
Condition	3 - Fair
Deficiency	BULKHEAD/PENTHOUSE WALLS/EXTERIOR: DETERIORATED JOINTS

Violations	Roof 1 - Bulkhead 1 No violations recorded.
<b>CUPOLA/ SPIRES/ TOWERS</b>	Does not Exist
<b>DORMER</b>	Does not Exist
<b>DUNNAGE STEEL</b>	Inspected
Condition	2 - Between Good and Fair
Deficiency	No deficiencies recorded
<b>SKYLIGHT/ROOF VENT</b>	Inspected
Material Type(s)	Glass, Plastic
Condition	2 - Between Good and Fair
Deficiency	No deficiencies recorded
<b>ROOF/GRAVITY TANK</b>	Does not Exist
<b>STAIRS/RAMPS: EXTERIOR</b>	Inspected
<b>BUILDING CHEEK/FLANK WALLS</b>	Inspected
Condition	3 - Fair
Deficiency	CAST IN PLACE CONCRETE: CRACKS/SPALLING - MAJOR

Deficiency Quantity	400
Quantity Uom	S.F.
Potential Action	REPOINT
Urgency of Action	PRIORITY 3
Purpose of Action	LEVEL 2
Deficiency Photo1

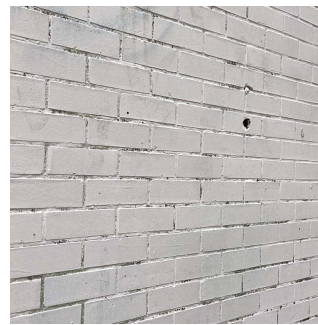
Facade D

CONCRETE: CRACKS/SPALLING - MINOR

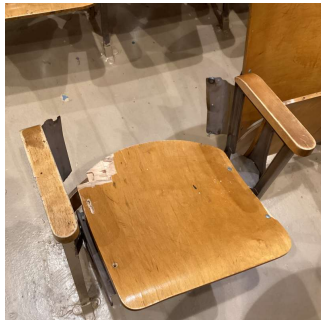
Seat X/17
Violations	No violations recorded.
Deficiency	DAMAGED/BROKEN/INOPERABLE
Deficiency Location/Instance	Seats B/101, K/111, L/22, M/103, N/111, and others.
Deficiency Quantity	167
Quantity Uom	EACH
Potential Action	REPLACE
Urgency of Action	PRIORITY 3
Purpose of Action	LEVEL 2

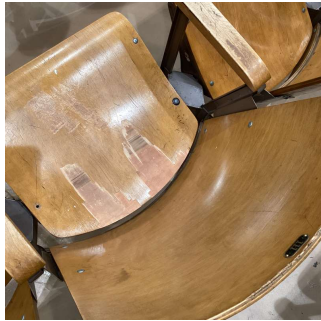
Seat N/111
Violations	No violations recorded.
<b>Floor Finish</b>	
Instance on 1st Floor (961 Seats)	Inspected
Condition	2 - Between Good and Fair
Deficiency	CONCRETE: CRACKS
Deficiency Location/Instance	Room Left Side
Deficiency Quantity	20
Quantity Uom	S.F.
Potential Action	REPLACE
Urgency of Action	PRIORITY 3
Purpose of Action	LEVEL 2
Deficiency Photo1

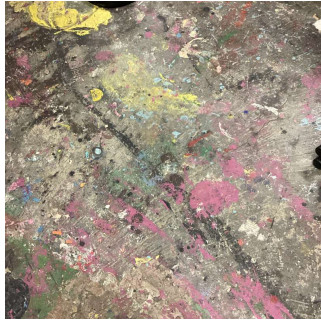
Room Left Side
Violations	No violations recorded.
Deficiency	VINYL TILES: BROKEN/DETERIORATED/MISSING TILES
Deficiency Location/Instance	Near Entrance
Deficiency Quantity	10
Quantity Uom	S.F.
Potential Action	REPLACE
Urgency of Action	PRIORITY 3
Purpose of Action	LEVEL 2

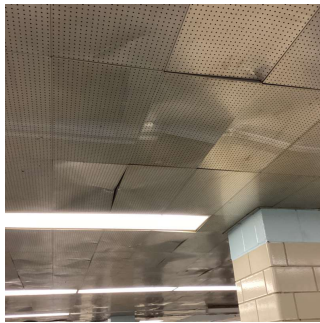
Near Entrance
Violations	No violations recorded.
<b>Door(s)</b>	
Instance on 1st Floor - Students	Inspected
Condition	5 - Poor
Deficiency	METAL: DETERIORATED DOOR AND FRAME
Deficiency Location/Instance	Entrance
Deficiency Quantity	4
Quantity Uom	EACH
Potential Action	MAINTENANCE
Urgency of Action	PRIORITY 3
Purpose of Action	LEVEL 2
Deficiency Photo1	 
	Entrance
Violations	No violations recorded.
Deficiency	WOOD: DETERIORATED DOOR
Deficiency Location/Instance	Entrances
Deficiency Quantity	3
Quantity Uom	EACH
Potential Action	MAINTENANCE
Urgency of Action	PRIORITY 3
Purpose of Action	LEVEL 2

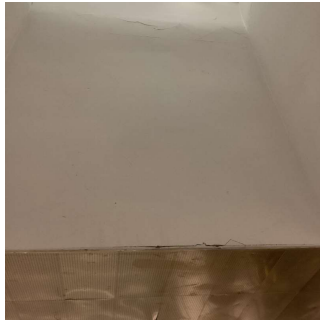
Violations	Near center No violations recorded.
Deficiency	GLAZED BLOCK: CRACKS/SPALLING
Deficiency Location/Instance	Columns, Near Entrances
Deficiency Quantity	50
Quantity Uom	S.F.
Potential Action	REPLACE
Urgency of Action	PRIORITY 3
Purpose of Action	LEVEL 2
Deficiency Photo1	 
Violations	Near Entrance No violations recorded.
<b>Window Curtains/Shades/Blinds</b>	
Instance on 1st Floor - Students	Does not Exist
Instance on 1st Floor - Staff	Does not Exist
<b>CLASSROOMS/CORRIDORS/ADMIN SPACES</b>	
<b>Ceiling</b>	Inspected
Condition	2 - Between Good and Fair
Deficiency	ACOUSTIC TILES ON PLASTER: DAMAGED/MISSING - ACTIVE LEAK
Deficiency Location/Instance	Rooms 304, 306
Deficiency Quantity	50
Quantity Uom	S.F.
Potential Action	REPLACE
Urgency of Action	PRIORITY 5
Purpose of Action	LEVEL 2

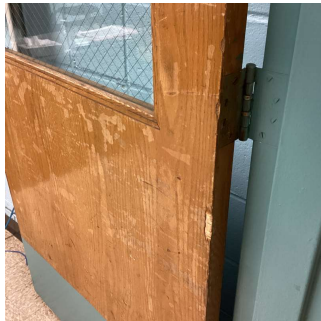
Room 328
Violations	No violations recorded.
<b>Floor Finish</b>	Inspected
Condition	3 - Fair
Deficiency	TERRAZZO: CRACKS
Deficiency Location/Instance	Main Entrance Area
Deficiency Quantity	20
Quantity Uom	S.F.
Potential Action	REPLACE
Urgency of Action	PRIORITY 3
Purpose of Action	LEVEL 2
Deficiency Photo1

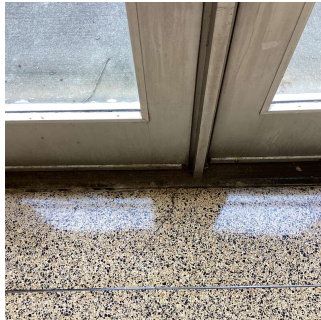
Main Entrance Area
Violations	No violations recorded.
Deficiency	VINYL TILES: BROKEN/DETERIORATED/MISSING TILES
Deficiency Location/Instance	Rooms 339B, 324, 320, 207, 122, and others
Deficiency Quantity	3,400
Quantity Uom	S.F.
Potential Action	REPLACE
Urgency of Action	PRIORITY 3
Purpose of Action	LEVEL 2
Deficiency Photo1

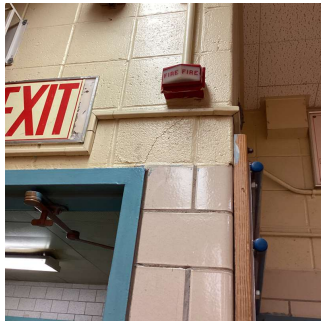
Near Room 151
Violations	No violations recorded.
Deficiency	GLAZED BLOCK: CRACKS/SPALLING
Deficiency Location/Instance	Near Stair K, Exit 13
Deficiency Quantity	20
Quantity Uom	S.F.
Potential Action	REPLACE
Urgency of Action	PRIORITY 3
Purpose of Action	LEVEL 2
Deficiency Photo1

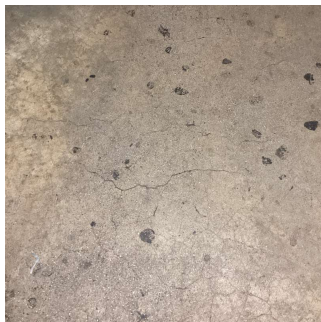
Stair K/Basement
Violations	No violations recorded.
Deficiency	TERRAZZO: CRACKS
Deficiency Location/Instance	Stairs CD/2, GH/1, 2, EF/2, J/1, and others.
Deficiency Quantity	250
Quantity Uom	S.F.
Potential Action	REPLACE
Urgency of Action	PRIORITY 3
Purpose of Action	LEVEL 2
Deficiency Photo1
