NYC Department of Education
Building Condition Assessment Survey 2023 - 2024

Architectural Inspection

Q483

Asset: 3K CENTER @ 207-01 JAMAICA AVENUE - QUEENS, 207-01 JAMAICA AVENUE, New York, 11428

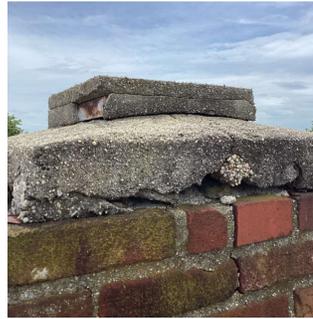
Roof 1

Deficiency
 Roof Plan reference
 BRICK: DETERIORATED CAP

BRICK: DETERIORATED JOINTS

Deficiency Quantity	10
Quantity Uom	L.F.
Potential Action	REPLACE
Urgency of Action	PRIORITY 4
Purpose of Action	LEVEL 2

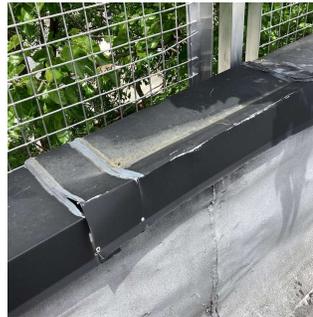
Roof 1
 No violations recorded.

METAL: DETERIORATED

10
 L.F.
 REPLACE-IN-KIND
 PRIORITY 4
 LEVEL 2

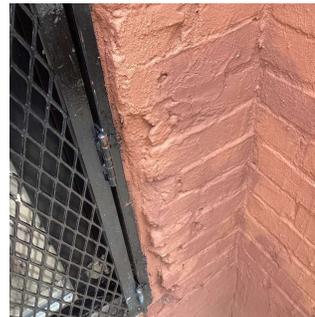
Facade C

BRICK: MINOR CRACKS AND SPALLING

Potential Action

RESTITCH

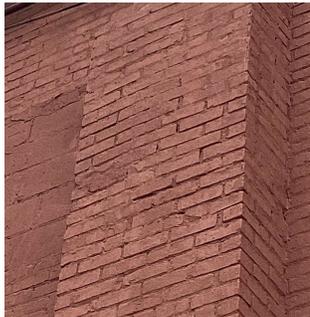
Facade C

BRICK: DETERIORATED JOINTS

Potential Action

REPOINT

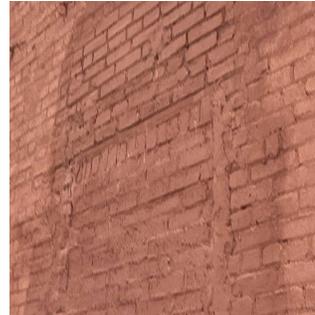
Facade C

BRICK: DETERIORATED JOINTS

Potential Action

REPOINT

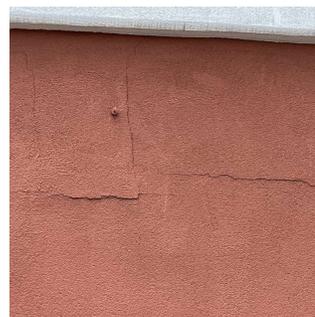
Facade A

STUCCO CEMENT SURFACE: CRACKS, SPALLING

30
S.F.
REPLACE
PRIORITY 4
LEVEL 2

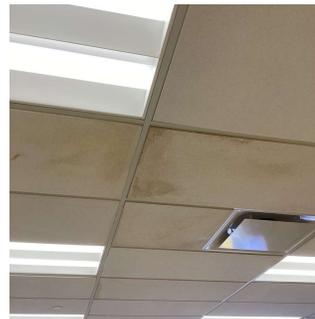
Roof 1 - Room 205, also Room 202

MODIFIED BITUMEN: ROOFING: MAJOR ACTIVE ROOF
LEAKS IN INSTRUCTIONAL SPACE

Potential Action

REPLACE ROOFING WITHOUT MAJOR EQUIPMENT
REMOVAL

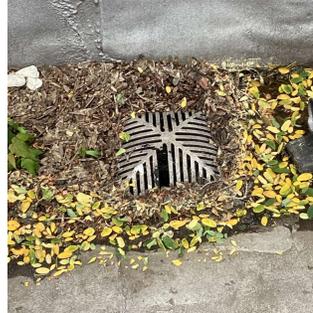
Roof 1

DETERIORATED

Potential Action

REPLACE

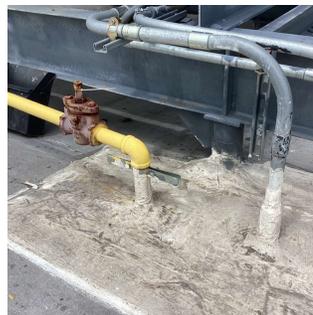
Roof 1

HEIGHT LESS THAN 18"

Potential Action

REPLACE

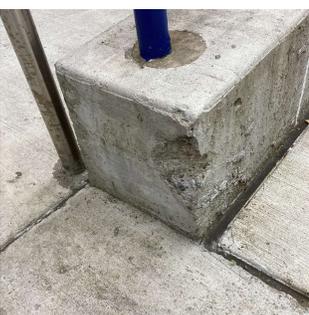
Question	Response
EXTERIOR	
ROOF	Inspected
Specialties	Inspected
ROOF/GRAVITY TANK	Does not Exist
STAIRS/RAMPS: EXTERIOR	Inspected
BUILDING CHEEK/FLANK WALLS	Inspected
Condition	3 - Fair
Deficiency	CAST IN PLACE CONCRETE: CRACKS/SPALLING - MAJOR
Roof Plan reference	<p>Q483</p>

Deficiency Quantity	10
Quantity Uom	S.F.
Potential Action	REPLACE
Urgency of Action	PRIORITY 4
Purpose of Action	LEVEL 2
Deficiency Photo1

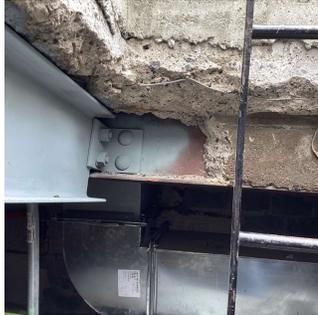
Question	Response
EXTERIOR	
WINDOWS	
WINDOWS	
Material Type(s)	Aluminum
Instance on Aluminum - Other: Facades A, C	Inspected
Instance Condition	3 - Fair
Instance Quantity	1,500
Instance Quantity Uom	S.F.
Are these windows insulated	Yes
Installation Year	2006
Source of Installation	Custodial Staff
Deficiency	No deficiencies recorded
INTERIOR	Inspected
POOLS	Does not Exist
STRUCTURAL	Inspected
COLUMNS/BEAMS/BEARING WALLS	Inspected
Condition	2 - Between Good and Fair
Deficiency	No deficiencies recorded
FLOOR STRUCTURE	Inspected
Condition	2 - Between Good and Fair
Deficiency	No deficiencies recorded
FOUNDATION WALLS	Inspected
Material Type(s)	Concrete
Condition	2 - Between Good and Fair
Deficiency	No deficiencies recorded
ROOF STRUCTURE	Inspected
Condition	3 - Fair
Deficiency	STEEL COLUMNS/BEAMS: DETERIORATED CONCRETE FIREPROOFING
Deficiency Location/Instance	Attic
Deficiency Quantity	10
Quantity Uom	S.F.
Potential Action	REPLACE

Urgency of Action	PRIORITY 3
Purpose of Action	LEVEL 5
Deficiency Photo1

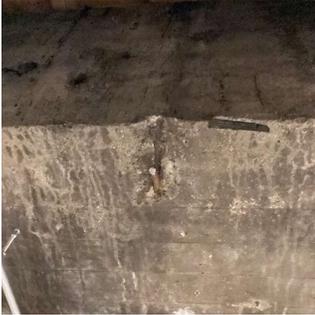
Violations	Attic No violations recorded.
Deficiency	CONCRETE: CRACKED/SPALLED/REINFORCEMENT EXPOSED
Deficiency Location/Instance	Attic
Deficiency Quantity	30

Question	Response
INTERIOR	
STRUCTURAL	
ROOF STRUCTURE	
Quantity Uom	S.F.
Potential Action	REPAIR
Urgency of Action	PRIORITY 3
Purpose of Action	LEVEL 5
Deficiency Photo1

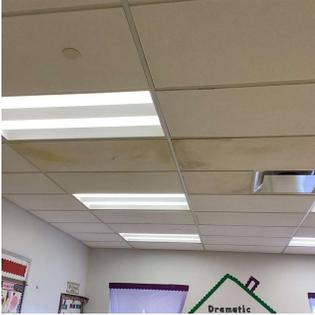
Violations	Attic No violations recorded.
VAULTS-BUNKERS	Does not Exist
AUDITORIUM	Does not Exist
CAFETERIA	Does not Exist
CLASSROOMS/CORRIDORS/ADMIN SPACES	Inspected
Ceiling	Inspected
Condition	2 - Between Good and Fair
Deficiency	ACOUSTIC TILES: DAMAGED/MISSING - ACTIVE LEAK
Deficiency Location/Instance	Rooms 202, 205
Deficiency Quantity	170
Quantity Uom	S.F.
Potential Action	REPLACE
Urgency of Action	PRIORITY 5
Purpose of Action	LEVEL 2
Deficiency Photo1

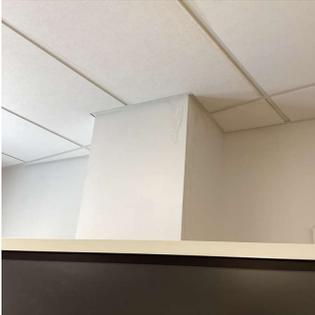
Question	Response
INTERIOR	
CLASSROOMS/CORRIDORS/ADMIN SPACES	
Walls	
Deficiency	GYPSUM BOARD: DETERIORATED - ACTIVE LEAK
Deficiency Location/Instance	Room 202
Deficiency Quantity	20
Quantity Uom	S.F.
Potential Action	REPLACE
Urgency of Action	PRIORITY 5
Purpose of Action	LEVEL 2
Deficiency Photo1

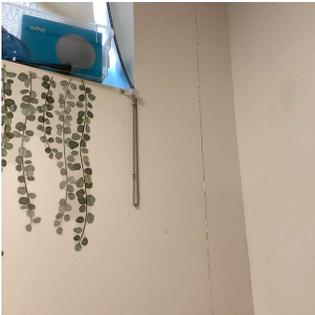
Room 202
Violations	No violations recorded.
Deficiency	GYPSUM BOARD: DETERIORATED
Deficiency Location/Instance	Rooms 117, 119, 206, 207, Corridor near Room 216, and others
Deficiency Quantity	60
Quantity Uom	S.F.
Potential Action	REPLACE
Urgency of Action	PRIORITY 3
Purpose of Action	LEVEL 2
Deficiency Photo1

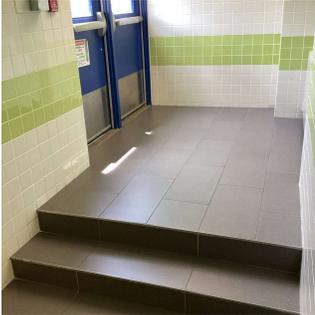
Question	Response
INTERIOR	
MULTI-PURPOSE ROOM	
Stage	
Instance on 1st Floor (1000 SF)	Does not Exist
Instance on 2nd Floor (900SF)	Does not Exist
Walls	
Instance on 2nd Floor (900SF)	Inspected
Condition	1 - Good
Deficiency	No deficiencies recorded
Instance on 1st Floor (1000 SF)	Inspected
Condition	1 - Good
Deficiency	No deficiencies recorded
Window Curtains/Shades/Blinds	
Instance on 2nd Floor (900SF)	Does not Exist
Instance on 1st Floor (1000 SF)	Does not Exist
SCIENCE DEMO ROOM	Does not Exist
SCIENCE LAB	Does not Exist
SCIENCE PREP ROOM	Does not Exist
SHOWER ROOM	Does not Exist
STAIRS/RAMPS: INTERIOR	Inspected
Do Letter Stair Signs Exist?	Yes
Ceiling	Inspected
Condition	1 - Good
Deficiency	No deficiencies recorded
Door(s)	Inspected
Condition	1 - Good
Deficiency	No deficiencies recorded
Partition	Does not Exist
Railings	Inspected
Condition	3 - Fair
Deficiency	METAL: MISSING
Deficiency Location/Instance	Stair B/1
Deficiency Quantity	10

Quantity Uom	L.F.
Potential Action	REPLACE
Urgency of Action	PRIORITY 5
Purpose of Action	LEVEL 6
Deficiency Photo1

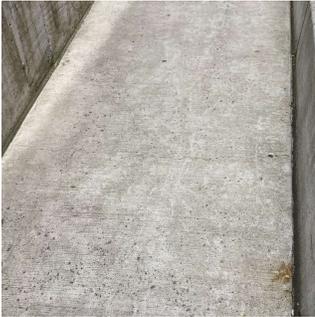
Question	Response
SITE	
FENCES	Inspected
Condition	1 - Good
Deficiency	No deficiencies recorded
IRRIGATION SYSTEM	Does not Exist
PAVING	Inspected
Student Non-Use	Inspected
Gravel Exists?	No
Asphalt	Does not Exist
Concrete	Inspected
Condition	1 - Good
Deficiency	No deficiencies recorded
Pavers	Does not Exist
Student Use	Does not Exist
Site Sidewalks & Walkways	Inspected
Asphalt	Does not Exist
Concrete	Inspected
Condition	3 - Fair
Deficiency	DAMAGED/DETERIORATED/MISSING SECTIONS
Deficiency Location/Instance	Jamaica Avenue, Near Stair C Ramp
Deficiency Quantity	100
Quantity Uom	S.F.
Potential Action	REPLACE
Urgency of Action	PRIORITY 3
Purpose of Action	LEVEL 2
Deficiency Photo1

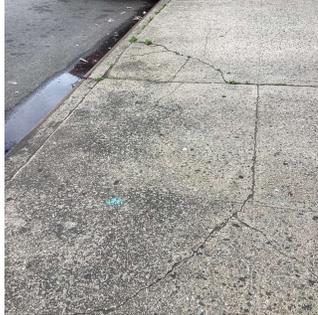
Near Stair C Ramp	
Violations	No violations recorded.
Pavers	Does not Exist
DOT Sidewalk	Inspected
Asphalt	Does not Exist
Concrete	Inspected
Condition	4 - Between Fair and Poor
Deficiency	DAMAGED/DETERIORATED/MISSING SECTIONS
Deficiency Location/Instance	Jamaica Avenue, 207th Street

Deficiency Quantity	450
Quantity Uom	S.F.
Potential Action	REPLACE
Urgency of Action	PRIORITY 3
Purpose of Action	LEVEL 2

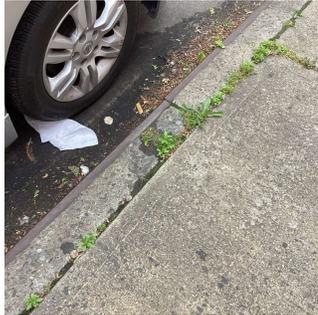
Violations	Jamaica Avenue No violations recorded.
Deficiency	DAMAGED CURBS
Deficiency Location/Instance	Jamaica Avenue, 207th Street
Deficiency Quantity	145
Quantity Uom	L.F.
Potential Action	REPLACE
Urgency of Action	PRIORITY 3
Purpose of Action	LEVEL 2
Deficiency Photo1

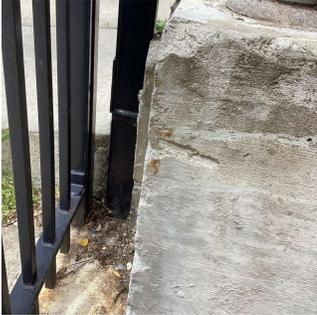
Question	Response
SITE	
PLAYGROUNDS	Inspected
Unpaved Area	
Instance on Rear Yard	Does not Exist
PLAYING SURFACE	Does not Exist
RETAINING WALLS	Inspected
Are there any Retaining Walls 6' OR higher facing public street/sidewalk?	No
Condition	3 - Fair
Deficiency	CAST IN PLACE CONCRETE: CRACKS/SPALLING - MAJOR
Deficiency Location/Instance	Near Stair C Ramp
Deficiency Quantity	50
Quantity Uom	S.F.
Potential Action	REPLACE
Urgency of Action	PRIORITY 3
Purpose of Action	LEVEL 2
Deficiency Photo1
