NYC Department of Education
Building Condition Assessment Survey 2023 - 2024

Architectural Inspection

Asset: P.S. 16 (OLD Q721 SPED) - QUEENS, 41-15 104 STREET, New York, 11368

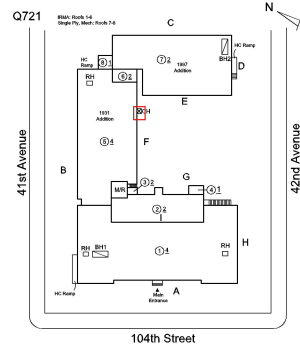
BRICK: MINOR CRACKS AND SPALLING

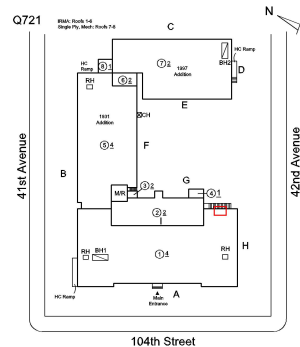
CAST STONE: CRACKED/BROKEN PIECES

REPLACE-IN-KIND

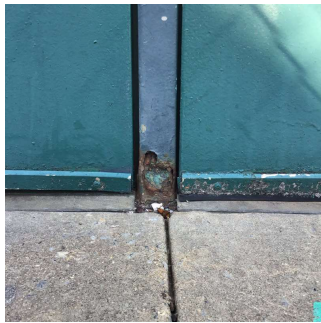
Violations	Facade B - Exit 6 No violations recorded.
Deficiency	METAL: DETERIORATED DOOR AND FRAME - MINOR DETERIORATION
Roof Plan reference

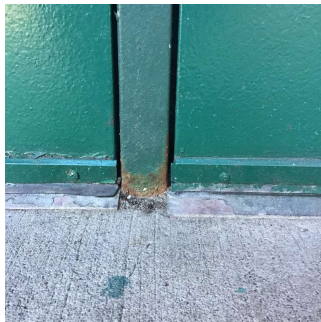
Violations	Facade B - Exit 5 No violations recorded.
DOOR HARDWARE	Inspected
Condition	2 - Between Good and Fair
Deficiency	No deficiencies recorded
LINTELS	Inspected
Condition	2 - Between Good and Fair
Deficiency	No deficiencies recorded
TRANSOM/SIDE LIGHT	Inspected
Condition	2 - Between Good and Fair
Deficiency	No deficiencies recorded

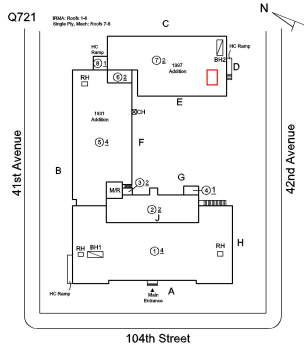
Roof 7
Instance Quantity	7,400
Instance Quantity Uom	S.F.
Does the roof have major mechanical equipment sitting on Dunnage Steel less than 18" above the Roofing?	No
Does this roof instance have a Sustainable Roof System?	No
Do solar panels exist on these roofs?	No
Is/Are the roof(s) suitable for Solar Panel installation?	No
Installation Year	1997
Source of Installation	Custodial Staff
Deficiency	SINGLE PLY, MECHANICALLY FASTENED ROOF: ROOFING: MAJOR ACTIVE ROOF LEAKS IN NON-INSTRUCTIONAL SPACE
Roof Plan reference

Deficiency Quantity	100
Quantity Uom	S.F.
Potential Action	REPLACE ROOFING WITHOUT MAJOR EQUIPMENT REMOVAL
Urgency of Action	PRIORITY 5
Purpose of Action	LEVEL 2

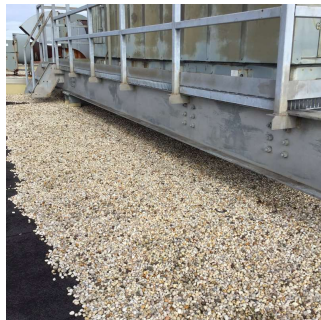
Violations	Roof 1 No violations recorded.
SKYLIGHT/ROOF VENT	Does not Exist
ROOF/GRAVITY TANK	Does not Exist
STAIRS/RAMPS: EXTERIOR	Inspected
BUILDING CHEEK/FLANK WALLS	Inspected

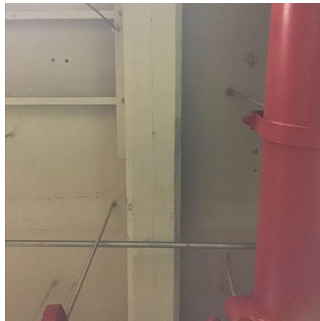
Violations	Sprinkler Valve Room No violations recorded.
Deficiency	STEEL COLUMNS/BEAMS: DETERIORATED/MISSING SPRAY-ON FIREPROOFING
Deficiency Location/Instance	Roof 5 - EMR, Basement - Chiller Room
Deficiency Quantity	20
Quantity Uom	S.F.
Potential Action	REPLACE
Urgency of Action	PRIORITY 4
Purpose of Action	LEVEL 5
Deficiency Photo1

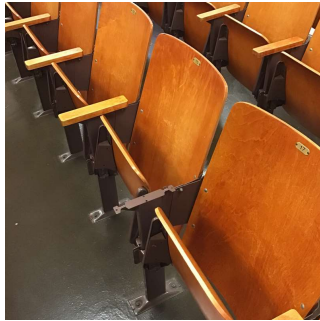
Seat G/17
Violations	No violations recorded.
Floor Finish	
Instance on 1st Floor (400 Seats)	Inspected
Condition	2 - Between Good and Fair
Deficiency	CONCRETE: CRACKS
Deficiency Location/Instance	Near Seats E/1, F/1, G/1, H/1, J/1 and others
Deficiency Quantity	60
Quantity Uom	S.F.
Potential Action	REPLACE
Urgency of Action	PRIORITY 3
Purpose of Action	LEVEL 2
Deficiency Photo1

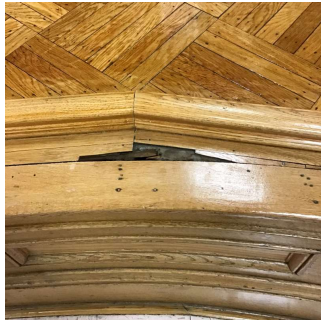
Right Side
Violations	No violations recorded.
Stage Curtain Rigging	Does not Exist
Instance on 1st Floor (400 Seats)	Does not Exist
Stage Curtains	Does not Exist
Instance on 1st Floor (400 Seats)	Does not Exist
Walls	
Instance on 1st Floor (400 Seats)	Inspected
Condition	2 - Between Good and Fair
Deficiency	PLASTER: CRACKS/SPALLING
Deficiency Location/Instance	Left Side of Stage

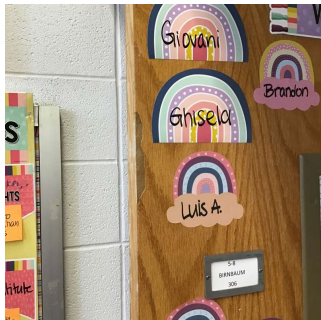
Room 306
Violations	No violations recorded.
Floor Finish	Inspected
Condition	2 - Between Good and Fair
Deficiency	VINYL TILES: DETERIORATED SUBSTRATE
Deficiency Location/Instance	Corridor near Rooms A211, A207, A202, 124, 117 and others
Deficiency Quantity	700
Quantity Uom	S.F.
Potential Action	REPLACE
Urgency of Action	PRIORITY 3
Purpose of Action	LEVEL 2

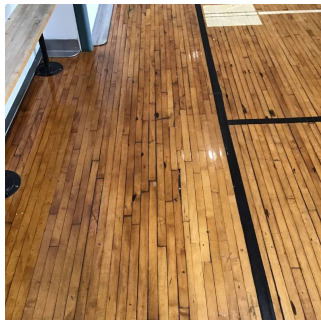
Violations	Left Side Near Windows No violations recorded.
Seating	
Instance on 4th Floor	Inspected
Condition	2 - Between Good and Fair
Deficiency	No deficiencies recorded

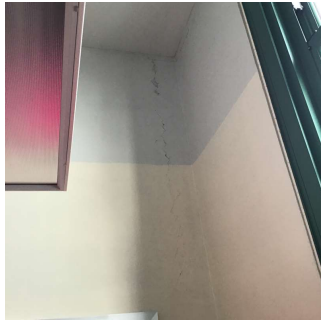
Violations	Office No violations recorded.
Window Curtains/Shades/Blinds	
Instance on 4th Floor	Does not Exist
INTERIOR DOOR HARDWARE	
Condition	Inspected
Deficiency	3 - Fair
Deficiency	No deficiencies recorded
INTERIOR GUARDS	
Condition	Inspected
Condition	2 - Between Good and Fair
Deficiency	DETERIORATED/TORN-OUT/MISSING
Deficiency Location/Instance	Stairs A/Bulkhead, B/2
Deficiency Quantity	40
Quantity Uom	S.F.
Potential Action	REPLACE
Urgency of Action	PRIORITY 3
Purpose of Action	LEVEL 2

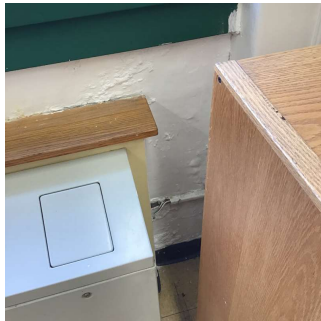
Violations	Near Windows No violations recorded.
LOCKER ROOM	Does not Exist
MULTI-PURPOSE ROOM	Does not Exist
SCIENCE DEMO ROOM	Does not Exist
SCIENCE LAB	Does not Exist
SCIENCE PREP ROOM	Does not Exist
SHOWER ROOM	Does not Exist
STAIRS/RAMPS: INTERIOR	Inspected
Do Letter Stair Signs Exist?	Yes
Ceiling	Inspected
Condition	2 - Between Good and Fair
Deficiency	PLASTER: CRACKS/SPALLING
Deficiency Location/Instance	Stairs B/Basement, C/3
Deficiency Quantity	40
Quantity Uom	S.F.
Potential Action	REPLACE
Urgency of Action	PRIORITY 3
Purpose of Action	LEVEL 2
Deficiency Photo1

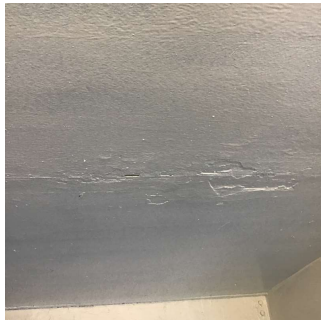
Violations	Stair C/3 No violations recorded.
Door(s)	Inspected
Condition	2 - Between Good and Fair
Deficiency	No deficiencies recorded
Partition	Inspected
Condition	2 - Between Good and Fair
Deficiency	No deficiencies recorded
Railings	Inspected

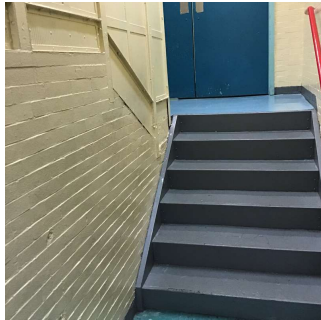
Question	Response
INTERIOR	
STAIRS/RAMPS: INTERIOR	
Railings	
Condition	3 - Fair
Deficiency	METAL: MISSING
Deficiency Location/Instance	Stair A/Basement
Deficiency Quantity	10
Quantity Uom	L.F.
Potential Action	REPLACE
Urgency of Action	PRIORITY 5
Purpose of Action	LEVEL 6
Deficiency Photo1

Stair A/Basement
Violations	No violations recorded.
Stairs and Landings	
Condition	Inspected
Condition	5 - Poor
Deficiency	CONCRETE: CRACKS/SPALLING - MAJOR
Deficiency Location/Instance	Stairs A/1, Bulkhead
Deficiency Quantity	50
Quantity Uom	S.F.
Potential Action	REPLACE
Urgency of Action	PRIORITY 3
Purpose of Action	LEVEL 2
Deficiency Photo1

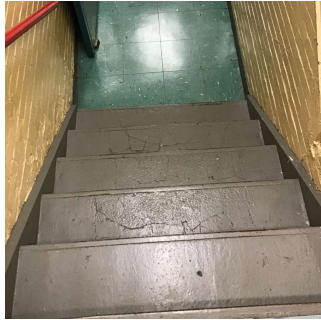
Stair A/Basement
Violations	No violations recorded.
Deficiency	STONE: WORN-OUT TREAD/NOSINGS
Deficiency Location/Instance	Stairs A/1 - 4, B/Basement - 3
Deficiency Quantity	450
Quantity Uom	S.F.
Potential Action	REPLACE
Urgency of Action	PRIORITY 3
Purpose of Action	LEVEL 2

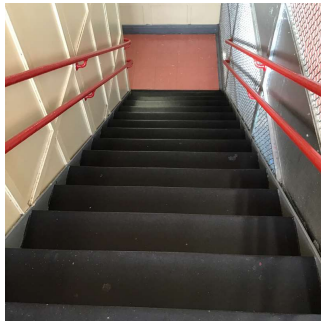
Violations	Stair B/2 No violations recorded.
Deficiency	VINYL TILES: BROKEN/DETERIORATED/MISSING TILES
Deficiency Location/Instance	Stairs A/2, B/1, C/1, I/1, 2 and others
Deficiency Quantity	80
Quantity Uom	S.F.
Potential Action	REPLACE
Urgency of Action	PRIORITY 3
Purpose of Action	LEVEL 2
Deficiency Photo1

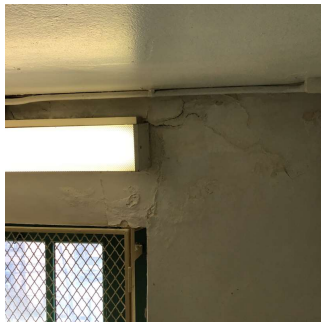
Violations	Stair B/2 No violations recorded.
Deficiency	PLASTER: CRACKS/SPALLING - ACTIVE LEAK
Deficiency Location/Instance	Stair B/2
Deficiency Quantity	20
Quantity Uom	S.F.
Potential Action	REPLACE
Urgency of Action	PRIORITY 5
Purpose of Action	LEVEL 2
Deficiency Photo1

Violations	Stair B/2 No violations recorded.
Deficiency	GYPSUM BOARD: DETERIORATED
Deficiency Location/Instance	Stair I/2, 1
Deficiency Quantity	40
Quantity Uom	S.F.
Potential Action	REPLACE
Urgency of Action	PRIORITY 3
Purpose of Action	LEVEL 2

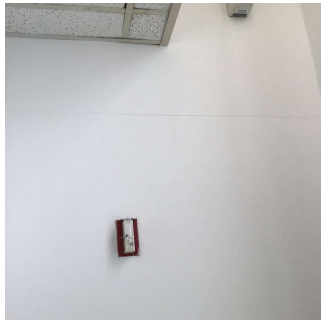
Violations	Room 116A No violations recorded.
Deficiency	PLASTER: CRACKS/SPALLING
Deficiency Location/Instance	Room 116A
Deficiency Quantity	20
Quantity Uom	S.F.
Potential Action	REPLACE
Urgency of Action	PRIORITY 3
Purpose of Action	LEVEL 2
