NYC Department of Education
Building Condition Assessment Survey 2023-2024

Architectural Inspection

Asset: I.S. 2 - STATEN ISLAND, 333 MIDLAND AVENUE, STATEN ISLAND, NY, 10306

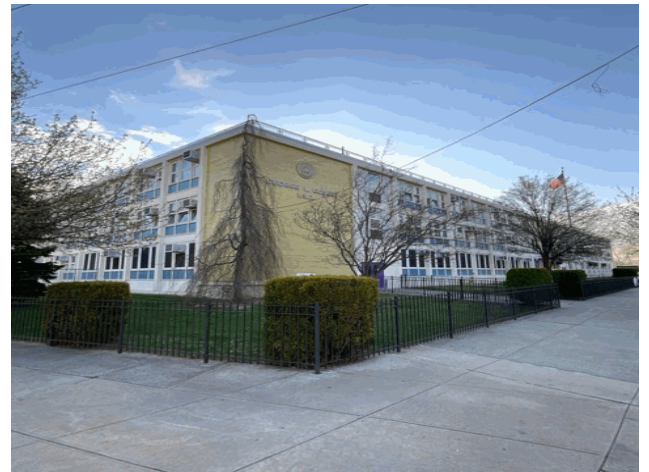
Corner of Midland Avenue and Boundary Avenue - East View

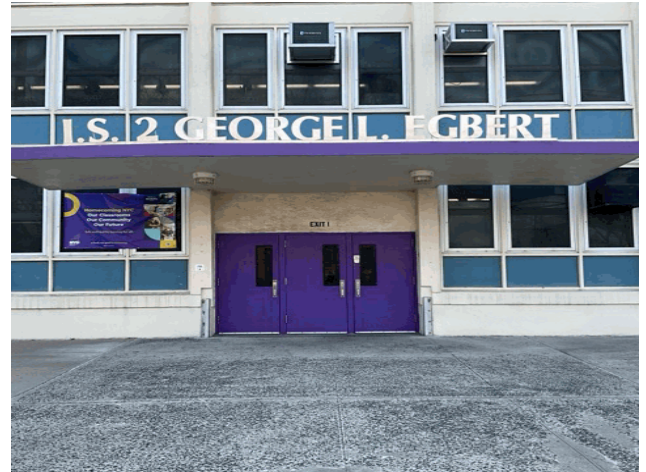
Facade A - Midland Avenue

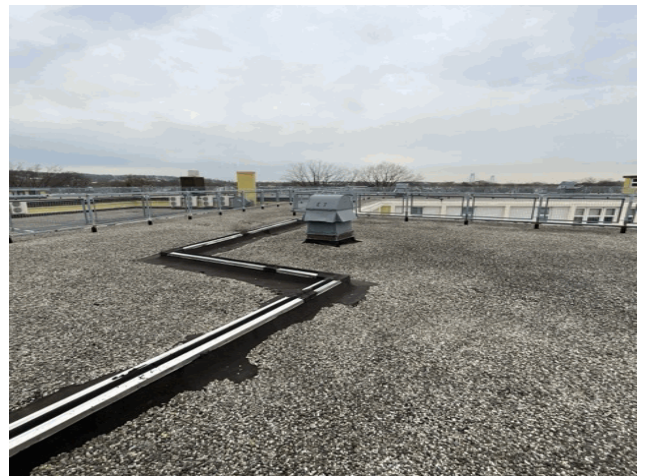
Roof 1 - North View
