**NYC Department of Education**  
**Building Condition Assessment Survey 2023-2024**

**Architectural Inspection**

**Asset:** P.S. 396 - BRONX, 1930 ANDREWS AVENUE, BRONX, NY, 10453

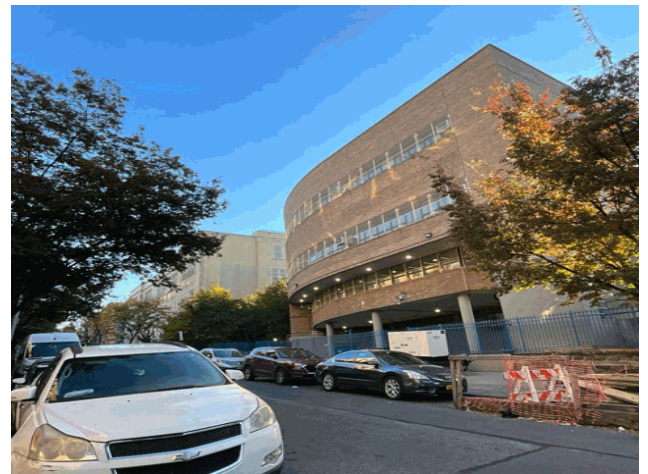
Corner of Andrew's Avenue South and West Burnside Avenue  
Northeast View

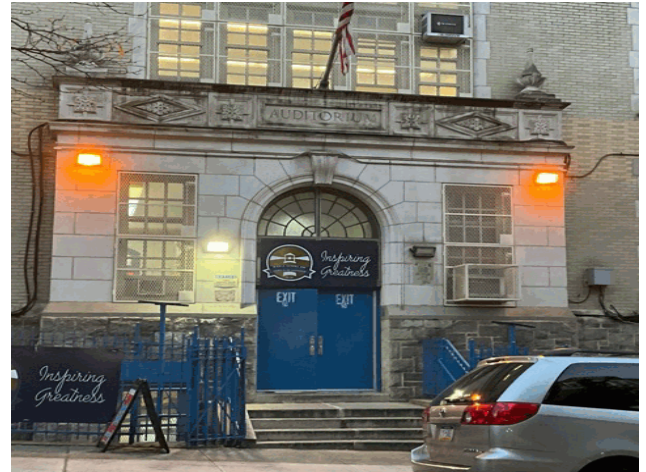
Facade A - Andrew's Avenue South

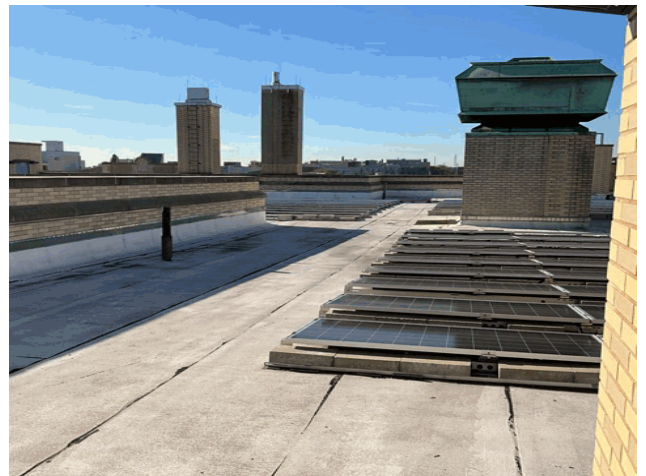
Roof 3 - Southeast View
