NYC Department of Education
Building Condition Assessment Survey 2023-2024

Architectural Inspection

Asset: P.S. 108 - BRONX, 1166 NEILL AVENUE, BRONX, NY, 10461

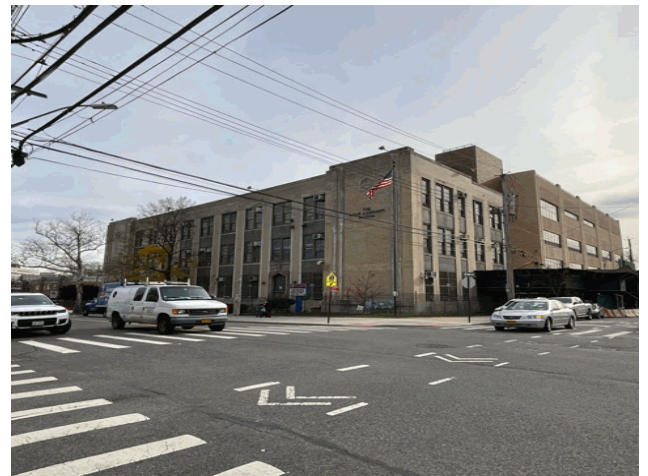
Corner of Neill Avenue and Yates Avenue - Southeast View

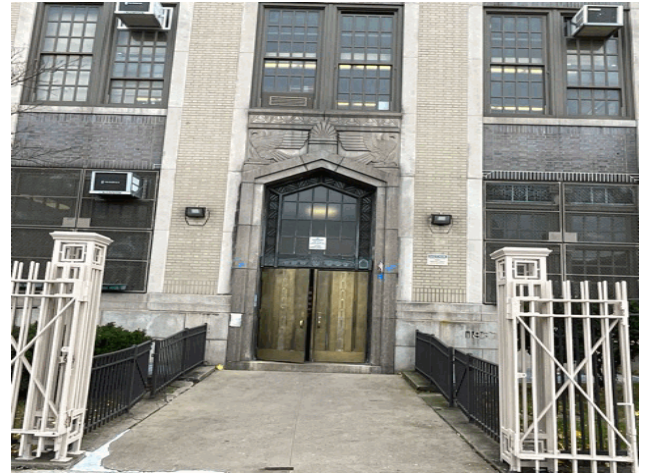
Facade A - Neill Avenue

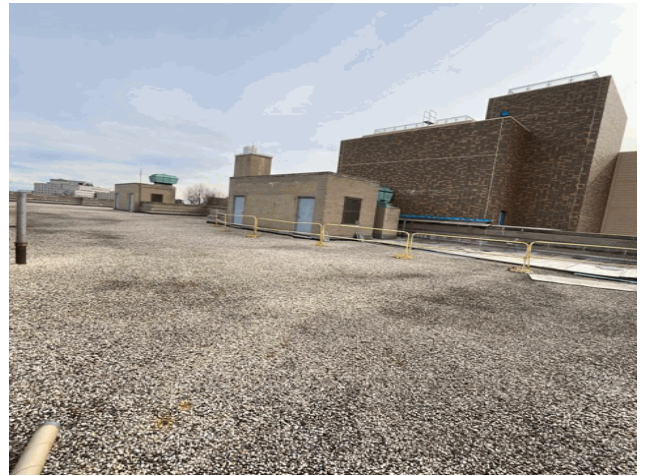
Roof 1 - Northeast View
