**NIST NCSTAR 1-5A
Federal Building and Fire Safety Investigation of
the World Trade Center Disaster**

**Visual Evidence, Damage Estimates,
And Timeline Analysis**

Visual Evidence, Damage Estimates, and Timeline Analysis

September 2005

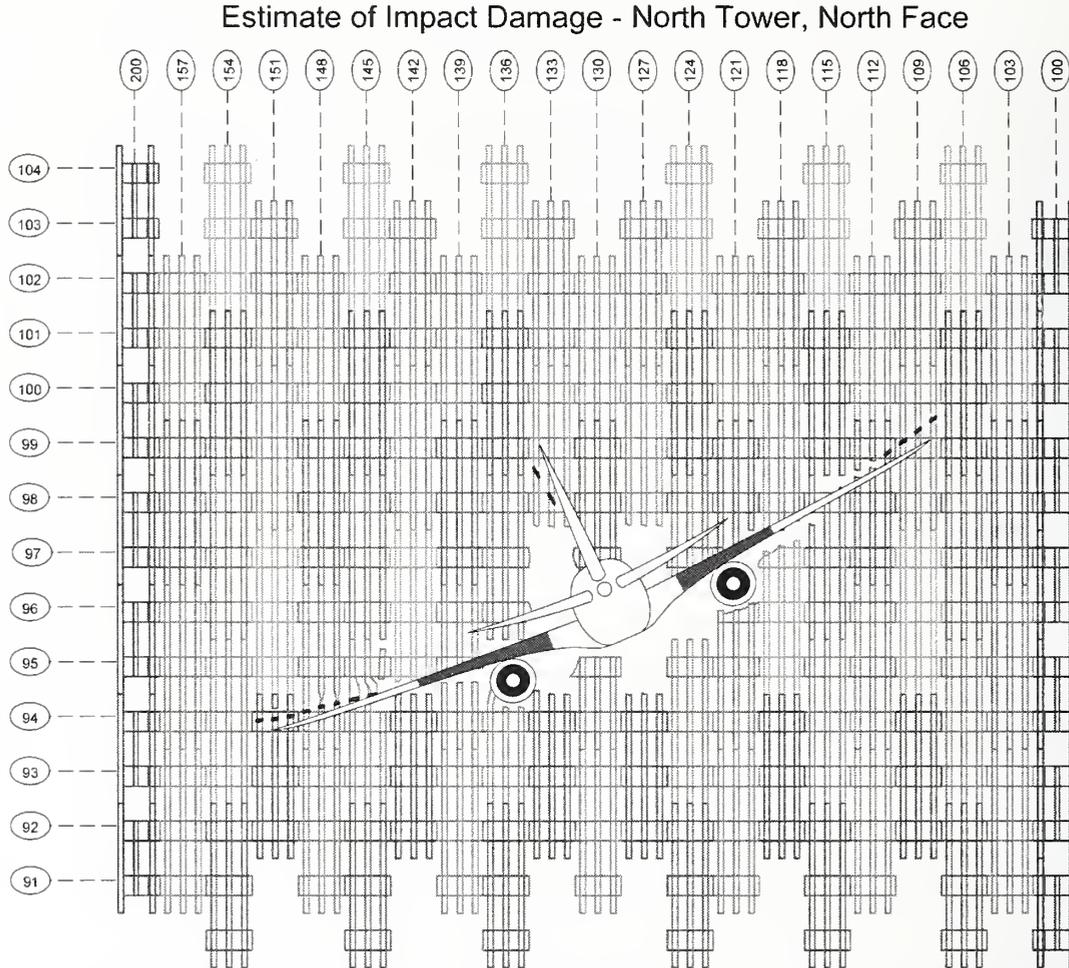
Close-up photographs and videos showing the area of the aircraft impact on the north face were used to generate the damage diagram shown in Figure E-1. Images show that substantial areas of the concrete floor slabs for the 95th through 97th floors were destroyed to an unknown depth within the tower in the immediate vicinity of the aircraft impact area. Locations where the two wing tips and the aircraft's vertical stabilizer struck the façade are represented by dashed lines in Figure E-1. The locations of the wing marks indicate that the aircraft struck between the 93rd and 99th floors. A properly scaled outline of a Boeing 767-200ER is superimposed on the damage diagram. The position of the aircraft has been adjusted to provide good agreement with the observed damage pattern and the wing and vertical stabilizer marks. The drawing indicates that the nose of the aircraft struck close to the center of the face near columns 129 and 130 at a height that was near the concrete floor slab for the 96th floor.

Figure E-1. A scaled outline of a Boeing 767-200ER is superimposed on the damage diagram for the north face of WTC 1. The position of the aircraft has been adjusted to best match the damage pattern and marks showing where the wing tips and vertical stabilizer struck. The red areas correspond to the approximate locations of fuel on the aircraft based on an analysis reported elsewhere (NIST NCSTAR 1-2B).

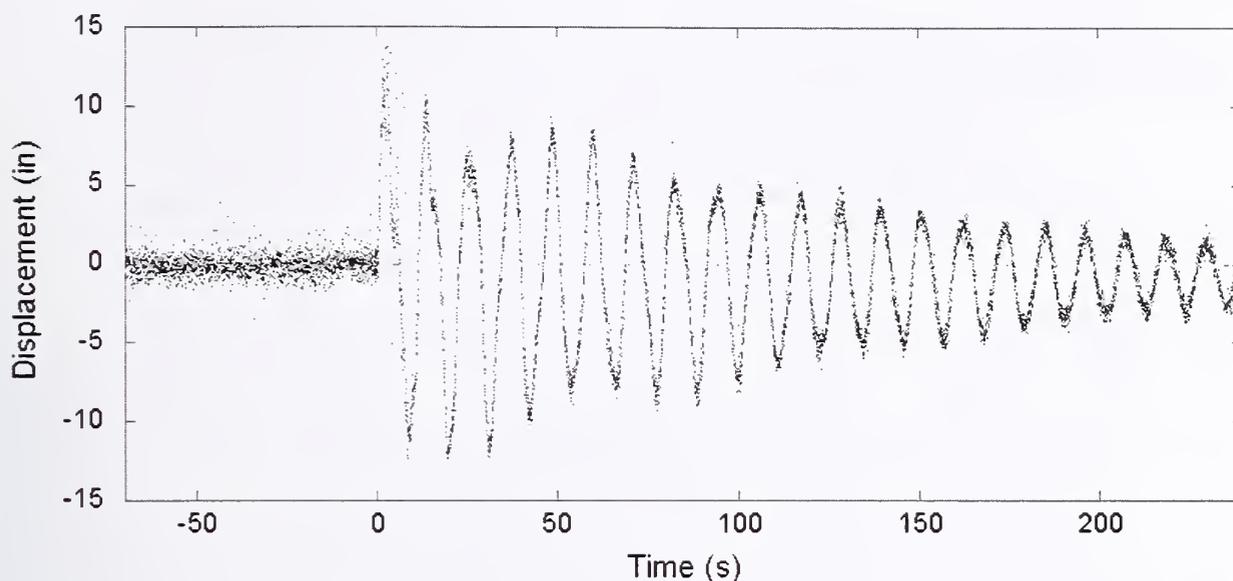
Close examination of this video revealed a perceptible north-south movement of WTC 2 after it was struck by the aircraft. Image analysis of the video allowed the movement of the tower at the 70th floor to be determined as shown in Figure E-2. The maximum deflection was determined to be 12 in. \pm 1 in. at this height, which extrapolates to a value of 22 in. \pm 5 in. at the roofline. The primary period for the motion was 11.4 s \pm 0.1 s, consistent with the fundamental natural mode of the building. Similar measurements using a brief video shot from the north yielded an amplitude near the roof line of 6 in. \pm 1 in. for the east-west direction with a period of 5.3 s \pm 0.1 s. This period and motion are consistent with the first torsional (twisting) mode of the tower.

Figure E-2. The displacement of the first (left-most) window line on the 70th floor of WTC 2 determined using moiré analysis is shown as a function of time.

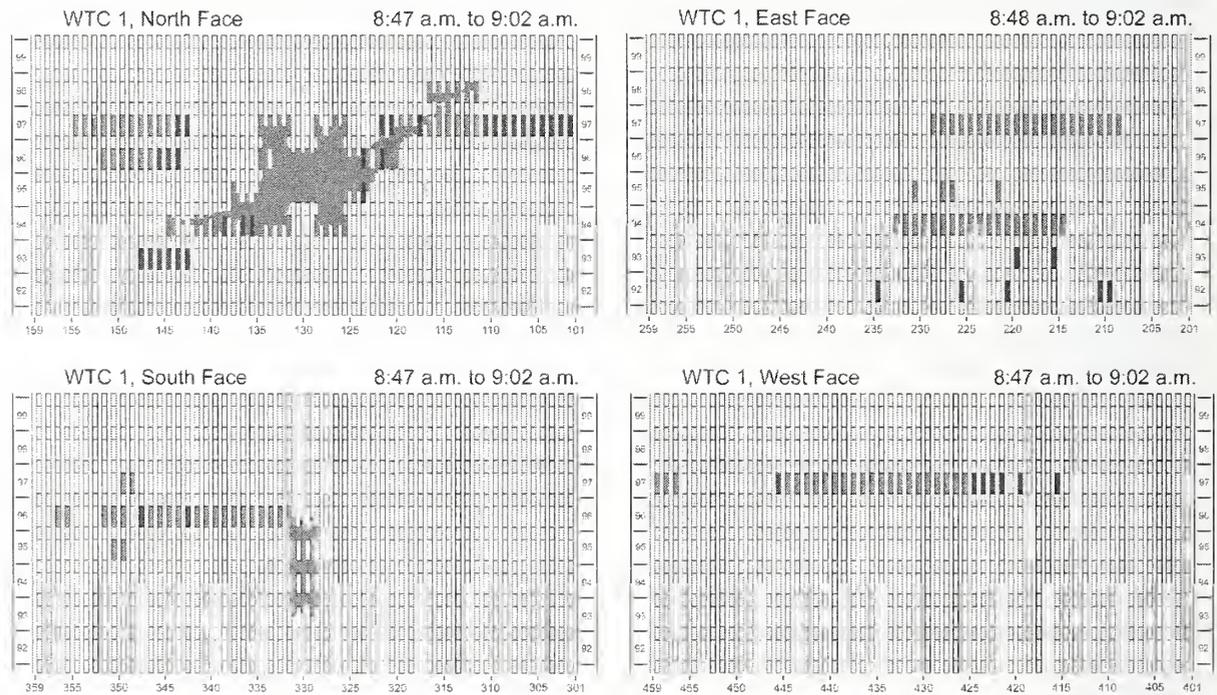
Fire observations for the period are summarized by the façade maps in Figure E-4, which show fire locations integrated over the period. The color coding indicates the highest fire intensity recorded during the period, with yellow representing a spot fire, red a more extensive fire burning inside the tower, and orange a fire with flames extending out of the window.

Figure E-4. Maps of integrated fire observations between 8:47 a.m. and 9:03 a.m. are shown for the four faces of WTC 1.

The most extensive fire growth took place on the 97th floor. The apparent rapid development of these fires, particularly on the west face, may be an indication that the fire growth and spread was accelerated by the presence of initially unburned aviation fuel that may have been dispersed over this floor during the aircraft impact.

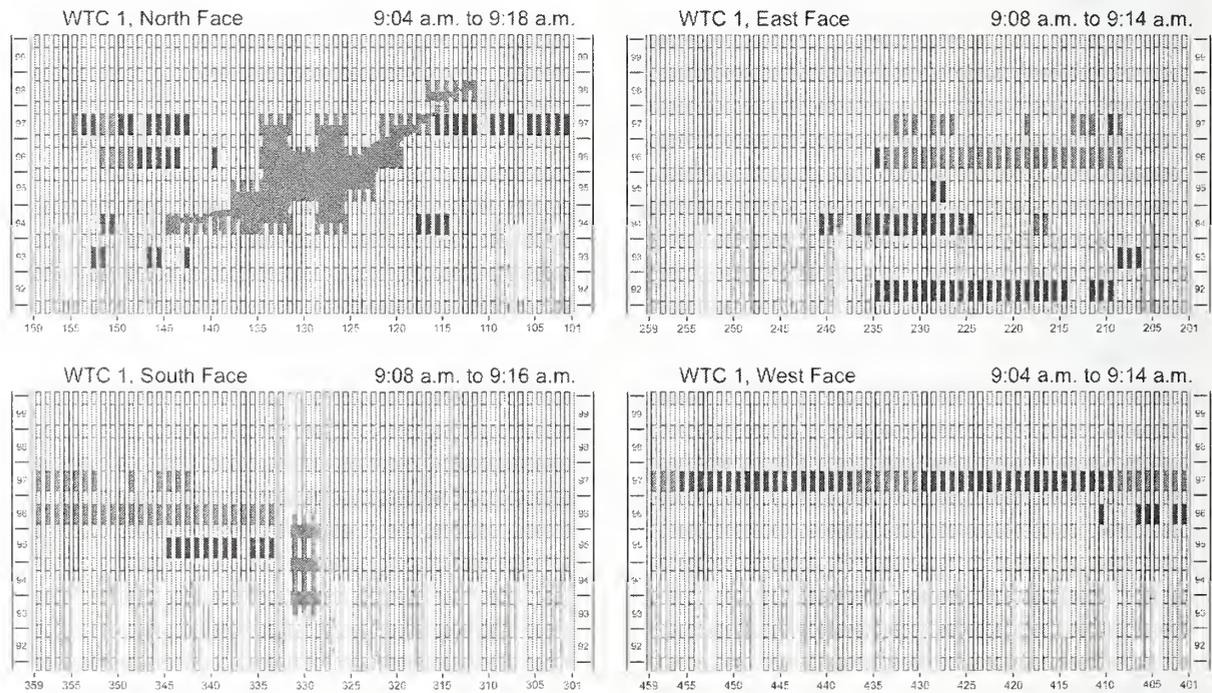
Figure E-5 shows integrated fire maps for the four faces of WTC 1 covering the period. Comparison with Figure E-4 reveals the changes in fire distributions between the two time periods. The most prominent feature in Figure E-5 is the extent of the fires on the 97th floor, with flames visible in a nearly continuous band running clockwise from just west of the center of the south face, along the western and northern faces, and reaching just past the center of the east face. Another feature which stands out is the general lack of visible fire in the southwest quadrant of the tower.

Figure E-5. Maps of integrated fire observations between 9:03 a.m. and 9:18 a.m. are shown for the four faces of WTC 1.

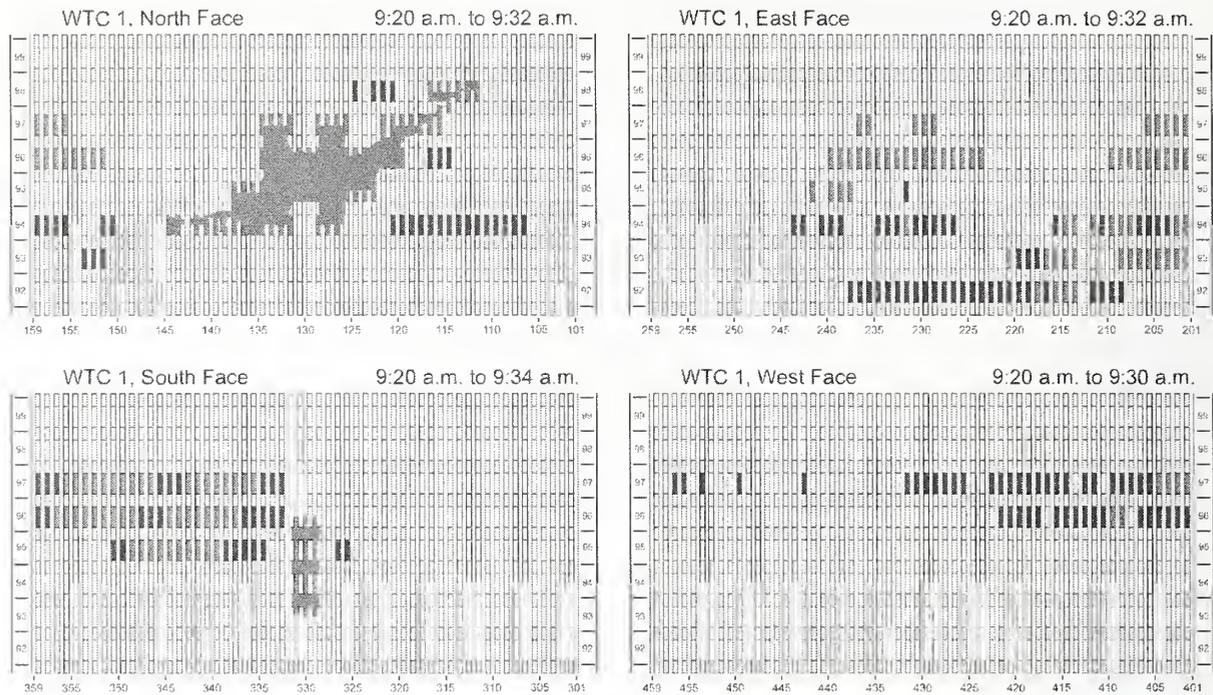
Integrated façade maps for the fires observed during the period are shown in Figure E-6. In general, fire spread during this period was reduced compared to the first two periods. While intensely burning fires with extended flames developed in northeast corner rooms on several floors, most of the new fire growth involved less intense flames that did not extend from windows. Such fires included those on the west side of the 94th floor and the central section of the 98th floor on the north face and the south side of the 96th floor on the west face.

Figure E-6. Maps of integrated fire observations between 9:19 a.m. and 9:35 a.m. are shown for the four faces of WTC 1.

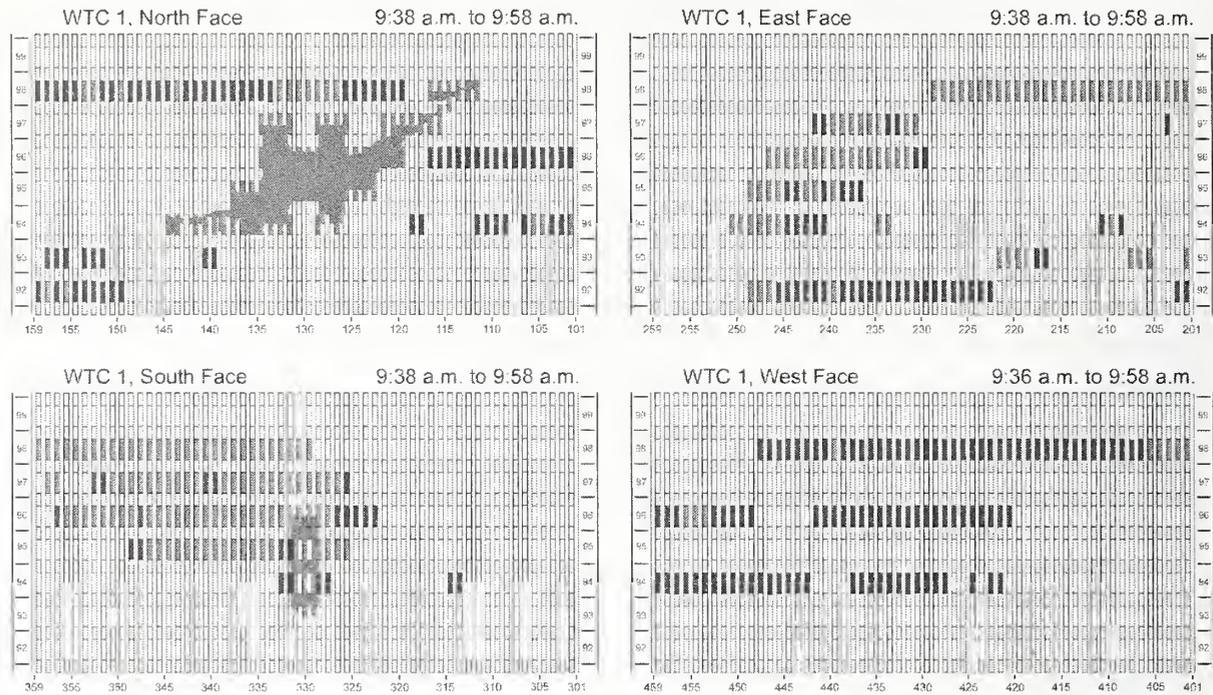
Figure E-7. Maps of integrated fire observations between 9:36 a.m. and 9:59 a.m. are shown for the four faces of WTC 1.

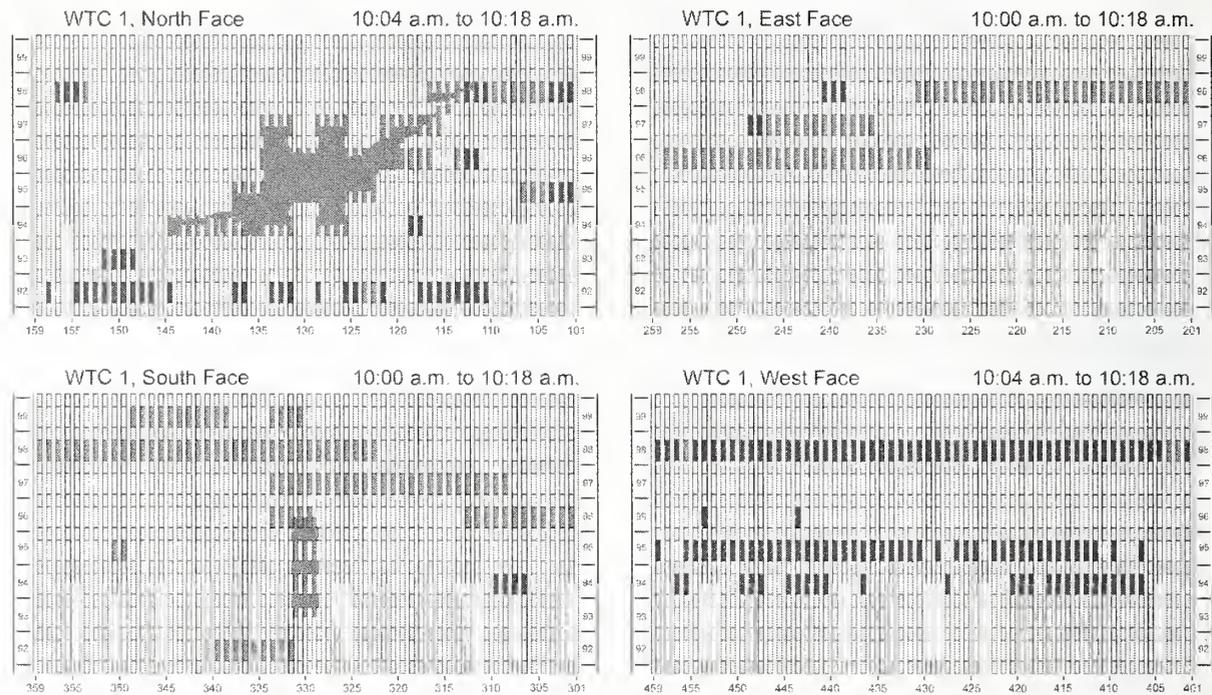
Integrated fire maps of the four faces for the period are included in Figure E-8. These maps likely underestimate the actual extent of the fires due to the limited visibility on the east and south faces. The extensive fires on the 98th floor are a dominant feature. Keep in mind that the much of the fire on the north side of this floor had already died down. The intense fires that developed rapidly along the periphery of the southeast quadrant also stand out. The broad extent of the low intensity fires on the west

sides of the 94th and 95th floors is also evident. Note that the intense fire that grew on the south side of the west face of the 104th floor is not displayed in the façade map.

Figure E-8. Maps of integrated fire observations between 10:00 a.m. and 10:18 a.m. are shown for the four faces of WTC 1.

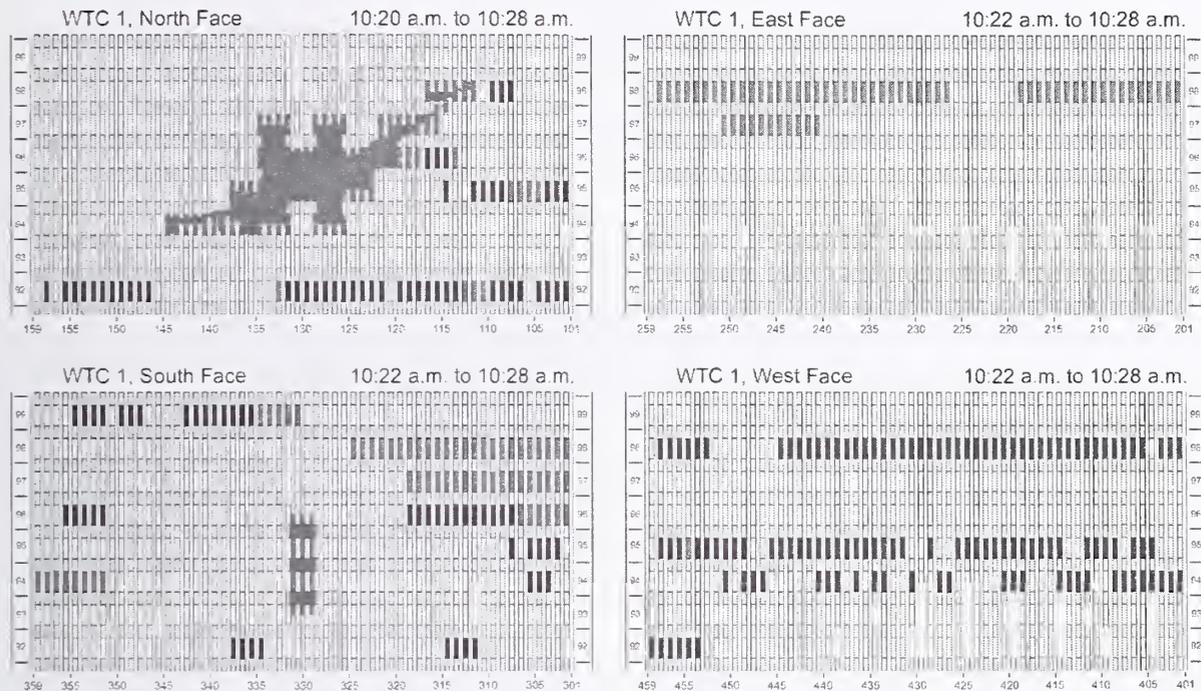
The integrated fire data for the period are shown in Figure E–10. A notable feature is the widespread presence of intense fire in the southeast quadrant of the tower following a long period when the area seemed to be isolated from fires burning elsewhere.

Figure E–10. Maps of integrated fire observations between 10:20 a.m. and 10:28 a.m. are shown for the four faces of WTC 1.

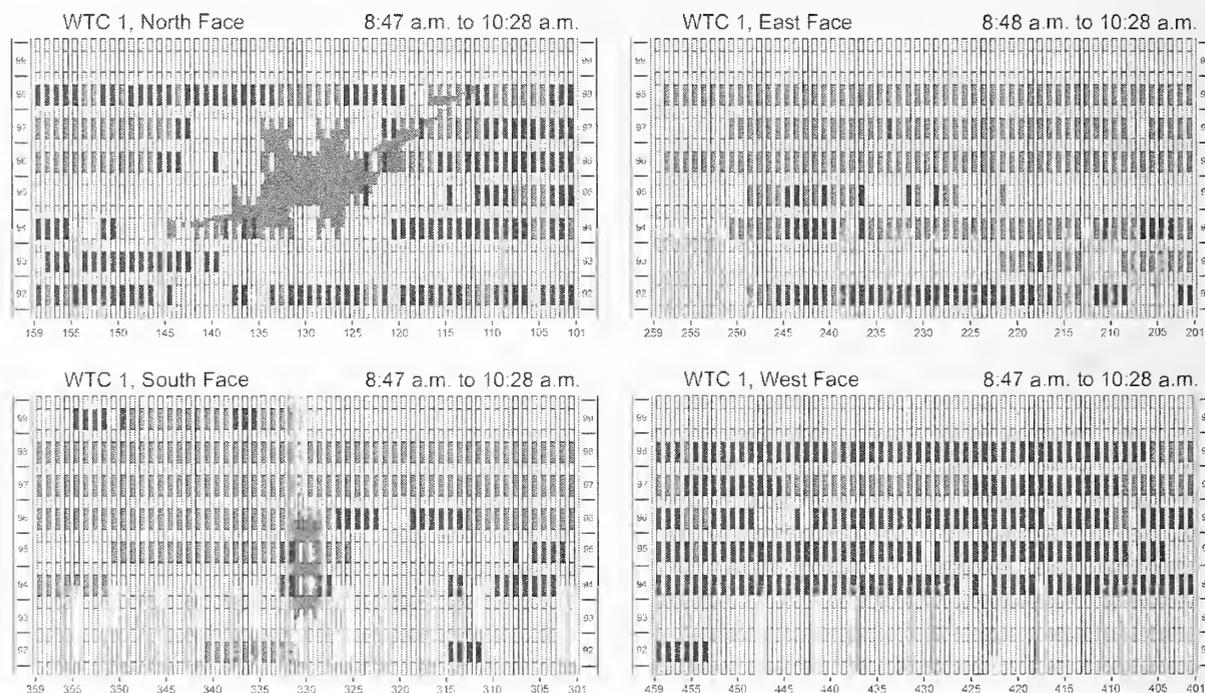
An interesting aspect of the fire behavior in WTC 1 was the variation in burning behavior observed on the different faces. Fires at most locations on the west and north faces of the towers burned without flame extension or release of large amounts of smoke from nearby windows. In many cases the fires appeared to burn as relatively low intensity distributed flames. The preponderance of red in the north and west face maps in Figure E-11 reflects this type of burning. In contrast, the fires burning on the east and south faces

most often generated external flames and heavy smoke flows at nearby windows as indicated by the extensive areas of orange on the façade fire maps. Various explanations for the different burning behaviors were considered. The most plausible is the effect of the prevailing wind. On September 11, the wind was striking WTC 1 from the northwest and then flowing down the north and west faces. This wind created positive pressures at the windows on these faces that tended to resist gas flows out of the tower. On the east and south faces the effect of the wind was the opposite, creating low pressure areas at the windows that tended to draw gases out of the building. The net effect of these pressure forces was a tendency for gases to flow internally on a floor, if a pathway was available, from the west and north faces to the east and south faces.

Figure E-11. Maps of integrated fire observations between 8:47 a.m. and 10:28 a.m. are shown for the four faces of WTC 1.

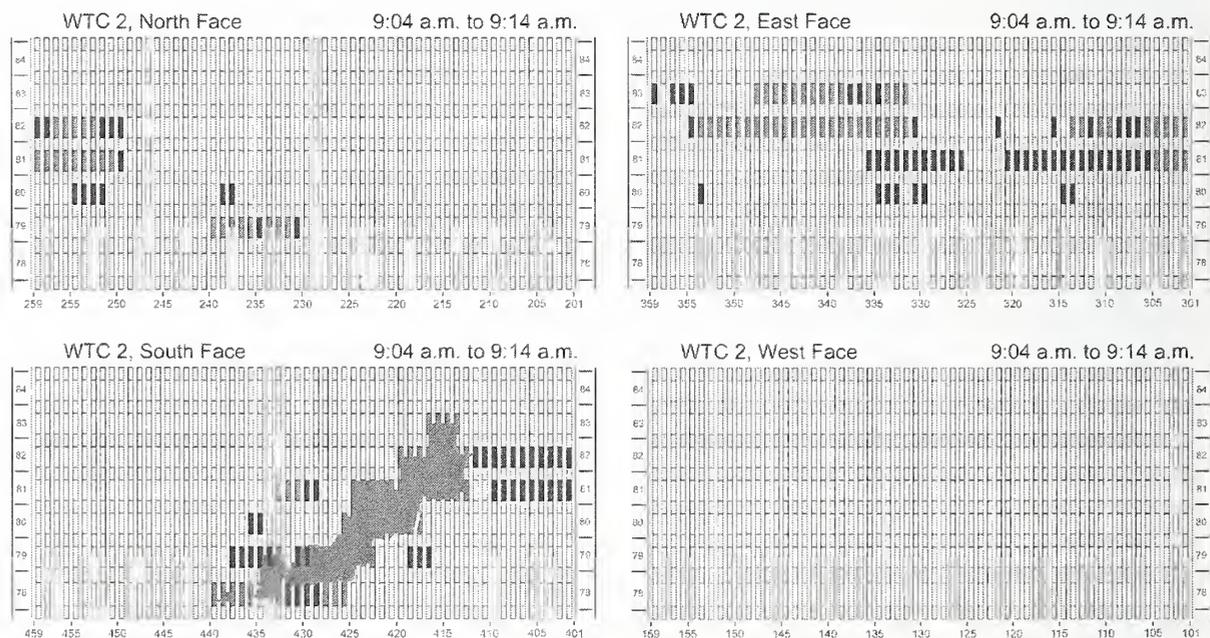
The fire data sheets for the period were integrated as a means for summarizing the fire distributions. The results are shown in Figure E-12. From these maps it is clear that the major visible fires were burning on the east and north faces of the tower. The most intense fires were on the 81st through 83rd floors, i.e., the upper portion of the floors impacted by the aircraft.

Figure E-12. Maps of integrated fire observations between 9:04 a.m. and 9:14 a.m. are shown for the four faces of WTC 2.

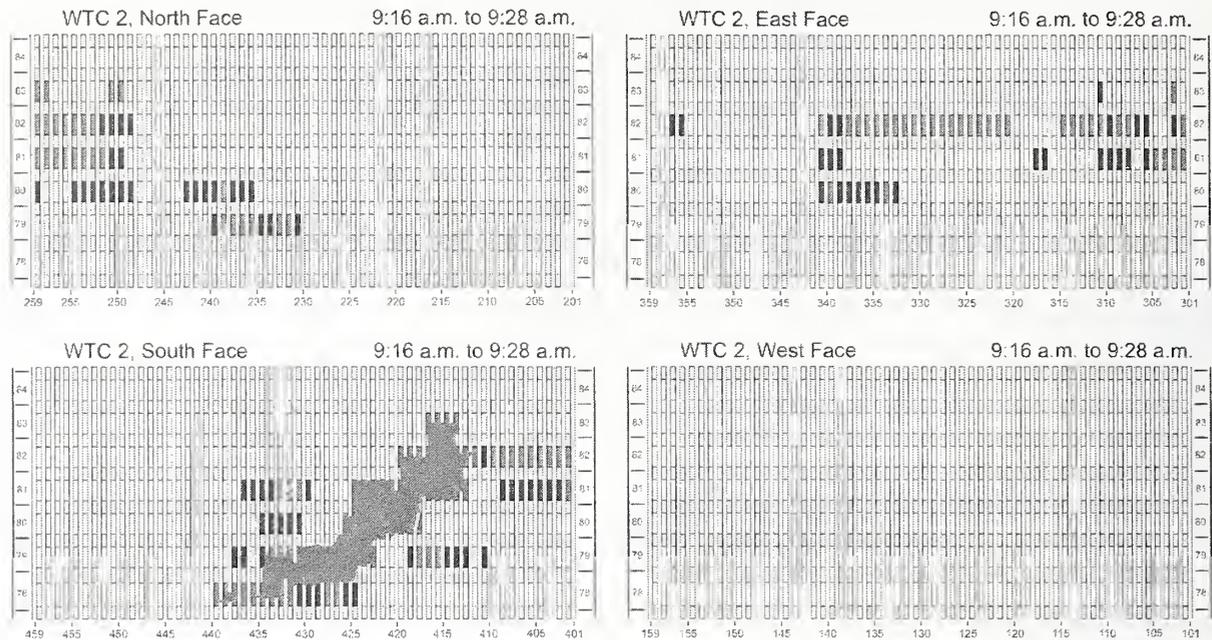
Maps of integrated fire intensities over the period for the four faces are shown in Figure E-13. Comparison with Figure E-12 confirms that minimal fire spread was taking place during the period. The fire distributions on the east face for the two periods appear quite different due to the rapid changes in the fires observed near the beginning of the first period and the continued northward spread of the fire on the 81st floor, which initially developed on the south side of the face, while going through a cycle of growth, intense burning, and decay. As during the initial time period, the largest fires were in the northeast corners of the tower on the 81st and 82nd floors and near the center of the north face on the 79th and 80th floors. These fires had been burning since the aircraft impact and were slowly dying down.

Figure E-13. Maps of integrated fire observations between 9:15 a.m. and 9:29 a.m. are shown for the four faces of WTC 2.

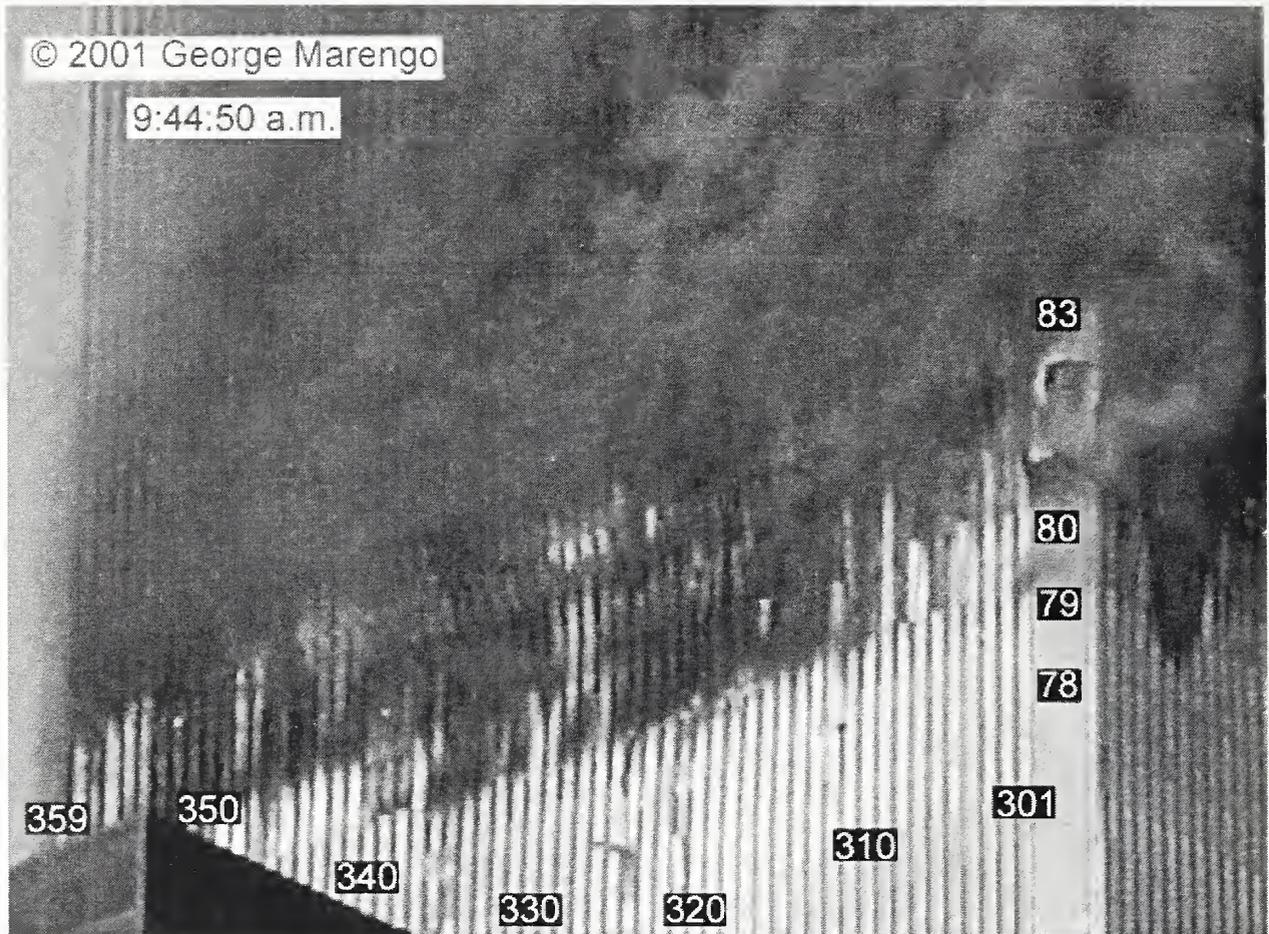
Figure E-14. This cropped photograph was shot from the northeast and shows the east face of WTC 2 at 9:44:50 a.m. The original intensity levels have been adjusted, and column and floor numbers have been added.

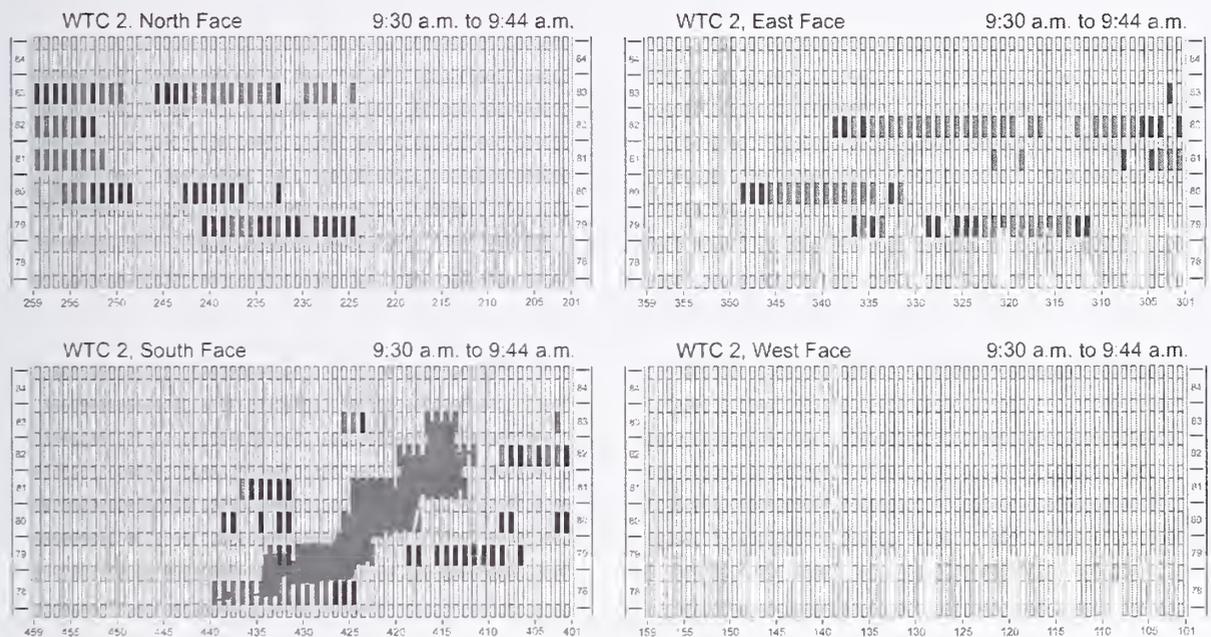
Figure E-15 shows integrated fire maps for the period. The new areas of fire that appeared on the 79th and 83rd floors of the north face are evident. Extensive new areas of fire were also present on the 79th and 80th floors of the east face. It should be remembered that a fraction of the observed fire indicated on the maps for these floors was associated with the three roughly one-minute-duration periods during which heavy smoke flows and fires were present.

Figure E-15. Maps of integrated fire observations between 9:30 a.m. and 9:45 a.m. are shown for the four faces of WTC 2.

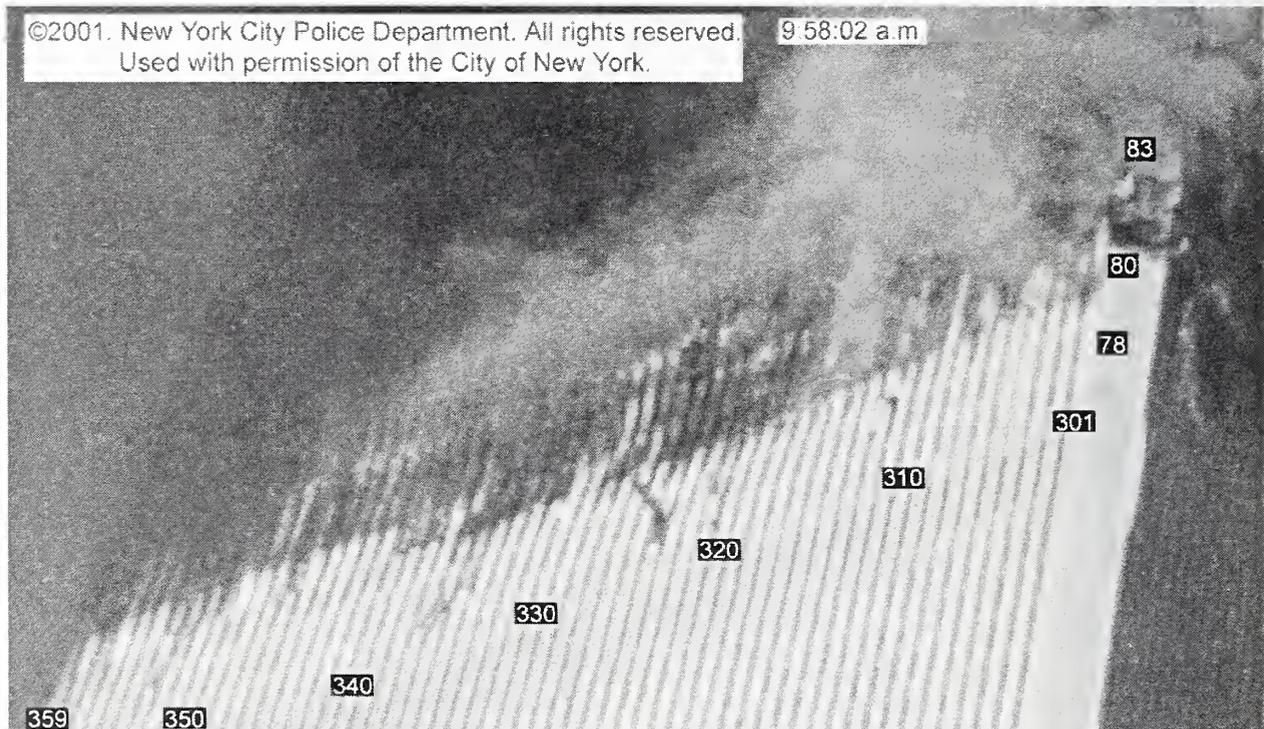
through windows on the 82nd floor changed again, with the northernmost window where the object could first be seen located slightly to the north. A prominent feature on the east face during the period was the inward bowing of the outer wall. This can be seen clearly over the 79th to 82nd floors in Figure E-16, which was taken less than a minute before the collapse started. During the 20 s prior to the collapse, a large number of pieces of debris fell from the northern sides of the 80th and 81st floors. The falling debris coincided with a heavy flow of molten metal from the north face. When WTC 2 collapsed, very little flame was expelled from the east face windows. Based on observations elsewhere on the two towers, regions of intense burning would have been expected to generate short-lived jets of flames. Their absence suggests that large fires were not burning near the east face at the time of collapse.

Figure E-16. This cropped image shows the east face of WTC 2 at 9:58:02 a.m. The intensity levels have been adjusted, and column and floor numbers have been added.

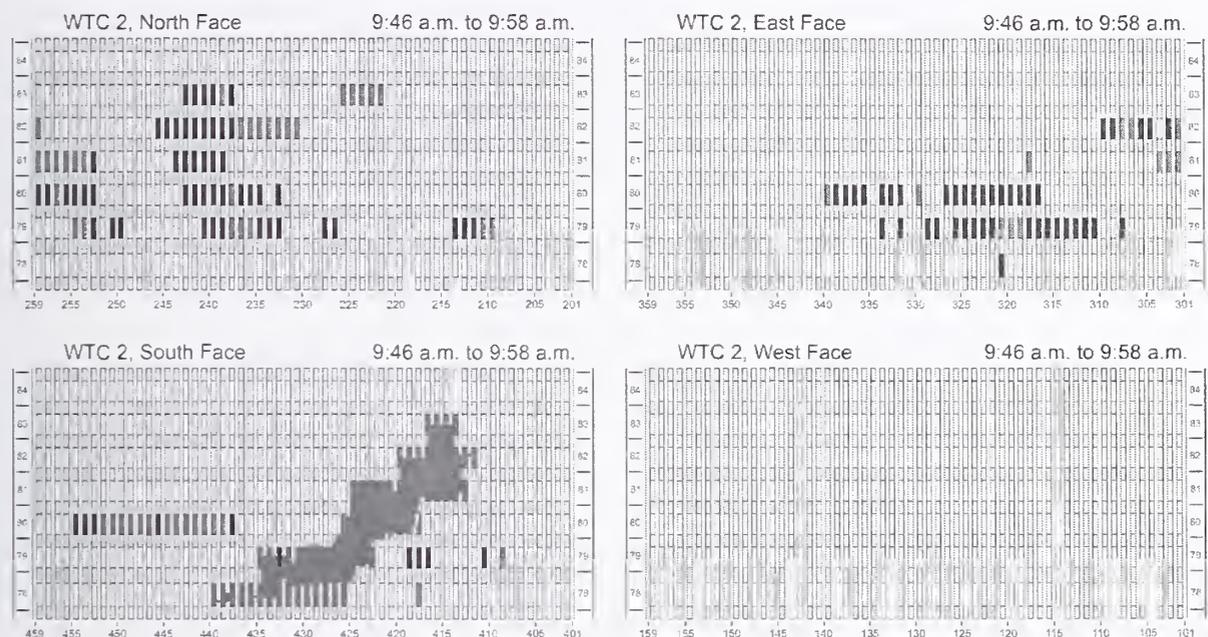
Façade maps of integrated fire intensities for the period are shown in Figure E-17. Many of the fires present during earlier periods were either no longer visible or were dying down during the final interval prior to the tower collapse. Some fire spread to the west had taken place on several floors on the north face. Areas with substantial fires included those on the north sides of the east face on the 79th and 80th floors (recall that the observed fires are combinations of sustained fires and short-lived flame releases) and the intense fire that grew on the west side of the south face on the 80th floor.

Figure E-17. Maps of integrated fire observations between 9:45 a.m. and 9:59 a.m. are shown for the four faces of WTC 2.

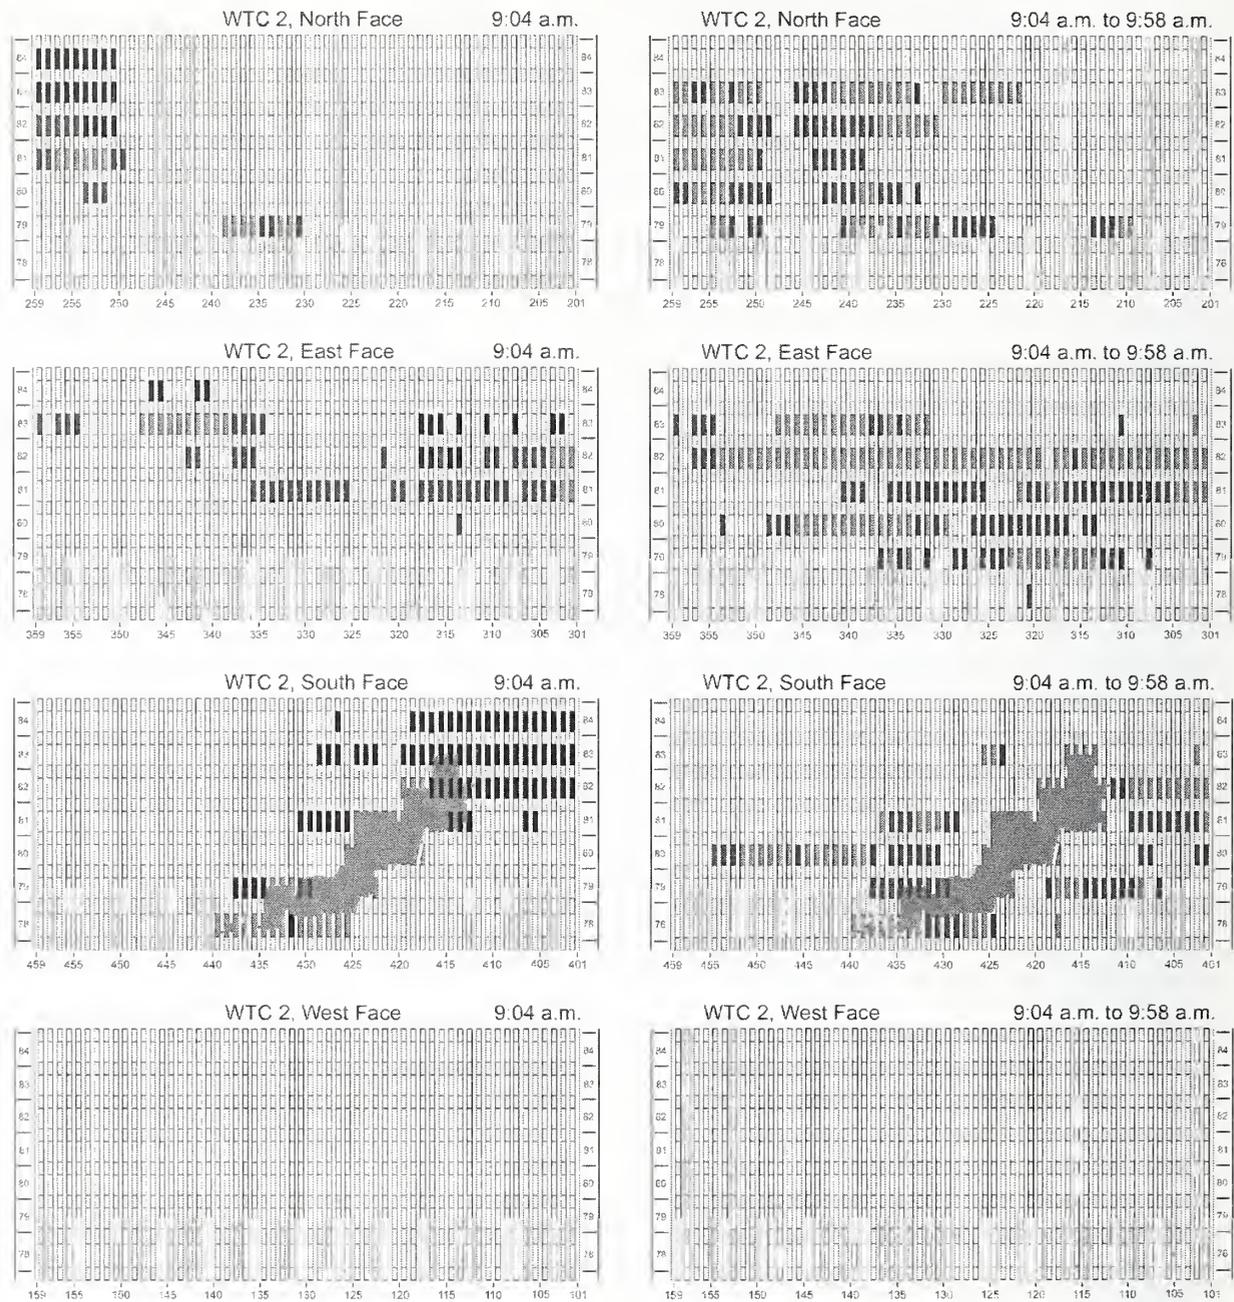
Compared to WTC 1, there was less observed fire spread in WTC 2, even when the difference in available time (102 min for WTC 1 and 56 min for WTC 2) is taken into account. Figure E-18 compares WTC 2 integrated façade maps of fire observations for the entire 56 min period with fire distributions present shortly after the aircraft impact. Primary areas of fire growth and spread include the east side of the 83rd floor and locations to the west of the cold spot on several additional floors of the north face, much of the 81st floor and extensive areas toward the centers of the 79th and 80th floors on the east face, and areas on either side of the aircraft impact cavity on the south face, particularly to the west side of the 80th floor and to the east on the 81st and 82nd floors. The absence of visible fire indicates that substantial fires did not reach the west face of the tower during the available time.

Figure E-18. Maps of observed fire distributions on the four faces of WTC 2 shortly after the aircraft impact (near 9:04 a.m.) are compared with the corresponding integrated fire observations for the entire period between 9:03 a.m. and 9:59 a.m. Blue represents windows where observations were not possible.

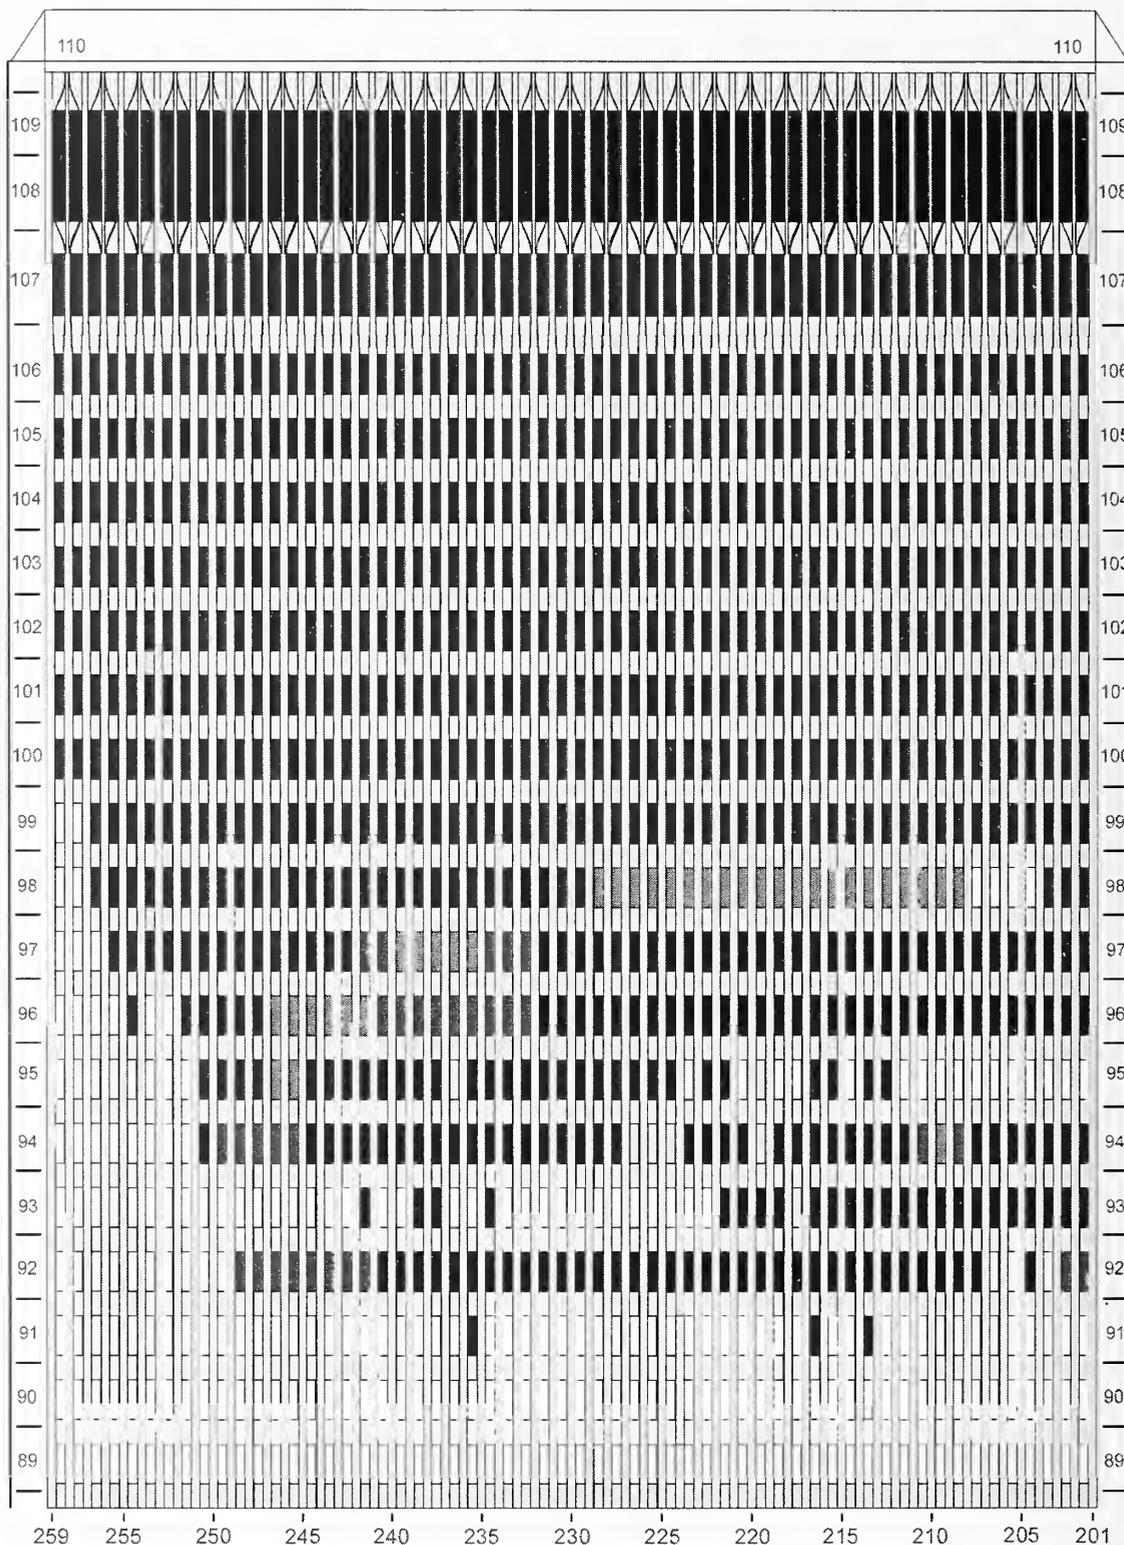
Color coding has been used to map the data included in the data sheets onto the façade. Figure 5–1 includes the key used for mapping the different types of data. Figure 5–6 shows an example of a map that combines datasheet results for windows and fires. Individual windows are coded such that if a fire is present or if a value cannot be assigned its color code is displayed. Otherwise, the window code is displayed. For the vast majority of time, this is equivalent to displaying the window data since fires were typically observed only when the window glass had been removed. Very seldom was fire observed through window glass that was still in place.

Figure 5-6. An example of a façade drawing combining data for window condition and fires is shown. The data is for the east face of WTC 1 around 9:50 a.m.

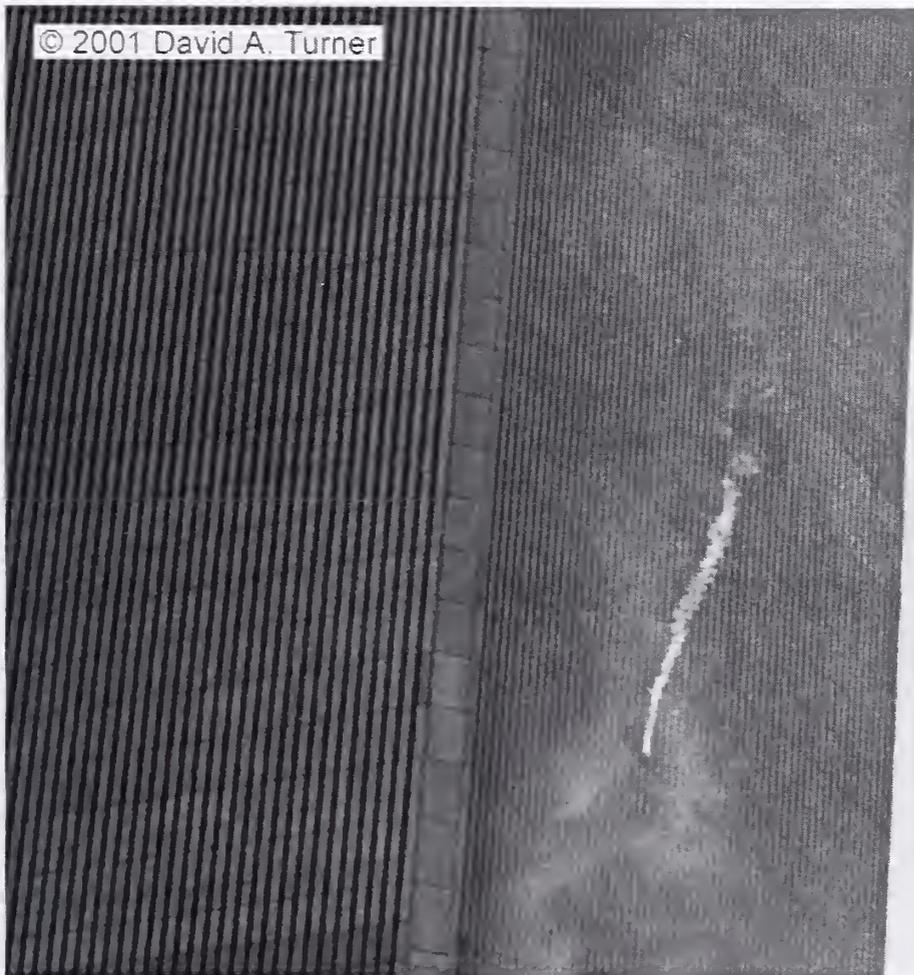
During the review of visual material, two additional behaviors were identified that seemed to correlate with the local fire intensity at the periphery of the buildings. One of these was the frequent release of “streamers” during periods of active burning. Figure 5–7 shows three streamers that fell nearly simultaneously from the south face of WTC 1. The exact time of this photograph is not known. As is clear from the photograph, when the lighting was correct, the streamers could be observed from long distances.

Figure 5-7. This cropped and enhanced photograph shows the west and south faces of WTC 1. An intense streamer is falling near the south face of the tower, and two additional streamers have already fallen through the image to the south. The exact time of this photograph is unknown.

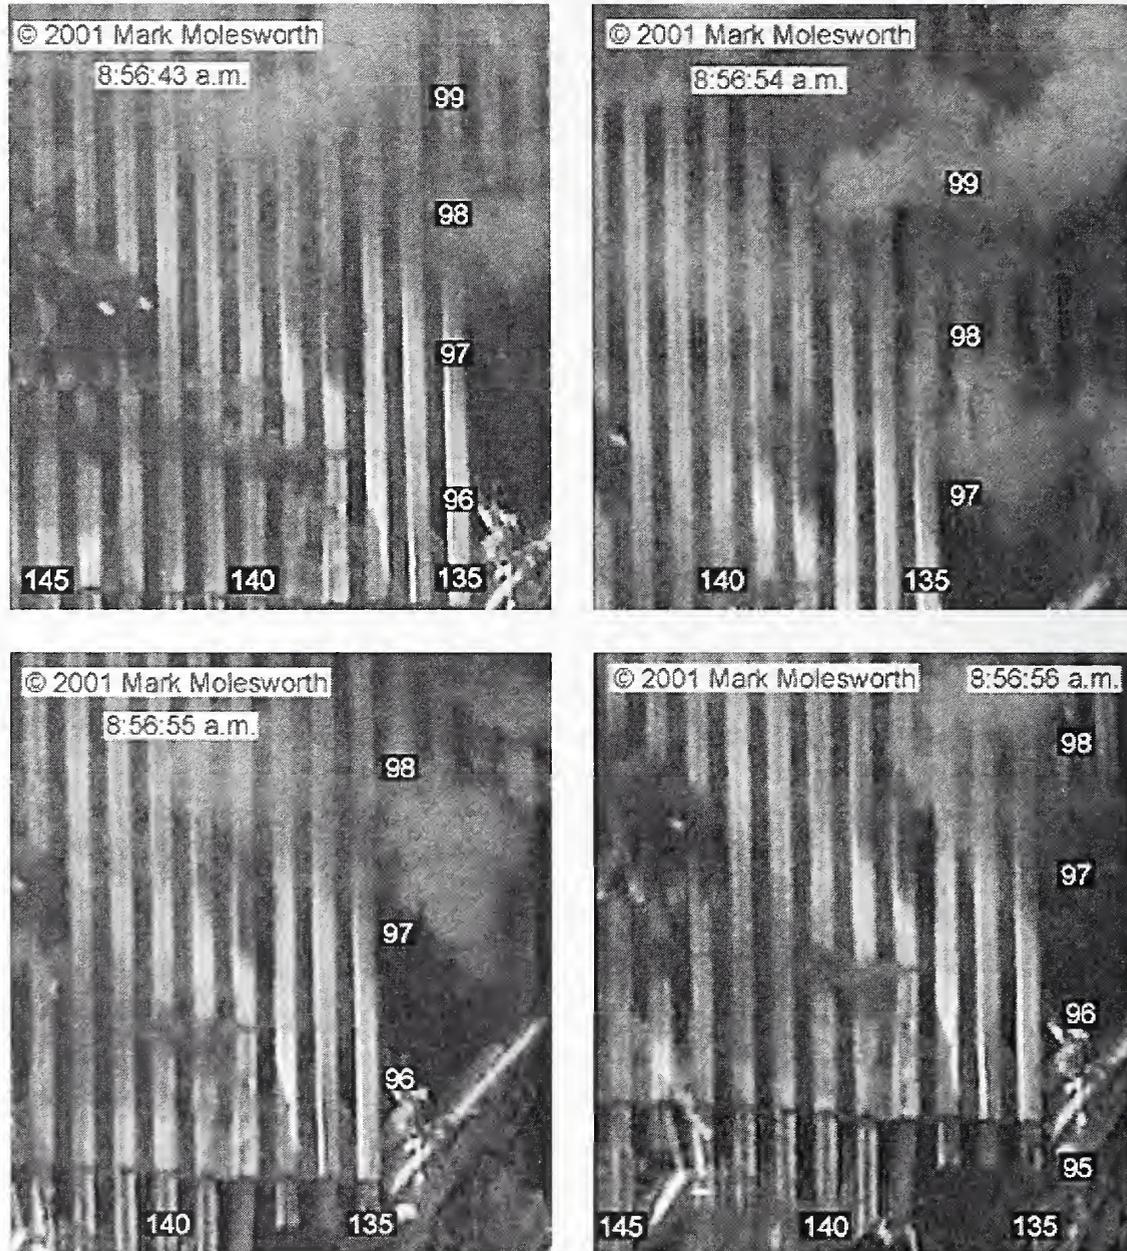
Figure 5–8 shows a series of four frames taken from a video that recorded the formation of a streamer on the north face of WTC 1. At 8:56:43 a.m. two small areas of flame are visible at the tops of windows 97-142 and 97-143. At 8:56:54 a.m. the flame at the top of window 97-142 was still in place (note that window 97-143 was out of the frame at this point). Very shortly afterward, the flame at the top of window 97-142 began to fall. The frame at 8:56:55 a.m. was taken 1.2 s later. The flaming object can now be seen near the base of window 97-142. This object extinguished very rapidly and formed the streamer that is visible curving downward at 8:56:56 a.m. near the base of the 96th floor. Note that the area of fire at the top of window 97-143 is still in place.

flames are visible on top of these lines, while in others only the lines are apparent. A likely explanation for these observations is that the thin lines are the edges of aluminum head casings that have dropped down from above the windows and that the fires seen above the lines are burning on the polyurethane located above the head casing. The large number of isolated fires seen at the tops of windows suggests that the polymer burned for a period of time before falling and forming streamers.

Figure 5-8. A series of four cropped frames from a video were recorded during the period when an isolated area of fire at the top of window 97-142 on the 97th floor dropped and formed a streamer. The intensity levels have been adjusted. Column and floor numbers have been added.
