**NIST NCSTAR 1-5A
Federal Building and Fire Safety Investigation of
the World Trade Center Disaster**

**Visual Evidence, Damage Estimates,
And Timeline Analysis**

Visual Evidence, Damage Estimates, and Timeline Analysis

September 2005

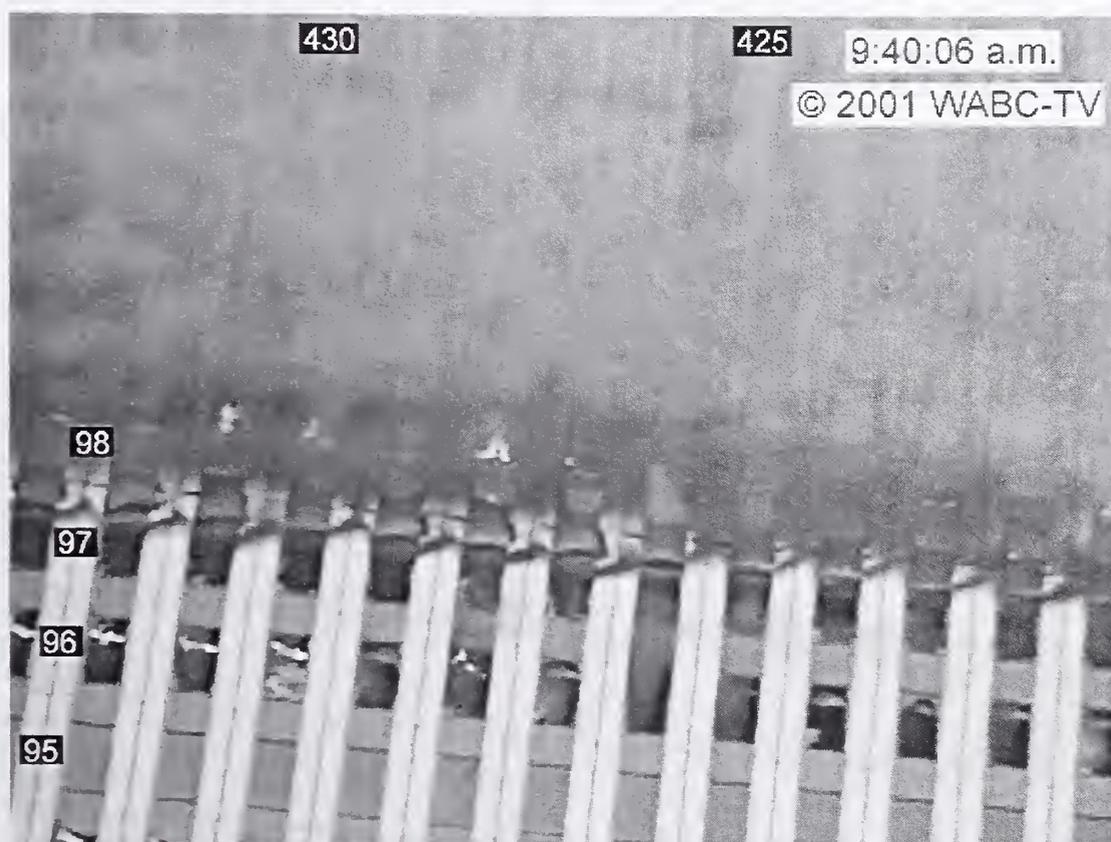
Relatively small fires at the tops of windows, such as those in Figure 5–8, were a common feature when active burning was present near the outer walls and the aluminum façade was intact. Such fires were often the only flames visible in a given window. Figure 5–9 shows a frame taken from a video in which a number of such fires burning on the 96th and 98th floors of the west face of WTC 1 are visible. As discussed in Section 8.5, the fires on this floor appeared to burn with low intensity. Nevertheless, the material at the tops of the window was exposed and ignited.

Figure 5-9. This close up view of the west face of WTC 1 was captured from a video recorded at 9:40:06 a.m. It has been enhanced by adjusting the intensity levels. Column and floors numbers have been added.

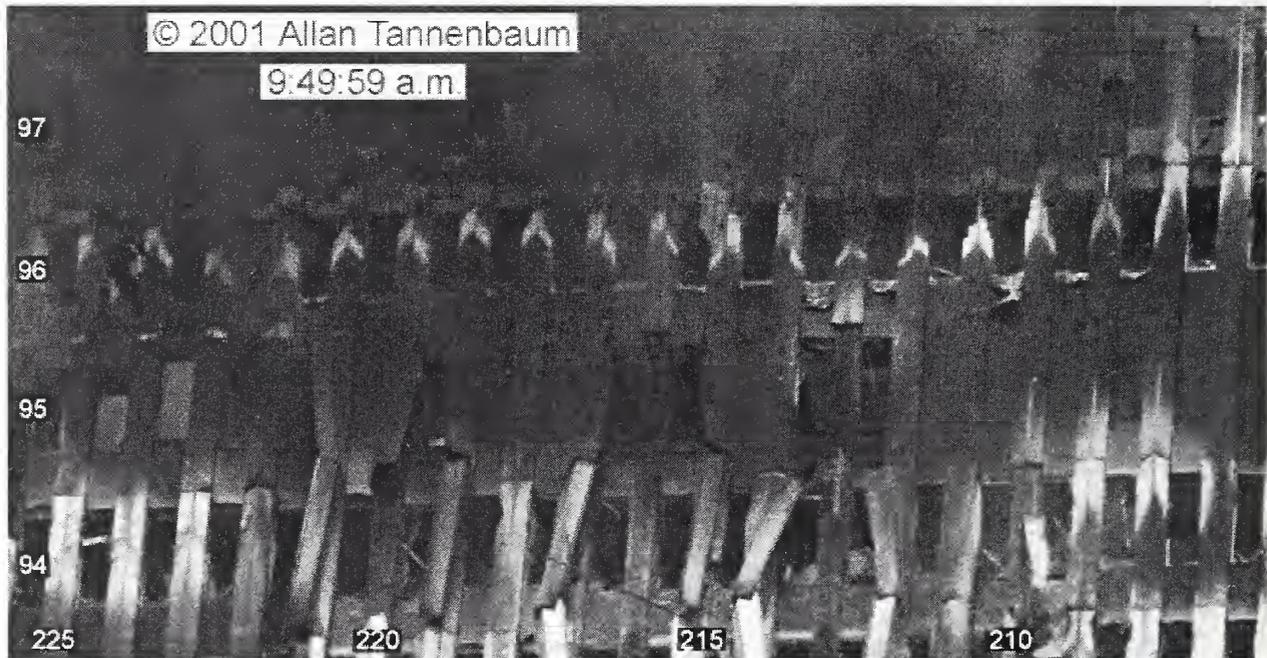
exiting a window. This flow pattern resulted in the formation of distinct patterns on the columns near the base of the burning flow that were easily identified. The marks resulted from deposited soot on the underside of the flames. Due to their shapes, this type of column pattern will be referred to as a “caret.” Figure 5–10 show examples of carets observed on the 96th floor of the east face of WTC 1. Variations in the heights of the patterns are evident from window to window. The location of a caret on a column cover provides an indication for the distance between the top of the window and the lower region of the burning gases leaving the window. This, in turn, reflects the depth of the layer of rich combustion gases behind the window. Typically, a deeper layer corresponds to a local region of higher combustion gas formation and temperature and generally indicates a location of more intense burning.

Figure 5-10. This cropped photograph shows a portion of the east face of WTC 1 at 9:49:59 a.m. The image has been rotated and enhanced by adjusting the intensity levels. A number of carets are visible near the tops of windows on the 96th floor. These carets were created during periods of external flaming from adjacent open windows. Column and floor numbers have been added.

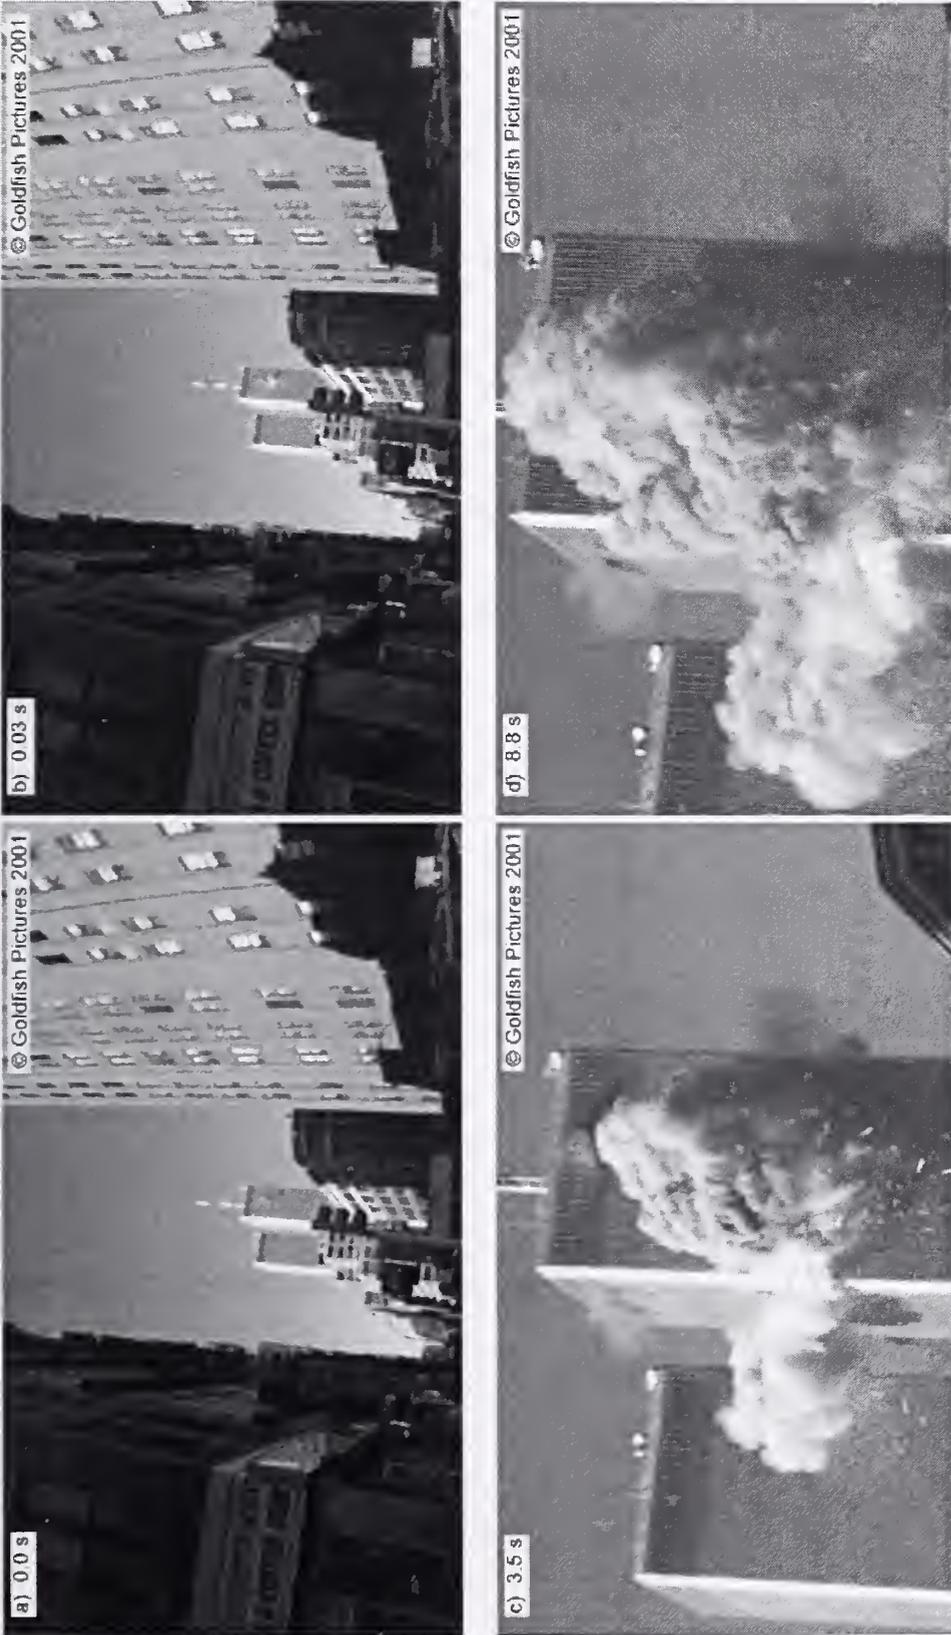
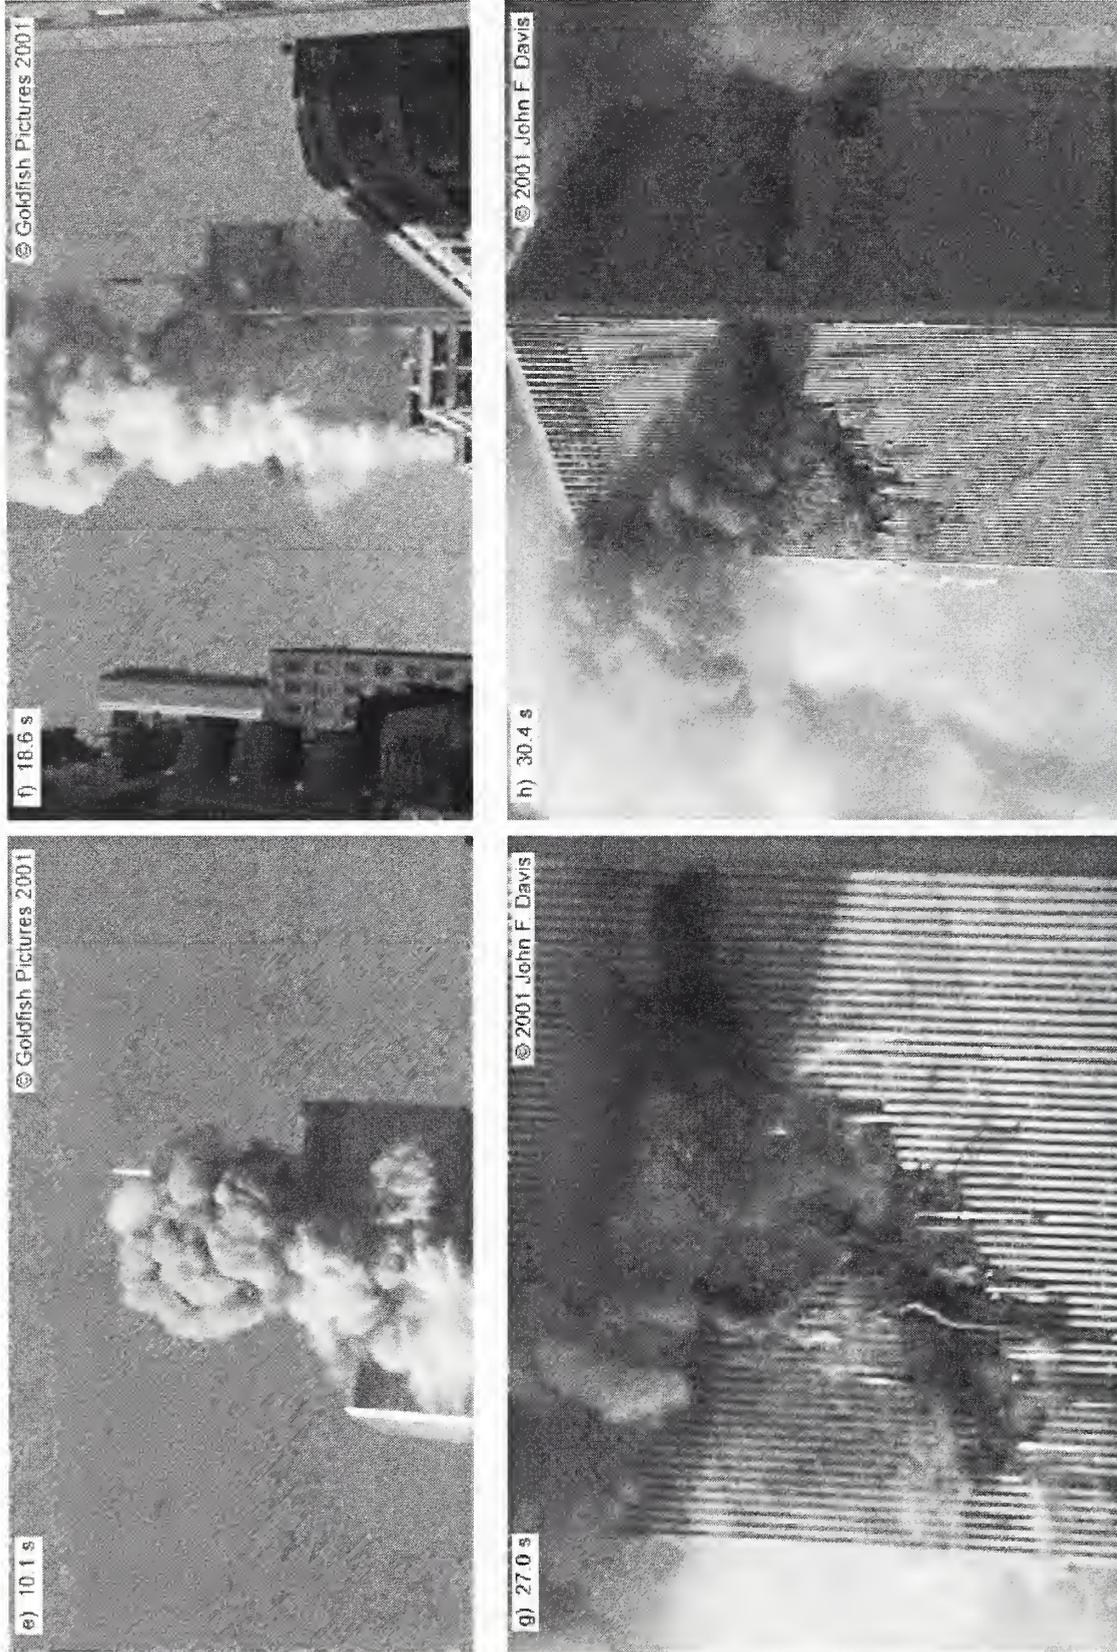
Roughly 5 s later (frame d), the dust clouds on the north and east faces have grown substantially. The north-face dust cloud is considerably larger, and extensive flames can now be seen throughout the cloud, interspersed with the white dust. A large amount of debris can be seen falling below the aircraft impact location. The prevailing wind has begun to blow the external fireball and falling debris across the north face toward the east. Flames on the east face seem to be present only near the building, suggesting that much less aviation fuel has been expelled on this face. A small region of fire is still visible extending beyond the southern edge of the east face, i.e., apparently coming from the south face of the tower.

At 10.07 s following the aircraft impact (frame e), the fireball that formed on the north face appears to have dissipated, leaving a “thermal” that is continuing to rise. For this report, the word “thermal” is used to identify a mushroom-shaped buoyant plume generated by the rapid release of a large amount of heat. The dust cloud created by debris falling from this face has developed a tube-like appearance and has been blown to the east edge of the tower. A bright region of flame is present across much of the region where the aircraft entered. The dust cloud on the east face has continued to expand, and no flames are now evident within this cloud.

Figure 6-1. A series of frames from videos shows American Airlines Flight 11 striking WTC 1 and the immediate aftermath. Times relative to the aircraft impact time are shown in the upper left-hand corner.

The next frame, (f), was recorded roughly 8.5 s later. At this time the dust-filled cloud sinking below the impact area and the rising thermal created on the north face have been blown further by the wind and are now more than a building width to the east of the northeast corner of the tower. The tube-like cloud of debris extends downward many stories and has developed the appearance of a concentrated vortex. The wind has also blown the debris away from the east face, and this face can now be observed. Substantial fires are now evident on the north and east faces in areas where the dust plumes were initially observed. Even though frame (f) is more zoomed out than frame (e), it is evident that the fire on the north face is much smaller than it was just 8.5 s earlier, suggesting that fires due to the aviation fuel released by the aircraft impact are already beginning to burn out. A thermal can be seen rising behind WTC 1, which provides additional evidence that the south face was damaged by debris passing through the tower.

In Figure 6-7 a scaled outline of a Boeing 767-200ER has been superimposed on the damage diagram for the north face. The inclination of the impact damage and aircraft overlay indicate that the aircraft was banking as it struck the tower. This is consistent with the appearance of the aircraft as it collided with the building (see Figure 6-1a).

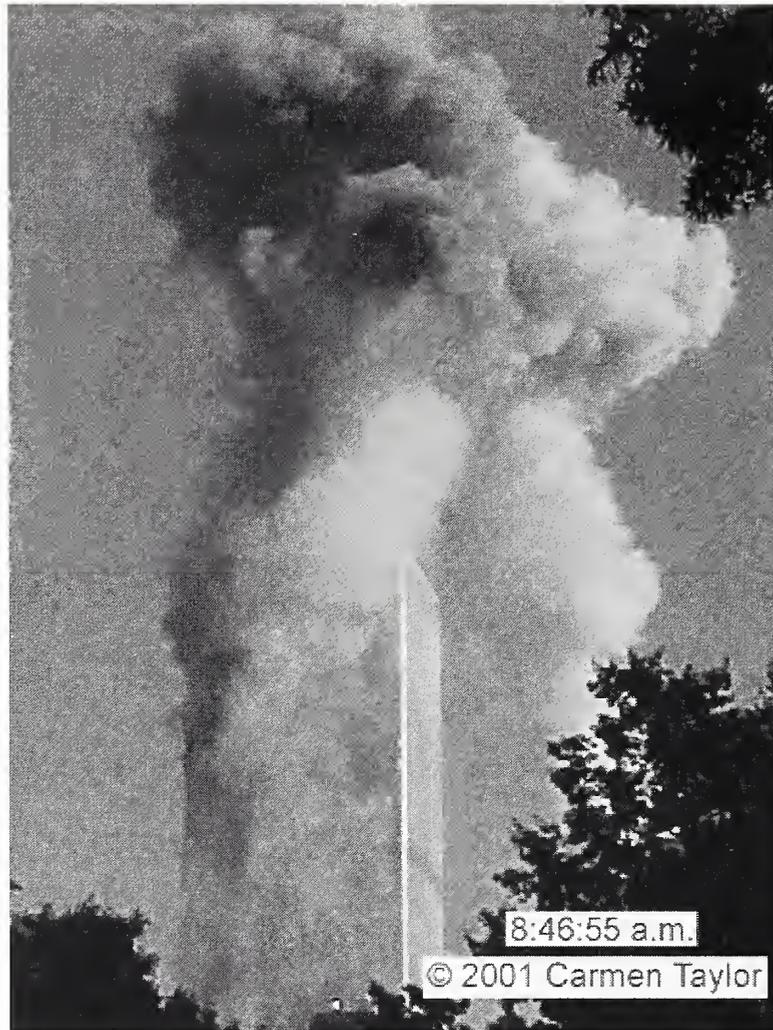
The photograph shows both WTC 1 and WTC 2, with the south face of WTC 1 partially hidden by WTC 2, which is in the foreground. An area of intense fire is apparent on the western side of the south face of WTC 1. This fire is in the vicinity of the 96th floor. An area of falling debris can be seen moving in front of the south face of WTC 2. This debris fell from the south face of WTC 1 and was blown to this location by the prevailing wind. Above the debris cloud a small thermal can be seen rising above the tower. This thermal must have resulted from a fireball that formed on the south face of WTC 2 following the aircraft impact. The occurrence of this fireball is consistent with the area of fire on the south face described above. The formation of a fireball on the south face indicates that a significant amount of aviation fuel from the aircraft passed all the way through the tower and burned on the other side.

Figure 6-2. View of the WTC towers shot at 8:46:55 a.m. from the southeast shortly after American Airlines Flight 11 struck WTC 1. A dust-filled vortex is visible on the right side. A second area of falling debris can be seen passing on the south side of WTC 2. Significant fires are present on the west side of the south face of WTC 1, which can be seen to the left and behind WTC 2.

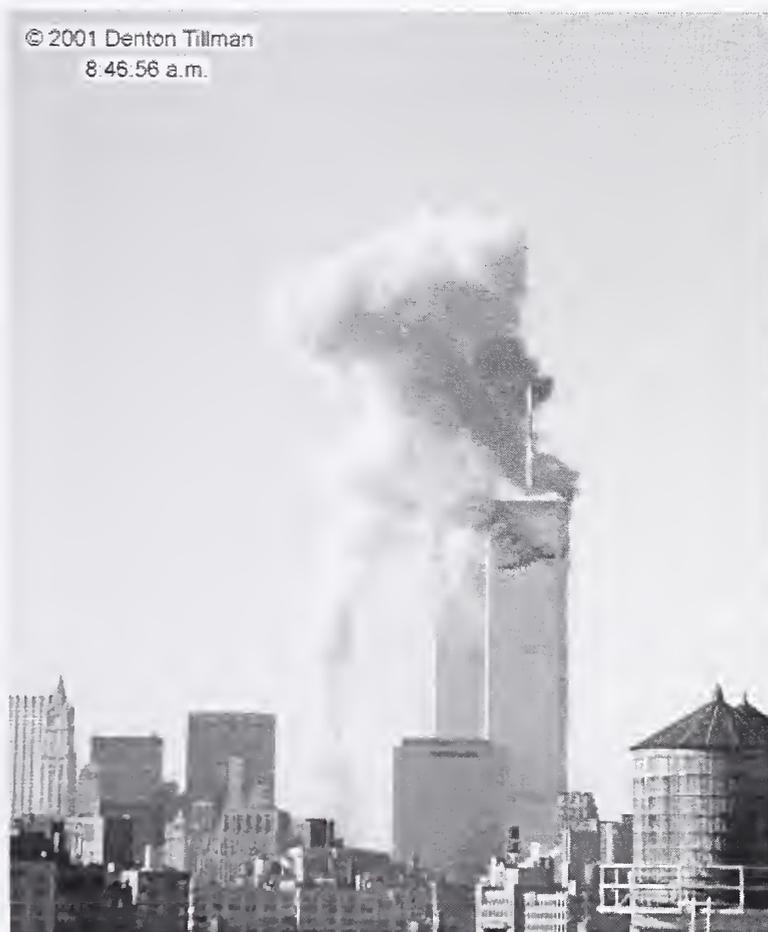
The presence of significant burning on the south face of WTC 1 is also indicated by the photograph shown in Figure 6-3 that was taken 26 s (i.e., 8:46:56 a.m.) after the aircraft impact on the tower. The thermal formed by the fireball on the rear side can be seen behind the large thermal formed by the fireball on the north face. A large amount of smoke is rising from behind the tower, consistent with the heavy fire seen on the south face in Figure 6-2. This photograph also provides an excellent view of the vortex generated on the north face of WTC 1 by the aircraft impact. The vortex is large, extending all the way down to near the ground. It has been transported a large distance by the prevailing wind. Even at this distance, the large fire burning inside the impact cavity in the tower is evident. This is consistent with Figure 6-1 (g), which was recorded at nearly the same time.

Figure 6-3. A cropped photograph taken from the north shows the WTC towers at 8:46:56 a.m., i.e., 26 s after the aircraft impact on WTC 1. Colors have been adjusted.

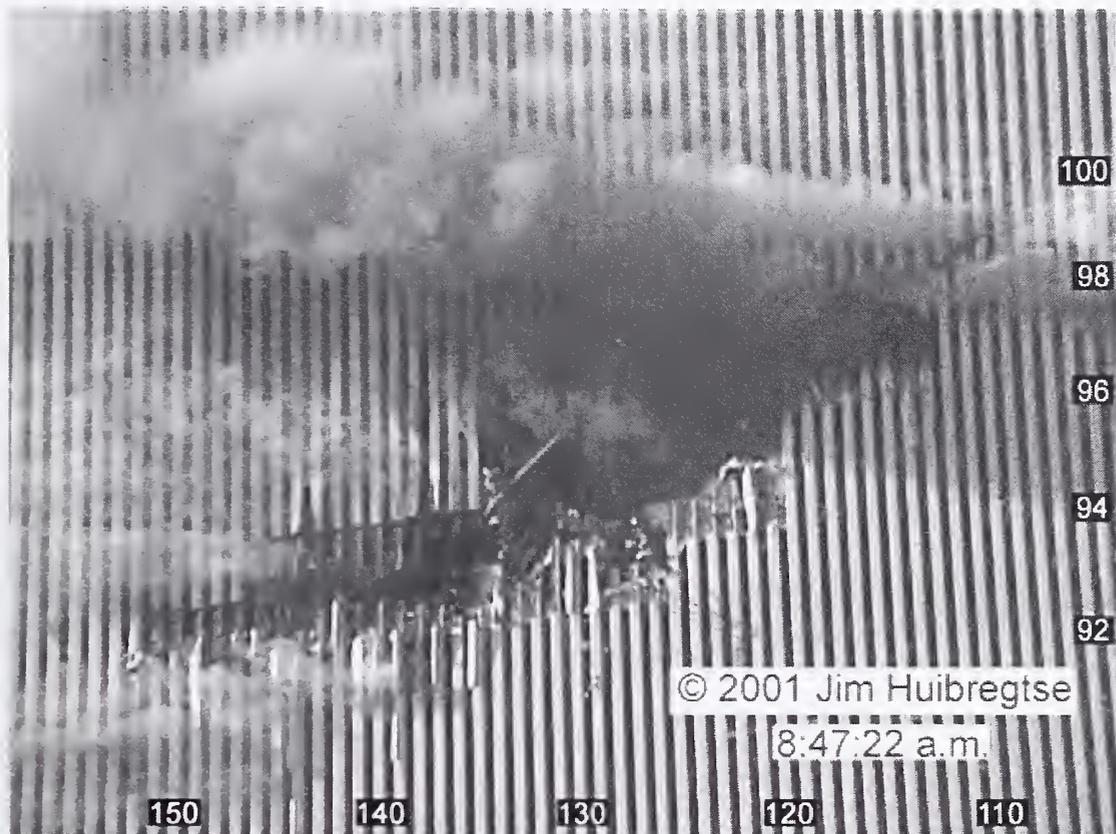
By inspection of Figure 6-4 and similar images, it was observed that the wing tips and the top of the vertical stabilizer at the tail of the aircraft damaged the aluminum column covers on the steel façade without cutting through the steel below or completely removing the covers. Using these images, it was possible to map out locations on columns where the wingtips and the vertical stabilizer struck the tower. These locations were then transferred to the representation of the damaged steel façade shown in Figure 6-6 and are represented by dashed lines, with wings to the right and left and the vertical stabilizer in the center. The good agreement between the damage pattern and the wing-tip locations is evident. It was reported in the FEMA report (McAllister 2002) and widely in the media that American Airlines Flight 11 struck floors 94 to 98 of WTC 1. The dotted horizontal lines on the left side of Figure 6-6 indicate the locations of concrete floor slabs. It can be seen that while the tip of the left wing of the aircraft struck very close to the base of the 94th floor, the wing end marked column 153 at the very top of the 93rd floor. It is evident from the Figure that the right wing actually struck well up on the 99th floor on column 109. The impacted floors therefore range from the 93rd floor to the 99th floor.

Figure 6-4. This image of the north face of WTC 2 is a frame taken from a video recorded at 8:47:22 a.m. Column and floor numbers have been added.

It is evident from Figure 6-4 and Figure 6-5 that substantial areas of the concrete floor slabs for the 95th through 97th floors were destroyed in the immediate vicinity of the aircraft impact location. There is a large open area in the impact region in which no floor slabs are visible. A substantial section of collapsed floor slab is apparent in the enlarged portion of Figure 6-5 shown in Figure 6-8. One of the trusses (indicated by an arrow) that supported the floor slab and the corrugated sheet metal on which the concrete was poured are visible. The floor slab section appears to have collapsed from above and is at least 17 ft wide. No visual material has been identified that allows the depth into the building of the floor removal and damage to be determined (it is apparently too dark to see inside), but it clearly extends many feet.

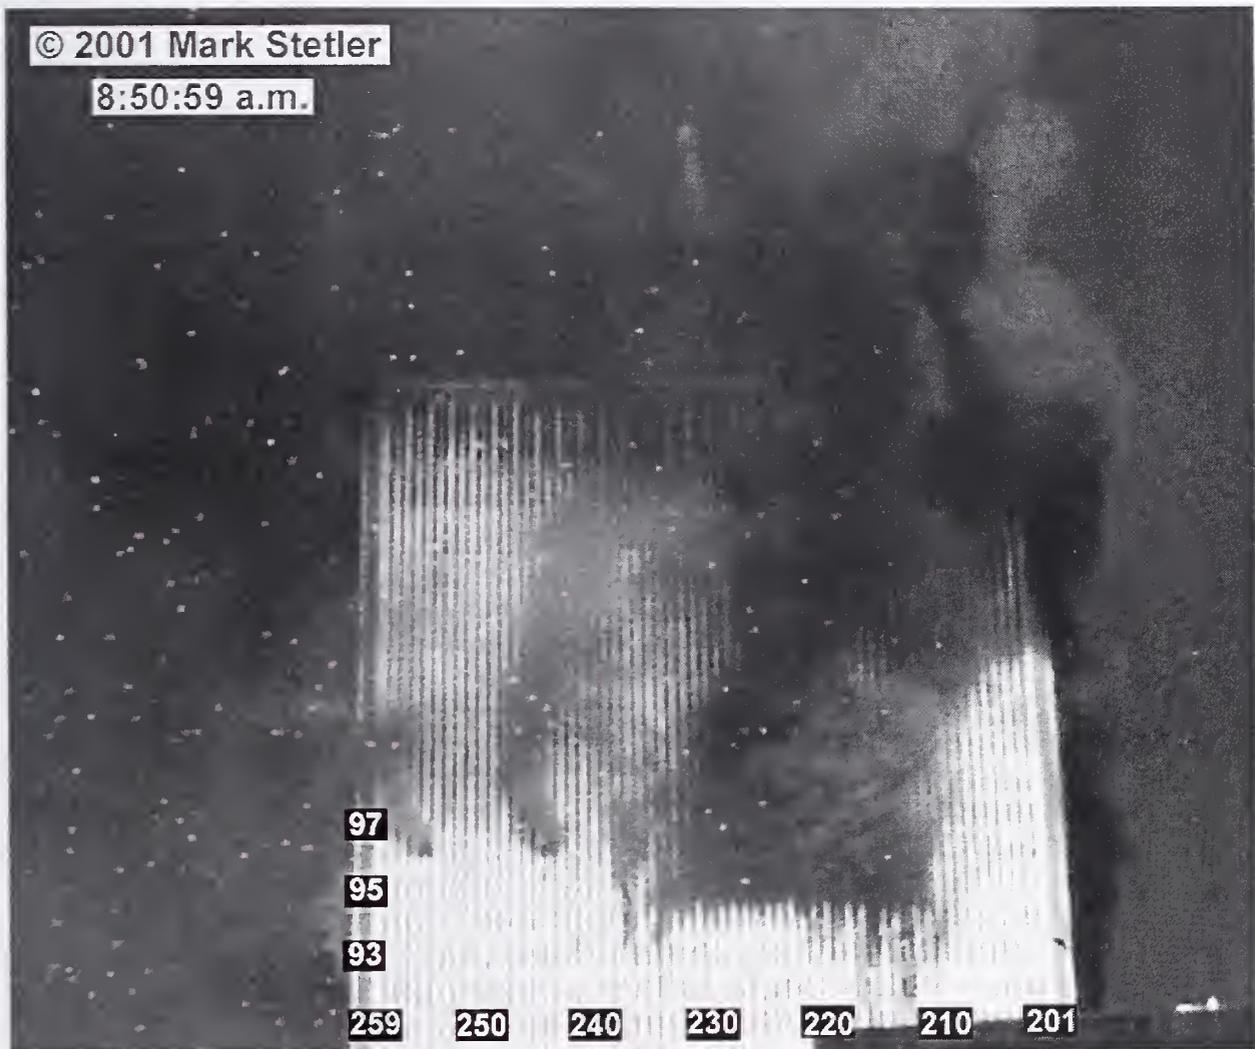
Figure 6–10 shows a photograph of the east face of WTC 1 taken roughly four and a half minutes after the aircraft impact. It looks similar to more distant videos that were recorded very shortly after the event, suggesting that the appearance of this face has not changed significantly since the aircraft impact. Figure 6–11, which also looks similar, was taken just over a minute later and provides a closer view. Numbers indicating floors and columns have been added to both figures for reference.

Figure 6-10. Photograph showing the east face of WTC 1 recorded at 8:50:59 a.m. Column and floor numbers have been added.

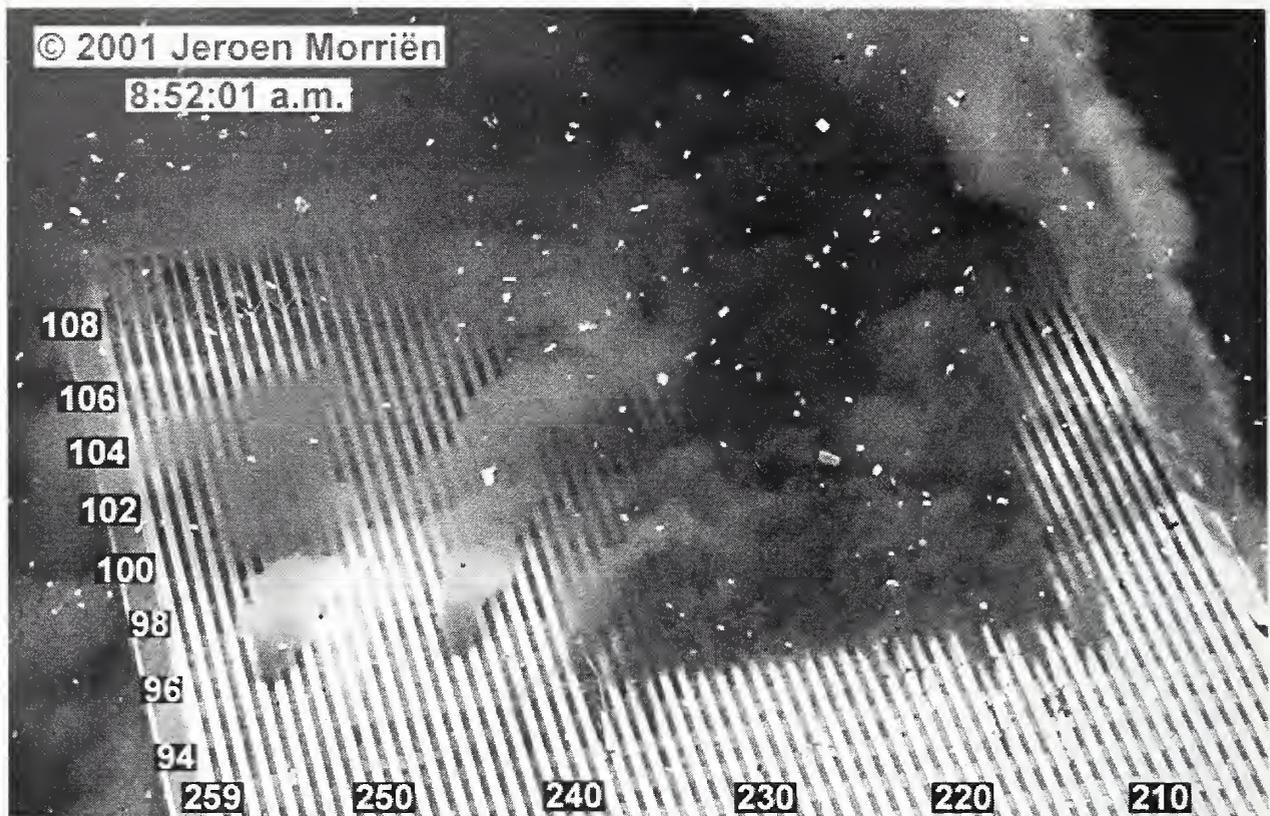
The most prominent feature in Figure 6–11 is a long line of smoke on the 94th floor extending from roughly window 94-210 to window 94-237, or a distance of nearly 90 feet. Clearly, all of the glass in the windows over this length has been broken out. Closer inspection shows that several of the aluminum covers on these columns have been partially dislodged as well. Most are near the right edge of the region, but the cover for column 94-237 has been nearly removed. Two covers, for columns 94-213 and 94-216, are missing completely. The aluminum cover on the northeast corner for this floor has also been partially

displaced. This proved to be an easily recognized marker for the floor. Isolated windows at 94-241 and 94-250 are also missing.

Figure 6-11. Photograph of the east face of WTC 1 taken at 8:52:01 a.m. The photograph has been enhanced and cropped. Floor numbers are indicated along the left edge of the building and column numbers along the bottom of the photo.

Some damage and missing window glass are present on lower floors that were not directly impacted by the aircraft. Window glass has been broken out and some column covers have been displaced or removed completely on the 93rd floor from columns 93-209 to 93-216 as well as columns 93-219 and 93-220. The glass for window 93-237 is missing, and the aluminum cover for column 93-237 has been displaced. Damage is also apparent on the 92nd floor, where windows 92-212 and 92-213 have been broken out. A chair is stuck in window 92-212, and the aluminum cover on column 92-212 has been removed. Covers on columns 92-216 and 92-217 have been displaced, and the window glass between these two columns is missing. On the 91st floor, the covers on columns 91-213, 91-214, and 91-216 have been displaced, and windows 91-213 and 91-216 are open. There is no apparent damage lower than the 91st floor.

Portions of the east face above the 94th floor are hidden by the smoke rising from this floor. Only minimal damage is seen on these higher floors, including a displaced column cover and missing window glass at window 95-237 and two broken windows on the 96th floor at windows 96-243 and 96-254. All window glass and column covers to the north of column 209 appear to be undisturbed.

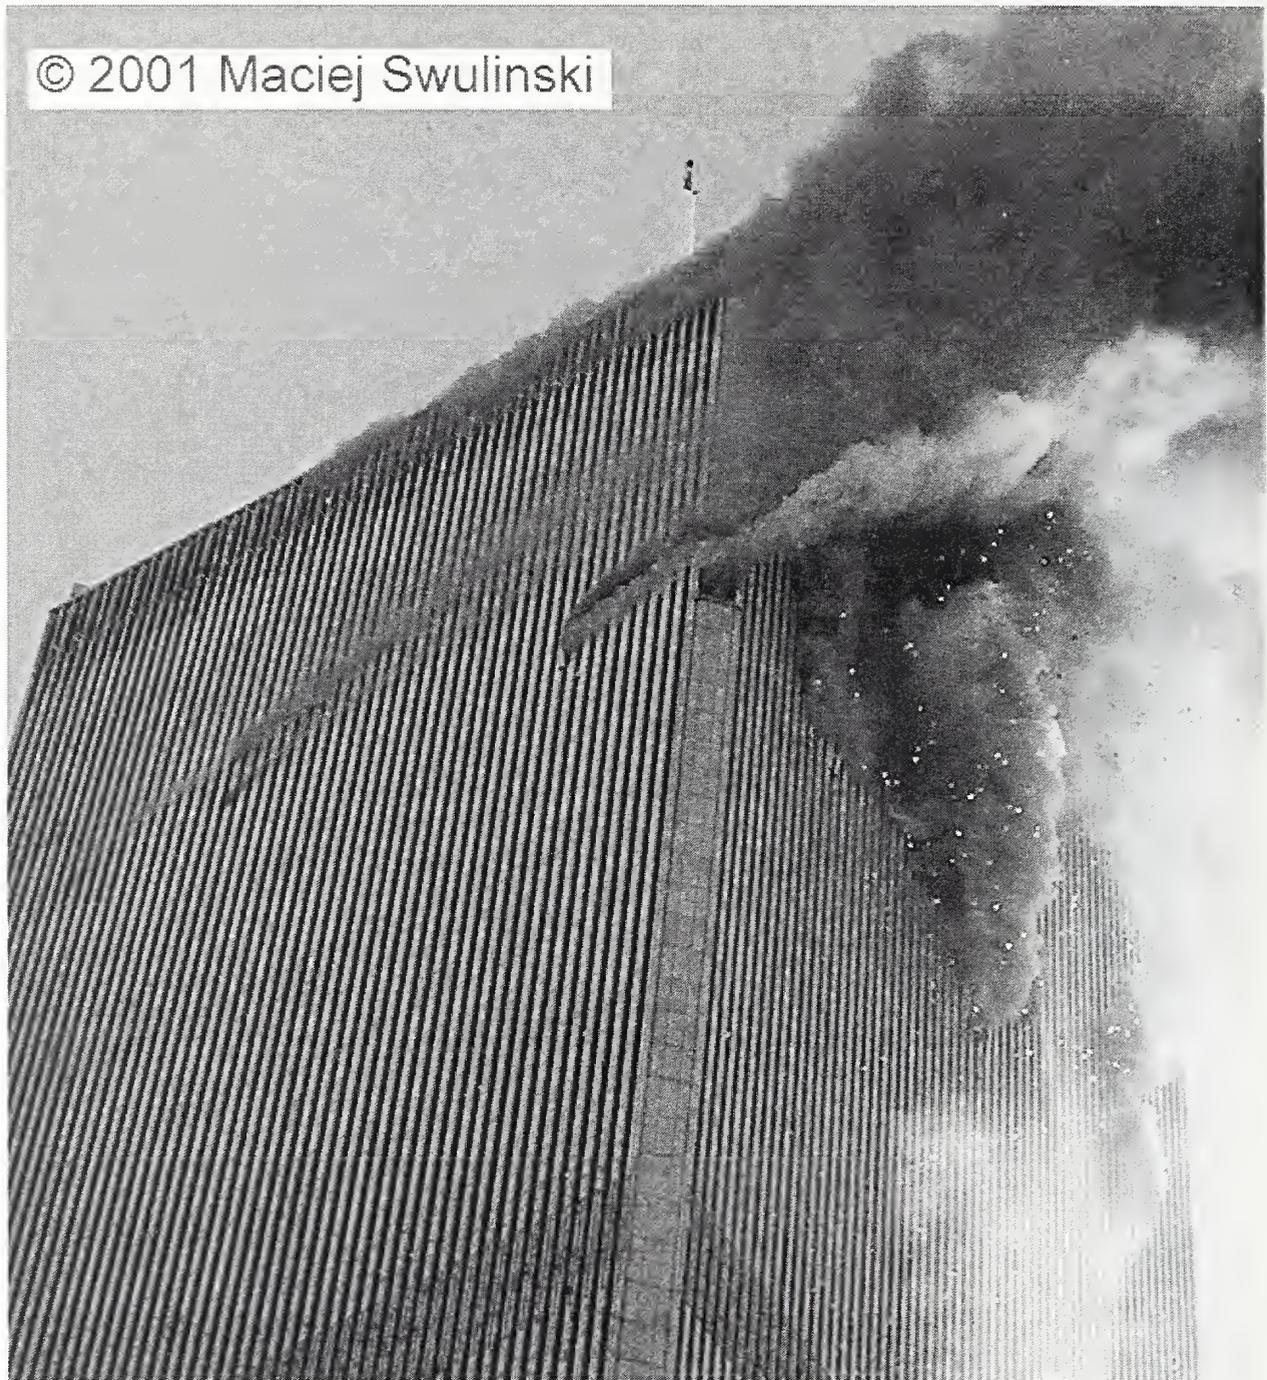
In contrast to the relatively large number of windows missing on the east and south faces of the tower, the number of windows initially opened on the west face was considerably less. This can be seen in Figure 6–12, which shows the west face shortly after the aircraft impact. The façade maps for window condition on the west face shown in Figure 6–9 is based on a number of photographs and videos and indicates that nine windows were broken open on this face by the aircraft impact and fireballs. The only obvious damage to the aluminum facing occurred on columns 410 and 411 at the 96th and 97th floors. The covers for column 410 were removed on both floors, while those on column 411 were partially dislodged.

Figure 6-12. A cropped photograph shows the west and south faces of WTC 1 shortly after the aircraft impact. The image has been enhanced by adjusting the intensity levels. The exact time of the image is unknown, but the appearance suggests that it was taken within two minutes of the aircraft impact.

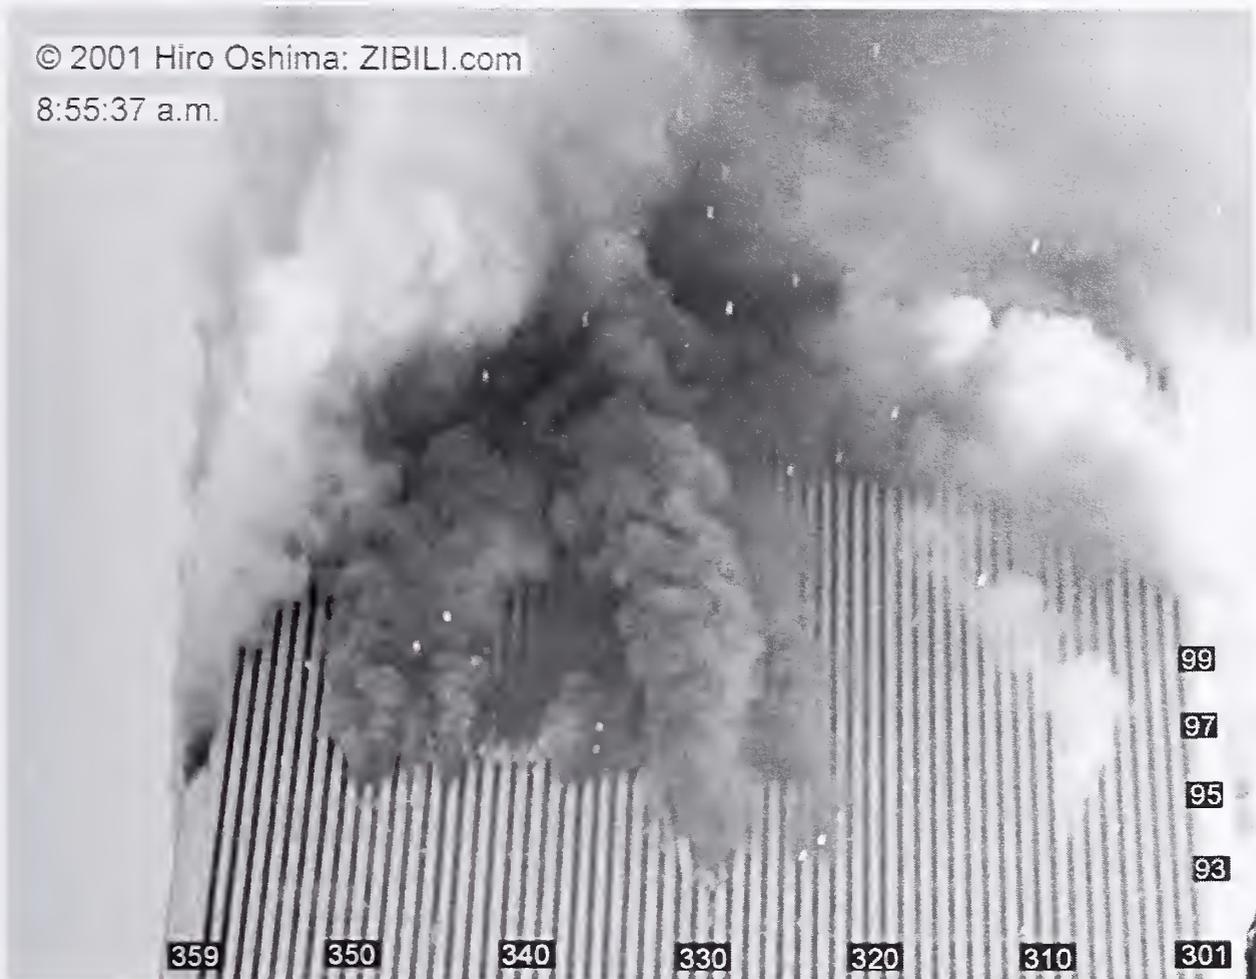
A prominent feature in both photographs is the missing aluminum cover on the southwest corner of WTC 1 at the 96th floor. Heavy smoke is flowing from this opening. This missing cover is easily recognized and provides a quick reference for identifying the tower, face, and floors in visual material. In addition to the missing corner, some of the aluminum column covers on the face have been displaced. Using the corner marker as a guide, it is apparent that most of the smoke seen issuing from broken windows on the south face is coming from the 95th and 96th floors on the western side. Only a single window (94-308) to the east of column 322 appears to be broken open. There is an area of heavy smoke at the center of the face coming from lower down on the 93rd floor. Comparison of a number of photos and videos taken during the event showed that the smoke released from this point remained heavy until the tower collapsed. It was never possible to get a clear view of the damage in the immediate vicinity. As discussed further in Section 6.4.3, it is believed that the damage in this area was the result of the removal of a complete three story steel panel section from the face.

Figure 6-13. This enhanced and cropped photograph shows the south face of WTC 1 at 8:55:37 a.m. Column and floor numbers have been added.

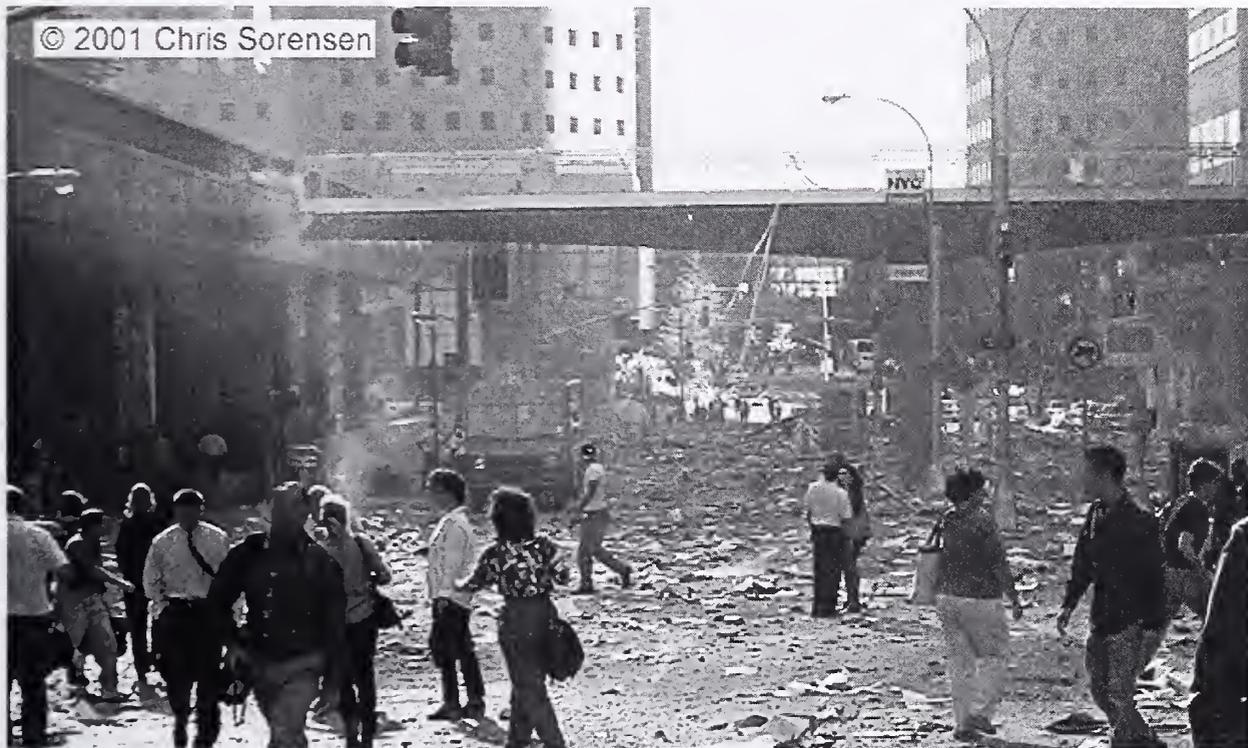
Figure 6–15 shows another view of the streets around the WTC shortly after the aircraft struck WTC 1. This shot was taken from the corner of Liberty Street and Church Street looking west down Liberty Street. It was taken before WTC 2 was struck, so the debris has come from WTC 1. The bridge across Liberty Street connected the southwest corner of WTC 4 to the Bankers Trust Building. The building visible on the right side beyond WTC 4 is WTC 3 (Marriott Hotel), which was located on the corner of West Street. A deep layer of debris is seen strewn across much of the visible length of Liberty Street. Most of this debris is lying to the south of WTC 2. The only possible way for it to have reached this location is by being blown by the prevailing wind from the south face of WTC 1. It is likely that it was dropped from the dust cloud seen to the south of WTC 2 in Figure 6–2. This image, along with several others, shows that, in addition to a lot of paper, the debris in the street consisted of a number of aluminum column covers and what appeared to be small chunks of concrete. The amount and nature of the debris

indicates that the aircraft impact and fireballs must have caused significant damage close to and on the south face of WTC 1. There were also a number of small fires burning on Liberty Street immediately following the aircraft impact (not visible in Figure 6-15).

Figure 6-15. This photograph was taken from the corner of Liberty Street and Church Street looking west down Liberty Street after WTC 1 was struck by American Airlines Flight 11 but before WTC 2 was hit by United Airlines Flight 175. Some faces are blurred.

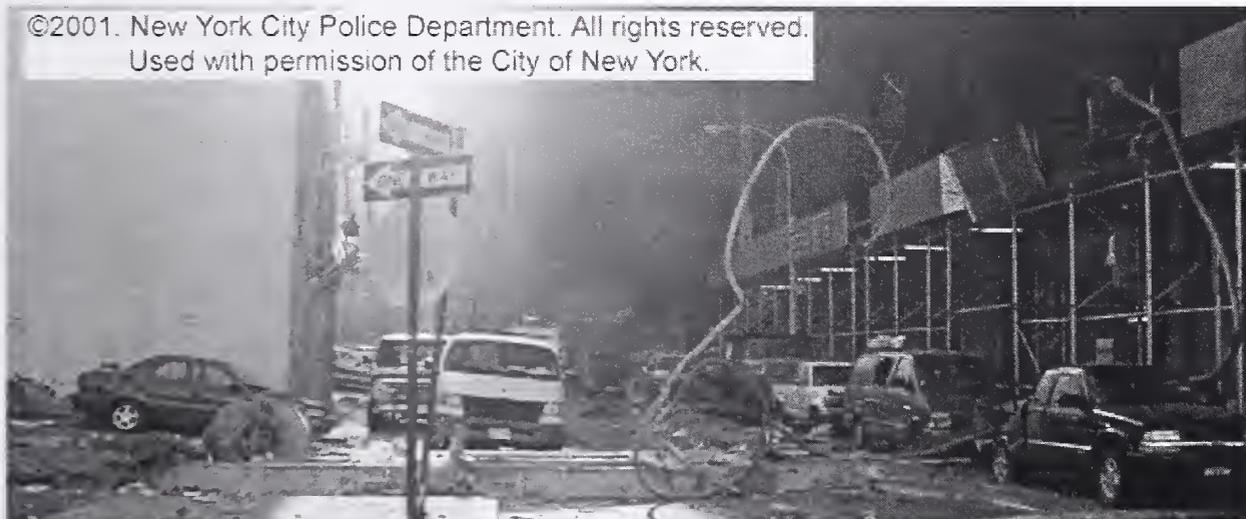
A curious aspect of Figure 6-16 is the large pipe that can be seen twisted about and rising above the panel section. A different view of the pipe is available in Figure 6-17, where it can be seen that it extends from well above the panel section across the pickup truck to the right and then up into the air. The force of the collision of the pipe with the pickup has crushed the cargo bay. The pipe section length is considerably longer than the panel section, which is 36 ft. The pipe diameter has been estimated as 1.5 in., based on its size relative to the panel section.

Figure 6-17. This cropped and enhanced photograph shows another view of the three-story steel panel section included in Figure 6-16. A long pipe section attached to the steel rises above both the panel section and the pickup truck to the right. The building on the left is Saint Nicholas Greek Orthodox Church, and the building on the right is 90 West Street.

Review of building plans and consultation with The Port Authority of New York and New Jersey staff and consultants have provided a plausible explanation for the source of this pipe. Cooling at the perimeter of the towers was accomplished by means of cold-water induction units located along the outer wall at the base of the windows. These units were fed cooled water by a series of vertical risers (pipes) that extended either up or down from the mechanical equipment rooms. Water was returned by parallel risers. The pipe in the figures seems to be attached to the bottom of the steel panel section on the center column, i.e., column 130 at the 93rd floor. Induction units on the 92nd floor and higher were connected to the mechanical equipment room on the 106th floor. Building plans indicate that supply and return risers were located just to the inside of column 130. The supply riser was 1.5 in. pipe and the return riser was 2 in. pipe. The appearance and location of the pipe in the figures indicate that it is mostly likely part of a supply riser that fed the induction coolers at this location.

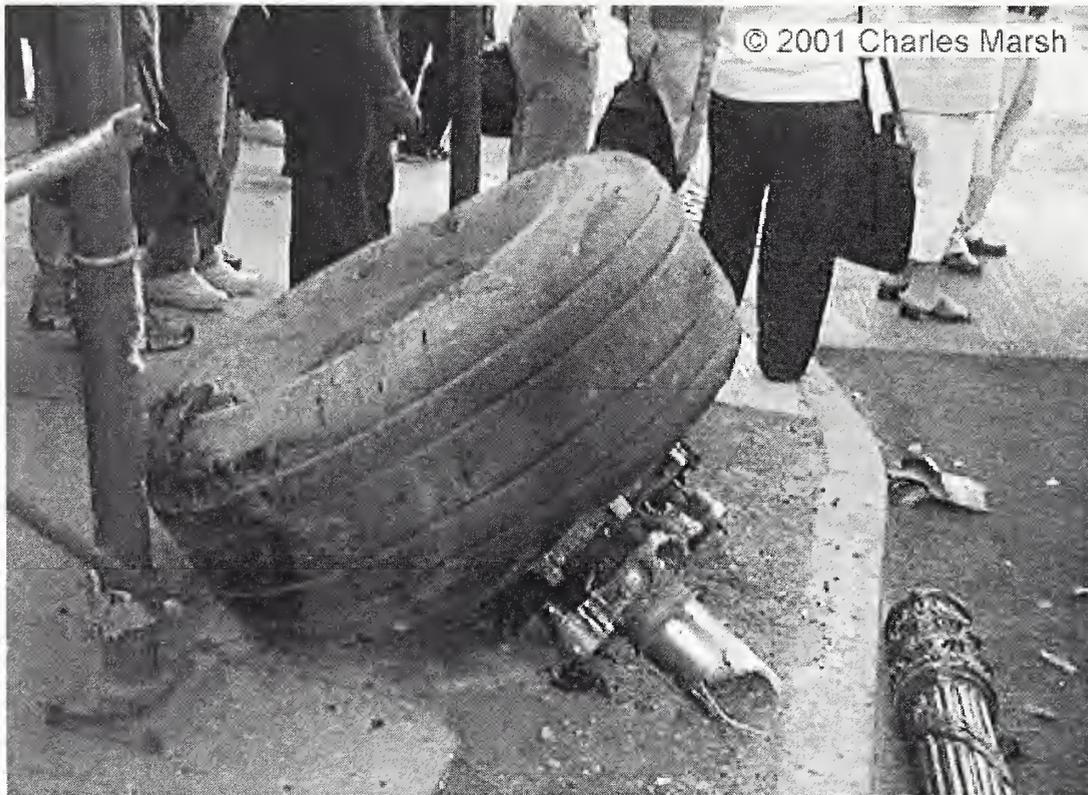
A second wheel from a landing gear, shown in Figure 6-18, was found much further south at the corner of Rector Street and West Street. This is a distance of roughly 1,385 ft from the base of the south face of WTC 1. The presence of a braking system indicates that this wheel also came from one of the two main landing gears.

Figure 6-18. The photograph shows a wheel from the aircraft that struck WTC 1 lying at the southeast corner of the intersection of Rector and West Streets.

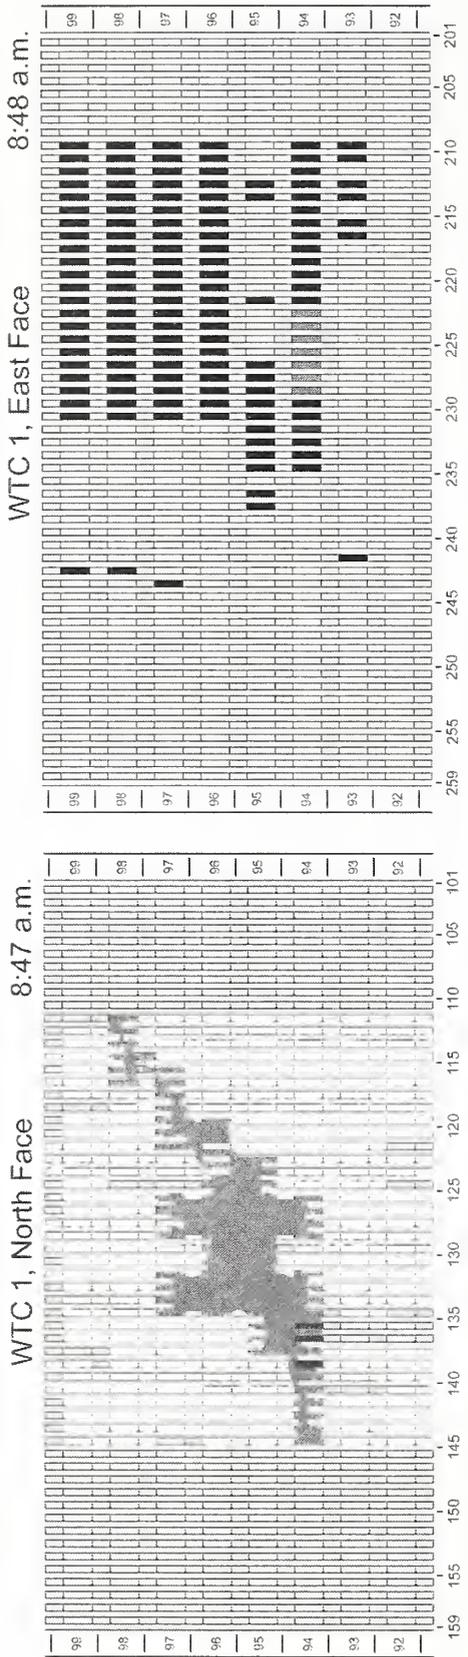
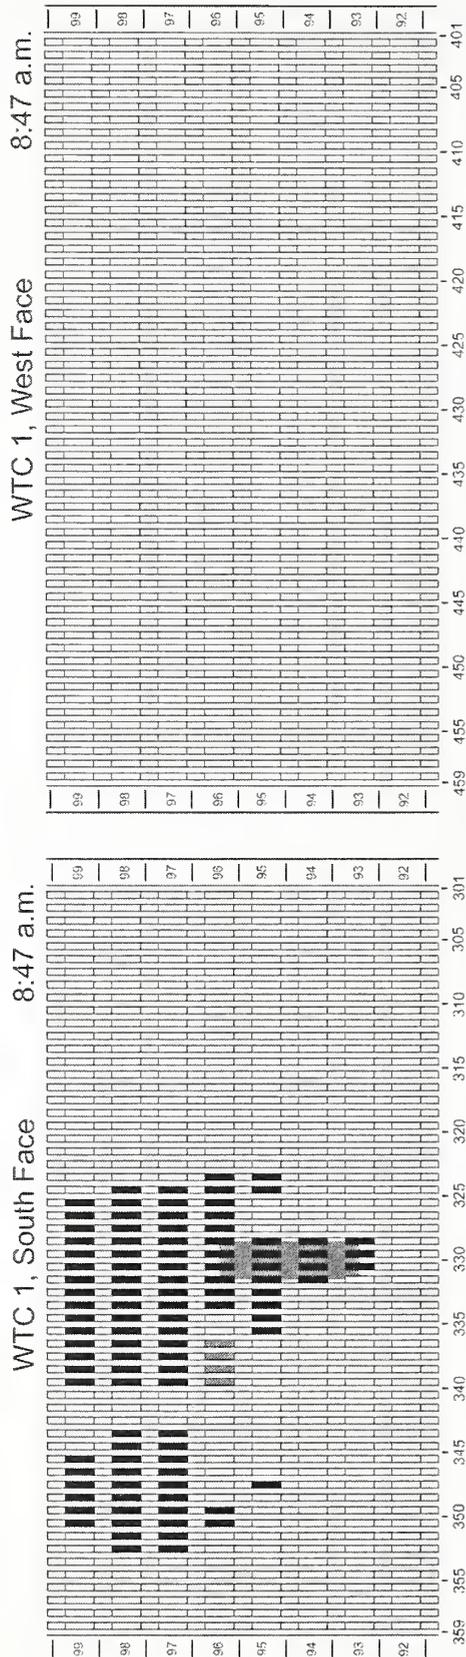
In the minutes immediately following the aircraft impact, relatively small fires were observed at a few isolated locations around the periphery of the building. This can be seen in Figure 6-19, which compares the observed fires on the four faces of WTC 1 for the first few minutes after the intense burning of aviation fuel initiated by the aircraft impact had subsided. These fires were likely burning small amounts of residual aviation fuel or building contents. They were not extinguished because they had direct access to outside air. During this period, light smoke was observed coming from numerous open windows where fire was not seen. These observations are consistent with the conclusion that internal fires were effectively damped down by oxygen depletion. The presence of significant smoke indicates some smaller fires were still burning in the interior of the building.

Figure 6-19. Maps of observed fires on the four faces of WTC 1 are shown for the period shortly after the rapid burn off of fuel released during the aircraft impact. The colors represent - no fire observed, - spot fire, - fire inside, - external flaming, and - not visible.
