**NIST NCSTAR 1-5A
Federal Building and Fire Safety Investigation of
the World Trade Center Disaster**

**Visual Evidence, Damage Estimates,
And Timeline Analysis**

Visual Evidence, Damage Estimates, and Timeline Analysis

September 2005

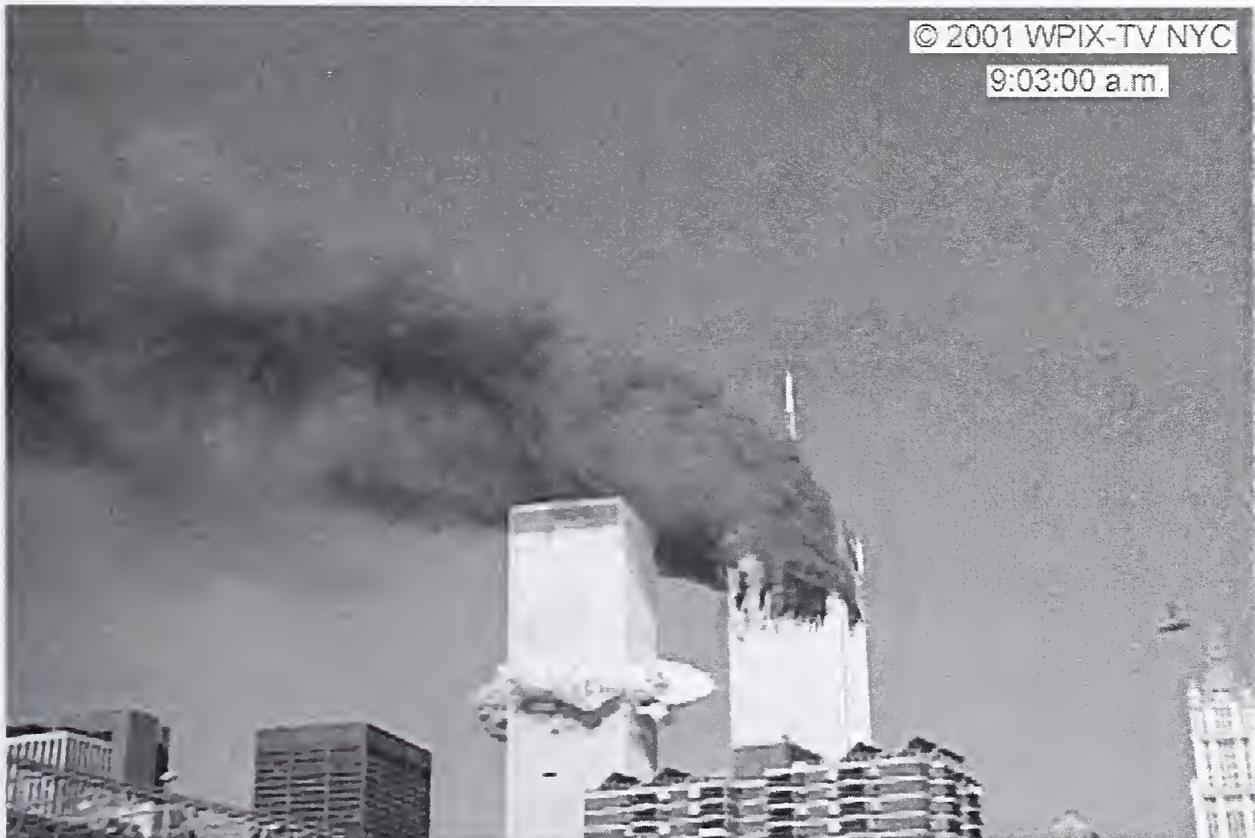
Close inspection of Figure 7-1 shows that there are three distinct fireballs present on the north face. Videos shot from the north indicate that the largest of these grew from the area of fire that originally

appeared on the 80th, 81st, and 82nd floors in the vicinity of windows 239 to 249 (see Table 7-1). The second, somewhat smaller, of the fireballs is at roughly the same height and emanates from near the northeast corner. The third fireball is the smallest and is located below the other two. Northern views show that this fireball was formed from fire exiting from windows 79-233 to 79-240 on the 79th floor (see Table 7-1).

Figure 7-1. The nascent fireballs and dust clouds formed on WTC 2 1.2 s after the aircraft impact on the tower are shown. The image is a frame from a video.

A large cloud of dust is evident in Figure 7-1 on the south face that does not appear to be burning despite the fact that ignition was observed on this face (see Table 7-1). It appears as if there was much less fuel in the material that was expelled from this face than observed on the east and north faces. Other regions of dust can be seen below the fireball on the east face and in the vicinity of the mechanical equipment room on the 75th and 76th floors on the east and north faces.

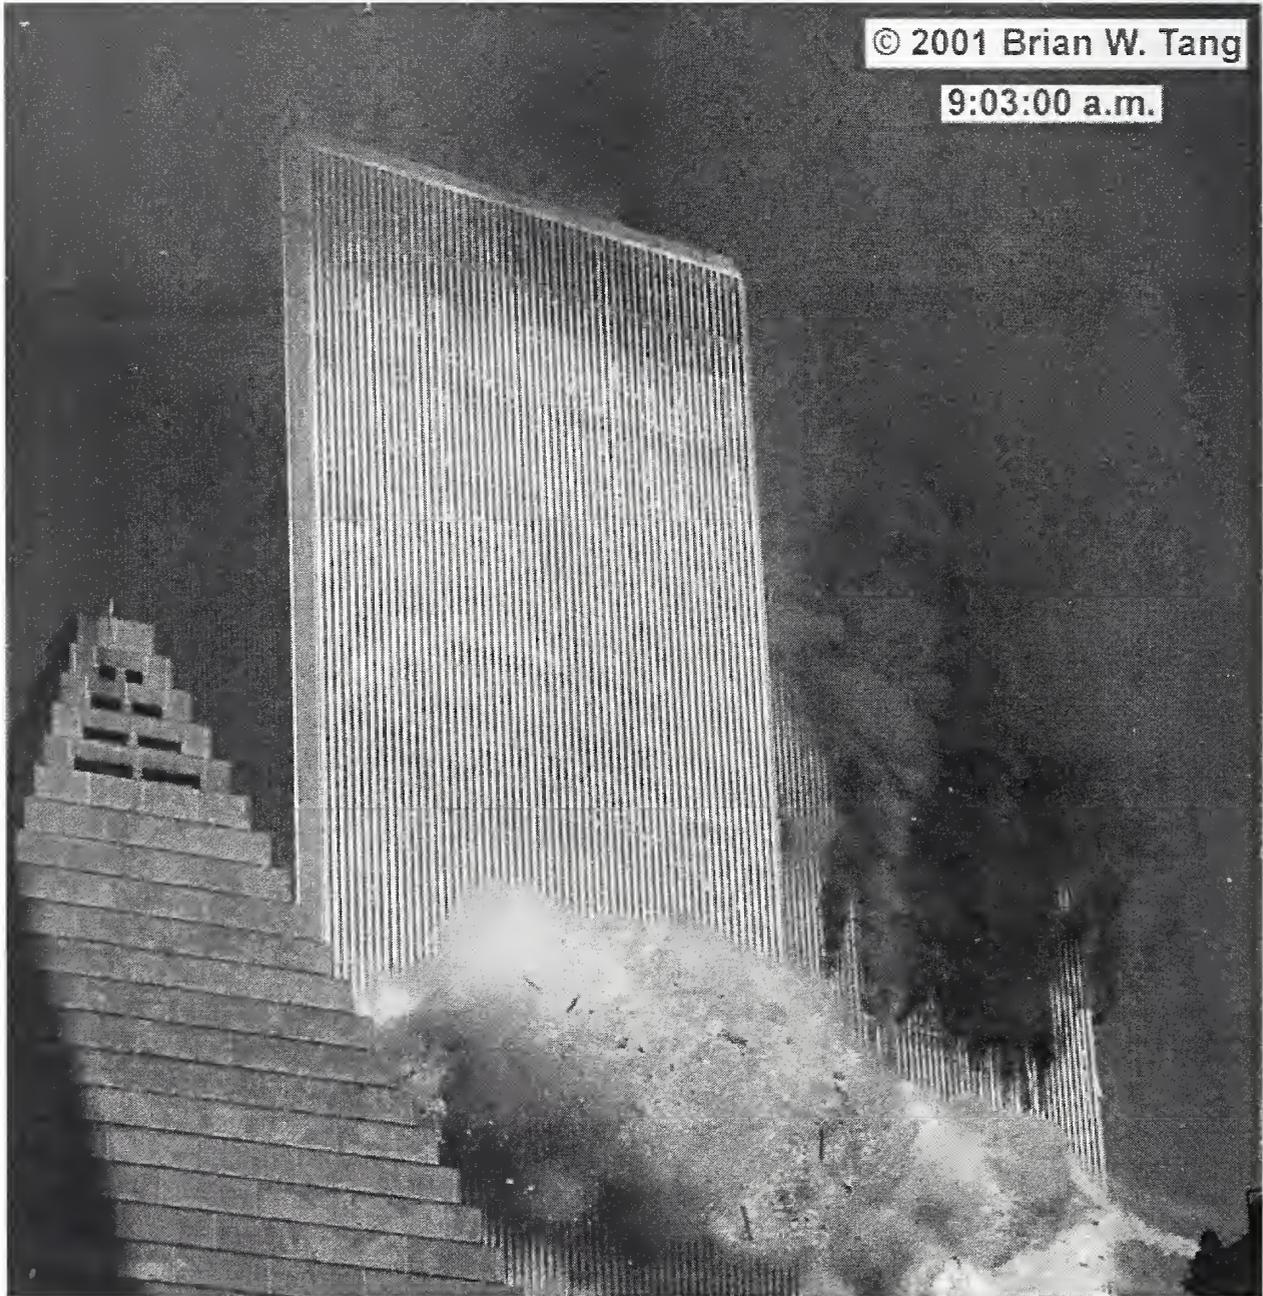
Figure 7-2. This cropped photograph shows the fireball formed on the east face of WTC 2 following the aircraft impact that took place 1.1 s earlier. The east face of WTC 1 is visible in the background

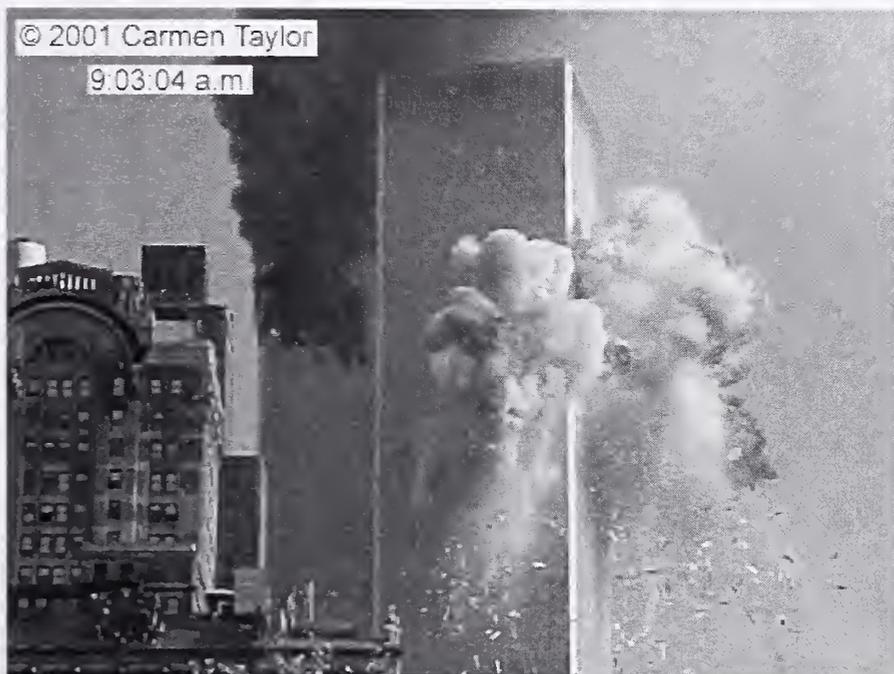
Figure 7-3. An image of WTC 2 recorded from the southeast is shown. The photograph was taken 4.3 s after the aircraft impact on the tower. The south face of WTC 1 can be seen burning in the background.

Burning on the south face seems to be concentrated more on the west side, with little flame evident in the dust cloud toward the east.

The debris in Figure 7-35 and Figure 7-36 most likely made up a portion of the dust cloud evident on the south face of WTC 2 in Figure 7-3 and Figure 7-9. This material was blown backward out of the tower by the overpressure generated by the initial fire inside the building that appeared shortly after the aircraft impact. The relatively large amount of what appears to be concrete, as well as its small size, suggests that the aircraft impact pulverized a significant amount of concrete floor slabs as it entered the tower. This is consistent with the large scooped-out cavity seen in the aircraft impact location (see Figure 7-22 to Figure 7-24). As noted previously, it has not been possible to visually observe the depth of such damage.

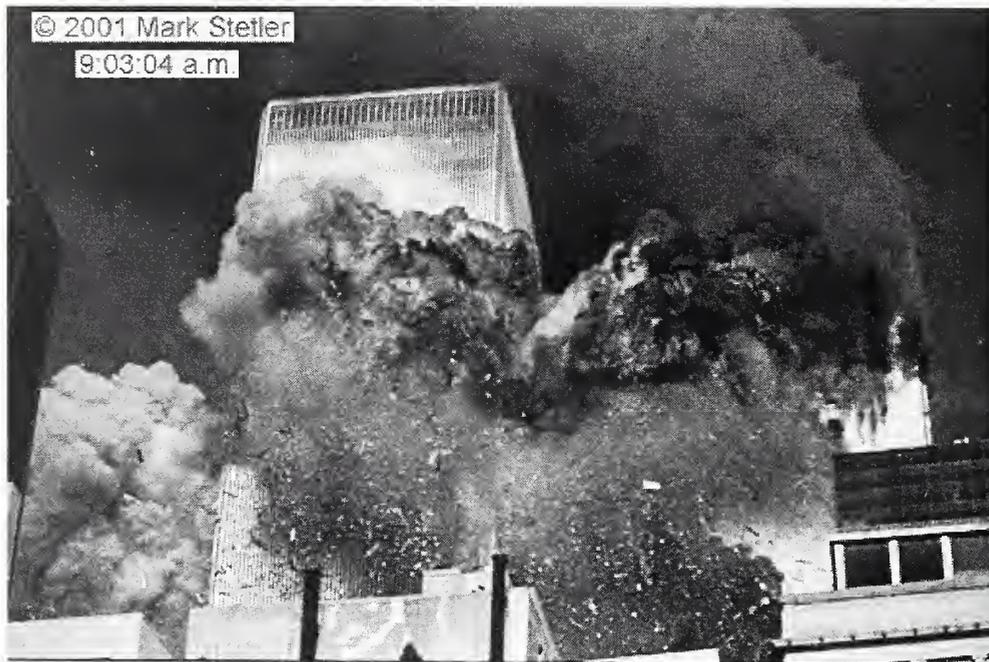
Figure 7-4 shows a photograph of the fireballs taken from just north of due east 4.6 s after the aircraft impact. The features of the fireballs are similar to those already described. The large extent of the fireball on the north face is apparent by noting that the width of each tower is 209 ft. The large amount of dust and larger debris (some flaming) generated by the collision and fireballs can be seen falling below the fireballs. Some isolated regions of fire are evident in the dust cloud on the south face.

Figure 7-4. An image of the fireball on WTC 2 recorded from just north of due east is shown. The photograph was taken 4.6 s after the aircraft impact on the tower.

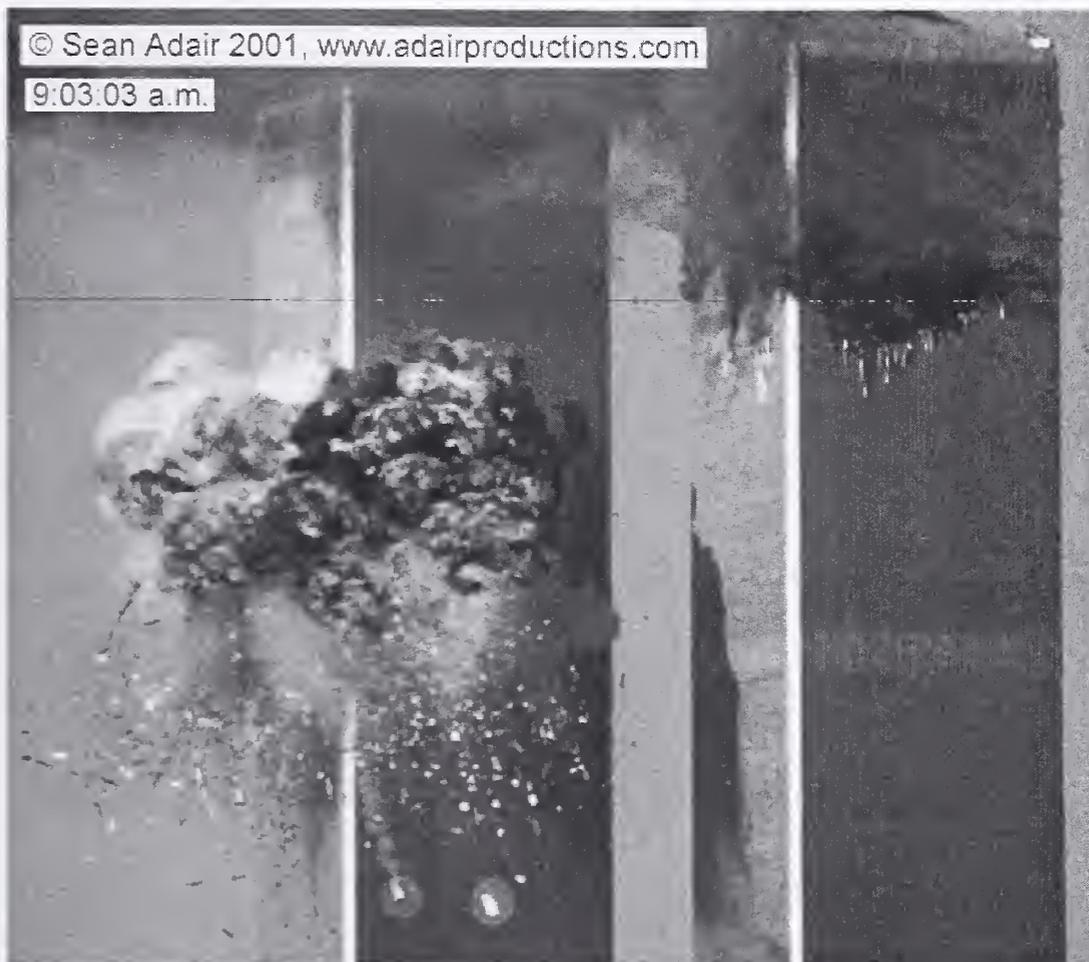
Figure 7-5. An image of the towers recorded from the north northeast is shown. The photograph was taken 4.3 s after the aircraft impact on WTC 2. Highlighted areas show two large pieces of aircraft debris that passed through the building and landed in the vicinity of the Church and Murray Streets intersection.

Videos and photographs indicate that several pieces of the aircraft passed all the way through WTC 2 and exited at high speeds from the north side. Most of these were relatively small, but at least two were of substantial size. These two objects are highlighted in Figure 7-5. Both large pieces left smoke trails that formed parabolas as they fell to the ground. The object on the right was burning, and videos show that the flames suddenly grew dramatically and formed a long tail after the debris had passed by WTC 1. The object on the left, i.e., to the east, was spiraling as indicated by the smoke trail it left behind.

It is likely that the two large aircraft pieces visible in Figure 7-5 are the part of an engine and the landing gear subsequently identified. If correct, this means the two large aircraft pieces highlighted in Figure 7-5 landed at the corner of Church Street and Murray Street and 45 Park Place. The resting locations of the debris indicate the spiraling object was the engine (a plausible conclusion based on the shape of the component in Figure 7-34), and the flaming component was the landing gear.

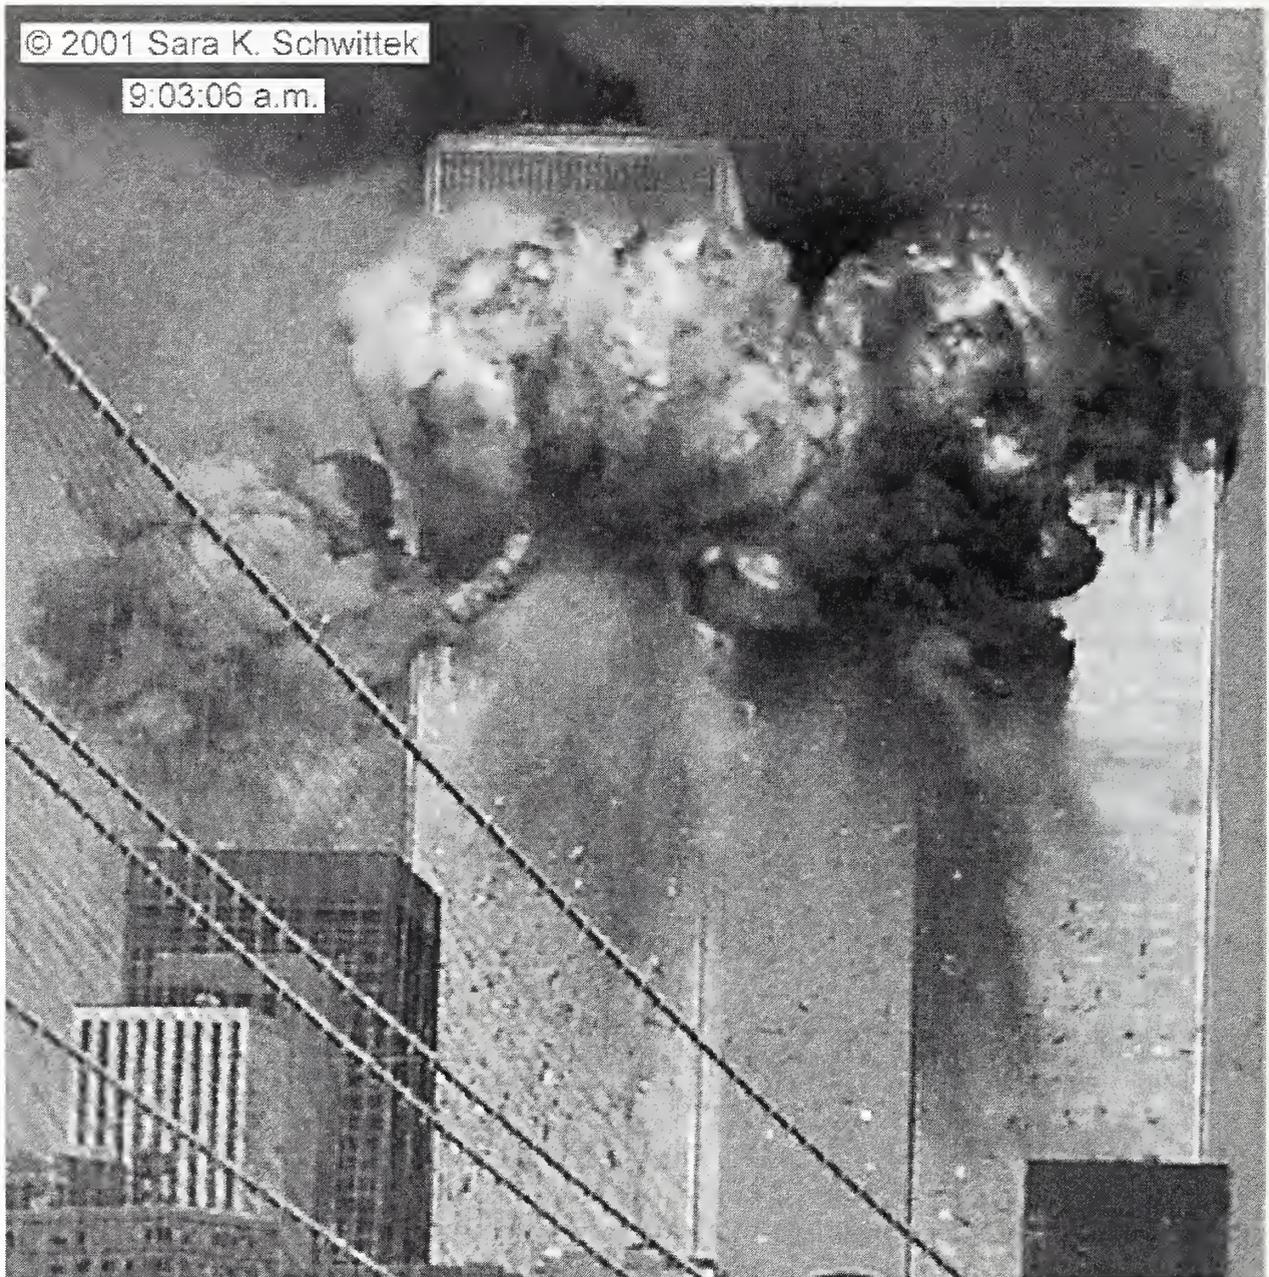
Figure 7-6. This cropped image of the towers recorded 6.5 s after the aircraft impact on WTC 2 was shot from the east on the opposite side of the East River in Brooklyn.

A variety of photographs and videos indicate that, during the 5 s to 10 s period following the aircraft impact, intense flames extended from windows on the south face, east face, and north face of the tower. Examples of these flames can be seen in Figure 7-6 to Figure 7-8. The most intense flames were located on the south face and east face near the southeast corner of the 82nd floor, on the east face near the northeast corner, and on the north face near the northeast corner on the 81st floor. These flames increased in intensity after the formation of the fireball, with the largest flames observed roughly 8 s after impact.

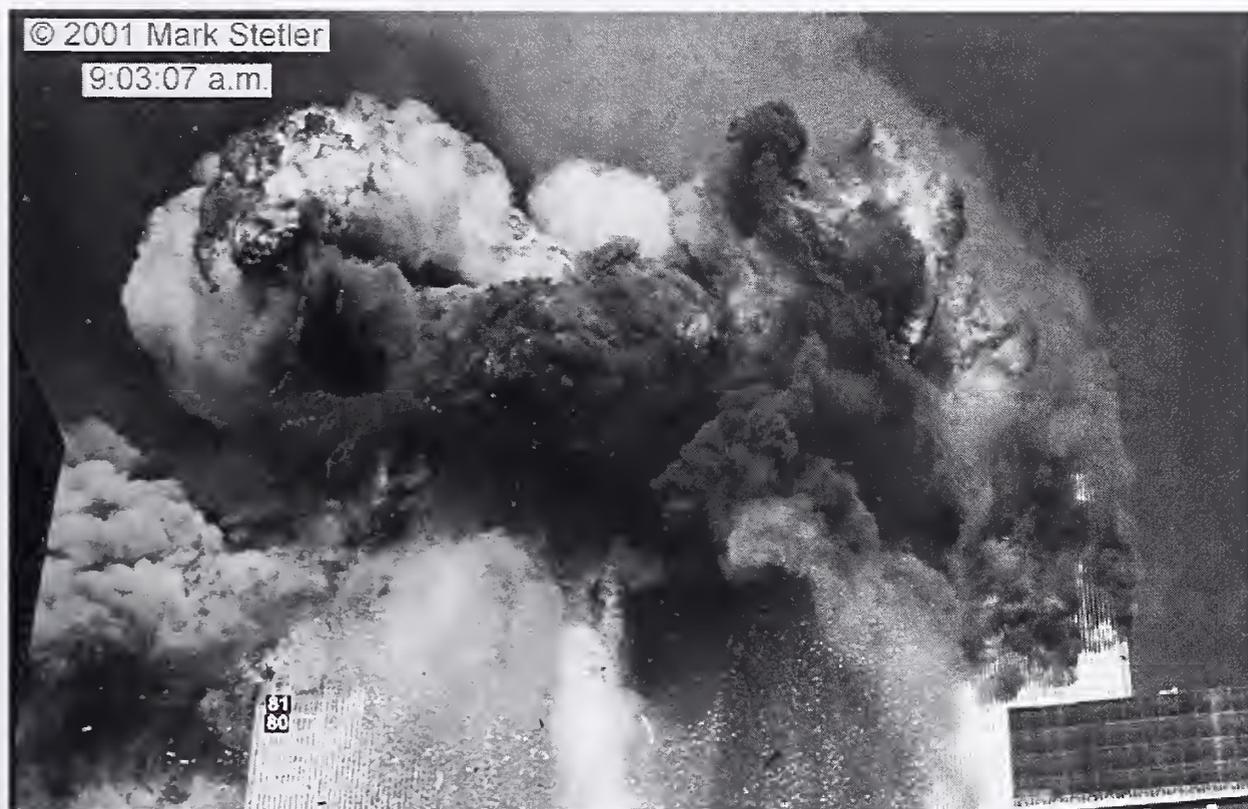
Figure 7-7 is an image recorded 7.9 s following the aircraft impact from the same perspective as Figure 7-4. The large fireball formed by the rapid expulsion of aviation fuel from the tower immediately following the aircraft impact has continued to rise and has begun to separate from the release point. Intense flaming is still seen in the vicinity of the building where the aircraft impact occurred. Even though significant façade damage is evident on the south side of the east face over three floors (80th, 81st, and 82nd), flames are emanating primarily from the 82nd floor windows. It is possible that flaming from higher windows is also occurring, but is hidden. Similar flaming is evident on the south and north faces.

Dark regions are beginning to show over large areas of the fireballs, particularly at lower locations. These dark regions are due to heavy smoke. As time passes the dark surface areas grow larger, while areas of orange flames become relatively smaller.

Figure 7-7. An image of WTC 2 recorded from just north of due east is shown. The photograph was taken 7.9 s after the aircraft impact on the tower. The locations of the 80th and 81st floors are identified

Large amounts of debris and dust are falling from the central region of the east face. Some of this debris is higher than the aircraft impact floors. This indicates that a portion of the debris that was expelled from the building was initially carried upward by the fireball. Since the debris is heavier than air, it eventually loses its upward momentum and drops from the bottom of the fireball.

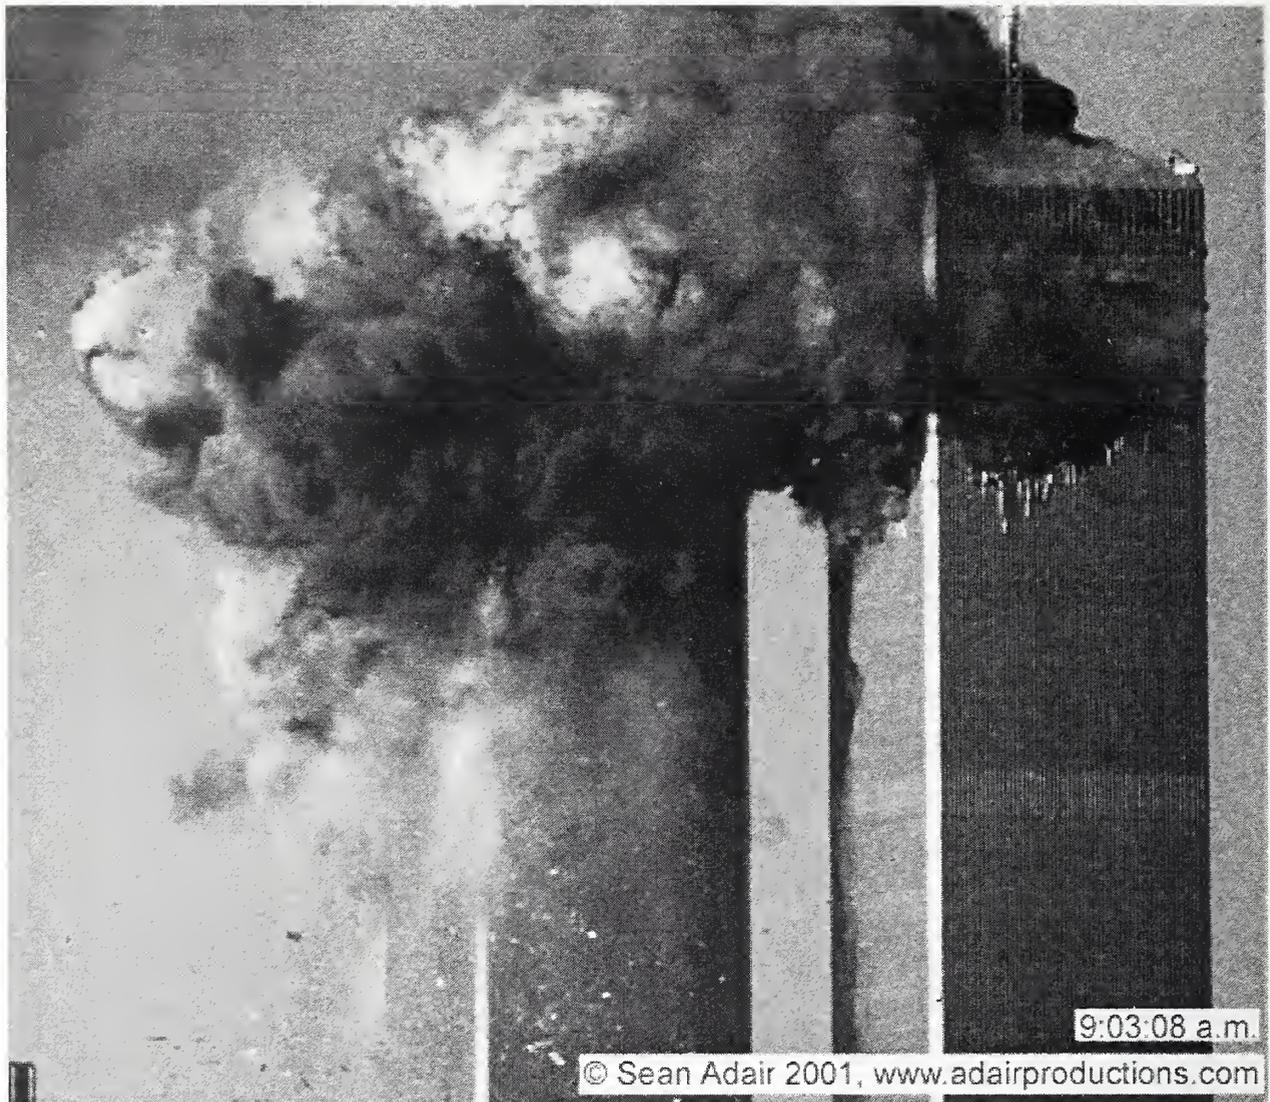
Figure 7-8 shows a northern view of the fireball taken 8.7 s after the aircraft impact. The perspective is the same as in Figure 7-5. The appearance of the fireball is consistent with that described for Figure 7-7, but the amount of visible flame in the fireball appears to be significantly reduced, indicating that it is beginning to burn out. There appears to be a large amount of debris falling on the northeast corner of the tower and considerably less from regions of the north face more toward the center. The falling debris on the northeast corner is evident in Figure 7-7 as well. Similar to the east face photographs shown in Figure 7-6 and Figure 7-7, which were taken at roughly the same time, significant flaming from the tower is evident below the fireball in the vicinity of the aircraft impact location.

Figure 7-8. An image of the towers recorded from the north northeast is shown. The photograph was taken 8.7 s after the aircraft struck WTC 2.

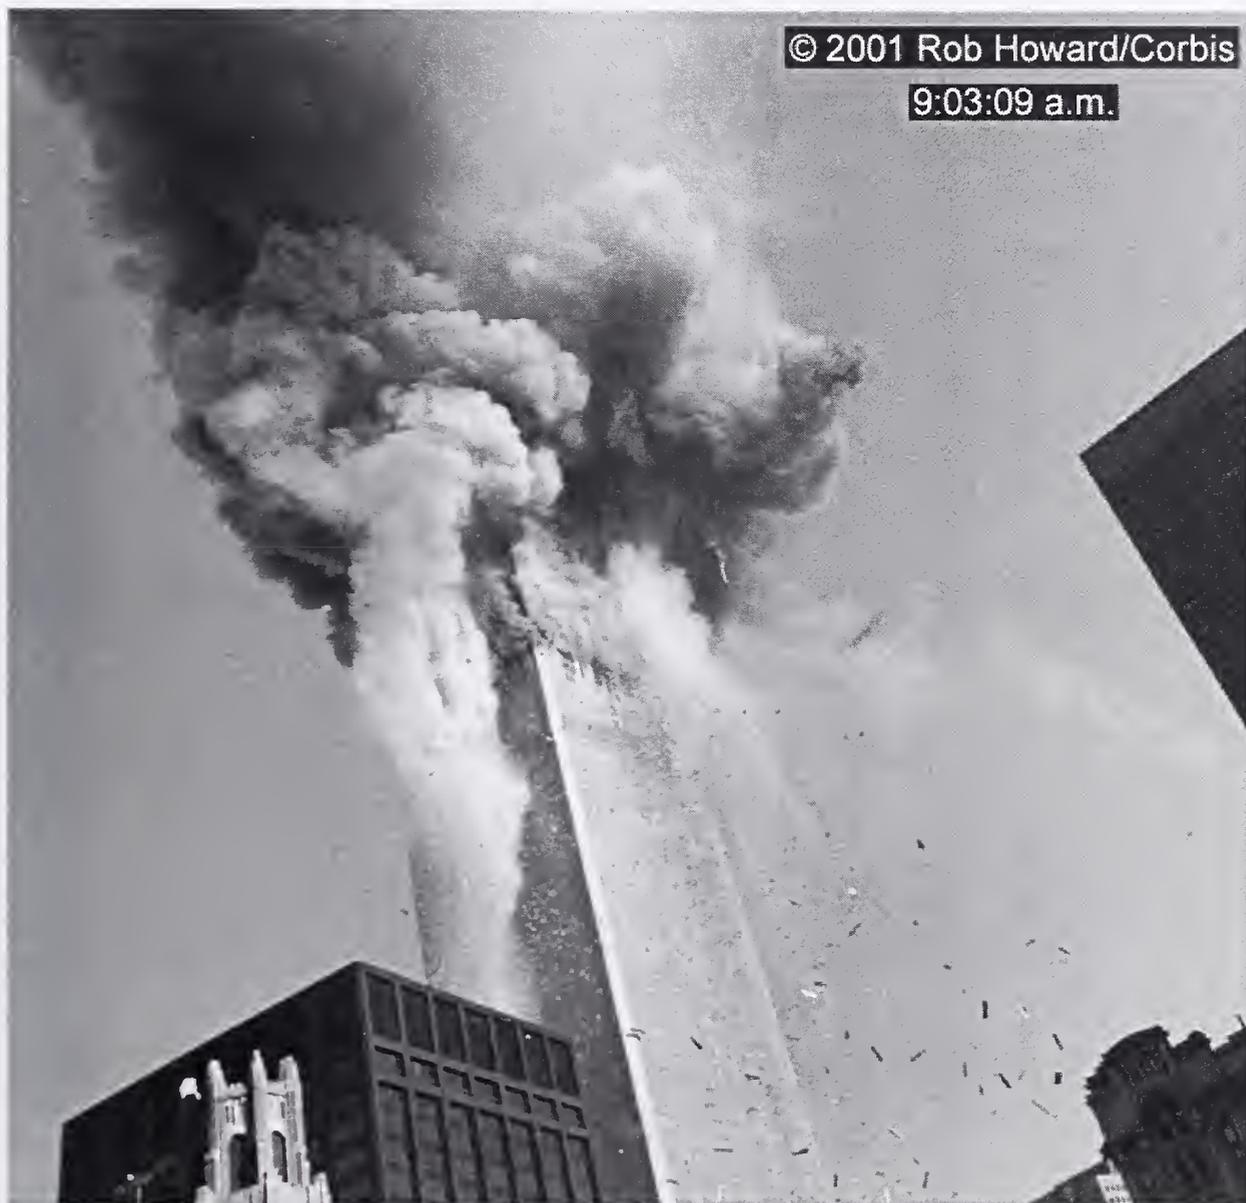
Figure 7-9, taken 10 s after the second aircraft struck WTC 2, shows the debris and dust clouds on the south and east faces of WTC 2. The cloud on the south face is much larger than that on the east face. This is consistent with the conclusion that more debris was expelled from the south face than from either the east face or north face. The observation of a smaller, shorter-lived fireball on the south face suggests that less fuel was consumed by this fireball than those on the east face and north face.

Figure 7-9. This cropped black and white photograph was recorded from the southeast of WTC 2 10 s after the second aircraft impact.

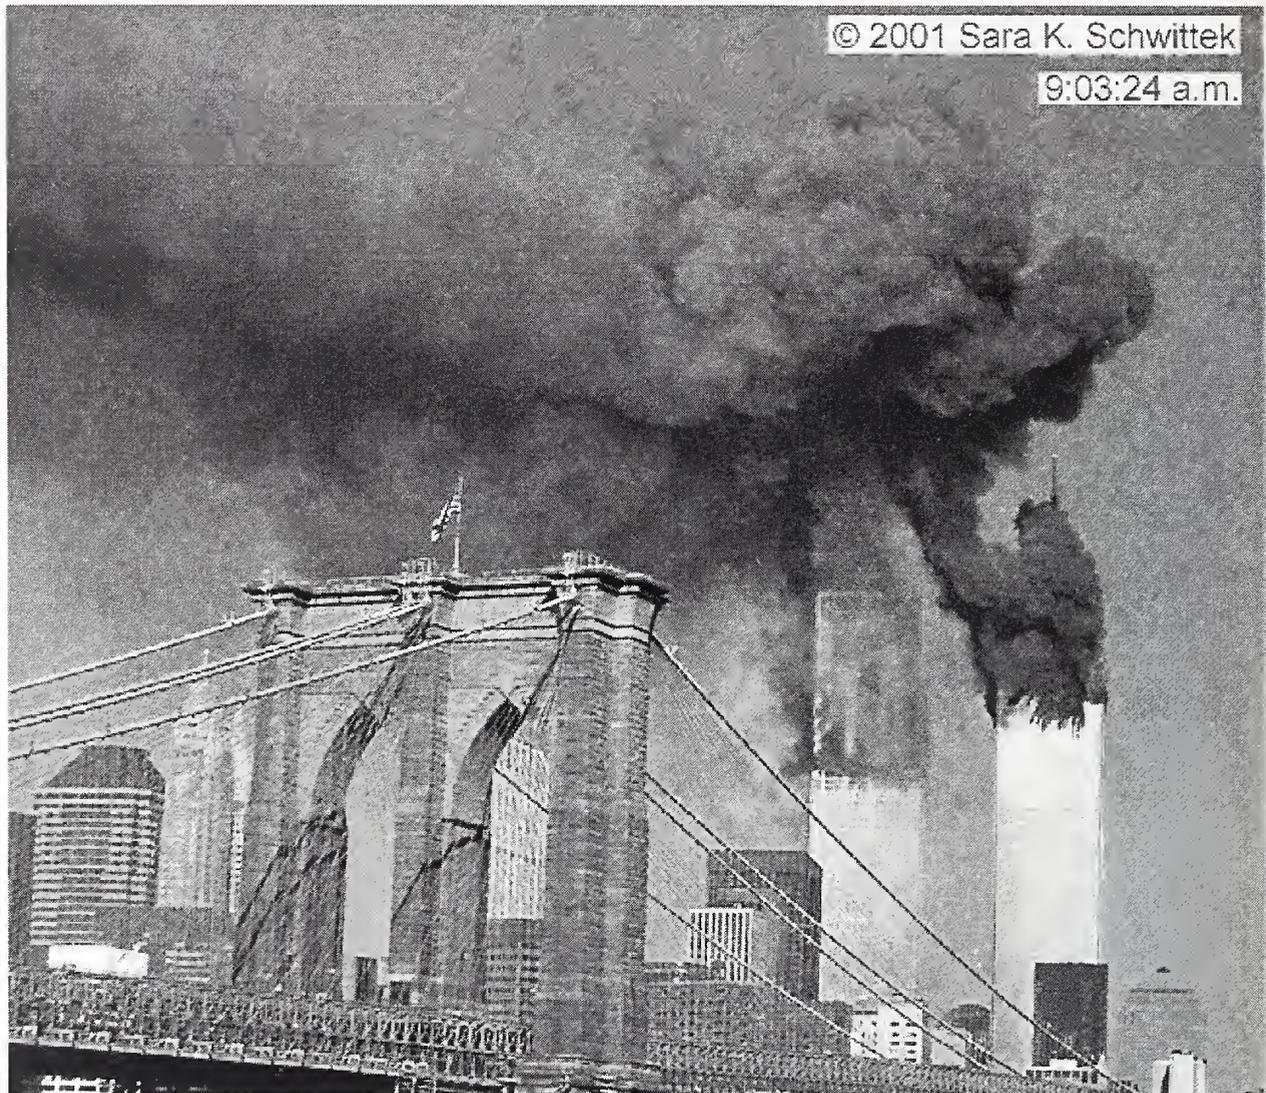
After the flames in the rising fireball extinguished, the heated gases continued to rise, ultimately forming a distinct mushroom cloud. In this report the structure formed by these hot gases from a fireball is referred to as a “thermal” in order to distinguish it from the smoke plumes created by fires burning within the buildings and from the fireballs, which contain flame. Figure 7–10 shows the appearance of the thermal shot from the east from across the East River at 9:03:24 a.m. or 25 s after the aircraft impact. A view of the thermal from the west is shown in Figure 7–11. The exact time of this photograph has not been determined, but it was taken between three and four minutes after the aircraft impact. By simply using the known heights of the towers (roughly 1,365 feet), it is possible to estimate that the center of the head of the thermal had risen more than 1,400 feet in this period of time.

Figure 7-10. This cropped photograph recorded at 9:03:24 a.m., i.e., 25 s after the aircraft impact on WTC 2, shows the nascent thermal created by the fireballs on WTC 2. The intensity levels of the image have been adjusted.

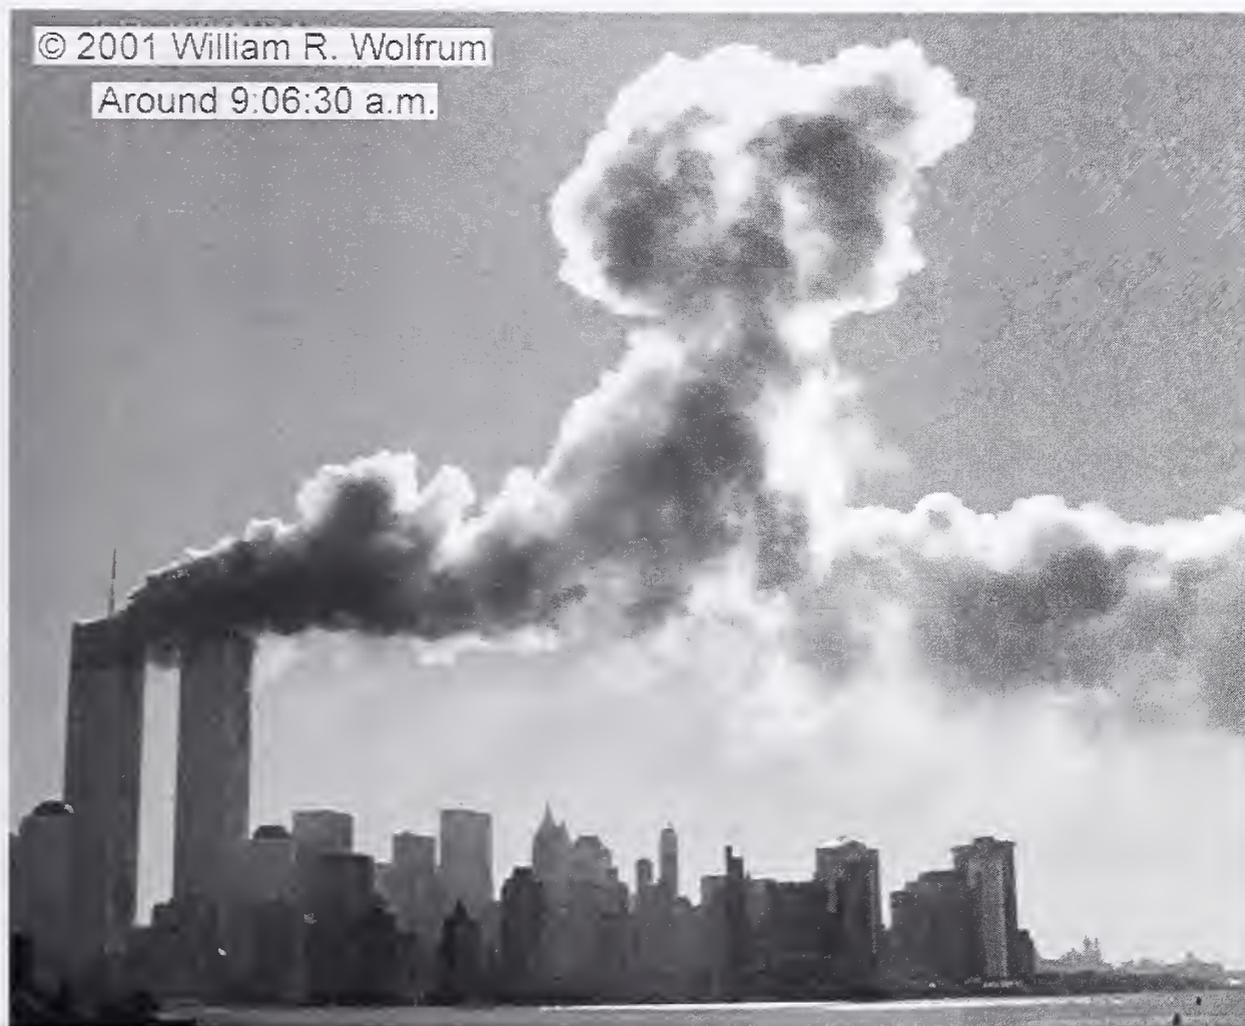
Figure 7-11. This cropped photograph shows the thermal created by the aircraft impact and subsequent fireballs on WTC 2. The picture was shot from across the Hudson River to the west southwest of the WTC complex.

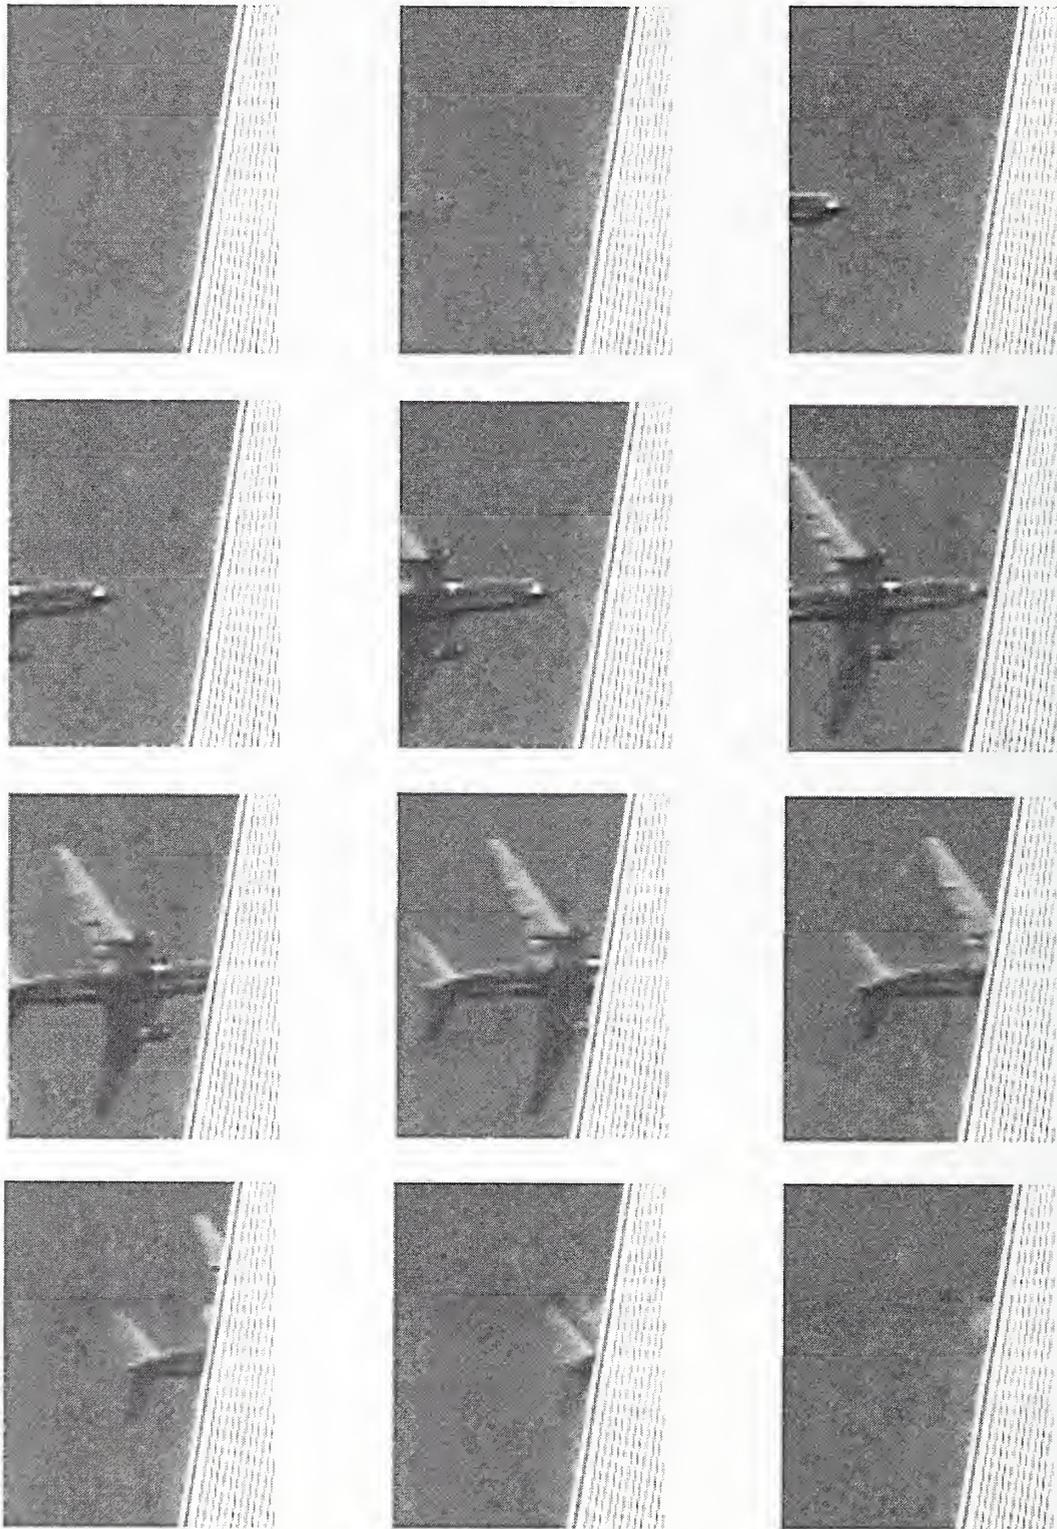
Figure 7-12 shows a series of cropped frames captured from the video shot from the east that shows the aircraft approaching WTC 2 and disappearing inside. These images have been used to determine the speed of the aircraft as it approached the tower. This was done by identifying the locations of the nose and tail of the aircraft relative to a fixed point defined to be the location on the frames where the aircraft passes out of sight behind the corner of the building. The aircraft was very nearly level relative to this point, so it is appropriate to simply count the number of picture elements, pixels, between this location and the two measurement points on the aircraft.

Figure 7-12. Series of sequential cropped frames taken from a video shot on September 11th showing the aircraft approaching WTC 2. The frames, ordered from left to right and top to bottom, are separated by 33.3 ms.

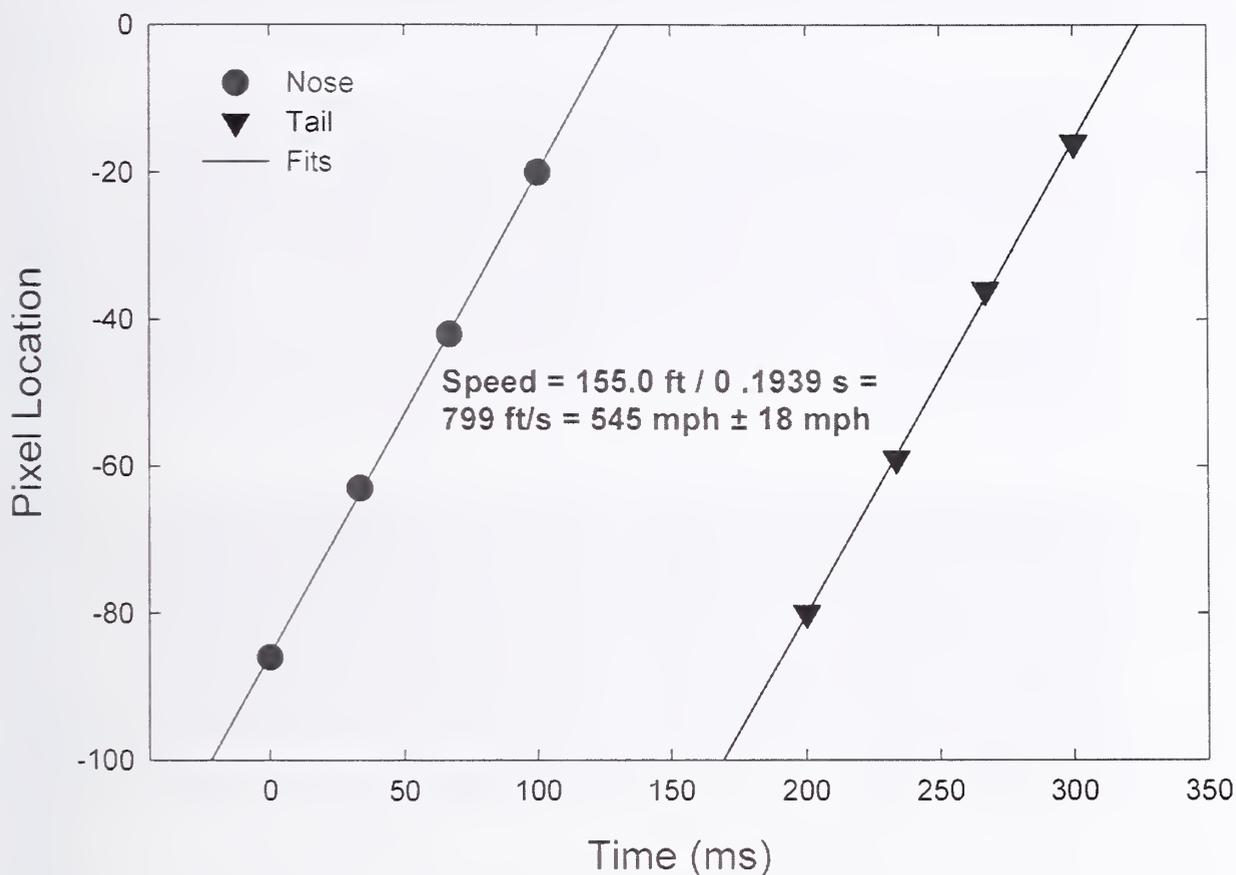
Figure 7–13 shows the pixel locations of the two points as a function of time. Using linear least squares curve fits, it was possible to estimate the exact relative times when the nose and tail pass the reference location. The difference between these two times is the period required for the entire length of the aircraft to pass the reference location. The result is 0.1939 seconds. Since the distance between these two locations on the aircraft is known to be 155.0 ft, the average speed can be estimated by simply dividing this length by the passage time to give $155.0 \text{ ft} / 0.1939 \text{ s} = 799 \text{ ft/s} = 545 \text{ mph}$. An uncertainty estimate based solely on the uncertainty in the determined time difference yields a value of $\pm 18 \text{ mph}$, with 95 % confidence.

Figure 7-13. Plots of pixel locations for the nose and tail of the aircraft that struck WTC 2 as a function of time taken from the images shown in Figure 7–12. Straight lines are the results of linear least squares curve fits to the data. Extrapolation of the lines to pixel 0 allows the time for the passage of the aircraft to be calculated.

The speed estimated using this approach can be compared with a value of $542 \text{ mph} \pm 24 \text{ mph}$ reported in NIST NCSTAR 1-2B, which was derived using a more sophisticated motion analysis of several videos available in the data base. The two values agree well, and the difference easily falls within the estimated uncertainties. These two estimates are compared with other published speeds in NIST NCSTAR 1-2B.

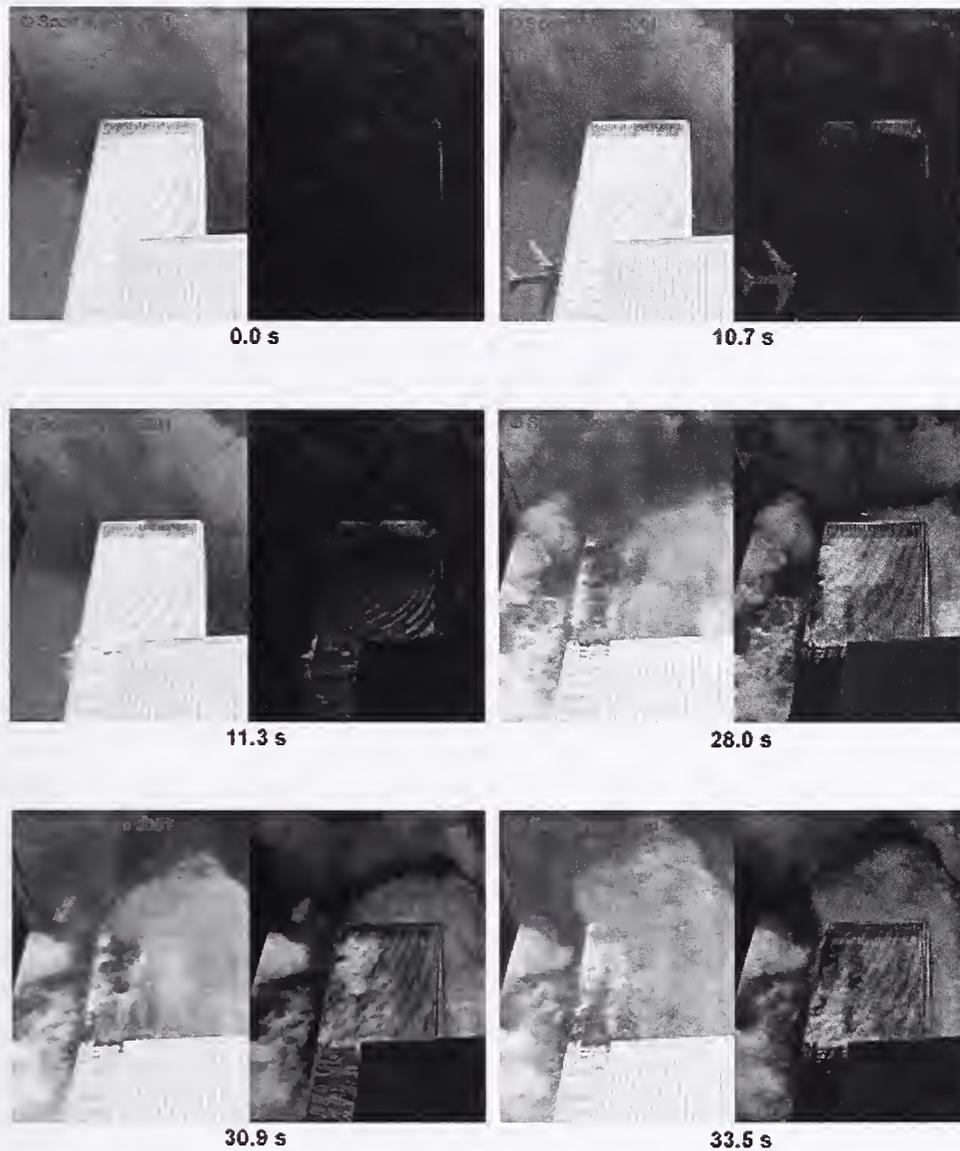
When this approach was applied to the video, a region of windows was observed on the building that seemed to appear and disappear. Figure 7–14 shows several frames of a composite video formed by overlaying half frames of the original video and the difference video. In the initial frame (time = 0.0 s) the aircraft has not yet appeared, and the difference frame is black. In the next frame (time = 10.7 s) the aircraft is approaching the building. The aircraft is evident in the difference frame since it represents a change in the frame. WTC 2 is still dark except near the top where changes due to smoke movement are apparent. In the third frame (time = 11.3 s) the aircraft has struck the building and dramatic changes in the appearance of the building façade in the difference frame are evident. Close inspection shows what appear to be curved lines running across the face of WTC 2. These curves result from an interaction between the straight lines formed by the windows and columns on the tower and the straight lines of picture elements (pixels) that make up the detector in the digital video camera. This well known behavior is called the moiré effect. As discussed in the following section, the moiré effect provides a sensitive approach for determining the displacement of the building as a function of time and allows a detailed analysis of the various oscillation frequencies of the tower following the aircraft impact.

Figure 7-14. Frames from a composite video are shown. The half frames on the left are taken from a video showing the aircraft impact on WTC 2, while the half frames on the right are generated by subtracting a frame recorded prior to the aircraft impact from all subsequent frames in the original video. Times refer to the period since the start of the difference video.

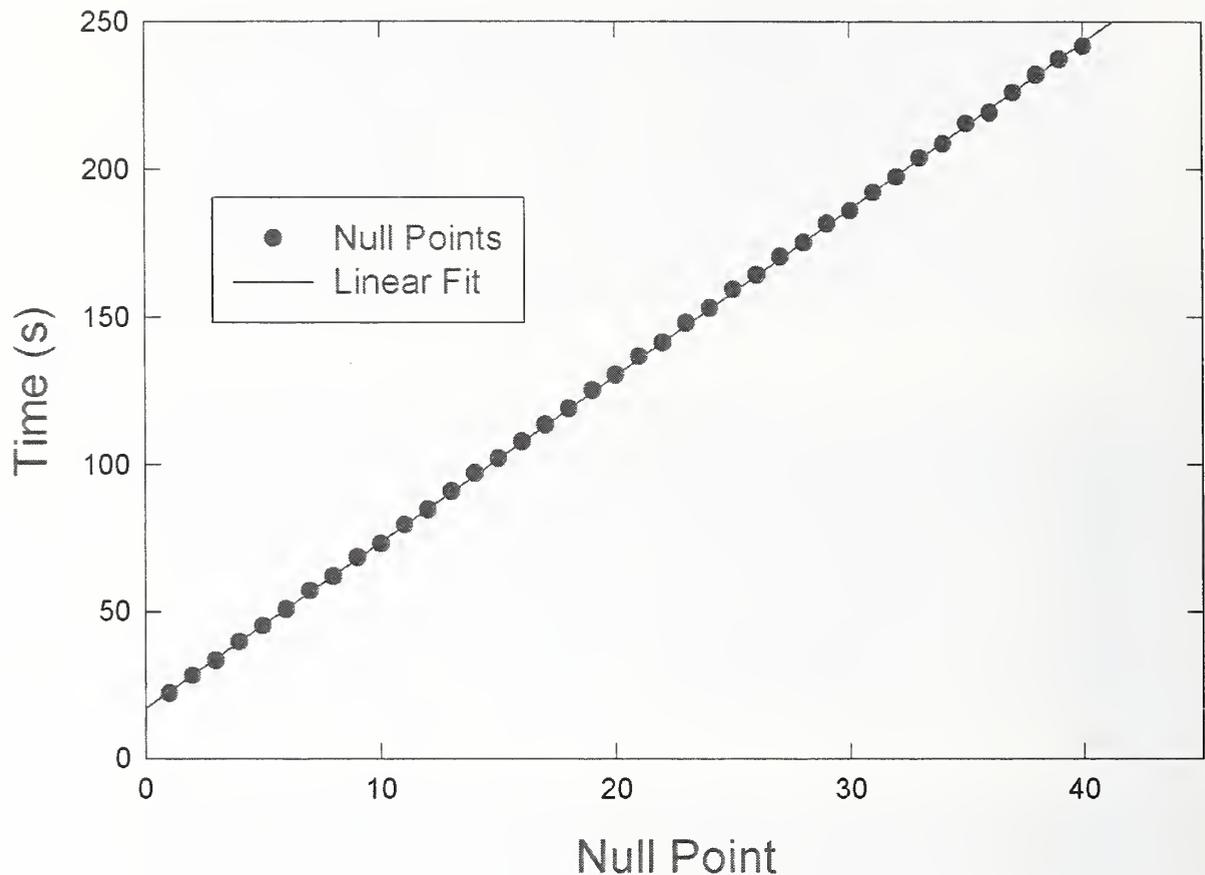
Since the absence of color is easiest to identify, it is straight forward to determine times when the null points occur in the difference video. Figure 7–15 shows a plot of time versus null point number obtained from the difference video. The points fall on a straight line having a slope of $5.647 \text{ s} \pm 0.008 \text{ s}$ (95 % confidence interval). Since the building passes through a null point twice during a single full oscillation, the period required is 11.3 s.

Figure 7-15. The time when null points are observed in the difference video of WTC 2 are plotted versus the null point number. The points fall on a straight line having a slope of $5.647 \text{ s} \pm 0.008 \text{ s}$.

The measured oscillation period is consistent with measurements that are available from WTC 1, accounting for the difference in orientation of the cores in the two buildings, which yielded average periods of 10.9 s in the east-west direction (averaged over a 9-year period that ended in 1993) and 11.6 s in the north-south direction (averaged over a 14-year period that also ended in 1993). (NIST NCSTAR 1-2) The value also agrees well with that determined for the primary period using the moiré analysis in the following section.
