**NIST NCSTAR 1-5A
Federal Building and Fire Safety Investigation of
the World Trade Center Disaster**

**Visual Evidence, Damage Estimates,
And Timeline Analysis**

Visual Evidence, Damage Estimates, and Timeline Analysis

September 2005

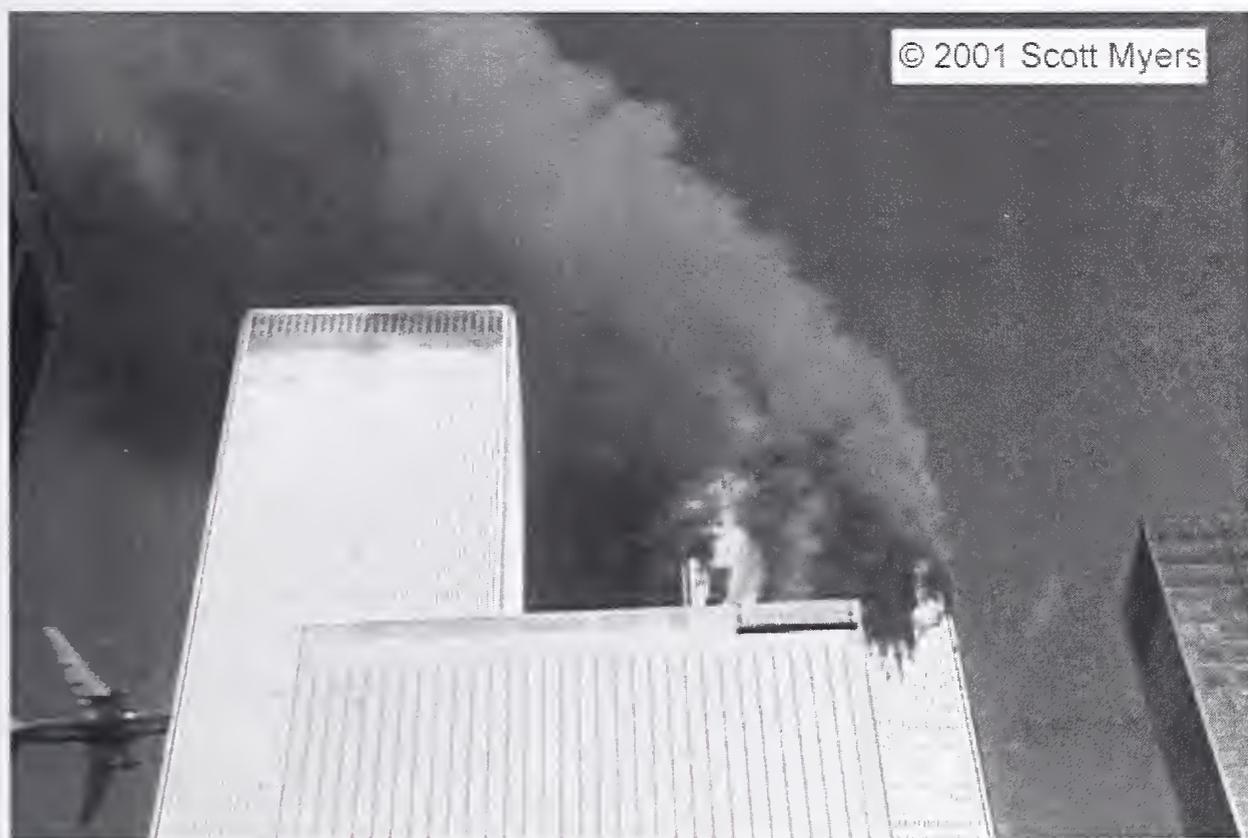
Figure 7–16 shows a single frame from the video shot from the east as the aircraft impact on WTC 2 was taking place at 9:02:59 a.m. The video was filmed from a thirteenth-floor balcony located approximately 1,000 ft to the east and slightly north of WTC 2. WTC 2 appears to the left of the frame, WTC 1 to the right, and overlapping both towers in front is 22 Cortlandt Street, a 34-story office building located across from the WTC on the east side of Church Street. The lowest point of WTC 2 visible in the frame is the 70th floor. The camera was mounted on a tripod and was undisturbed for thirteen minutes prior to the aircraft impact on WTC 2 and for eleven minutes afterward. This period was sufficient to track the oscillations of WTC 2 induced by the impact until they had faded to background noise.

Figure 7-16. A single frame taken from a video shows the aircraft impact on WTC 2 at 9:02:59 a.m.

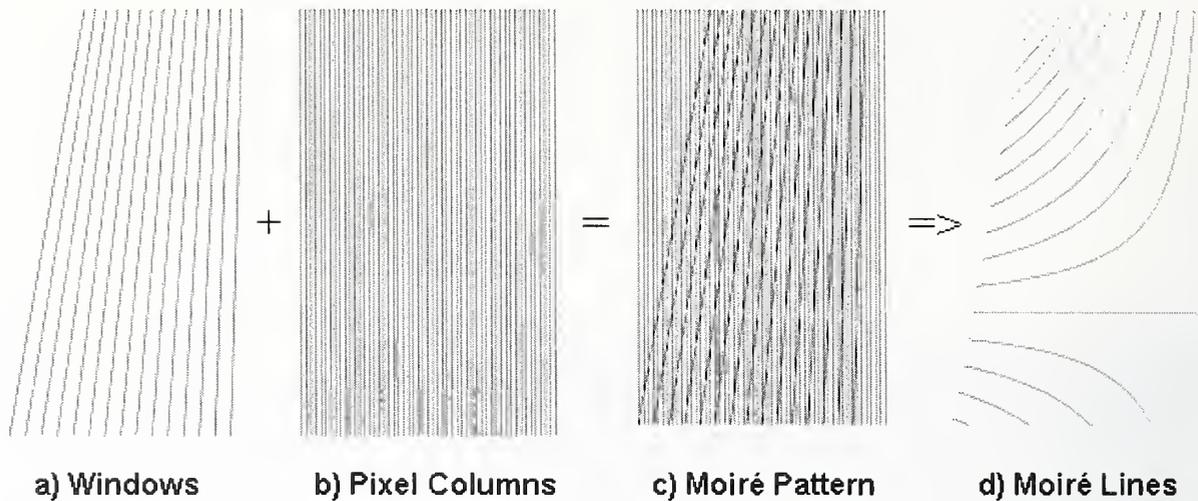
The moiré effect occurs when two images containing closely spaced lines are superimposed, generating interference patterns that attract the eye. Figure 7–17 demonstrates this effect for conditions chosen to mimic those present in the video. In the case of the video, the two line patterns are the set of lines on the WTC 2 façade formed by the alternating columns and windows, as indicated in (a) and the vertical columns of picture elements (pixels) that form the images recorded by digital video cameras, shown in (b). The superposition of the sets of lines results in the visual appearance of light curved lines shown in (c)—a moiré fringe pattern—that appears in the recorded image. The set of curves in (c) and (d) can be observed in Figure 7–14, especially in the difference frame at 11.3 s, and in Figure 7–16.

Figure 7-17. Drawings demonstrate the formation of a moiré fringe pattern (c and d) by the superposition of the lines on a tower façade (a) with the vertical columns of picture elements (pixels) of a digital camera.

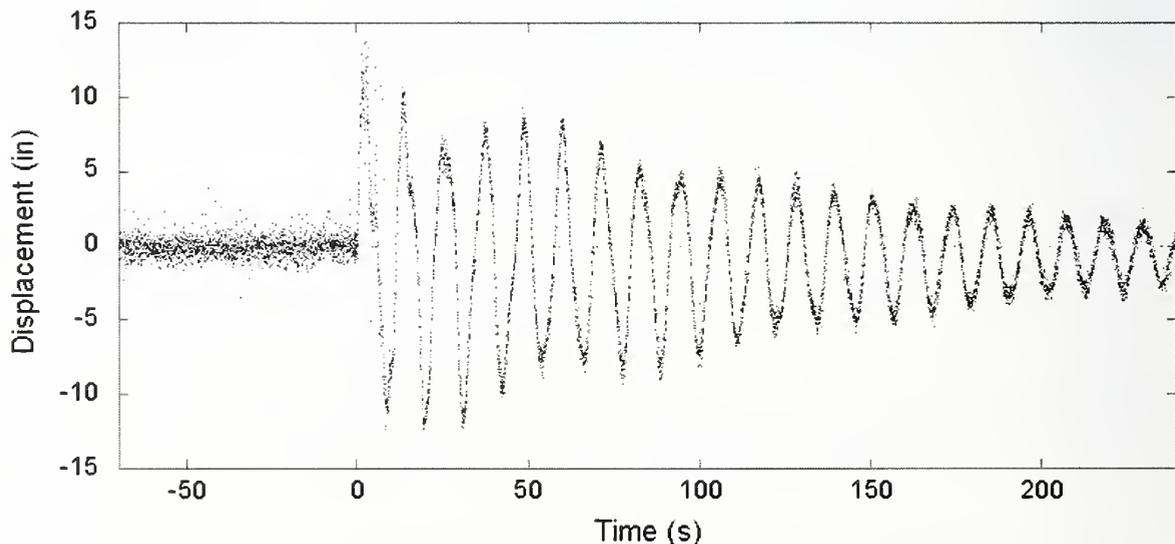
Figure 7-18. The displacement of the first (left-most) window line on the 70th floor of WTC 2 determined using moiré analysis is shown as a function of time.

Detailed frequency analysis of the displacement data shown in Figure 7-18 revealed the fundamental north-south mode with a period of 11.4 s, a torsional mode with a period of 5.3 s, and two higher frequency modes with periods of 3.9 s and 2.2 s. All periods are accurate to better than ± 0.1 s. The period of the fundamental mode is comparable to the computational value for WTC 2 and within normal expected variations as evidenced by measurements on WTC 1 (NIST NCSTAR 1-2). The torsional mode dominates the window spacing variation, as twisting of the building makes the camera's viewing angle of the east face alternatively more and less perpendicular. The highest frequency mode causes some jerkiness in the motion over the first few oscillations.

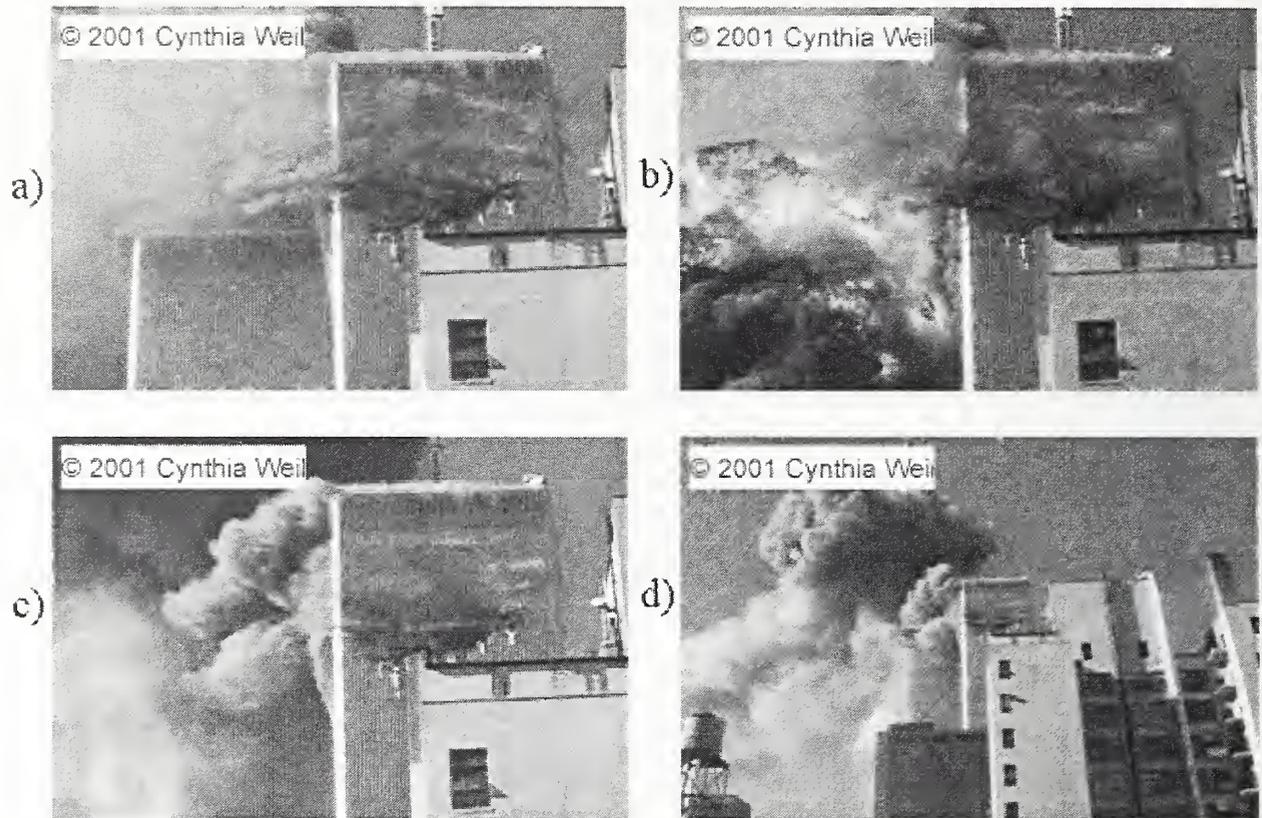
A second video, filmed from the north with the camera mounted on a tripod, provided an opportunity to determine the east-west motion of WTC 2 for a brief period following the aircraft impact. The four frames in Figure 7-19 illustrate the appearance of the video from this time. Frame (a) from just before impact shows the composition, with the top floors of WTC 1 and WTC 2 filling much of the frame. The base of the frame corresponds to the 94th floor of WTC 2. WTC 2 was observed to move for about seven seconds, first to the west then east, until the fireball covered the visible surface of WTC 2, as in frame (b). Frame (c) shows that the smoke gradually cleared from the west (right) side of the north face, allowing the building motion to once again be followed. Unfortunately, the camera zoomed back from the initial view about 19 s after the aircraft impact, as can be seen in frame (d), resulting in the loss of detail necessary for the moiré analysis.

Figure 7-19. These four frames are taken from a video shot from the north around the time of aircraft impact, 9:02:59 a.m., on WTC 2.

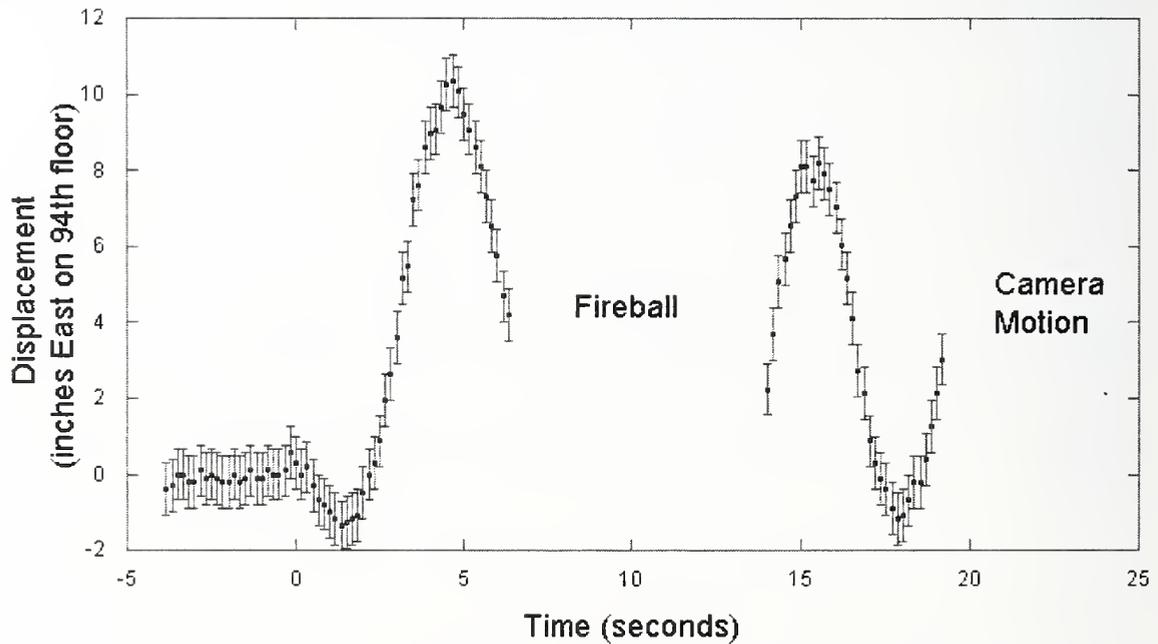
Although the motion of WTC 2 in this video covers less than a pixel width horizontally, the moiré pattern for the nearly vertical lines of windows greatly amplifies this motion. Figure 7-20 shows the calculated east-west displacement of the 94th floor of WTC 2, with a total apparent sway of 12 in. \pm 2 in. A frequency analysis of this brief set of data yielded a period of 5.3 s. This is consistent with the torsional mode found in the analysis of north-south motion and can be explained as follows. The aircraft struck WTC 2 on the south face off-center toward the east while moving toward the northeast relative to the tower. As a result, the tower was twisted in the counter-clockwise direction as seen from above, i.e., the aircraft impact imparted a brief angular momentum as seen from above. To an observer from the north, points on the north face appeared to suddenly move toward the west. The tower resisted this motion and tried to return to its original position. In doing so, it rotated clockwise, causing the apparent motion to the east evident in Figure 7-20. The torsional motion would have continued until it died down. It is uncertain why the estimated building motion is asymmetric relative to the original undisturbed position.

Figure 7-20. East-west motion of WTC 2 just before and after the aircraft impact. Error bars indicate measurement uncertainty.

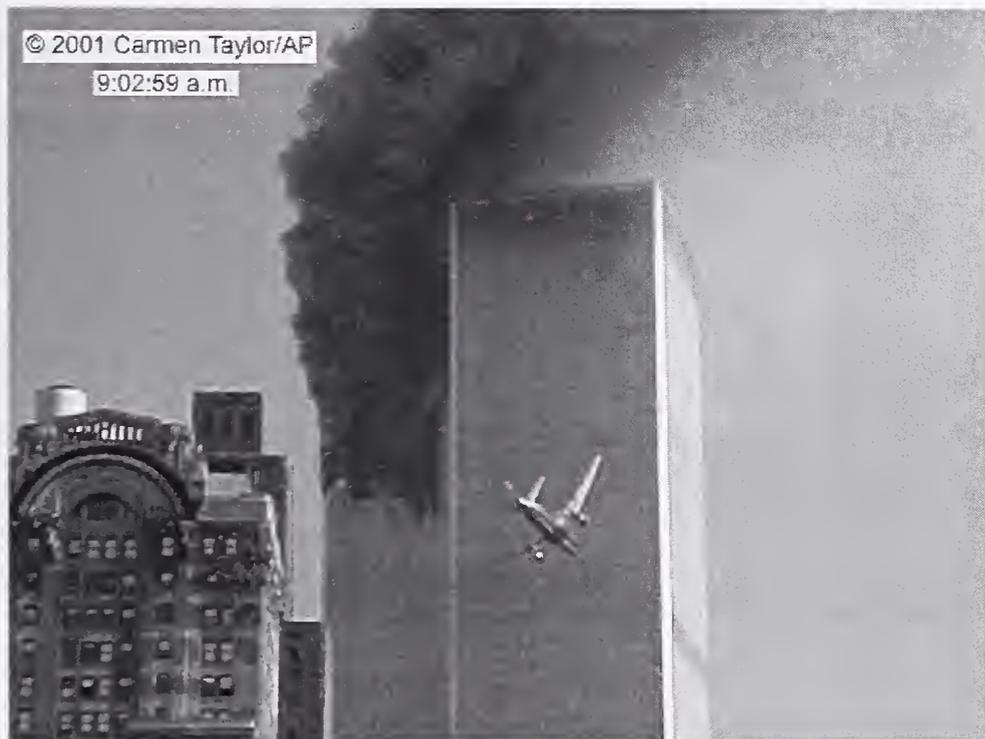
Figure 7–21 shows a photograph that was taken just prior to United Airlines Flight 175 striking WTC 2. The right wing of the aircraft is raised, as if the aircraft was turning to the left. Videos show that when the aircraft struck it appeared to disappear into the tower leaving a hole shaped like the aircraft. Very shortly after the aircraft impact, a large cloud of debris and burning aviation fuel exited the tower from the impact location, obscuring the region. Table 7–1 in Section 7.2 details some of the observations during the period immediately following the aircraft impact. As the fireball rose and the dust cloud cleared, the hole in the building became visible once again.

Figure 7-21. This photograph shows United Airlines Flight 175 just prior to its collision with the south face of WTC 2 at 9:02:59 a.m.

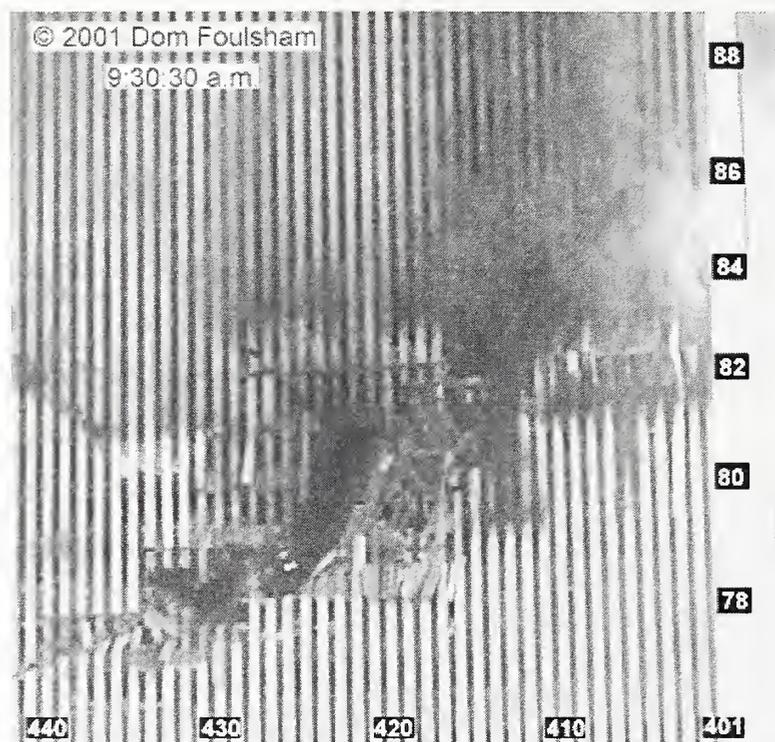
Figure 7-22. This cropped photograph shows the damage to the south face of WTC 2 caused by the aircraft impact. The image was enhanced by adjusting the intensity levels. Column and floor number have been added.

Inspection of Figure 7-22, Figure 7-23, and Figure 7-24 shows that portions of the aluminum cladding that formed the curtain wall for the building were partially or completely removed at locations close to where the aircraft impact occurred. This includes areas on the 80th floor extending from column 80-426 to column 80-431, on the 81st floor extending from column 81-425 to column 81-430, and on the 82nd floor extending from column 82-420 to column 82-426. In Figure 7-24 it can be seen that the aluminum cladding covering the southeast corner on the 82nd floor was pushed outward during the event. It is likely that this occurred as a result of the overpressure within the building generated by burning of aviation fuel released from the tanks of the aircraft. This damage provided a convenient marker for identifying the 82nd floor.

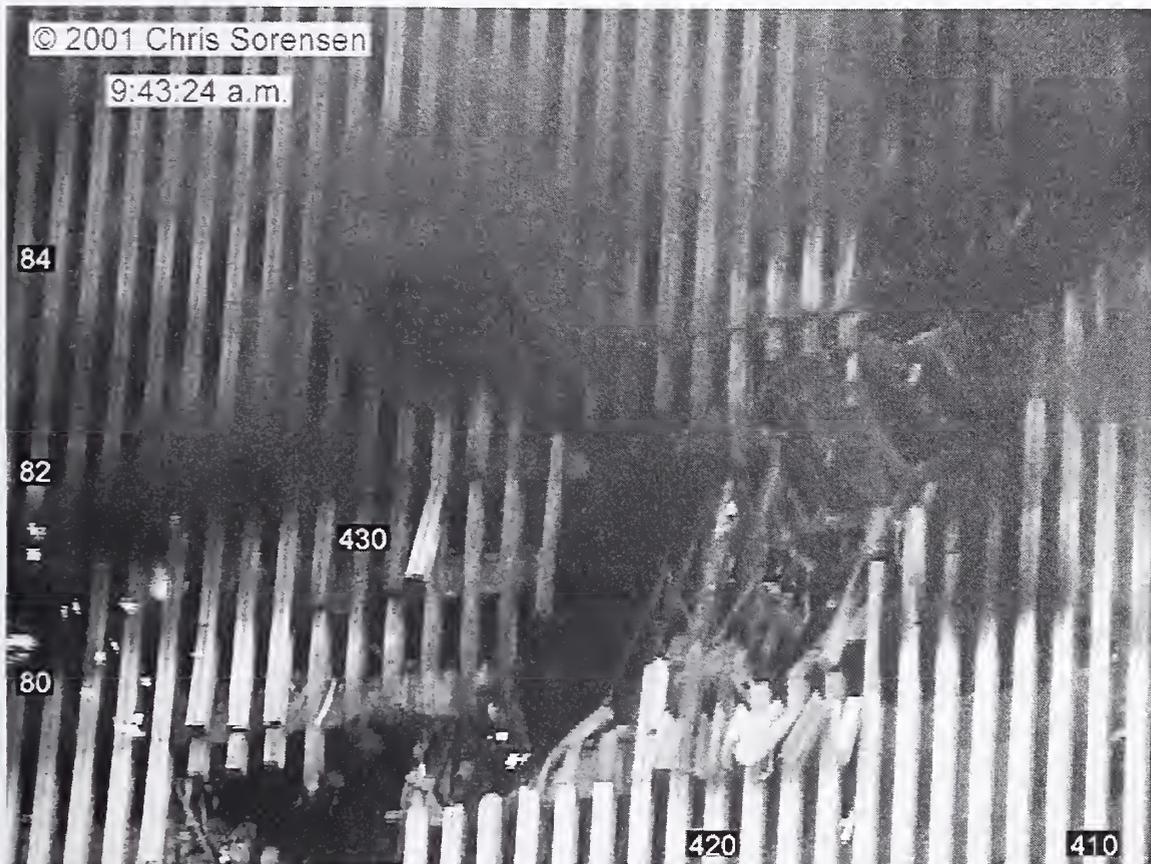
Figure 7-23. A frame captured from a video recording of the aircraft impact location on the south face of WTC 2 is shown. The image has been enhanced by adjusting the intensity levels. Column numbers and floor numbers have been added.

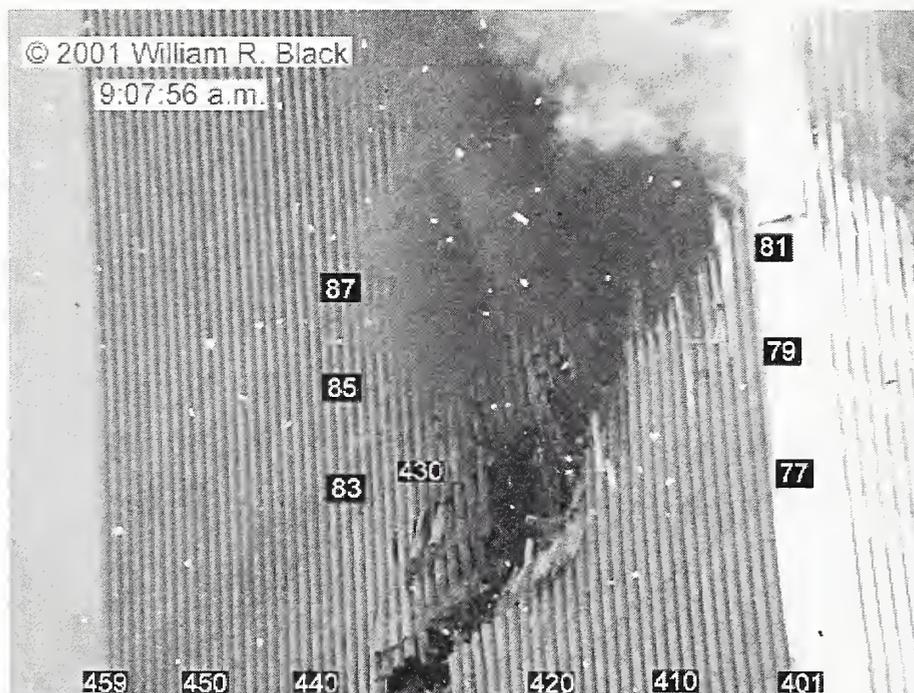
Figure 7-24. This cropped photograph shows the damage to the south face of WTC 2 caused by the aircraft impact. The original image has been enhanced by adjusting the intensity levels. Column and floor numbers have been added.

Close inspection of the photographs and videos reveals a great deal of debris piled on the right-hand side of the opening created by the aircraft impact. This debris, along with the depth of the opening, indicates that floor slabs in this area were partially collapsed by the collision. There is insufficient information to determine the exact areas over which the floor slab collapses occurred or the depth of the collapses inside the building. Visual evidence to be discussed in Section 7.4.3 suggests that at least some of the concrete in the floor slabs was pulverized during the collision.

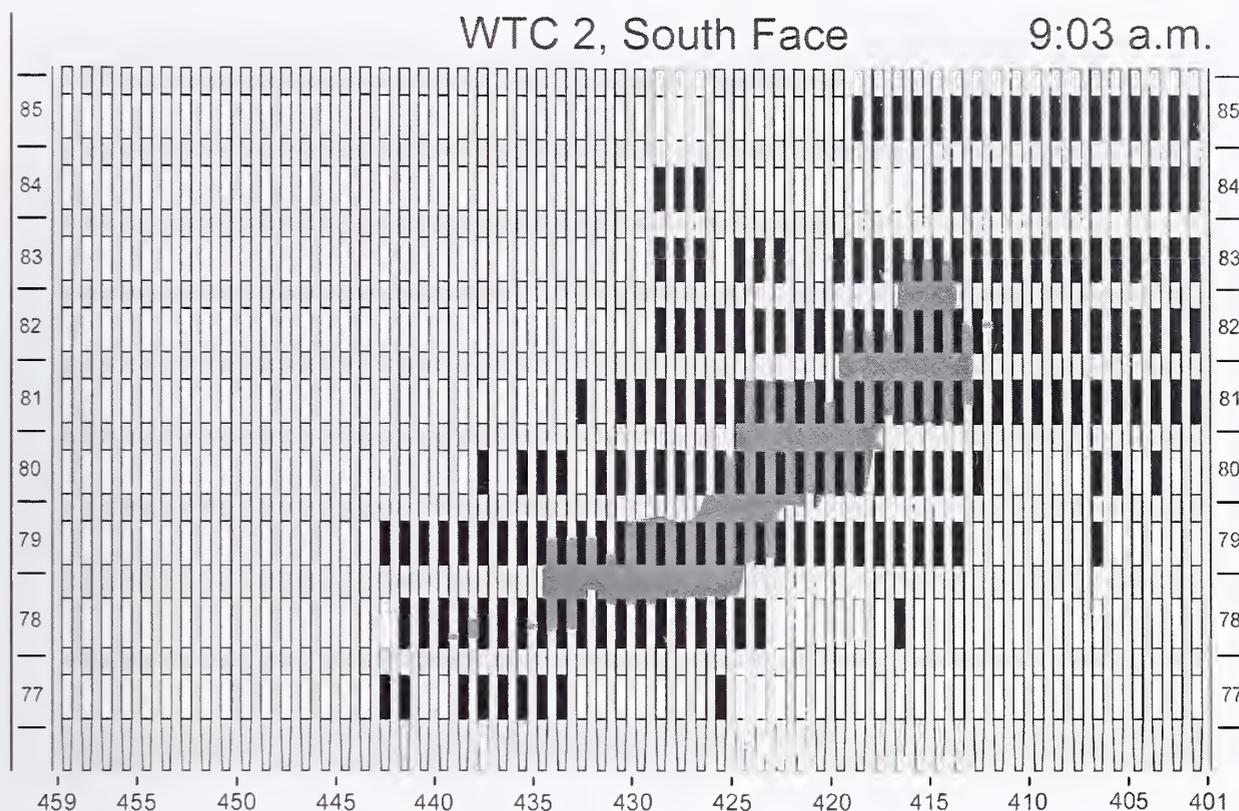
In general, the glass in windows near the aircraft impact location was broken out, while those windows further away tended to remain intact, although some windows were blown open by the overpressure generated by the initial fireball formation within the building. Figure 7-27 is a color-coded representation showing the condition of the windows on the south face in the area immediately following the aircraft impact. Note that a portion of the face was hidden by smoke at this time.

Figure 7-27. A schematic of observed window conditions on the south face of WTC 2 immediately following the aircraft impact is shown. Window and floor numbers are indicated. The colors represent ■ - window broken open, □ - glass in place, and ▒ - not visible.

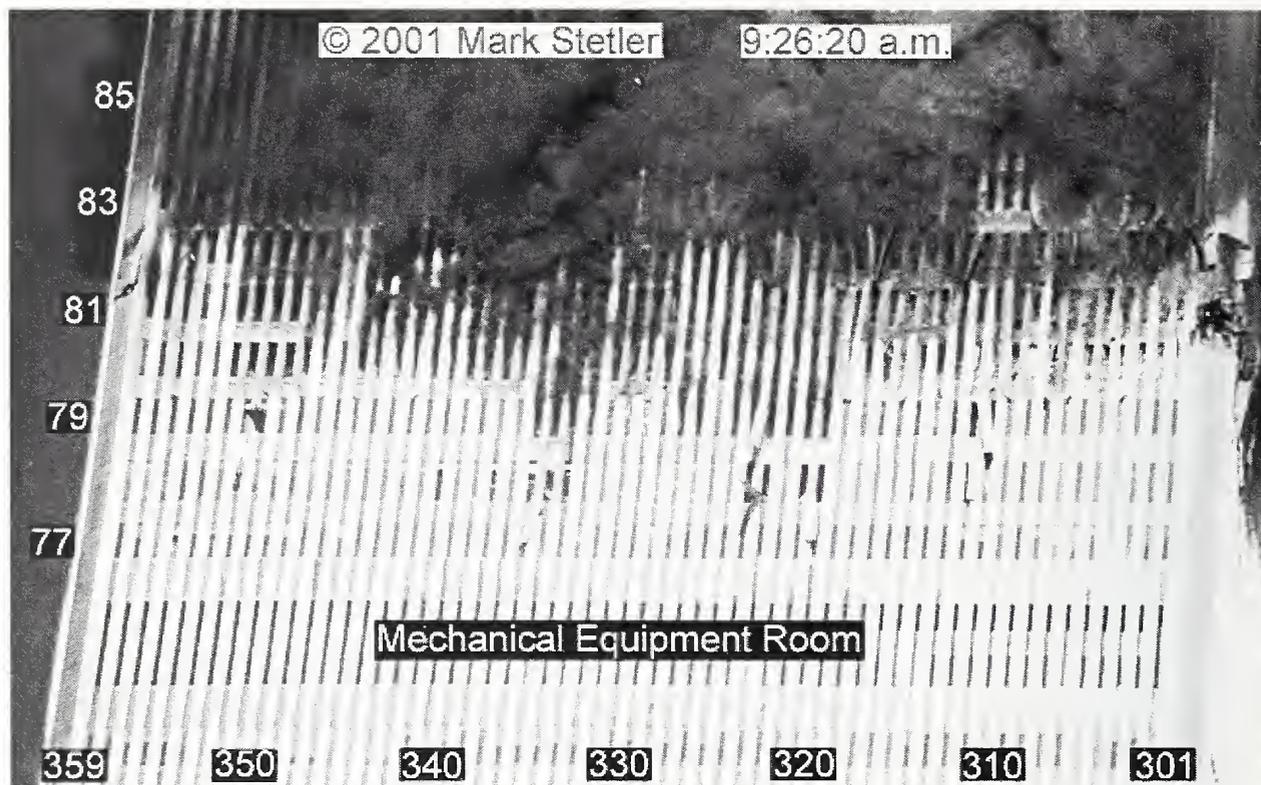
Substantial areas of the aluminum curtain wall have been removed over multiple floors. These areas appear dark due to the color of the underlying column and spandrel steel and fireproofing. In other areas the aluminum column and spandrel covers were disturbed, but remained in place. Video evidence and the wide extent of the damage indicate that much of this damage was due to the overpressures generated within the building by the sudden ignition of atomized aviation fuel and that these overpressures were sufficient to “blow off” numerous sections of the curtain wall. The potential magnitude of the overpressure generated within the tower was discussed in Section 6.5.

Figure 7-28. A cropped photograph shows the east face of WTC 2 at 9:26:20 a.m. The image has been rotated, and column and floor numbers have been added.

Figure 7-28, along with numerous other photographs and videos, was used as the basis for a detailed assessment of the initial damage to the curtain wall on the east face. Figure 7-29 shows the results. The information displayed includes details about the condition of the aluminum facing and whether or not window glass is missing or is still in place. It is apparent that the largest areas of damage were concentrated on the 80th, 81st, and 82nd floors. Based on Figure 7-26, these correspond to the two floors struck by the body of the aircraft (80th and 81st floors) and the floor where the majority of fuel from the starboard fuel tank was dumped (82nd floor). Interestingly, much less damage is apparent on the 79th floor, which is the floor where most of the fuel from the aircraft's port tank should have been released.

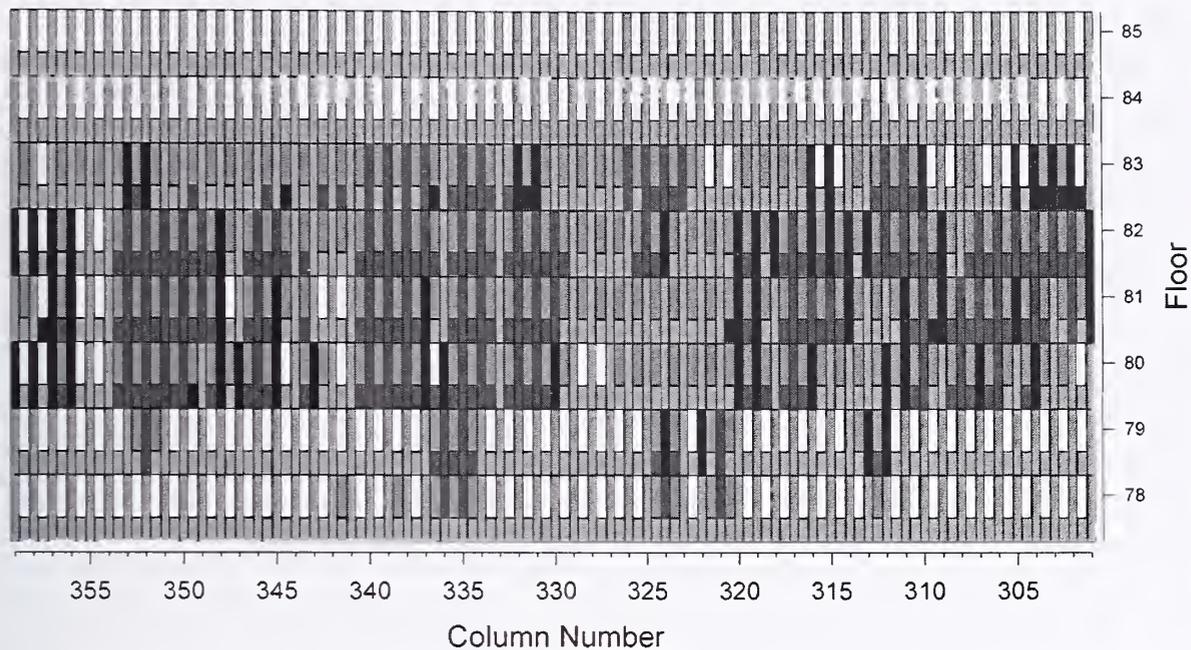
Figure 7-29. A color-coded map of the damage to the east face of WTC 2 as a result of the aircraft impact and fireball is shown. Details concerning damage to the aluminum curtain wall (■ - undisturbed, ■ - disturbed but still in place, and ■ - aluminum facing missing) and windows (■ - glass missing and ■ - glass in place) are combined.

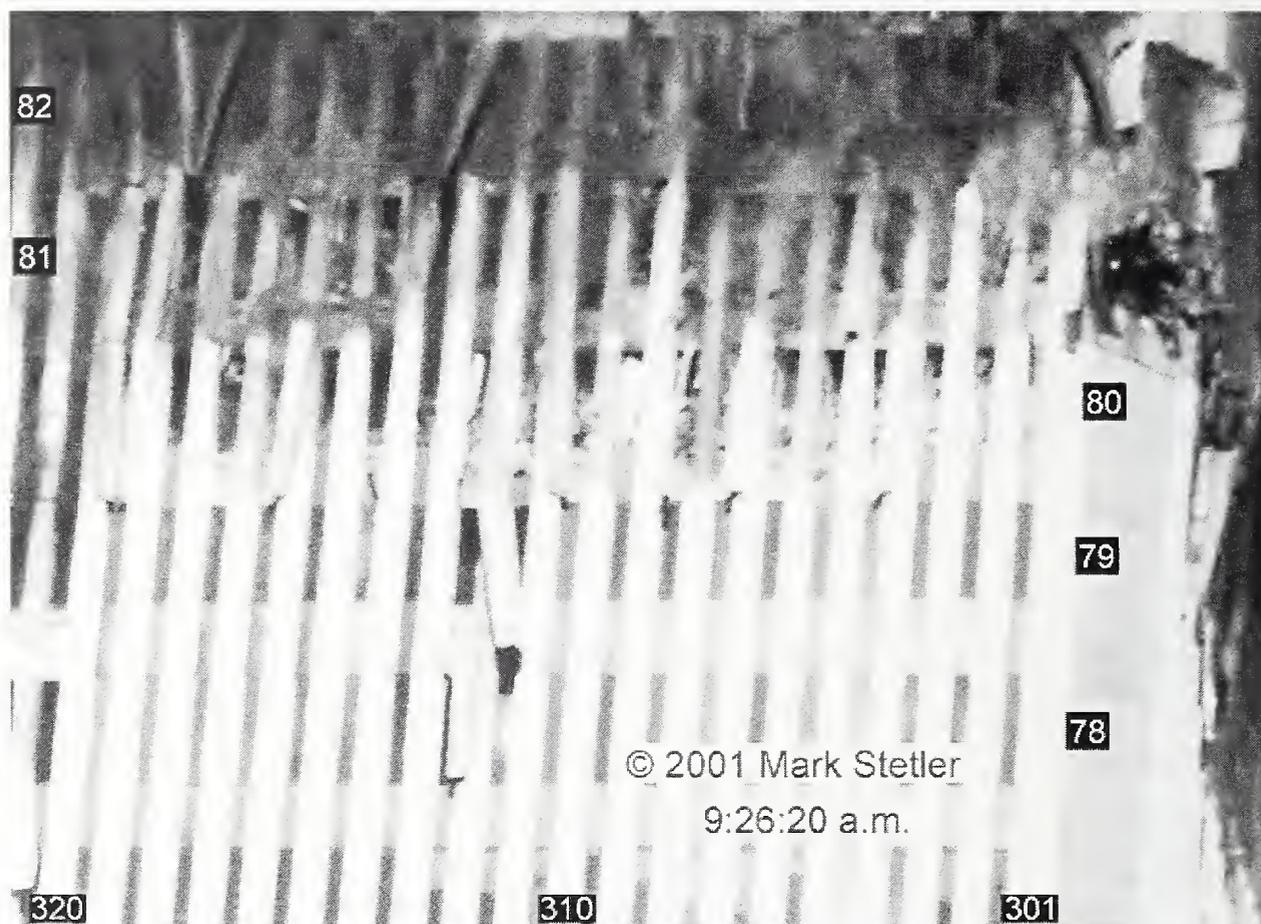
Figure 7-30 shows an enlarged region of the northeast corner of the tower taken from Figure 7-28. Large piles of debris can be seen through the windows near the corner on the 80th and 81st floors. It is likely that a large fraction of this debris was derived from the aircraft, since its body impacted on these two floors (see Figure 7-26). This suggests that either the debris was deflected from the core or that the aircraft was moving toward the east when it struck the tower, since the nose struck near column 422 on the south face.

Figure 7-30 also shows that the aluminum panels on the 80th and 81st floors of the northeast corner have been pushed out and partially removed. This damage was present immediately following the aircraft impact. Observations included in Table 7-1 indicate that the initial damage in this area appeared 0.4 s after the aircraft impact. As discussed below, it is likely that one of the engines of the aircraft passed through this corner. A pile of debris can also be seen jutting from this corner on the 81st floor. The debris in the corner can be seen more clearly in Figure 7-31, which was shot from the northeast. Additional debris extends from windows on either side of the corner.

Figure 7-30. This photograph showing a portion of the east face of WTC 2 was cropped from the image shown in Figure 7-28. The image has been rotated, and column and floor numbers have been added. Note the large piles of debris on the 80th and 81st floors.

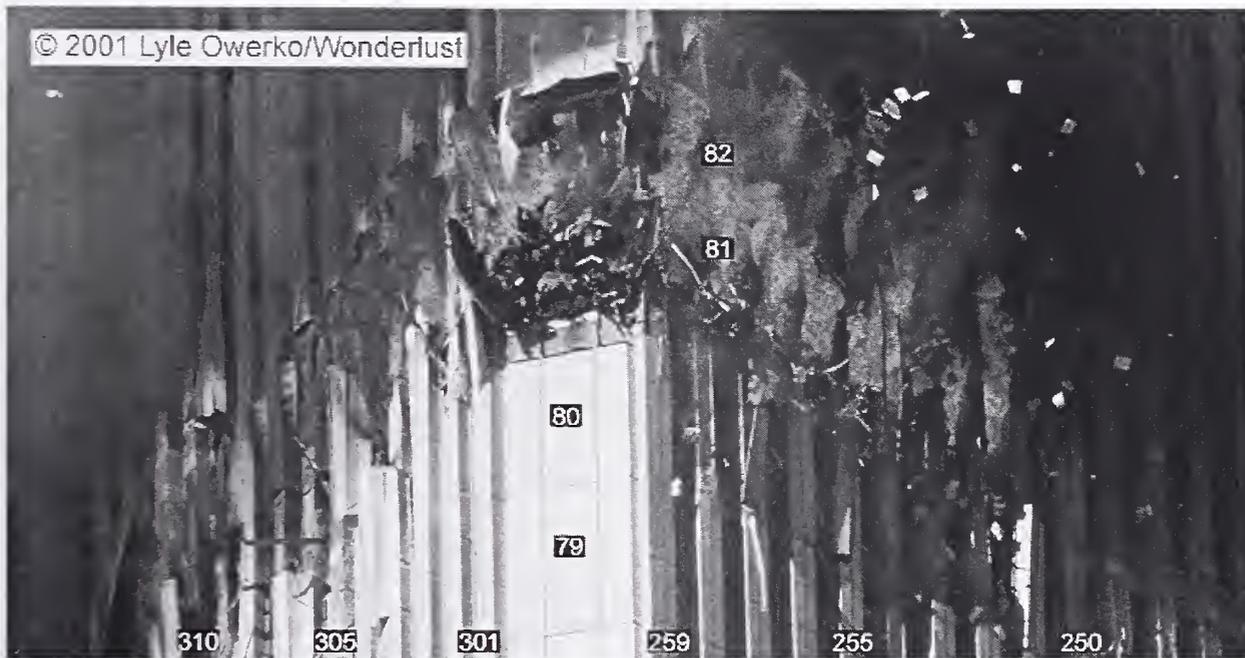
Figure 7-31. This cropped photograph shows the northeast corner of WTC 2. This image was recorded between 9:05 a.m. and 9:19 a.m. Column and floor numbers have been added. The corner aluminum panels on the 81st and 82nd floors have been pushed outward. A large pile of debris is evident in the opening on the 81st floor, and a vertical steel column, numbered 82-300, can be seen on the 82nd floor.

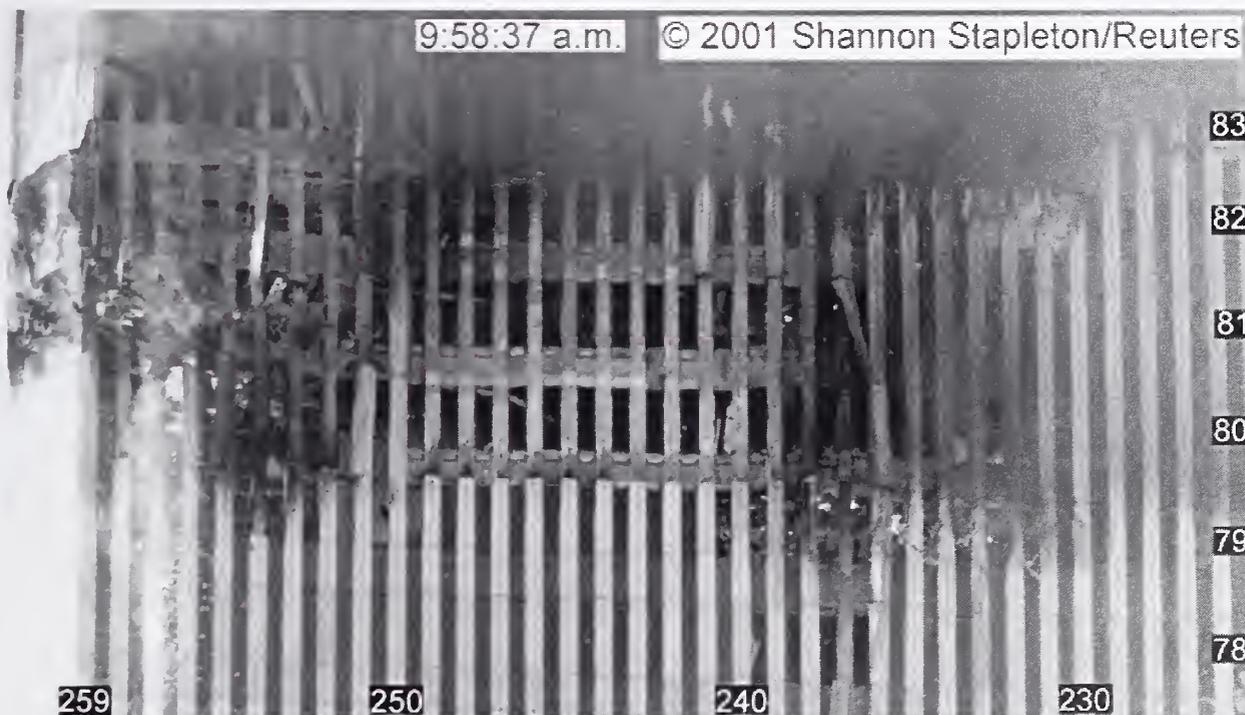
A casual inspection of Figure 7-32 reveals that significant areas of the aluminum curtain wall are missing. Reviews of early photographs and videos indicate the vast majority of this damage was present immediately after the fireball created by the aircraft impact dissipated. The most prominent region of missing curtain wall is a roughly rectangular area extending from column 238 to column 249 and covering the 80th, 81st, and 82nd floors. This area coincides with the locations (see Table 7-1) where the nascent fireball was first observed on this face 0.63 s following the aircraft impact. As will be discussed in more detail in Chapter 9, the observed fire behavior in this area following the fireball and before the

collapse of the tower was unusual in that very little fire was observed, and the area was close to the ambient temperature well after the aircraft impact. As a result, this area is referred to as the “cold spot”.

Three large piles of debris are evident through the windows on the north face. Two of these piles start at the northeast corner and extend out about eight windows toward the west on the 80th and 81st floors. These are the same floors where similar piles were observed on the east face at the north edge, suggesting that the debris essentially filled up the corners of the tower on these two floors. The third pile of debris can be seen on the 79th floor extending from roughly column 79-231 to column 79-240. As indicated in Table 7-1, these windows overlap an area where a distinct line of fire appeared 0.92 s after the aircraft impact.

Closer inspection of Figure 7-32 shows that column 253 has been severed just below the spandrel between the 81st and 82nd floors. The adjacent column, 81-254, is bent and split. This damage must be the result of a large part of the aircraft passing through the tower. As indicated in Table 7-1, such an object was observed breaking through the north face at this location 0.5 s after the aircraft impact on the tower.

Figure 7-32. A cropped and enhanced photograph of WTC 2 taken at 9:58:37 a.m. shows the east side of the north face. Piles of debris are evident on the 80th and 81st floors at the northeast corner and on the 79th floor to the right of column 241. The “cold” spot extends over the 80th to 82nd floors from column 238 to 249.

In the photograph the glass for four windows, 78-236 to 78-239, is missing. Again, this observation is consistent with the events listed in Table 7-1, which indicates that this damage first appeared on the north face 0.86 s after the aircraft impact. While not shown in Figure 7-32, the uncropped version of this photograph and numerous earlier photographs and videos indicate that the glass in windows 78-224 to 78-226 was broken out during the aircraft impact. The time line in Table 7-1 indicates that façade damage and dust appeared at this location 0.56 s after the aircraft impact. It is interesting that even though aircraft and/or parts of the building exited the north face on the 78th floor at two locations, no fire was observed emanating from windows on this floor.

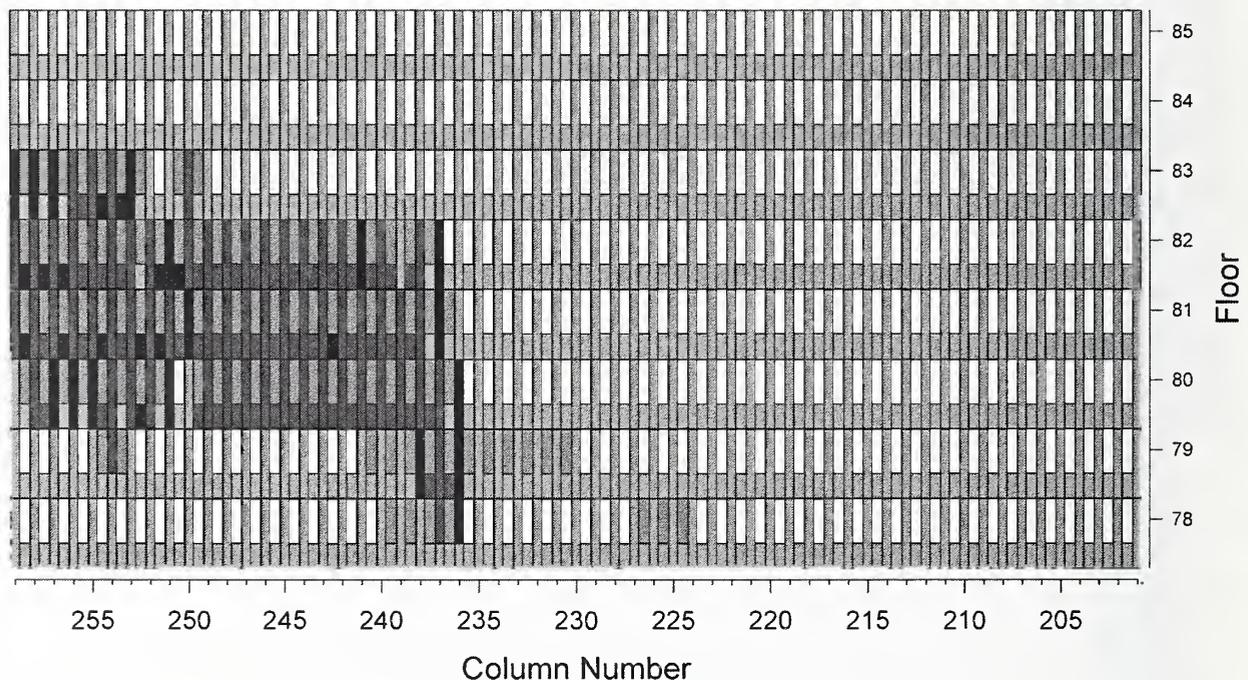
Figure 7-32, along with other photographs and videos, was used to develop the map for exterior damage shown in Figure 7-33 for the north face of WTC 2 that combines damage to the aluminum facing and window glass that make up the curtain wall. Damage on this face is inclined at an angle which roughly matches that at which the aircraft struck the tower on the south face on the opposite side of the tower. This suggests that debris from the aircraft tended to pass straight through the tower, perhaps passing between and being guided by the floor slabs.

Figure 7-33. A color-coded visualization of initial damage to the north face of WTC 2 is shown. Information concerning damage to the aluminum on the curtain wall (■ - undisturbed, ■ - disturbed but still in place, and ■ - aluminum facing missing) and windows (■ - glass missing and ■ - glass in place) are combined.

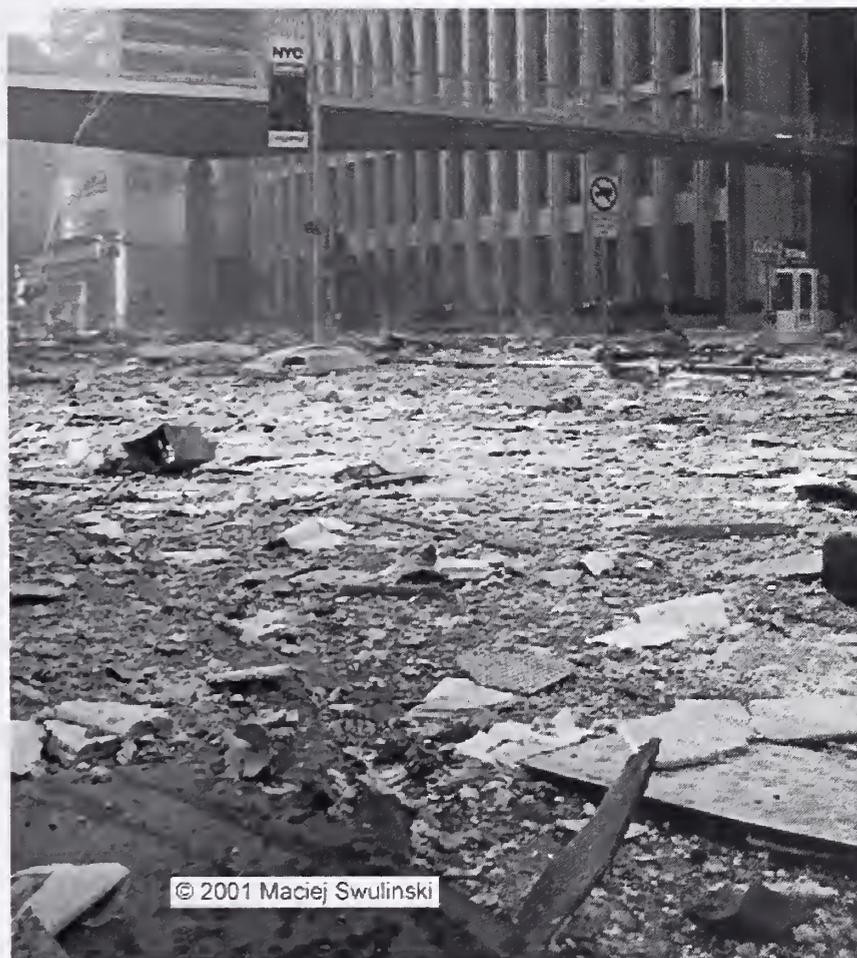
Figure 7-35. This cropped photograph taken from near the corner of Greenwich Street and Liberty Street shows debris on Liberty Street following the second aircraft impact on WTC 2. WTC 2 and WTC 3 are located in the background.

The debris in Figure 7-35 and Figure 7-36 most likely made up a portion of the dust cloud evident on the south face of WTC 2 in Figure 7-3 and Figure 7-9. This material was blown backward out of the tower by the overpressure generated by the initial fire inside the building that appeared shortly after the aircraft impact. The relatively large amount of what appears to be concrete, as well as its small size, suggests that the aircraft impact pulverized a significant amount of concrete floor slabs as it entered the tower. This is consistent with the large scooped-out cavity seen in the aircraft impact location (see Figure 7-22 to Figure 7-24). As noted previously, it has not been possible to visually observe the depth of such damage.

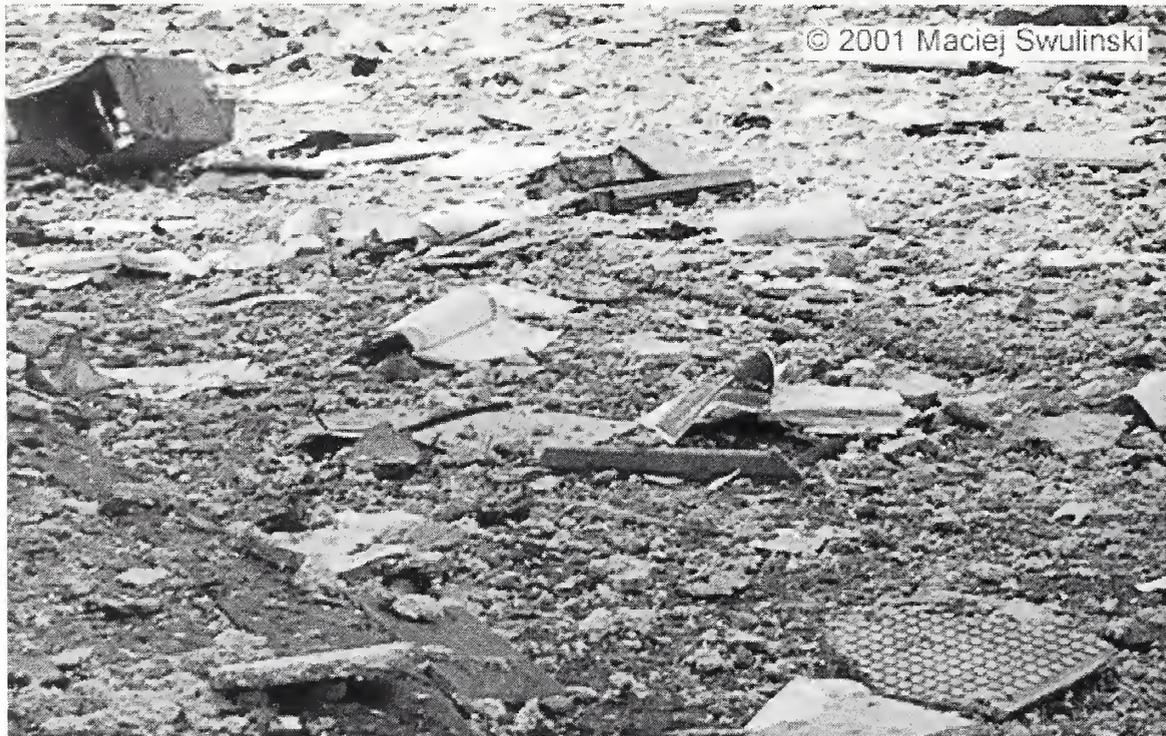
Figure 7-36 shows an enlarged portion of Figure 7-35. This photograph is typical of other photographs of the debris taken in the vicinity. Various types of debris, including papers and cardboard boxes, are identifiable. There is also a great deal of what appears to be crushed concrete. A dimpled material is evident in the foreground. Similar material is seen elsewhere in the street debris. This material is likely a portion of a ceiling tile.

Figure 7-36. A close-up of the debris on Liberty Street created by the second aircraft impact is shown in an enlarged section from Figure 7-35.

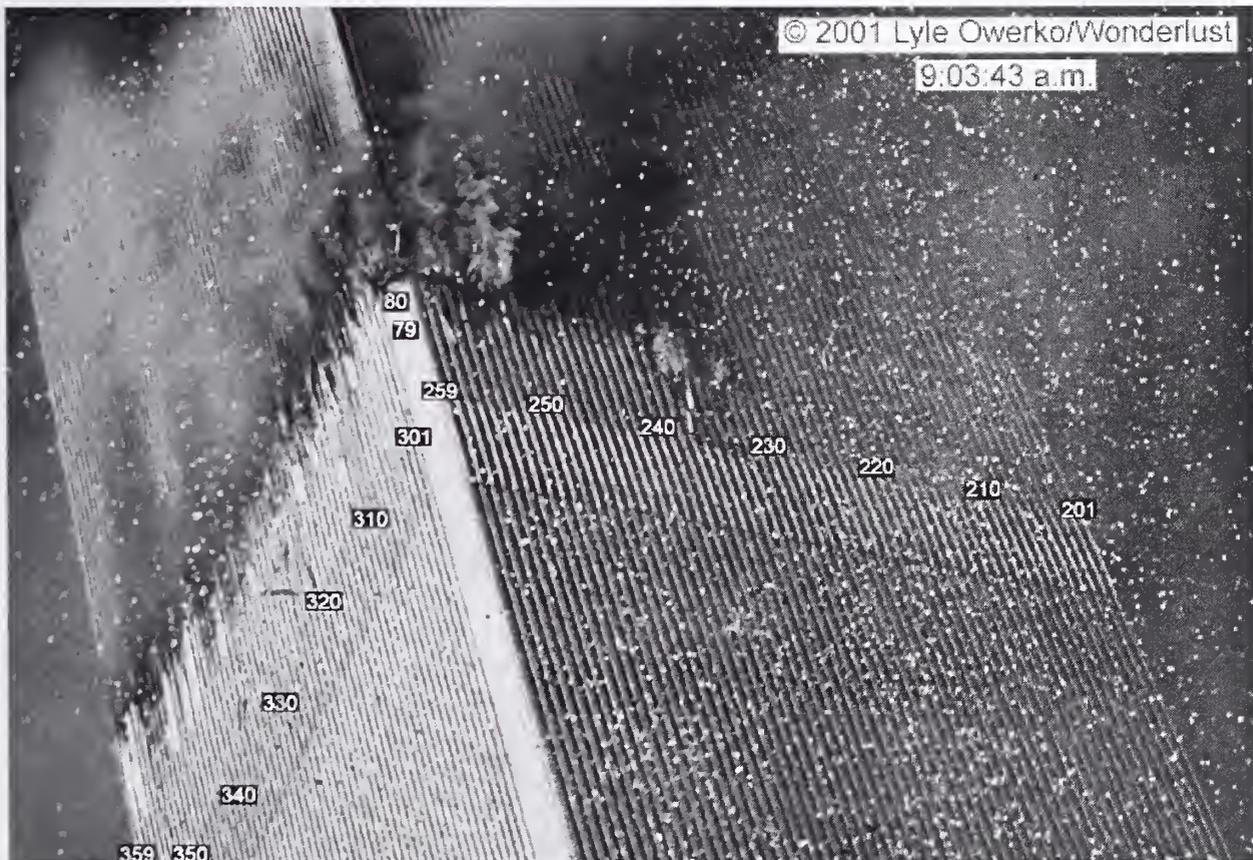
After the initial ten-second period following the aircraft impact, most of the large fires burning around WTC 2 began to decrease in size and to recede back into the building. In many locations fires were no longer visible after about 30 s. Figure 7-37 shows a photograph that was taken 44 s after the aircraft impact. Comparison with Figure 7-6 to Figure 7-8 indicates to what a large extent the flames coming from open windows have died down. Only relatively small fires are now observed on the east face. Substantial flame extension is still present on the north face, with large flames evident on the 81st floor near the northeast corner, and somewhat smaller flames located near the center of the north face on the 79th floor. Both of these flaming regions are in areas where large piles of debris can be seen through the windows. The cold spot discussed earlier stands out between the two fire zones due to the absence of flame. Similar close-up photographs and videos from the south are not available in the database for this early time, but more distant images indicate only a few isolated small fires were present on this face at this time.

Figure 7-37. This cropped photograph showing WTC 2 from the northeast was taken from the corner of Vesey Street and Church Street at 9:03:43 a.m., i.e., 44 s after the aircraft impact. The intensity levels have been adjusted, and column and floor numbers have been added.

The lack of significant burning in interior regions in the immediate aftermath of the fireballs is also reflected in the absence of heavy smoke coming from the tower. Some smoke is evident in Figure 7-37, but it does not obscure the faces of the tower. Most of it seems to be emanating from the flaming areas visible near the outer edge of the tower. Figure 7-38 shows the east side of WTC 2 at roughly the same time. Only very light smoke is present, and most of the façade area above the floors with fires is visible.
