**NIST NCSTAR 1-5A
Federal Building and Fire Safety Investigation of
the World Trade Center Disaster**

**Visual Evidence, Damage Estimates,
And Timeline Analysis**

Visual Evidence, Damage Estimates, and Timeline Analysis

September 2005

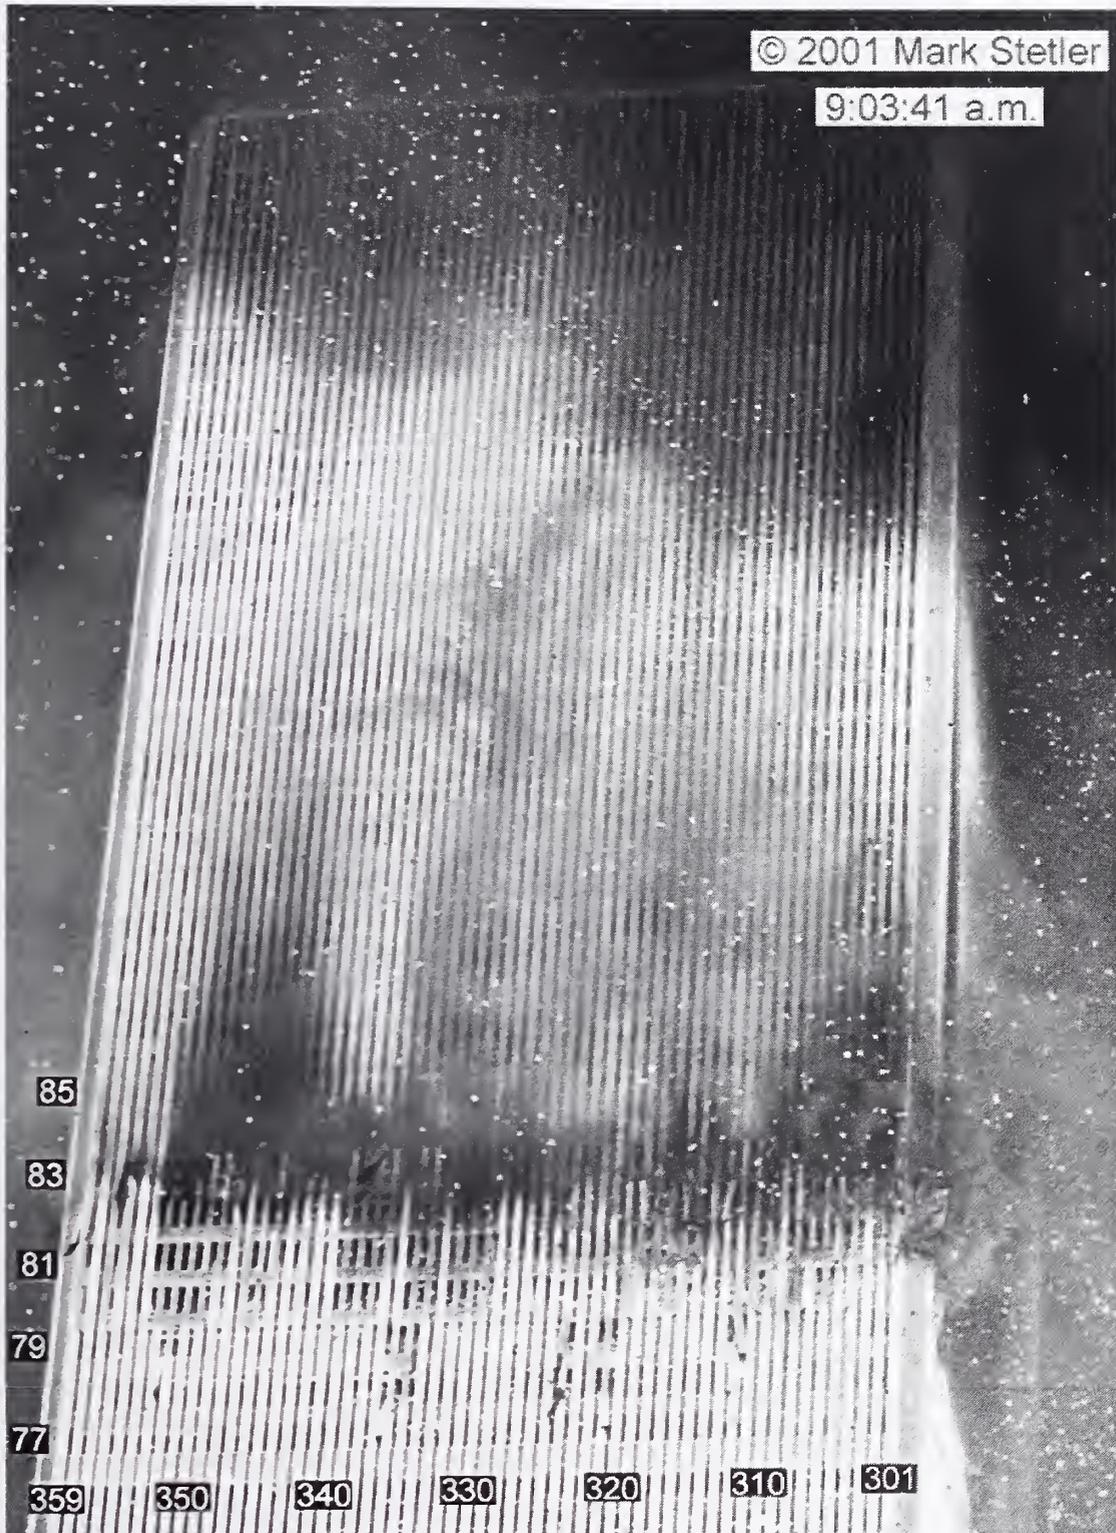
Figure 7-38. This cropped photograph shows the east face of WTC 2 at 9:03:41 a.m. Column and floor numbers have been added.

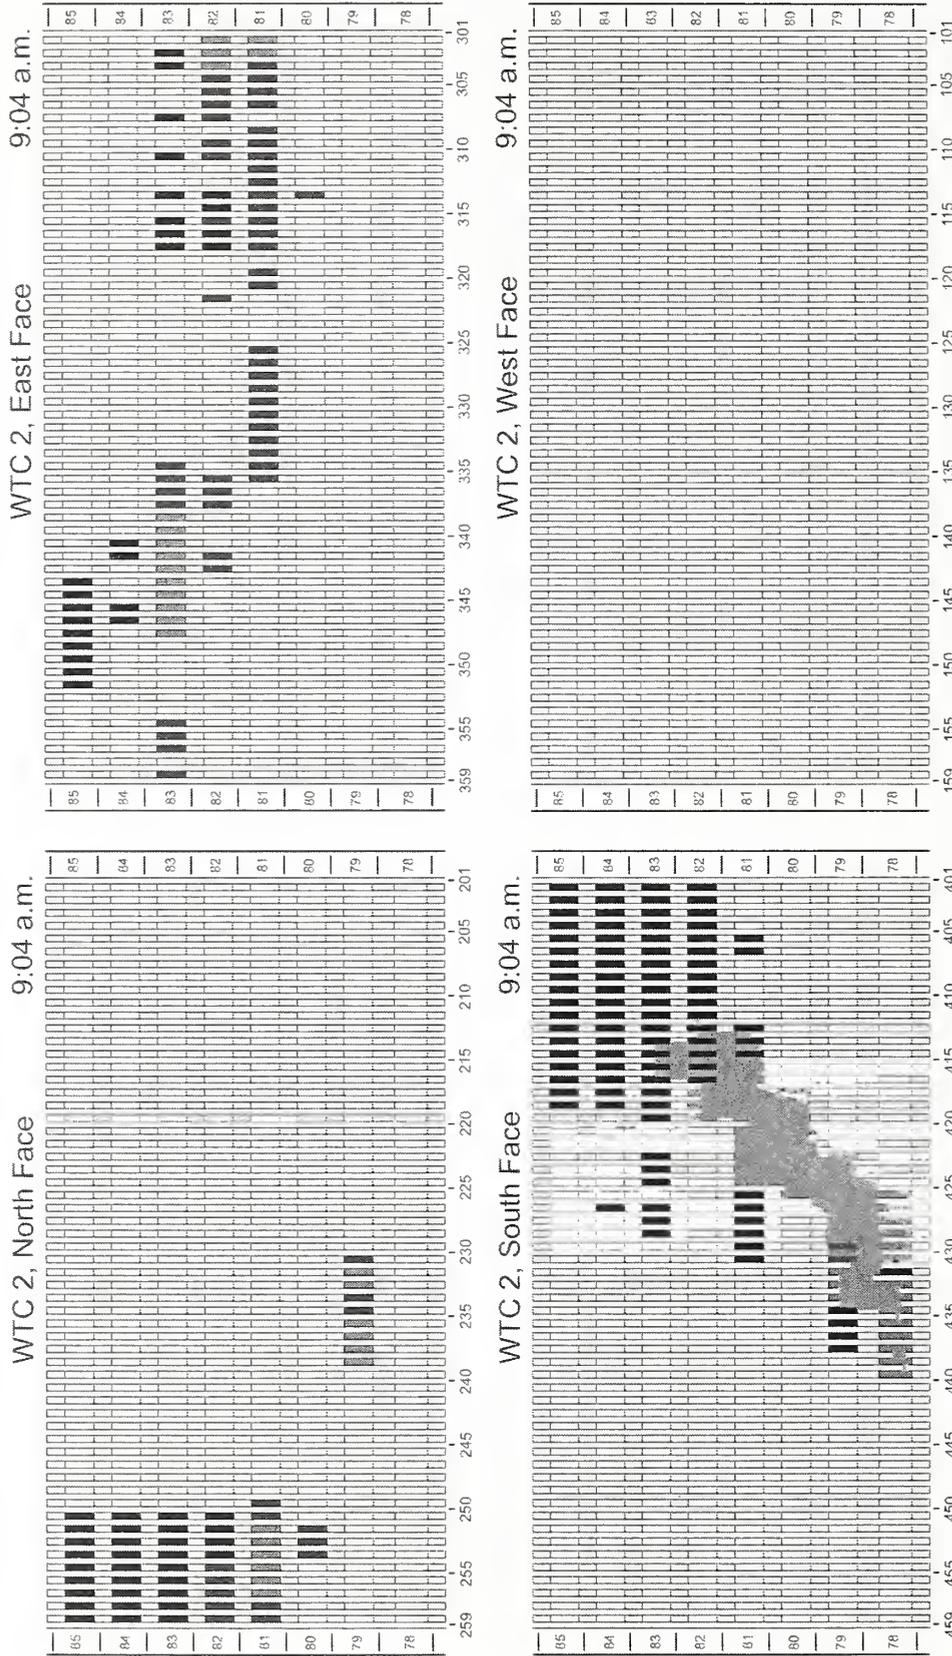
In the immediate aftermath of the aircraft impact and fireballs, large fires were present at several locations on the periphery of the tower. The largest of these fires were burning on large debris piles created by the aircraft impact. The absence of heavy smoke indicated that large interior fires were not present at this time, consistent with oxygen having been depleted at interior locations.

Figure 7-39. Maps of observed fires on the four faces of WTC 2 are shown for the period shortly after the rapid burn off of aviation fuel released during the aircraft impact. The colors represent - no fire observed, - spot fire, - fire inside, - external flaming, and - not visible.

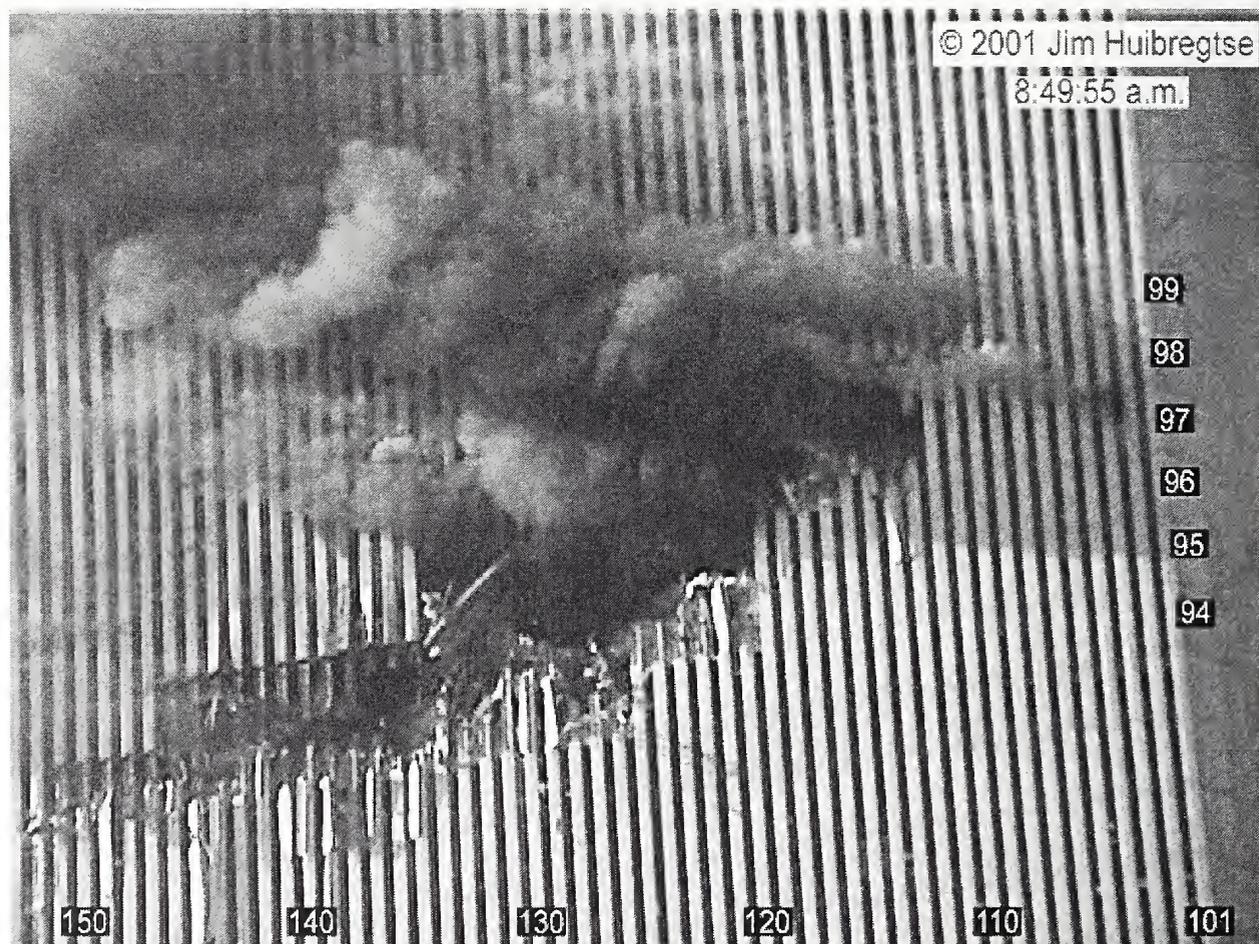
Figure 8-1. This image is extracted from a video recording that shows the north face of WTC 1 at 8:49:55 a.m. Column and floor numbers have been added.

At 8:50:55 a.m., light smoke began to come from window 97-144 on the 97th floor, which is located on the north face to the east of the cavity created by the aircraft impact. Fourteen seconds later the smoke suddenly became very dark and heavy. Shortly afterward flames appeared. As evident in Figure 8-1, prior to this time little or no smoke was seen in this region, and the windows in the area appeared to be intact. This developing fire grew rapidly and by 8:52 a.m. fire was visible in windows 97-142 to 97-146, with flames extending from windows 97-144 and 97-145.

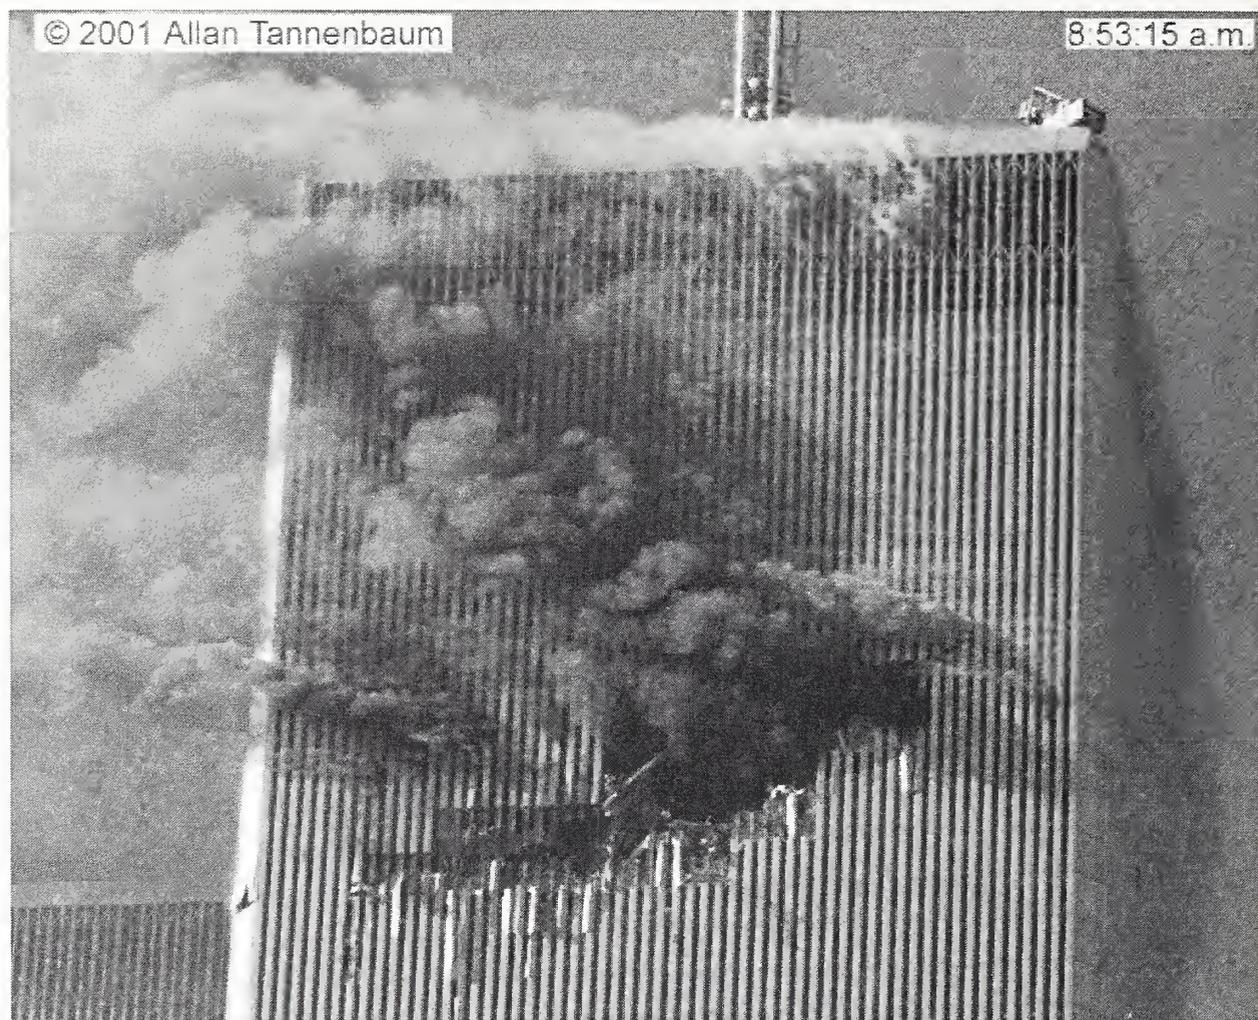
Figure 8-2, showing the north face, was shot at 8:53:15 a.m. An enlarged portion of the image is reproduced as Figure 8-3. The fire to the east of the aircraft impact area has continued to spread, now extending from windows 97-142 to 97-148. In three of the windows (97-142, 97-143, and 97-144) isolated fires are burning at the tops of the open window frames. Videos show that pieces of solid burning fuel from these areas eventually fell and formed the white streamers described in Section 5.2 as the material floated downward. Appendix L summarizes observations of streamers on the four faces of WTC 1. The first streamer from the left of the impact cavity was observed at 8:54:52 a.m., falling from the top of window 97-145, and many additional streamers were observed during the next few minutes.

In Figure 8-2 and Figure 8-3 light smoke is coming from near window 96-150. This smoke is an early indication of a developing fire that will appear shortly and grow rapidly in this area.

Smoke is also flowing from the mechanical equipment rooms at the 108th and 109th floors in Figure 8-2. Smoke and/or dust were observed coming from these floors immediately following the aircraft impact, suggesting that ductwork within the core area had been compromised. Smoke was observed continuously coming from these floors after the impact. As described in Section 4.2.5, the smoke was actually flowing from louvers mounted in an interior wall located nearly 5 feet behind the exterior facade that is visible. The smoke appears to be coming from three distinct locations centered near windows 113, 122, and 132. Figure A-1 in Appendix A shows the locations of the various louvers on these floors and identifies which parts of the ventilation system were serviced by these louvers. On the north face of WTC 1 the louvers were part of the fresh air intake system that serviced the upper portion of the building extending from the 92nd floor to the top. The three locations are close to the three intakes that provided air to the core, interior, and peripheral areas of the lower floors in the northwest quadrant of the building. The ductwork for these ventilation systems extended downward through a shaft located on the northwest corner of the core. Smoke was clearly entering these three sets of ducts at some point. It should be noted that in order for the smoke to backflow through the intakes as observed, it had to pass through an extensive series of fans, preheating and cooling coils, and air filters.

Figure 8-2. A photograph of the north face of WTC 1 recorded at 8:53:15 a.m. is shown. The original has been cropped.

At the time that the photograph in Figure 8–2 was taken, there was no indication that any windows on the north face above the 99th floor were missing. This situation changed abruptly 43 s later, i.e., at 8:53:58 a.m., when a light smoke plume appeared from the 104th floor at window 104-116. At the same time an object was seen falling from this location. This observation was the first indication on the north face that people trapped on floors above the aircraft impact area were breaking windows to provide access to outside air. Nine seconds later another object was observed falling from window 104-115, and shortly

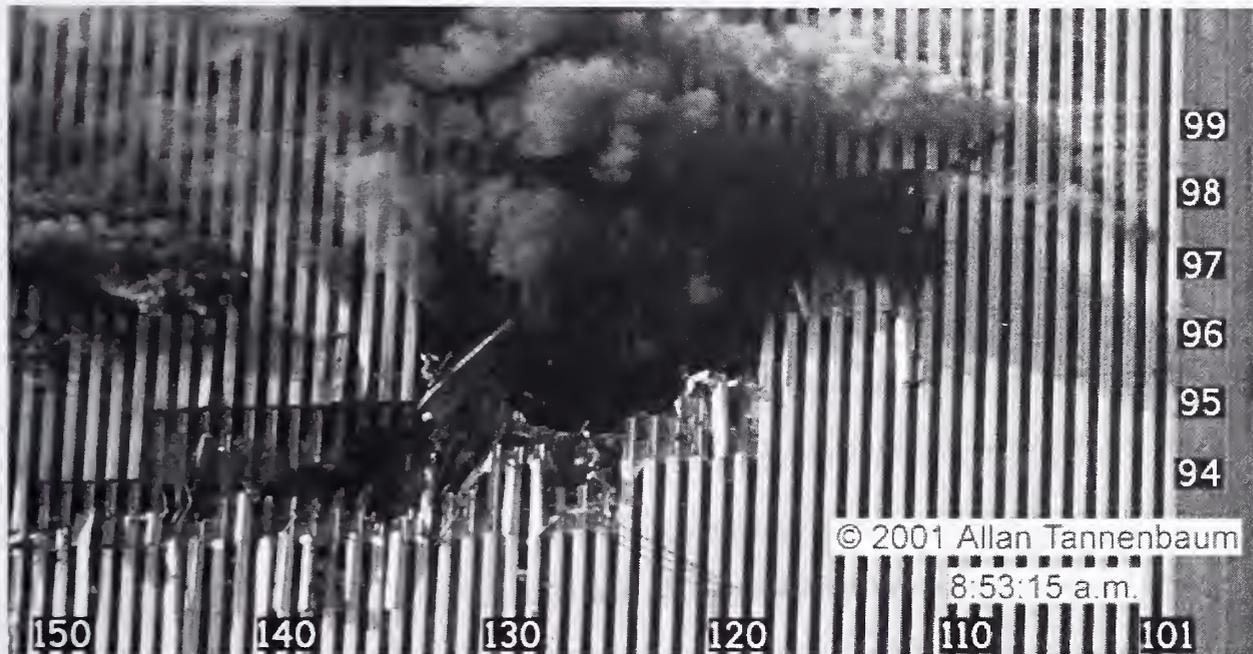
Figure 8-3. An enlargement of a portion of the photograph reproduced in Figure 8-2 showing the north face of WTC 1 at 8:53:15 a.m. is shown. Labels showing floor and column numbers have been added.

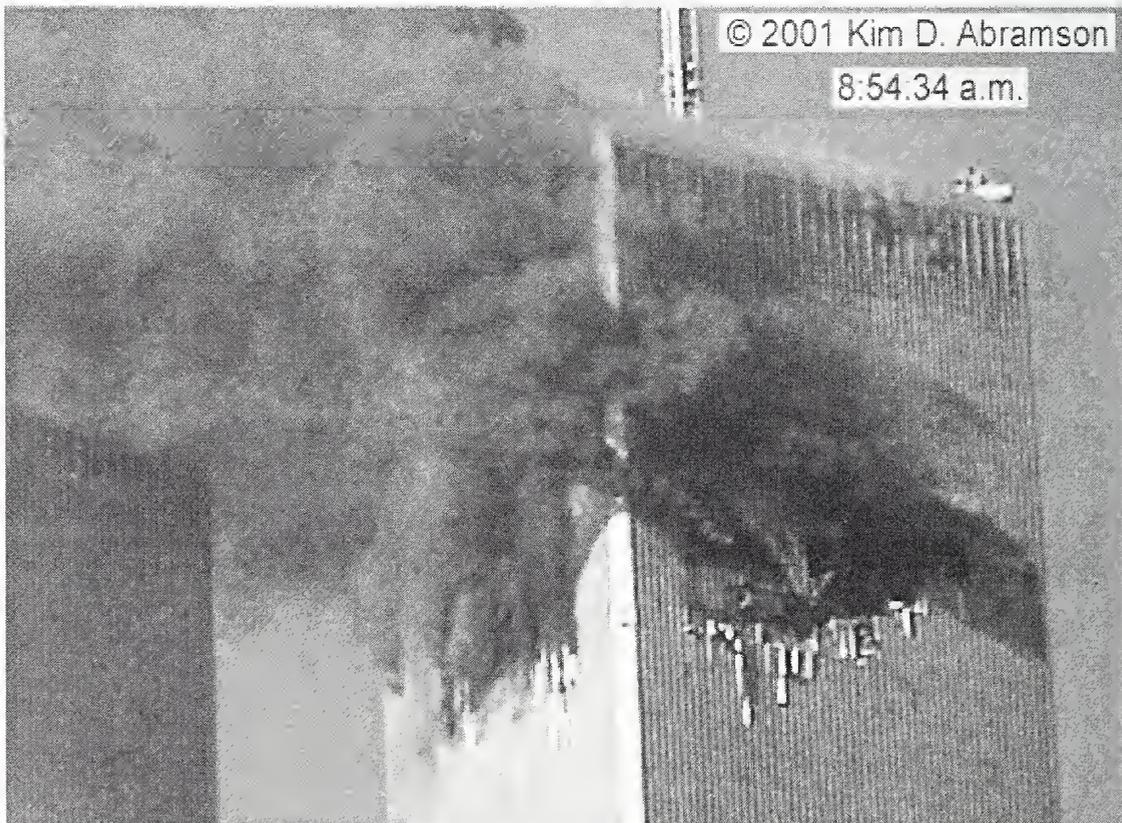
Near the top of the tower in Figure 8-4 there appears to be a heavy flow of smoke from the area of the mechanical equipment room floors near the north edge of the east face. Smoke was present in this region continuously until the tower collapsed over an hour later. This area is close to the exhaust spill louver that served the northeast quadrant of the tower (see Figure A-2), and it is possible that the observed smoke was flowing from this system. However, there is another plausible explanation for these observations based on predictions of smoke movement obtained using the Fire Dynamics Simulator (FDS) (McGrattan 2004). For the simulations, smoke was assumed to come from the 94th floor across

Even though a large amount of smoke hides much of the east face in Figure 8–4, it is still possible to see portions of the façade for floors above the 94th floor where fire is present. This is true for a small region on the lower northern edge and a larger area on the southern side of the face. In these areas smoke was observed coming from windows higher on the face, which indicates that people were also breaking windows on this face at roughly the same time as on the west and north faces. At 8:53:24 a.m. dense smoke plumes appeared at windows 105-245 and 105-246 on the 105th floor. Several additional windows on this floor were broken around this time. The nearly simultaneous decisions by people to break windows on three sides of the tower suggest that smoke had already spread over extensive volumes of the upper floors. Two windows, 99-201 and 99-202, were also broken out on the 99th floor around 8:53 a.m. Light smoke was observed flowing from these windows. Earlier, the windows appeared to be intact.

Figure 8-4. A frame captured from a video shot from the northeast shows the north and east faces of WTC 1 at 8:54:34 a.m. The undamaged WTC 2 is to the left.

In Figure 8-4, heavy smoke can be seen on the east face, coming from a few windows on the 93rd floor, located immediately below the 94th floor where significant fires and smoke flow are evident. An area of light smoke is also coming from a section of the open windows on the 92nd floor. Review of visual material around this time indicates that both the number of windows where smoke was observed and the smoke density appeared to be increasing on these floors. These observations suggest that fires, which were not yet visible from the outside, were growing on these two floors.

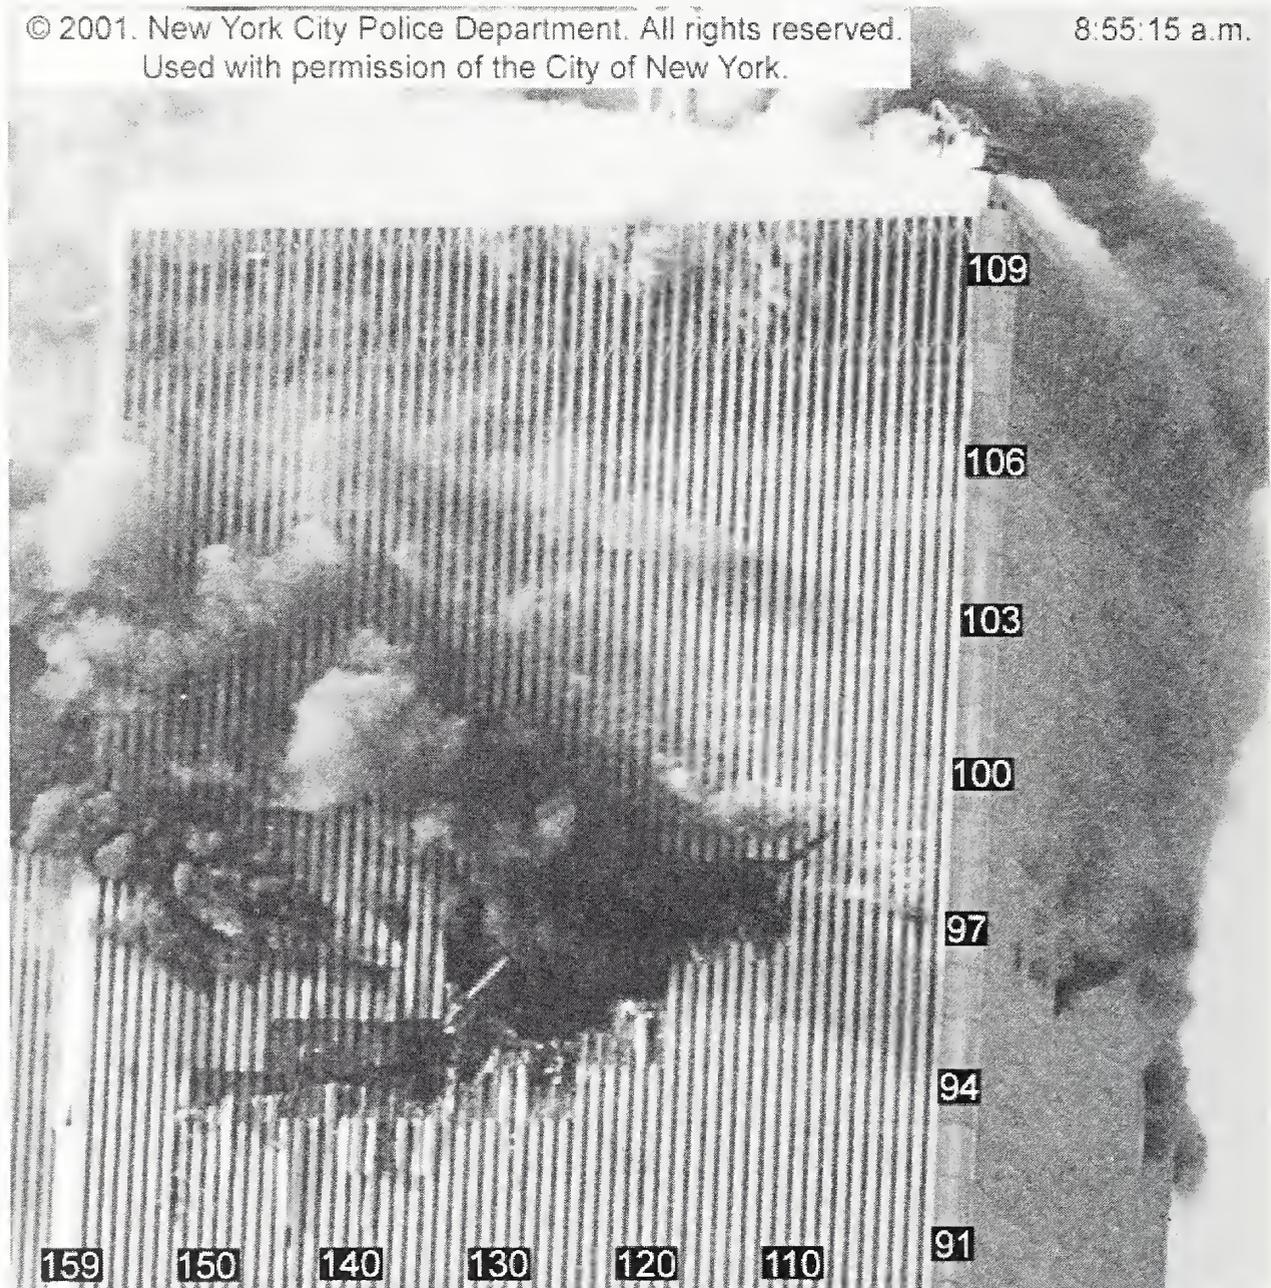
Figure 8-5 was taken just after the beginning of a dramatic change in the fire behavior on the west face of the tower. Videos show that at 8:55:09 a.m. there was a sudden increase in the volume of smoke coming from near window 97-435 on the 97th floor. Almost immediately, smoke began to appear at additional windows, and flames were observed shortly afterwards. The initial stages of this rapid change are indicated by the appearance of smoke at multiple windows on the 97th floor in Figure 8-5. Within a minute following the initial increase in smoke, external flaming was observed from roughly

Figure 8-5. A photograph of WTC 1 recorded at 8:55:15 a.m. shows the north and west faces. The original image has been rotated and cropped. Numbers indicating column numbers for the north face and floors have been added.

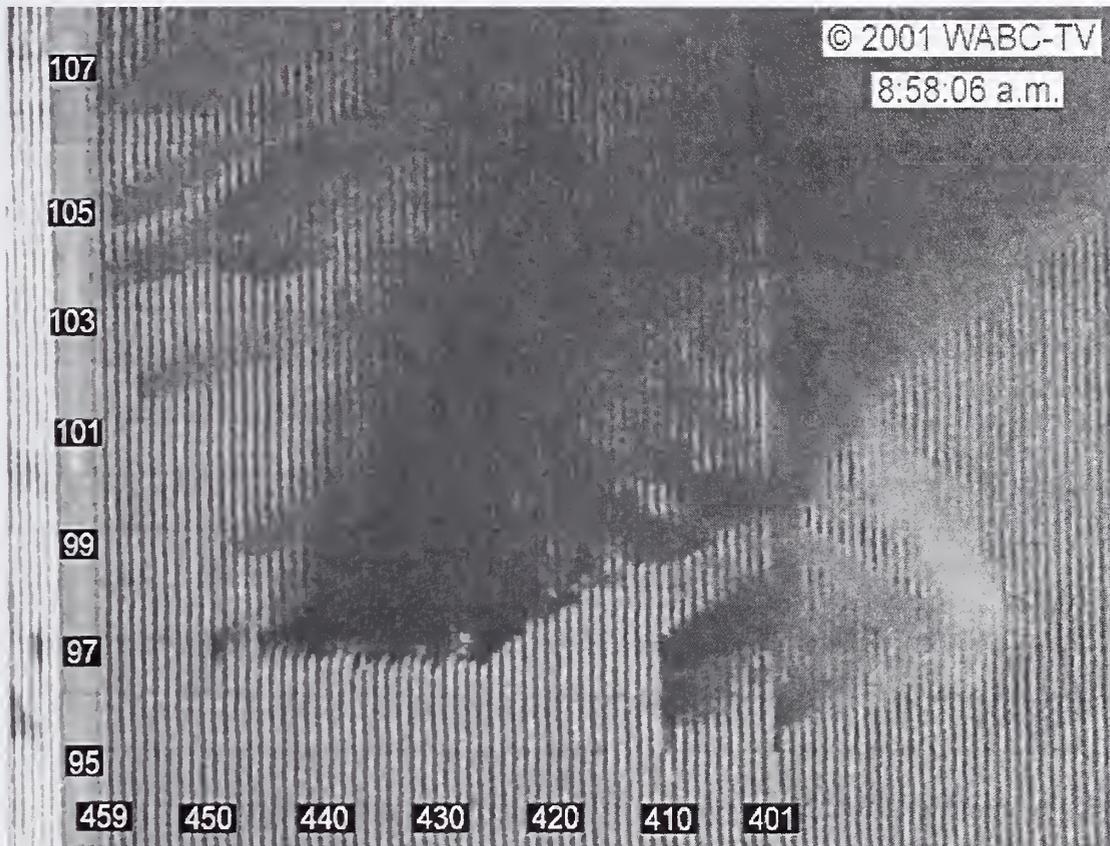
The west face of WTC 1 was filmed from a helicopter around this time. Figure 8–6 shows a frame taken from this video that was recorded at 8:58:06 a.m. Intense fire and heavy smoke are present over the same range of windows observed roughly two minutes earlier. Following the extremely rapid fire spread during the minute that started around 8:55 a.m., the fire appears to have stabilized for a period of time. It

Another feature of the west face around 8:58 a.m. can be seen in Figure 8-6. Numerous plumes of heavy dark smoke are flowing from windows high above the 97th floor on the north side of the face. These plumes are present on the 102nd, 104th, 105th, and 107th floors. People in these areas have broken out the window glass. It is difficult to determine exactly when these windows were opened due to the quality of the imagery during this period, but smoke first appears from the upper regions of the northern side around 8:55:30 a.m. Multiple windows over several floors had been broken by 8:56 a.m., and the number continued to increase during the next two minutes.

Figure 8-6. This image shows the west face of WTC 1 at 8:58:06 a.m. It is a frame taken from a video shot from a helicopter. Floor and column numbers have been added for WTC1. WTC 2 is in the background on the right side. Smoke is flowing from the damaged area on the corner of the 96th floor.

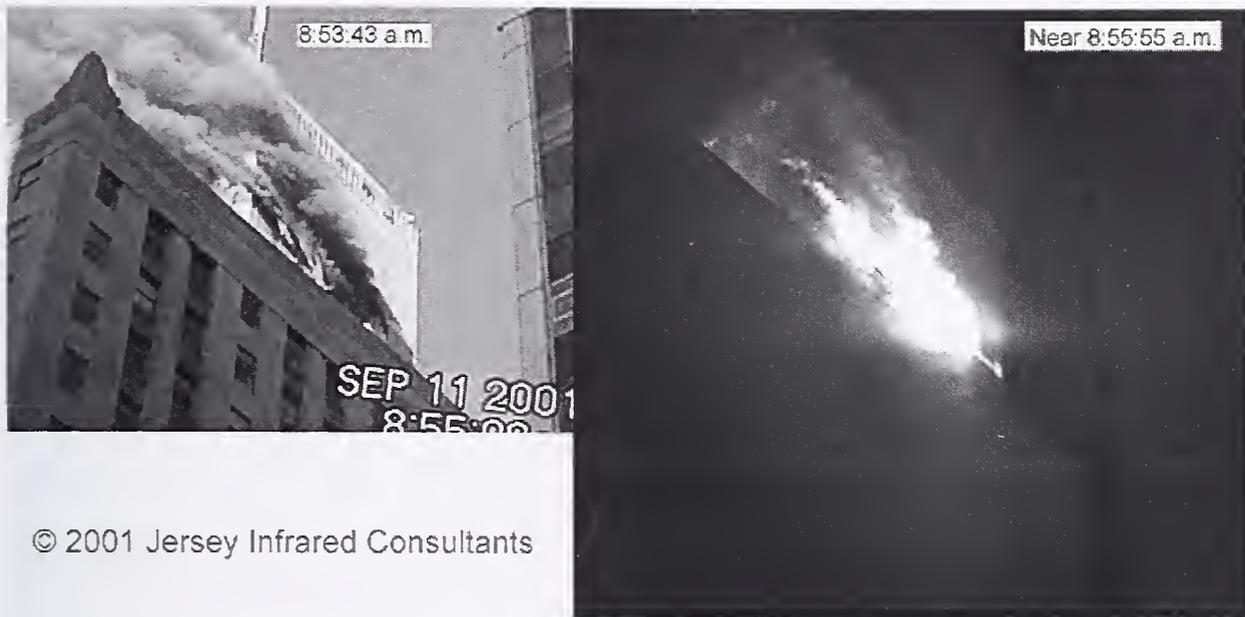
Nonetheless, the infrared images provide unique insights into the heat distribution inside the towers. One of the infrared images showing the north face of WTC 1 around 8:55:55 a.m. (the time uncertainty is estimated to be 15 s) is shown in Figure 8-7. The dimensions of the infrared image are 255 pixels × 240 pixels. It is compared with a frame from a video that was shot from the same location roughly two minutes earlier. The video frame has been rotated and scaled to match the infrared image.

It is immediately clear that large areas of the infrared image are saturated, indicating the presence of strong heating. Even so, there are some interesting features resolved in the image. By comparing the standard and infrared images it is seen that the smoke plumes leaving the aircraft impact cavity and the area of fire on the 97th floor to the east are hot and radiating as they exit the building, but cool rapidly as they move away. There is an isolated bright area near the western edge of the north face, indicating a high temperature region. In Figure 8-5, it can be seen that there is a smoke plume exiting from window 97-102 on the 97th floor. This plume is the source of the high temperature spot. A distinct line connects to the bright spot. This line shows that heat is being radiated from the 97th floor even though, as can be seen in Figure 8-5, the windows are still in place and no smoke and fire are visible in these windows.

The fire on the 97th floor to the immediate right of the aircraft impact cavity has saturated the camera output. Much of the area inside the aircraft impact cavity is also saturated, showing that the smoke flowing from this area was hot. The heat distribution on the east side of the cavity is consistent with the visible fire distribution. There is an extensive length across the face that is saturated. This corresponds to the large fire on the 97th floor that is visible in the video frame and Figure 8-5. This area does not extend all the way to the east edge of the face, and the northern edge of the east face is still relatively unheated. There is a shorter heated length on the floor below that is separated from the aircraft cavity by a cooler

region. This heating is due to the fire that was growing on the 96th floor and had not yet appeared on the face. There is evidence of an isolated fire burning in the eastern half of the 94th floor on the north side.

Figure 8-7. Images of the north face of WTC 1 recorded using a standard video camera (left) and an infrared camera (right) are shown. The frame from the video camera was recorded at 8:53:43 a.m., and the infrared image was shot around 8:55:55 a.m. (the uncertainty is estimated as 15 s) from roughly the same location. The infrared image intensity levels were adjusted. The video frame has been cropped, rotated and sized to match the infrared image. The building in the foreground is the post office on the corner of Church and Vesey Streets.

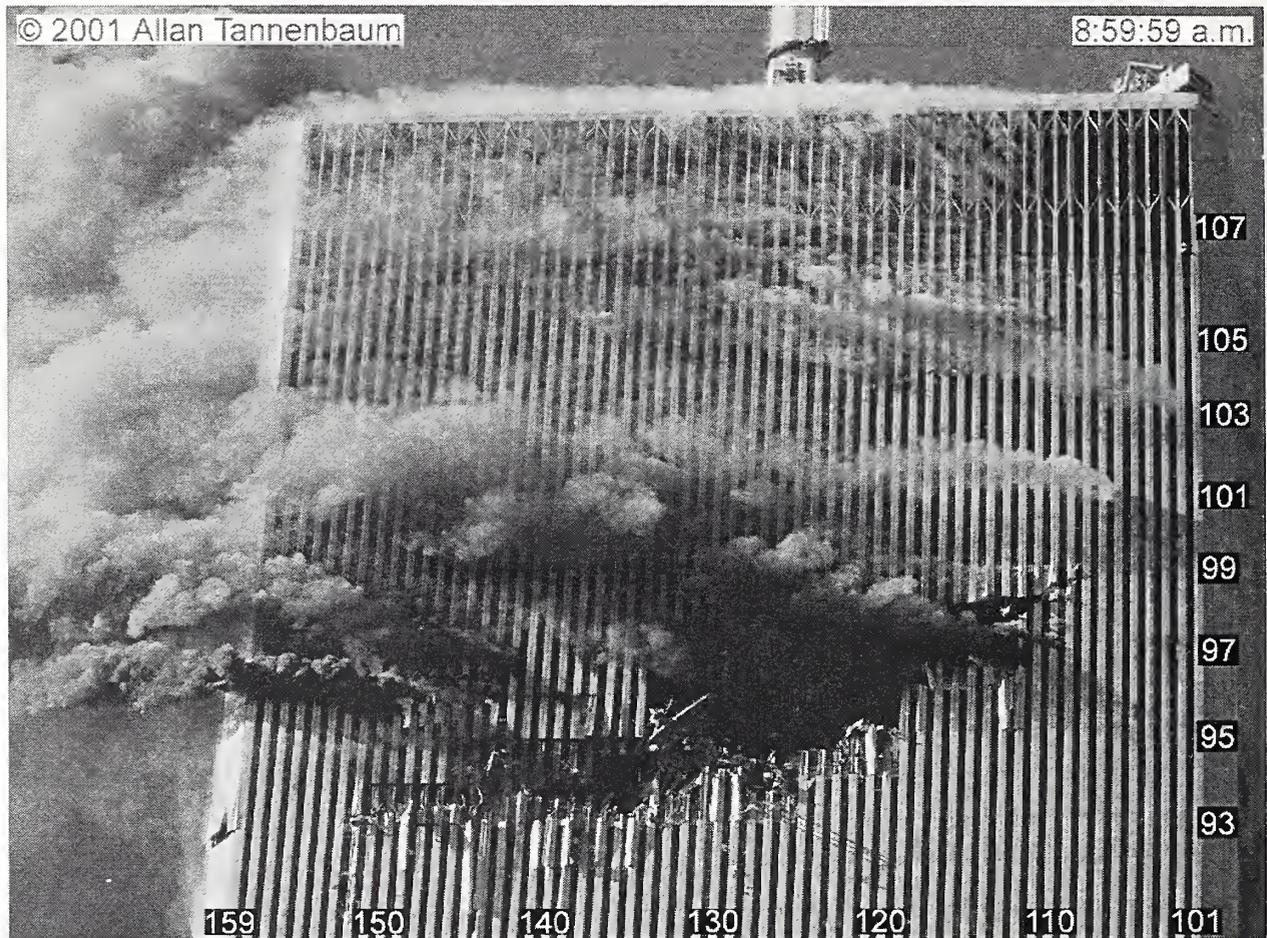
In Figure 8-8, numerous plumes of smoke are seen exiting from windows well above the fire floors on the north façade. There are also many additional windows that have been broken by people at these locations, but they do not have dense smoke flowing from them. The smoke coming from the mechanical equipment room on the 108th and 109th floors can also be seen in this photograph.

Figure 8-8. This photograph of the north face of WTC 1 was recorded at 8:59:59 a.m. The image has been cropped and floor and column numbers have been added.

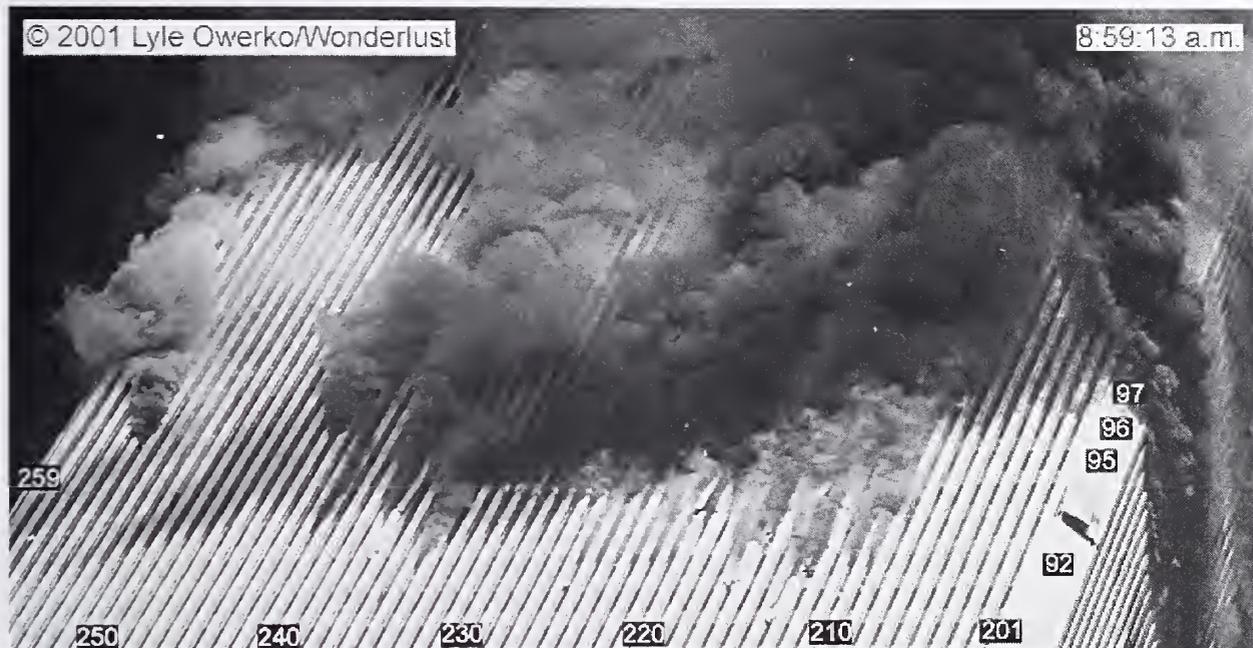
Figure 8-9 shows the east face of WTC 1 at 8:59:13 a.m. As observed earlier, a significant fire continues to burn over a large extent of the 94th floor. Intense burning was particularly evident at windows 94-226 and 94-227. Closer inspection of the photograph shows that distinct “caretts” are present on the column covers next to these windows as well as on the covers for columns 94-229 to 94-232. As discussed in Section 5.2, these caretts indicate that sometime earlier flames were extended out of windows 94-229 to 94-231 and subsequently withdrew back into the windows. These caretts are an additional indicator of the intensity of the fires burning on this floor.

A major change in the east façade fire behavior is also apparent in Figure 8–9. Flames can now be seen at windows 97-208 to 97-210 on the 97th floor. It is difficult to determine exactly when fire growth started at this location due to obscuration by smoke coming from below. However, at least two videos showed flames erupting from these windows at 8:56:45 a.m., while another video showed an intense flame near window 97-211 at 8:58:19 a.m. A close-up photograph showed fire in window 97-114 at 8:57:38 a.m. It seems likely that fire first broke out on the 97th floor on this face around 8:56:45 a.m. and rapidly spread over at least seven windows.

Figure 8-9. This view of the east face of WTC 1 was recorded at 8:59:13 a.m. The original image has been rotated and cropped. Column and floor numbers have been added.

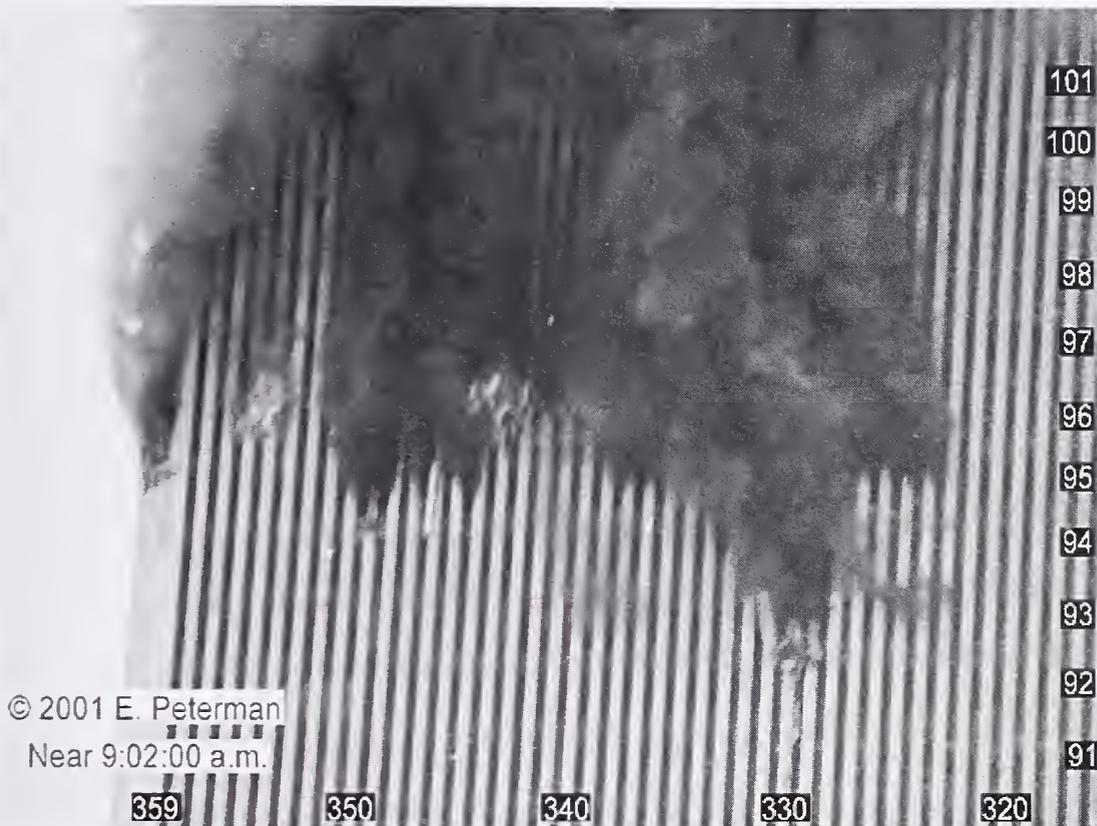
As seen in Figure 8–10, there is a large amount of smoke coming from broken windows on the 95th floor, even though no flames are apparent. This may be an indication that a substantial fire was present somewhere on this floor. The heavy smoke coming from the center of the face at the 93rd floor continues to hide the location where the steel panel section is believed to have been dislodged during the aircraft impact. Lighter smoke is flowing from several other windows on the 93rd floor.

Figure 8-10. This image showing the south face was captured from a video. It was not possible to time this image exactly, but it was recorded within a minute of 9:02 a.m. Column and floor numbers have been added.

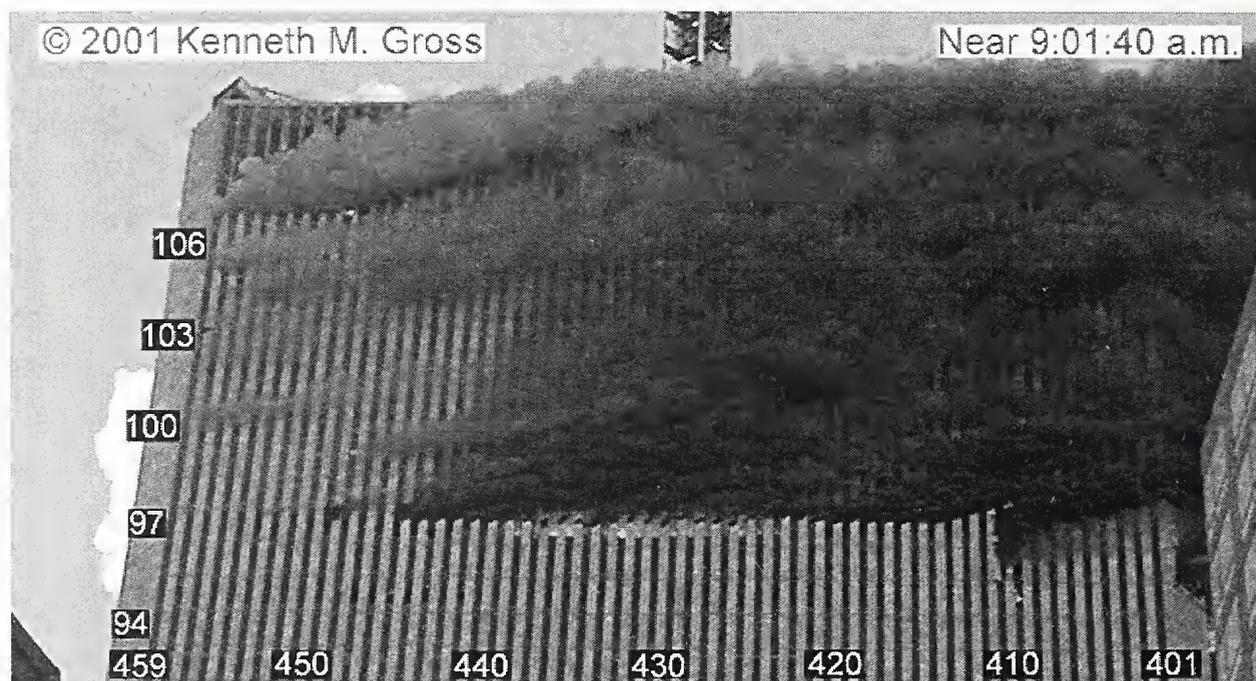
Figure 8–11 is a photograph of the west face of WTC 1 taken shortly after the second rapid fire spread episode. It has not been possible to time this image exactly, but based on observed fire behaviors on this face, it was taken between 9:01:09 a.m. and 9:02:17 a.m., or roughly around 9:01:40 a.m. Intense fires are present in the windows where the initial rapid fire spread took place, and heavy smoke is coming from

windows where the second took place. In the area with flames, carets are present at the tops of the columns, indicating the past presence of flames coming out of these windows.

The figure shows large amounts of smoke continuing to pour from windows well above the 97th floor on the north side of the face. The smoke is particularly heavy from window 107-458. A row of open windows is also present on the 95th floor extending from window 95-441 to window 95-447, with window 95-442 still in place. It is not known exactly when these windows were broken since they were not observed until around 9:00 a.m. They may have been broken during the aircraft impact or by people, who were observed in the open windows. The absence of any smoke or dust coming from the area may indicate that the latter explanation is more likely. The same is true for two windows (windows 92-424 and 92-434) on the 92nd floor that appear to be open in the uncropped version of Figure 8-11.

Figure 8-11. Image of the west face of WTC 1 recorded between 9:01:09 a.m. and 9:02:17 a.m. The image has been cropped and rotated, and column and floor numbers have been added.

Several videos show that heavy smoke was released suddenly from window 97-458 on the north edge of the west face at 9:02:17 a.m. Shortly thereafter fire was observed in this area. Interestingly, there is no indication of a fire at this location in Figure 8-11, which was taken less than a minute earlier.

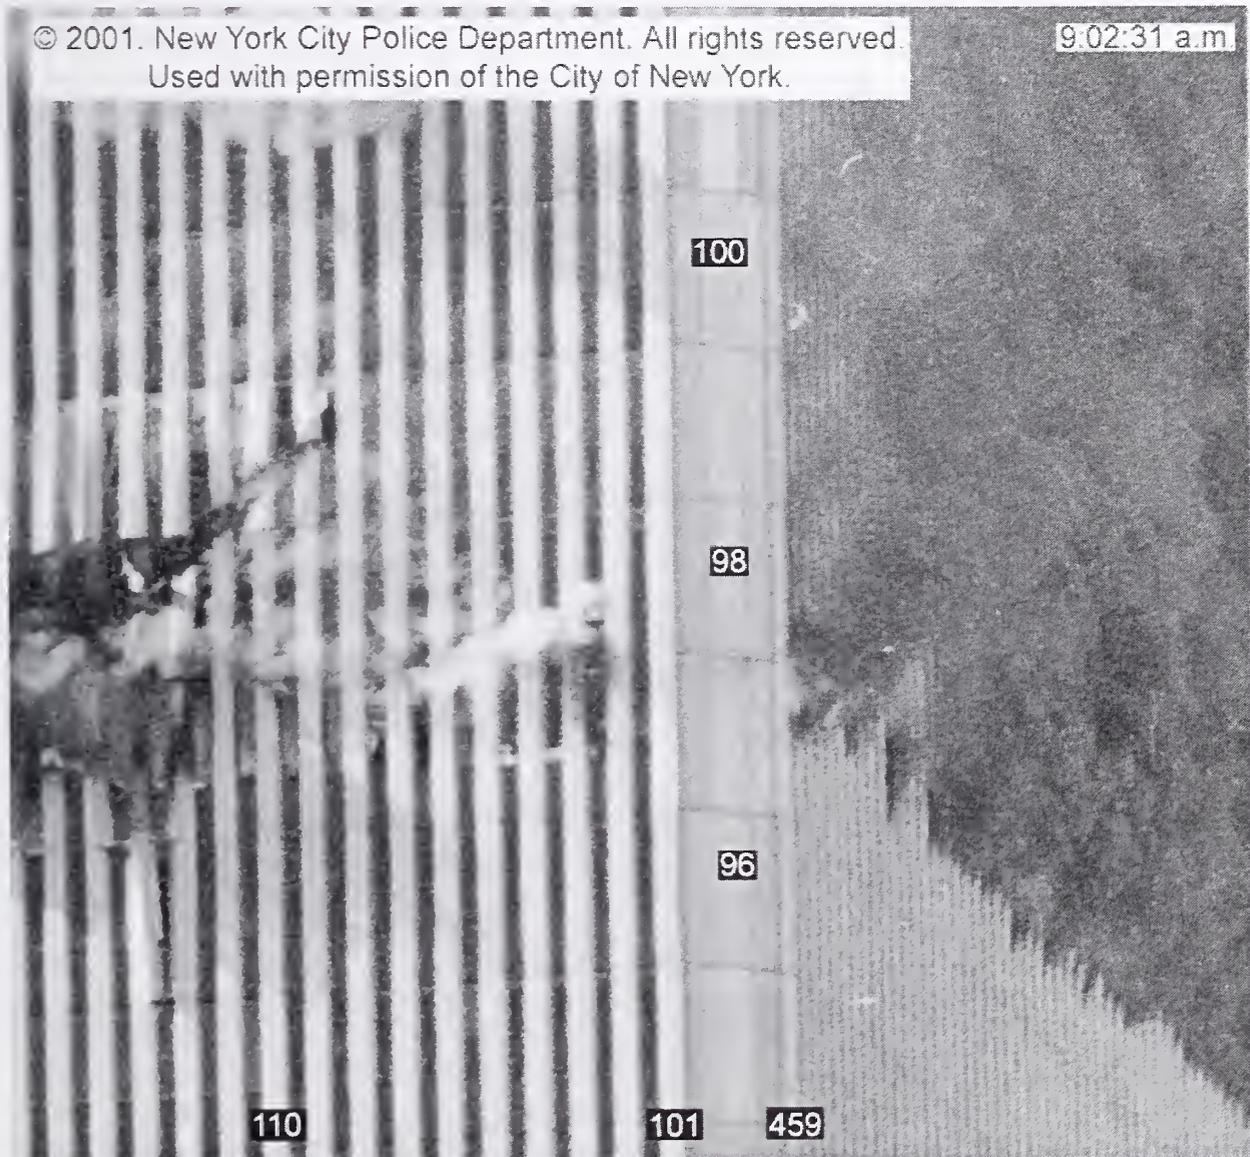
Figure 8-12 shows a photograph of the north face and an oblique view of the west face shot at 9:02:31 a.m., or 14 s after the initial release of smoke at the corner. Flames appear to extend from windows 97-458 to 97-453, and smoke is coming from locations near windows 97-453 and 97-449, as well numerous windows starting near window 97-445 and going toward the south.

In Figure 8-12, fire is present in windows 97-101 to 97-113 on the north face. Window 97-101 still appears to be in place. If so, this observation represents one of the few examples where flames were visible through an intact window. Even though heavy flames are present along the north side of the 97th floor, there is no flame extension, and very little smoke is coming from the windows. It is possible to estimate when flame spread occurred over the final western portion of the north side of the 97th floor. A close-up photograph taken at 8:59:59 a.m. showed that flames were present in windows 97-111 to 97-115, window 97-109 was in place, smoke was coming from window 97-108, and the remaining windows towards the west were intact, except for window 97-102, which had been broken immediately after the aircraft struck the tower. At 9:00:19 a.m. a video shows that heavier smoke started coming from window 97-104 and, shortly thereafter, from window 97-102. Even though the video was shot from a distance, a short burst of flame from window 97-106 was observed at 9:00:20 a.m.

The fire behavior described above suggests that the fire that erupted from window 97-458 at 9:02:17 a.m. was a continuation of the fire spread observed on the north face. It is interesting to consider why the intense fire that grew rapidly over windows 97-110 to 97-116 around 8:50 a.m. did not spread westward for the next ten minutes. A review of the floor plan layouts for the 97th floor (see Figure B-6) shows that

Figure 8-12. This photograph was shot from the northwest and shows the north and west faces of WTC 1 at 9:02 31 a.m. The image has been cropped and the intensity levels have been adjusted. Column and floor numbers have been added.
