**NIST NCSTAR 1-5A
Federal Building and Fire Safety Investigation of
the World Trade Center Disaster**

**Visual Evidence, Damage Estimates,
And Timeline Analysis**

Visual Evidence, Damage Estimates, and Timeline Analysis

September 2005

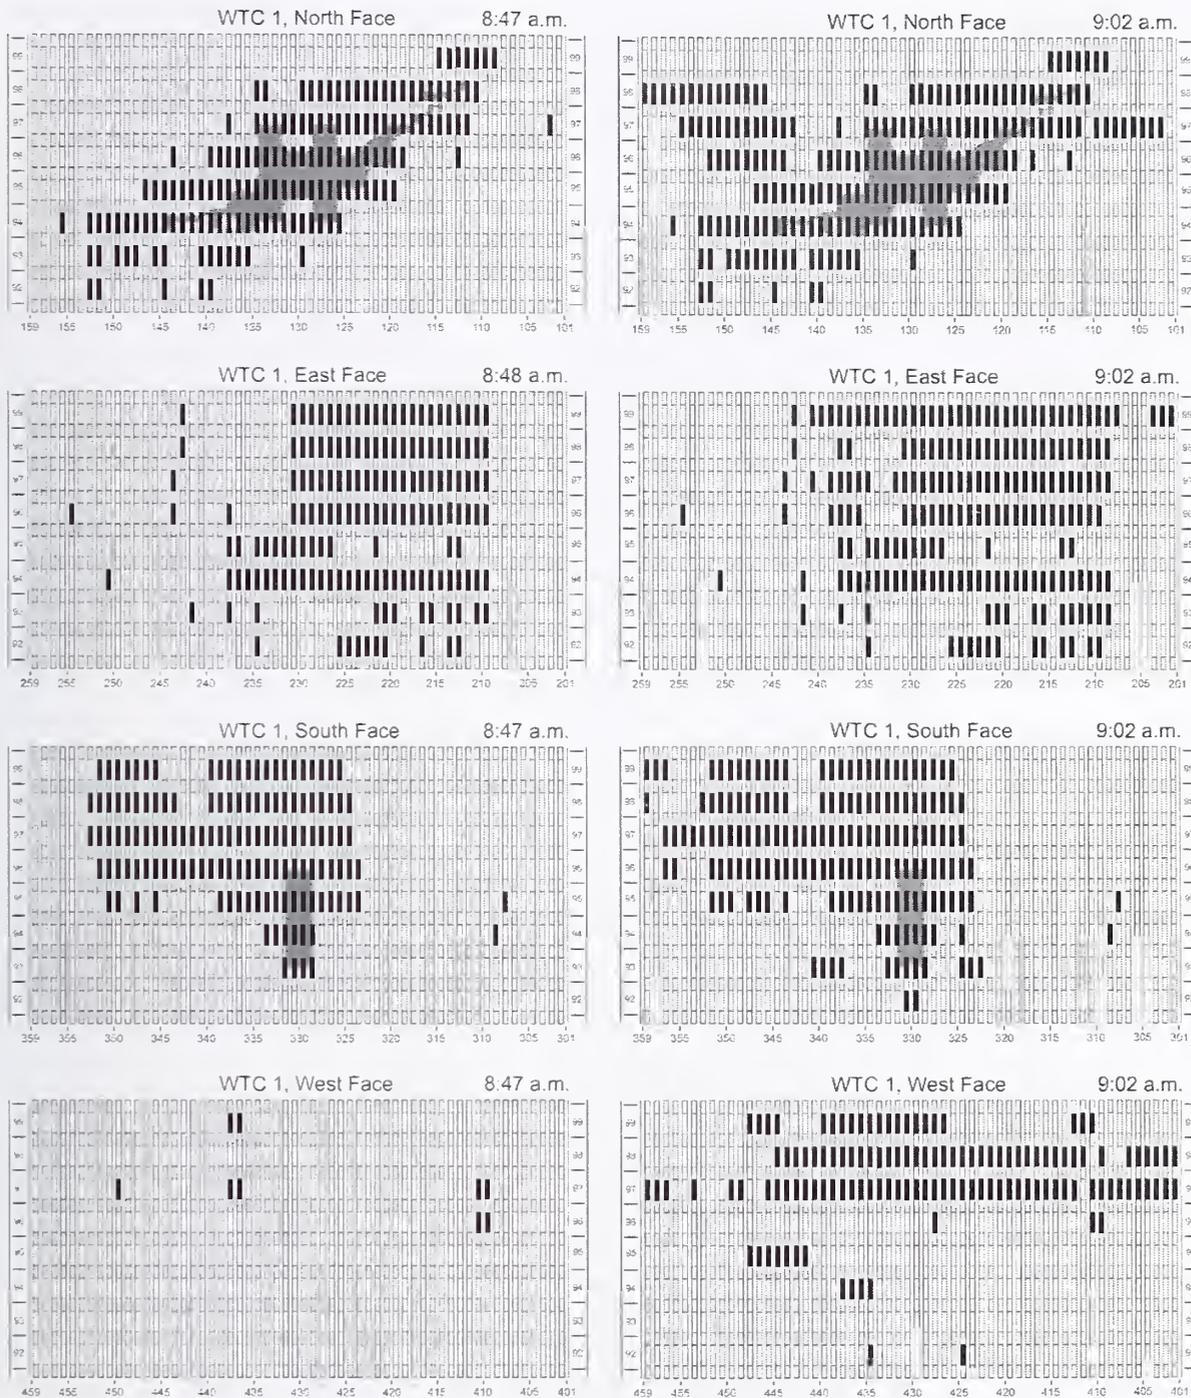
A quick glance at the maps shows that the most extensive fire growth took place on the 97th floor. This growth can be quantified by counting the various window conditions on the four faces of WTC 1 shortly after it was impacted by the aircraft and around 9:03 a.m., when WTC 2 was struck. Table 8–1 is a summary of the results of such an analysis for the 92nd through 99th floors, which include the floors where most of the early fire growth was seen. One simple approach, which is approximate due to the presence of hidden windows, but revealing, is to determine the increase in the number of open windows on each face and to sum the results for each floor. The results are 4, 19, 22, and 85 for the 94th, 95th, 96th, and 97th floors, respectively. Based on the visual observations discussed above, the increases in observed open windows on the 94th and 95th floors were not likely due to spreading fires, but were mostly due to either people breaking windows or to windows that were hidden at the earlier time becoming visible later. On the other hand, the changes for the 96th and 97th floors were primarily due to fire spread. By far, the largest fire growth during the period occurred on the 97th floor, with the number of observed open windows increasing from 30 to 115. On the 96th floor, the initial number was 41, which increased to 63.

Figure 8-13. Maps for the 92nd through the 99th floors compare missing window glass for the four faces of WTC 1 at two times, shortly after the aircraft impact and roughly 15 minutes later. The color coding used for the maps is indicated in Figure 5-1.

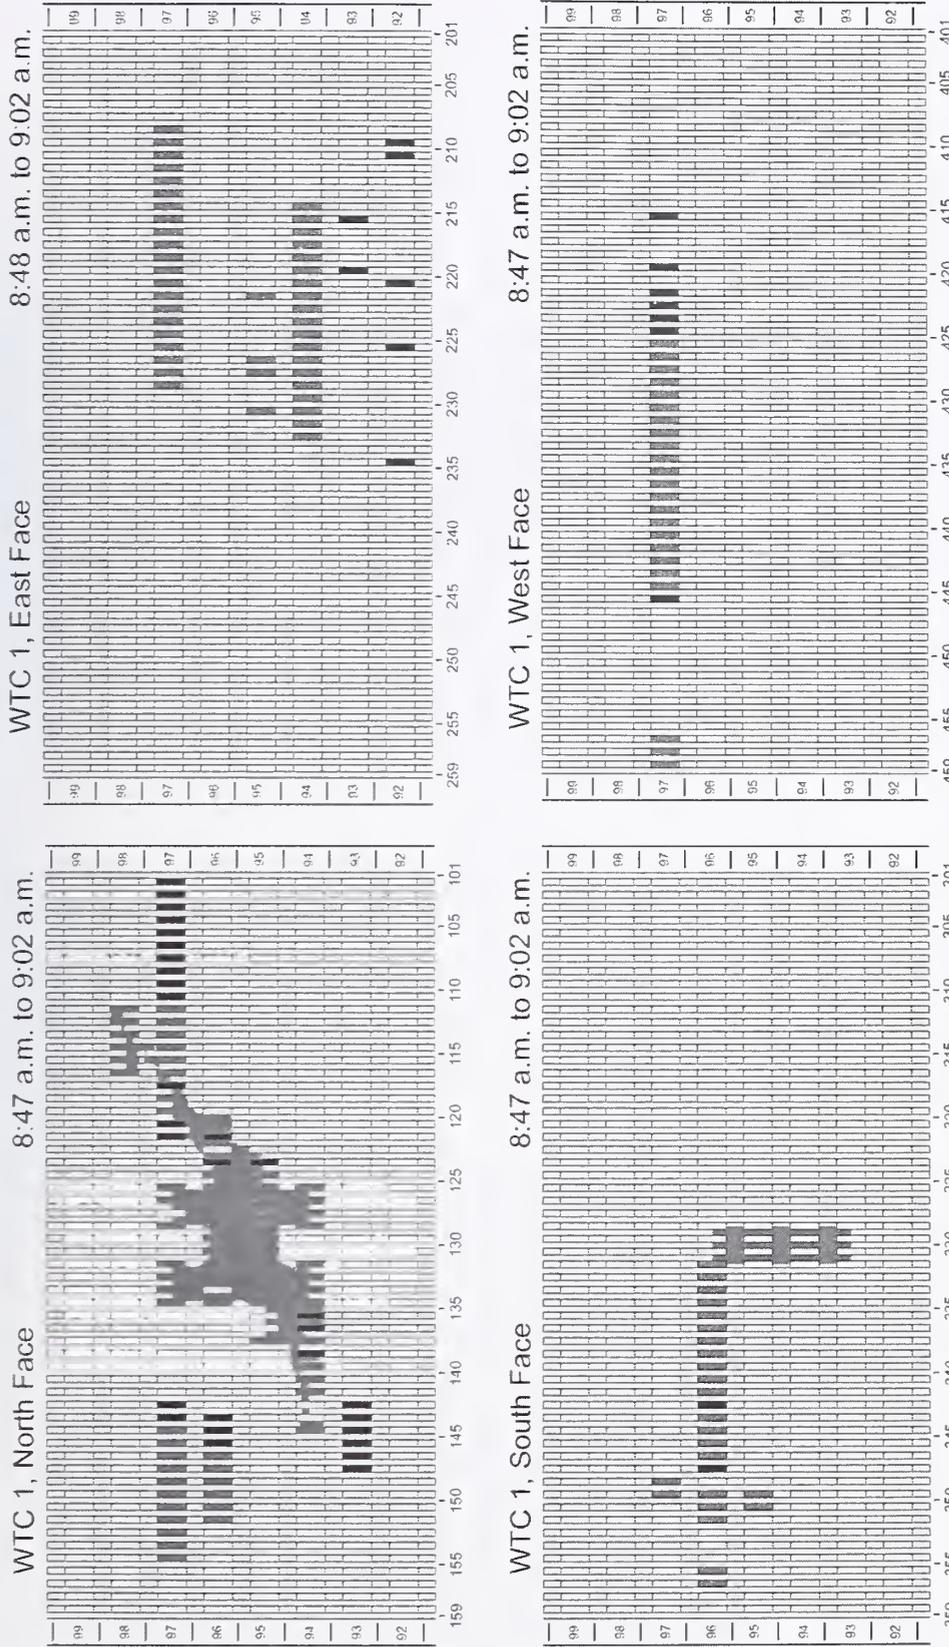
Comparison of these maps with similar maps in Figure 6-19 showing the fire distribution shortly after the aircraft impact provides a clear indication of the fire growth and spread during the period. The extensive fire growth on the 97th floor on the north, east, and west faces stands out. The fire growth on the 94th and 96th floors is also easily identified. The relatively high number of windows which had flames extending from the windows (orange) suggests that the fires that grew during the period were, in general, quite intense.

Figure 8-14. Maps of integrated fire observations between 8:47 a.m. and 9:03 a.m. are shown for the four faces of WTC 1. Colors represent the highest intensity fire observed in a window using the color scale defined in Figure 5-1.

The extraordinarily rapid fire spread and intense flames observed on the 97th floor are likely associated with the presence of unburned aviation fuel distributed in these areas. As discussed in Section 6.5, a significant amount of fuel was likely dumped on this floor from the starboard fuel tank of the aircraft. The absence of extensive window breakage immediately after impact in locations away from the impact zone implies the absence of significant overpressures, which suggests, in turn, that a large area of the distributed aviation fuel on the 97th floor did not ignite immediately following aircraft impact. This unburned fuel was presumably distributed over areas extending along the intact north exterior wall and the central sections of the east and west walls, since subsequent rapid fire growth occurred in these areas.

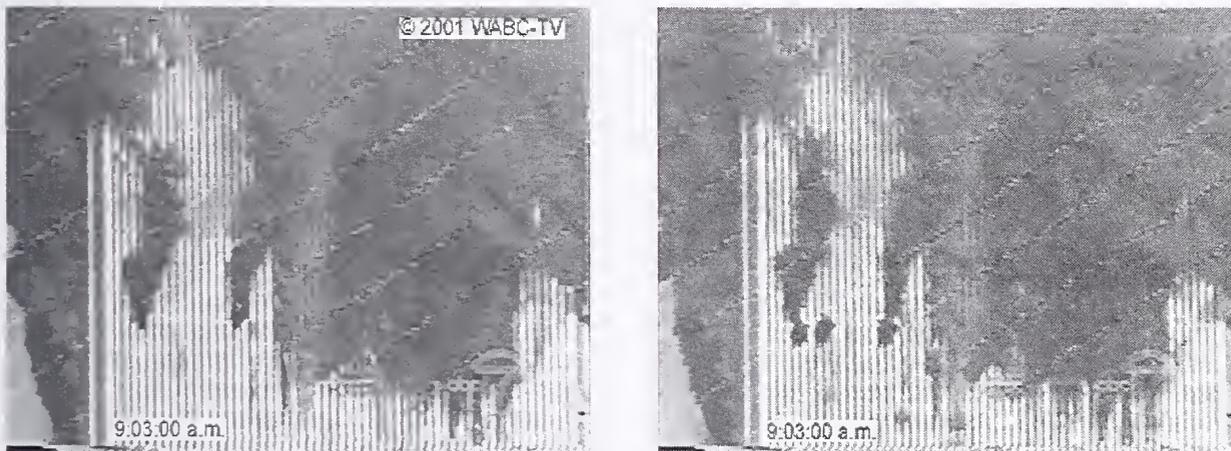
The impact of United Airlines Flight 175 on WTC 2 resulted in some interesting short-term effects in WTC 1. Almost exactly one second after the nose of the aircraft entered WTC 2, a pressure pulse passed through WTC 1 that pushed smoke, and in a few cases fire, from windows located throughout the upper portion of the tower. Figure 8–15 shows the results of this pressure pulse on the east face of WTC 1. The two images are separated by 0.4 s and were recorded roughly one second after the aircraft struck. In the image on the right, puffs of smoke have been pushed out of several windows on the south side of the 96th floor (the floor with smoke coming from a window near the south edge) as well as windows on the 92nd

through 95th floors. Other videos show that almost simultaneously similar puffs of smoke appeared from broken windows on the 92nd, 93rd, 94th, 96th, 97th, 101st, 103rd, 104th, 105th, and 107th floors, as well as from the mechanical equipment room on the 108th and 109th floors. A large burst of flame was ejected by the fire burning on the 97th floor at the north edge of the west face. These observations suggest that a pressure pulse created either by the entry of the aircraft into WTC 2 or the resulting ignition of aviation fuel within the tower was transmitted to WTC 1. The widespread observation of ejected gases suggests that low resistance pathways existed that allowed pressure pulses to be transmitted throughout the upper regions of WTC 1.

Figure 8-15. This figure shows two frames taken from a video that were recorded 12 frames apart, i.e., 0.4 s. The images show the east face of WTC 1 at 9:03:00 a.m.

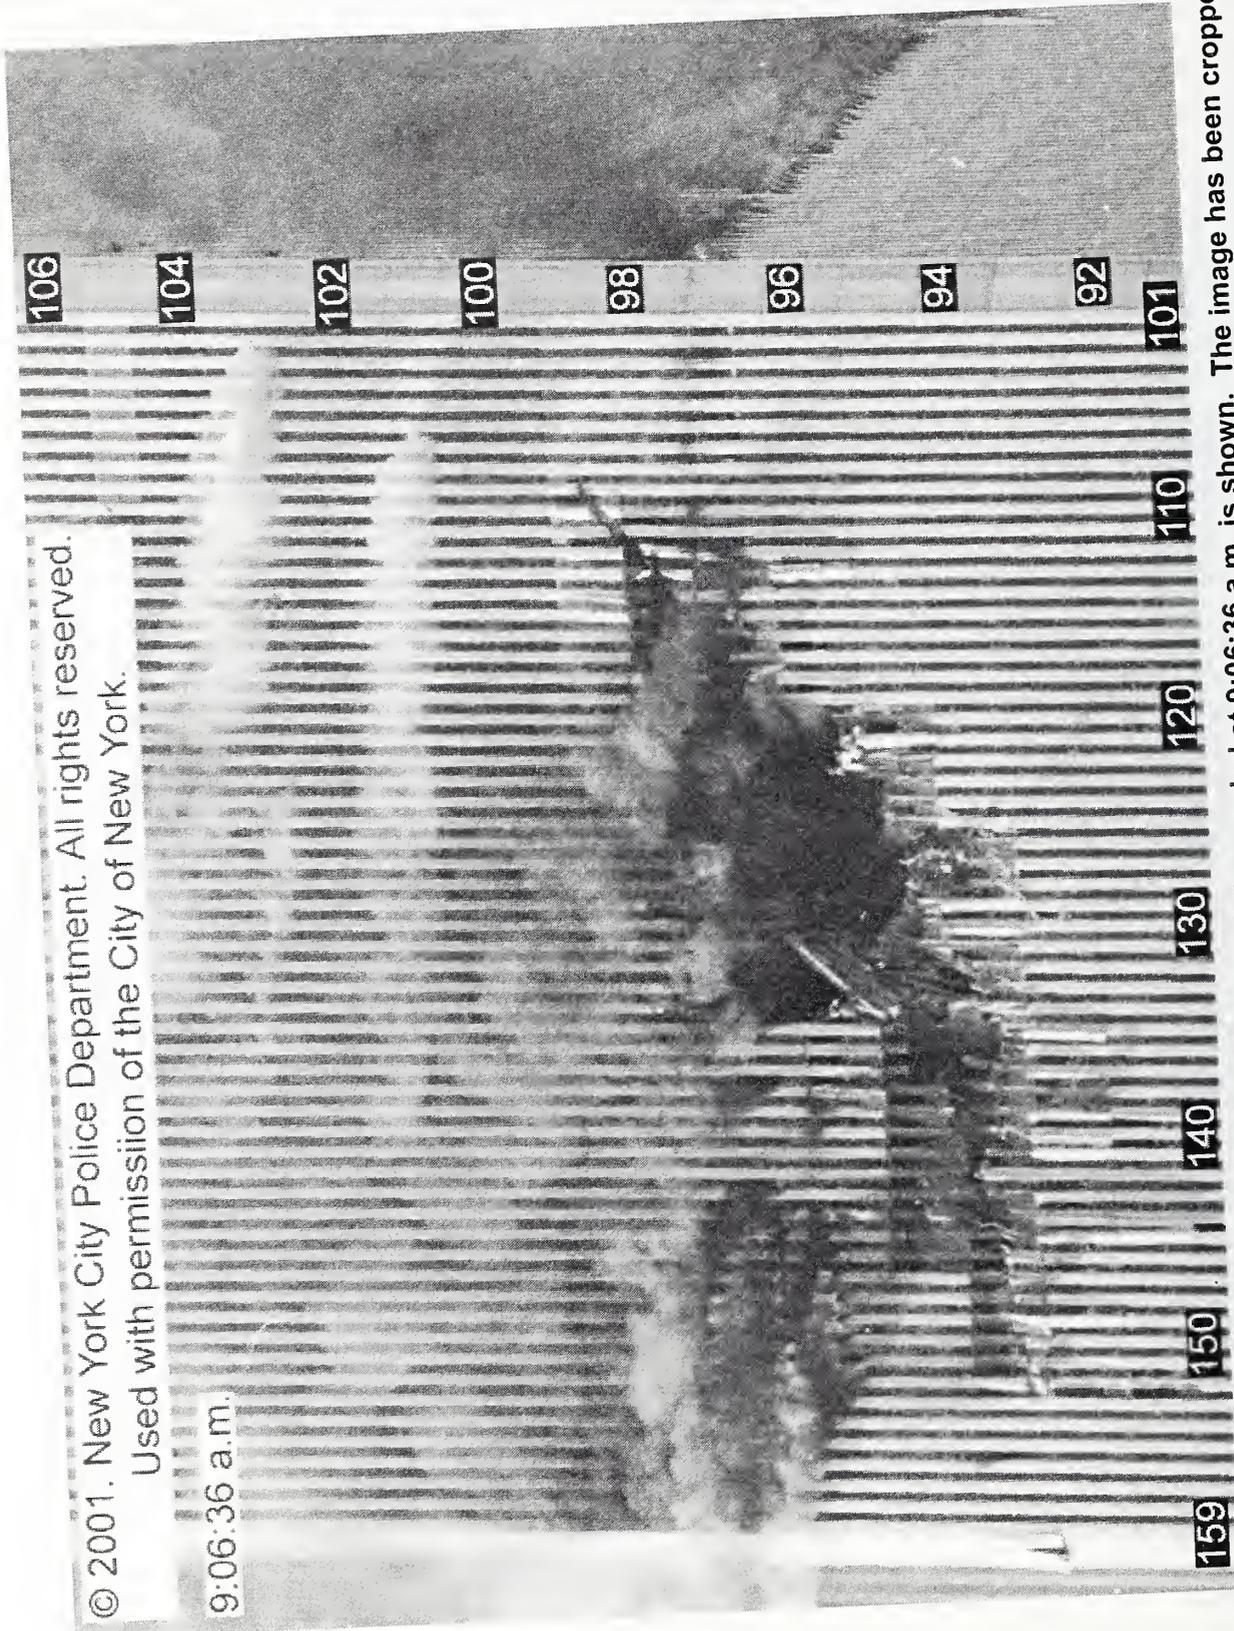
Compared to the rapid fire growth on the north face of WTC 1 during the first fifteen minutes of the event, fire spread during the following fifteen minutes was much reduced. The intense fires that grew on the 96th and 97th floors retreated into the building and began to die down. Figure 8-17 shows a photograph of the north face that was shot at 9:06:36 a.m. Even though the fire on the west side of the 97th floor had spread all the way to the west wall somewhat earlier, the two fires burning eastward on the 96th and 97th floors appear to have stopped spreading. The last window with fire present on the 97th floor is window 97-154. Flames are also evident at the other end of the area, starting at window 97-141. On the 96th floor fire is present at window 96-151, and from window 96-152 on to the east end of the floor, windows appear to be intact. This is clearer in Figure 8-18, which shows a blowup of the area taken from Figure 8-17.

Figure 8-17. A photograph of the north face of WTC 1 recorded at 9:06:36 a.m. is shown. The image has been cropped, rotated, and enhanced. Column and floor numbers have been added.

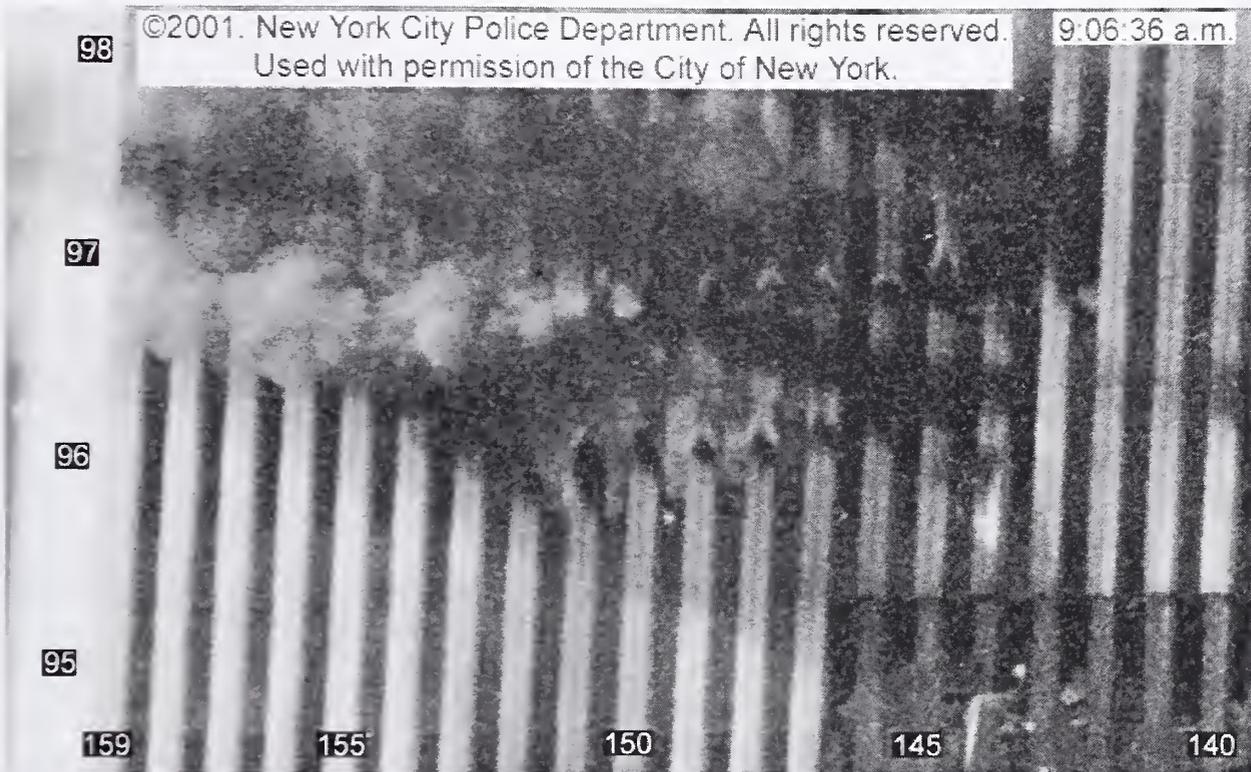
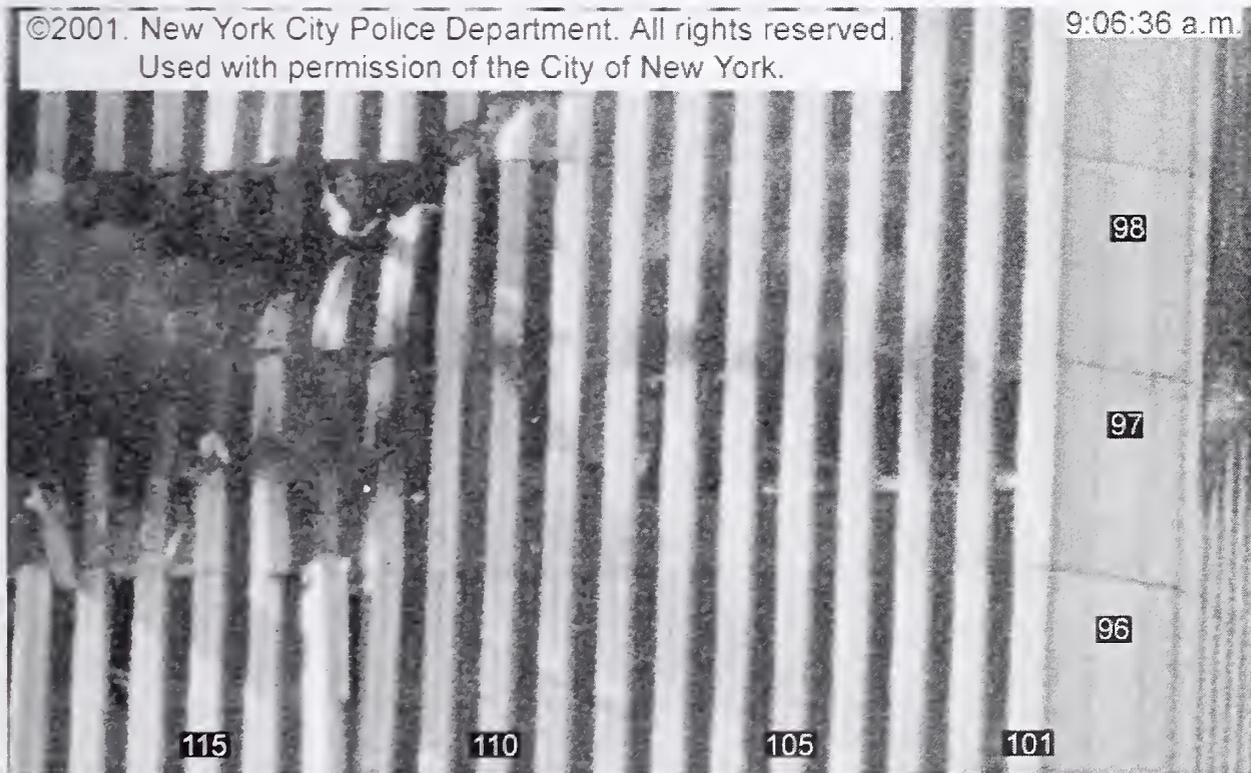
Another prominent feature in Figure 8-18 is the row of carets running across the tops of the column covers. These provide a clear visual indication of how intense the earlier fires in these windows were. It is interesting to compare the appearance of the column covers in this area with those on the 97th floor to the west of the aircraft impact cavity. A blowup of this area is also included in Figure 8-18. The columns are barely marked despite the presence of an active fire in the area for many minutes. This suggests that this fire must be venting somewhere other than through the open windows on the north face. As already discussed, and can be seen in the figure, flames and smoke were coming from this area on the west face of the tower. The smoke issuing from the right side of the aircraft impact cavity may also be due to effluent from this fire. Comparison of Figure 8-17 with earlier images of the north face shows that the flow of smoke from the cavity had also decreased with time. The pathways of venting are expected to influence the local heating of the exterior columns since the imposed heat flux will vary with changes in the flow direction through the opening. Exhausting fire gases will tend to heat the columns, while in-flowing outside air will cool the columns.

Figure 8-18. Two close-ups of the north face of WTC 1 taken from the photograph in Figure 8-17 show the east and west sides of the face around the 97th floor. The photos have been rotated, enhanced, and column and floor number have been added.

In-place windows can be seen in Figure 8–18. On the east side of the building window panes are in their frames on the 95th floor as well as on either side of the fire areas on the 96th and 97th floors. On the west side most windows are still in place on the 96th floor and on the 98th and 99th floors at locations removed from the immediate vicinity of the aircraft impact. These observations suggest that windows are only removed when active burning is present in the immediate area of the window.

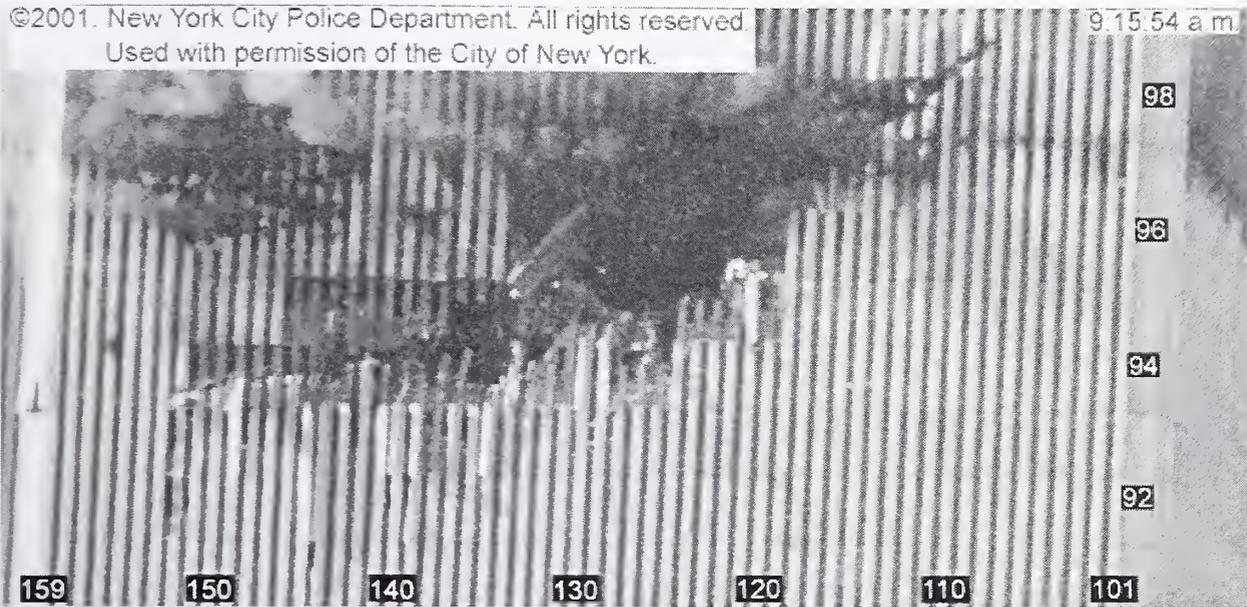
Figure 8-19. An image recorded at 9:15:54 a.m. shows the north face of WTC 1. The original has been cropped, rotated, and enhanced. Column and floor numbers have been added.

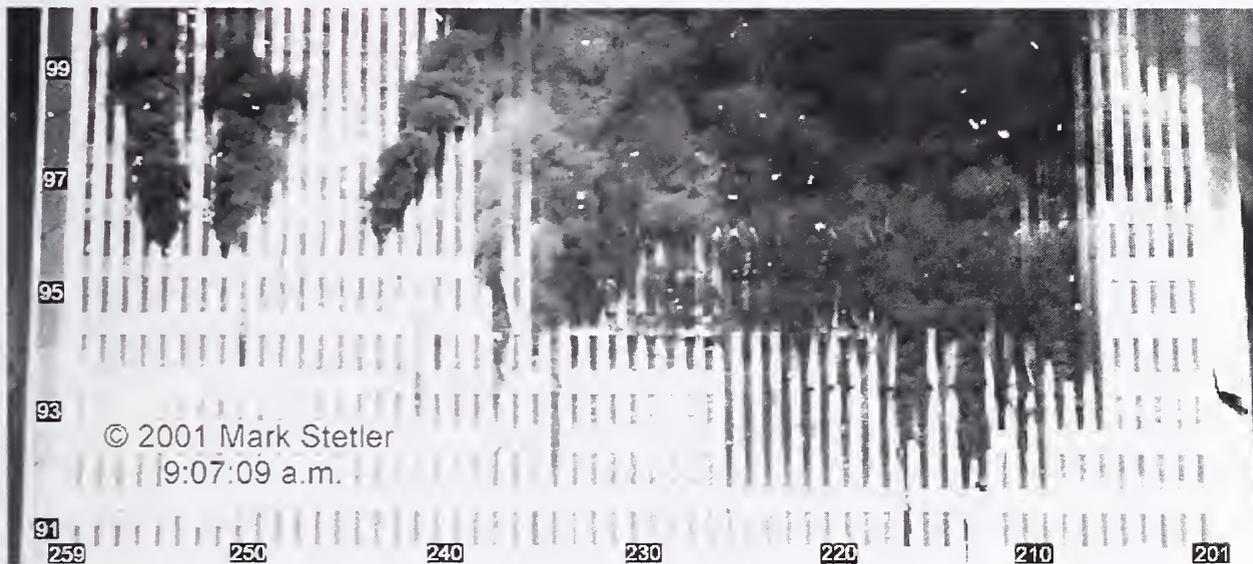
In contrast to the north face of WTC 1, the fires burning on the periphery of the east side of the tower continued to spread during this time period, initiating new areas of intense burning, while areas ignited somewhat earlier were dying down. Figure 8–20 shows the east face at 9:07:09 a.m. The appearance has changed considerably in the four minutes since 9:03 a.m. (see Figure 8–15 and Figure 8–16) and even more so from earlier times. Two important changes are the appearance of extensive areas of flame on the 92nd floor (extending roughly from window 92-216 to window 92-225) and on the 96th floor (visible over at least windows 96-217 to 96-227). Several distinct carets can already be seen on column covers on the 96th floor, indicating that strong external flaming had already taken place from windows adjacent to these columns. At the earlier time there had only been indications of small fires on both of these floors.

Figure 8-20. This cropped photograph shows the east face of WTC 1 at 9:07:09 a.m. It has been rotated slightly and enhanced to emphasize the presence of fire. Column and floor numbers have been added.

Around 9:03 a.m. there was a fire near column 95-225 on the 95th floor. In Figure 8-20, the fire on this floor now extends to window 95-231. The extended flames observed on the 93rd floor near column 93-210 around 9:03 a.m. have receded back into the building and are not obvious in the photograph. In their wake they left a dark caret at the top of the aluminum cover for column 93-210.

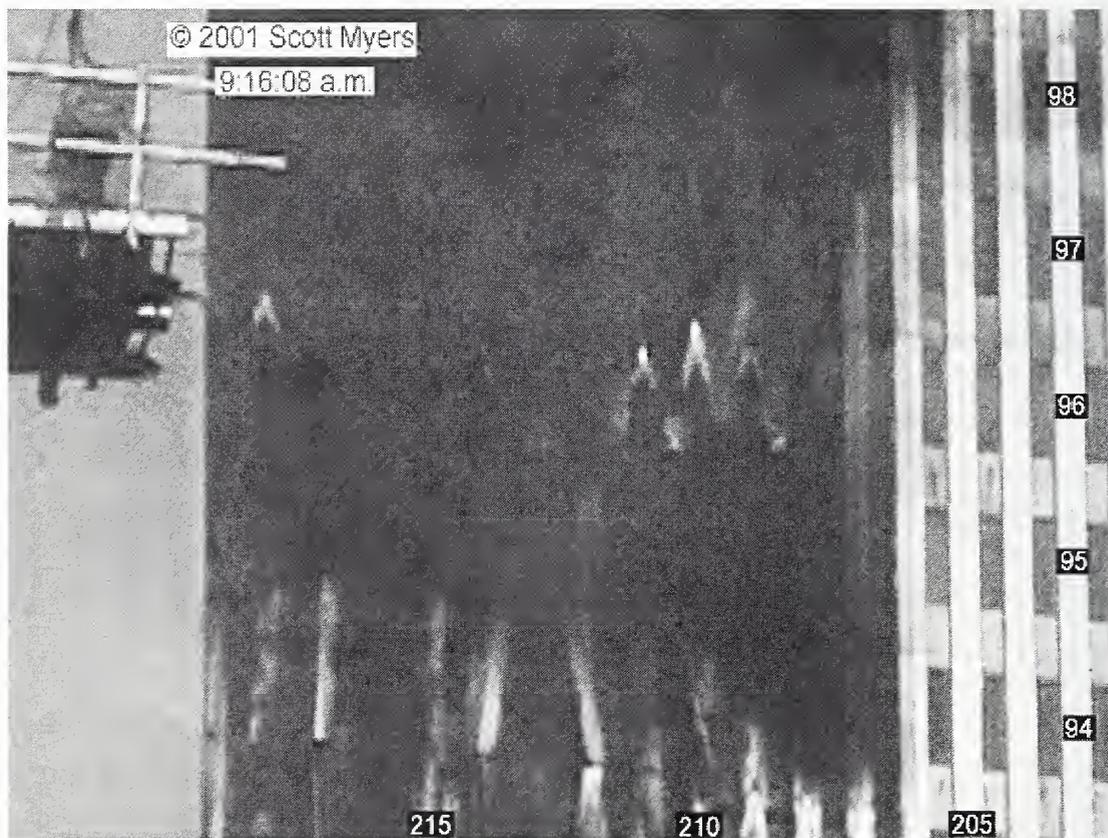
Figure 8-21 shows a close-up frame from a video of a portion of the east face recorded at 9:16:08 a.m. Intense flames are coming from windows 96-208 and 96-209. In the video it is clear that flames are exiting from across the entire burning region that is visible on this floor. A series of carets are seen at the tops of the column covers. The carets appear to be glowing near the center. The physical mechanism responsible for this glow is not known, but it does suggest that significant heating was taking place at this time. Recall that flames were observed on the 97th floor immediately above this location around 8:59 a.m. (see Figure 8-9). These flames are no longer visible, providing additional evidence that flames are growing and then decaying in relatively short period of times.

Figure 8-21. A close up of a portion of the east face of WTC 1 is shown. The image is a frame taken from a video recorded at 9:16:08 a.m. Column and floor numbers have been added. The area to the left with the scaffolding is another building in the foreground.

Even though flames have been observed extending from windows 96-208 and 97-208 on the 96th and 97th floors, the adjacent windows to the north, window 96-207 and window 97-207, are still intact. In fact, the entire area to the east of column 208 on floors 94 through 98 appears to be unaffected by the fires, except for soot deposited on the left side of the area. The sharp demarcation line for the fires on the 96th and 97th floors suggests that fire spread is being inhibited in a manner similar to that already described for the north face. The plan layouts for these floors shown in Appendix B (Figure B-5 and Figure B-6) indicate that both floors had rooms in the northeast corners, with walls that terminated at column 208.

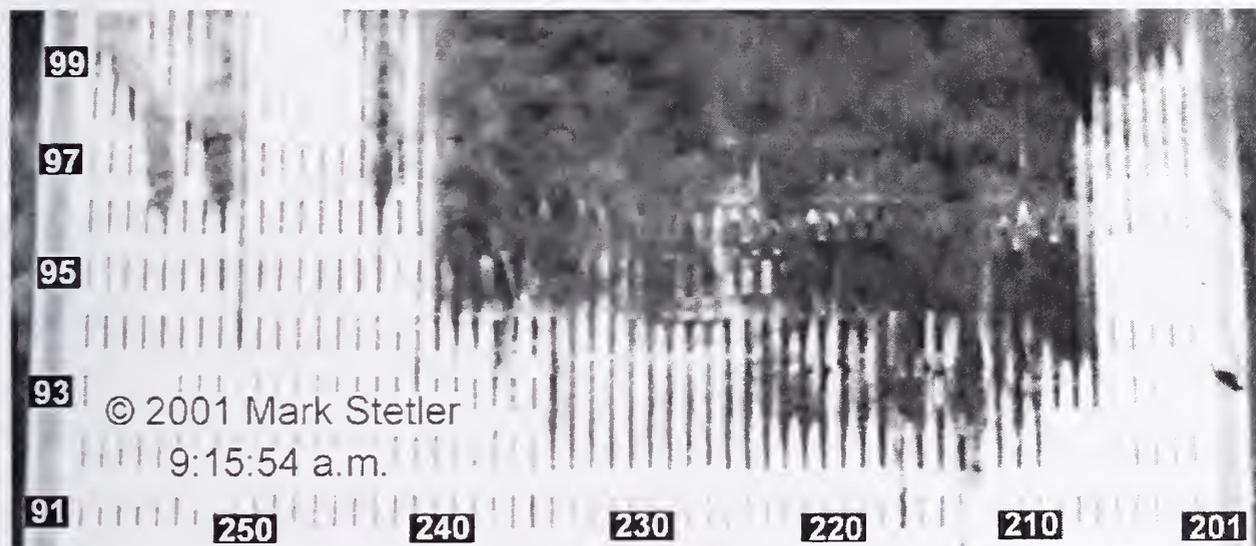
These general trends in the observed fire behavior for the east face continued over the next several minutes. Figure 8-22 shows a photograph that was taken at 9:15:54 a.m. There are regions of extensive fire. Flames can be seen on the 92nd floor from window 92-209 to window 92-235. One curious aspect of these flames is that there is little, if any, flame extension, and there is only heavy smoke coming from windows on the right side of the area. As a result of these characteristics, in many images of the east face recorded around this time, the fire on the 92nd floor is not readily apparent, and the smoke flow from these windows appears to be light. Fire is only observed in images taken nearly perpendicular to the face from relatively long distances. As discussed in Section 4.2.7, such observations are due to the geometry of the building and either suggest the fires are located near the floor or are set back from the windows.

Figure 8-22. This cropped photograph shows the east face of WTC 1 at 9:15:54 a.m. The image has been rotated and enhanced to improve the dynamic range. Column and floor numbers have been added.

On the 93rd floor, there appears to be a small fire covering several windows starting at window 93-206. There is some smoke coming from the area.

Unlike earlier, at this moment, only limited flame extension is observed from windows on the 94th floor. Flames can be seen inside the windows starting near window 94-224, and they have now spread as far south as window 94-240. Even though smoke is still coming from some windows, there is little flame evident in windows to the north of window 94-223.

The fire observed earlier on the 95th floor in windows 95-225 to 95-231 has died down. Interestingly, intact windows can be seen to the immediate right of this area. Images recorded much later show that many windows to the north remained intact.

The fire on the 96th floor continues to burn fiercely. A continuous region of flames extends from windows 96-208 to 96-234. There is significant flame extension from around windows 96-208 and 96-209 and from windows 96-227 to 96-234. A distinct row of carets at the tops of the column covers is visible over much of the fire length, providing an indication of the maximum depths of the layer of flaming gases that flowed earlier from the adjacent windows. The layer depth is related to the local intensity of burning, with a deeper depth indicating a more intense fire.

Some of the 97th floor is hidden by smoke. This is especially true near the center of the face, where a substantial fire may still be present. Many open windows can be seen to the north of this area in which there does not appear to be fire present. In other places, e.g., near window 97-211, relatively low-level burning is taking place. Similar to part of the 94th floor, the fires on the 97th floor that grew the earliest on this face now appear to have died down.

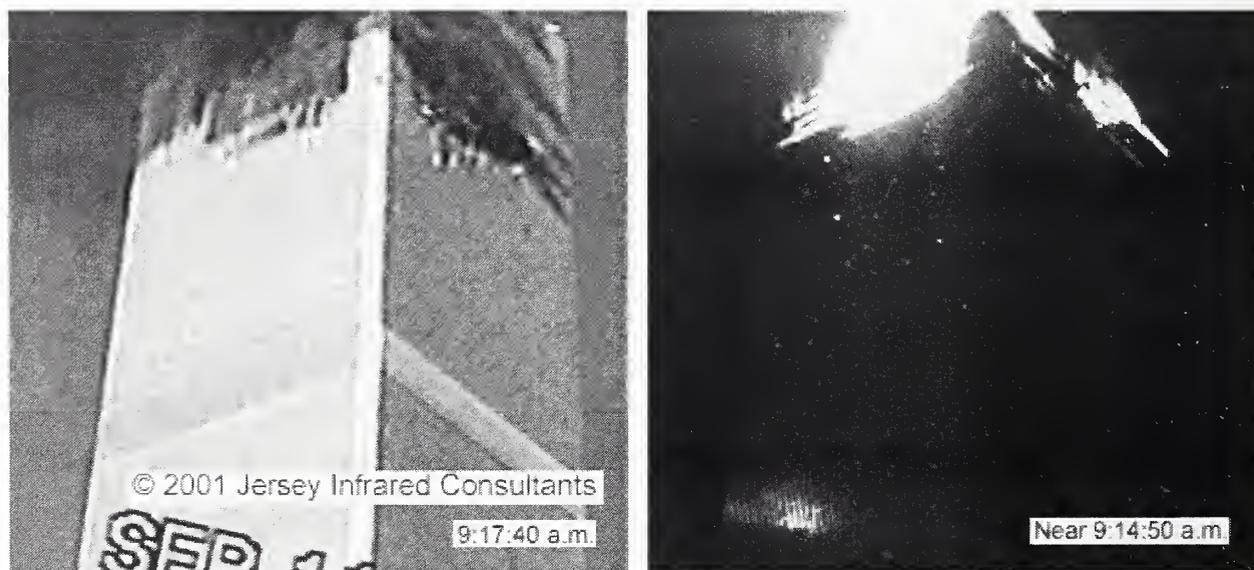
Figure 8-23. A frame from a standard video camera (left) and an image from an infrared camera (right) showing the north and east faces of WTC 1 are compared. The video frame was shot at 9:17:40 a.m., and the infrared image was taken around 9:14:50 a.m. (an uncertainty of 15 s has been assigned). The infrared image intensity levels were adjusted. The video frame has been rotated and sized to match the infrared image.

There is considerable heating in the immediate vicinity of the aircraft impact cavity. This is most likely associated with the heavy smoke (presumably heated) that is still flowing from the area. The two bright lines on the east side of the north face are due to heating by the fires that have been burning on the 96th and 97th floors. It is interesting that there is a region between the aircraft impact cavity and these heated regions that has remained relatively cool. This means that this area had neither burned nor been heated by fire gases from nearby fires.

Two small areas of strong heating are visible on the north face at the eastern side of the 94th floor in Figure 8-23 and Figure 8-24. A similar locally heated spot can be seen immediately below on the 93rd floor. The fires present on the 93rd floor have already been described based on visual imagery.

In Figure 8-23 there appears to be a heated area on the east face many floors below the fire floors. There are no other indications of a fire burning in this area, and it is believed that this apparent heating results from a reflection of the fires burning in WTC 2.

The difference in the amount of heating on the north and east faces in Figure 8-23 and Figure 8-24 is striking. Much of the area above the fires on the 92nd floor at the center of the east face is saturated, i.e., strongly heated. This is likely due to the large amounts of smoke and heat flowing from open windows near the intense fires burning on multiple floors of this face.

Despite this strong heating, there are parts of the east face in Figure 8-23 where individual floors and windows can be identified. On the south side of the face heat has migrated along the 94th through 97th floors, resulting in the bright lines that are visible in the infrared image. Individual windows are barely resolved. Figure 8-22 shows that smoke was flowing from only a few of the windows in this area and that most of the windows were still closed around this time. Heavy smoke can be seen coming from two windows (96-251 and 96-254) on the southern side of the 96th floor in Figure 8-22. In Figure 8-23 these two windows stand out as two larger bright spots near the southern edge of the tower. Using these windows for reference, it can be seen that the heated sections of the 95th, 96th, and 97th floors do not extend beyond column 250, while the heating on the 94th floor seems to have reached the south end of the

floor. The southern portion of the east side of the 92nd floor appears unheated despite the presence of a substantial fire near the center of this floor.

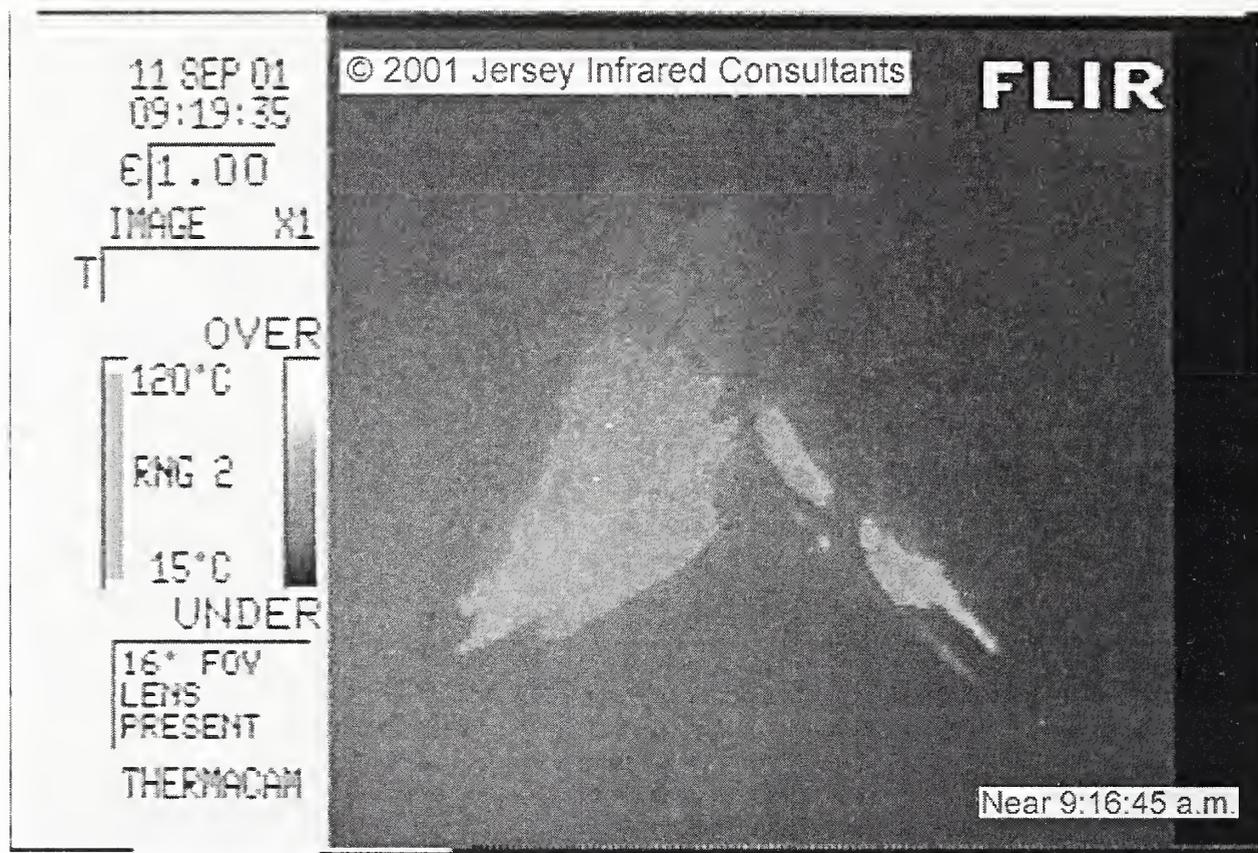
Figure 8-24. This frame from a standard video recording of the display from an infrared camera shows the north and east faces of WTC 1. It was shot around 9:16:45 a.m. (an uncertainty of 15 s is assigned) using a false-color scale for intensity. The output is strongly saturated.

On the northern side of the east face there are heated areas that reach as far as the northeast corner on the 96th and 97th floors. This is clearer in Figure 8–24, which shows more of the tower. Recall that at the times these images were taken the glass for all of the windows inside the northeast corner rooms was still in place on these floors despite the presence of nearby intense fires. On the lower floors there appears to be mild heating at the northern edges of the 92nd and 94th floors, while the 93rd and 95th floors are close to the ambient temperature.

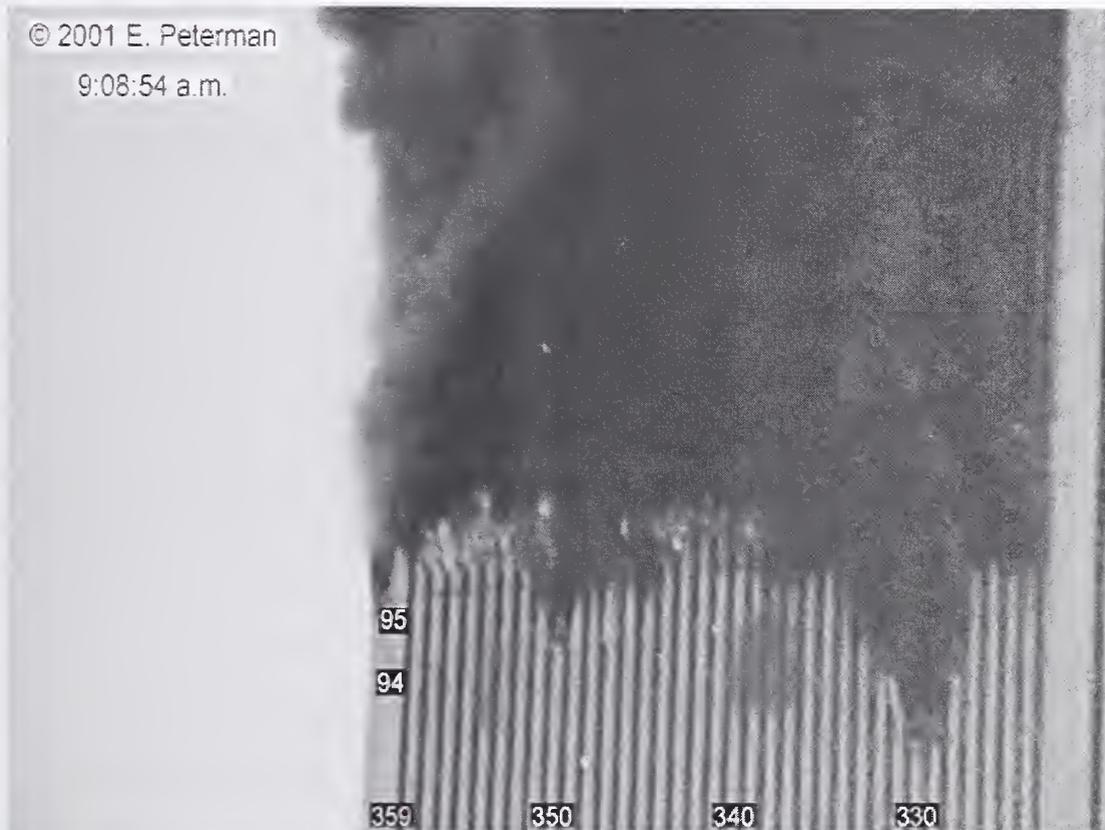
During the initial part of this time period, the fires on the west side of the 96th floor on the south face continued to spread and grow. Distant images indicate that fire fully covered the area near the west wall shortly after 9:03 a.m. Figure 8–25 shows the west side of the south face as it appeared at 9:08:54 a.m. The image was captured from a video recording. On the 96th floor, flames now extended from at least

window 96-335 all the way west to window 96-358. The flames were particularly heavy on the west edge from windows 96-350 to 96-358. At this time, flames are not visible on other floors.

Figure 8-25. This image showing the south face of WTC 1 at 9:08:54 a.m. is a frame taken from a video. Column and floor numbers have been added.

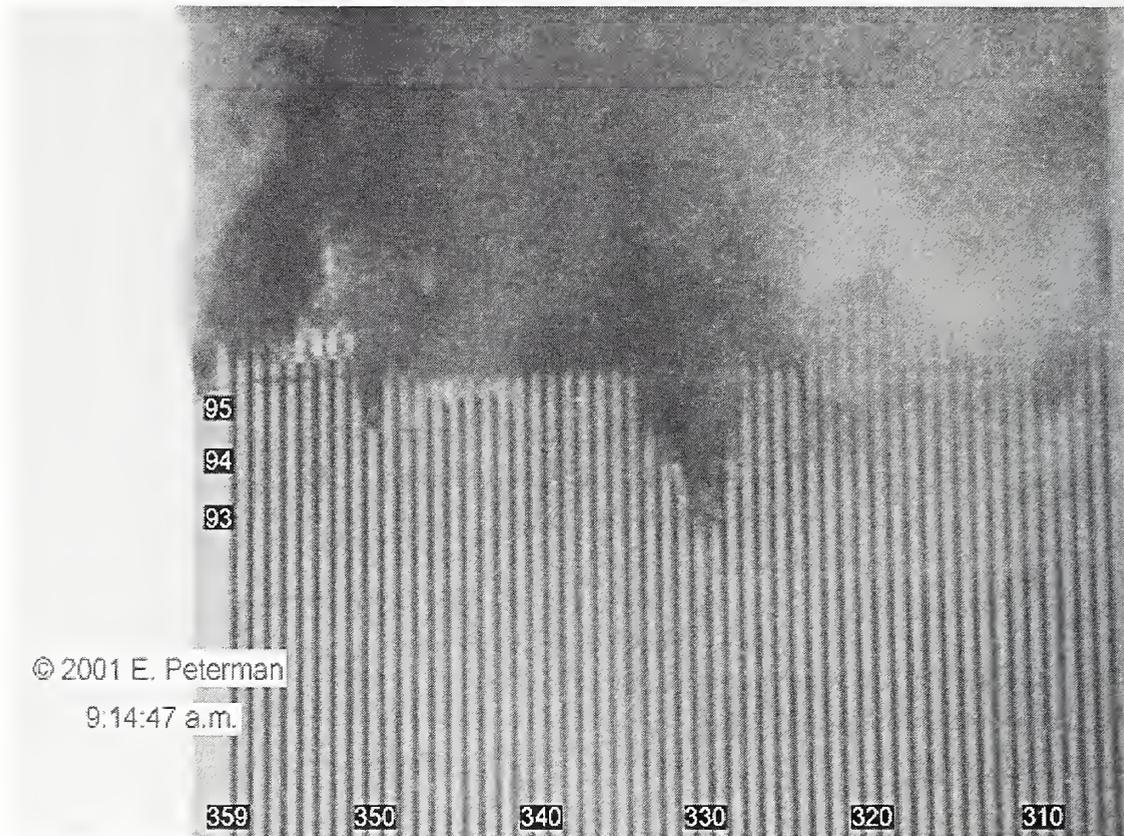
During the next five minutes, the appearance of the south face changed dramatically as can be seen by comparing Figure 8-25 with another captured video frame shown in Figure 8-26. While the fires on the 96th floor were beginning to die down and recede back into the tower, extensive areas of flame were now apparent on both the 95th and 97th floors. The fire on the 95th floor can be seen in windows 95-340 to 95-346, while flames are visible extending from windows 97-336 to 97-354 on the 97th floor. The fire on the 97th floor may actually extend to the west face, but this cannot be confirmed since the area was hidden by heavy smoke coming from below.

Even though the west side of the south face is heavily involved in flames, there has been no apparent fire spread toward the east beyond the initially damaged area near the center of the face.

Figure 8-26. This image showing the south face of WTC 1 at 9:14:47 a.m. is a frame taken from a video. Column and floor numbers have been added.

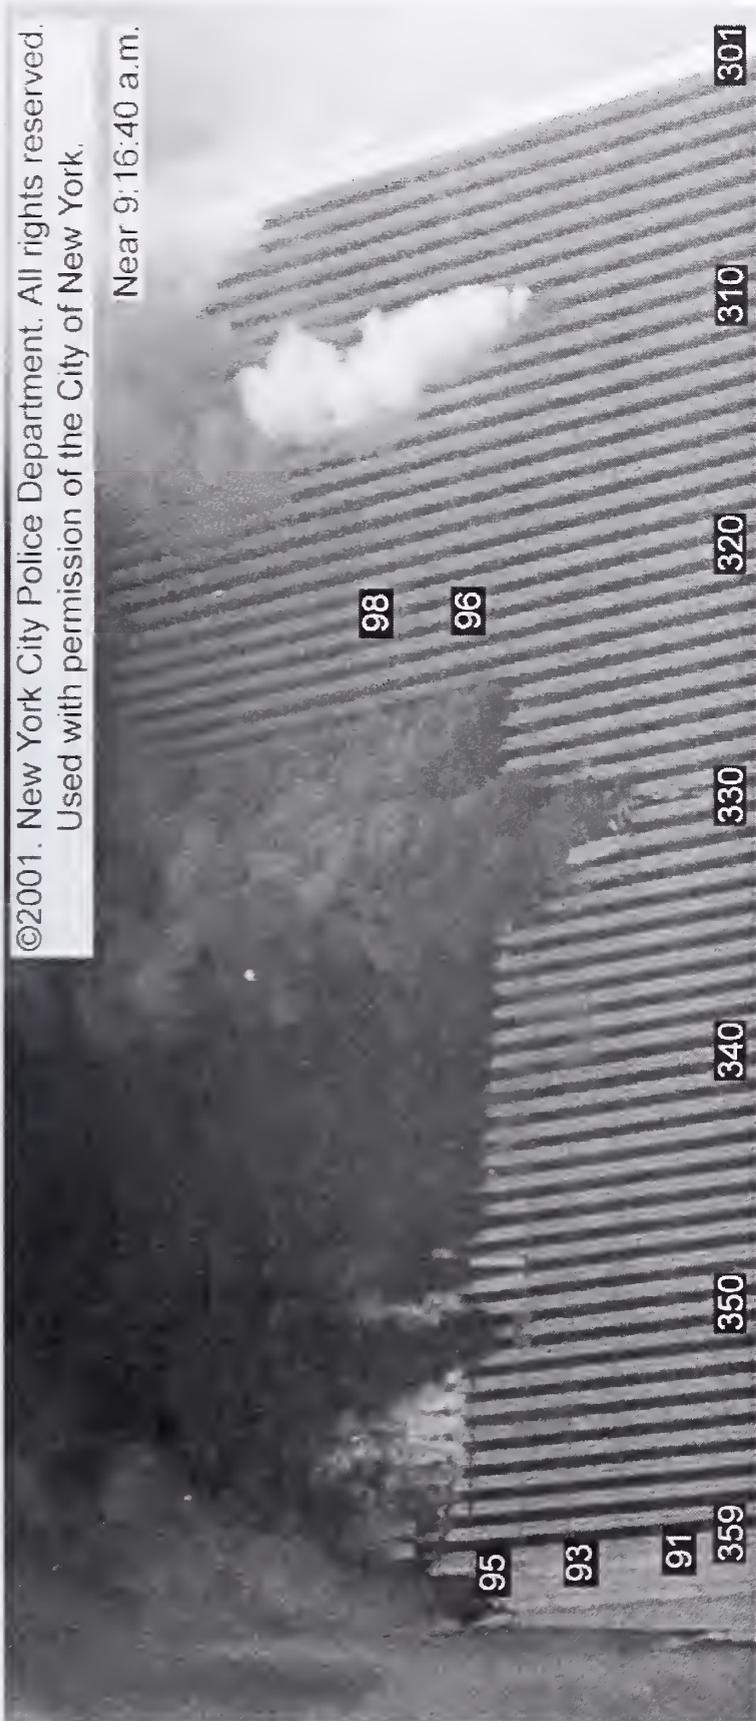
The fire intensity on the south face appears to have gone through several cycles, alternating between periods during which flames extended large distances from multiple windows and those where the flames receded back into the building. Figure 8-27, a photograph shot at around 9:16:40 a.m., i.e., roughly two minutes later than Figure 8-26, shows an example of one of the intense burning periods. The fire on the 95th floor has spread to the east and now extends to at least window 95-333. Flames are coming from several windows to the left of window 95-340. Heavy smoke, which partially obscures the areas above, is pouring from the openings. Bright yellow flames, which appear to reach down to the bases of the

windows, are now jetting from multiple windows on the 96th floor. It appears as if a portion of the exterior wall is covered by a continuous sheet of flame several stories tall. Fire is evident on the 97th floor, but it is not possible to judge whether flames are coming out of the windows on this floor due to the heavy smoke and flames rising from the 95th and 96th floors.

A row of carets is already visible at the tops of the covers for columns 96-352 to 96-359. Despite the intense flames, few streamers were observed falling from the south face as shown in Appendix L. This is not unexpected since imagery from this direction is more limited than for the north and east faces, and many of the available shots are from such distances that streamers are difficult to identify. During this time period, the south face was in shadow, and streamers were not illuminated by sunlight until they had traveled a considerable distance from the building.

Figure 8-27. This image of the south face has been cropped from a high-resolution photograph. There is a 35 s uncertainty in the assigned time of 9:16:40 a.m. The image has been enhanced and rotated. Column and floor numbers have been added.
