**NIST NCSTAR 1-5A
Federal Building and Fire Safety Investigation of
the World Trade Center Disaster**

**Visual Evidence, Damage Estimates,
And Timeline Analysis**

Visual Evidence, Damage Estimates, and Timeline Analysis

September 2005

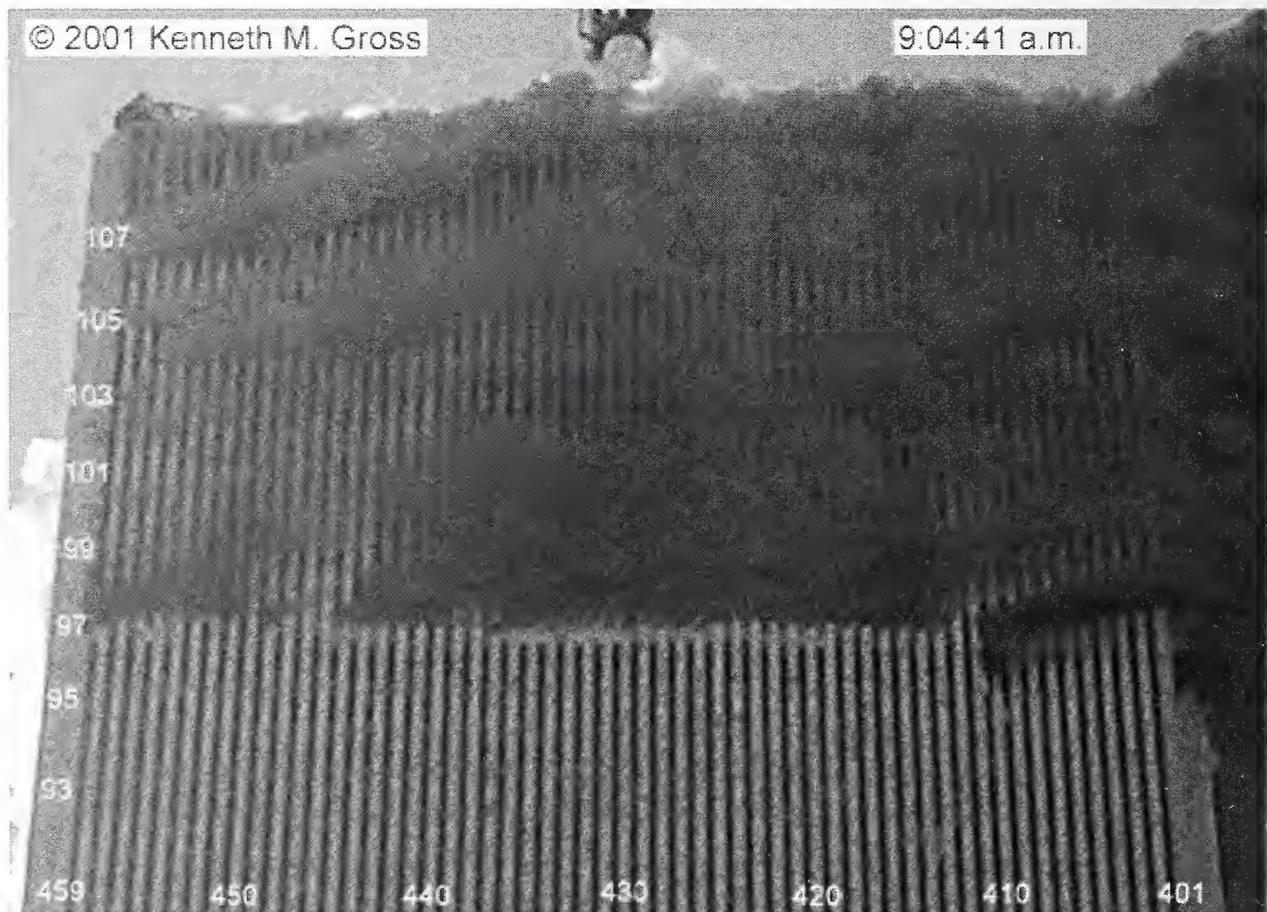
The fires on the west face during this time period continued to undergo unusual and dramatic changes in behavior. But first, following the two periods of rapid fire spread prior to 9:03 a.m., the fires again underwent another pause during which further fire spread was not evident. Figure 8–28 shows the west face as it appeared at 9:04:41 a.m. Flames, with a couple of breaks, can be seen in or extending from window 97-412 to window 97-458. This is roughly the same area that was burning just prior to 9:03 a.m., although the flames in the southern part of the area are more evident than earlier. Heavy smoke is pouring from multiple windows on this floor. Other features present in Figure 8–28 include heavy smoke flow from windows 96-409, 96-410, 97-409, and 97-410 on the 96th and 97th floors, the heavy smoke coming from broken windows in the upper northern portion of the face, and the fire coming from the southwest corner of the 96th floor where the aluminum panel was dislodged during the aircraft impact and subsequent fireball. A streamer can be seen near column 414 at the bottom of the photograph.

The open windows on the 95th floor, visible in Figure 8–11, can also be seen in Figure 8–28. There are also four windows, 94-434 to 94-437, on the 94th floor that are now open, but were in place in the earlier photograph taken at 9:01:40 a.m. These windows are believed to have been broken out by people. At this time there is no smoke coming from either set of open windows despite the presence of fires elsewhere on both floors.

Figure 8-28. A cropped photograph of the west face of WTC 1 taken at 9:04:41 a.m. is shown. The image has been enhanced and rotated. Window and floor numbers have been added. A streamer can be seen falling near the bottom of the image at column 414.

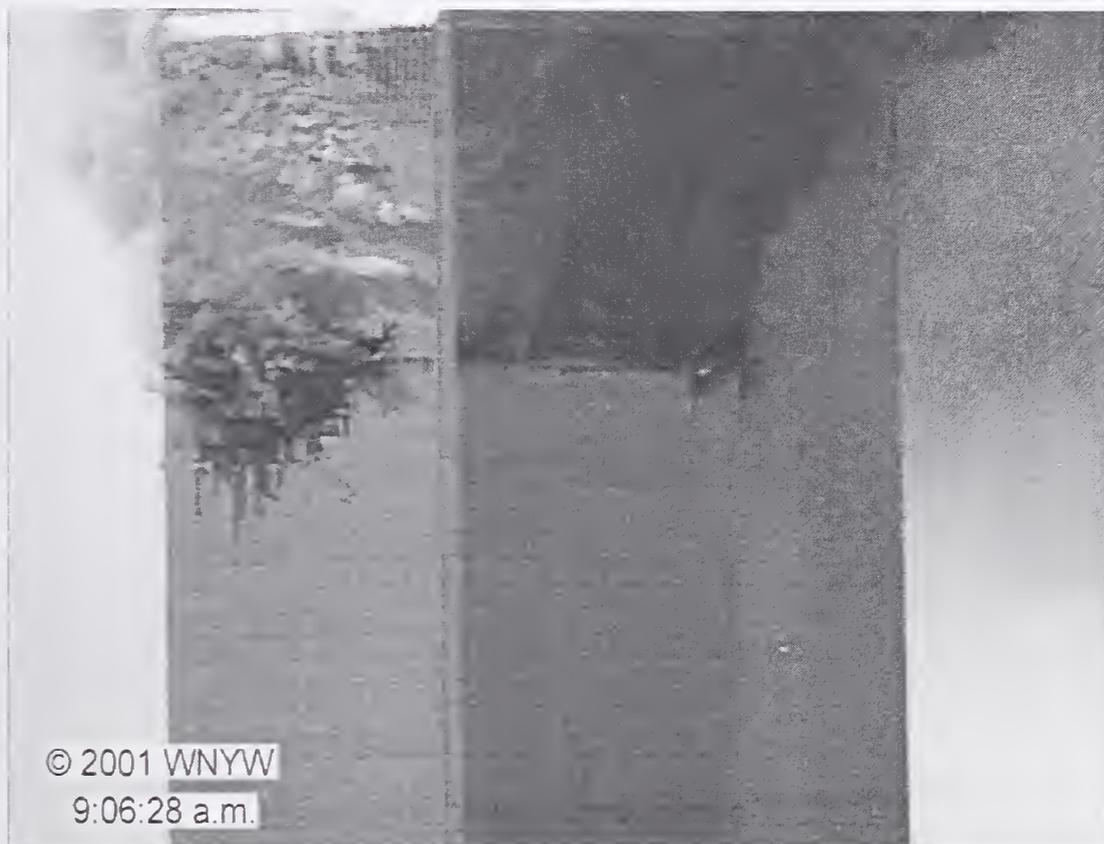
Mostly long-distance photographs and videos show that the conditions present in Figure 8–28 did not change appreciably until 9:06:27 a.m. At this time a short-lived, but intense, burst of flame appeared near the top of window 97-408, as can be seen in Figure 8–29. Very shortly after this flame appeared, the amount of smoke coming from open windows on the 97th floor decreased dramatically, and it was possible to see parts of the west façade that had been hidden just before. The heavy smoke is still evident in Figure 8–29.

Figure 8-29. This image of the north and west faces of WTC 1 is a frame from a video recorded by a news helicopter at 9:06:28 a.m. WTC 2 can be seen behind WTC 1. Note the burst of flame from near window 97-408 at the southwest corner of WTC 1.

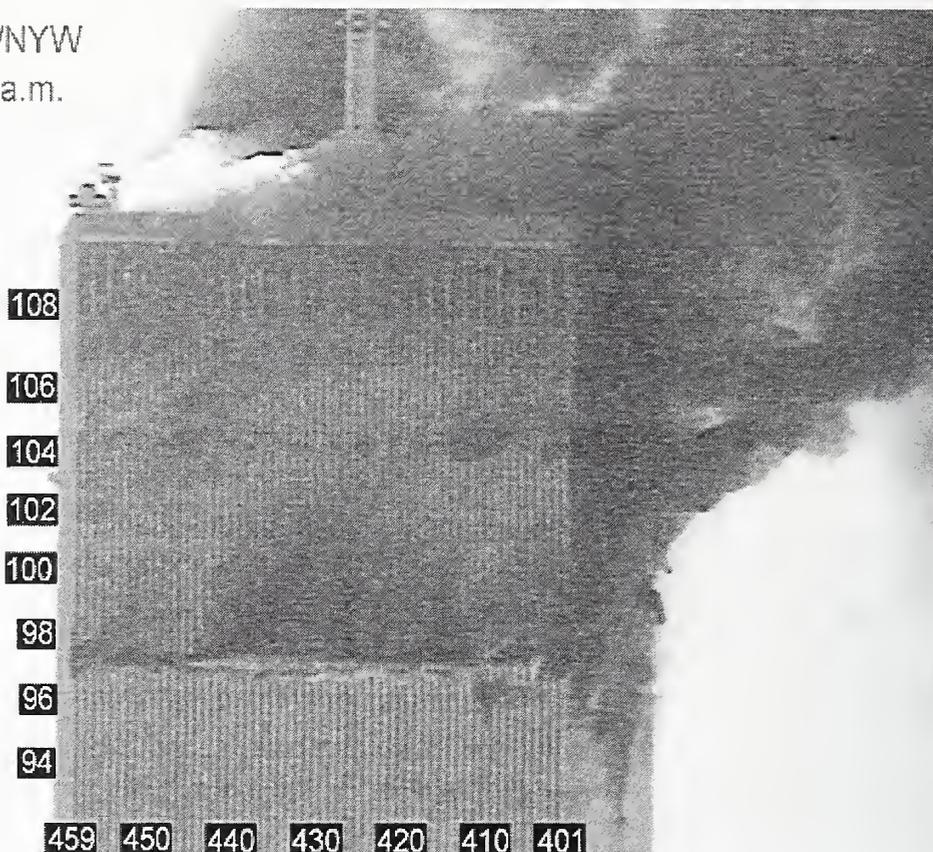
Another frame taken from a video shot by a news helicopter is shown in Figure 8–30. This image was taken four and a half minutes later than Figure 8–29. An extensive area of flame is still present on the 97th floor, but the flames toward the center of the face appear to have receded deep inside the building. There is very little smoke coming from the region. Most of the west face is now visible. In particular, the smoke coming from two areas on the south side of the face at the 104th floor can now be seen clearly. On the north side of the face the heaviest smoke flow from the upper floors is coming from the 107th floor, with strong smoke plumes also issuing from open windows on the 104th and 105th floors.

There appears to be a small fire on the 96th floor at window 96-406. Small fires such as this one were not observed on the west face of the 96th floor until around 9:08 a.m. This was the case despite the fact that an intense fire had been burning just around the southwest corner on this floor for over 20 minutes. Several windows did open near the corner during this time period, suggesting that heating was taking place in the area. There is a remarkable difference in the fire growth and spread on the western

Figure 8-30. This image of the west face of WTC 1 and an oblique view of the south face is a frame from a video recorded by a news helicopter at 9:10:58 a.m. Column and floor numbers have been added.

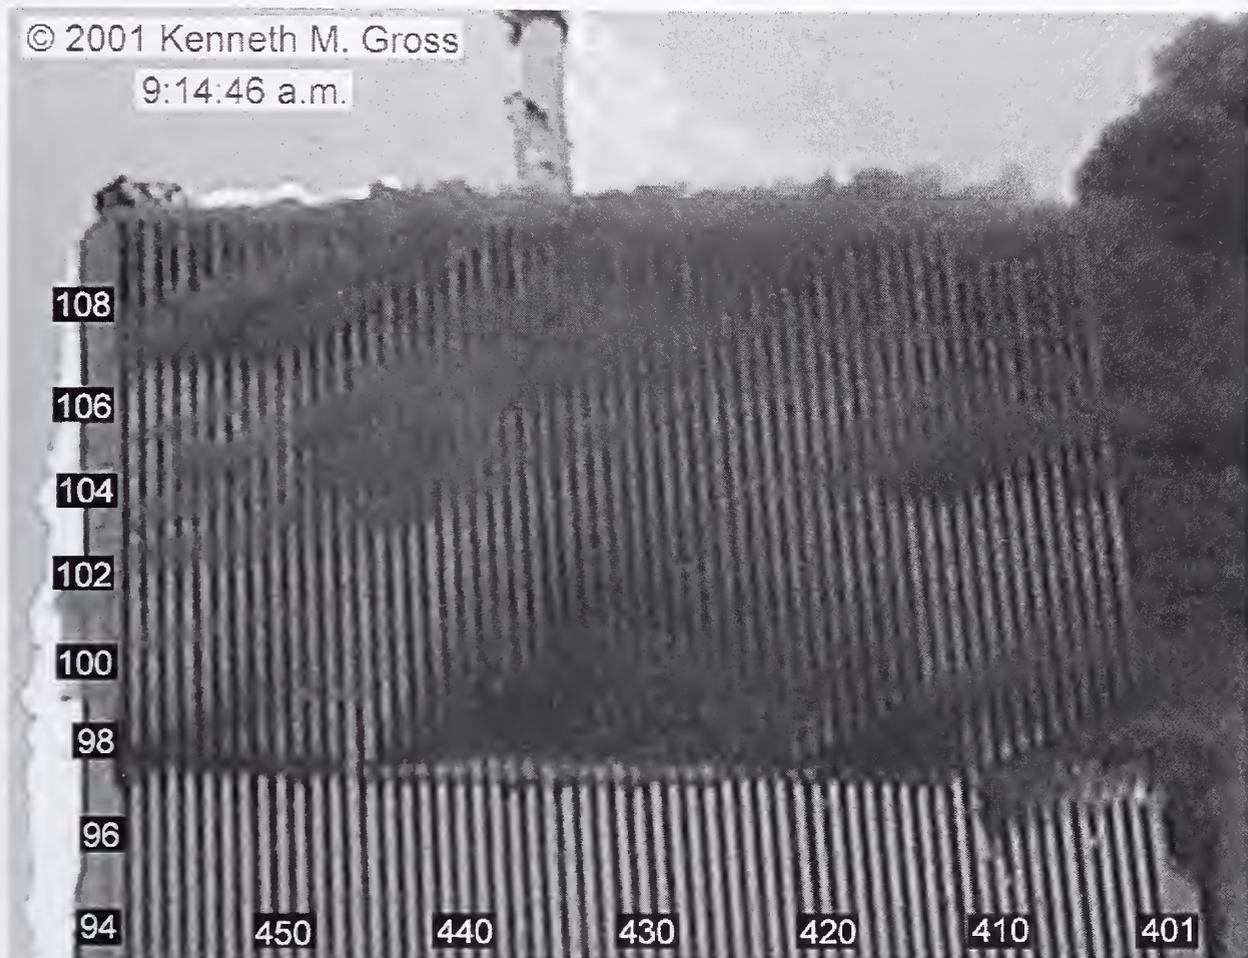
A higher resolution photograph of the west face taken at 9:14:46 a.m. is shown in Figure 8–31. The photographer was located just to the west of the WTC site and was, therefore, shooting up at the building from a steep angle. The only area in which fire is evident in this photograph is on the 97th floor at the south edge in windows 97-401 to 97-406. While the flame lengths are fairly short, there does appear to be some flame extension from these windows. The smoke plumes from higher floors described above are also visible, and a spot fire is present in window 96-404. There are still no indications of smoke or fire on floors below the 96th.

Figure 8-31. This cropped photograph shows the west face of WTC 1 at 9:14:46 a.m. It was shot from the ground a short distance from the WTC site. Column and floor numbers have been added.

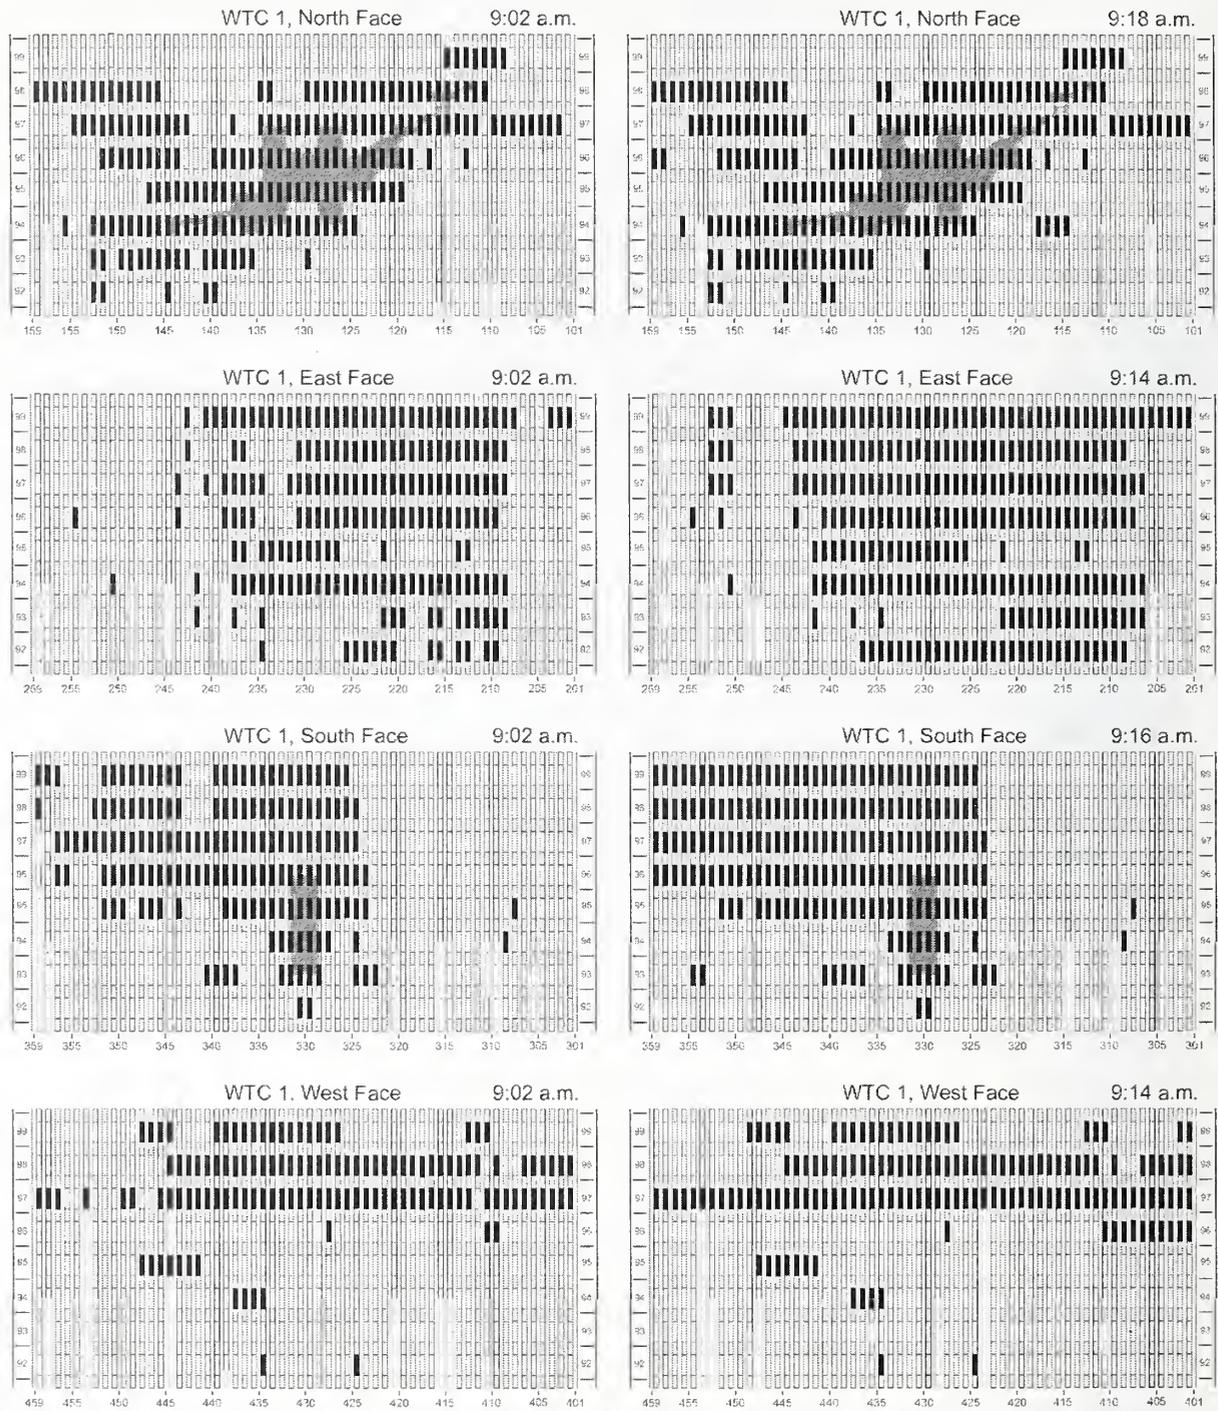
In Figure 8-32, window breakage is used as a surrogate for fire spread to provide a visual indication for fire growth during the period covering roughly 9:03 a.m. to 9:18 a.m. It should be kept in mind that open windows do not provide a perfect history of fire locations since many windows were broken during the aircraft impact and accompanying fireballs. It is also likely that some of the windows that were open at this time were broken by people. This is particularly the case on the 94th and 95th floors on the west face.

Figure 8-32. Maps for the 92nd through the 99th floors compare missing window glass for the four faces of WTC 1 at two times, around 9:02 a.m. and roughly 15 minutes later. The color coding used for the maps is indicated in Figure 5-1.

As described in detail above, the primary areas of fire growth during this period were on the east and south faces of the tower. On the east face, the major fire expansion was on the 92nd and 96th floors, with smaller areas of growth on the 94th and 95th floors. On the south face, fire spread continued on the western side of the 96th floor and wide-spread fires appeared on the same side of the face on the 95th and 96th floors.

In Section 6.4.2 it was pointed out that the aircraft and fireball damage to the tower was asymmetrical and that the southeast quadrant appeared to be relatively undamaged. Figure 8–32 and Figure 8–33 show quite distinctly that major fire development has not yet occurred at the periphery of this quadrant. This is further evidence that aircraft debris and/or fuel did not reach the periphery of this quadrant to any great extent.

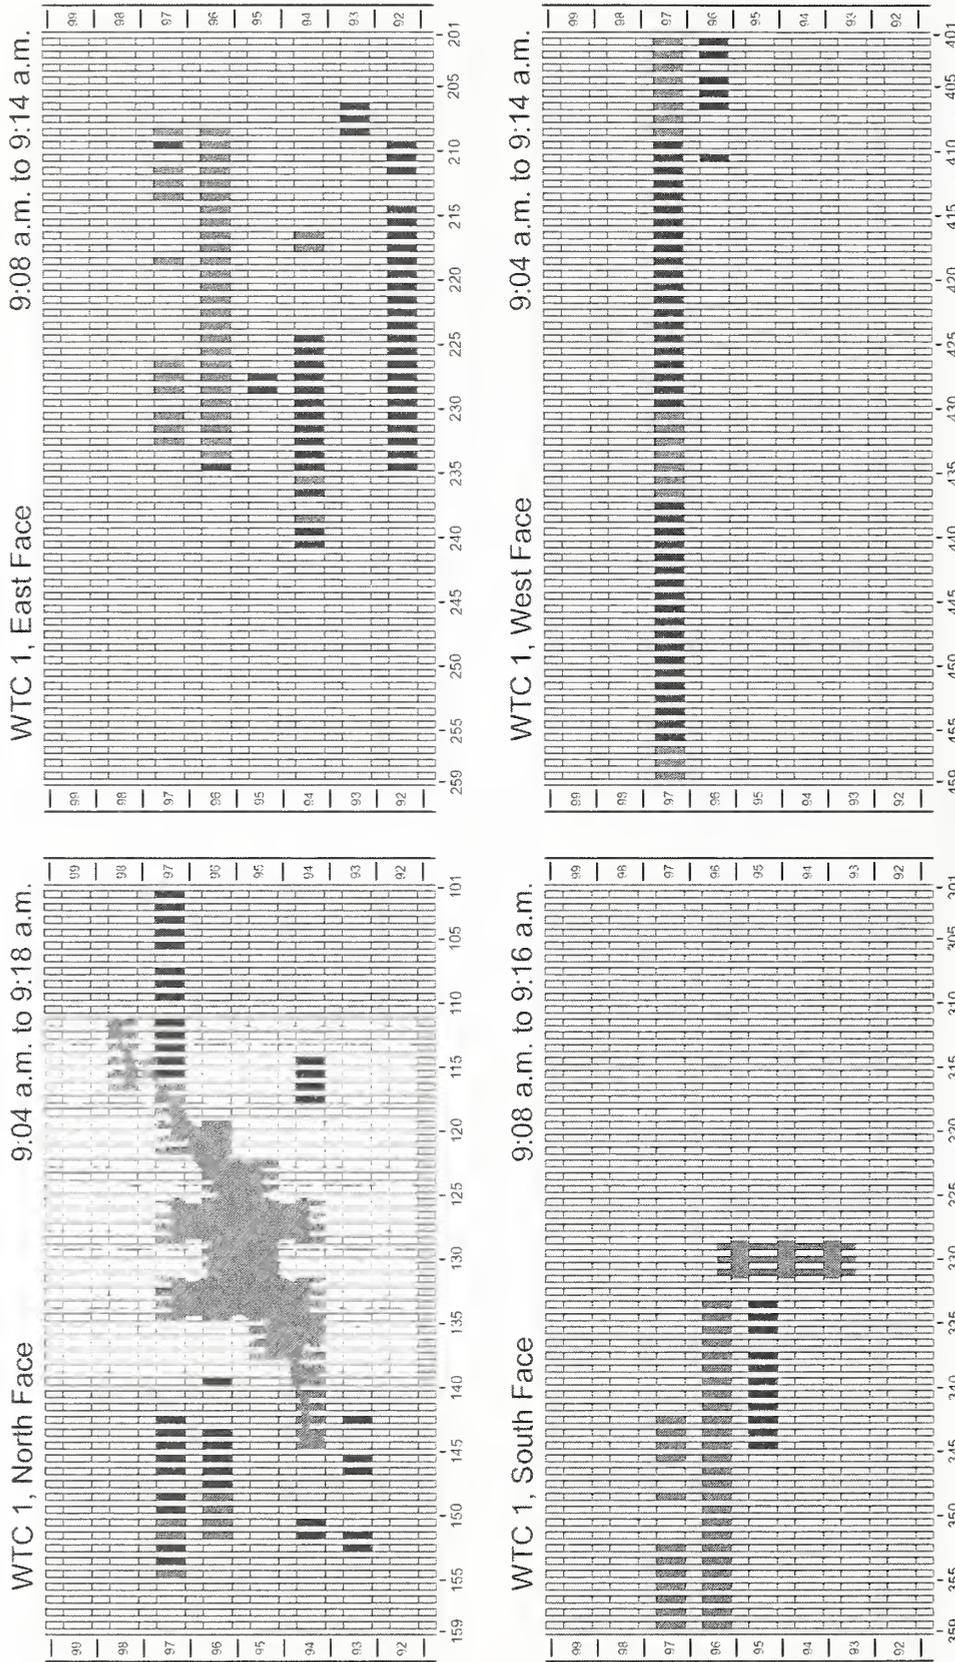
Integrated maps for fire intensity for the period, similar to those shown in Figure 8–14, are included in Figure 8–33. Comparison of these two figures confirms the general trends in fire spread described above. Such a comparison also shows that some of the fires observed during the initial period have died down and are not apparent during the second time period. Examples include fires on the 97th floor on the north face and areas on the 94th and 97th floors on the east face.

From Figure 8–33 it appears as if the most intense and widespread fires during the period from 9:03 a.m. to 9:18 a.m. were on the 96th and 97th floors. The east side of the tower had the most widespread fires, with flames visible from the 92nd floor to the 97th floor. The absence of burning in the southwest quadrant of the tower is evident from the maps.

Despite the presence of fires near the center of the east face on floors 92 to 97 and nearby intense fires on the 96th and 97th floors of the north face, most window glass in the northeast corner of the tower is still in place at 9:18 a.m. This suggests that walls for rooms located in the corners of these floors had been effective in slowing the spread of the fires.

Figure 8-33. Maps of integrated fire observations between 9:03 a.m. and 9:18 a.m. are shown for the four faces of WTC 1. Colors represent the highest intensity fire observed in a window using the color scale defined in Figure 5-1.

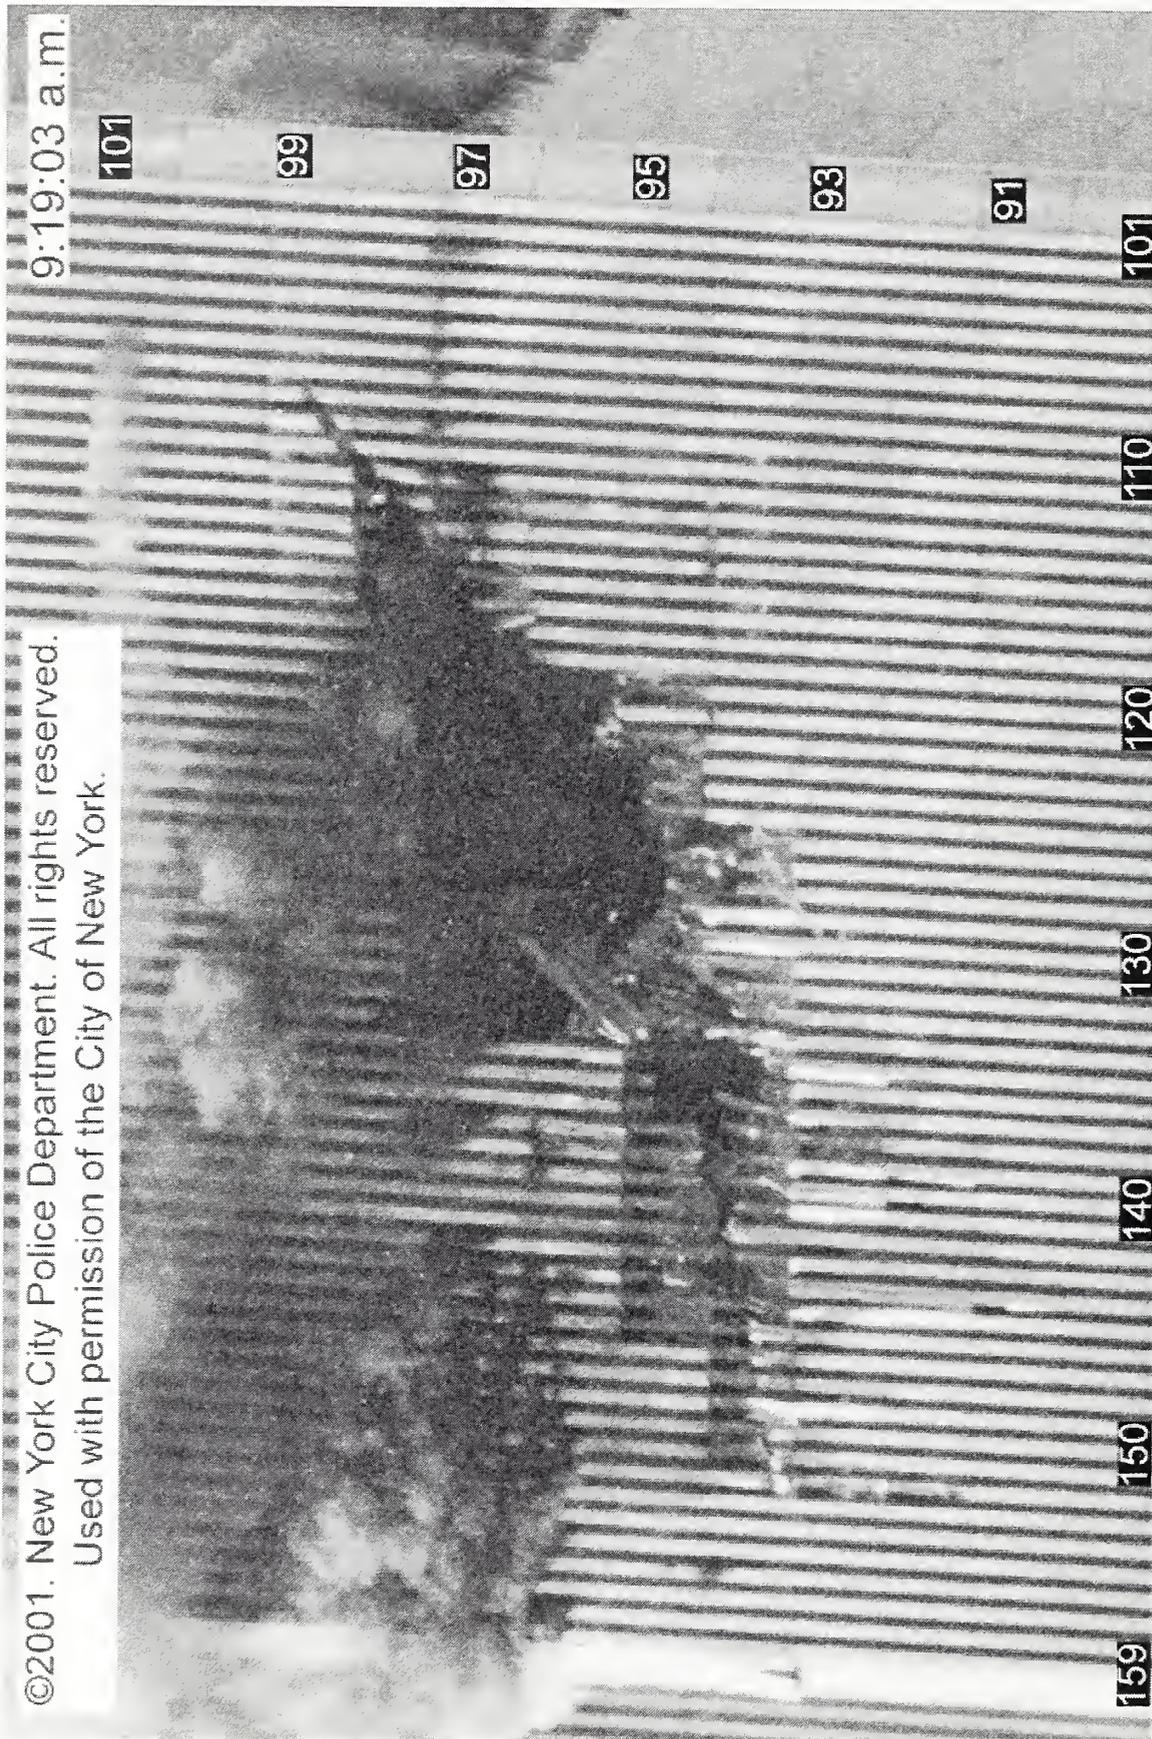
The smoke and flame from the fire on the 96th floor made it difficult to identify what was happening in the windows immediately above on the 97th floor in images taken from a distance. In a close-up photograph taken at 9:19:44 a.m., flames are observed on the 97th floor in windows 97-155 to 97-158. Sometime from just before 9:19 a.m. to 9:19:44 a.m., this fire penetrated the wall located at column 97-155 and broke out the four north face windows inside the room.

A close-up photograph taken at 9:20:51 a.m. shows that the appearance of the fires on the 96th and 97th floors was somewhat changed from that seen in Figure 8–34. Heavy flames were present in all of the north side windows that were originally within the corner rooms. Flames were extended primarily from the two windows nearest the east face on both floors. The fire on the 94th floor had a similar appearance to that in Figure 8–34, with extensive flames present inside the building, numerous areas burning at the tops of window openings, and only light smoke coming from the windows. This fire had continued to spread to the east and now extended from windows 94-106 to 94-117.

Figure 8-34. An image recorded at 9:19:03 a.m. shows the north face of WTC 1. The original has been cropped, rotated, and enhanced. Column and floor numbers have been added.

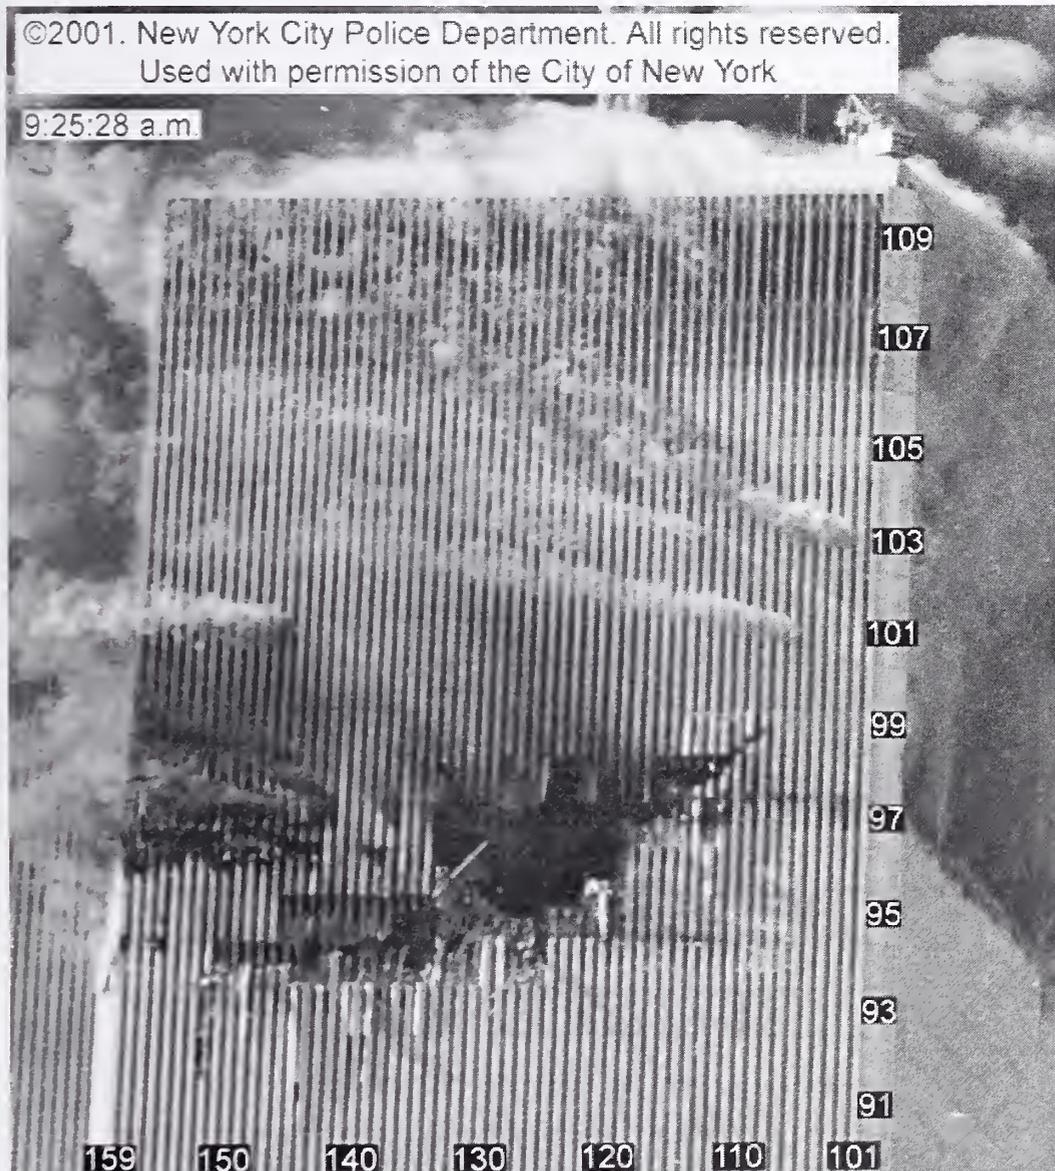
Figure 8–35 shows the north face of WTC 1 as it appeared at 9:25:28 a.m. The amount of smoke coming from the north face, particularly the aircraft impact cavity, has decreased markedly as compared to images taken earlier. There are fires visible on multiple floors, but the amount of smoke coming from these floors is very low. In fact, the densest smoke appears to be coming from open windows that are well above the fire floors. This observation indicates that smoke is still moving upward inside the building and following flow pathways to windows opened by people trapped above the aircraft impact floors. Smoke is still flowing from the air intakes on the 108th and 109th floors.

Figure 8-35. An image recorded at 9:25:28 a.m. shows the north face and an oblique view of the west face of WTC 1. The original has been cropped, rotated, and enhanced. Column and floor numbers have been added.

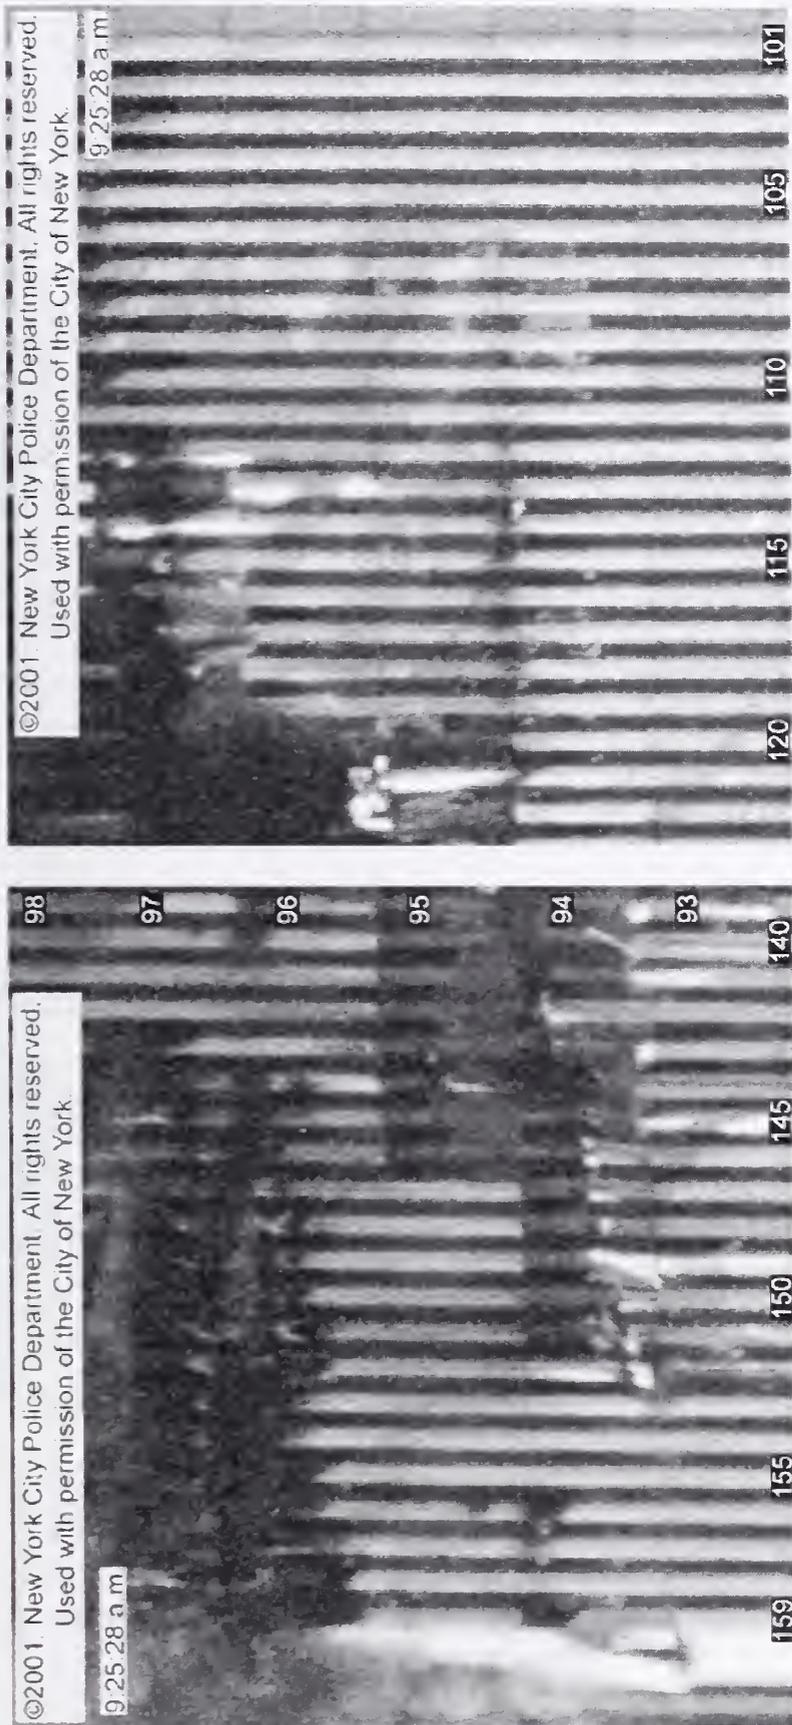
In Figure 8–36 two areas on either side of the aircraft impact cavity in Figure 8–35 have been blown up in order to provide a better view of the active fires. On the east side, fires can be seen on the 93rd, 94th, 96th, and 97th floors. Fires that appear to be relatively small and isolated are present at two locations centered near windows 93-139 and 93-151 on the 93rd floor. On the 94th floor an isolated fire is also present near window 94-151, but the major change from earlier times is that the glass in windows 94-155 to 94-158 is now missing, and an intense fire is evident burning within the building behind the four open windows. Isolated fires are present at the tops of the two windows in the center of the group. Note that the two adjacent windows, 94-153 and 94-154, are still in place. Flames can be seen through multiple open windows on the 96th and 97th floors. There is now no flame extension from the north face windows, and the fires have died down considerably from their levels of a few minutes earlier (e.g., compare with Figure 8–34 recorded at 9:19:03 a.m.).

On the west side of the north face, fire is only visible on the 94th floor. The apparent intensity of this fire has also died down somewhat from a few minutes earlier. The fire has broken into two sections on either side of a central region running from roughly windows 94-109 to 94-113, where only small fires near the bases or tops of the windows are evident. The fire spread to the west has paused at window 94-106, and the five windows to the west have glass in place. This suggests that the fire spread to the west had been slowed down by an internal wall located at column 94-106. The floor plan layout in Figure B-3 indicates that there was indeed an internal wall that terminated on this column.

The areas of the north face of WTC 1 included in Figure 8–36 provide good examples of the correlation of local fire behavior with the column cover marks observed next to windows where fire is present. On the 96th and 97th floors the fires created conditions in which flames extended from the windows. A series of carets are present at the tops of the windows running across these two floors. The heights of the carets vary over the region providing an indication of the local maximum burning intensity. In contrast, fires on the 93rd and 94th floors did not generally extend from windows and did not generate a great deal of smoke flow from the windows. For these windows there were sometimes narrow, dark lines at the tops of the adjacent aluminum column covers, and for others very little marking of the column covers occurred.

An enlarged image of the fires on the west side of the north face is also included in Figure 8–36. The marks on the column covers on the 97th floor show evidence for both types of fires. Those nearest the airplane strike point are marked with carets. Flame extension was observed in this area shortly following the aircraft impact. Further to the west there are black marks above the windows, except for the column covers on either side of window 97-102, which are marked with carets. As discussed earlier, fires on this part of the 97th floor did not extend from these windows for any significant period of time. The same types of narrow black bands are observed at the tops of the columns above the burning region on the 94th floor. Recall that this was a region of heavy burning, but without flame extension.

Figure 8-36. Two blowups from Figure 8-35 of areas on the north face of WTC1 are shown. The photograph was taken at 9:25:28 a.m. The images have been enhanced, and column and floor numbers have been added.

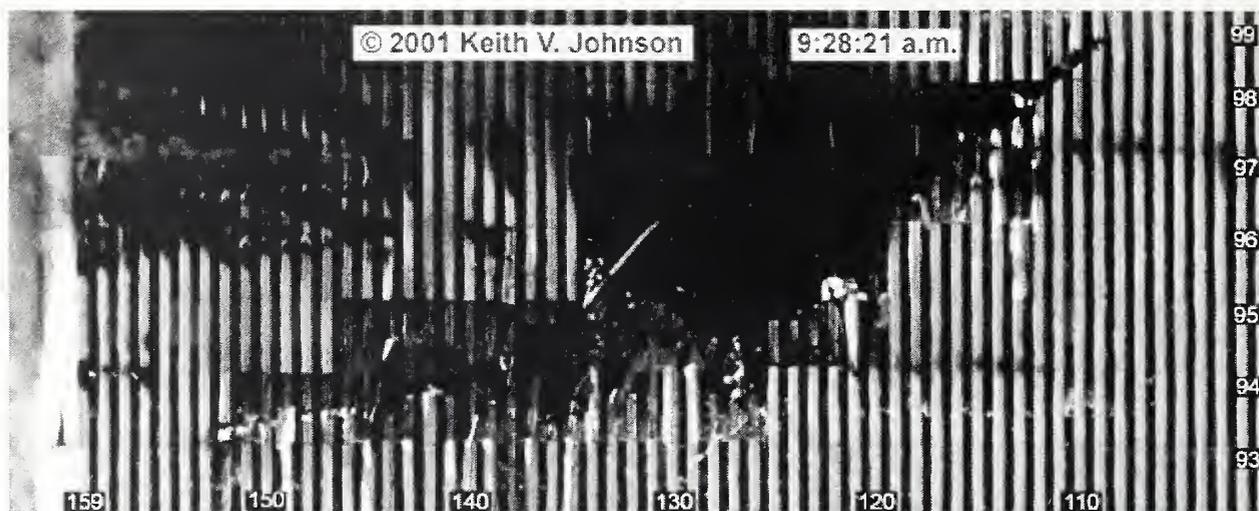
Figure 8-37. This cropped photograph shows the north face of WTC 1 at 9:28:21 a.m. The image has been rotated and enhanced. Column and floor numbers have been added.

Figure 8–37 shows a photograph of the fire floors on the north face taken at 9:28:21 a.m. The fires which grew rapidly at the start of the period are continuing to die down. In particular, the large fires that appeared within the rooms on the northeast corners of the 96th and 97th floors are now barely visible. The fires on either side of the aircraft impact cavity on the 94th floor are also decreasing in size. On the east side there are still fires burning at the window head casings of windows 94-156 to 94-158. An isolated fire can still be seen on the 93rd floor through open windows 93-152 and 93-153.

While it is difficult to make out in Figure 8–37, close inspection shows that there is a small spot fire visible in window 98-123 on the 98th floor. Recall that a similar fire was observed on this floor in window 98-115 around 9:06 a.m. Most windows were still in place on this floor around the time Figure 8–37 was taken.

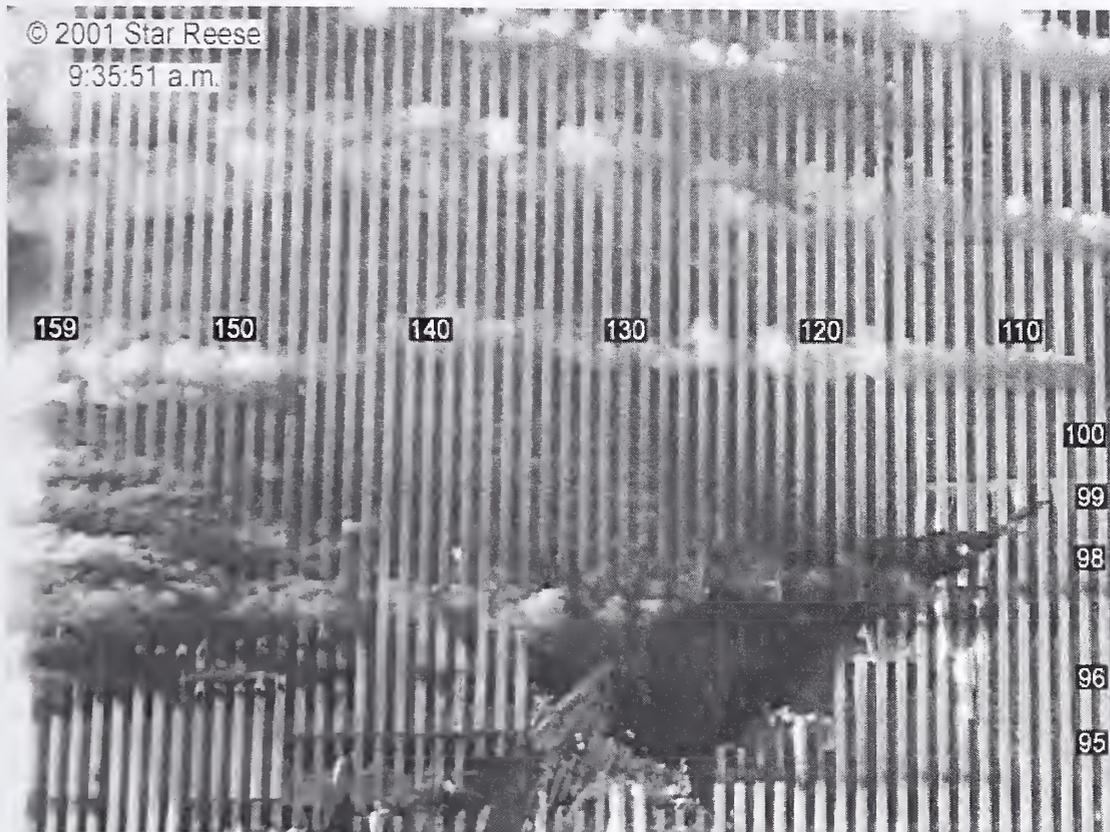
Figure 8-38. A frame taken from a video shows the north face of WTC 1 at 9:35:51 a.m. The image has been enhanced. Column and floor number have been added.

A portion of a photograph showing the fire floors on the north face of WTC 1 at 9:37:58 a.m. is reproduced as Figure 8-52. This photograph was taken just over two minutes later than the image shown in Figure 8-38. The fire on the 98th floor has spread over a wider area and has grown in intensity during this time. Fires are observed (not continuously) from window 98-122 to window 98-150. Even though the flames extend over roughly half the length of the floor, and in some locations appear to fill the volume behind the windows, there is very little smoke and flame evident coming from the 98th floor windows. This is likely another case where the fire gases are exhausting elsewhere than through nearby windows.

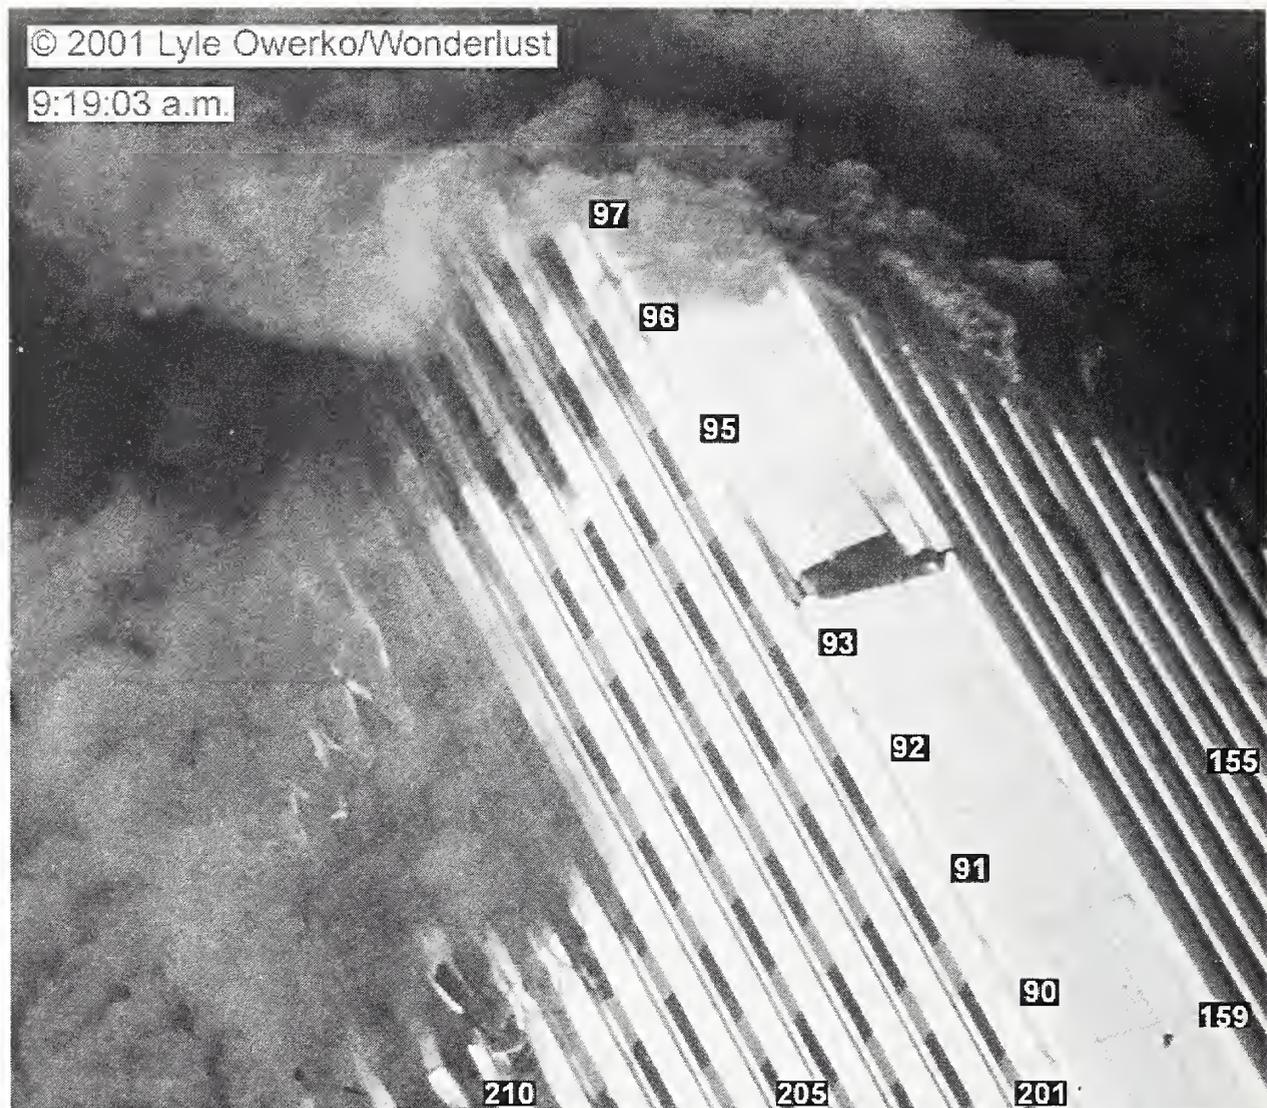
The close-up photograph in Figure 8–39 shows the northeast corner of WTC 1 at 9:19:03 a.m. On the north face, the flames that first emerged from windows on the 96th floor at 9:19:00 a.m. are evident. At the time of Figure 8–39, the largest flame jet was coming from window 96-154. On the east face heavy flames were present in windows 96-208 to 96-211. The distinct carets on the column covers attest to the intensity of the fires that have been burning in the area. The window glass on the inside of the internal wall at column 96-208 is still in place. This is not the case on the 97th floor. Flames are evident through a partially opened window 97-207, indicating that fire had penetrated the wall at column 97-208 by this

time. Recall that fire appeared in windows on the north face at the northeast corner of the 97th floor around this time, but that it was not possible to determine exactly when the windows opened.

On the 95th floor, windows from the north edge out to window 95-207 appear intact. It looks as if there was a small fire in window 94-207, and the window may be partially broken out. This is not clear. Carets on the covers of columns 93-206 to 93-208 are telltale signs of the extended flames that came from windows 93-206 to 93-208 at an earlier time. Glass for windows to the north of column 93-205 is still intact. These observations suggest that a wall at column 93-205 may have slowed the spread of this fire. However, it is not possible to confirm this since the plan layout for this floor shown in Figure B-2 does not cover this section of the floor. For the 92nd floor, glass is intact in windows extending from the north edge to at least window 92-207. The floor plan layout in Figure B-1 indicates that there was a room in the northeast corner of this floor with walls that extended to columns 92-155 and 92-204. The interior wall on the south side of this room was glass.

Figure 8-39. This cropped close-up photograph showing the northeast corner of WTC 1 was taken at 9:19:03 a.m. It has been enhanced, and column and floor numbers have been added.

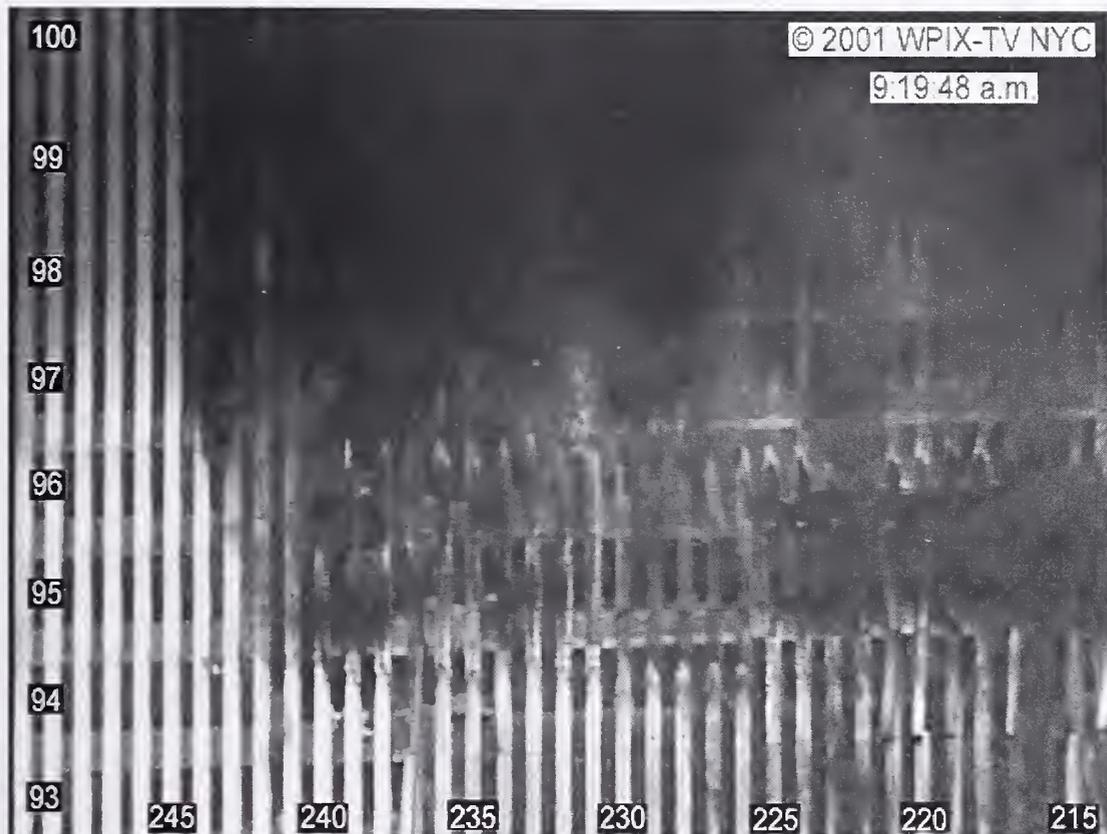
The image in Figure 8-40 was taken from a close-up video showing the central portion of the east face. It was recorded at 9:19:48 a.m. A fire on the 96th floor extends from at least window 96-214 to window 96-233. The fires in the northern part of the photograph on the 96th floor are less intense than those further to the south. When combined with Figure 8-39, this suggests that the fires on the 96th floor are still most intense at either end of the burning area, with an area of dying fire in the center.

Extended flames are coming from window 96-231 in Figure 8-40. The presence of carets indicates that flames had earlier been present at least as far south as window 96-238, but at this time these flames were not visible. The floor plan layout for this floor (see Figure B-5 in Appendix B) does not provide an explanation for this fire distribution, since there are no walls or rooms indicated in this area of the floor.

A region of flame is also evident on the 97th floor, starting near window 97-225 and going west. The full extent of this flaming region is not known, since fire and smoke from the 96th floor hides a portion of these windows. The flames visible on the 97th floor do not extend from windows and appear to be dying down.

There are no extensive flame regions evident on the 93rd or 94th floors. A review of videos recorded around this time indicates that the fires on these floors had indeed died down. Smoke is visible coming from below in Figure 8-40. This smoke is coming from the 92nd floor.

Figure 8-40. A frame taken from a video shows a portion of the east face of WTC 1 at 9:19:48 a.m. The image has been enhanced, column and floor numbers added.

There are some interesting variations in the column smoke markings in Figure 8–40. In particular, consider the 94th floor. Many of the column covers have distinct carets that are characteristic of locations next to windows that have experienced extended flames. Clear examples of carets can be seen on the covers for columns 94-226 to 94-230. On other column covers the smoke marks take the form of alternating horizontal bands of light and dark areas. The marks on the covers for columns 94-231 to 94-234 show good examples of this type. By comparing the markings with the local fire behavior, it has been possible to correlate the formation of this type of smoke mark with windows from which there had been a heavy smoke flow, but for which external flaming was not observed. In contrast to the mixed fire behavior seen on the 94th floor, carets are present on nearly all of the columns on the 96th floor visible in Figure 8–40.
