**NIST NCSTAR 1-5A
Federal Building and Fire Safety Investigation of
the World Trade Center Disaster**

**Visual Evidence, Damage Estimates,
And Timeline Analysis**

Visual Evidence, Damage Estimates, and Timeline Analysis

September 2005

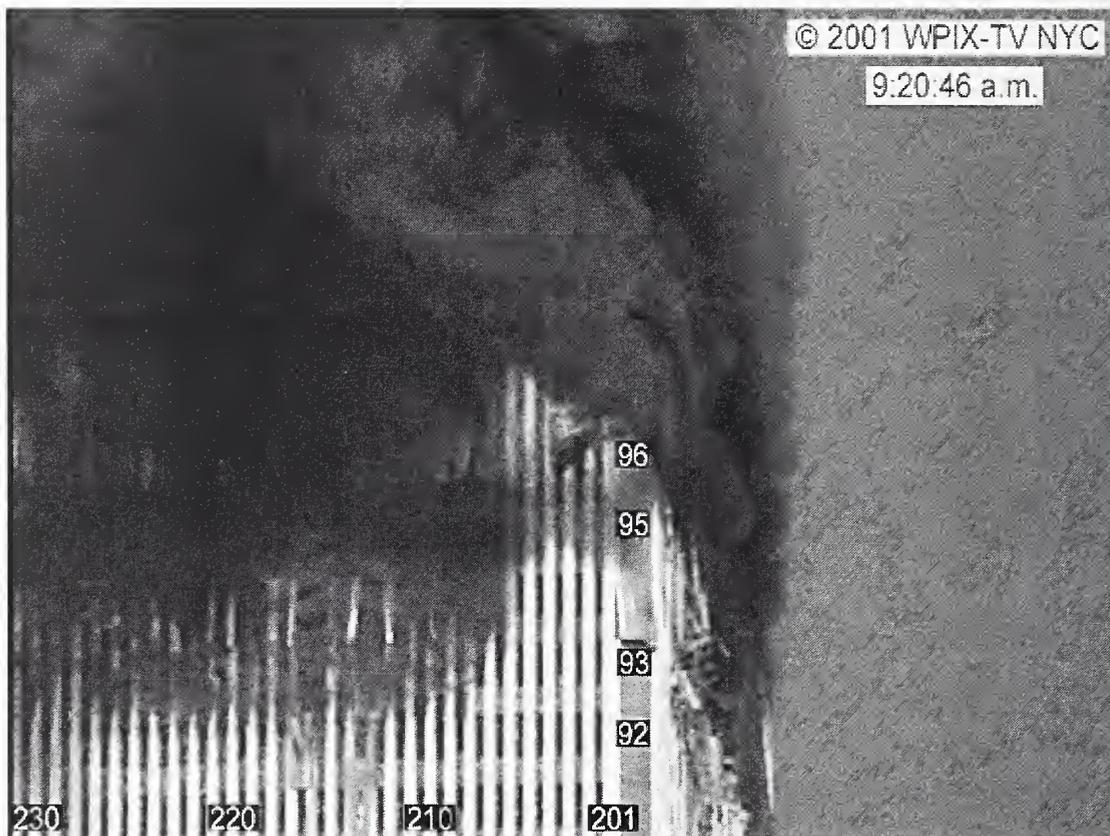
approximately one and a half minutes. As seen by referring to Figure B-5 in Appendix B, there was a second room on the east outer wall just to the south of the rectangular corner room. This room had four windows on the east wall. By 9:20:46 a.m., this room was already on fire since flames can be seen in window 96-207. Fire is visible in the image extending from at least window 96-207 to window 96-231. At 9:21:01 a.m. flames appeared abruptly at window 96-207. Interestingly, this was the same time when the external flames on the north face of the building receded back into the tower.

Figure 8-41. A frame taken from a video shows a portion of the east face of WTC 1 at 9:20:46 a.m. The image has been enhanced. Column and floor numbers have been added.

In Figure 8-41 heavy smoke is flowing from a number of windows on the 92nd floor, starting at window 92-208 and running to the last visible window, 92-230. A dull orange glow is evident in the vicinity of windows 92-214 to 92-218, but the remaining open windows appear to be dark. Shortly after Figure 8-41 was shot, the video zoomed out, revealing that internal fires were present inside the tower at least as far south as window 92-234, with open windows as far as window 92-237. Figure 8-22, which was taken at 9:15:54 a.m., showed internal fires in this same area. During the intervening period, the fire had moved north one window, having opened window 92-208. There is no obvious reason for the fire spread to slow down at this location, since the floor plan layout in Figure B-2 in Appendix B indicates there was not a wall at column 92-208. At 9:15:54 a.m. the fire had already moved as far south as window 92-234. During the next five minutes, three additional windows were opened. Fire spread in this direction also appears to have been retarded. The floor plan layout for this floor does indicate that there was a wall located at column 92-238, i.e., right next to open window 92-237. Detailed drawings for this floor show

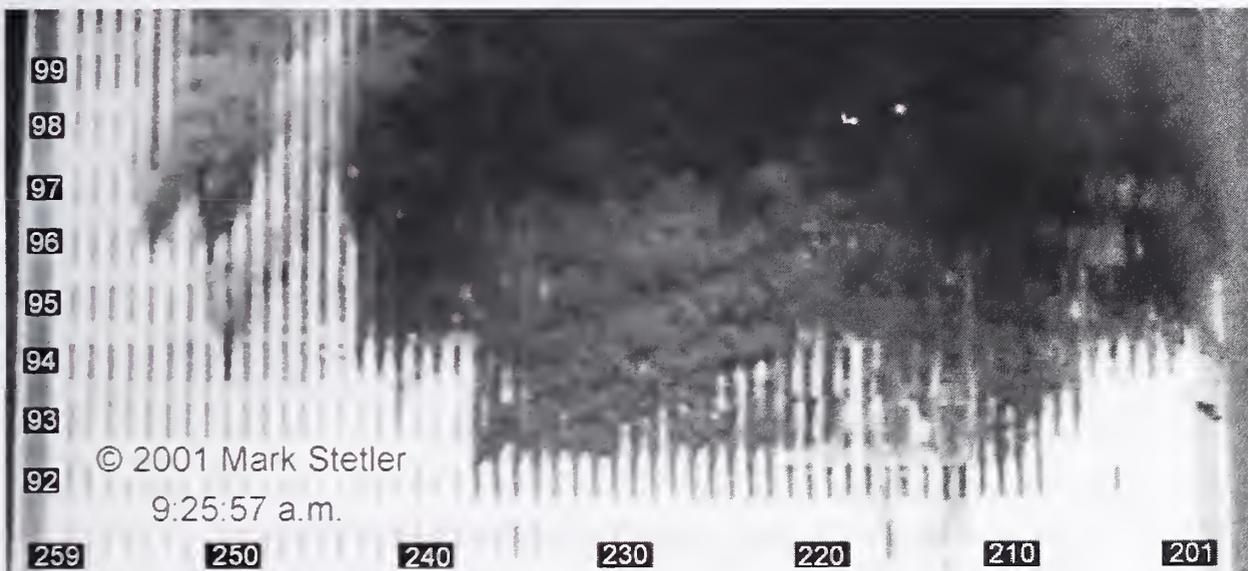
Figure 8-42 is a photograph of the east face taken at 9:25:57 a.m. The flames which had earlier spread into rooms located on the northeast corners of the 94th and 96th floors are still burning intensely. There is also now a large fire burning in the northeast corner room on the 97th floor. It has not been possible to identify exactly when this fire appeared because smoke and fire from the 96th floor hid its development from view. However, a video taken near 9:23:30 a.m. shows that flames were coming from window 97-203 at that time, so it must have appeared between 9:20:45 a.m., when fire was first visible in the area on the 96th floor, and this time.

Figure 8-42. This cropped photograph shows the east face of WTC 1 at 9:25:57 a.m. The image has been rotated slightly and column and floor numbers have been added.

Fire is evident at a couple of locations on the 93rd floor. It appears as if flames are present inside window 93-206, while adjacent windows to the north still have glass in place. Recall that window 93-206 was already open at 9:19:03 a.m. (see Figure 8-39) and that fire spread to the north had seemed to pause at this location prior to this. The observations continue to suggest the presence of a room in the northeast corner of this floor with a wall at column 93-206, even though the incomplete floor plan layout in Figure B-2 does not allow this to be confirmed.

The exhausting smoke and flames visible in Figure 8-42 indicate the presence of an active fire on the 94th floor at windows 94-238 to 94-244. Fire in this region was not evident roughly six minutes earlier when the image in Figure 8-40 was recorded. The pause in fire spread on the 94th floor suggests that the fire had been temporarily blocked by a wall. It is not clear that this was the case since, even though there was a wall connecting column 94-238 to the core (see Figure B-3 in Appendix B), this is not the exact location where the fire paused. As early as 9:15:54 a.m. (see Figure 8-22) there was evidence that the fire had spread as far as window 92-240 on the east face. This is one of the few examples identified thus far where a spreading fire did not appear to pause immediately outside of a known existing wall. It is possible that this wall was breached during the aircraft impact, since there was minor façade damage on the 94th floor in this quadrant on both the east and south faces. However, this does not provide an explanation for the reduced rate of fire spread after the fire had passed through the wall.

In Figure 8-42 fires are visible between windows 96-230 and 96-240 on the 96th floor and windows 97-230 and 97-240 on the 97th floors. This indicates that the fires on these floors are continuing to spread toward the south.

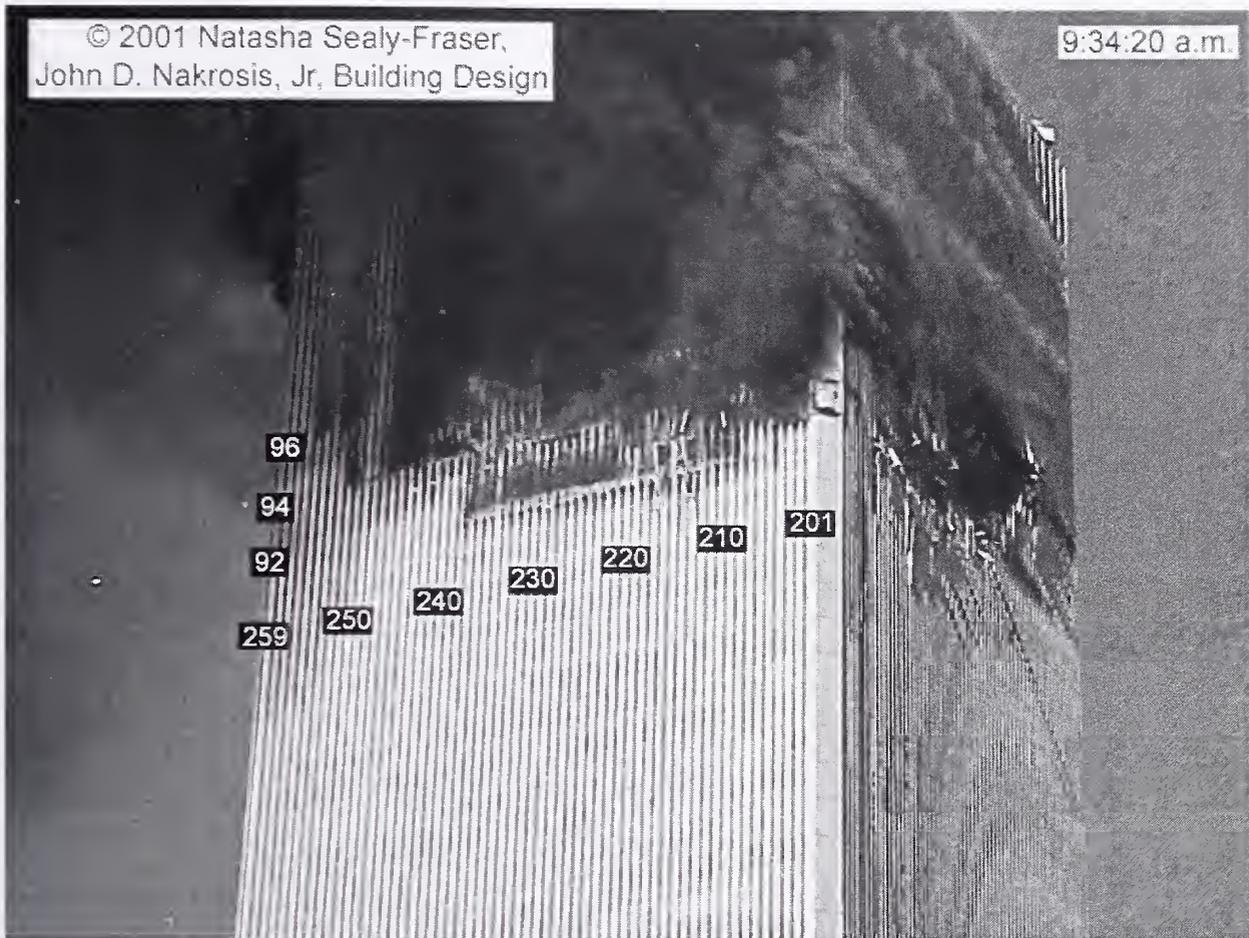
At 9:32:58 a.m., smoke emerged from the northeast corner of the 93rd floor at window 93-205. During the next 31 s, the successive windows toward the north opened, reaching window 93-201. At this time, 9:33:29 a.m., flames appeared in the area. Figure 8-43 shows a photograph of the east face recorded at 9:34:20 a.m. From this angle and distance, only flames extending from windows are apparent. Flames are coming out of windows 93-201 to 93-205. The sudden fire development and flame extension from windows is a strong indication that flashover has occurred within an enclosed space located around windows 93-201 to 93-205. The evidence for an enclosed space with walls that hindered fire spread into the northeast corner of the 93rd floor is quite strong even though the presence of such a room cannot be confirmed from the incomplete floor plan layout shown in Figure B-2.

Intense flaming was also taking place on the 96th floor near windows 96-236 and 96-237. Much more of the façade is now visible through the smoke than earlier. In particular, this is an indication that fires on the 92nd floor and 94th floor, which were generating large quantities of smoke at earlier times, have largely died down.

Figure 8-43. Photograph of the east face of WTC 1 recorded at 9:34:20 a.m. Column and floor numbers have been added.

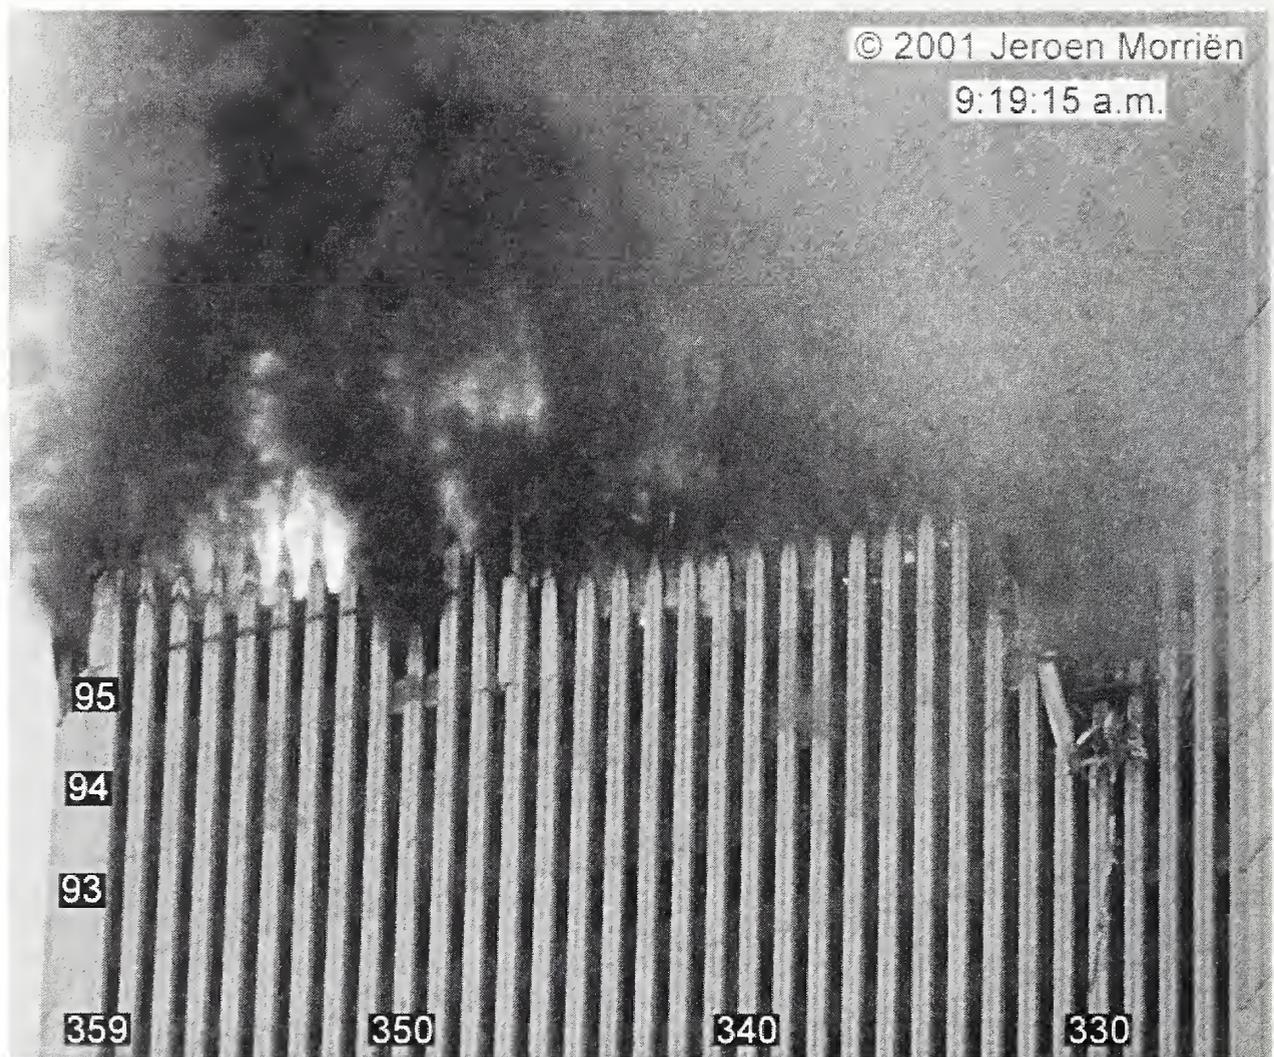
Figure 8-44 provides a view of the south face at 9:19:15 a.m. The general appearance of the fires is little changed from that in Figure 8-27, which was recorded near 9:16:40 a.m. The intense jets of flames coming from windows 96-352, 96-353, and 96-354 on the 96th floor remain a prominent feature. This image provides a particularly good view of the area on the 93rd floor, near column 330, where the steel panel section, which was found near the corner of Cedar and West Streets, is believed to have originated. Extensive damage is evident in the vicinity, but it is not possible to visually confirm that the section is actually missing. There is a long section of what appears to be a pipe hanging below the suspected opening that appears to be attached to a cylindrical object. Recall that a long section of pipe was seen in photographs of the detached panel section lying in the street (see Figure 6-16 and Figure 6-17). The presence of piping near the suspected origin for the panel section provides further support that the panel section actually did come from this spot.

Figure 8-44. This cropped image shows a portion of the south face of WTC 1 at 9:19:15 a.m. The photograph has been enhanced and column and floor numbers have been added. The corner of WTC 2 is visible at the far right side of the image.

A line of deposited soot is visible at the top of columns 95-351 to 95-357 at the western side of the 95th floor. These markings can be seen more clearly in Figure 8–44. No smoke is apparent coming from the windows, and it appears likely that the glass is still in place for these windows. The formation of these marks may be an indication that fire gases and smoke were leaking from the tower at locations where windows still had intact glass. Presumably, the leaks took place through the expansion joints located between column covers on different floors.

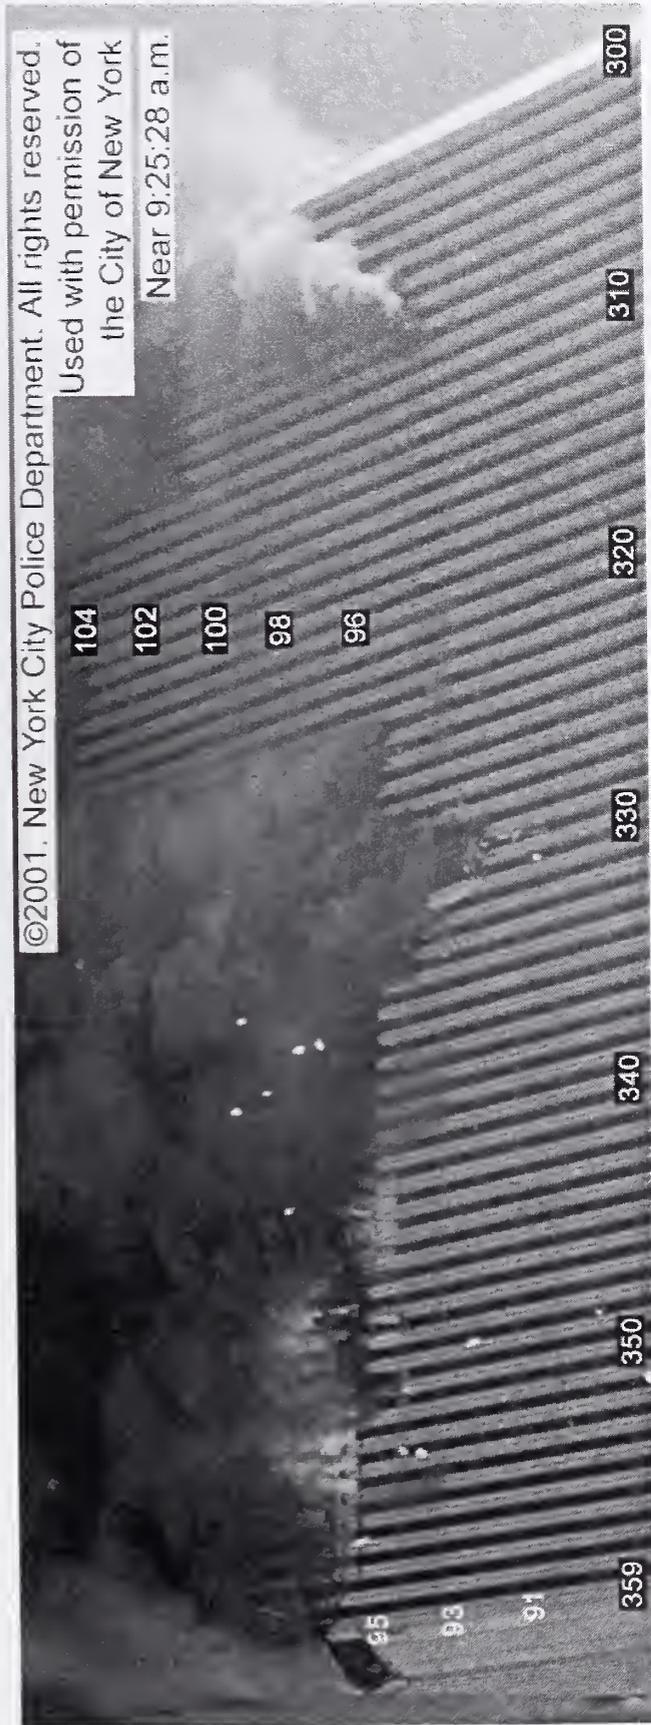
A later view of the burning area on the south face is shown in Figure 8-45, which was recorded around 9:25:28 a.m. There are a large number of pages of paper visible in the photograph. A video of the west face showed that these pages had traveled from the west face of the tower, where they had been released from an upper window. The fires present at this time remain quite intense and extensive, but there have been some changes since 9:19:15 a.m. The fires at the western edge of the 96th floor appear to be dying down and have receded back into the windows, while the strong jets of flame evident in Figure 8-44 on this floor are not as distinct. The fires on the 95th floor appear to have grown stronger. There is now flame extension from windows 95-340 to 95-343. The flames near the center of the face indicate that the fires on either the 96th floor or 97th floor, or both, extend continuously from the west edge of the south face to very near the center, i.e., column 330.

Figure 8-45. This cropped photograph shows the south face of WTC 1. It was taken around 9:25:28 a.m. with an assigned time uncertainty of 15 seconds. The original image has been enhanced and rotated. Column and floor number have been added. A number of pages of paper are present in the photograph.

Even though fires have been burning on the south face for well over a half hour, there is no indication in Figure 8–45 that the flames have begun to spread toward the east. With the exception of broken windows on floors well above the fire, the appearance of the east side of the façade has not changed since the aircraft impact.

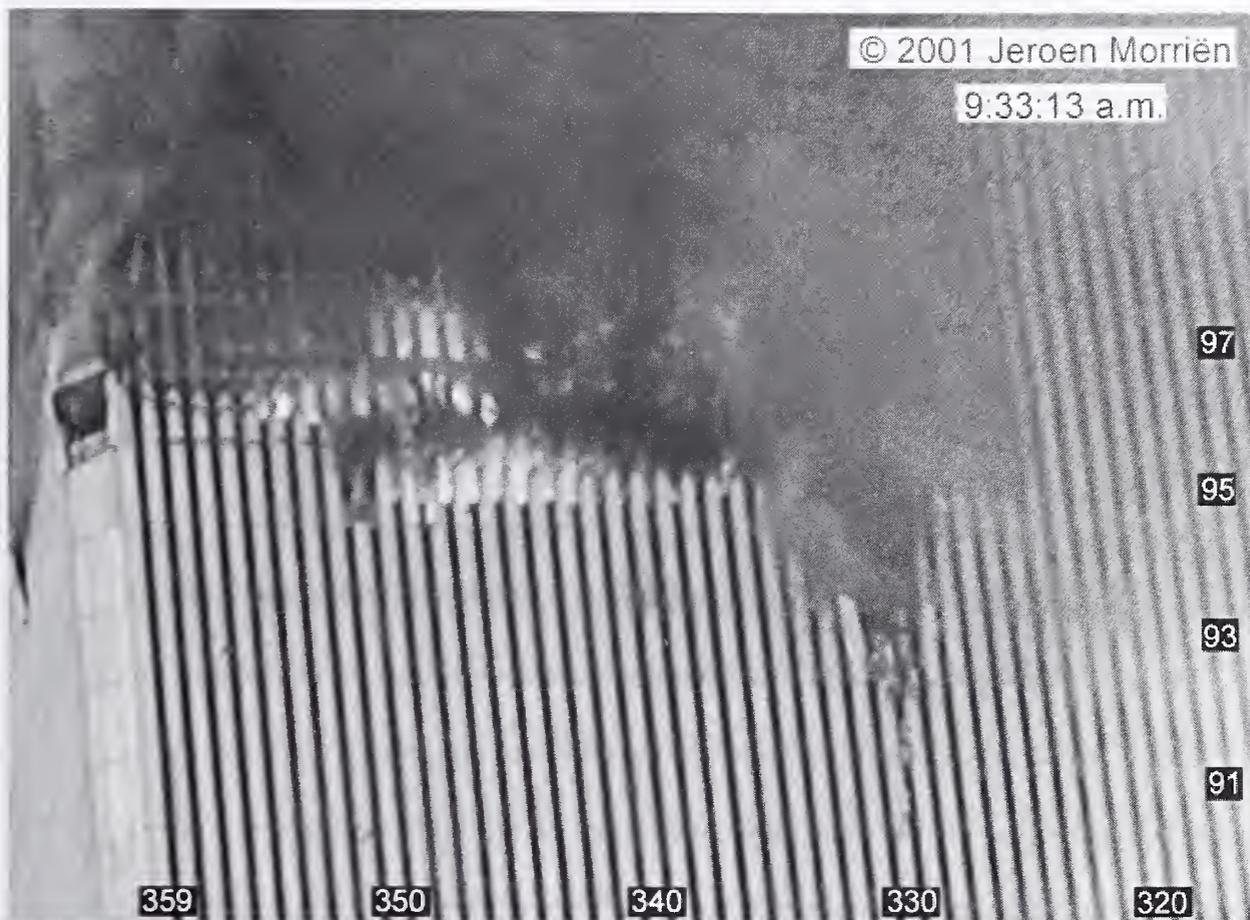
Figure 8–46 shows a view of the south face taken at 9:33:13 a.m. By this time, the intense fires on the 96th and 97th floors near the western edge of the face have diminished greatly, and flames are no longer prominent in the windows nearest the edge, while flames closer to the center have receded back into the windows. It is now possible to observe individual windows on the 96th, 97th, and 98th floors all the way from the western edge to windows 96-344, 97-344, and 98-344. Note that it appears as if these windows on the 98th floor are missing. It is not possible to conclude this definitely, since it is possible that smoke has been deposited on the windows, which would make them dark and thus appear to be missing. In either case, there are no obvious flames present in this area of the 98th floor.

Figure 8-46. This cropped image shows a portion of the south face of WTC 1 at 9:33:13 a.m. The photograph has been enhanced, and column and floor numbers have been added.

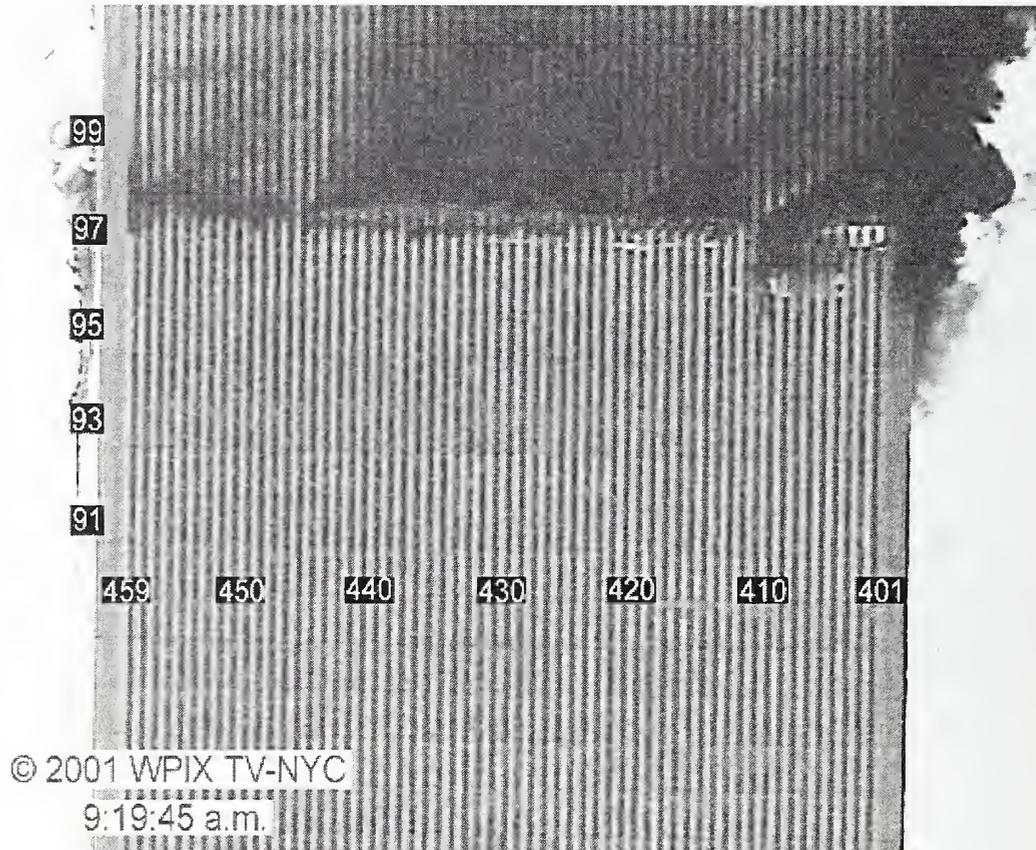
One such image taken from a video recorded at 9:19:45 a.m. is shown in Figure 8-47. The fire distribution is consistent with that observed from the ground at 9:14:46 a.m. in Figure 8-31. A flaming region is prominent at the south edge of the 97th floor over windows 97-401 to 97-405. While these flames appear to fill the windows, they do not seem to extend out of them. Further toward the north on the 97th floor, a number of relatively small fires are visible through the lowest portions of the window openings. Most of these flames are observed between the intensely burning corner and the center of the face. When viewing the video, it appears as if this gentle burning is relatively continuous across this length. The only location on the face where flames are apparent even further to the north is in window 97-455. Keeping in mind that the bases of the windows are raised 15 in. from the floor, it is clear that most of the intense fires that were burning earlier on the west side of the 97th floor have died down to a condition in which widely distributed flames are gently burning near the floor on the remaining fuel. A comparison of Figure 8-47 with Figure 8-30, which was recorded at 9:10:58 a.m., provides a good visual measure of how much the fire intensity on this floor has decreased over this nearly 9 min period.

The only other floor on which flames are apparent in Figure 8-47 is the 96th. A region of fire, which fills the window openings, runs from window 96-404 to perhaps window 96-410. The flames in windows 96-408 and 96-409 extend from these windows. As discussed above, fire was present in the

same general location around 9:11 a.m. (see Figure 8–30). Two regions of small flames around windows 96-412 and 96-414 are visible just to the north of the flaming area. Even though these flames are similar in appearance to the dying flames just above on the 97th floor, there is a major difference. Based on the visual evidence, there has not yet been an intense burning phase in this region of the 96th floor. The absence of smoke marks on the nearby aluminum cladding is consistent with this conclusion.

Figure 8-47. This image of the west face of WTC 1 is a frame captured from a video recorded by a news helicopter at 9:19:45 a.m. The image has been enhanced by adjusting the intensity range, and areas to the left and right of the tower are saturated. Column and floor numbers have been added.

It is interesting to compare Figure 8–47 with the view of the south face shown in Figure 8–44. These images were taken approximately 30 s apart. While there are intense flames issuing from numerous windows on the 95th, 96th, and 97th floors on the west side of the south face, from the west flames are only observed near the south corners of the 96th and 97th floors, and they do not appear to be nearly as intense. These observations indicate that either the flames on the south face are isolated near the outer wall or that interior portions of these floors are actually hidden from view by obscuring smoke or walls. There is no indication of fire on the 95th floor from the west. Figure B-4 in Appendix B shows that there were a group of rooms in the southwest corner of this floor with a wall extending to column 95-350. The walls associated with these rooms may still be in place, protecting the west side of the floor from the fire raging on the south face. One piece of visual evidence argues against this conclusion. In Figure 8–44, smoke is observed coming from windows 95-349 and 95-350 on the south face, and there is evidence of façade damage below both of these windows. This suggests that both windows were removed during the

aircraft impact and subsequent fireball. It is unclear if such damage could have taken place without severely damaging the wall located between these two windows.

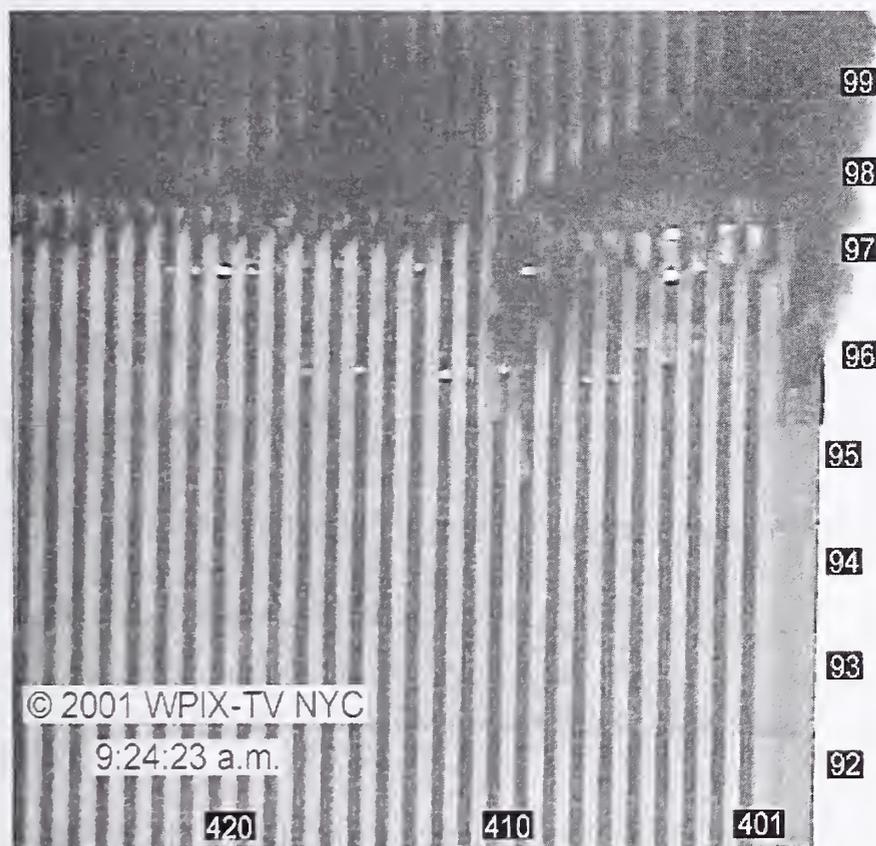
Figure 8–48 shows a closer view of the south side of the west face captured from a news helicopter video recording at 9:24:23 a.m. The general appearance is very similar to that of Figure 8–47. The relatively intense fires burning at the south edges of the 96th and 97th floors are still present. A number of small, apparently isolated, fires can be seen on both of these floors. On the 96th floor there are now indications of fires as far north as window 96-417. This is slightly farther than observed at 9:19:45 a.m. and suggests that these low-level fires are slowly moving toward the north along the outer west wall of the 96th floor. The image has sufficient resolution to just identify, albeit with some uncertainty, whether window glass is still in place. It appears that the glass is missing from those windows where the small fires are visible and is intact in windows at the intervening locations.

Figure 8-48. This image of a portion of the west face of WTC 1 is a frame captured from a video recorded by a news helicopter at 9:24:23 a.m. The image has been enhanced by adjusting the intensity range, and the area to the right of the tower is saturated. Column and floor numbers have been added.

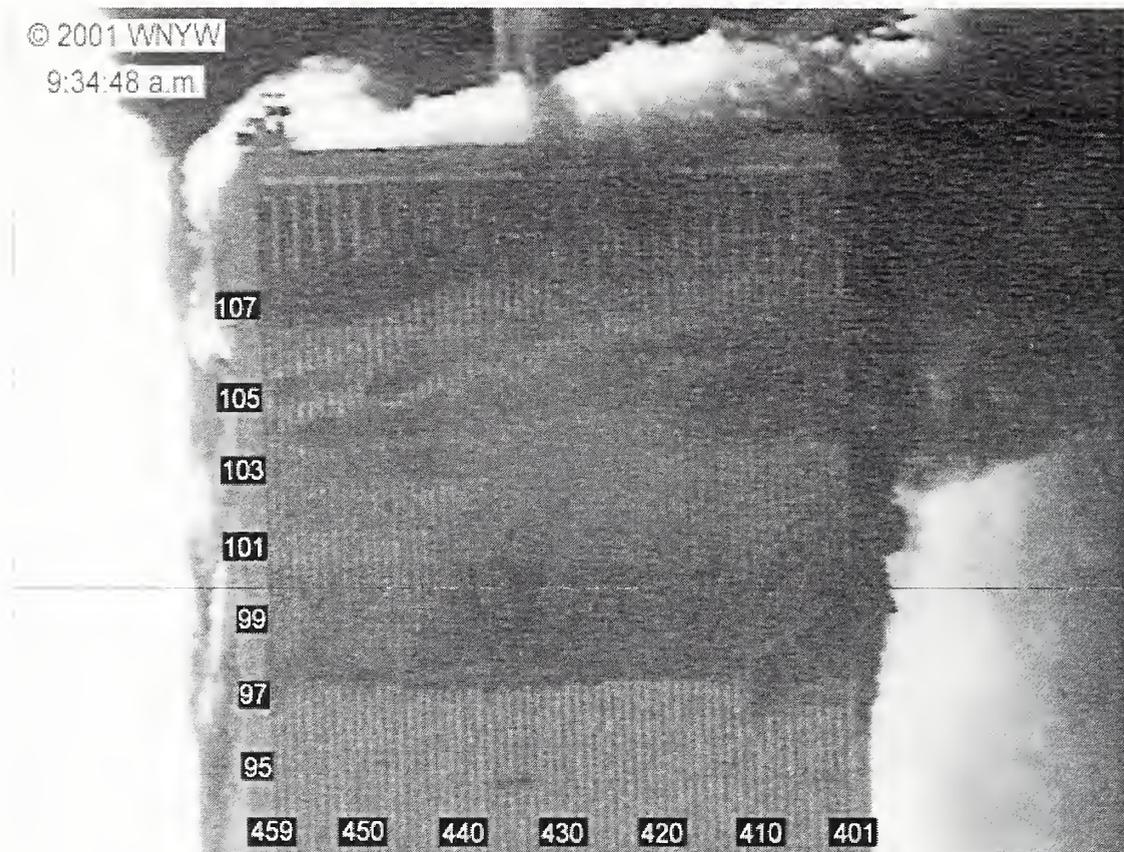
Figure 8–49 shows another view of the west face of WTC 1 taken from a video that was recorded from a helicopter at 9:34:48 a.m. The fires on the south ends of the 96th and 97th floors are no longer as prominent as they were earlier. In fact, at this distance and clarity it is difficult to identify fires in these locations. There is evidence of low-intensity fires further to the north on both the 96th and 97th floors. The most visible flames on the 96th floor are in windows 96-224 to 96-226. This area is north of where flames were observed earlier, indicating that the fires are continuing to spread slowly toward the north.

Figure 8-49. This image of the west face of WTC 1 is a frame captured from a video recorded by a news helicopter at 9:34:48 a.m. The image has been enhanced by adjusting the intensity range, and some areas to the left and right of the tower are saturated. Column and floor numbers have been added.

Even at the distance from which Figure 8–49 was taken, a black mark is visible running across the tops of windows 94-433 to 94-436 on the 94th floor. These marks are not evident in Figure 8–47, which was taken at 9:19:45 a.m. This suggests that smoke began to flow from these windows at some point between these two times. A review of video recordings shows that visible smoke was apparent coming from these windows starting around 9:26 a.m. As discussed earlier, windows had been opened in this general area as early as 9:04 a.m. Recall also that several windows are open just to the north on the 95th floor. There is still no indication of smoke coming from these windows.

Even though the fires on this face appear to have nearly died down by the end of the period, there are still large quantities of smoke flowing from windows that have been broken out higher on the tower. In particular, heavy plumes of smoke are coming from the north side of the 107th floor and from the south side of the 104th floor. The plumes from the higher windows seem to be heavier than those coming from the floors where fires had been observed on this face, i.e., the 96th and 97th floors.

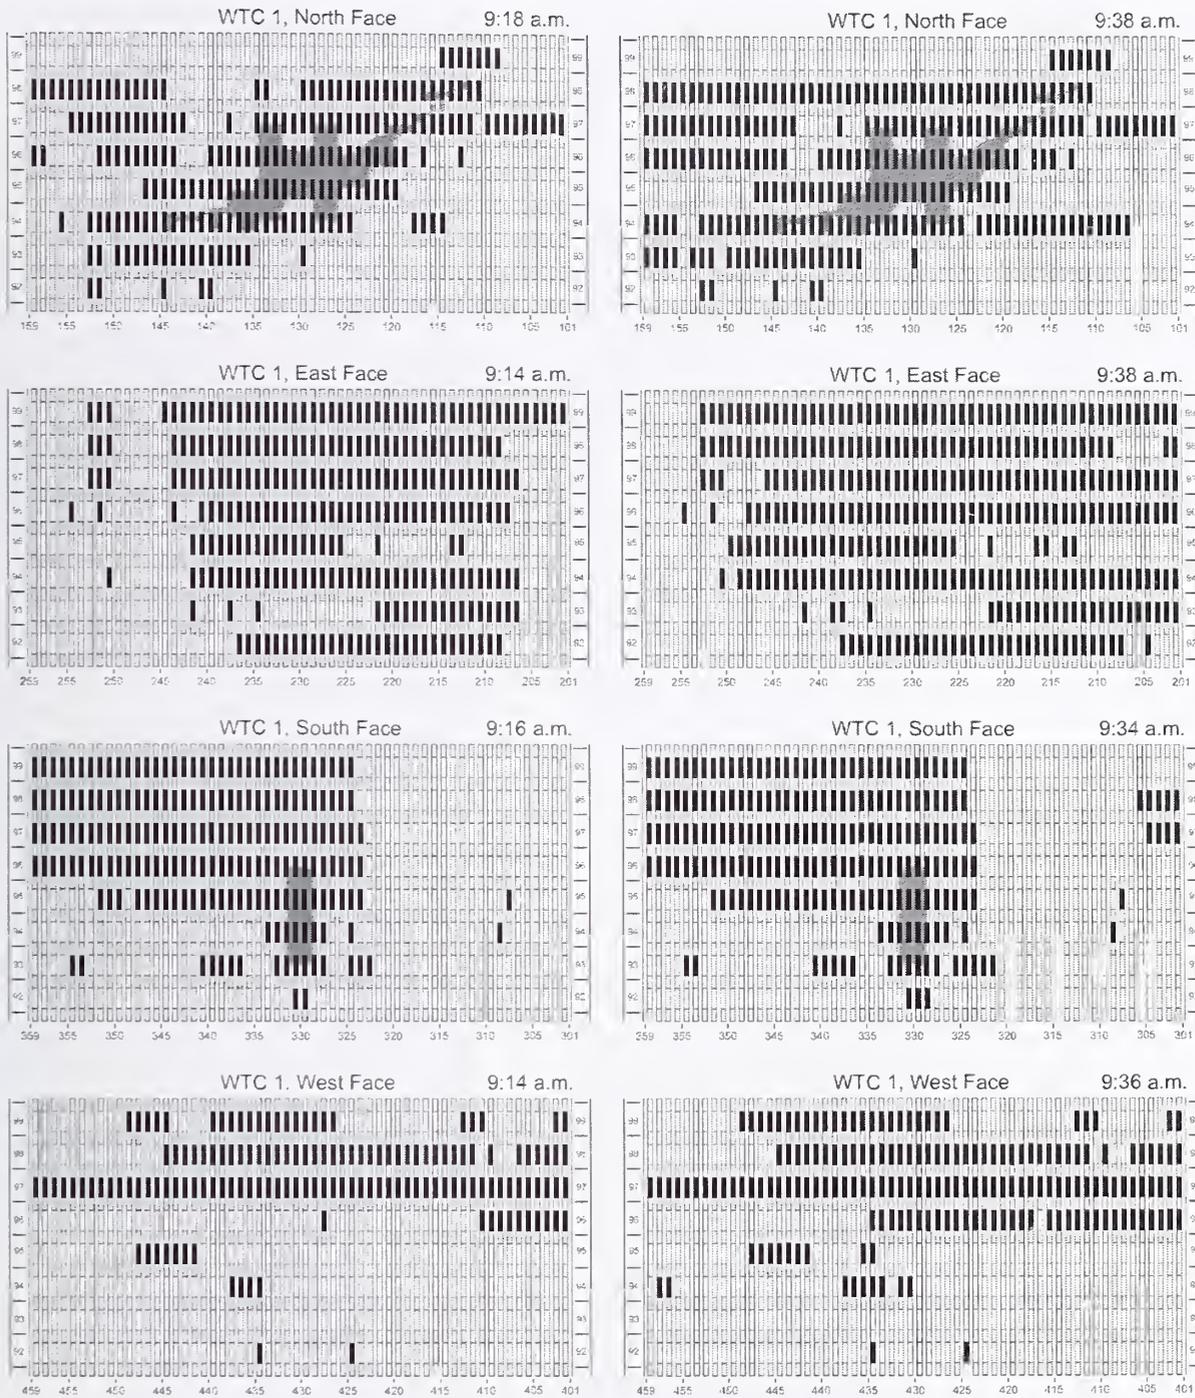
Figure 8–50 compares maps for open windows on the four faces of WTC 1 for times near the start and end of the current time period. These maps capture the general trends that emerge from the detailed discussion of fire behavior during the period. In particular, on the north face fires on the 93rd, 94th, 96th, and 97th floors breached walls and entered northeast corner rooms, and the contents inside began burning. A new region of fire grew along the north face on the 94th floor to the west side of the aircraft impact

Figure 8-50. Maps for the 92nd through the 99th floors compare missing window glass for the four faces of WTC 1 at two times, around 9:18 a.m. and roughly 17 minutes later. The color coding used for the maps is indicated in Figure 5-1.

cavity. The changes in window conditions on the east face reveal that the fires that entered rooms at the northeast corners of the 93rd, 94th, 96th, and 97th floors also removed windows on the east faces of the rooms. It is also clear that fires that were originally present near the center of the face on the 94th, 95th, 96th, and 97th floors had begun to slowly spread toward the south. On the south face there was very little fire spread during the period. The same is true for the west face, but there are indications that fires on the 96th floor had begun to spread from the southwest corner back toward the north face.

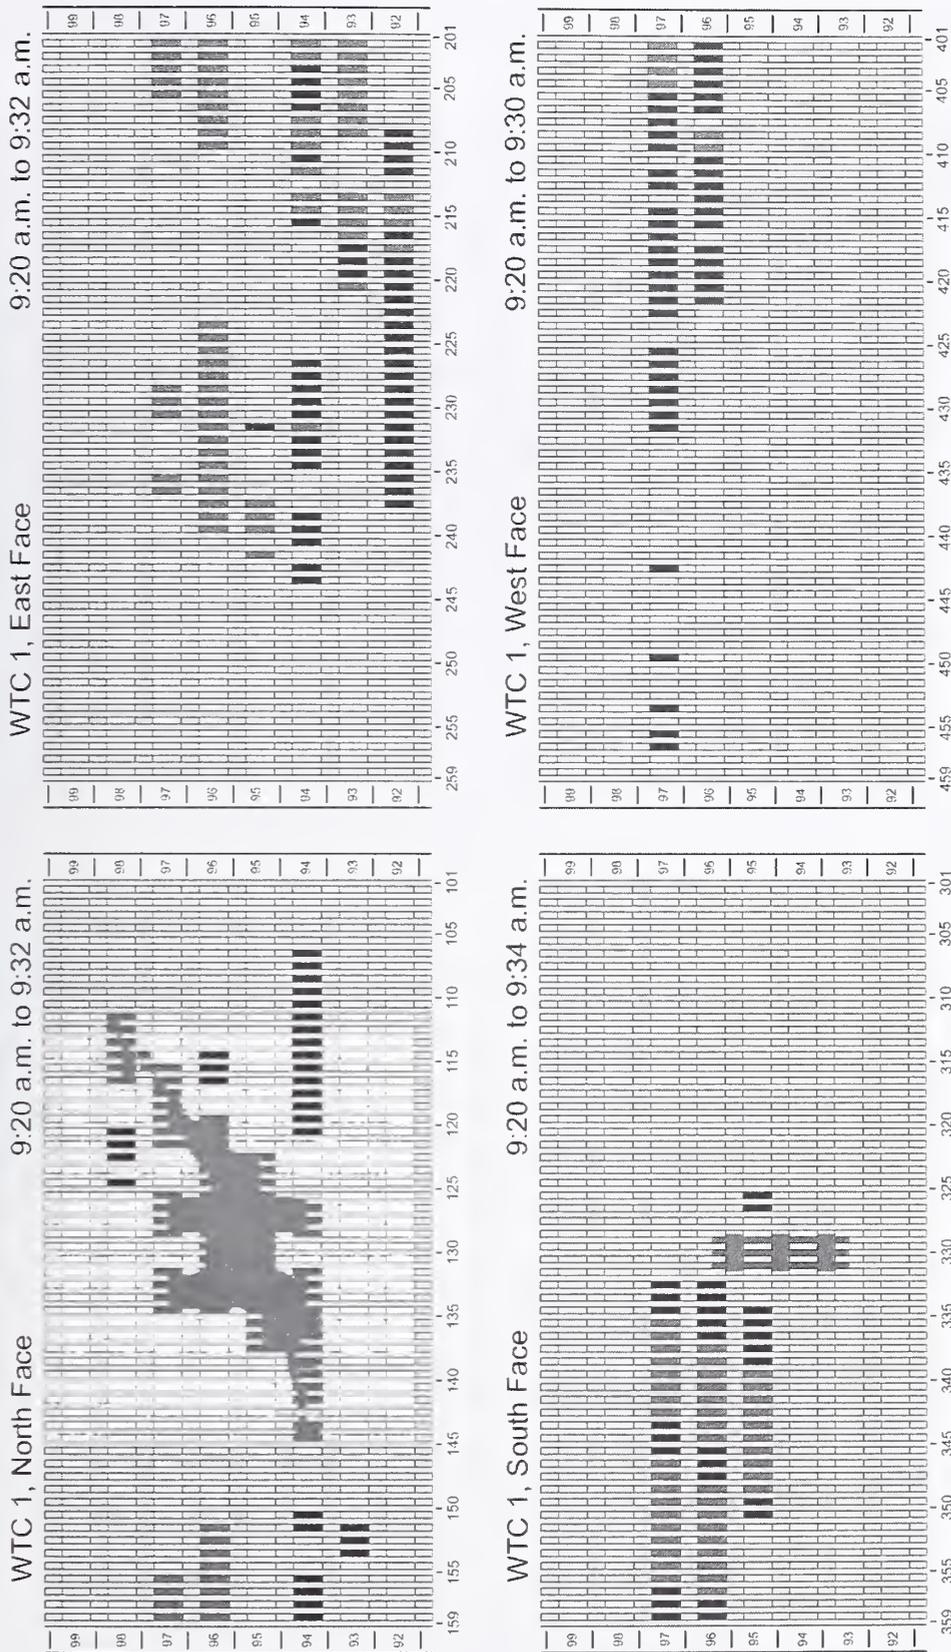
The effects of the life cycle of the fires are also apparent in comparisons of the integrated fire maps prepared for the different time periods. Figure 8–51 shows integrated fire maps on the four faces for the current period from 9:18 a.m. to 9:35 a.m. These maps can be compared with the maps for the two earlier periods shown in Figure 8–33 and Figure 8–14. Such a comparison indicates that there are many windows where fire was observed during the earlier periods where it is no longer visible. These include windows near the aircraft impact area on several floors of the north face, windows on multiple floors around the center of the east face, and many windows on the 97th floor on the west face.

On the north and east faces the windows with observed fire appear to surround areas near the centers of the faces where the fires had already died or were dying down. This suggests that fire spread along the north and east peripheries of these floors has occurred primarily by horizontal fire movement in both directions away from regions initially ignited near the centers of the faces. The fire distribution on the south face indicates that fire spread and growth had occurred differently than on the north and east, with large fires growing and spreading nearly simultaneously on multiple floors at the western side of the face. The integrated fire distribution on the west face reflects both the very rapid fire spread that was observed earlier across the 97th floor and the much slower fire spread from west to east that was observed on the 96th floor.

Figure 8-51. Maps of integrated fire observations between 9:19 a.m. and 9:35 a.m. are shown for the four faces of WTC 1. Colors represent the highest intensity fire observed in a window using the color scale defined in Figure 5-1.

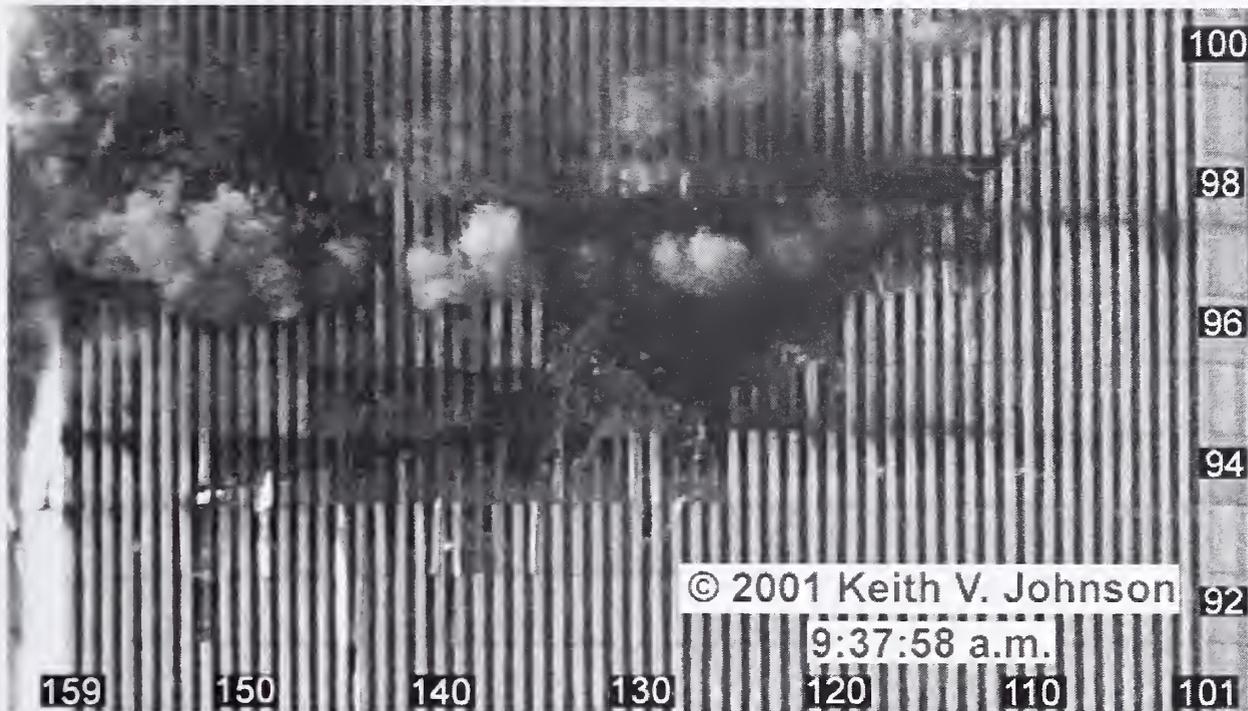
A portion of a photograph showing the fire floors on the north face of WTC 1 at 9:37:58 a.m. is reproduced as Figure 8-52. This photograph was taken just over two minutes later than the image shown in Figure 8-38. The fire on the 98th floor has spread over a wider area and has grown in intensity during this time. Fires are observed (not continuously) from window 98-122 to window 98-150. Even though the flames extend over roughly half the length of the floor, and in some locations appear to fill the volume behind the windows, there is very little smoke and flame evident coming from the 98th floor windows. This is likely another case where the fire gases are exhausting elsewhere than through nearby windows.

Only a few small isolated fires are visible elsewhere on the north face. A low-level fire is still burning on the 94th floor to the west of the aircraft impact cavity. This is the remnant of the fire that first appeared in this area around 9:18 a.m. No fire spread past the wall located at column 94-106 is evident despite the fact that fire was present at window 94-106 by 9:21 a.m. There are also two relatively small fires visible on the 93rd floor.

Figure 8-52. This enhanced and cropped photograph shows the north face of WTC 1 at 9:37:58 a.m. Column and floor numbers have been added.

On the 93rd floor there are two isolated regions of flame visible. One of these is at window 93-139 and the second is at windows 93-151 and 93-152. Many of the windows on this floor are open. The only fire evident on the 94th floor is a small spot fire in the cavity created by the aircraft. The fire on the northeast corner, which developed rapidly around 9:25 a.m. (see Figure 8-36) and filled windows 94-155 to 94-158 with flames, has already died down to a level where it not visible from this vantage point. The image provides sufficient detail to determine that the glass for windows 94-153 and 94-155 is still in place. This is an example where the apparent flame movement does not align with the wall placement indicated by the floor plan layout. The layout in Figure B-3 indicates that the wall for the room in this corner terminated at column 94-154. It is surprising that window 94-154 is not broken. No flames are visible on the 95th to 97th floors.

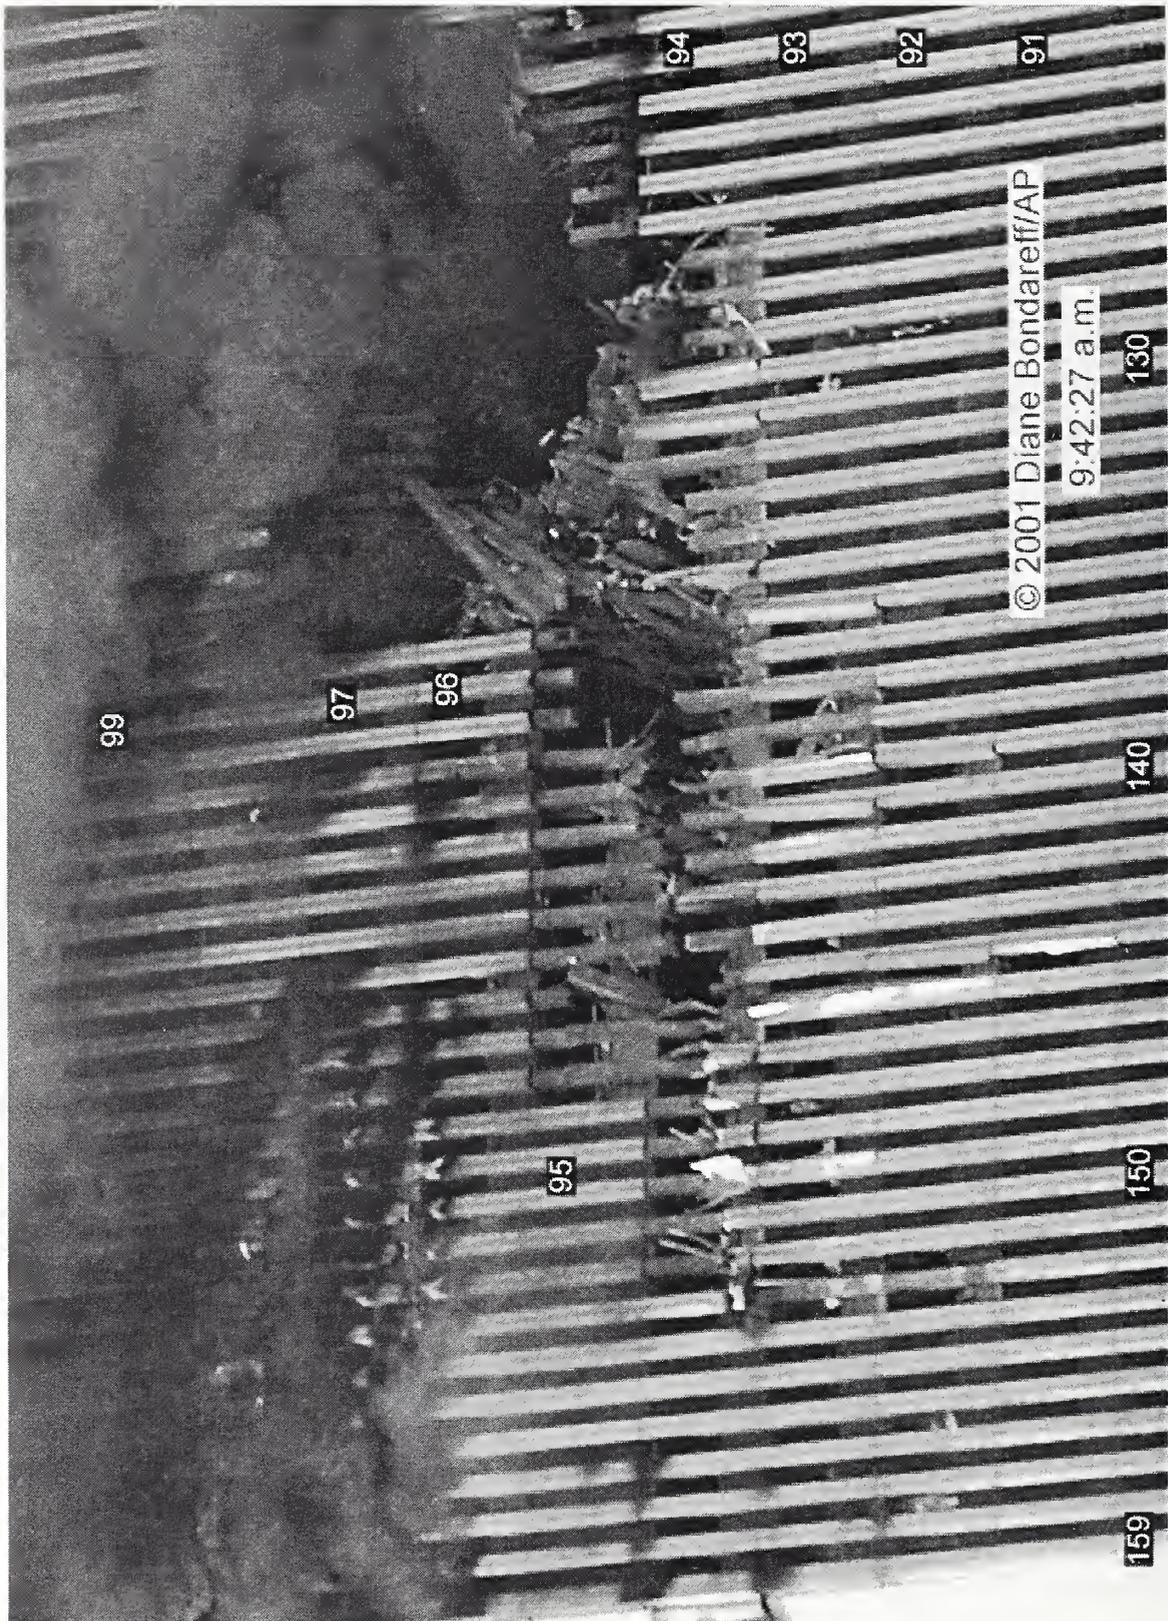
Figure 8-53 provides a clear view of the fires on the 98th floor, which extend from beyond the center of the floor on the west side to at least window 98-154 on the east. Even though the flames appear to be continuous, close inspection shows that in many windows there is simply an orange glow, suggesting that the fires are burning away from the windows at interior locations. The number of windows where flames are directly visible is limited. The only areas where flames appear to fill the windows are near the center of the face and around window 98-153.

Figure 8-53. This sharp photograph shows the eastern portion of the north face of WTC 1 at 9:42:27 a.m. The original version has been cropped and enhanced. Column and floor numbers have been added.

The fires on the north side of the 98th floor do not appear to be as intense as those observed at many other locations on the tower faces. Even so, they were large enough to break out the glass in multiple windows. Windows that were closed prior to the fire are now open. A review of the streamer observations summarized in Appendix L shows that numerous streamers were observed on the north face coming from the 98th floor during the early part of this time period when the fires were growing. Their source locations were spread out across the floor. This provides additional evidence that the streamers formed in regions where fires were breaking window glass.
