**NIST NCSTAR 1-5A
Federal Building and Fire Safety Investigation of
the World Trade Center Disaster**

**Visual Evidence, Damage Estimates,
And Timeline Analysis**

Visual Evidence, Damage Estimates, and Timeline Analysis

September 2005

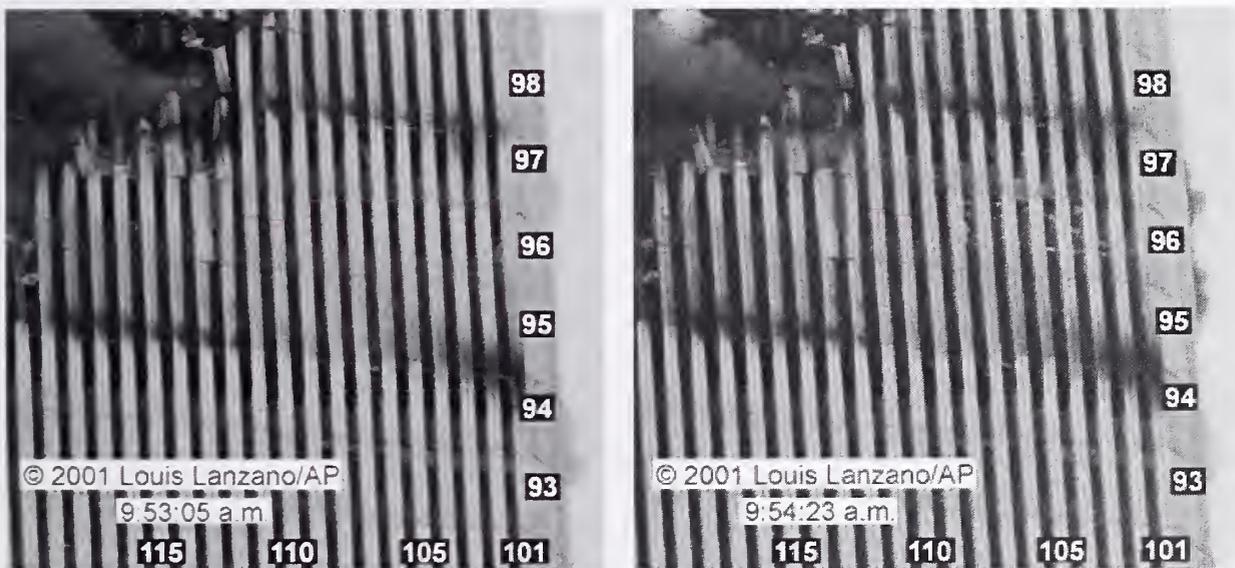
Figure 8-54 includes a photograph of this area taken at 9:53:05 a.m. Windows 94-101 to 94-105 are clearly open. The fires in the corner room have already died down to the point where they are no longer visible from this vantage point. All of the windows on the 94th floor within the view of the image are missing. At the same time, windows on the 92nd, 93rd and 95th floors and windows 98-101 to 98-108 on the 98th floor still have glass panes in place.

Figure 8-54. Two photographs of the west side of the north face of WTC1 taken at 9:53:05 a.m. and 9:54:23 a.m. are compared. The original photographs were cropped and enhanced. Column and floor numbers have been added.

In the photograph taken at 9:53:05 a.m., a small fire can be seen at the western edge of the 96th floor in window 96-101, while the glass for windows 96-102 to 96-110 is still in place. Videos show that there was a flash of light at window 96-101 at 9:53:00 a.m., which was likely associated with this window opening. At 9:53:20 a.m. the fire in window 96-101 grew visibly larger. During the following 13 s, fire appeared, moving from west to east over windows 96-102 to 96-107. This fire is evident in the second photograph included in Figure 8–54, which was taken at 9:54:23 a.m. The adjacent window, 96-108, was still in place at this time. According to the floor plan layout shown in Figure B-5, one of the walls for the room at this corner was located at column 96-108.

Even though the glass panes for windows 96-108 to 96-111 are still in place, a fire is visible growing rapidly further to the west in windows 96-112 to 96-115. The fire seen in window 96-113 is one of the few examples where flames are observed through a closed window. As discussed below, a significant fire was observed on the west face near the northwest corner prior to the rapid fire growth in the northwest corner room. This suggests that the fire broke into this corner room through the south wall located at column 96-456 (see Figure B-5). Note that there were two adjacent rooms attached to the south side of this wall. Fire movement from the south is also the likely source for the fire seen in windows 96-112 to 96-115.

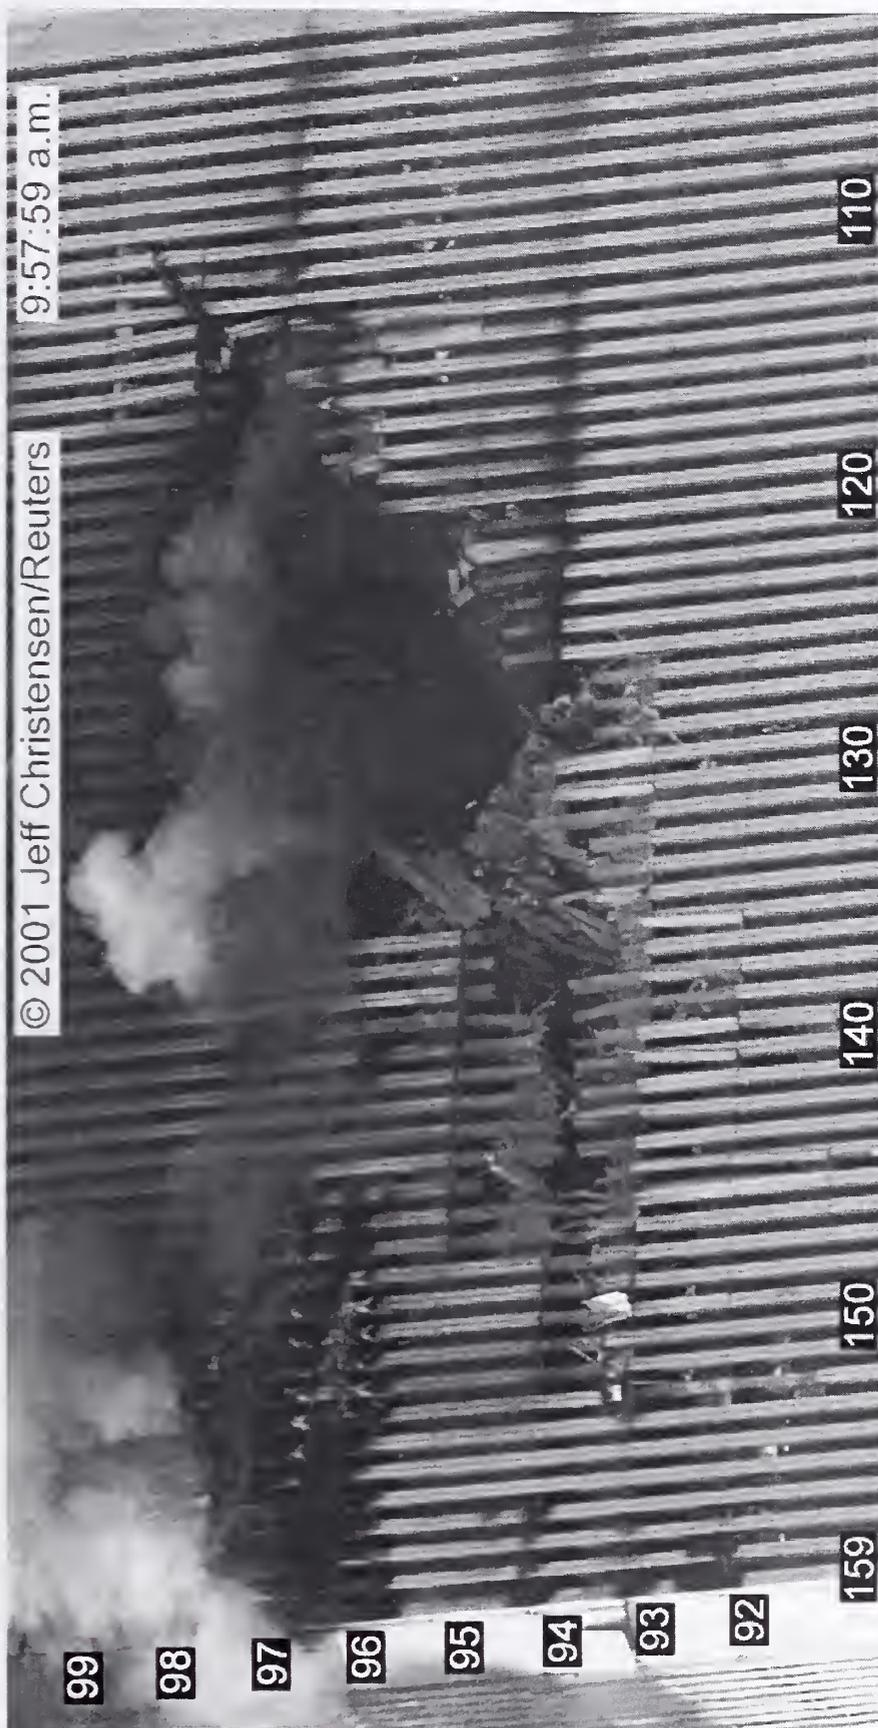
A photograph of the north face of WTC 1 taken at 9:57:59 a.m., i.e., one minute prior to the collapse of WTC 2, is shown in Figure 8–55. Several changes have taken place since the photographs in Figure 8–53 and Figure 8–54 were taken. The fires on the 98th floor have died down considerably, with fire primarily evident on the east side of the north face. The fires on the 92nd and 96th floors have also spread a little further. On the 96th floor, windows 96-108 to 96-111 are now open, and flames are visible in these windows. On the 92nd floor, the panes for windows 92-153 and 92-154 are missing, and flames are visible through these windows, as well as windows 92-151 and 92-152. Recall that walls for rooms in this area were located at columns 92-152 and 92-155 (see Figure B-1). This photograph has sufficient resolution to identify details inside the windows. It appears as if both of these walls are still present.

Figure 8-55. This image shows the north face of WTC 1 at 9:57:59 a.m. The original has been rotated, cropped, and enhanced. Column and floor numbers have been added.

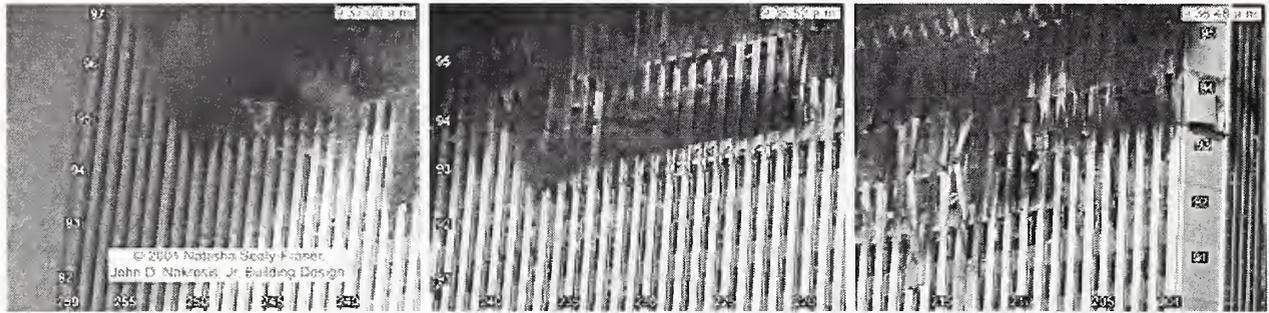
A number of close-up photographs and videos that provide views of the east face are available during the current time period. Figure 8–56 shows a series of three photographs that were taken around 9:37 a.m. They show the lower floors where fires have been burning. Note that the fires that are present on the 96th and 97th floors are not visible. In the right-most photograph fire is visible near the northeast corner of the

Figure 8-56. This series of three photographs shows various locations along the east face of WTC 1 around 9:37 a.m. Column and floor numbers have been added.

92nd floor in windows 92-201 to 92-207. Flames first appeared in this area around 9:33 a.m., and at 9:34:20 a.m. flames were coming from these windows. These flames had already begun to die down two and a half minutes later. The smoke markings on the adjacent column covers are interesting. They are a combination of carets and horizontal bands. There is also a smoke band above these windows. These markings suggest that while flames did extend from the windows, they were not intense enough or sustained for a long enough time to create well-defined carets. Well-defined carets are present just above on the 94th floor, as well as on numerous column covers on the 96th floor.

The same photograph provides an indication of the degree to which the flames that were present earlier on the 94th and 96th floors have died down. Only a couple of isolated fires are observed on the 94th floor, and no flames are obvious in windows 96-201 to 96-220.

In the center photograph of Figure 8-56, the fires that were present earlier on the 93rd, 94th, and 95th floors near the center of the east face have also died down and are no longer evident. There is still considerable evidence of interior fires on the 92nd floor, but the flames still do not seem to have progressed beyond window 92-237. As discussed earlier, flames were observed at window 92-237 at 9:21:01 a.m. The fires on the 92nd floor have caused some interesting effects on the surrounding façade. The variations in the types of smoke marks on the column covers adjacent to the windows have already been mentioned. Inspection shows that in the area immediately above windows 92-223 to 92-228, the aluminum spandrel covers have partially disappeared. The shapes of the missing areas indicate that they mostly likely melted due to heating from the hot fire gases flowing from below. In fact, spots of what appear to be solidified drops of aluminum can be seen on windows below this floor. Based on the melting temperature of aluminum, the fire gases leaving these windows must have been well in excess of 600 °C. Even though these gases were quite hot, they have not broken out the glass in the windows immediately above on the 93rd floor, which are heavily coated with soot, but remain in place.

The left-most photograph in Figure 8-56 shows the southern part of the east face. A jet of fire is coming from the 94th floor at window 94-246, and flames are visible in nearby windows. The carets on many nearby column covers indicate that flames have extended from many of these windows. The heavy smoke coming from window 94-149 indicates the fire on this floor has moved slightly toward the west since 9:34:20 a.m. (see Figure 8-43).

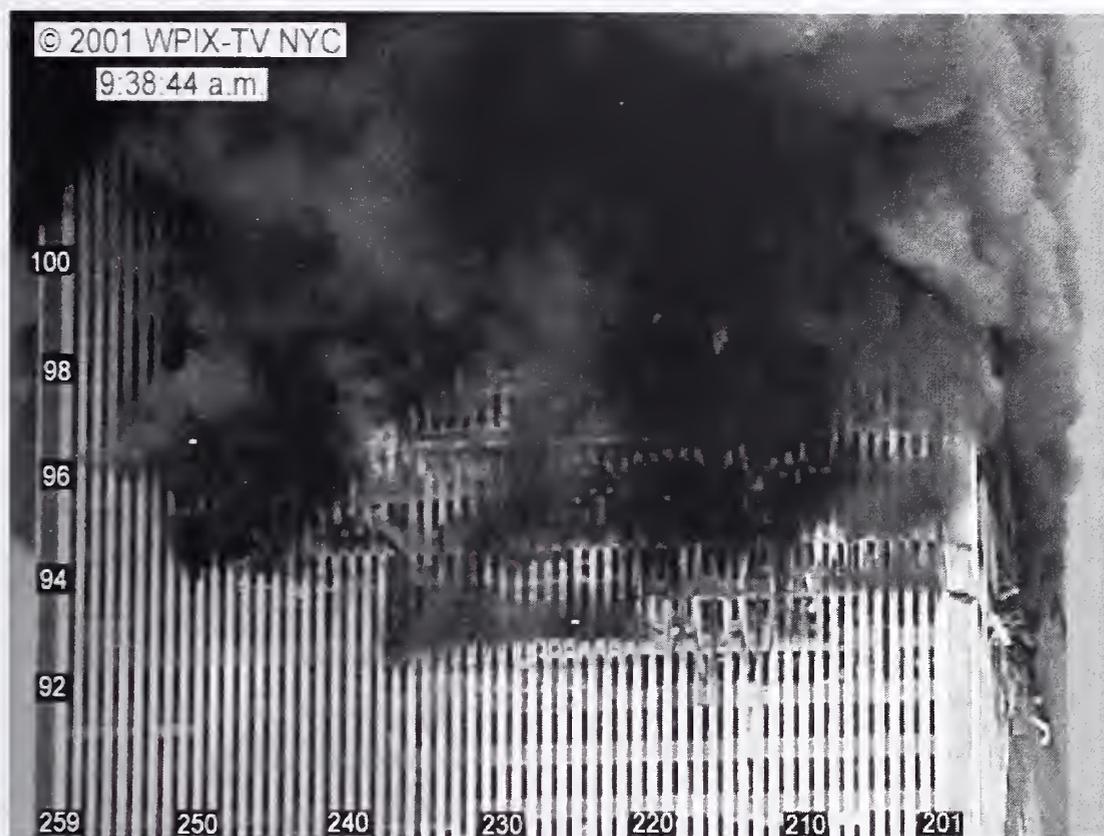
Figure 8-57 is a frame from a video of the east face taken at 9:38:44 a.m., which shows all of the floors with fires. This photograph was taken more directly from the east than Figure 8-56 and, therefore, provides a better indication of fire locations. Starting at the lower part of the figure, the fire on the

92nd floor is visible over a length from near window 92-223 to window 92-238. Despite the extent of the flames, visible smoke is only coming from near window 92-237. On the 93rd floor, flames are evident at the northeast corner and also in a region running from approximately window 93-213 to window 93-221. Flames are coming from the several windows on the 94th floor, centered near window 94-248, and flames extend over at least seven windows. A short flaming region is present on the 95th floor, centered near window 95-239.

Figure 8-57. This image of the east face of WTC 1 was captured from a video recorded at 9:38:44 a.m. It has been enhanced by adjusting the intensity levels. Column and floor numbers have been added.

There is an intense flaming region on the 96th floor, with flames extending a large distance from windows 96-237 and 96-238. Videos of this face around this time show that this intense flaming lasted several minutes. The intense region of burning has only moved a few windows to the south since 9:25:27 a.m. (see Figure 8-42). In contrast, very little flame is visible on the 97th floor, directly above, even though fires have burned to roughly the same location as on the 96th floor. Videos recorded at around the same time also indicate there was very little fire on this floor.

On the 98th floor, there is a localized jet of flame coming from window 98-215. A review of photographs and videos recorded around this time reveals that this flame was not apparent in close-up shots taken around 9:37 a.m. and that it is seen for the first time in more distant videos around 9:37:57 a.m. Recall that by this time a wide-spread fire had been observed on the north face of this floor for around 10 minutes. Unlike the fire that has just appeared on the east face, the flames did not extend from the north face and appeared to be of relatively low intensity. It is interesting that the first appearance of

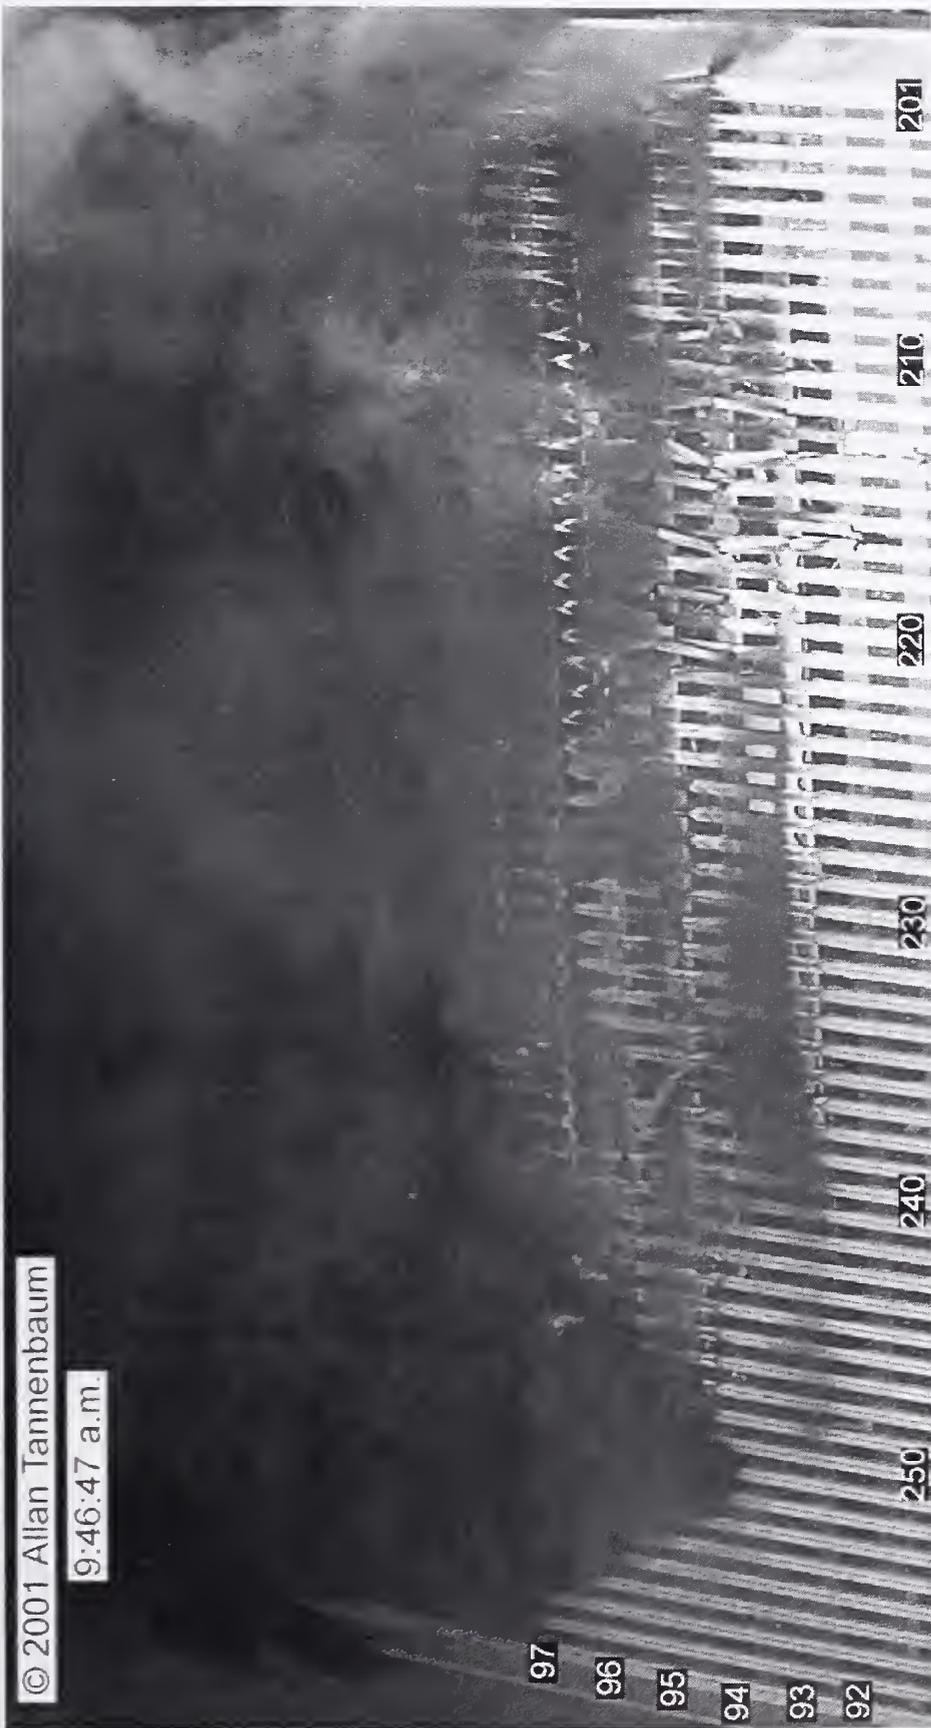
A close-up photograph of the east face, taken just over eight minutes later (at 9:46:47 a.m.) than Figure 8-57, is shown in Figure 8-58. There have been several changes in the fire distribution on the face during this time. The most dramatic change is on the 98th floor. Fire is now visible from window 98-208 to window 98-217. There is extensive external flaming from a large number of these open windows. The windows to the north of column 98-208 appear to have intact glass. The floor plan layout shown in Figure B-7 indicates that a wall for a room in the northeast corner terminated at this column.

On the 92nd floor, the fire, which had paused at window 92-237 for nearly 20 min, now has flames coming from window 92-248. At 9:39:28 a.m. there was a burst of flame from window 92-239. A photograph taken at 9:38:28 a.m. did not show any indication of fire having moved from its original location. In a photograph taken at 9:42:27 a.m., fire was present in window 92-240, but the windows further to the south still had intact glass. In a more distant photograph taken at 9:44:24 a.m., smoke appeared to be coming from a few more windows towards the south. Videos of the area show flames suddenly burst from window 92-248 at 9:45:06 a.m. Windows to the south of 92-248 were still intact in Figure 8-58 at 9:46:47 a.m.

In Figure 8-58, only small isolated fires are visible on the 93rd floor. On the 94th floor, the fire has continued its slow progress toward the south end of the face. Flames are now visible coming from window 94-250. This window had been open since the aircraft struck just over an hour earlier. Flames are visible in about ten windows to the north of this location. On the 95th floor, a smaller area of flame is present in roughly the same windows as on the 94th floor.

A large fire continues to rage on the 96th floor. Flames are apparent from around window 96-231 to at least window 96-247, with long flames extending from windows 96-244 and 96-246. At 9:38:44 a.m. much of this area was hidden by smoke, and no flames were apparent to the west of window 96-240. At this earlier time, the major area of flame extension was from around window 96-237. It is clear that the area of intense burning on this floor has moved south about eight windows during the intervening period. Unlike at the earlier time, a region of fire is now evident on the 97th floor in windows 97-231 to 97-237.

In areas of the face below and to the north of the current active fire areas there is little visual evidence of smoke or flames in the open windows. This indicates that fires observed earlier at these locations have either gone out or are now burning at very low levels. Figure 8-58 provides a good view of the various markings on the face described earlier, including the smoke marks on the column covers and partially melted spandrel covers.

Figure 8-58. This image shows the east face of WTC 1 at 9:46:47 a.m. The original image has been cropped, rotated, and enhanced. Column and floor numbers have been added.

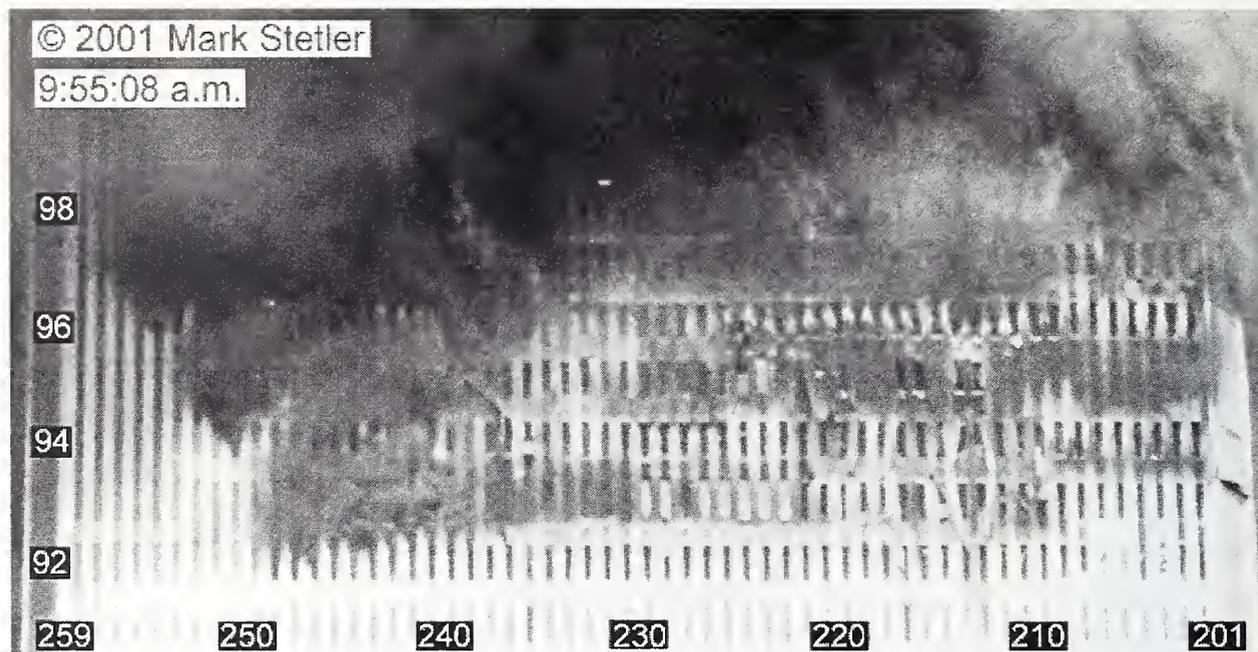
Figure 8-59 includes a photograph of the east face that was taken roughly eight and one half minutes (at 9:55:08 a.m.) after that shown in Figure 8-59. The fire burning on the 98th floor has continued to spread. It now extends from window 98-225 on the south to window 98-201 on the north. There is flame extension from windows 98-208 to 98-223. The fire has clearly moved into the room on the northeast corner, but the fire inside the room is burning at a lower intensity than the main fire region to the south.

Figure 8-59. This photograph shows the east face of WTC 1 at 9:55:08 a.m. The original has been rotated, cropped, and enhanced. Column and floor number have been added.

The fire on the 92nd floor has not moved further south than window 92-248 during the interval, but it has grown larger in the immediate area. The windows from window 92-240 to window 92-248 appear to be filled with flames, and there is some flame extension in the area. The fire on the 94th floor also seems to have remained in place, but it has decreased in intensity. The appearance of the fire on the 95th floor is little changed from the earlier photograph.

The changes in the appearance of the fire burning on the 96th floor are somewhat surprising. At 9:46:47 a.m. flames were evident all the way to window 96-249, with flame extension from window 96-248. At 9:55:08 a.m. the major flame region has apparently moved back to the north and is centered near window 96-235. Flames extend out of windows 96-234 and 96-235. The floor plan layout in Figure B-5 indicates that the space in this general area was open with no walls that could provide an explanation for this behavior. On the 97th floor there is a long flame coming from near window 97-237. This is roughly the same location where less vigorous flames were observed earlier.

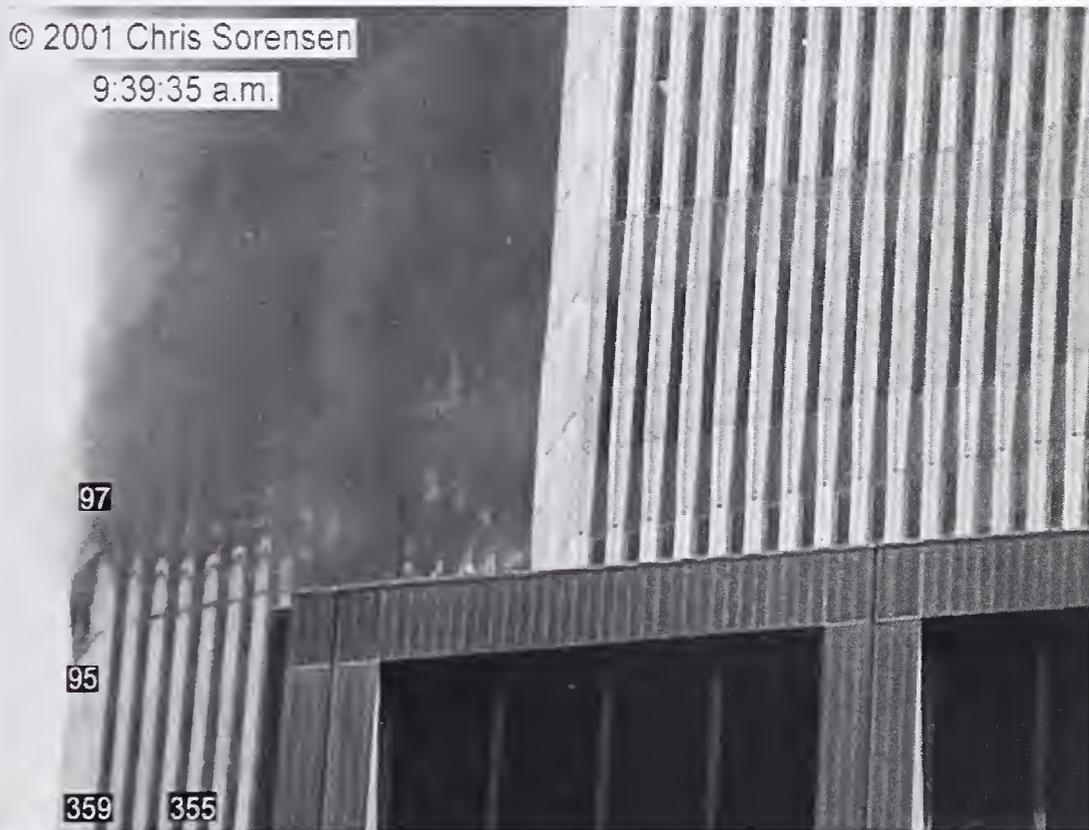
Figure 8–60 shows a partial view of the south face of WTC 1 taken from a video recorded at 9:39:35 a.m. WTC 1 is behind WTC 2, which appears to the right in the image. The first column that is visible on WTC 1 is column 343. The top of the 95th and higher floors are visible. Flames are visible on the 95th, 96th, and 97th floors, but the fire intensity appears to have decreased from that observed in Figure 8–46, which was taken at 9:33:13 a.m. Note that it is possible to see parts of the 98th floor through the smoke, and no flames are apparent.

Figure 8-60. This image of the south face of WTC 1 was captured from a video recorded at 9:39:35 a.m. It has been enhanced by adjusting the intensity levels. WTC 1 is on the left behind WTC 2. Another building appears in the foreground. Column and floor numbers have been added.

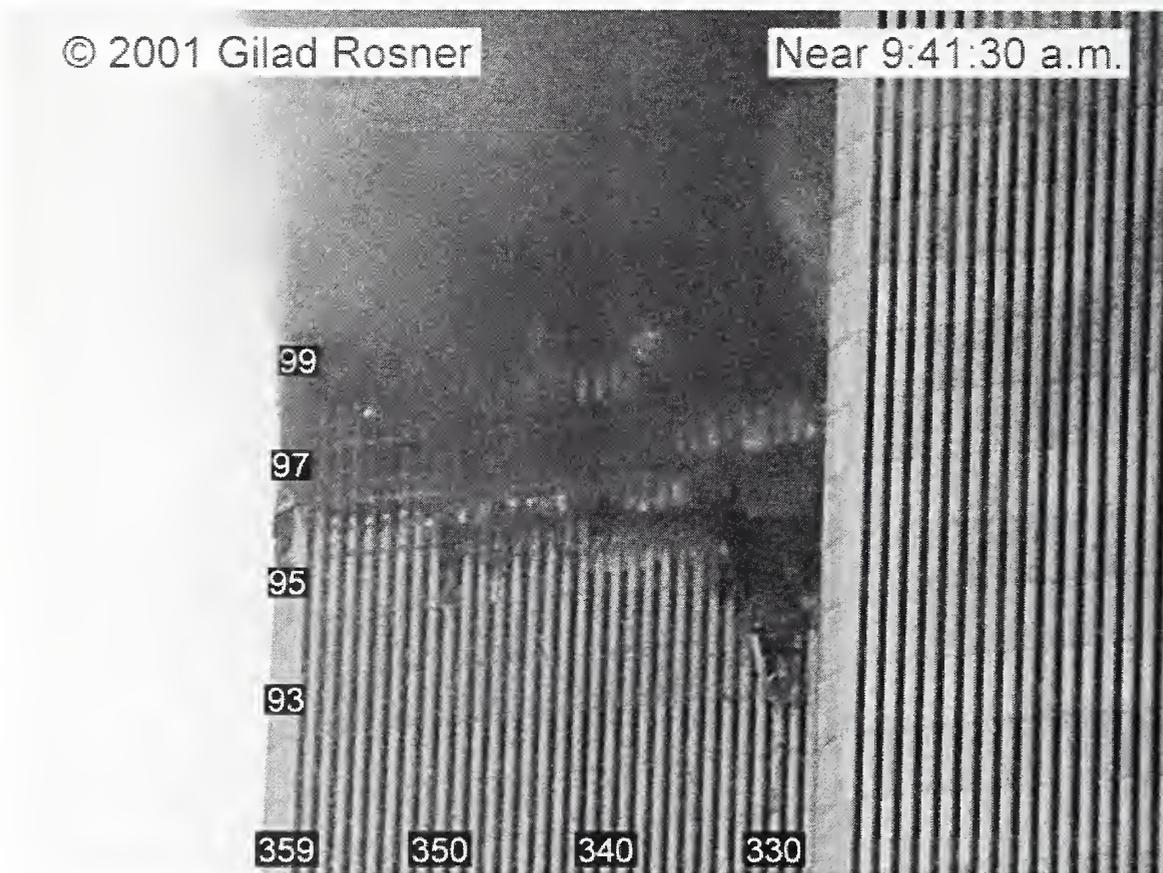
The photograph in Figure 8–61 was taken shortly after the initial rapid fire growth on the south face took place on the 98th floor. The exact time of the photograph is unknown. The assigned time of 9:41:30 a.m. has an uncertainty of just over one minute. The fire on the 98th floor has already covered a number of windows, and flames are extended from many of these. Significant fires are also evident on the 95th, 96th, and 97th floors. The intensities of these fires have continued to decrease relative to earlier times. Burning is also present on the 94th floor near the center of the face, where the panel section is believed to have been displaced during the aircraft impact. Flames were not evident at this location in Figure 8–46, which was taken at 9:33:13 a.m.

Figure 8-61. This untimed photograph shows the south face of WTC 1. It is estimated that it was taken between 9:40:40 a.m. and 9:42 a.m. Column and floor numbers have been added.

Another photograph (not shown) taken around this same time (estimated to be 9:42:25 a.m.) shows a fire distribution on the west side of the south face similar to that seen in Figure 8–61. However, unlike Figure 8–61, this image also shows the east side of the face. Small flames are visible on the 94th floor in windows 94-328 and 94-327 to the immediate east of the area where the panel section is believed to have been dislodged. Flames are also visible higher up on the 95th floor (windows 95-328 to 95-324) and the 97th floor (windows 97-330 to 97-325). Further to the east a small spot fire is visible inside window 94-308 on the 94th floor and light smoke is coming from the window. This window remains the only open window on this section of the façade, and it has been open since the aircraft impact. This small fire is the first indication that fire has spread into locations near the southeast corner of the tower on any floor.

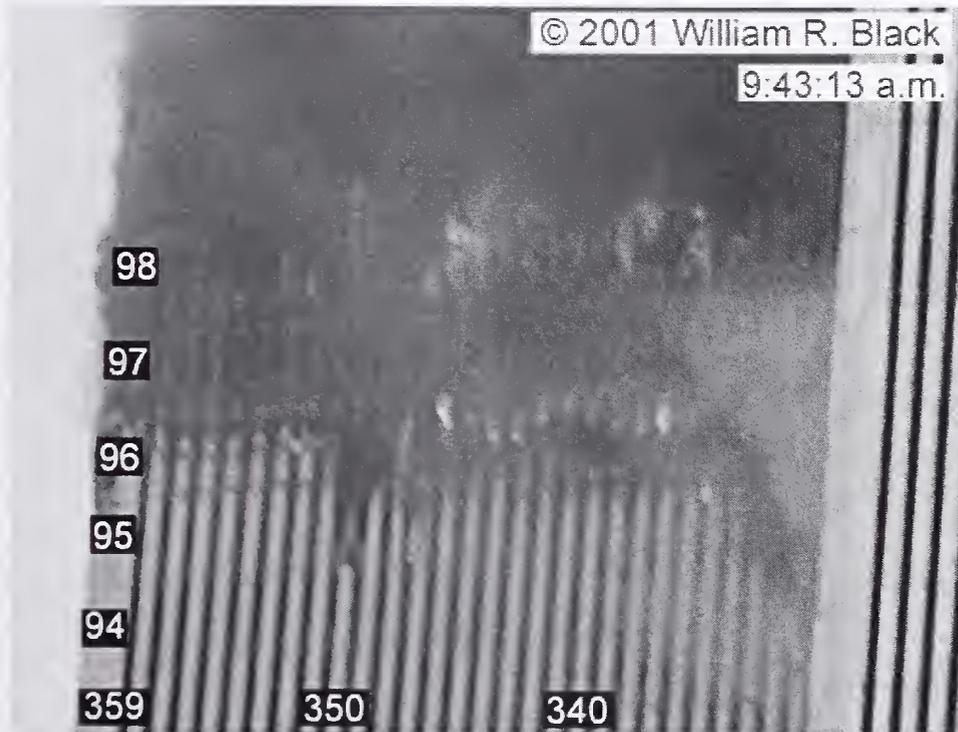
Figure 8–62 shows a partial view of the south face recorded at 9:43:13 a.m. The intensity of the fire on the 98th floor has increased markedly from that seen in Figure 8–61. Fire is now evident from at least window 98-335 to window 98-356. Well over ten of the windows on this floor have large extended flames. Forty seconds later the fire on the 98th floor had grown still more intense as shown in the somewhat closer view of the area reproduced in Figure 8–63. Flames are evident as far west as window 98-357. It is clear from this photograph that, while the intensities of the fires on the 95th, 96th, and 97th floors have decreased from earlier times, vigorous burning is still taking place on each of these floors. A small fire is burning on the 94th floor in window 94-332.

Figure 8-62. This cropped photograph of the south face of WTC 1 was recorded at 9:43:13 a.m. The image has been rotated and enhanced. WTC 2 appears at the right. Column and floor numbers have been added.

Comparison of Figure 8–60 to Figure 8–62 verifies the observation from the video that an intense fire appeared on the south face of the 98th floor shortly after 9:40 a.m. and very rapidly covered most of the western half of the face.

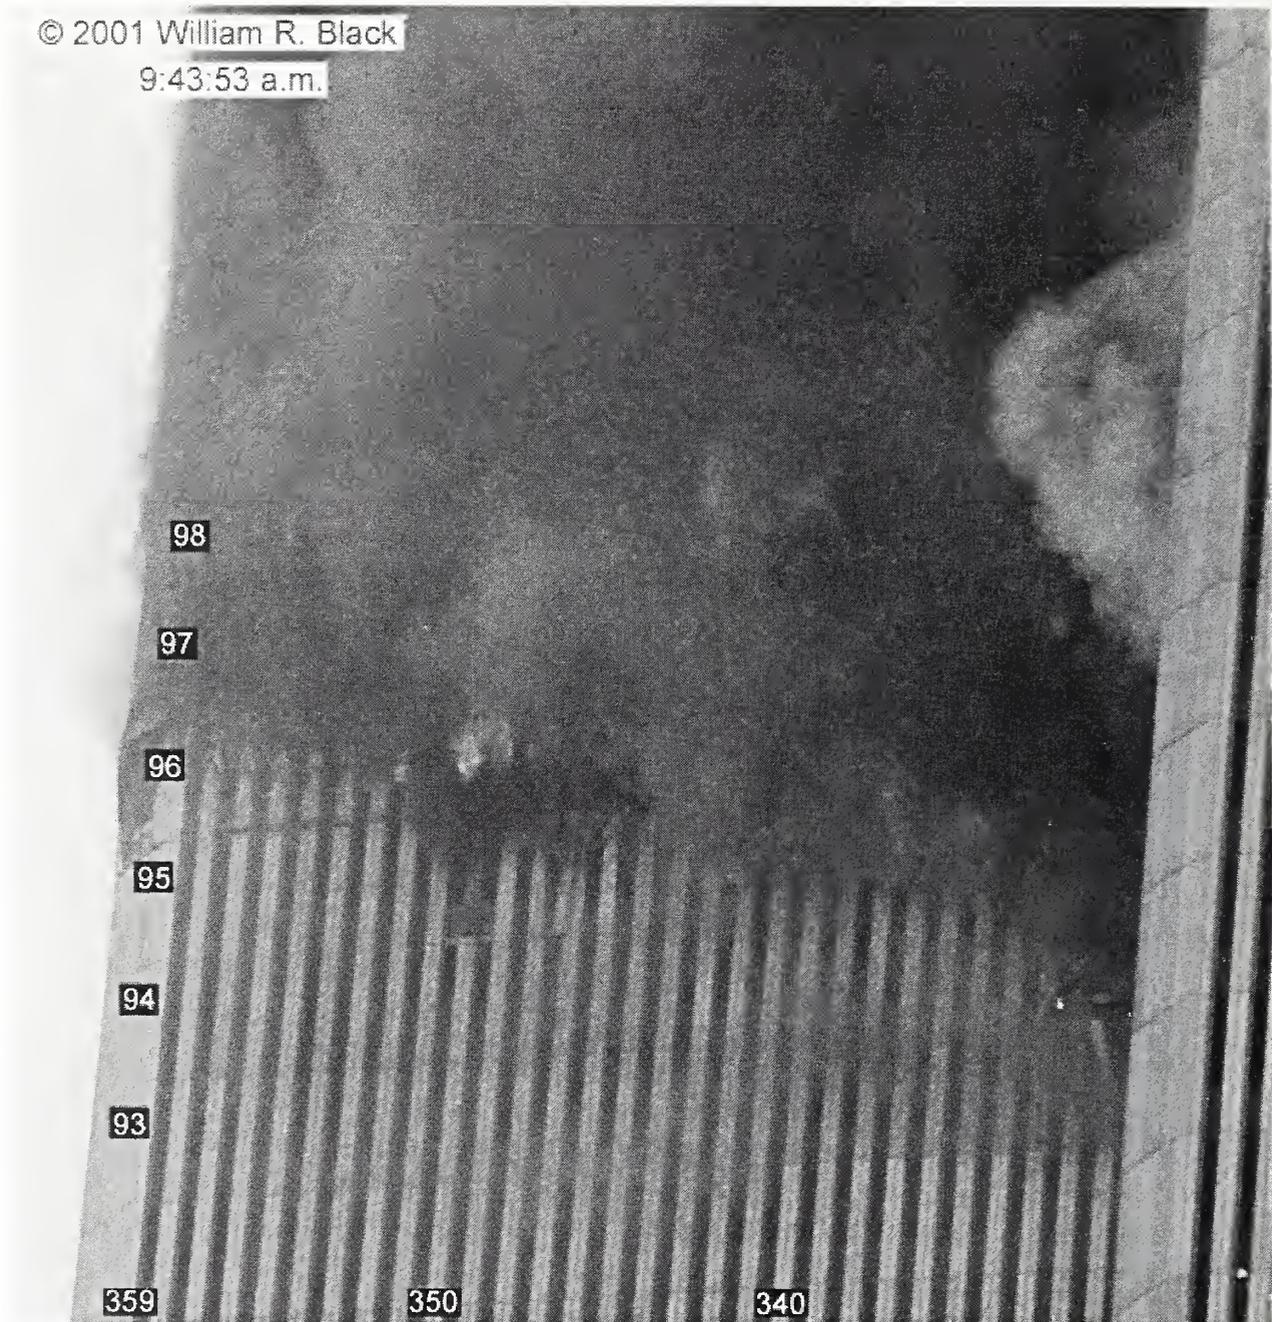
Figure 8-63. This cropped photograph of the south face of WTC 1 was recorded at 9:43:53 a.m. The image has been rotated and enhanced. WTC 2 appears at the right. Column and floor numbers have been added.

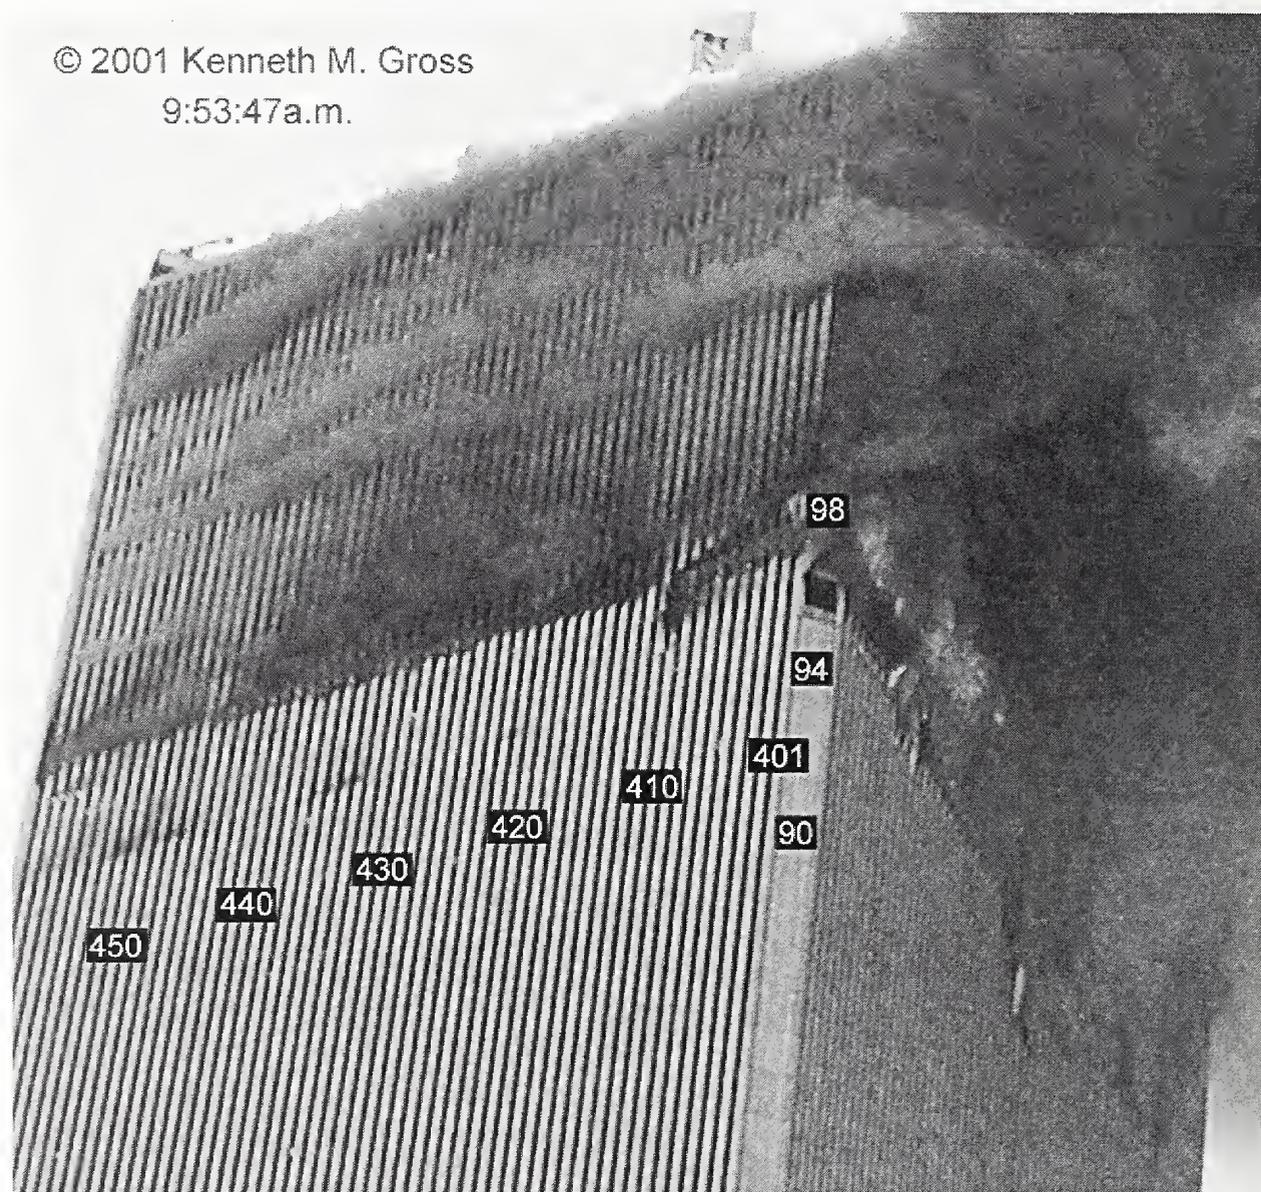
In Figure 8–65 there are indications of smoke coming from windows on the 93rd floor just to the right of the area where the panel section is believed to be missing. Higher floors on the east side are partially obscured by smoke, but there are no indications of intense fires or heavy smoke on this side for levels above the 94th floor. This figure provides a good qualitative indication of the relative intensity of the recently developed fire on the 98th floor as compared to the fires that had been burning longer on the 95th to 97th floors.

Figure 8-65. A photograph shot from the southwest shows the west and south faces of WTC 1 at 9:53:47 a.m. The original image has been cropped and enhanced. Column numbers for the west face and floor numbers have been added.

Fires are visible on the west face of the 94th floor in Figure 8-65. The smoke marks at the tops of the covers for columns 94-121 and 94-122 are distinct, indicating that the fire has opened windows in the room with walls at columns 94-421 and 94-425 (see Figure B-3). The dark red glow of the fire on the 98th floor that extends north from the south edge of the west face is also visible in Figure 8-65. This particular photograph provides a graphic illustration of the differences in burning behavior observed on the west and south faces for fires on this floor. Compare the intense flames extending from multiple windows of the 98th floor on the south face with the red glow present on the west face.

The fires on the 98th floor reinforced the trend in which fires burning on the north and west faces of WTC 1 appeared to burn with lower intensity, e.g., without generating external flames or large quantities of smoke, while fires on the east and south faces often appeared to be much more intense. Figure 8-65 shows a particularly striking example of this behavior.

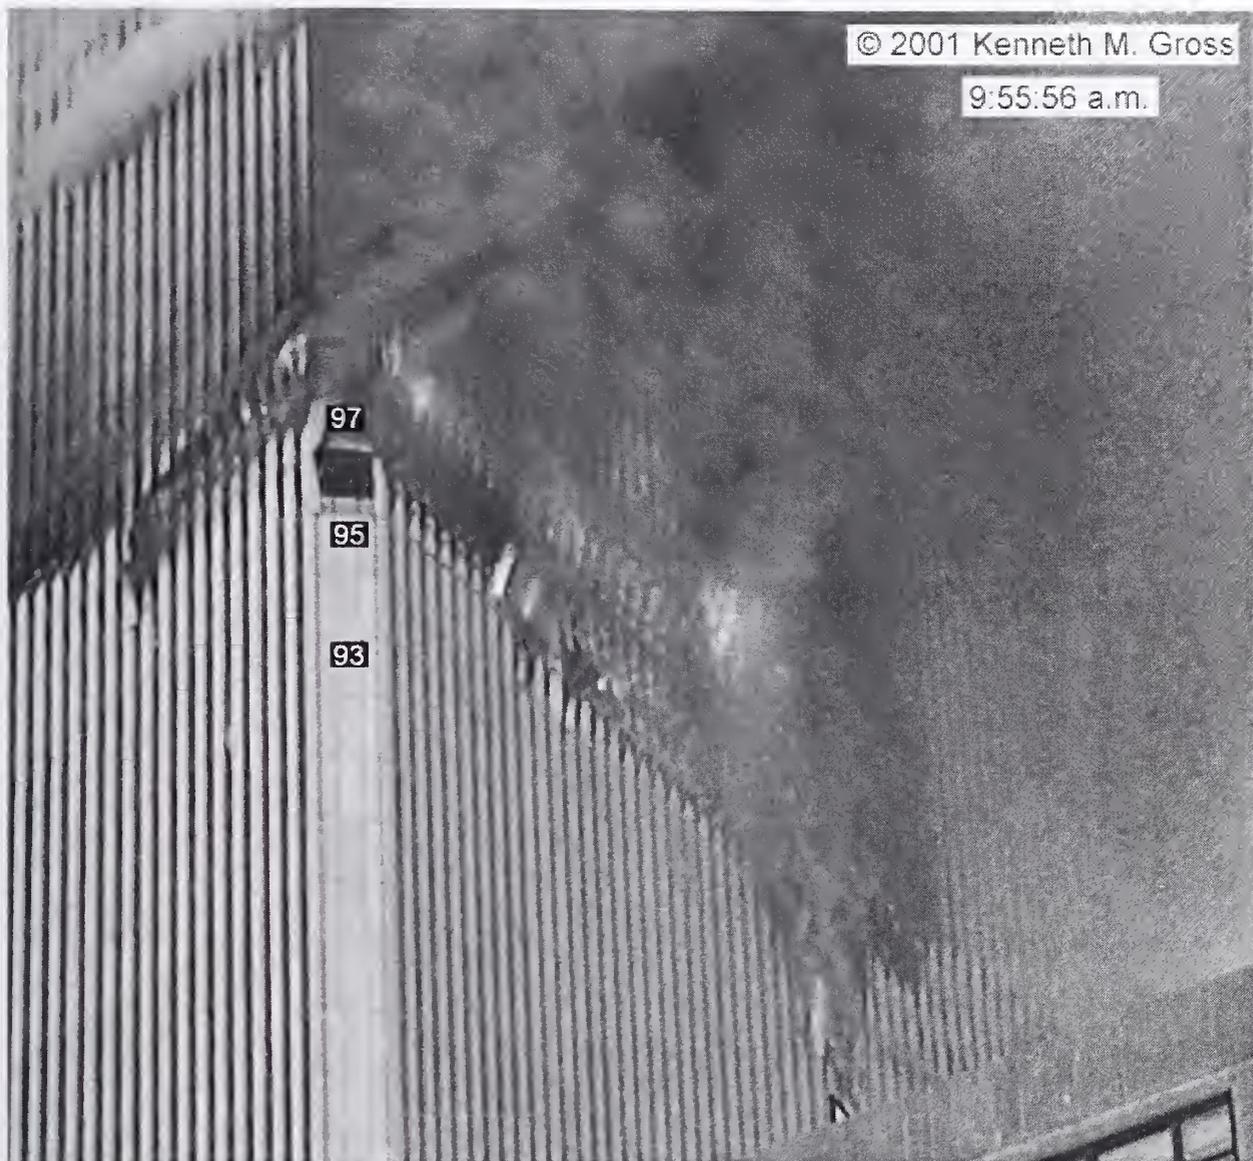
As seen by comparing Figure 8–65 and Figure 8–66, which was taken at 9:55:56 a.m., the intensity of the fire on the west side of the 98th floor decreased rapidly over the next two minutes. Even though bright fires are still evident, the flames have receded back into the building at most windows. In Figure 8–66, it

is clear that intense flames are present over several floors in the area at the center of the face where the panel section is likely missing.

Figure 8-66. A photograph shot from the southwest shows the west and south faces of WTC 1 at 9:55:56 a.m. The original image has been cropped and enhanced. Floor numbers have been added.

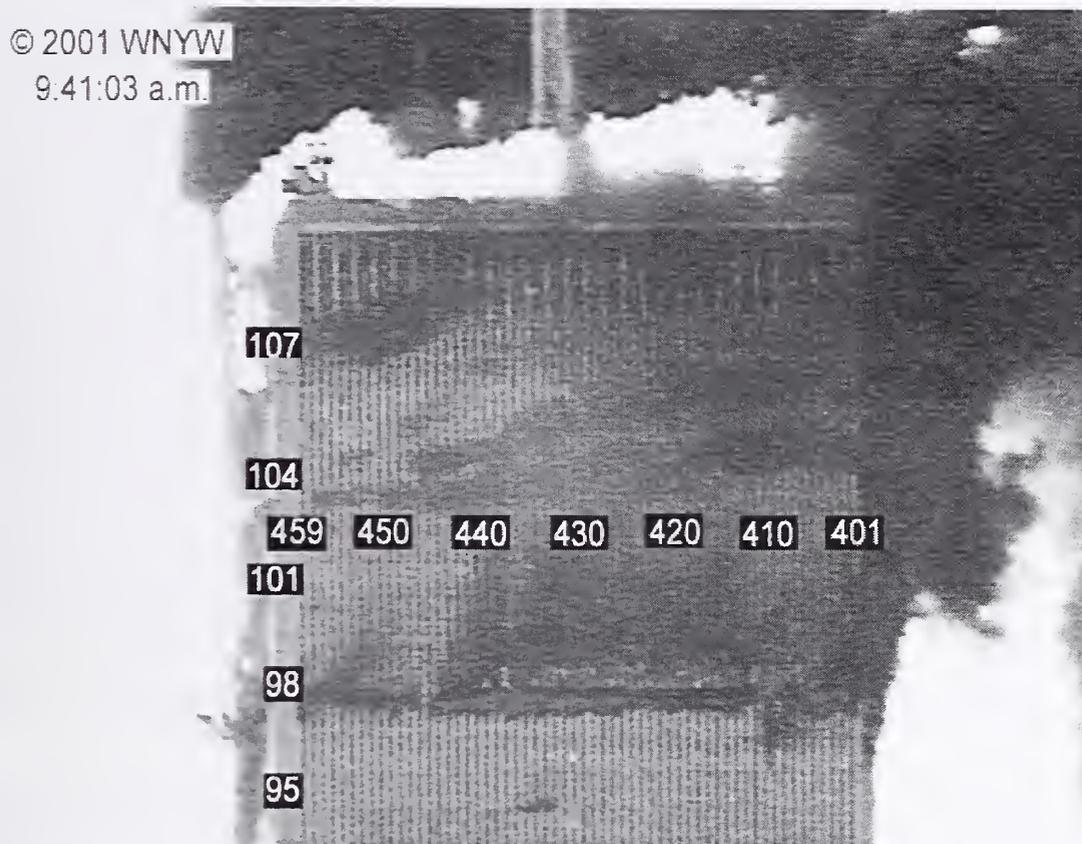
Fires are now visible near the center of the 94th floor just to the right of the black mark at the top of the columns covers, which starts at column 94-433, and very close to the north edge of the face. Flames are

also present on the 96th floor near the center of the face. This fire has apparently continued its movement to the north, since at 9:34:48 a.m. its northern edge appeared to be near window 96-426, and it can now be seen at least as far as window 96-433. While the flames are not completely visible in the frozen frame shown in Figure 8-68, by reviewing the video it is apparent that this low-intensity fire covers at least thirteen windows.

Figure 8-68. This image of the west face of WTC 1 is a frame captured from a video recorded by a news helicopter at 9:41:03 a.m. The image has been enhanced by adjusting the intensity range, and areas to the left and right of the tower are saturated. Column and floor numbers have been added.

The most dramatic change in the fire distribution is on the 98th floor. At the earlier time there was no indication of fire on the west side of this floor, while in Figure 8-68 flames can be seen over a length running from the south edge of the face to at least window 98-440. From the available imagery, it has proven difficult to determine precisely when this fire appeared, but a review of helicopter video suggests it occurred between 9:38:10 a.m. and 9:39:05 a.m. Given the low intensity of the fire, such apparent rapid fire spread is difficult to understand.

The development of the fire visible in Figure 8-68 on the 94th floor near window 94-430 was sudden. A video shot from a helicopter shows that it appeared at 9:39:08 a.m. The observations of falling people summarized in Appendix M also suggest that fire reached the area shortly after 9:35 a.m. At 9:38:37 a.m. a person was observed falling from this floor near the center of the face. During the next 97 s, at least six more people fell from the same vicinity. Appendix M lists the windows from which some of these people fell. The windows were either 94-435 or 94-437. There was an additional person who came from this

The floor plan layout for the 94th floor in Figure B-3 shows that there were a series of rooms located along the west face. It indicates that window 94-433 was in a room with walls located at columns 94-430 and 94-434, and windows 94-434 to 94-437 were in a second room with walls at columns 94-434 and 94-438. Recall that the glass in windows 94-434 to 94-437 was broken out shortly after 9:00 a.m. and that light smoke was later observed coming from these windows. This smoke flow explains the black band across the tops of the covers for columns 94-433 to 94-437, evident in Figure 8-68.

The other area of fire visible on the 94th floor at the north edge of the west face in Figure 8-68 also appeared abruptly. The video, shot from a helicopter, shows that fire first became visible in window 94-457 at 9:39:54 a.m. This window was located in the northwest corner room, with walls terminating at columns 94-106 and 94-454 (see Figure B-3). Recall that the first visual evidence for fire in this room from the north was at 9:39:51 a.m. The evidence suggests that windows opened on the north and west sides of the room nearly simultaneously, indicating that flashover occurred in the room at this time.

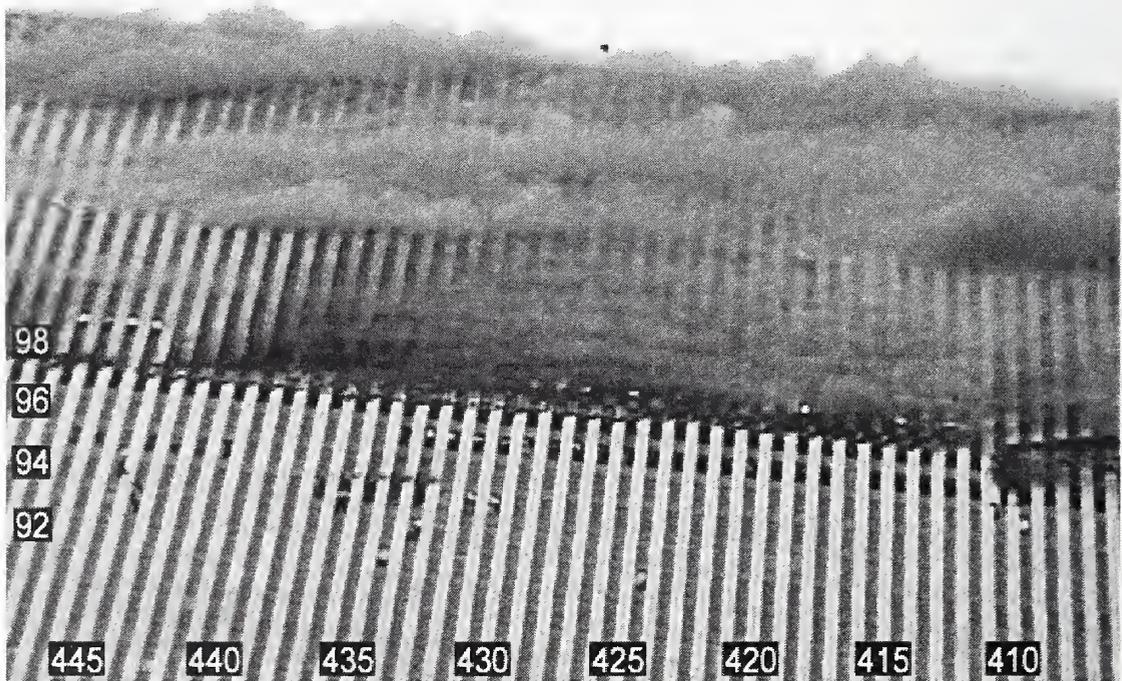
© 2001 WABC-TV
9:40:14 a.m.

There are no flames evident in the open windows across the entire extent of the 97th floor visible in Figure 8-70. The carets and smoke marks on the column covers near the tops of the windows on this floor contrast sharply with the appearance of the column covers next to the tops of the 96th floor windows.

Figure 8-70. This view of the west face of WTC 1 was captured from a video recorded at 9:40:14 a.m. It has been enhanced by adjusting the intensity levels, and some locations above the building are saturated. Column and floors numbers have been added.

The expanded view of Figure 8-70 shows that fire is visible on the 98th floor from roughly window 98-411 to window 98-439. Further to the north, the window glass appears to be intact. Bright fires are present at the tops of several of the open windows. Larger flames are also present in windows 98-428 and 98-439. Even so, compared to the intense burning observed on the other faces of the tower, these fires appear to be burning relatively gently at this time.

The smoke flows coming from some of the open windows above the 98th floor are quite heavy. At other open windows relatively little smoke is present. The four open windows on the 99th floor, windows 99-445 to 99-448, are an example of the latter behavior.
