**NIST NCSTAR 1-5A
Federal Building and Fire Safety Investigation of
the World Trade Center Disaster**

**Visual Evidence, Damage Estimates,
And Timeline Analysis**

Visual Evidence, Damage Estimates, and Timeline Analysis

September 2005

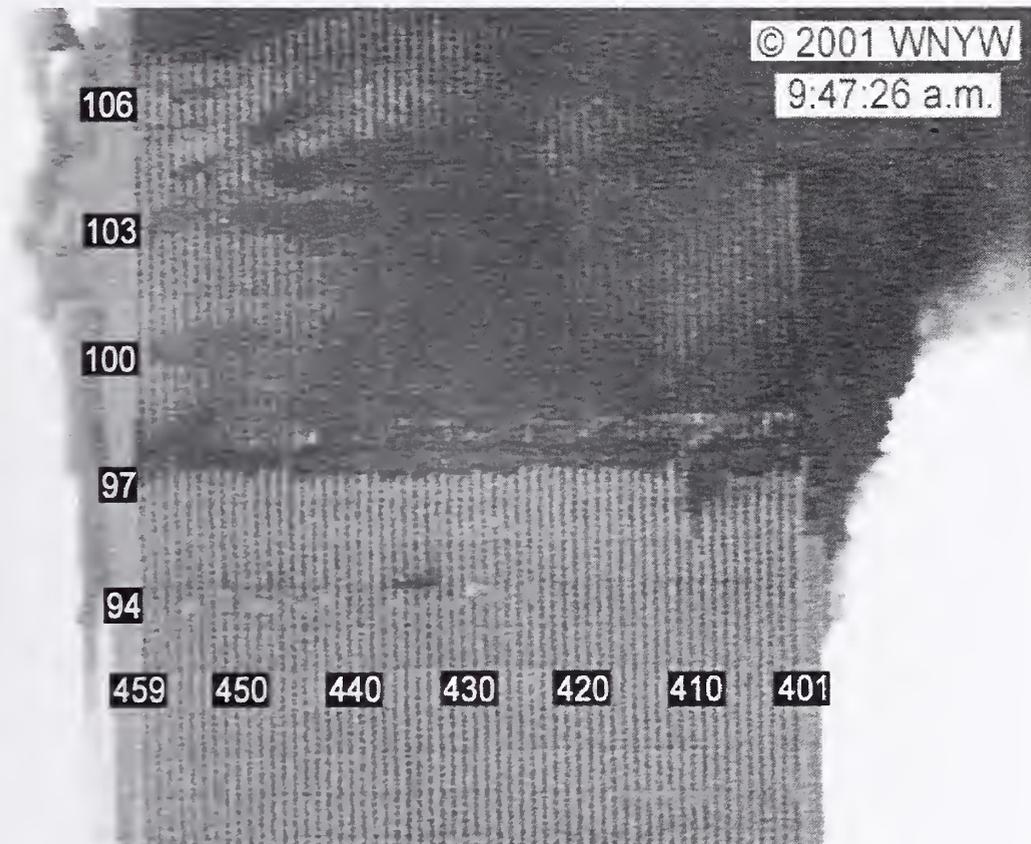
Another view of the west face taken from a video recorded from a news helicopter at 9:47:46 a.m. is shown in Figure 8-71. Since 9:41:03 a.m. (compare with Figure 8-68), the fires on the 94th floor have continued to spread; now appearing at several different locations ranging from the north edge of the face to window 94-425. By comparing the fire locations with the floor plan layout shown in Figure B-3, it is discovered that fires have entered seven of the eight rooms located along the west face, running from the north edge to as far south as column 94-425. The one exception is the room with walls at columns 94-438 and 94-442. Even though the fire area is extensive, the flames are not very vigorous. There is no apparent external flaming, and no smoke is visible coming from the windows.

Figure 8-71. This image of the west face of WTC 1 is a frame captured from a video recorded by a news helicopter at 9:47:26 a.m. The image has been enhanced by adjusting the intensity range, and areas to the left and right of the tower are saturated. Column and floor numbers have been added.

Small fires are still evident on the 96th floor. In the video the flames appear intermittently over a range of windows that reaches as far north as window 96-441. As at the earlier time, there is no smoke or flame coming from the windows.

The fire on the 98th floor has continued to spread north. It now extends from the south edge continuously to at least window 98-444. From this distance, the fire still appears to be located away from the west wall. There is little indication of fire or smoke coming from the windows on this floor.

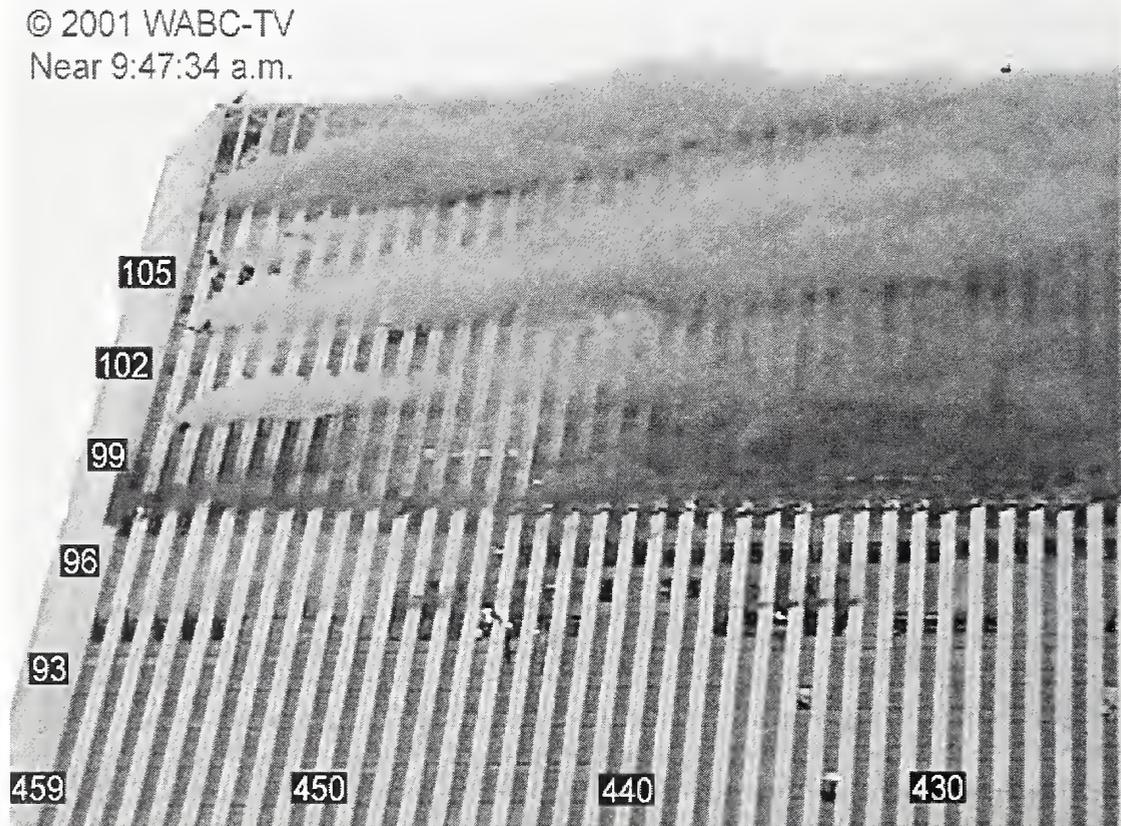
A much closer view of the north side of the west face recorded at roughly the same time as Figure 8-71 is shown in Figure 8-72. Even though this image is assigned a time of 9:47:34 a.m., there is an associated uncertainty of 30 s. The closer image provides confirmation of many of the conclusions drawn from Figure 8-71. On the 94th floor fire is visible at many of the windows, and a number are open from window 94-424 to window 94-459. The glass panes between windows 94-438 and 94-442 are indeed in place, with no indication of fire in the room located between these columns (see Figure B-3). The five windows along the west face in the northeast corner room are open. The adjacent room to the south has walls at columns 94-450 and 94-454 (Figure B-3). The fire is apparently just growing in this room since flames are visible, but three of the four windows are in place. Flames are visible, and most of the windows are missing for the next two rooms to the south. Window 94-424 is open, but the panes are still in place in nearby windows. This indicates that the observed fire has moved one room further south since 9:41:03 a.m.

Figure 8-72. This view of the west face of WTC 1 was captured from a video recorded at 9:47:34 a.m. There is a 30 s uncertainty in the assigned time. The image has been enhanced by adjusting the intensity levels, and some locations above the building are saturated. Column and floors numbers have been added.

On the 95th floor, two additional windows (95-438 and 95-439) have opened since 9:40:14 a.m. Since there is still no indication of fire in this area, it is possible that people have broken out the glass. Very

little fire is visible on the 96th floor, but there is an area of flame at the top of window 96-447. Windows to the north of this location are still in place. The northern advance of the fire on the 98th floor has reached roughly the same location. Fire is visible at the top of window 98-444, and window 98-445 appears to be open. A deep red glow on this floor from the windows that are open indicates that burning areas continue to be located well away from the windows.

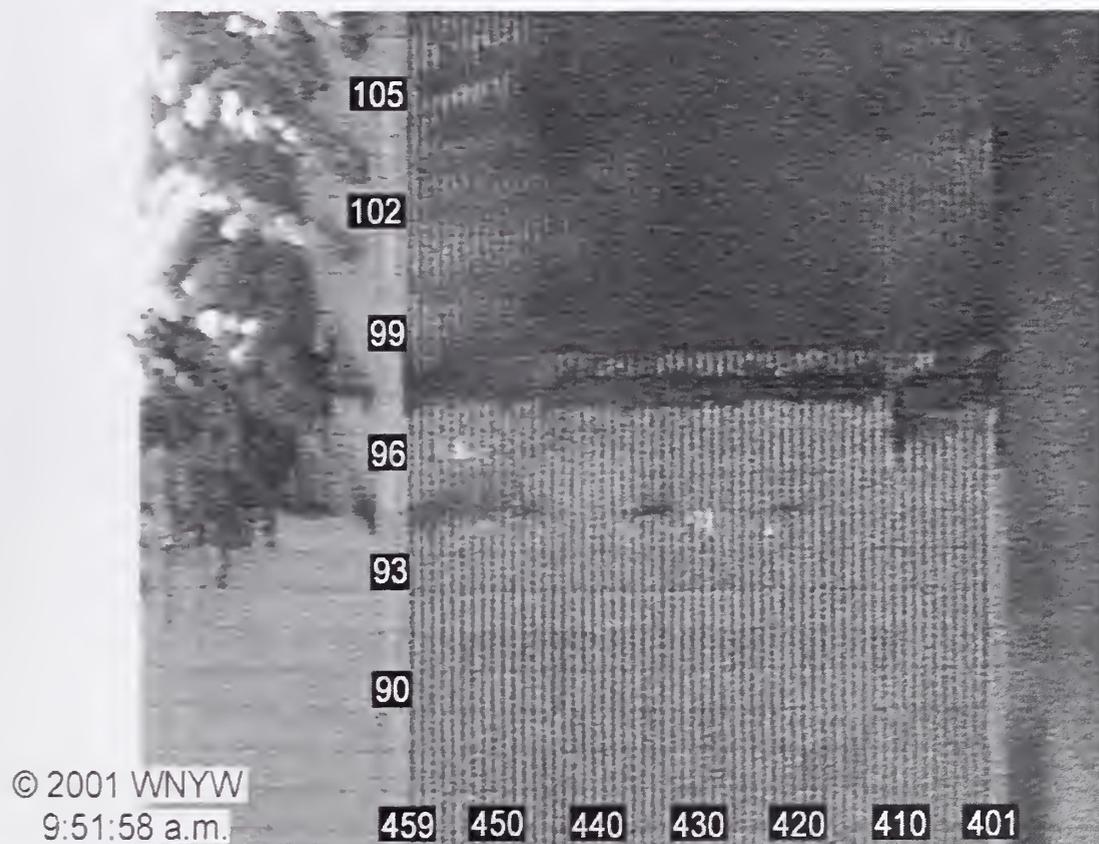
Another frame taken from a video shot from a helicopter at 9:51:58 a.m. is shown in Figure 8-73. Fire development on the west face has continued. The largest differences as compared to Figure 8-71, which was recorded at 9:47:26 a.m., are the appearance of fire at multiple windows on the 96th floor near the north edge of the west face and the spread of the fire toward the south on the 94th floor. It has not been possible to determine exactly when the fire at the north edge of the 96th floor appeared, but it was between 9:50:09 a.m. and 9:51:19 a.m. The flames are visible in windows 96-453 to 96-455. The floor plan layout in Figure B-5 indicates that these windows were inside a room with internal walls at columns 96-452 and 96-456. Fire is not yet visible from windows in the room on the northeast corner with walls at columns 96-456 and 96-108. On the 94th floor flames are now visible in windows 94-423 and 94-424. This indicates that a fire was growing within the room with walls located at columns 94-421 and 94-425. (see Figure B-3) The appearance of the fire on the 98th floor did not change dramatically over the four and a half minute period between the images.

Figure 8-73. This image of the north and west faces of WTC 1 is a frame captured from a video recorded by a news helicopter at 9:51:58 a.m. The image has been enhanced by adjusting the intensity range, and areas to the left of the tower are saturated. Column and floor numbers have been added.

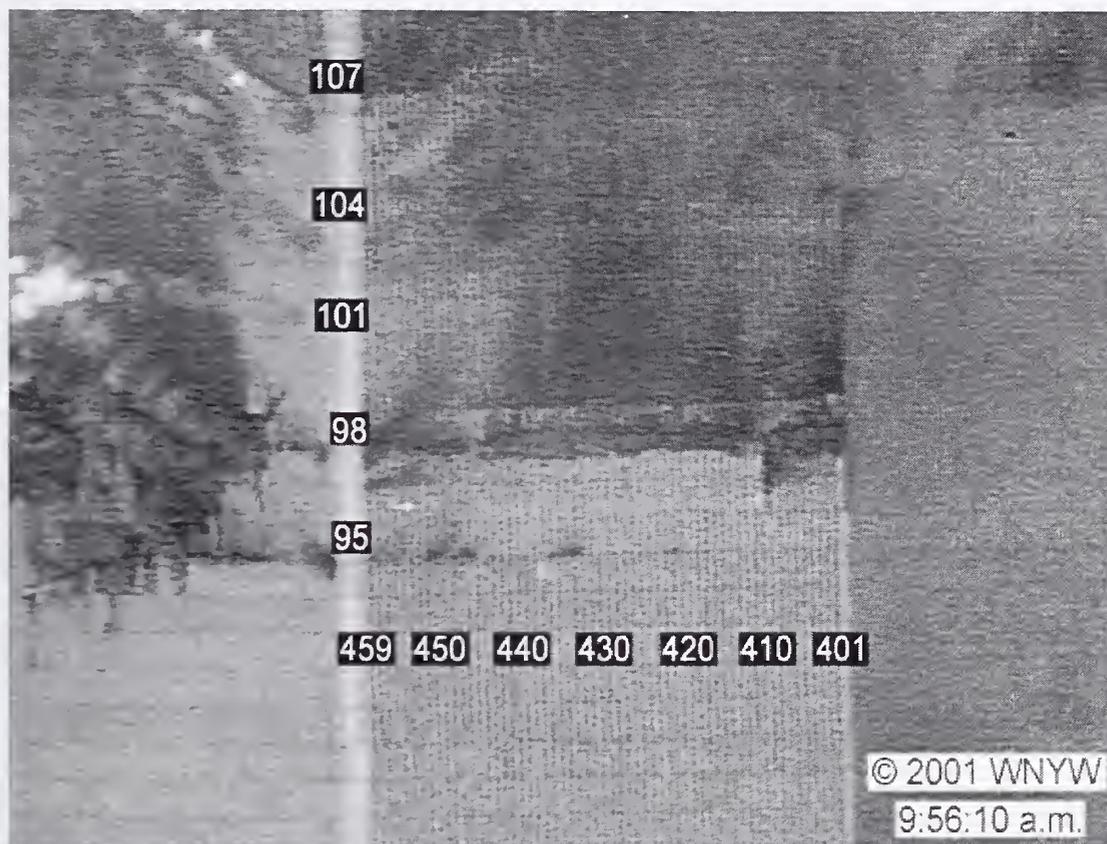
The appearance of the west face at 9:56:10 a.m. is shown in Figure 8-74. The fire distribution has not changed dramatically since 9:51:58 a.m. The amount of smoke coming from the fire floors remains small, and much of the face is visible. For the purposes of later discussion note that while significant smoke is coming from open windows on the south side of the 104th floor, it does not appear to be heavier than from other open windows near the top of the tower. There are no visible indications of a fire on this floor.

Figure 8-74. This image of the north and west faces of WTC 1 is a frame captured from a video recorded by a news helicopter at 9:56:10 a.m. The image has been enhanced by adjusting the intensity range. WTC 2 appears in the background to the right. Column and floor numbers have been added to WTC 1.

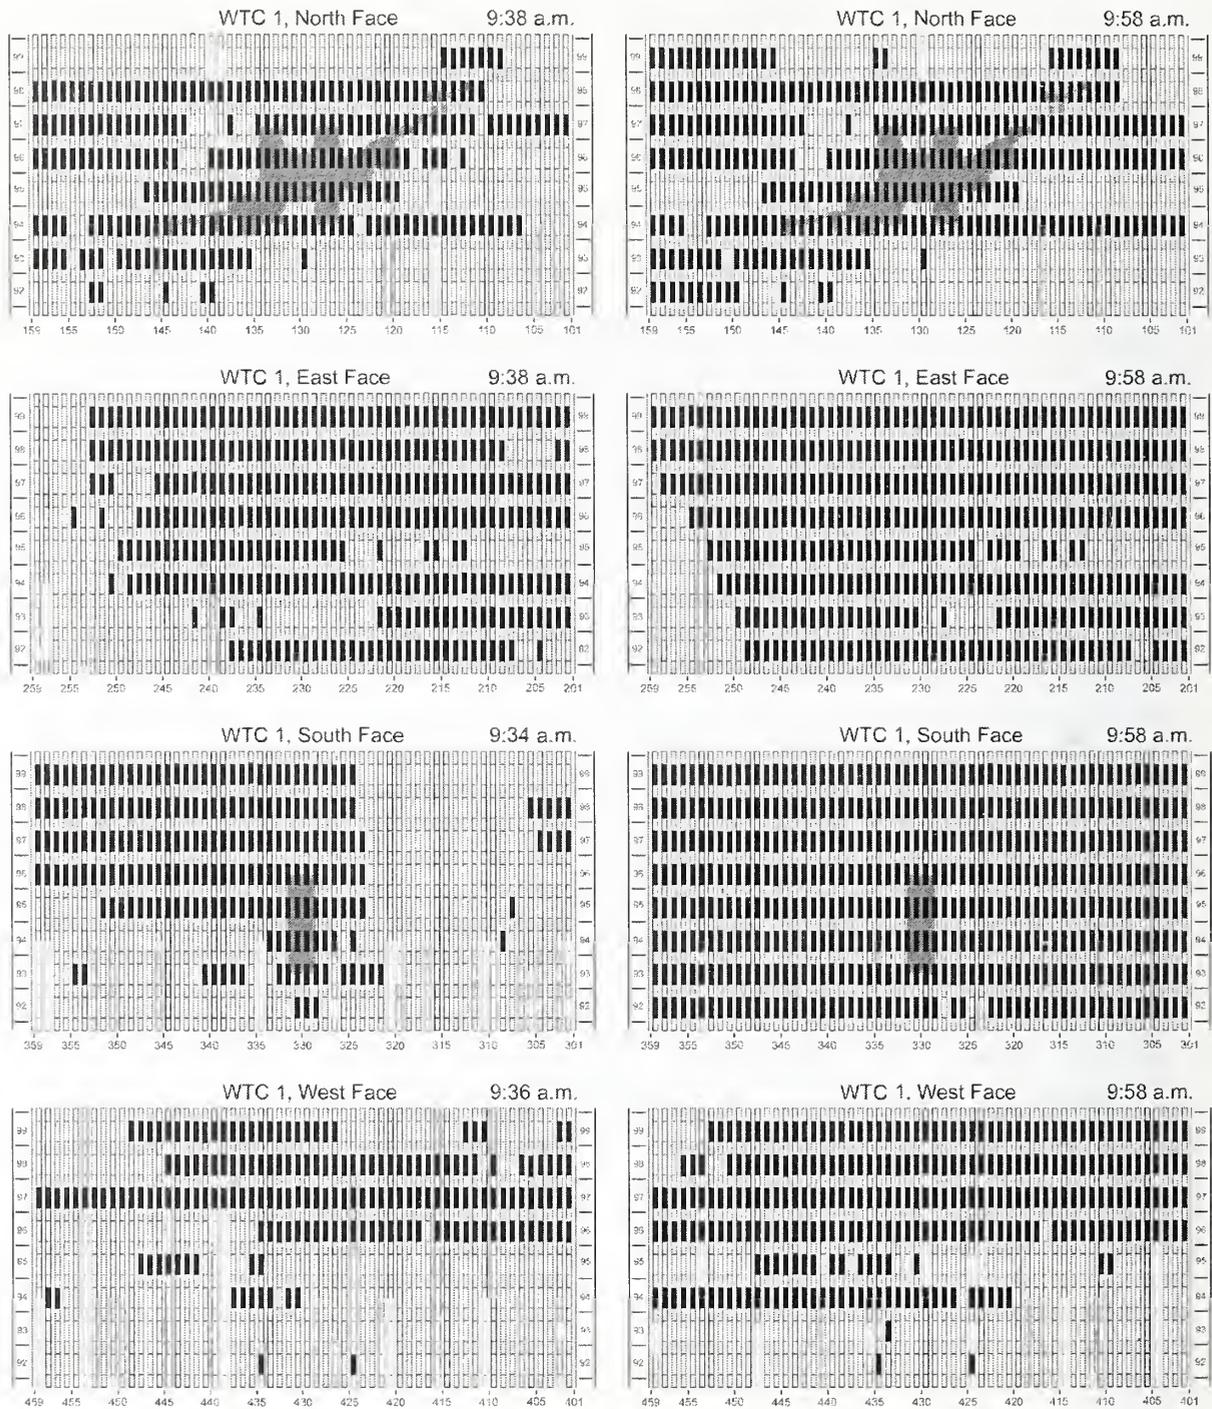
Observed window conditions for the four tower faces at the beginning and end of the period are compared in Figure 8-75. The windows that opened during the period, which generally implies the presence of an active fire, are consistent with the fire-spread observations discussed above. On the north face, windows opened along a long length of the 98th floor and near the eastern edge of the 92nd floor. The growth of the large fire on the east side of the 98th floor is reflected in the large increase in open windows at the later time. On the other floors the fires on the east face appear to be moving relatively deliberately toward the south, but note the large increase in the number of open windows on the 92nd floor. Windows also opened on the east side of the 92nd floor near the north edge. The maps for the south face are consistent with observations that major fire growth during the period was on the 95th and 98th floors. There was evidence of a small fire on the east side of the south face on the 94th floor, but in general, the fires on the south face still have not moved in this direction much beyond the center of the face. Note that most of the windows on the eastern side of the face at the later time are marked as not visible. This is because the imagery available does not allow the conditions of these windows to be assessed. The imagery does indicate that there was no significant smoke or fire coming from windows on the fire floors above the 94th floor. By far, the largest changes in window condition during the period were on the west face. Large numbers of windows have been opened on the 94th, 96th, and 98th floors. These changes are even more remarkable when the nature of the fires, which generally appeared to be gently burning, is recalled.

Figure 8-75. Maps for the 92nd through the 99th floors compare missing window glass for the four faces of WTC 1 at two times, around 9:35 a.m. and at 9:58 a.m. The color coding used for the maps is indicated in Figure 5-1.

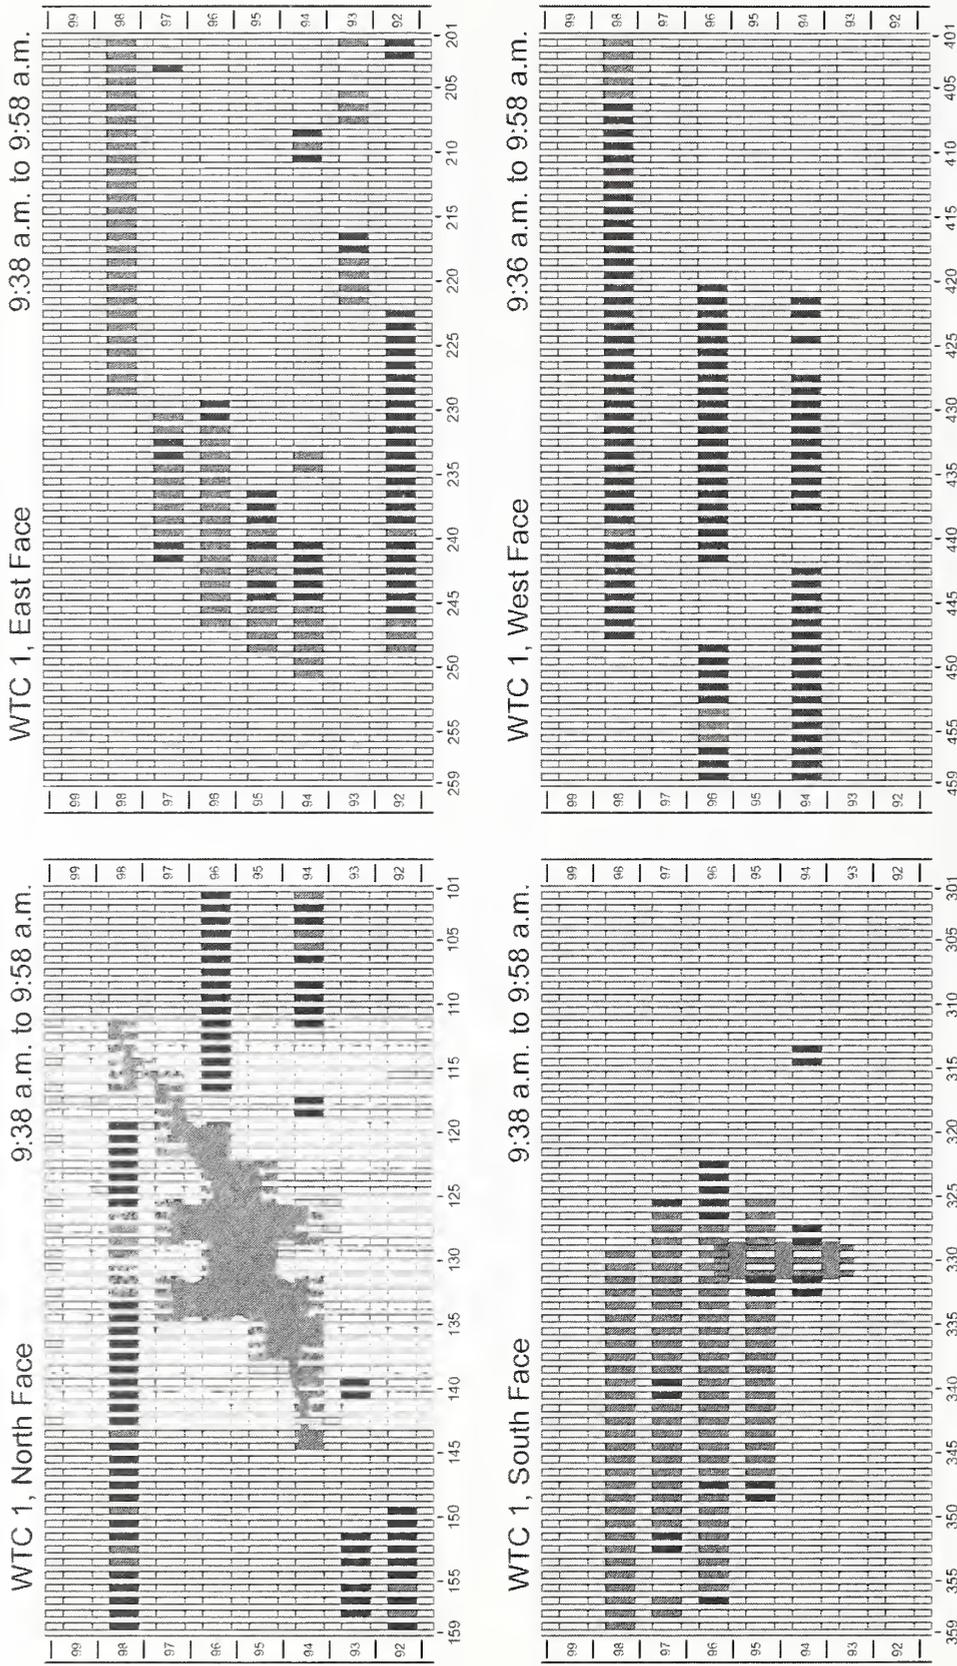
Maps of integrated fire behavior for the four tower faces for the period from 9:35 a.m. to 9:59 a.m. are shown in Figure 8-76. These maps can be compared with the corresponding versions in Figure 8-51 for 9:19 a.m. to 9:35 a.m. This comparison highlights the growth of fires on the north face across much of the 98th floor, on the 96th floor to the west of aircraft impact cavity, and on the 92nd floor near the east edge of the face. Other areas of fire that were identified during the earlier time period were no longer visible during the current period.

The most distinctive change in the window condition and integrated fire maps between 9:35 a.m. and 9:59 a.m. was the wide-spread appearance of fire on the 98th floor. By roughly twenty minutes after a growing fire first became evident on the north side of the 98th floor, fire was visible on this floor in two long bands. One of these bands started near the center of the south face, ran to the southwest corner and extended north on the west face to at least window 98-444. The second band began near window 98-119 on the north face and ran around the northeast corner to the vicinity of window 98-223 on the east face. The observed fire behavior of these rapidly developing fires varied from face to face. On the east and south faces very intense flames were observed extending large distances from open windows, while on the west and north sides, the fires appeared much less intense and to be burning at interior locations removed from the outer walls. These observations are reflected in the integrated fire distribution maps shown in Figure 8-76.

Figure 8-76. Maps of integrated fire observations between 9:36 a.m. and 9:59 a.m. are shown for the four faces of WTC 1. Colors represent the highest intensity fire observed in a window using the color scale defined in Figure 5-1.

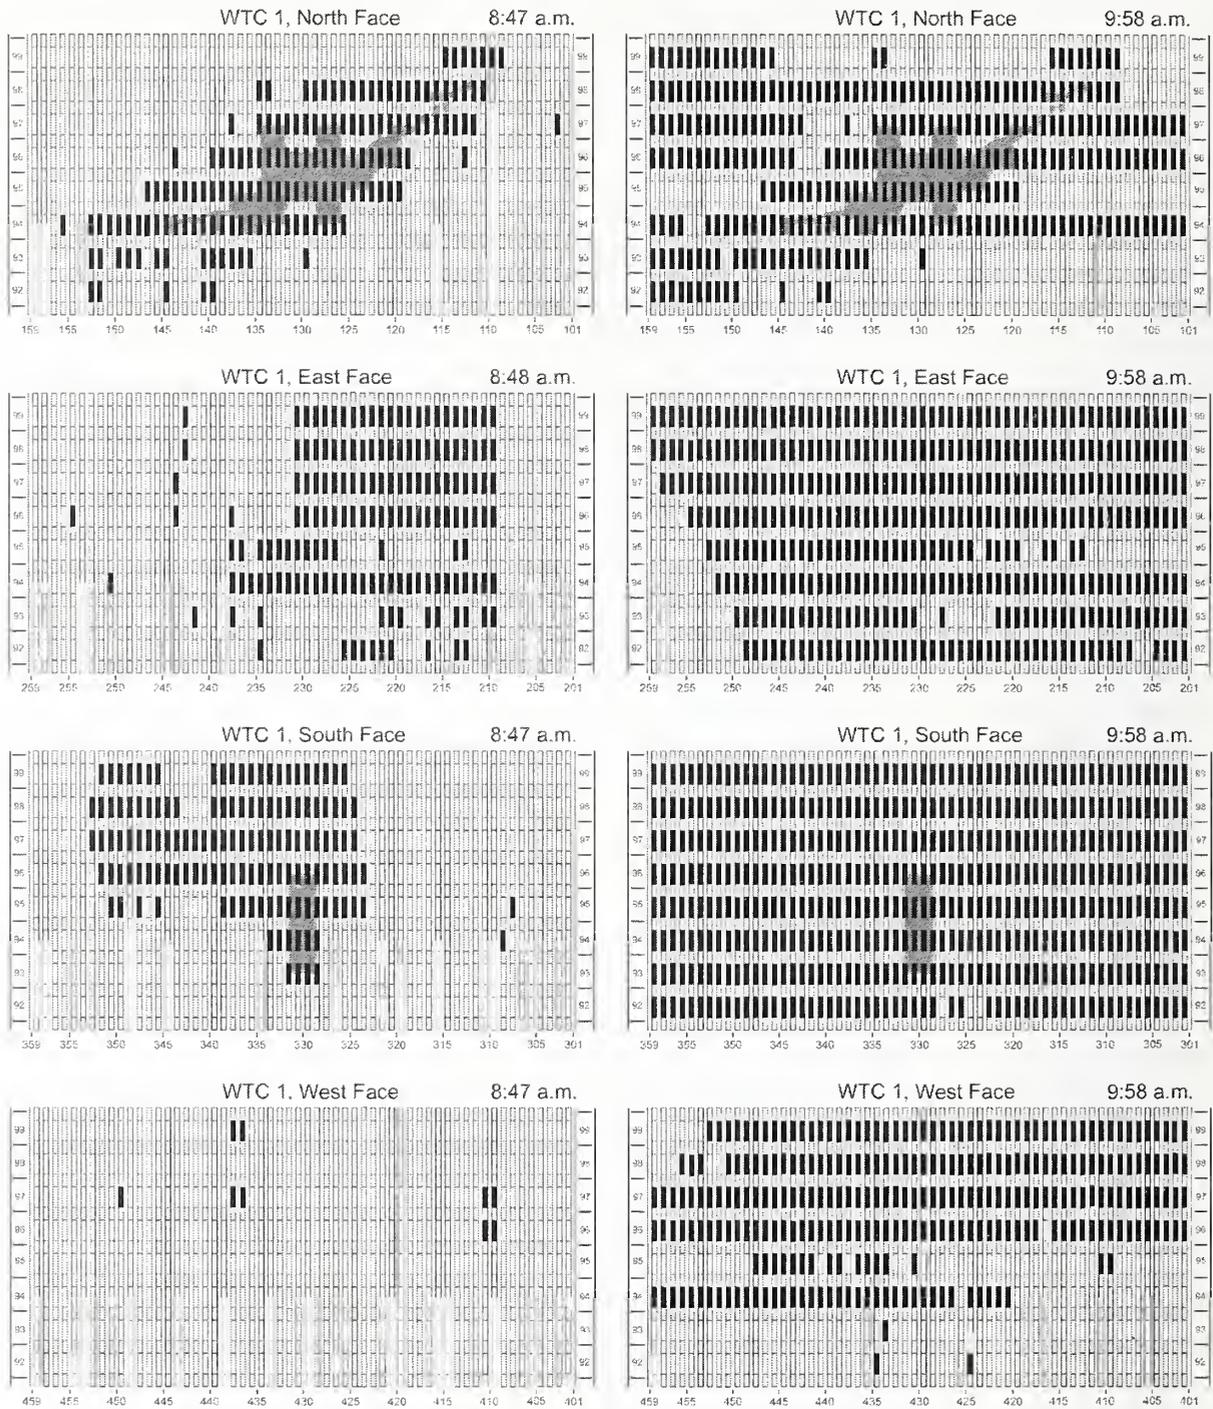
After WTC 2 fell at 9:58:59 a.m., the number of detailed views of WTC 1 decreased markedly. As a result, the time line and façade maps become less certain. Therefore, this is an appropriate point to quantitatively compare the changes in window condition that took place between the time of the aircraft impact on WTC 1 and the collapse of WTC 2. Façade maps for these two times are compared for the four faces of WTC 1 in Figure 8-77. Only a quick glance is necessary to recognize how extensive the fire spread and growth has been on the 92nd through 98th floors.

Figure 8-77. Maps for the 92nd through the 99th floors compare missing window glass for the four faces of WTC 1 at two times, immediately following the aircraft impact on WTC 1 at 8:46:30 a.m. and just prior to the collapse of WTC 2 at 9:58:59 a.m. The color coding used for the maps is indicated in Figure 5-1.

The changes in the number of open windows on the individual faces of WTC 1 are consistent with the observed fire behaviors. The largest increases were on the east and west faces. The façade maps in Figure 8–77 show how extensive the fire spread was on these faces during the period under consideration. There was also considerable fire spread observed on the north face, but the percentage increase in the number of open windows is smaller due to the large number of windows that were opened when the aircraft struck. The smallest increase in total open windows was for the south face. This reflects the fact that the fires did not migrate substantially into areas on the eastern side of this face during the 1 hr and 13 min period.

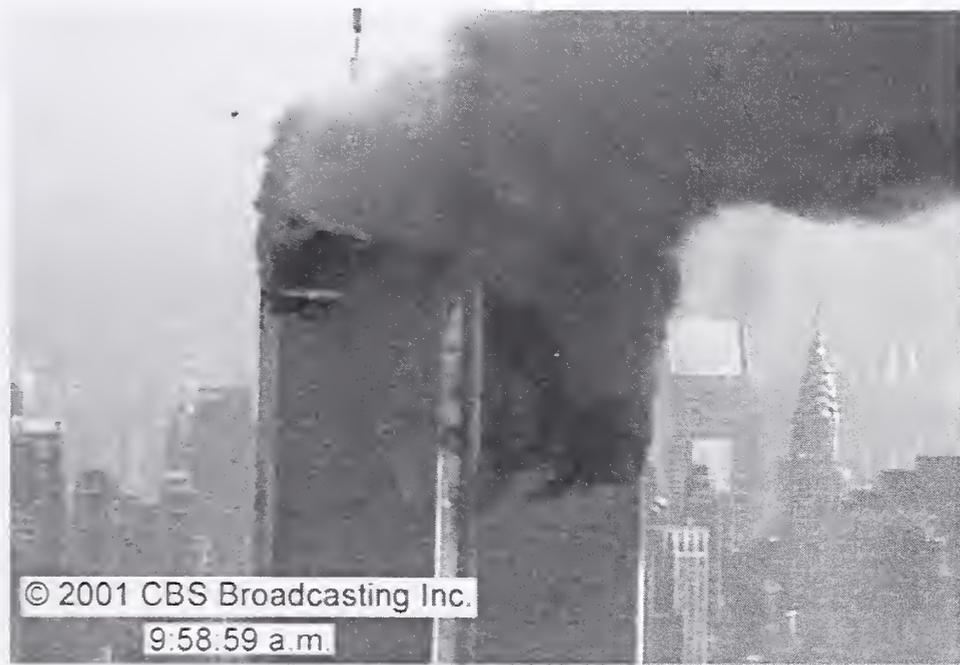
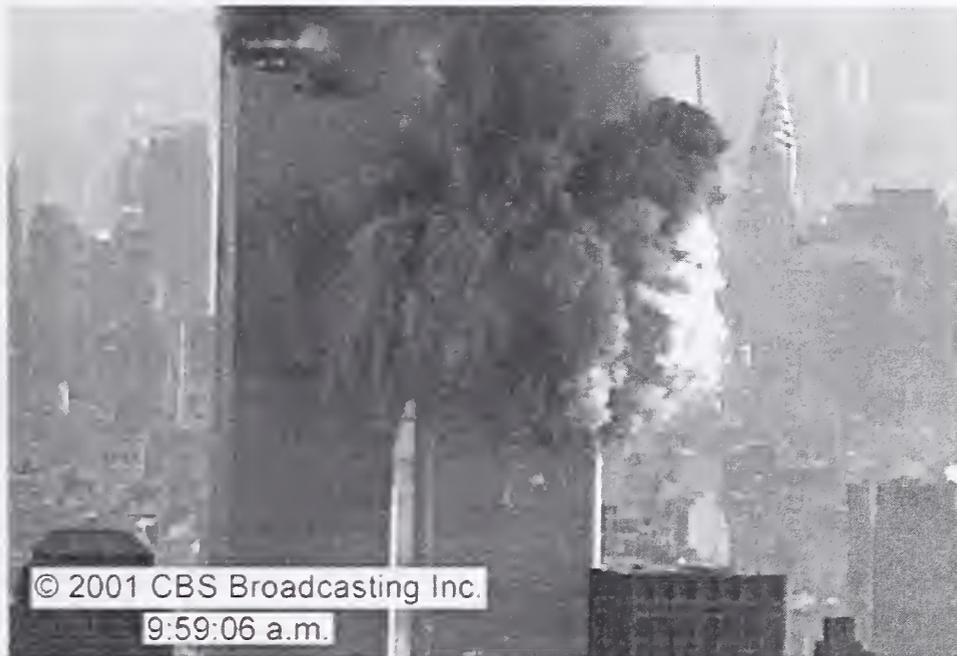
At 9:58:59 a.m. WTC 2 began to collapse, and roughly ten seconds later debris reached the ground. Very shortly after the collapse began, fire and smoke were pushed out of the south face of WTC 1. Figure 8–78 contains two frames taken from a video showing the south faces of the towers. The first frame was recorded just as WTC 2 began to collapse, and the second was shot seven seconds later. In both frames the fire burning on the 98th floor of WTC 1 is very distinct. At the earlier time there does not appear to be external flames, but in the second frame long flames extend from near the center of the face. Review of the video indicates that these flames were pushed out of WTC 1 starting four seconds after collapse initiation. Closer inspection shows that an area of flame is visible on the western side of the 96th floor at the later time that was not evident seven seconds earlier. It is significant that flames do not appear elsewhere on the face at the later time, perhaps indicating that large flames are only present near the periphery of the face at these locations.

Figure 8-78. Two frames taken from a video shot from a news helicopter show the south face of WTC 1 just as WTC 2 starts to collapse at 9:58:59 a.m. and 7 seconds later. WTC 1 and WTC 2 are to the left and right, respectively. Images have been enhanced by adjusting the intensity levels.

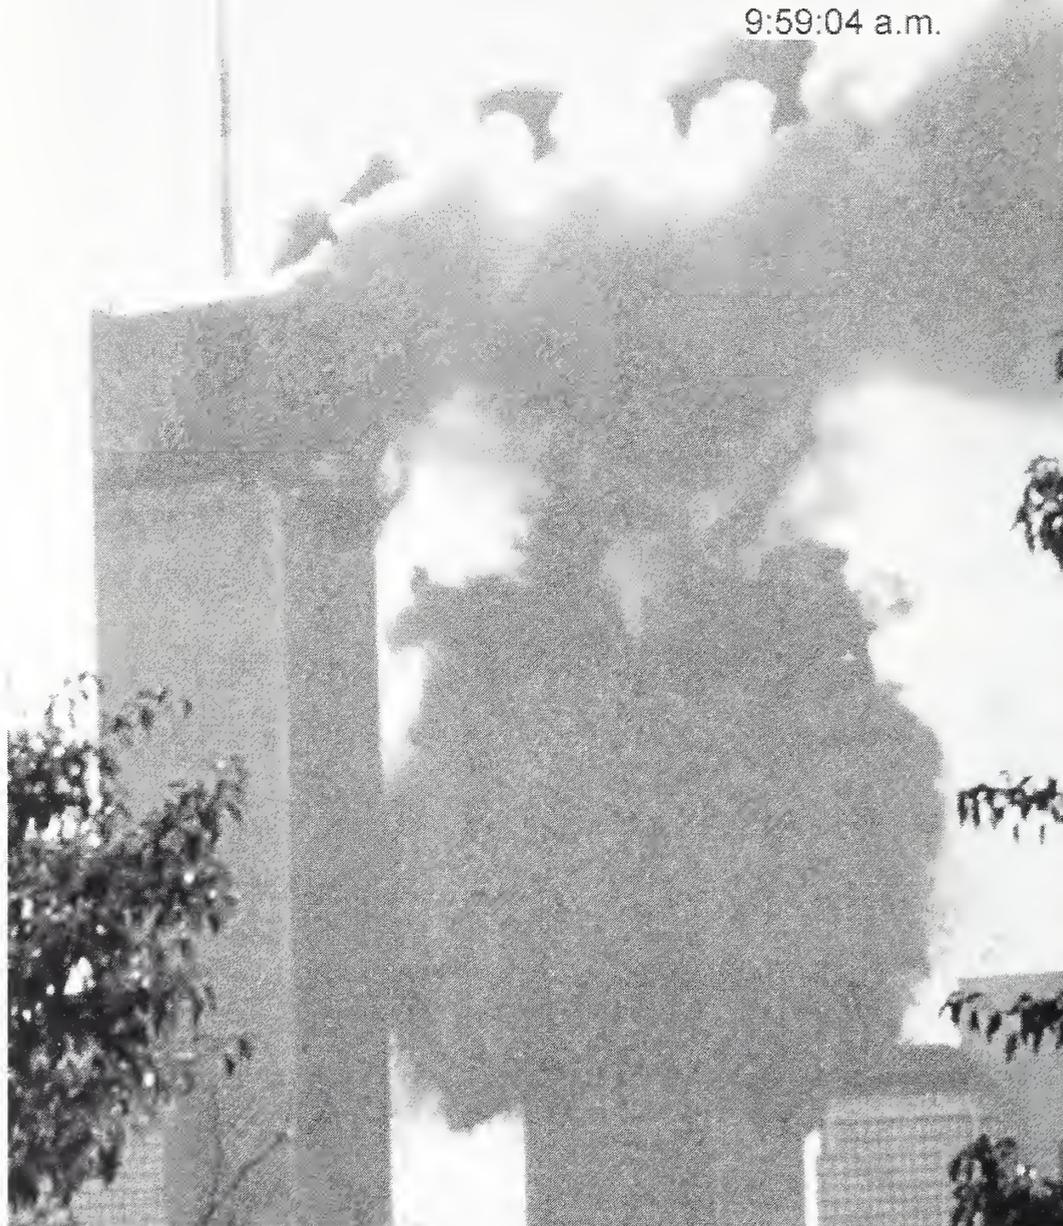
Figure 8-79. This cropped photograph was shot from the southwest and shows WTC 1 and the collapsing WTC 2 at 9:59:04 a.m. The image was enhanced by adjusting the intensity levels, and some bright areas are saturated.

Figure 8-79 includes a photograph that was shot at 9:59:04 a.m. and shows the flames coming out of the 98th floor windows while WTC 2 collapses nearby. Flames have also been pushed out of open windows on the 96th floor near the western edge of the south face. Fires are also visible on the west face of WTC 1 on the 94th, 96th, and 98th floors, but flames are not visible outside of the windows. In the photo it appears as if debris from WTC 2 is either striking WTC 1 or just passing by on the east side.

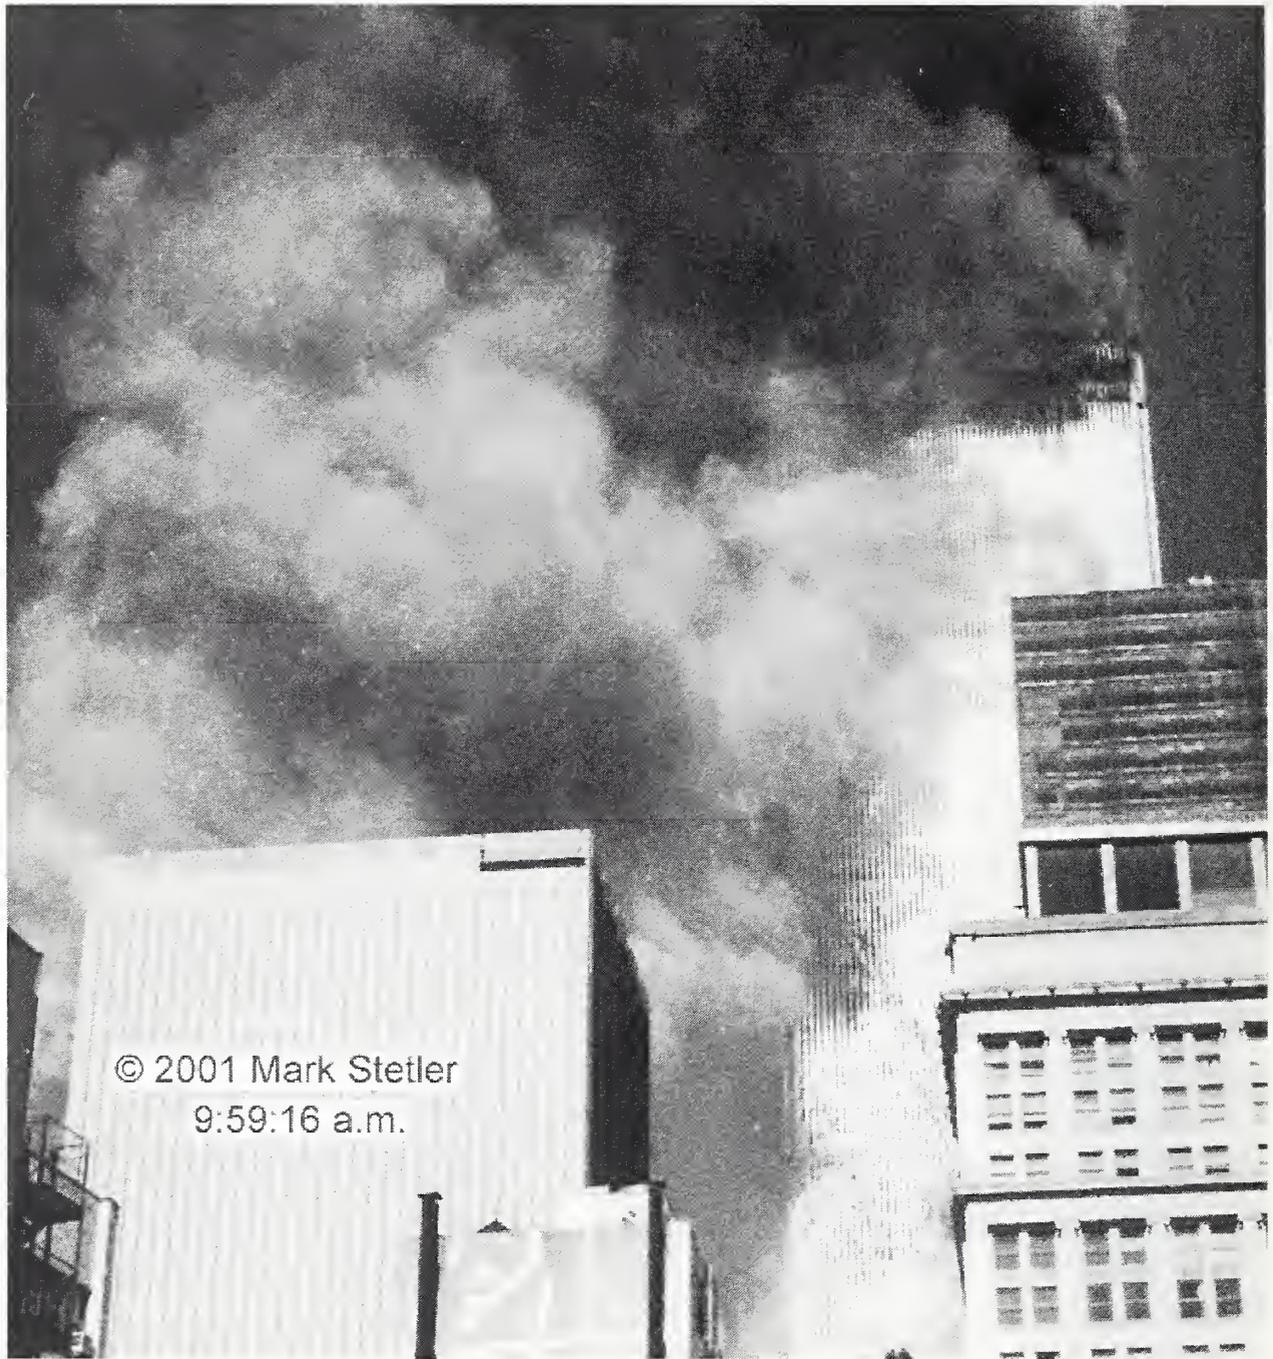
Videos shot from the east show that debris from WTC 2 did indeed pass in an arc across the east face of WTC 1. The damage created by this debris to the façade of WTC 1 can be seen in Figure 8-80 near the bottom of the photograph. This damage was only visible for a short period before dust rose upward from below and hid the area. The highest marks on the building are just below the mechanical equipment room on the 75th and 76th floors. The damage appears relatively superficial, and it is considered unlikely that it affected the subsequent fire behavior. Videos and eyewitness accounts indicate that large amounts of dust and some debris entered the lower floors of WTC 1 during the collapse of WTC 2. It is not known if damage at these lower locations could influence the fires near the top of the tower, but it seems unlikely.

Figure 8-80. This cropped photograph shows the east face of WTC 1 at 9:59:16 a.m., i.e., 17 s after WTC 2 began to collapse.

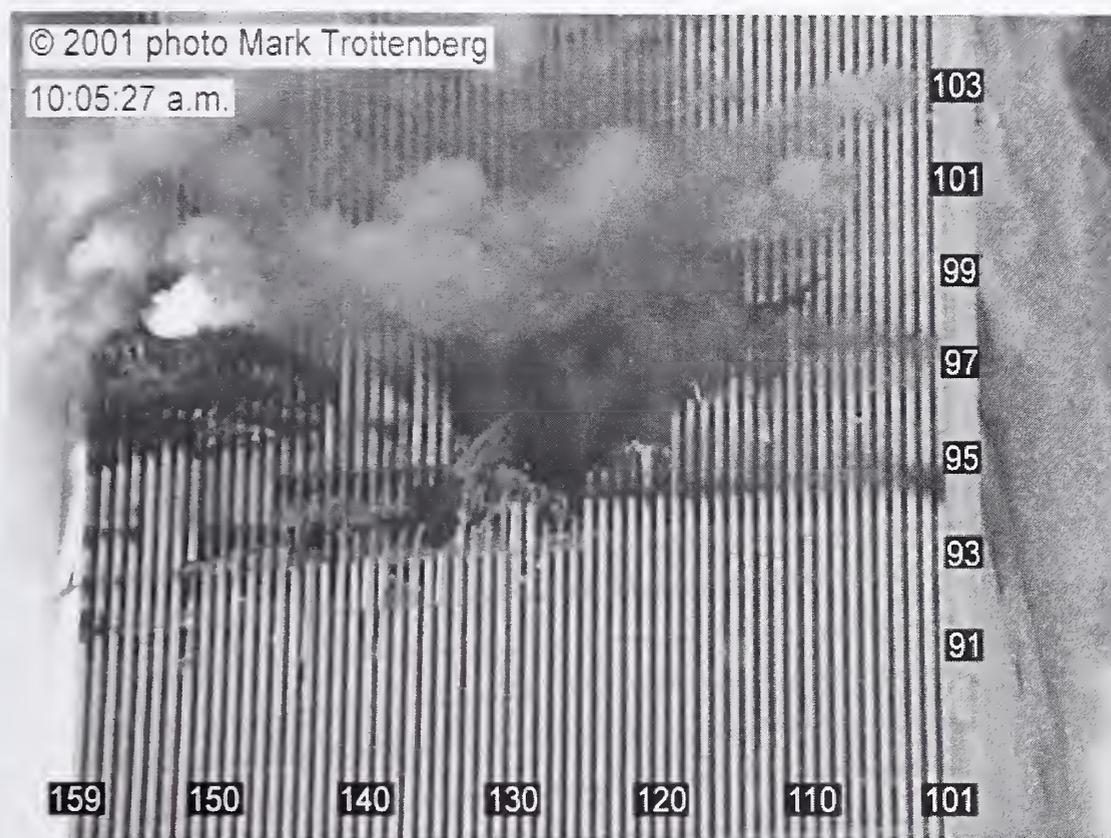
The most complete information during the current period is available for the north face of WTC 1. A view of this face at 10:05:27 a.m. is shown in Figure 8-81, which is a frame captured from a video. Remarkably little fire is visible in the image. Small flames are present near windows 92-146, 96-106, and 98-152. More extensive fires were evident at each of these locations at 9:57:59 a.m. (see Figure 8-55). Apparently, these fires had died down in the intervening seven and a half minutes.

Figure 8-81. This view of the north face of WTC 1 was captured from a video recorded at 10:05:27 a.m. The image has been enhanced by adjusting the intensity levels. Column and floor numbers have been added.

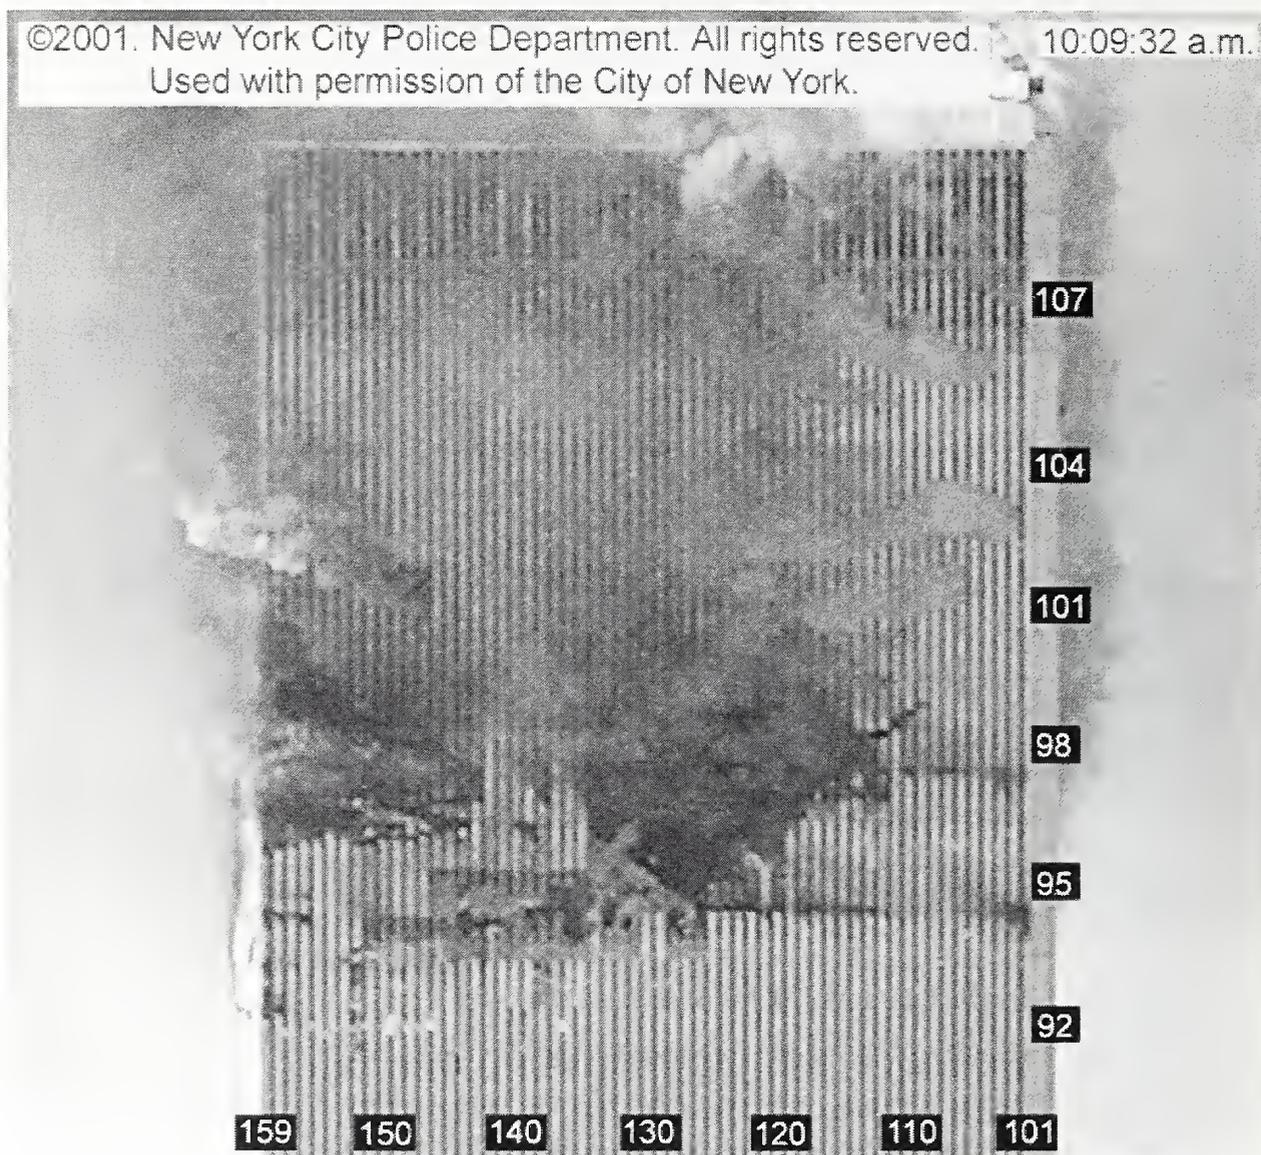
The photograph shown in Figure 8-82 was shot from a helicopter looking down on the north face of WTC 1 at 10:09:32 a.m. Considerably more flame is visible than could be seen in Figure 8-81. The difference is due to the angles from which the images were taken. The video frame shown in Figure 8-81 was taken from the ground a few blocks away from the WTC site, while the photograph in Figure 8-82 was shot from a much greater distance looking down into the windows. In effect, the latter photograph is looking much deeper into the building. On the 92nd floor a length of flames is evident extending from the eastern edge of the tower to window 92-146. At 9:57:59 a.m. flames were only visible as far as window 92-149. Windows further to the west were still intact. The fire has moved into the room that has walls terminating at columns 92-146 and 92-149 (see Figure B-1).

Low intensity fires are also visible in Figure 8–82 on the west sides of the 94th and 96th floors and over much of the eastern half of the 98th floor. These are locations where much larger fires were present at earlier times, and these fires are likely the remnants. They were not visible from the ground around this time because they were low intensity and were burning near the floors, where they were hidden from view.

In Figure 8–82 there is no evidence of fire on the north face near the west edge of the 98th floor. At 10:10:15 a.m. a burst of heavy smoke was released from window 98-105, and less than two seconds later smoke came from window 98-102. A series of photographs taken around this time indicates that fire appeared in window 98-102 between 10:10:19 a.m. and 10:10:20 a.m. A photograph recorded at 10:10:55 a.m. showed flames were present in windows 98-101 to 98-108 and that flames were coming from windows on the adjacent west face.

Figure 8-82. This cropped photograph was shot from a helicopter looking down on the north face of WTC 1 at 10:09:32 a.m. The intensity levels have been adjusted and column and floor numbers have been added.

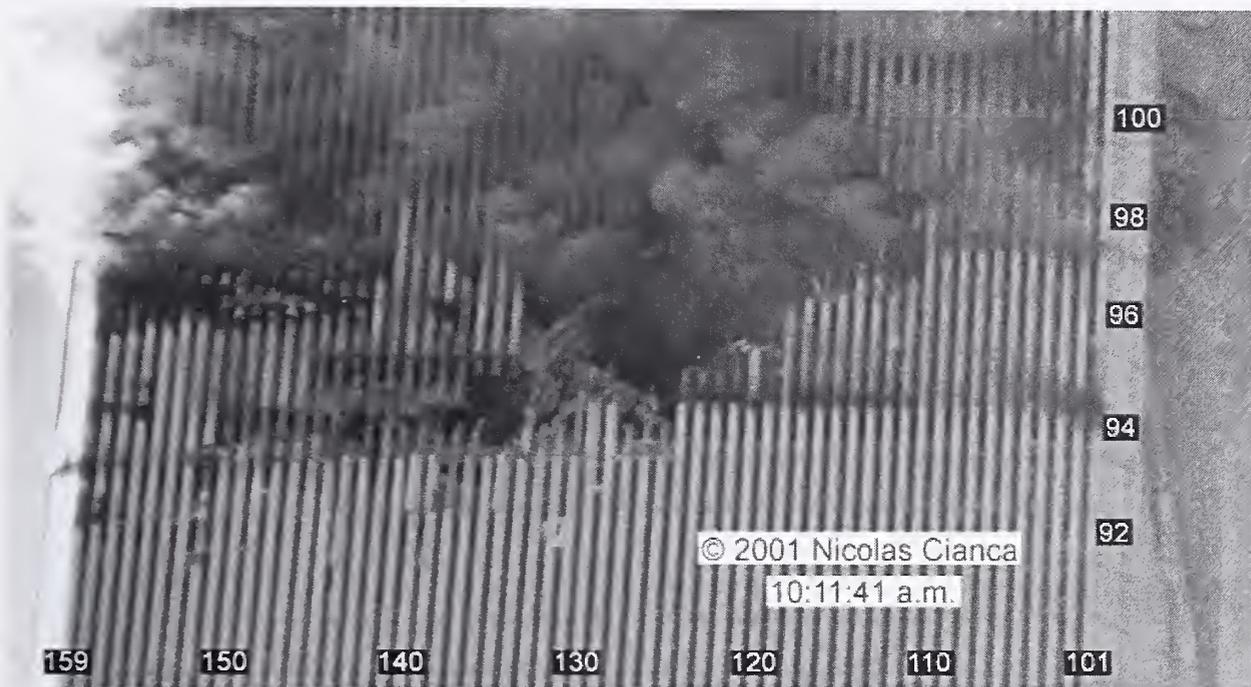
Figure 8-83 shows the north face at 10:11:41 a.m. The fire at the western edge of the 98th floor is visible in windows 98-101 to 98-110. On the 92nd floor there are bright flames present in windows 92-131 and 92-132. These two windows are on the west side of the room on this floor that has walls ending at columns 92-132 and 92-138 (see Figure B-1). The windows to the west of this point appear to still have glass in place. There appear to be some small fires on the east side of the 92nd floor, but flames are not observed elsewhere from this vantage point.

Figure 8-83. This photograph shows the north face of WTC 1 at 10:11:41 a.m. The original image has been cropped, rotated, and adjusted for intensity levels. Column and floor numbers have been added
