**NIST NCSTAR 1-5A
Federal Building and Fire Safety Investigation of
the World Trade Center Disaster**

**Visual Evidence, Damage Estimates,
And Timeline Analysis**

Visual Evidence, Damage Estimates, and Timeline Analysis

September 2005

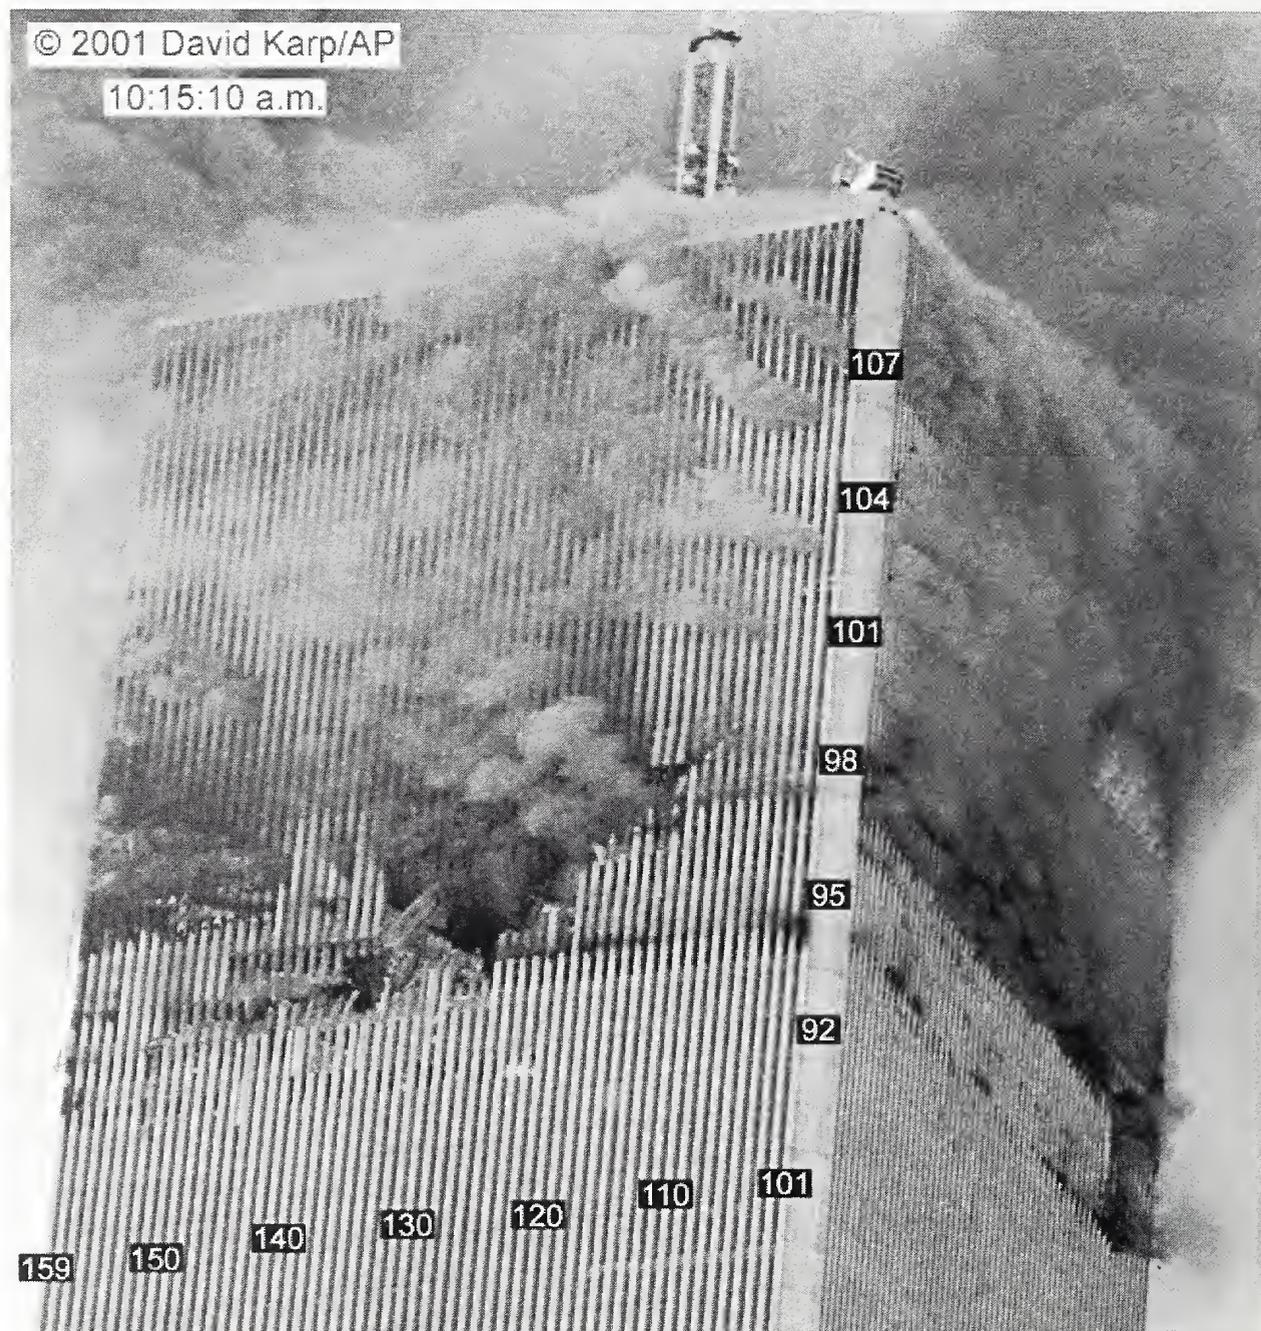
A view of WTC 1 shot from the northwest at 10:15:10 a.m. is shown in Figure 8–84. The fire on the north face of the 92nd floor has grown and moved toward the west. Flames are now visible as far west as window 92-121. As seen in Figure B-1, there was a large open area on the 92nd floor that ran between walls that terminated at columns 92-105 and 92-132. A fire is now burning on the east side of this open area, having apparently appeared in the room around 10:11:14 a.m. (see Figure 8–83). At the time the photograph in Figure 8–84 was taken, the glass for windows to the west of column 92-121 still appeared to be in place. It is interesting that even though a fire was growing in the area, there was no smoke coming from the open windows. This must be another case where the smoke was venting elsewhere.

Figure 8-84. This photograph of WTC 1 shows the north and west faces of WTC 1 at 10:15:10 a.m. The image has been cropped and rotated, and the intensity levels have been adjusted. Column and floor numbers have been added.

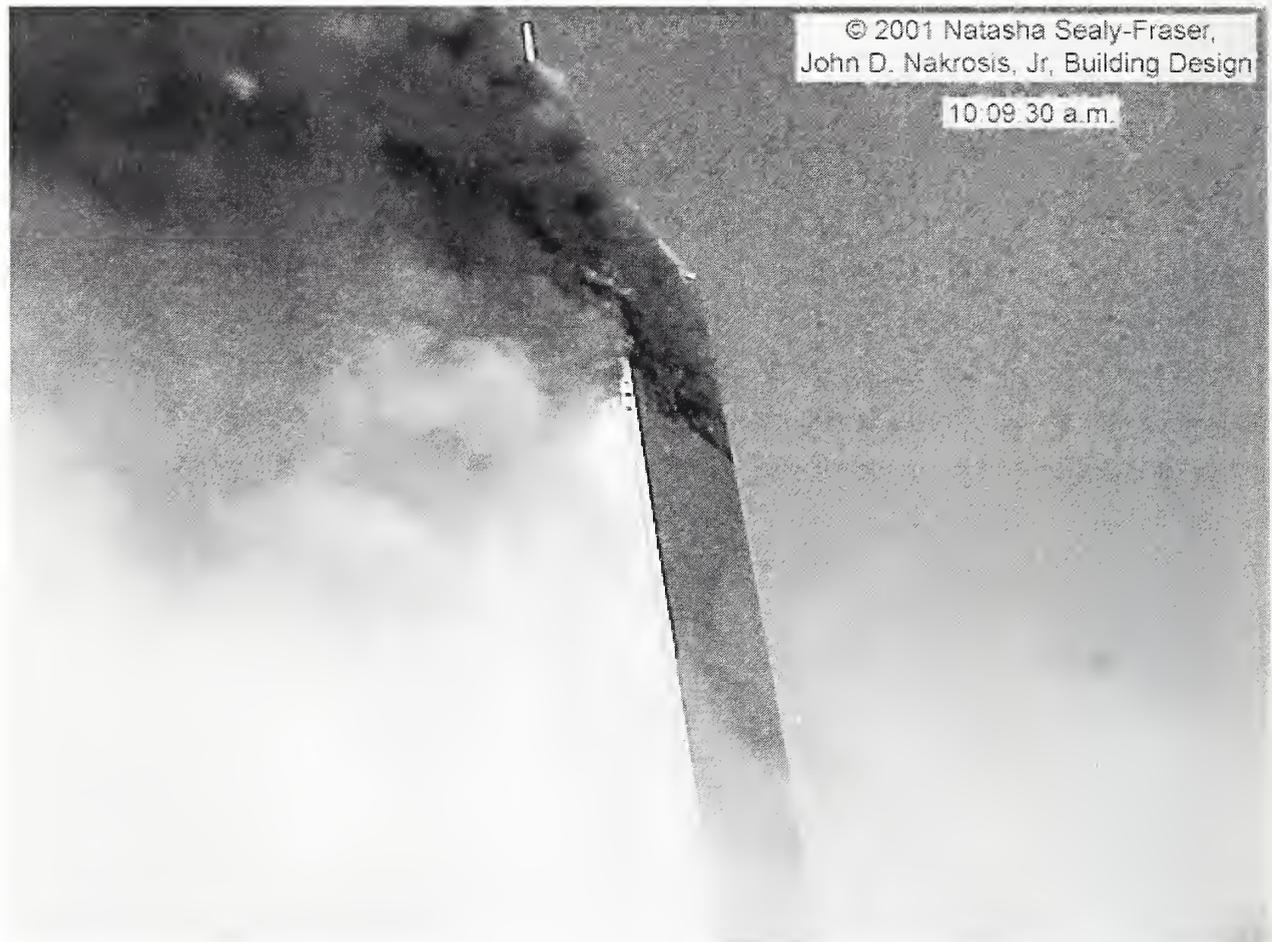
Figure 8-85 shows a photograph of the north and east face of WTC 1 that was taken at 10:09:30 a.m. It demonstrates the degree to which the east face was hidden by smoke and dust. The fire on the 98th floor of the east face is partially visible. While intense, the flames that are visible do not appear to be coming out of the windows.

Figure 8-85. This photograph shows the east and north faces of WTC 1 at 10:09:30 a.m. The intensity levels have been adjusted.

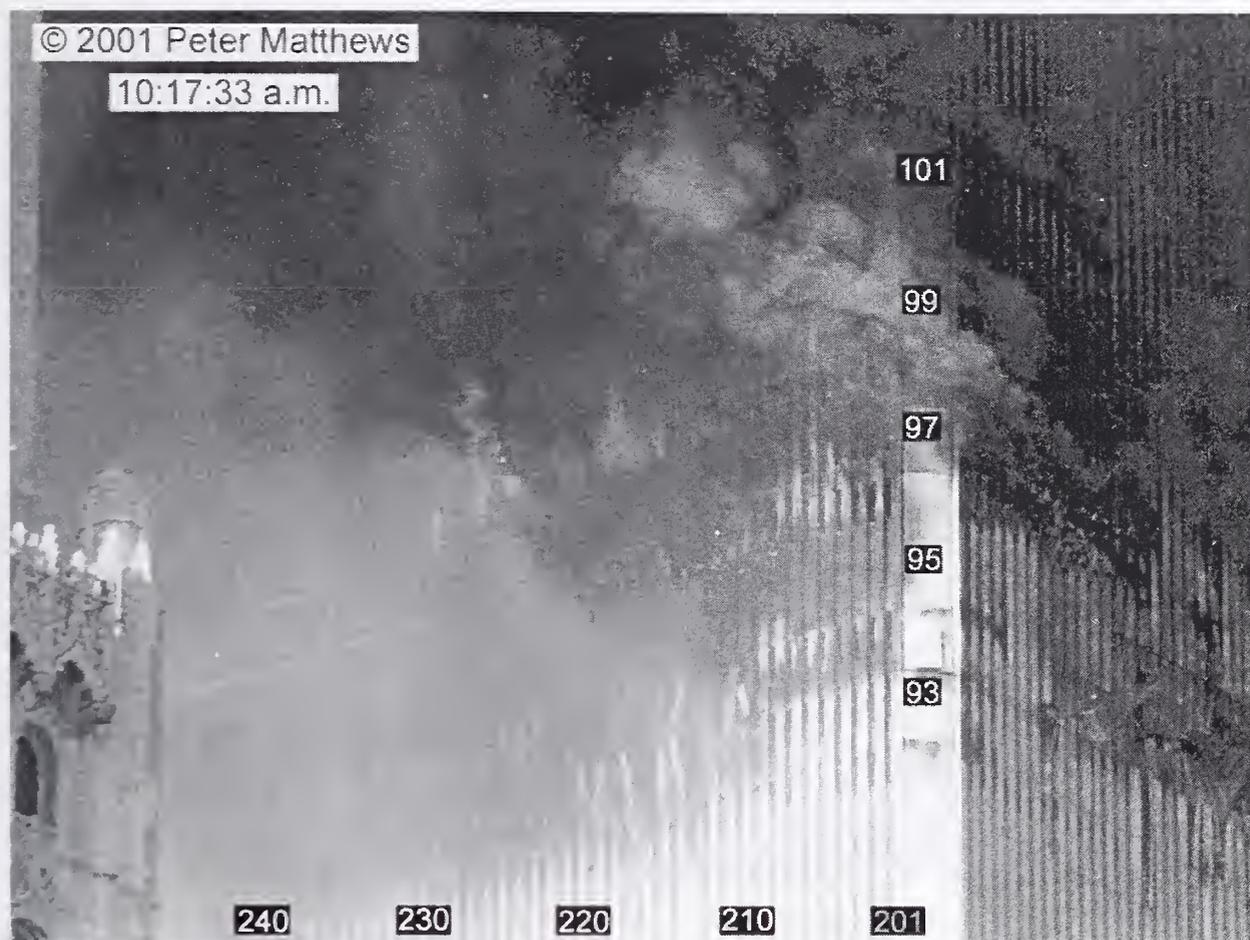
Figure 8-86 shows a partial view of the east face from a photograph taken at 10:17:33 a.m. The most prominent feature is the fire on the 98th floor. At 9:55:08 a.m. (see Figure 8-59) this fire had extended as far south as window 98-224, and there were many windows with extended flames. In Figure 8-86 flames are coming from window 98-229. During the just over 23 minutes in between the photographs, the fire had moved five windows to the south. The fire on the north side of the face has begun to die down. The longest external flames are now located near window 98-225.

Flames are also visible on the 96th and 97th floor extending south from near windows 96-240 and 97-240 to the last windows (96-245 and 97-245) that can be seen in the image. Closer inspection of Figure 8-86 shows what appears to be a small fire on the 101st floor near window 101-224. There is some ambiguity

because of the flames coming from below, but the fire visible higher up seems to be well isolated. This observation suggests that fire has spread upward on the east face by jumping over a couple of floors.

Figure 8-86. This photograph shows the north and east faces of WTC 1 at 10:17:33 a.m. The original has been cropped and enhanced by adjusting the intensities. Column and floor numbers have been added.

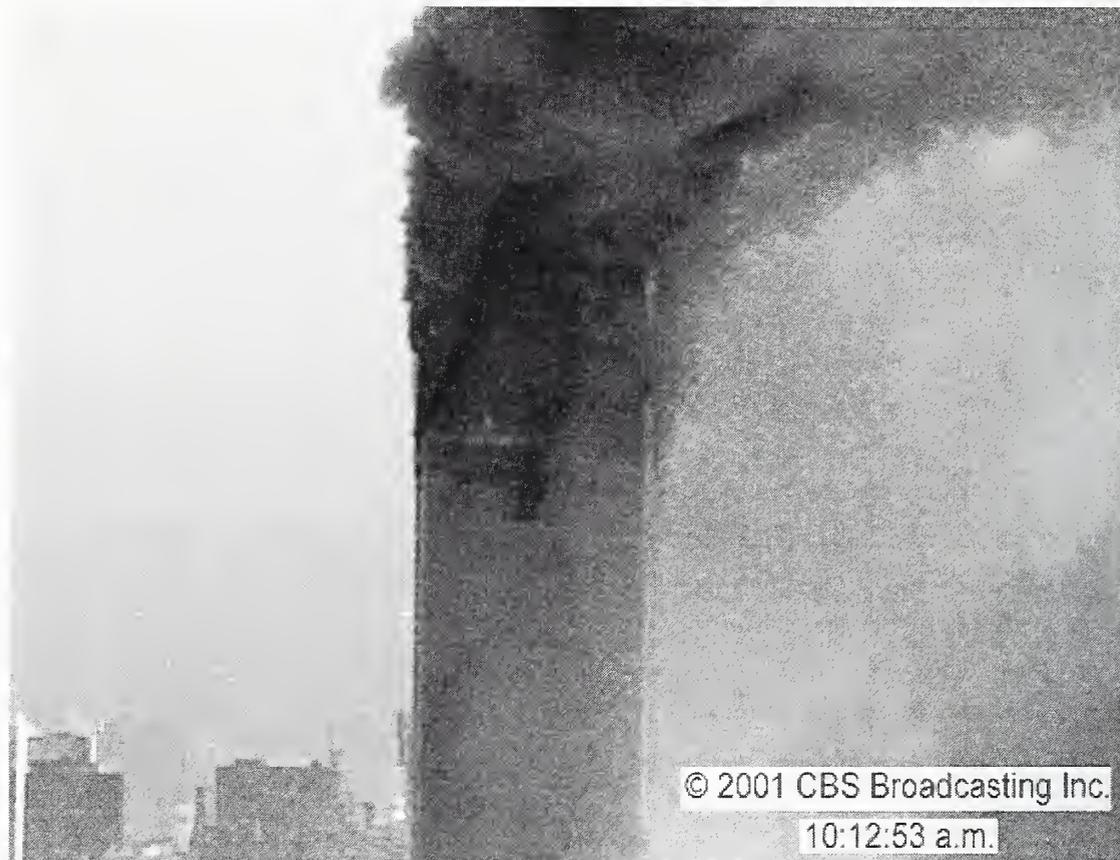
Figure 8-87 shows one of the clearer views of the south face captured from the news helicopter video. It was shot at 10:12:53 a.m. With one major exception, fires are distributed much as described above. The bright flames on the east sides of the 96th and 97th floors and the west side of the 98th floor are easily seen. In addition, an intense jet of flame is apparent on the west side of the face. This external flame, which is over a story tall, appears to be coming from the 99th floor. This is an indication that the fires had now progressed upward to this floor. Near the center of the face, there is a smoke plume coming from one of the lower floors. It is difficult to be sure, but this smoke appears to be coming from the 92nd floor. If correct, this suggests that a fire was burning on the south side of the 92nd floor.

Figure 8-87. This view of the south face of WTC 1 was captured from a video recorded by a news helicopter at 10:12:53 a.m. The image has been enhanced by adjusting the intensity levels.

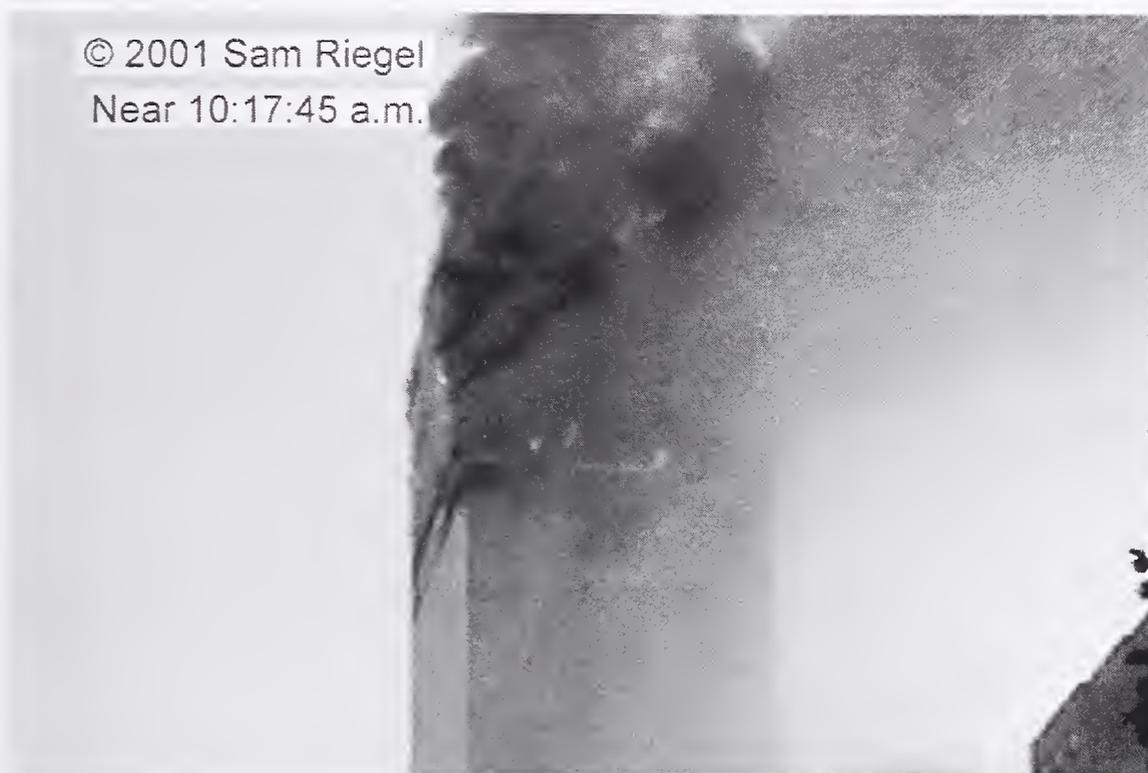
The line of fire on the 98th floor is still quite distinct. There is an intense external flame on the eastern side of this fire located at a point to the east of the center of the face. This fire appears to be moving toward the east. Two tongues of flame are evident coming from the floor above, i.e., the 99th floor, near the center of the western half of the south face. The video shows that the entire region between the two tongues of external flames is involved. The fire on the 97th floor on the eastern side of the face is just barely visible. Flames are not visible on the 96th floor. The smoke plume coming from windows lower down near the center of the face is also visible. Even though individual floors are not resolved in this image, the location of the smoke relative to other details indicates that it is indeed coming from the 92nd floor.

While limited, the visual information available indicates that fire had spread into areas on the east side of the south face of WTC 1 during this time period. A major fire has also grown on the 99th floor on the western side of the face.

Figure 8-88. This image shows the south face of WTC 1. It was captured from a video shot from the ground and has been enhanced by adjusting the intensity levels. The estimated time of 10:17:45 a.m. is based on a comparison of the fire distribution with a video recorded from a news helicopter and could be off by as much as a few minutes.

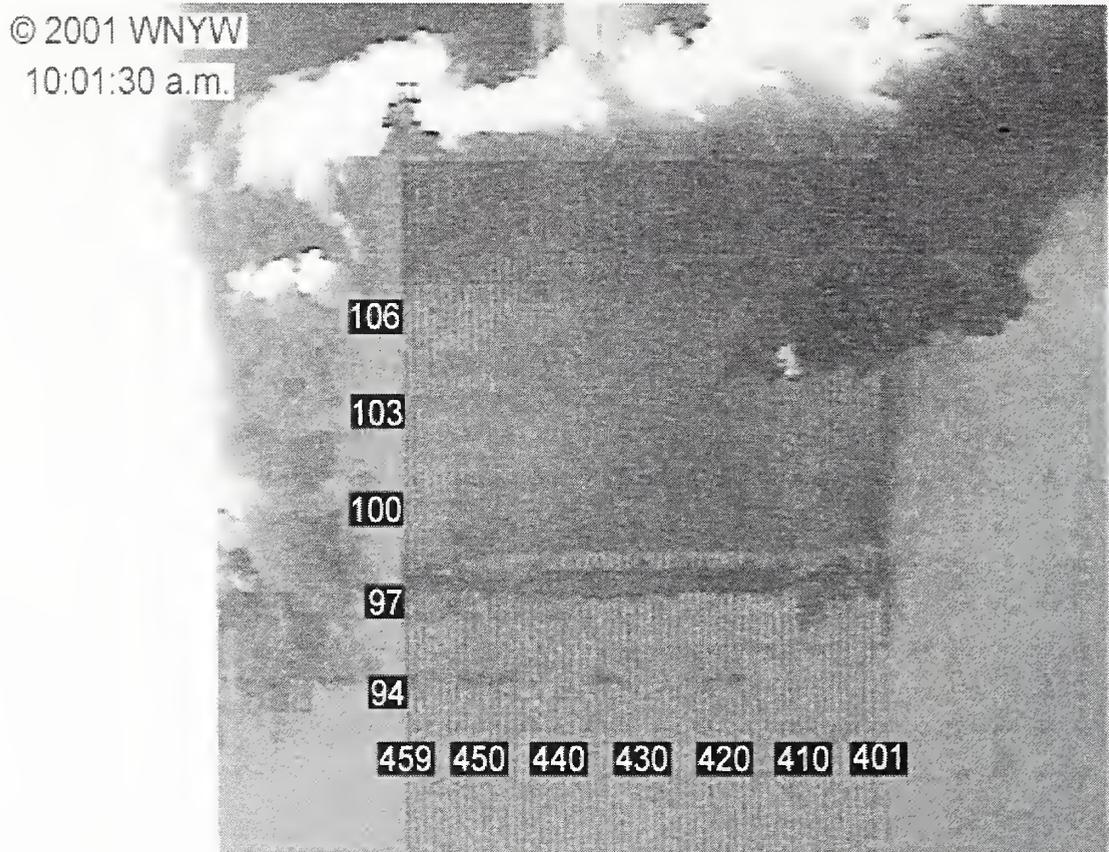
Figure 8-89 shows an image of the west face shot from a news helicopter at 10:01:30 a.m. The flames on the 104th floor are coming from several windows centered near window 104-411. Heavy black smoke is venting from multiple windows over a much larger area. It is informative to compare the appearance of the smoke in Figure 8-89 with that in Figure 8-74, which shows the west face at 9:56:10 a.m. The smoke has clearly become much heavier and darker.

Figure 8-89. This image of the north and west faces of WTC 1 is a frame captured from a video recorded by a news helicopter at 10:01:30 a.m. The image has been enhanced by adjusting the intensity range, and some areas are saturated. Column and floor numbers have been added.

The deep orange glow along the 98th floor in Figure 8–89 indicates that the interior fire on this floor is continuing to burn along much of the length of the west face. The fire on this floor has moved north since around 9:58 a.m. Flames can now be seen as far as window 98-455. The floor plan layout shown in Figure B-7 indicates that there were two rooms along the west face in the northwest corner of the 98th floor. Fire has entered the southernmost of these rooms, which had interior walls at columns 98-452 and 98-456. There is as yet no visual evidence for fire on the west side of the corner room with walls at columns 98-456 and 98-108.

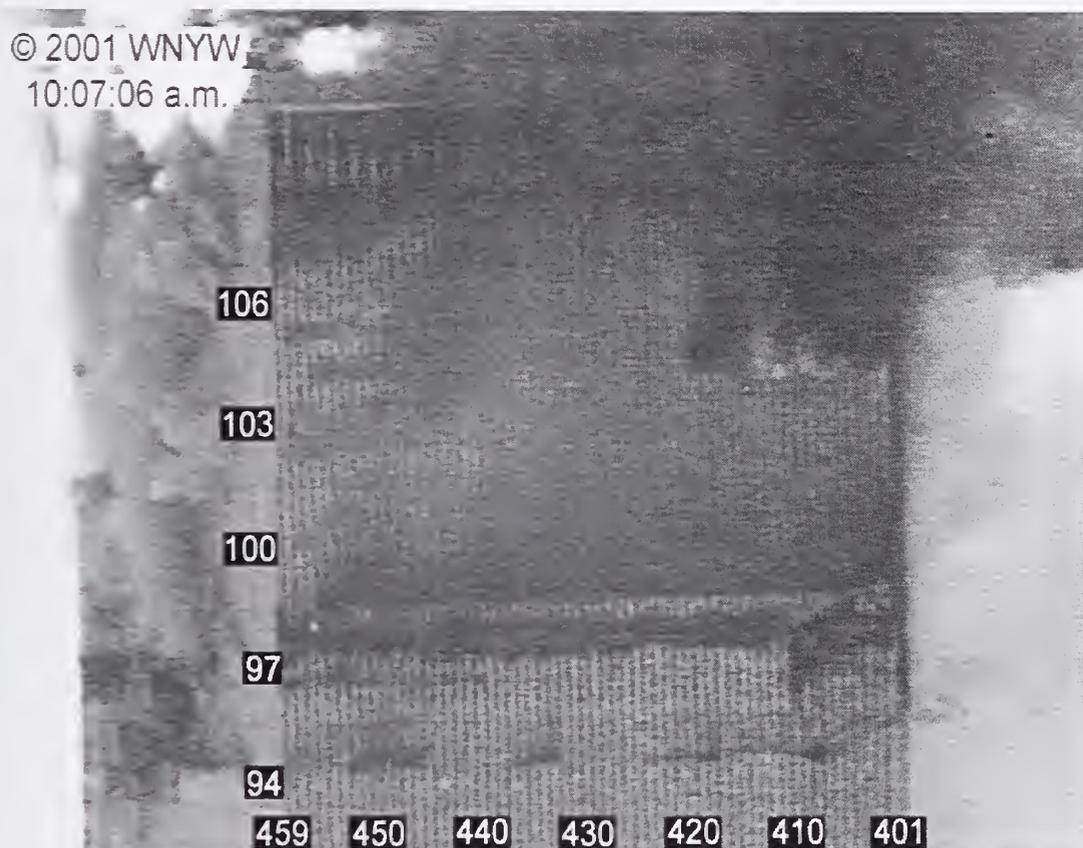
Another view of the west face taken from a video shot from one of the news helicopters at 10:07:06 a.m. is shown in Figure 8–90. The fire on the 104th floor is still raging, with flames coming from windows 104-404 to 104-414. On the 98th floor the deep orange glow from the internal fire is still present along nearly the entire length. A small flame extends from window 98-455, but the fire does not yet appear to have moved into the room on the northwest corner. On the 94th floor the most intense fire is observed in windows 94-412 to 94-414. Smoke is also evident coming from window 94-408. This smoke had appeared abruptly six seconds earlier.

Figure 8-90. This image of the north and west faces of WTC 1 is a frame captured from a video recorded by a news helicopter at 10:07:06 a.m. The image has been enhanced by adjusting the intensity range, and some areas are saturated. Column and floor numbers have been added.

In Figure 8–90 there is no visual indication of fire on the west side of the 95th floor. However, the summary of observations of falling people in Appendix M provides evidence that fires were moving into the area. At 10:06:11 a.m. a person fell from the west side of the 95th floor. During the next minute and forty-five seconds 12 more people fell from the same floor. For some of these people, the windows that they fell from have been identified. They ranged from window 95-424 to window 95-428. These windows were closed at 9:40:14 a.m. as seen in Figure 8–70.

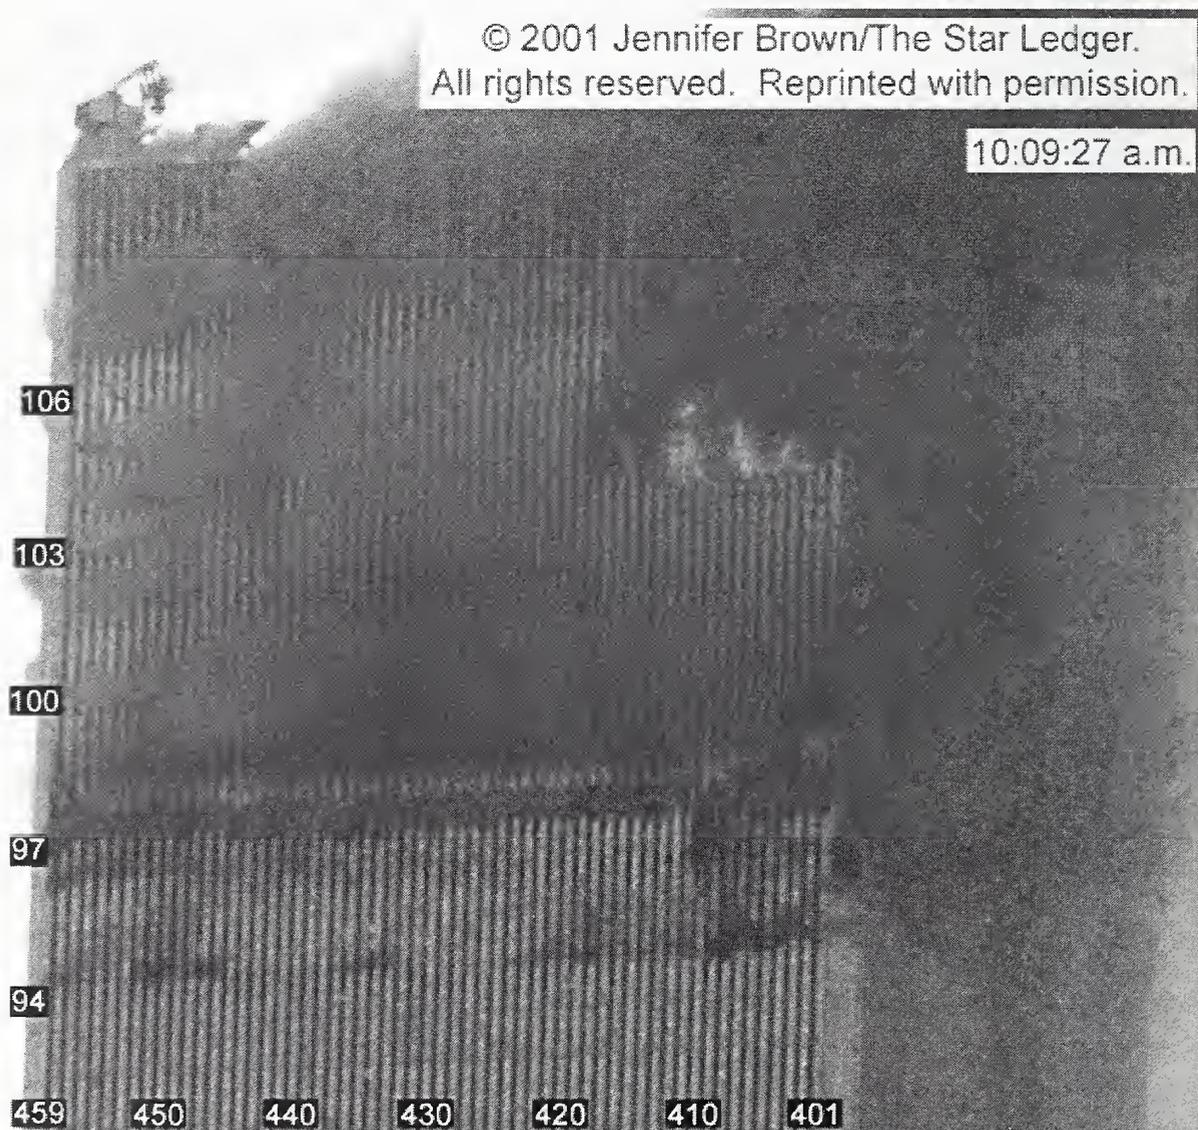
Figure 8–91 shows a photograph of the west face recorded shortly afterward at 10:09:27 a.m. Flames are visible on the 95th floor in windows 95-430 to 95-447. A video of the west face indicates that fire was present as far south as window 95-425 by 10:10:10 a.m. The images indicate that an extensive fire that had not been visible three minutes earlier appeared over a large length of the west side of the 95th floor.

Figure 8-91. This photograph, showing the west face of WTC 1 and an oblique view of the south face, was recorded at 10:09:27 a.m. The image has been cropped and enhanced by adjusting intensity levels. Column and floor numbers have been added.

At some point between 10:07:12 a.m. and 10:07:55 a.m., smoke began coming from the west windows in the room at the northwest corner of the 98th floor. In Figure 8-91 a flame is evident in window 98-458 at 10:09:27 a.m. This flame was not evident in a lower resolution video of the area taken at the same time, but flames did become visible in windows 98-456 to 98-458 starting around 10:10 a.m., with some flame extension from windows apparent. Recall that heavy smoke and flames appeared from the north windows inside this room starting at 10:10:15 a.m. The opening of so many windows in such a short period indicates that flashover took place in this room around this time. The flames coming from the west windows are visible in Figure 8-83, taken at 10:11:41 a.m.

The orange glow seen in Figure 8-91 over much of the 98th floor indicates that the interior fire present on this floor continued to burn at this time. By entering the room on the northeast corner around 10:10 a.m., this fire had completed its spread across the entire west side of the floor. Recall that the fire had entered the adjacent room with walls at columns 98-252 and 98-256 (see Figure B-7) around 10:00 a.m.

Small areas of isolated flames can be seen in several windows on the 94th floor in Figure 8-91. There appears to be a somewhat larger fire present at window 94-408 and windows immediately to the north. The smoke stream that appeared at 10:07:00 a.m. from window 94-408 is still apparent. Windows to the south appear to be intact. The fact that the fire did not appear to move south in the nearly 150 s period between these images is somewhat surprising because the floor plan layout (see Figure B-3) indicates that the fire was burning in a room with walls at columns 94-405 and 94-417. The fire might have been expected to spread to the southern wall of this room. Videos shot from the west indicate that the stream of smoke coming from window 94-408 was present until the end of the current period at 10:18 a.m.

Figure 8-91 provides a good view of the fire on the 104th floor of the west face. Flames continue to come from the open windows, and fire is evident from window 104-403 to window 104-416.

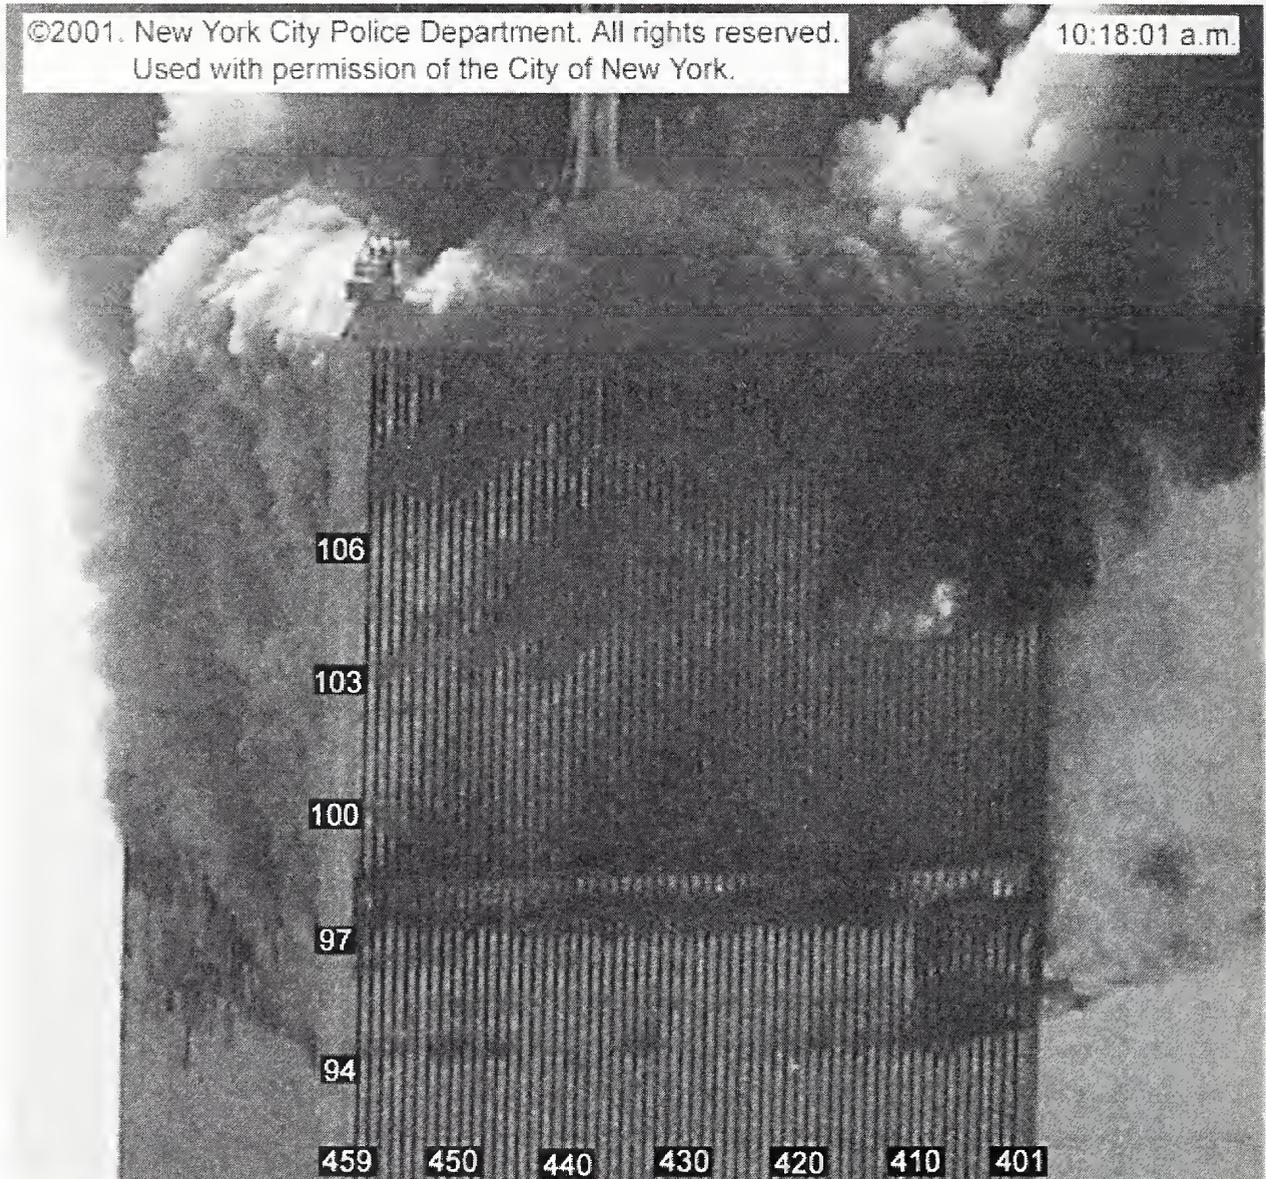
Figure 8-92 shows an image of the west face of WTC 1 recorded at the end of the current time period at 10:18:01 a.m. With a few exceptions, the appearance is similar to that seen around 10:10 a.m. The fire on the 95th floor has spread in both directions across the face. Low intensity flames can be seen in windows over a length from window 95-413 to window 95-455. Even though the fire extends over a long length of the face, there is very little smoke, and there are no flames coming from the windows on this

floor. The absence of significant smoke marks on the column covers near the tops of the windows is consistent with these observations. Based on the floor plan layout shown in Figure B-4, the fire on this floor has penetrated the room with walls at columns 95-452 and 95-456, but there is no indication that it is yet inside the room on the northwest corner with walls at columns 95-456 and 95-108.

Figure 8-92. This cropped photograph of the west face of WTC 1 and an oblique view of the north face was shot at 10:18:01 a.m. The image was enhanced by adjusting the intensity levels, and column and floor numbers have been added.

Relatively small fires are observed at several locations on the 94th floor. Heavy smoke continues to come from window 94-108. In fact, heavy smoke and fire are apparent at windows 94-108 and 94-109. The fire on the 98th floor can still be seen across most of the west face, and it is still primarily an interior fire. Heavy smoke and flames continue to come from the fire on the 104th floor. The location of this fire appears to be the same as at 10:10 a.m.

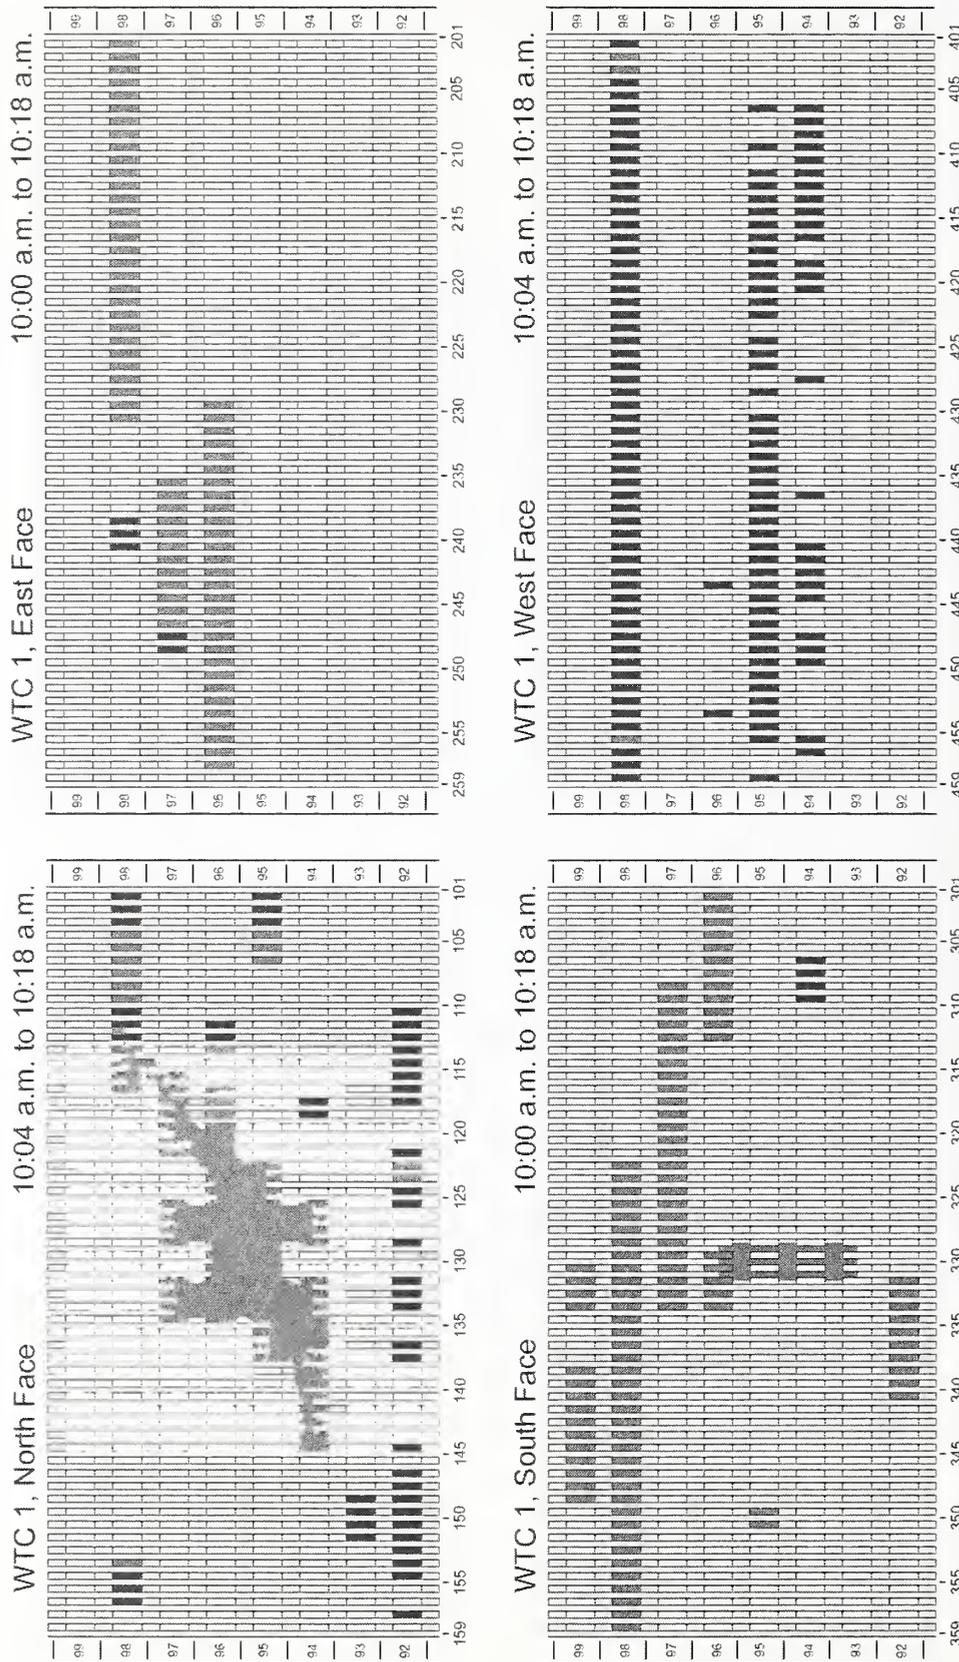
Integrated fire maps for the four faces of WTC 1 based on the data sheets prepared for times between 10:00 a.m. and 10:18 a.m. are shown in Figure 8-93. It should be remembered that observations during this period were hampered by partial obscuration of the east and south faces and the quality of the available imagery. As a result, only relatively large fires will be characterized on these faces, and there is likely some uncertainty in the window assignments for fire location. Figure 8-93 can be compared with Figure 8-76 which shows a similar plot for the period between 9:36 a.m. and 9:59 a.m.

Substantial fire spread and growth was observed on the south face during this period. The new areas where substantial fires were observed were on the east side of the face on the 96th and 97th floors and on the west side of the 99th floor, where a fire spread over a large fraction of this side of the floor. The spread of the fires onto the east side of the face are significant because, with the exception of relatively small fires observed in this area on the 94th floor prior to the collapse of WTC 2, this side of the face was not subjected to fire for well over an hour following the aircraft impact. There was also evidence of the growth of a fire near the center of the 92nd floor.

The most prominent feature of the fire growth on the west face was the appearance (not included in Figure 8-93) of an intense fire with extended flames on the 104th floor shortly after the collapse of WTC 2. This fire continued to burn intensely during the entire period. The fire on the 98th floor continued moving toward the north, reaching the north face during the period. A relatively low-intensity fire appeared on the 95th floor and subsequently covered a large fraction of the floor across the face. The fire burning on the 94th floor continued to spread toward the south early in the period, but then seemed to halt near window 94-108 for several minutes.

Figure 8-93. Maps of integrated fire observations between 10:00 a.m. and 10:18 a.m. are shown for the four faces of WTC 1. Colors represent the highest intensity fire observed in a window using the color scale defined in Figure 5-1.

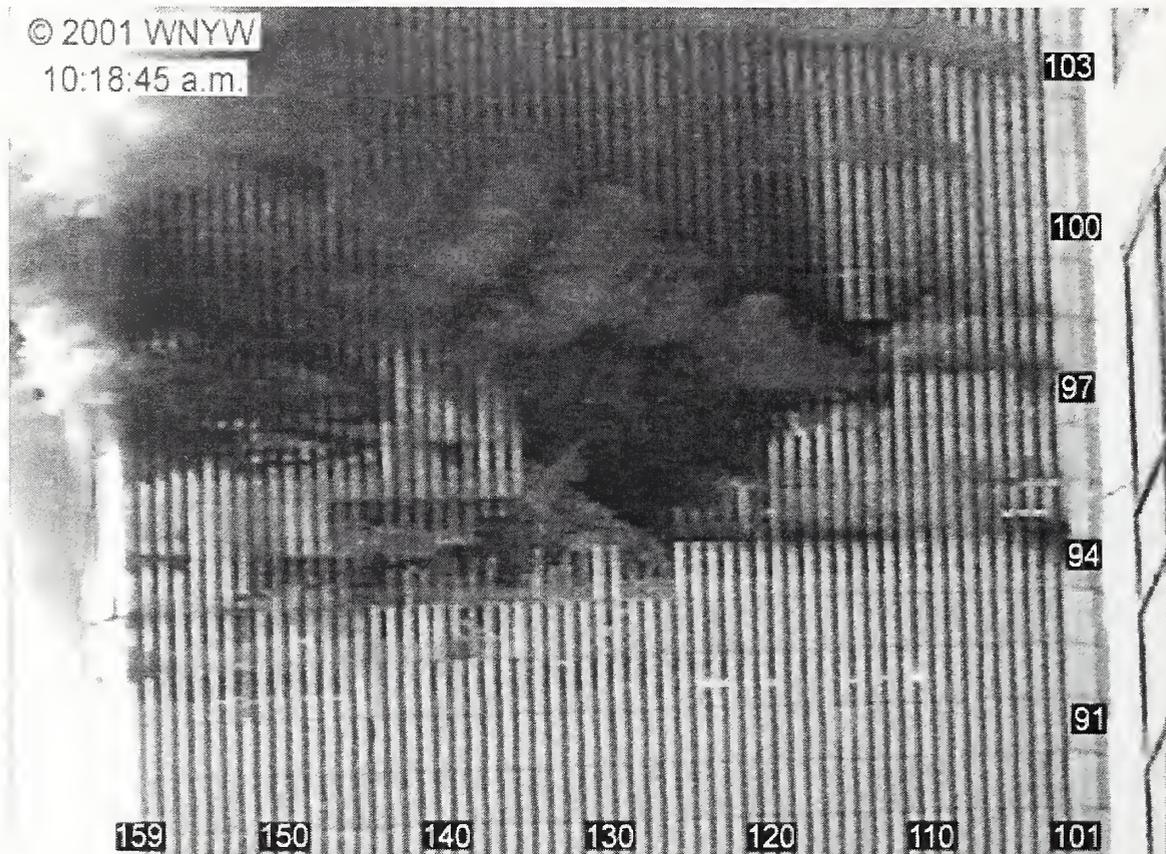
Figure 8–94 provides a view of the north face of WTC 1 at 10:18:45 a.m. Comparison with Figure 8–84 shows that, during the just over three and a half minutes between the images, the fire on the 92nd floor continued to move toward the west. In the later image fire is visible as far west as window 92-110. At the earlier time windows to the west of window 92-120 appeared to be intact, with fire present in window 92-121. Despite the presence of flames over a significant length of the floor, the fires appear to be burning at low levels at separated locations. There is essentially no smoke coming from the open windows on the north side of the floor. This indicates that the smoke is likely venting elsewhere.

Figure 8-94. This image of the north face of WTC 1 was captured from a video shot at 10:18:45 a.m. It has been enhanced by adjusting the intensity range. Some portions of the image to the left of the tower are saturated. Column and floor numbers have been added.

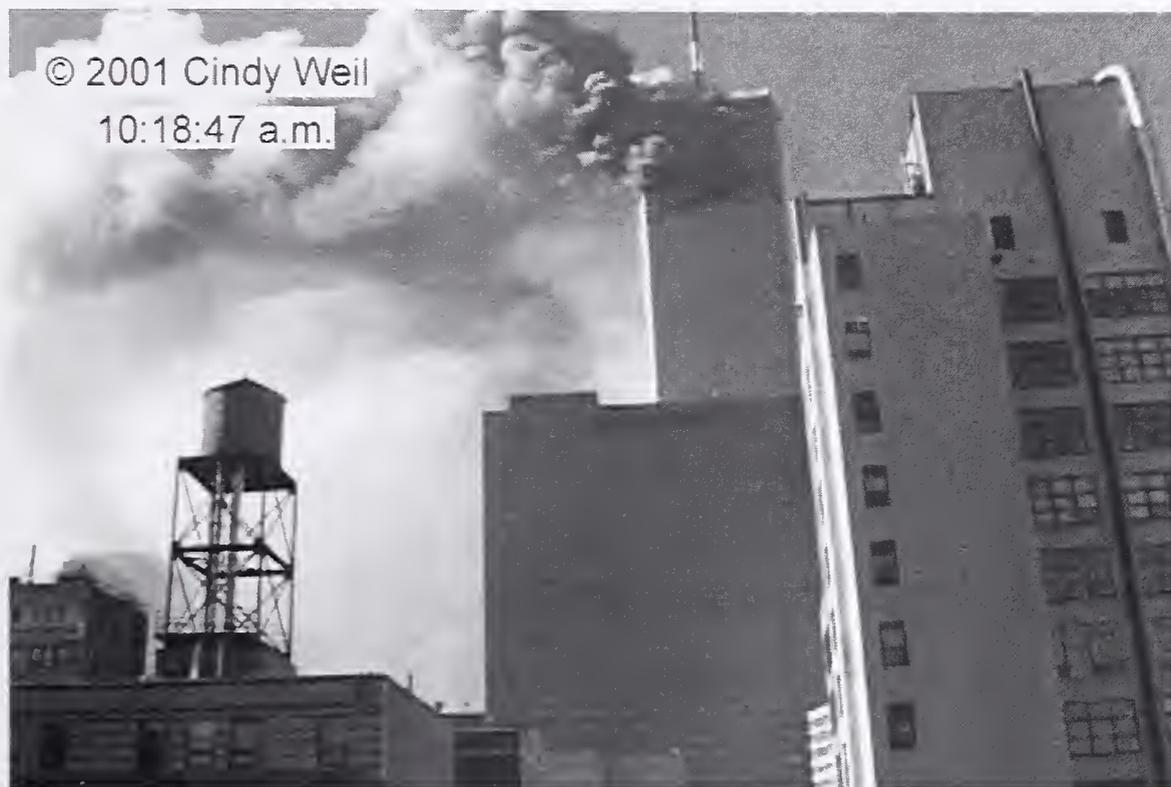
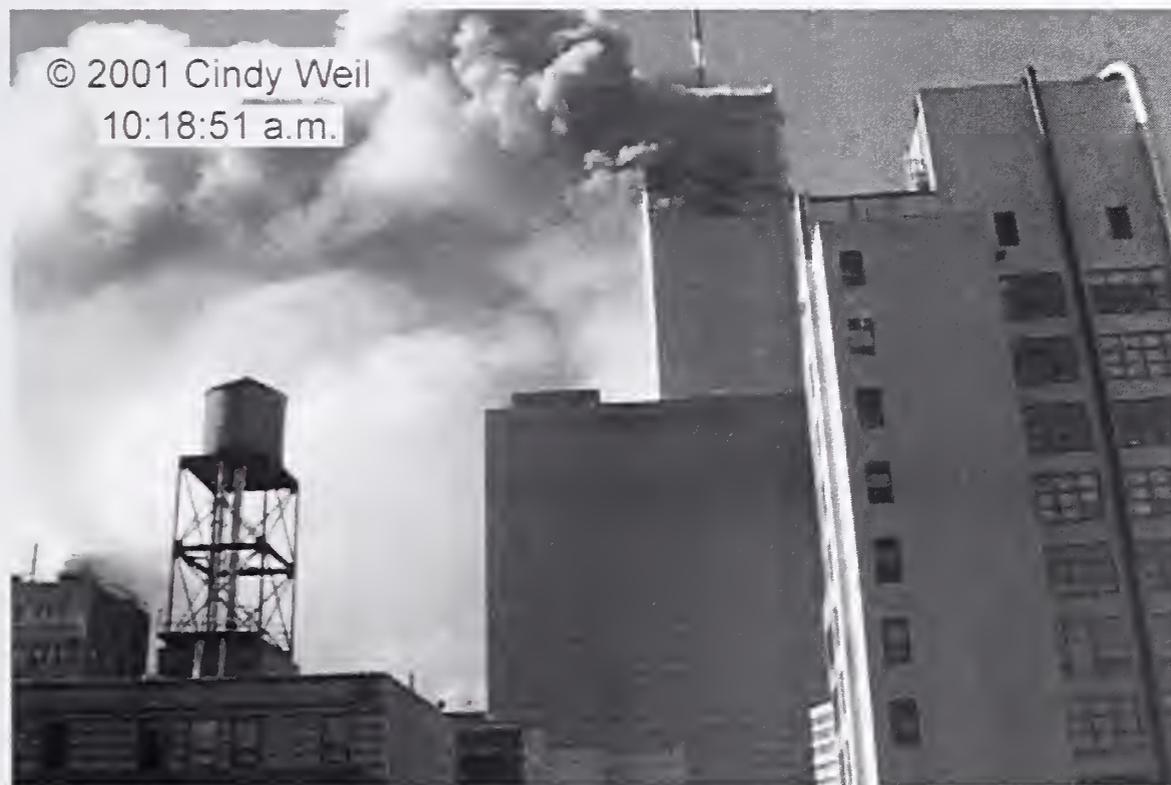
At 10:18:48 a.m. an event took place within the tower that created a pressure pulse of sufficient magnitude to force smoke out of numerous windows on the north face, as well as from the other faces. The most obvious effect of this pressure pulse was the release of a dense line of smoke along a length of the 92nd floor on the north face, extending from roughly window 94-110 to window 94-139. This smoke release was evident in numerous videos, including a number shot at great distances. Figure 8–95 compares two frames taken from a video showing the north face just prior to the smoke release and the appearance just over 4 s later. Even though the video was shot from a distance, the line of smoke that has appeared from the 92nd floor is readily apparent. It is significant that until this time very little smoke had been observed coming from the open windows on this floor, even though fires had been burning on the floor for some time.

Closer inspection of this video, as well as others, shows many additional effects of the pressure pulse at other locations on the tower. Smoke and/or dust were pushed out of windows on the east side of the north face at the 94th floor. This material is responsible for the light-colored “smoke” seen near the eastern edge of the building immediately above the darker smoke released from the 92nd floor in Figure 8–95.

Figure 8-95. Two images of the north face of WTC 1 captured from a video are shown. The times are 10:18:47 a.m. and 10:18:51 a.m.

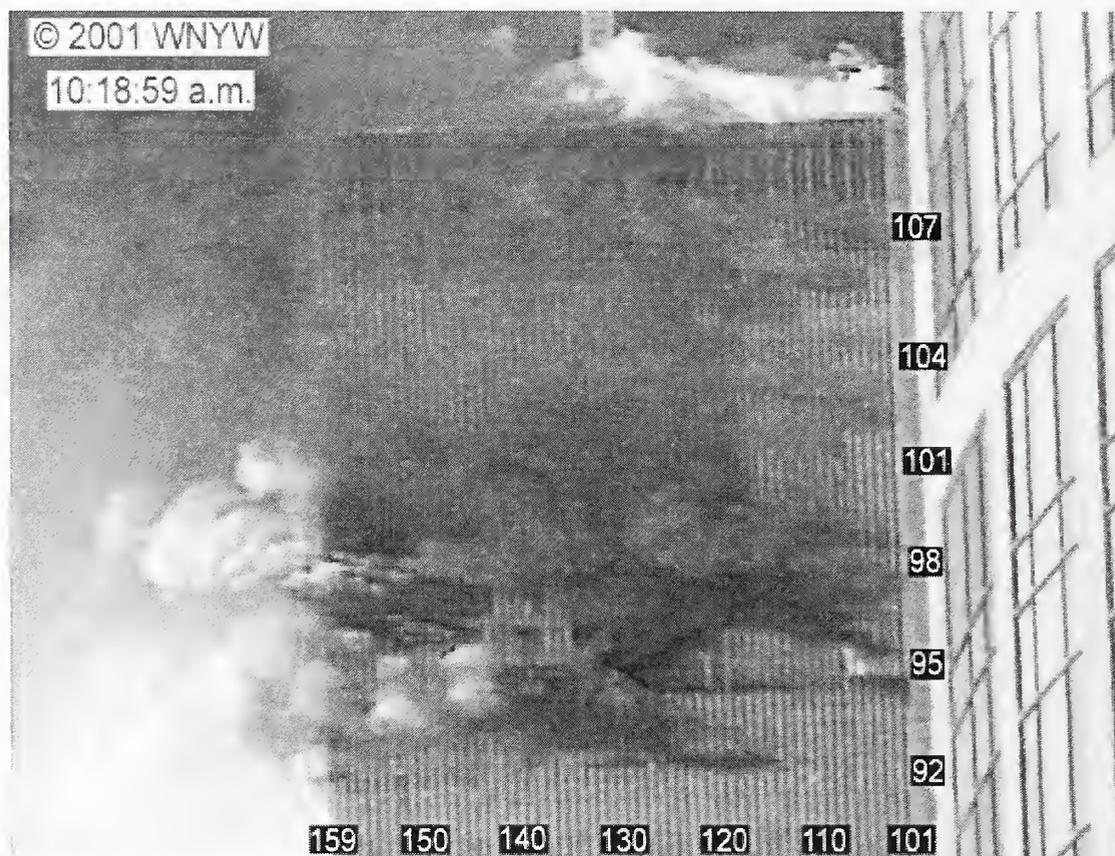
Figure 8-96 shows a closer view of the north face recorded at 10:18:59 a.m. This image is taken from the same video as Figure 8-94, which was recorded 14 s earlier. The effects of the changes in the smoke and fire described above are easily seen. The black line at the tops of the column covers on the 92nd floor created by the smoke release is visible. The fire on the western edge of the 95th floor has grown dramatically, and flames now extend from windows 95-105 and 95-106. Heavy smoke is now coming from windows on the 95th floor as well as windows at the western edge of the face on the 96th and 97th floors. Smoke is also now flowing from window 102-101 on the 102nd floor.

Figure 8-96. This image of the north face of WTC 1 was captured from a video shot at 10:18:59 a.m. It has been enhanced by adjusting the intensity range. Column and floor numbers have been added.

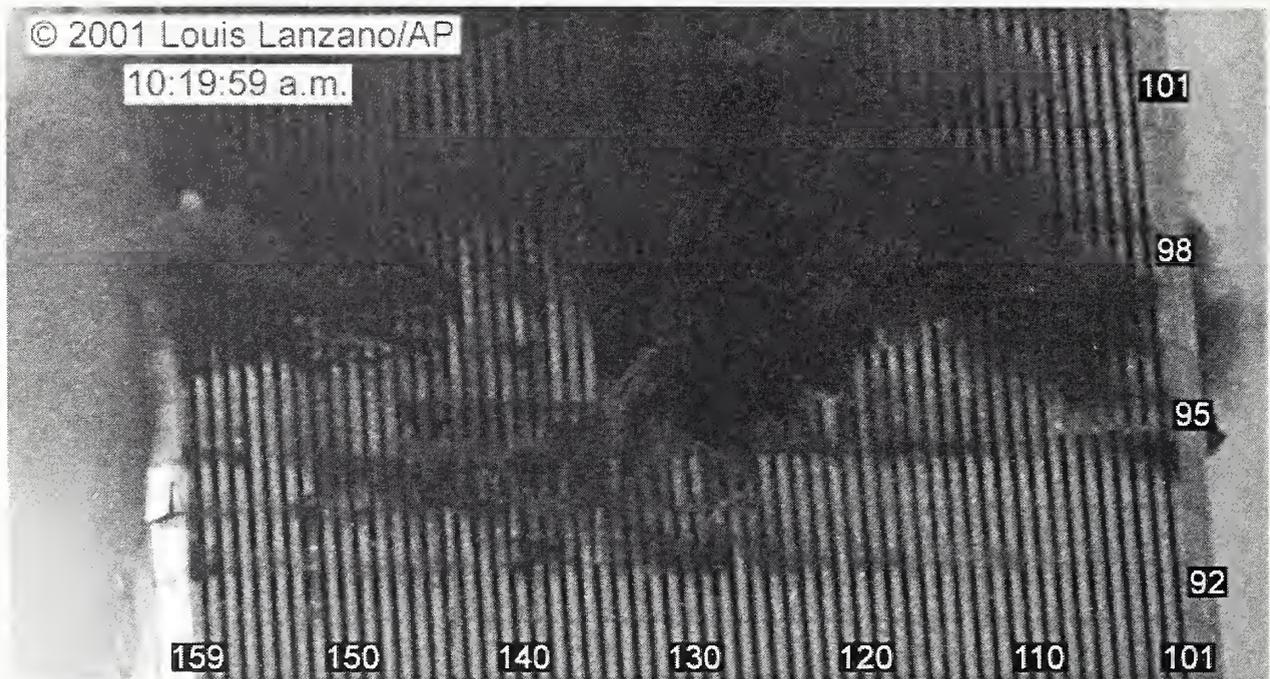
Figure 8-98 shows an image of the north face cropped from a photograph that was taken a minute later than Figure 8-96. Light smoke continues to come from the 92nd floor, where low level fires are apparent in windows 92-112 to 92-132. The fire that grew rapidly on the 95th floor immediately following the pressure pulse is still burning intensely, with flames coming from windows 95-106 and 95-107. A review of the floor plan layout for this floor in Figure B-4 shows that this fire is burning within a corner room with walls located at columns 95-456 and 95-108. Apparently, at this time the wall at column 95-108 has halted the spread of the fire toward the east. There does appear to be a fire even further to the east on this floor near window 95-115. A low level fire continues to burn on the 96th floor, with flames visible from windows 96-113 to 96-118. Heavy smoke is still flowing from windows on the 96th and 97th floors.

Figure 8-98. This cropped photograph shows the north face of WTC 1 at 10:19:59 a.m. The image has been enhanced by adjusting the intensity range. Column and floor numbers have been added.
