**NIST NCSTAR 1-5A
Federal Building and Fire Safety Investigation of
the World Trade Center Disaster**

**Visual Evidence, Damage Estimates,
And Timeline Analysis**

Visual Evidence, Damage Estimates, and Timeline Analysis

September 2005

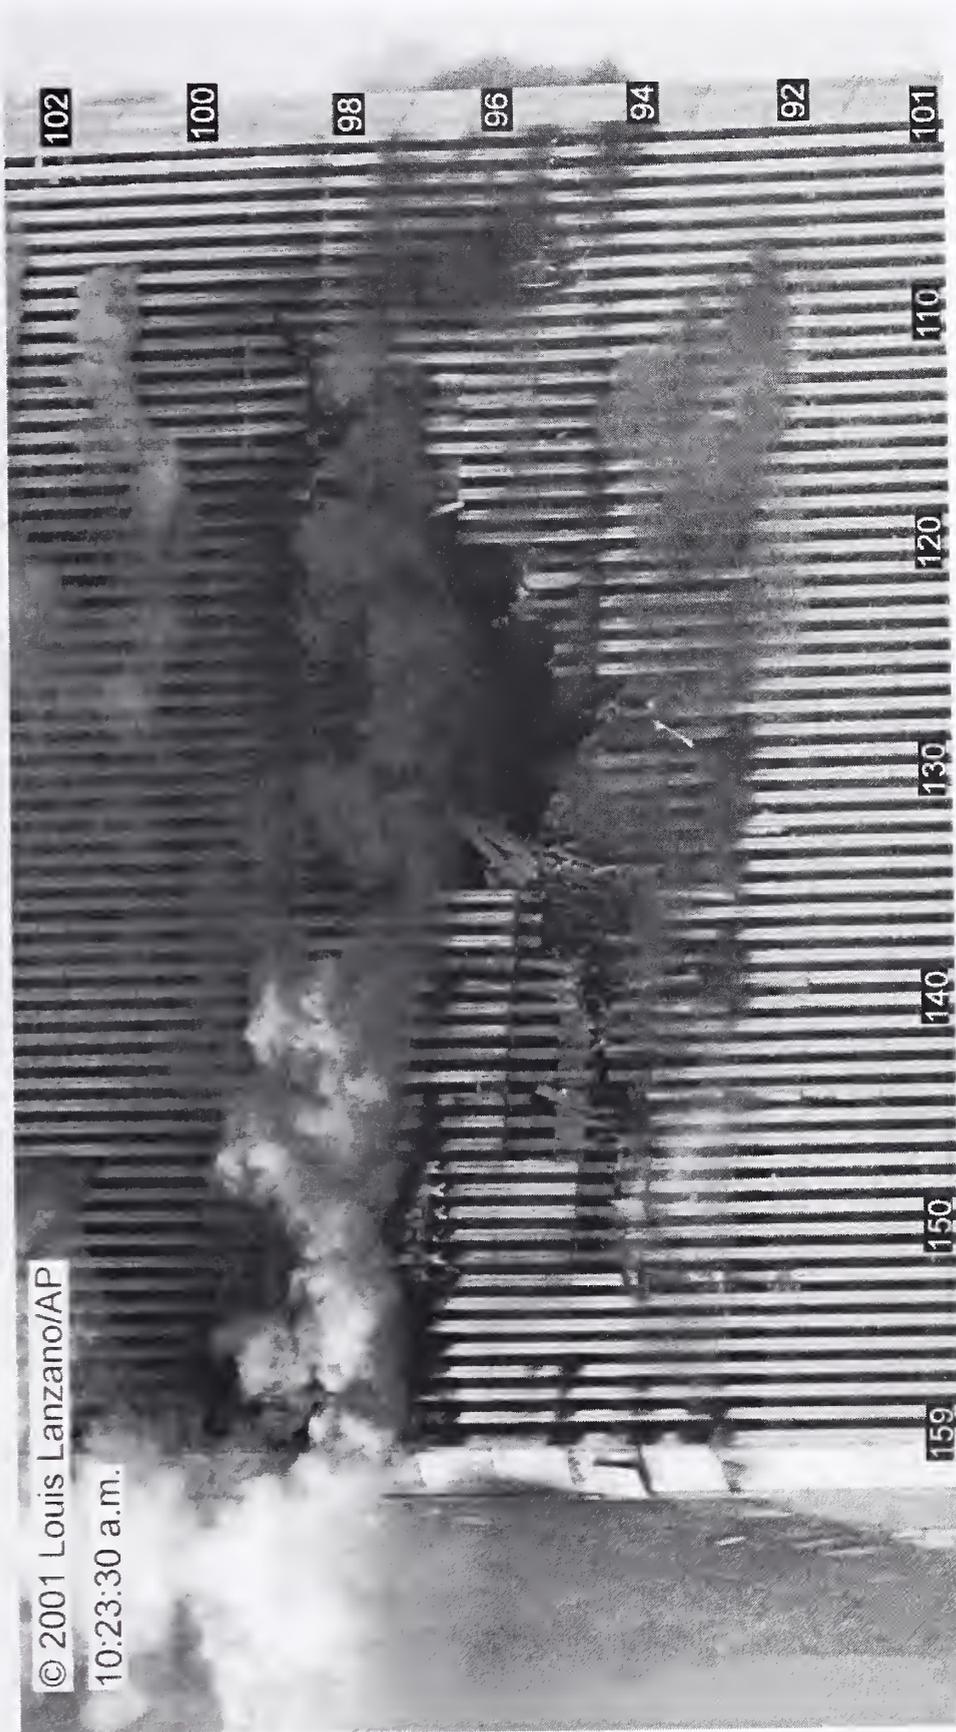
A view of the north face at 10:23:30 a.m. is shown in Figure 8-99. The fire on west side of the 92nd floor has grown dramatically since the photograph in Figure 8-98 was taken, three and a half minutes earlier. Heavy flames fill the openings from window 92-108 to window 92-114, and a nearly continuous region of flame is apparent from window 92-108 to window 92-132. The floor plan layout for the 92nd floor in Figure B-1 shows that a large open area extended along the north face between walls located at columns 92-132 and 92-105. Figure 8-99 indicates that nearly this entire area was involved in fire at this time. A small fire is evident in window 92-104, while windows 92-101 to 92-103 and window 92-105 appear to be closed. This indicates that a fire has moved into the northwest corner room with walls located at columns 92-105 and 92-455. Interestingly, in an almost identical photograph recorded five seconds earlier, the fire in window 92-104 was not visible, and all of the glass for windows in the corner room appeared to be intact. This suggests that the fire in the northwest corner room of this floor has just become large enough to break windows at this time. This close-up photograph also reveals that small spot fires continued to burn on this floor at the eastern side, where larger fires had been present earlier.

Figure 8-99. This cropped photograph shows the north face of WTC 1 at 10:23:30 a.m. The image has been rotated and enhanced by adjusting the intensity range. Column and floor numbers have been added.

By 10:23:30 a.m. the fire in the northwest corner room of the 95th floor had begun to die down, and the flames that were outside of windows at the time of Figure 8–98 had receded back into the building. The carets created by these external flames on the aluminum covers for columns 95-105 to 95-108 are distinct in Figure 8–99. Dull orange flames can be seen through windows 95-108 and 95-109, indicating that a fire was present on the other side of the wall located at column 95-108 (see Figure B-4). It is not clear whether the glass in these windows has broken or not. A small spot fire is also visible in window 95-115. The dying fire on the western side of the 96th floor is not visible in Figure 8–99, but small flames can be seen higher up on the 98th floor.

This area of flame on the southern side of the east face is visible in Figure 8-99, which was taken at 10:23:30 a.m. The fire is burning intensely with extended flames. Figure 8-103 shows a lower-resolution photograph taken at 10:23:41 a.m. that provides a slightly less oblique view of the east face in which it is easier to identify the flame location. The area where flames are visible coming from open windows has been highlighted. Flames can be seen on the 98th floor at two apparently separated locations. One of these is near the center of the face, and the second is well to the south. Even though the flames appear to be separated, videos and Figure 8-99 show that the flaming region was continuous over this length. A small area of fire is also visible on a lower floor. This fire is most likely on the 97th floor near the location where fire was present (near window 97-145) in Figure 8-102 at 10:18:15 a.m.

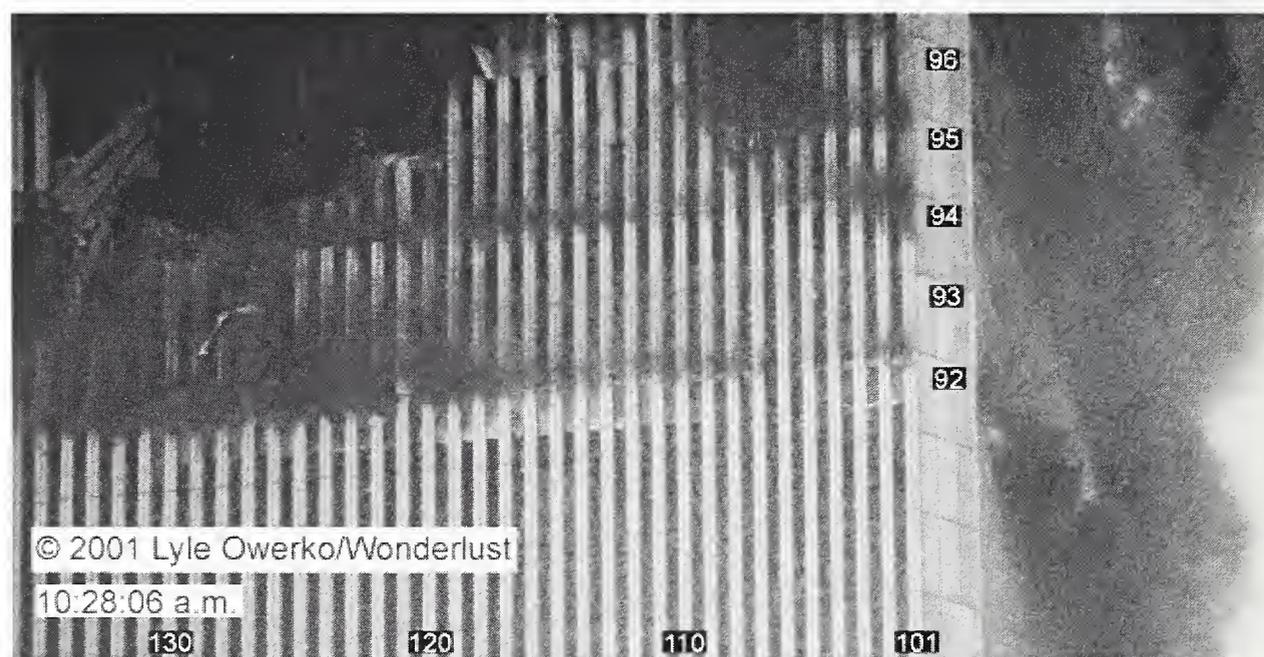
Figure 8-100. This cropped photograph shows a portion of the north face and an oblique view of the west face for WTC 1 at 10:28:06 a.m. The intensity levels of the image have been adjusted, and column and floor number have been added.

This photograph has sufficient resolution and contrast to allow a determination of whether windows are open or intact. It appears as if three windows on the 92nd floor, windows 92-105, 92-106, and 92-120, still have glass in place. The other windows visible on this floor are open.

The photograph in Figure 8–100 was shot from a ground location relatively close to and slightly west of the tower. For this reason it may not provide as complete a view of interior fires as some of the other images shown earlier. Nonetheless, it is clear that the fires that were easily identified minutes earlier on the 95th, 96th, and 97th floors are not visible and must be burning at relatively low levels. The fact that the fire on the 92nd floor is so prominent supports this conclusion.

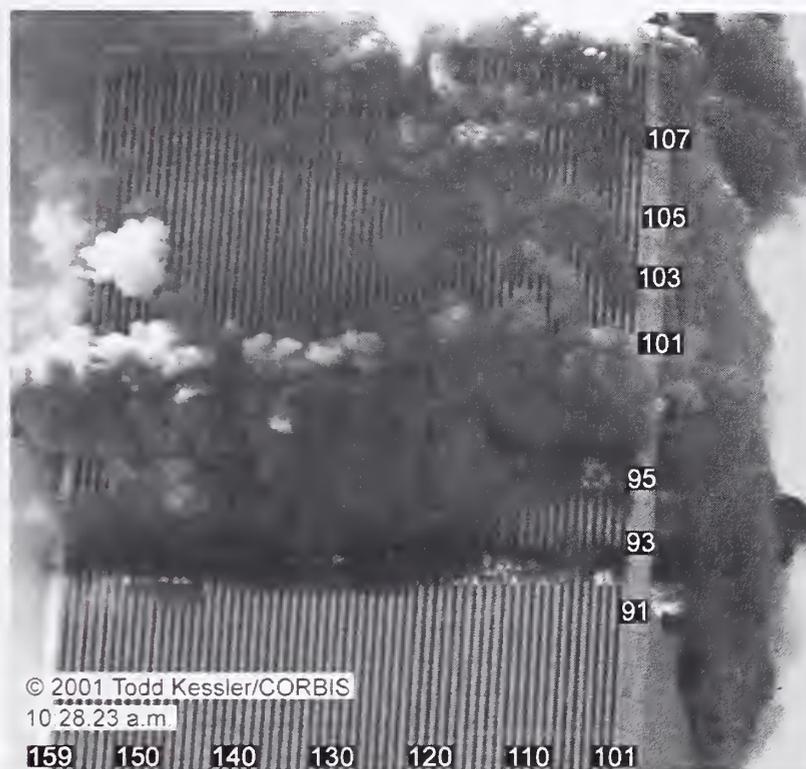
The photograph shown in Figure 8–101 was shot 1.4 s after WTC 1 began to collapse. The lines of dust visible coming from the 98th floor on the north and west faces of the tower may be an indication that the collapse began near this floor. As the building collapsed it acted as a piston, forcing air downward onto other floors. The resulting pressure increase forced gas flows out of open windows on lower floors. As a result of this process, fire and smoke were pushed out of the building.

Figure 8-101. This cropped photograph shows the north face of WTC 1 at 10:28:23 a.m. The image has been enhanced by adjusting the intensity levels. Column and floor numbers have been added.

In the photograph a large area of fire is being pushed from windows on the 92nd floor on the west side of the north face and the north side of the west face. This is the region where an intense fire had grown during the previous ten minutes or so. Fire is evident coming from windows across the large room on this floor with walls at columns 92-105 and 92-132 (see Figure B-1), as well as from the room in the northwest corner with internal walls at columns 92-455 and 92-105. The large volume of fire being pushed out of the windows provides an indication of how widespread the flames were in this area of the tower. Smaller flames are also visible coming from windows 92-146 to 92-152 on the eastern side of the

face. This indicates that fires had continued to burn in two of the small rooms located along the north face (see Figure B-1).

Flames were also pushed out of windows located in the northwest corner room on the 95th floor with walls at columns 95-108 and 95-456 (see Figure B-4). This is an area that had been burning earlier, but had appeared to have died down just prior to the initiation of the collapse. It is clear from this photograph that a significant fire was still burning in the immediate vicinity. The absence of visible fire being expelled elsewhere on the north face provides additional evidence that intense fires observed at other locations on the north face at earlier times had either died down or gone out.

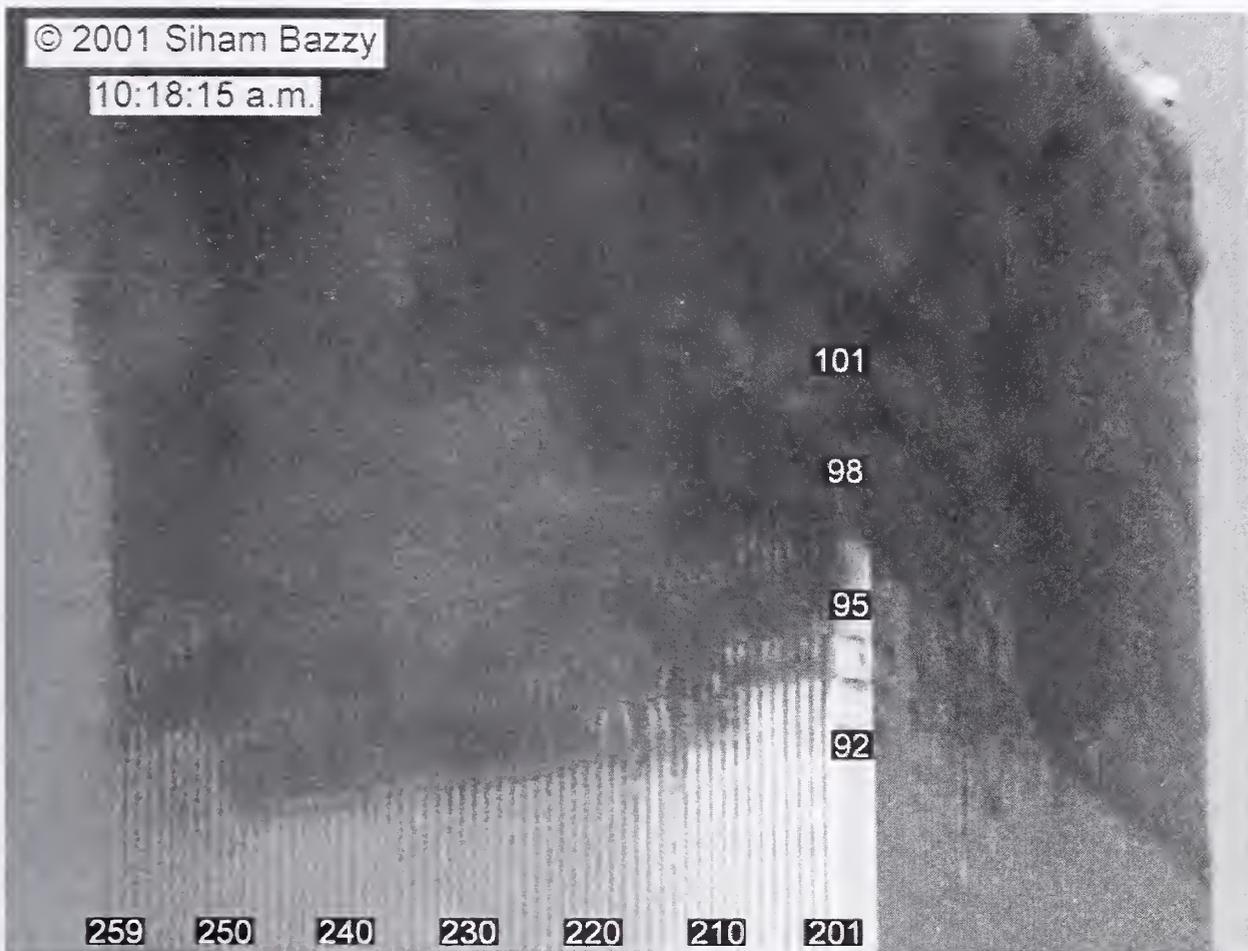
Figure 8-102 shows a view of the east face of WTC 1 recorded at 10:18:15 a.m. The face is still partially obscured by dust rising from below. The fire distribution is similar to that derived from the partial view of the east face shown in Figure 8-86 at 10:17:33 a.m. The largest fire is on the 98th floor and extends from roughly window 98-210 to window 98-228. There still appears to be some flame extension from open windows, but the large flames evident in Figure 8-86 are not present. Flames fill several adjacent windows on the 97th floor centered near window 97-244. Flames are also present on the 96th floor, but do not appear as intense as those seen on the 97th floor. There is definitely a fire burning higher up on the 101st floor near window 101-225. Recall that this fire was also visible in Figure 8-86, but that its presence could not be definitely confirmed due to the intense fire burning lower down on the 98th floor.

Figure 8-102. This cropped photograph showing the east and north faces of WTC 1 was shot at 10:18:15 a.m. It has been enhanced by adjusting the intensity levels. Column and floor numbers have been added.

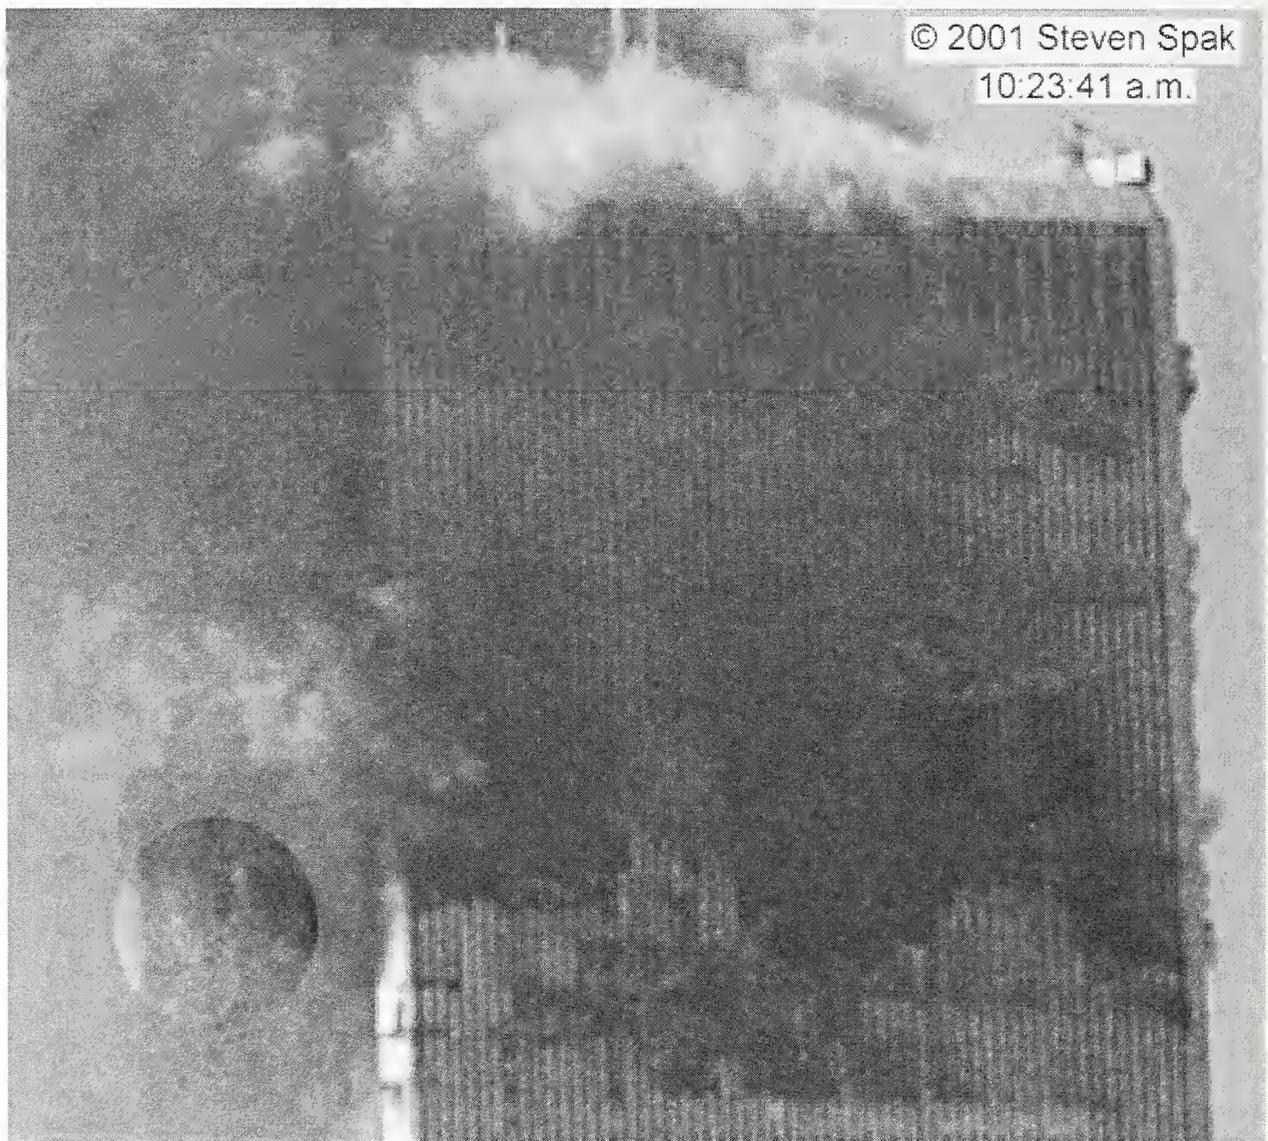
Figure 8-103. This cropped photograph shows the north face and an oblique view of the east face of WTC 1 at 10:23:41 a.m. The intensity levels in an area of the east face have been adjusted to highlight an area of extended flame.

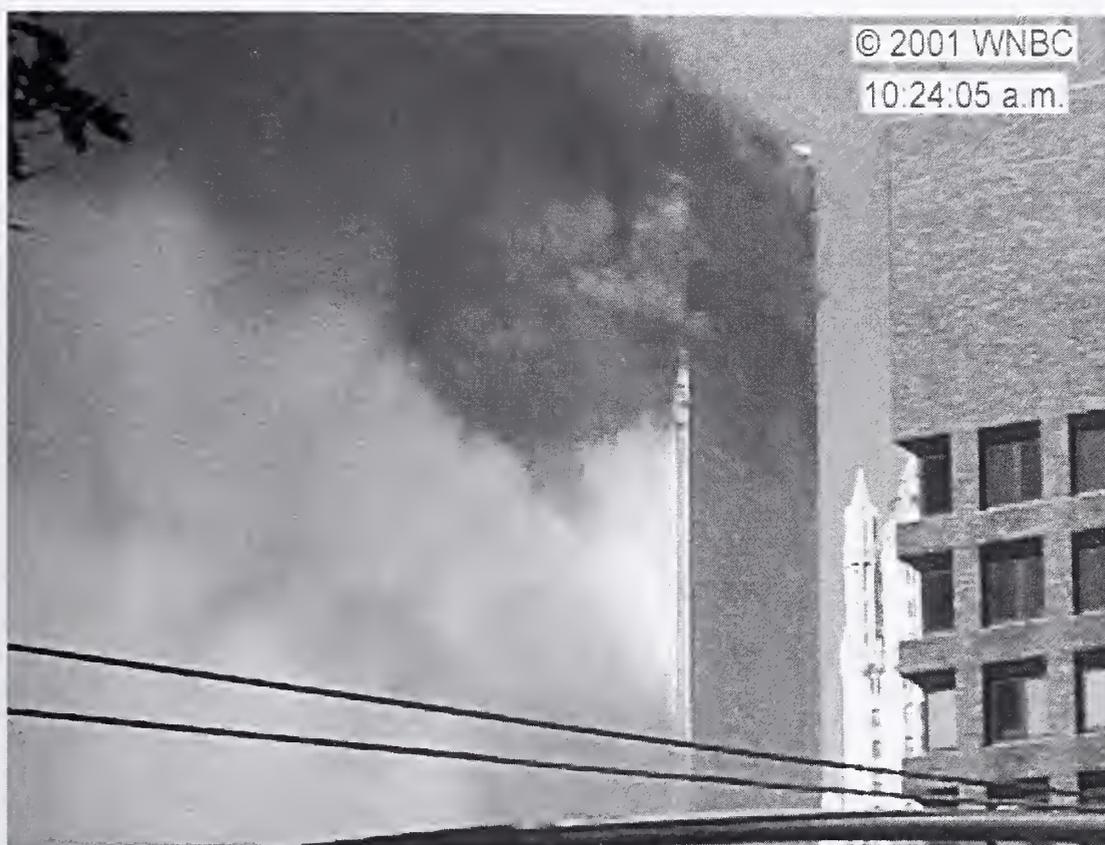
An image of the east face shown in Figure 8-104 taken from a video recorded at 10:24:05 a.m. provides another view of the fire burning on the south side of the 98th floor east face. Since this image was recorded from further east than Figure 8-103, it is easier to identify the location of the burning area. It does extend from near the center of the face toward the south. An area of fire on the 97th floor is visible immediately below. At 10:18:15 a.m. a similar area of fire was visible near window 97-245 (see Figure 8-102). This location is consistent with the apparent position of the fire in Figure 8-104. This suggests the intense fire present on the 98th floor roughly covers windows 98-230 to 98-245.

Figure 8-104. This frame was taken from a video recorded at 10:24:05 a.m. It was shot from the northeast and shows the north and east faces of WTC 1. The image has been enhanced by adjusting the intensity levels.

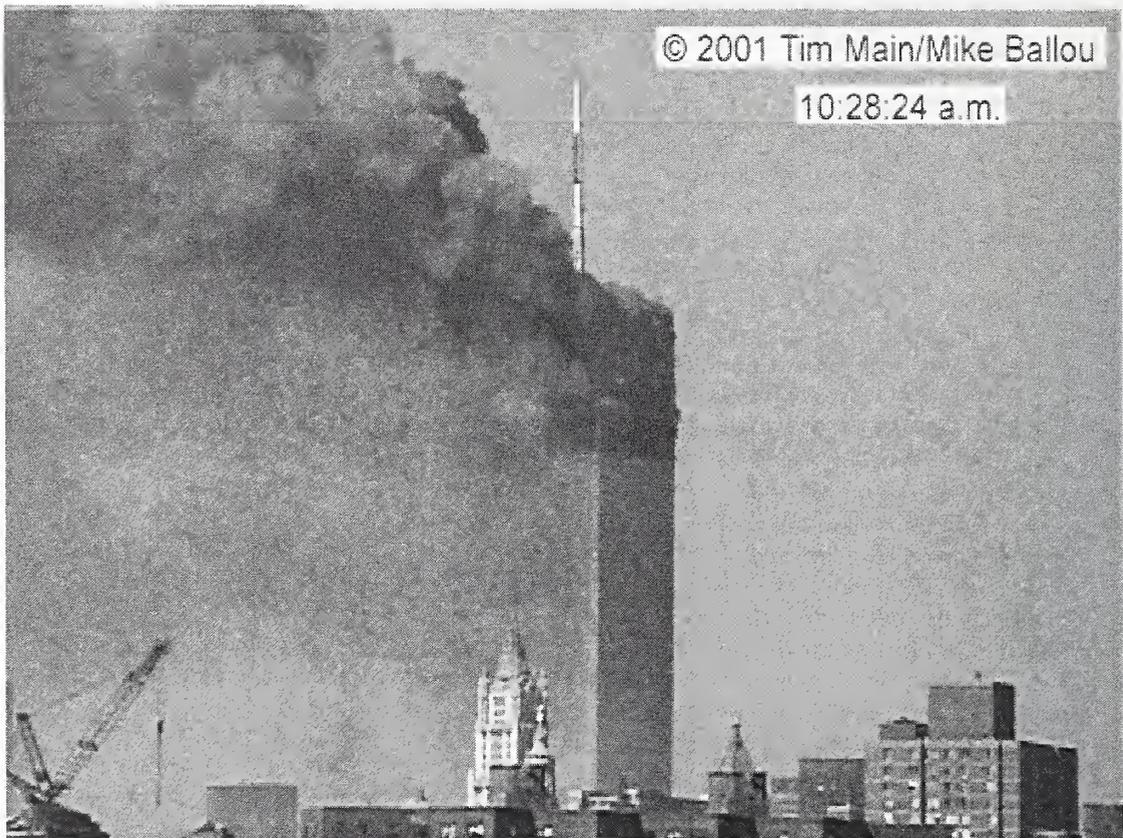
Roughly three seconds prior to the initiation of collapse at 10:28:22 a.m., the line of fire began to brighten noticeably, and intensely burning flames were coming from the 98th floor as the collapse began. As observed on the north face, flames were expelled from the east face by the pressure increase generated by the collapse. Figure 8-105 shows a frame taken from one of the long-range videos roughly two seconds after the collapse of WTC 1 began. The fire expelled from the 98th floor on the southern side of the east face is very bright. There was no apparent expulsion of fire from lower floors on this face. This supports the conclusion that the fire on the 98th floor was the largest fire present on this face at the time of collapse. In this same video a flame appeared much higher up on the south side of the east face roughly one and a half seconds after Figure 8-105 was recorded. It has not been possible to identify the origin of this expelled flame, but it does suggest that a fire was burning on a higher floor on this side of the tower.

Figure 8-105. This frame taken from a video recorded at 10:28:24 a.m. shows WTC 1 from the northeast.

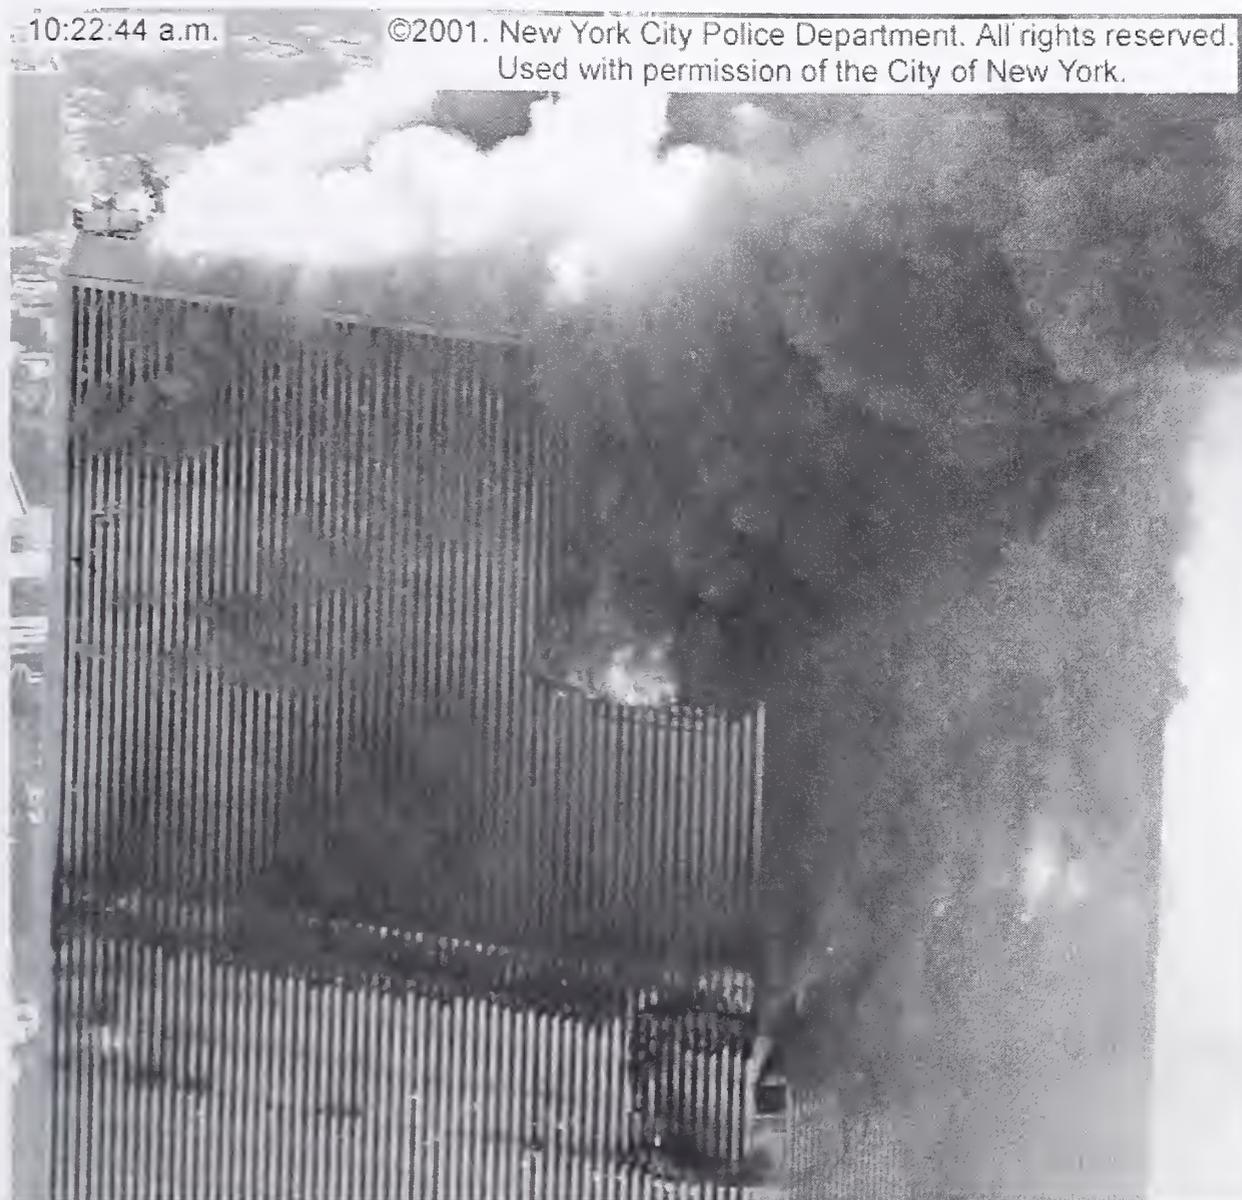
Figure 8–106 shows WTC 1 shot from the southwest at 10:22:44 a.m. The photographer was in a helicopter looking down on the tower. Individual floors are identifiable. Floor numbers can be assigned by noting that the floor with the missing aluminum panel on the southwest corner is the 96th floor. Fires are visible on both the south and west faces. Focusing on the south face, the most prominent feature is a flame jet emanating from an open window on the 98th floor on the east side. Flames are also coming out of nearby windows on this floor. Regions of fire are also visible on the 99th floor at locations starting on the west side of the face and reaching a position just to the east of the center of the face. From this angle, there are no flames evident on the 97th floor. Otherwise, the flame distribution is consistent with that described above.

Figure 8-106. This cropped photograph showing the south and west faces of WTC 1 was shot from a helicopter at 10:22:44 a.m. It has been enhanced by adjusting the intensity levels.

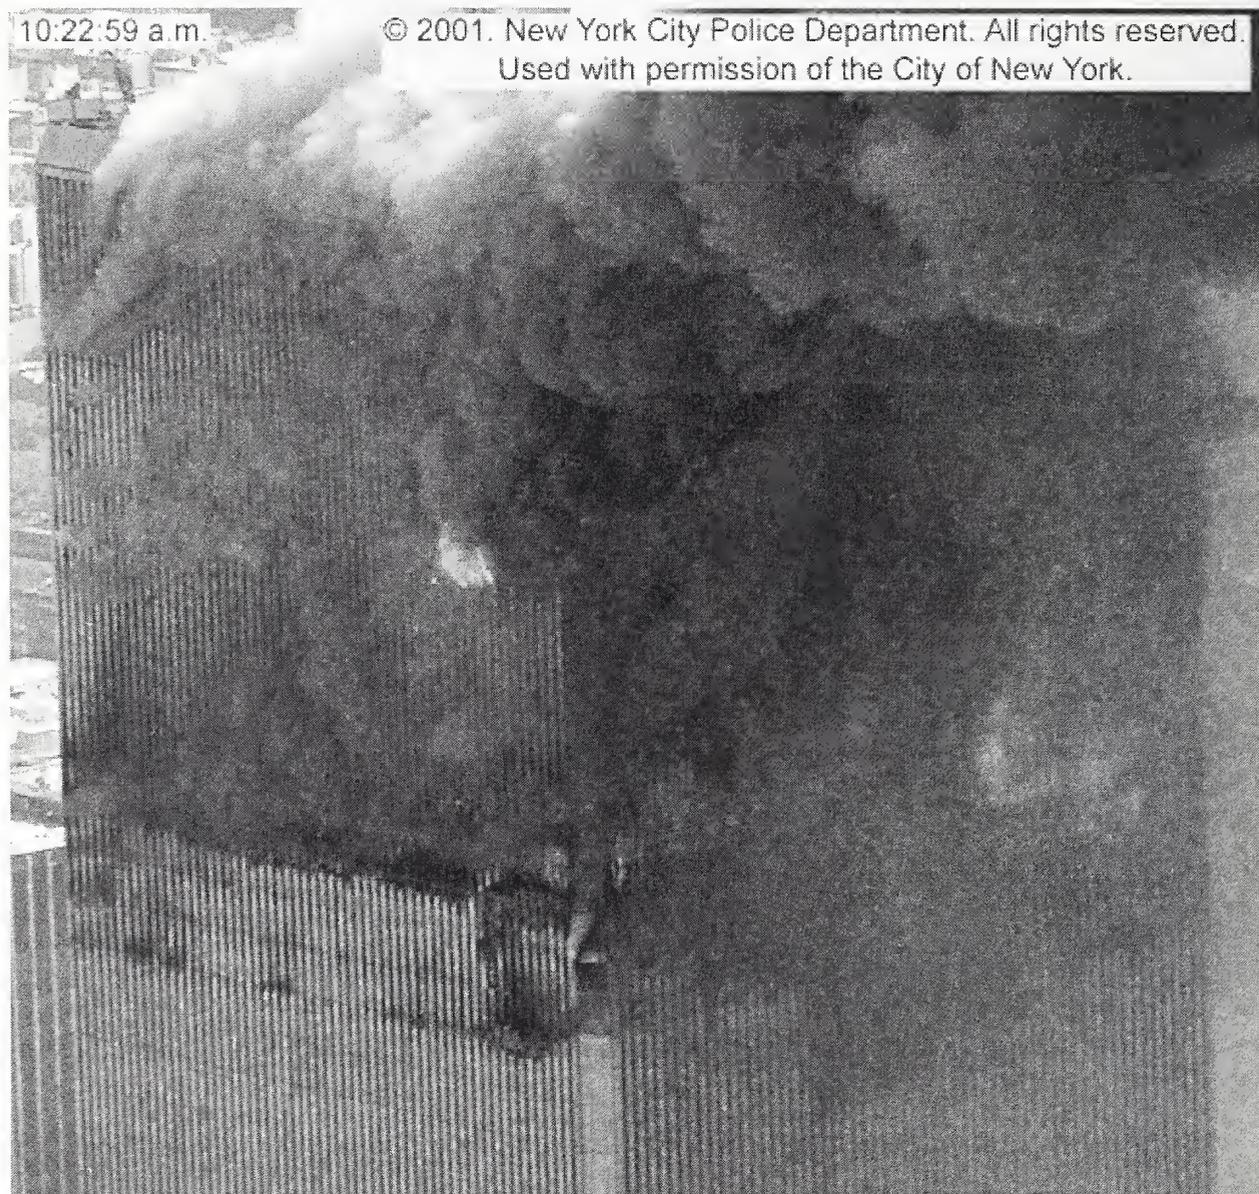
As the helicopter flew toward the south, the photographer continued to take pictures. Figure 8–107 shows a photograph taken 15 s later at 10:22:59 a.m. Since the helicopter was further south, this image has a more direct view of the south face than in Figure 8–106, and the view of the west face is from a more oblique angle. The fire distributions on both faces look quite different in the two photographs. This demonstrates the strong effects that the angle from which an image is taken can have on fire observations.

Figure 8-107. This cropped photograph showing the south and west faces of WTC 1 was shot from a helicopter at 10:22:59 a.m. It has been enhanced by adjusting the intensity levels.

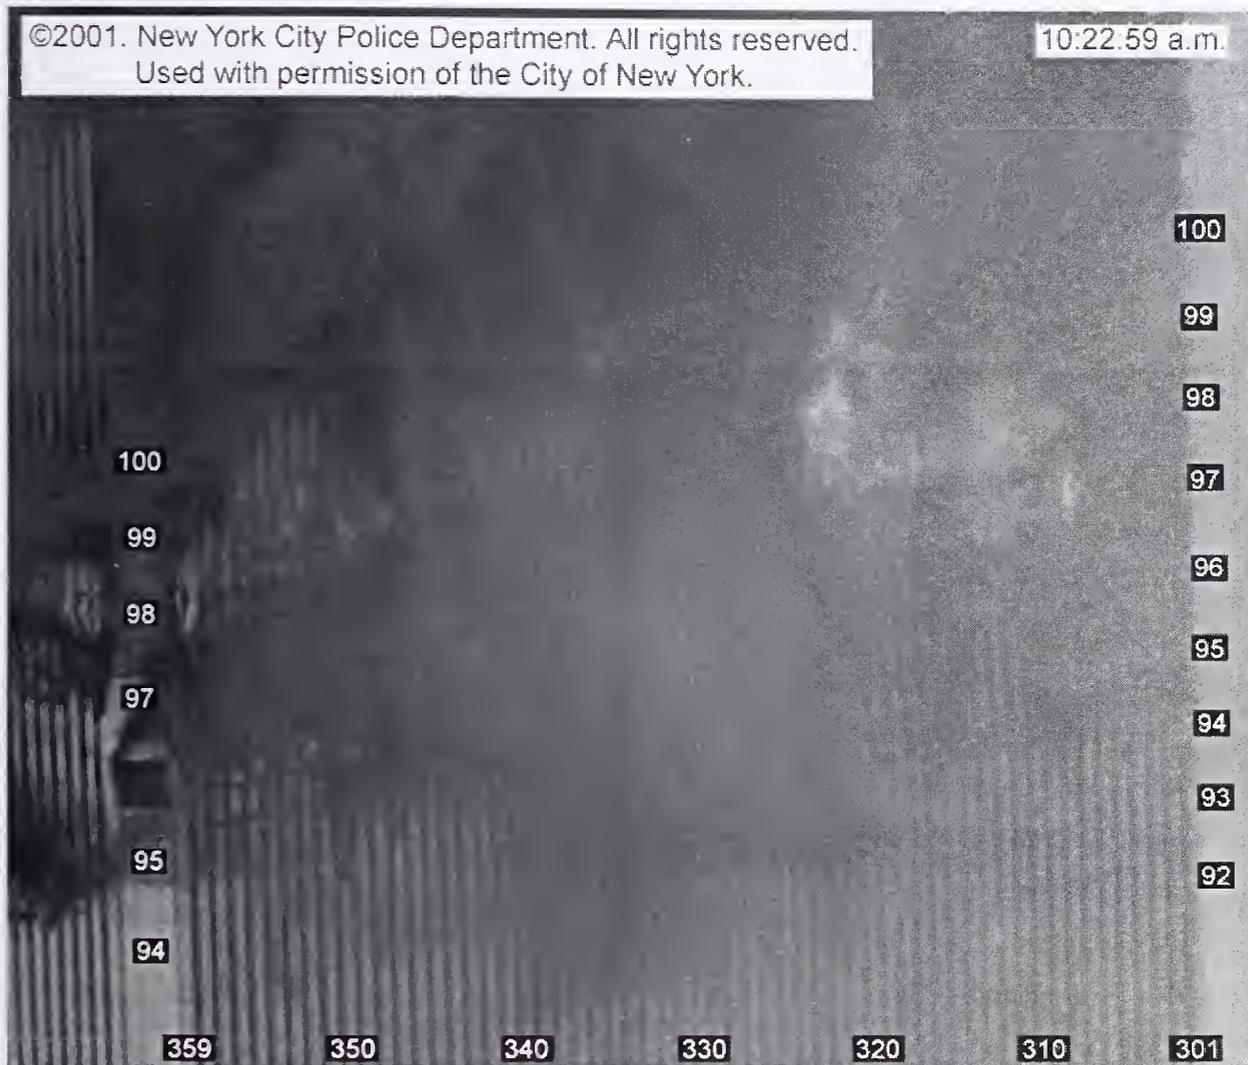
An important observation is readily apparent in Figure 8–108. Many of the columns on the south face in the vicinity of the 95th floor to 98th floors were bowed inward at this time. The easiest way to identify this bowing is to start lower down on the building and use your eyes to follow a particular column upward. The bowing appears as a curvature in the column. The bowing is most apparent on the eastern side of the face. It may be present on the western side as well, but it is more difficult to identify because of angular effects along with the blackening of the column covers on the western side of the face. Recall

that this blackening occurred as a result of the heavy smoke released on this side of the face by earlier fires on the 95th and 96th floors. The degree of column bowing is analyzed in the Investigation report dealing with the structural steel (NIST NCSTAR 1-3C) and compared with building response calculations in NIST NCSTAR 1-6.

Figure 8-108 shows that there were extensive fires on the south face of WTC 1 at 10:23 a.m. There is visual evidence for the presence of active fires on the 92nd floor upward through at least the 101st floor. Consistent with conclusions based on long-range images, the most intense fire is on the east side of the 98th floor. Flames that appear to be at least two stories in height are coming from windows 98-308 to 98-322. There are also large fires visible on the east side of the 97th floor and the west side of the

99th floor. On both floors the flames cover roughly half the width of the tower. In this photograph the flames on these floors do not appear to extend from the open windows. In reviewing the videos, it is clear that flames on both floors occasionally formed large external flares around this time. In fact, such a flare is visible coming from near window 97-308 in another photograph (not shown) taken from the helicopter at 10:22:50 a.m.

Figure 8-108. This photograph showing the south face of WTC 1 is a blowup of a portion of Figure 8-107. It was shot from a helicopter at 10:22:59 a.m. It has been enhanced by adjusting the intensity levels, and column and floor numbers have been added.

It is interesting that the fires on the 97th and 98th floors do not appear to have spread to the east end of the face. The last window with fire on the 97th floor appears to be window 97-308. A check of the floor plan layout in Figure B-6 shows that there was a room in the southeast corner of this floor with walls at columns 97-256 and 97-308. Recall that the fire spreading south on the east face of this floor did not appear to have reached the south edge at this time. These observations suggest that the walls of this room were acting as a fire barrier. A similar room was present and acting as a fire barrier on the 98th floor (see Figure B-7).

At some point between 10:24:20 a.m. and 10:24:55 a.m., heavy smoke began to pour from one or more south face windows on the 94th floor near the west edge. A burst of external flame occurred in the area at 10:25:10 a.m. In Figure 8–108 heavy flames and smoke can be seen coming from window 94-405 on the west face at 10:22:59 a.m. This window was located in a southwest corner room with walls at columns 94-405 and 94-353 (see Figure B-3). These observations indicate that the fire moving south along the west wall of the 94th floor entered this room and created flashover conditions around 10:23 a.m.

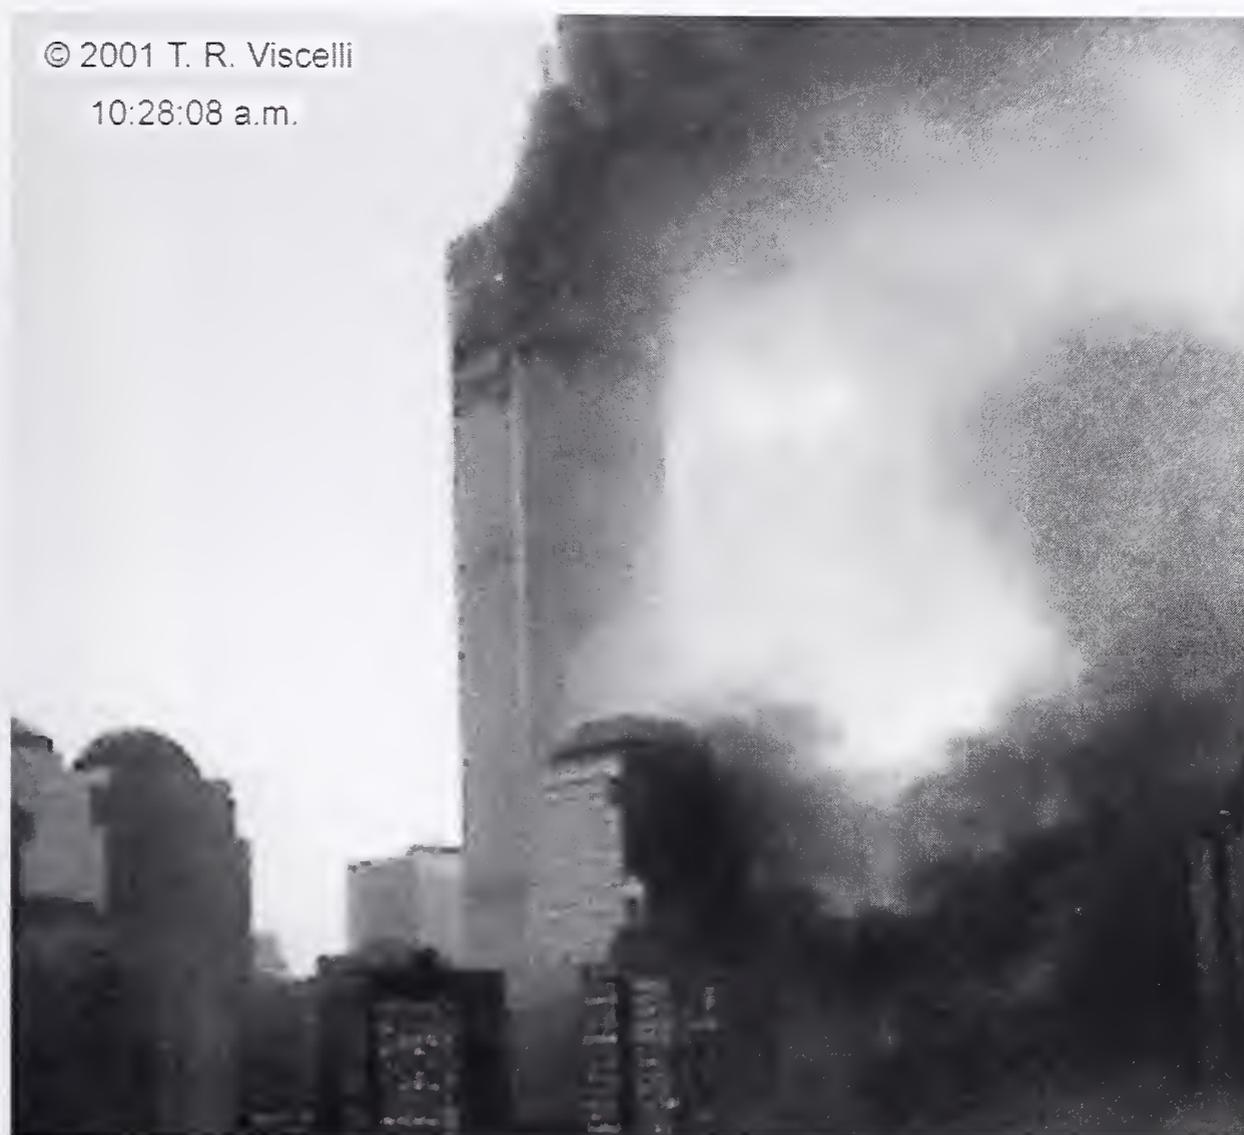
Figure 8–109 shows a long-distance photograph of WTC 1 that was shot at 10:28:08 a.m., i.e., 14 s prior to collapse. Even at this distance the intense fires burning on the east side of the south face on the 98th and 99th floors are readily apparent.

Figure 8-109. This cropped photograph taken from the south southwest shows WTC 1 at 10:28:08 a.m.

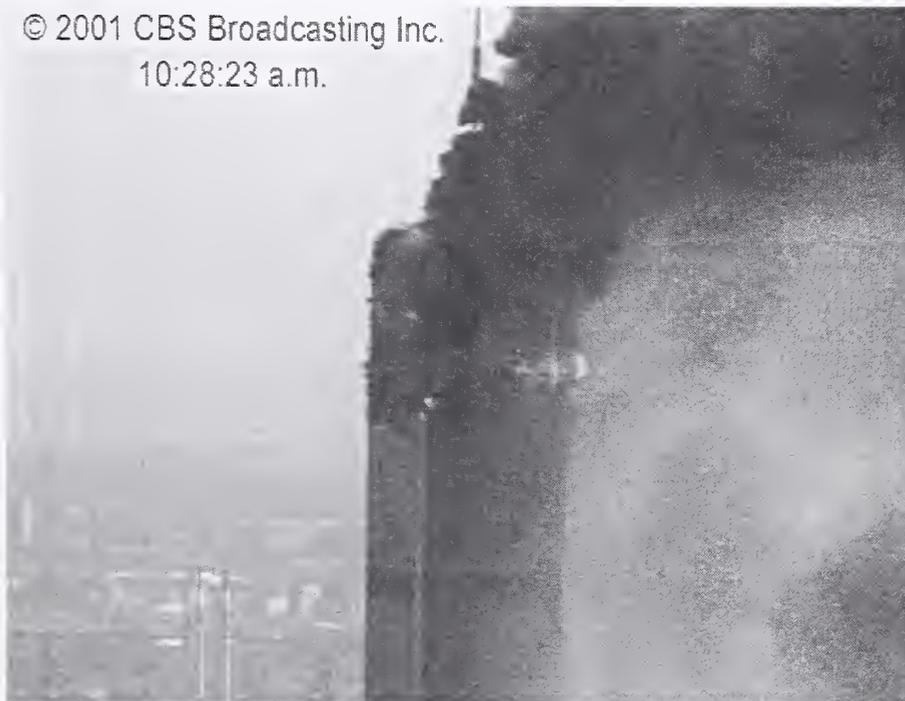
At 10:28:22 a.m. WTC 1 began to collapse. Unfortunately, the long-distance helicopter video is not particularly clear at this time. Even so, it is possible to see a large amount of flame being pushed from the tower on the south face by the pressure increase due to the collapse. The expelled fire appears to come from three separate locations on the south face. The first is from the vicinity of the intense fire burning on the east sides of the 98th and 99th floors. The second is from the fire burning on the western edge of the 94th floor. The location of the third area was more difficult to identify. It appears to come from the center of the eastern half of the face from near the 94th floor. It created a huge flame that at first was driven downward. So much fuel and heat were pushed out of the tower that a fireball formed and began to rise. The fireball burned out nearly 4 s after the collapse began.

Figure 8-110. This image showing the south face of WTC 1 was taken from a video shot from a news helicopter at 10:28:23 a.m. The intensity levels of the image have been adjusted. Two areas showing flames that were pushed out of the tower as it started to collapse are highlighted.

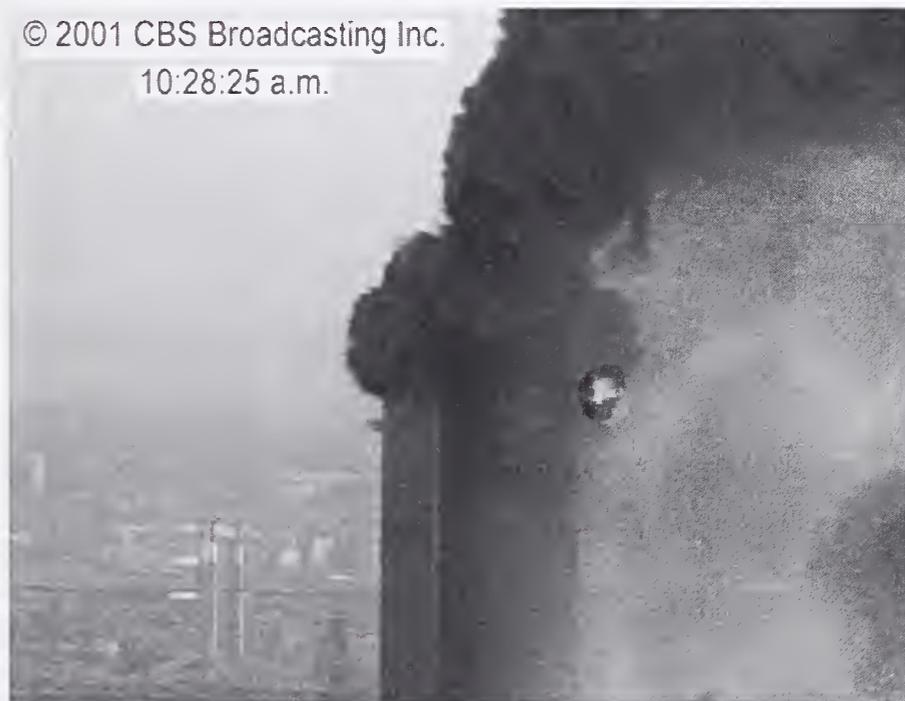
Figure 8-111. This image showing the south face of WTC 1 was taken from a video shot from a news helicopter at 10:28:25 a.m. The intensity levels of the image have been adjusted. An area showing a fireball generated by fire pushed from the tower by the collapse is highlighted.

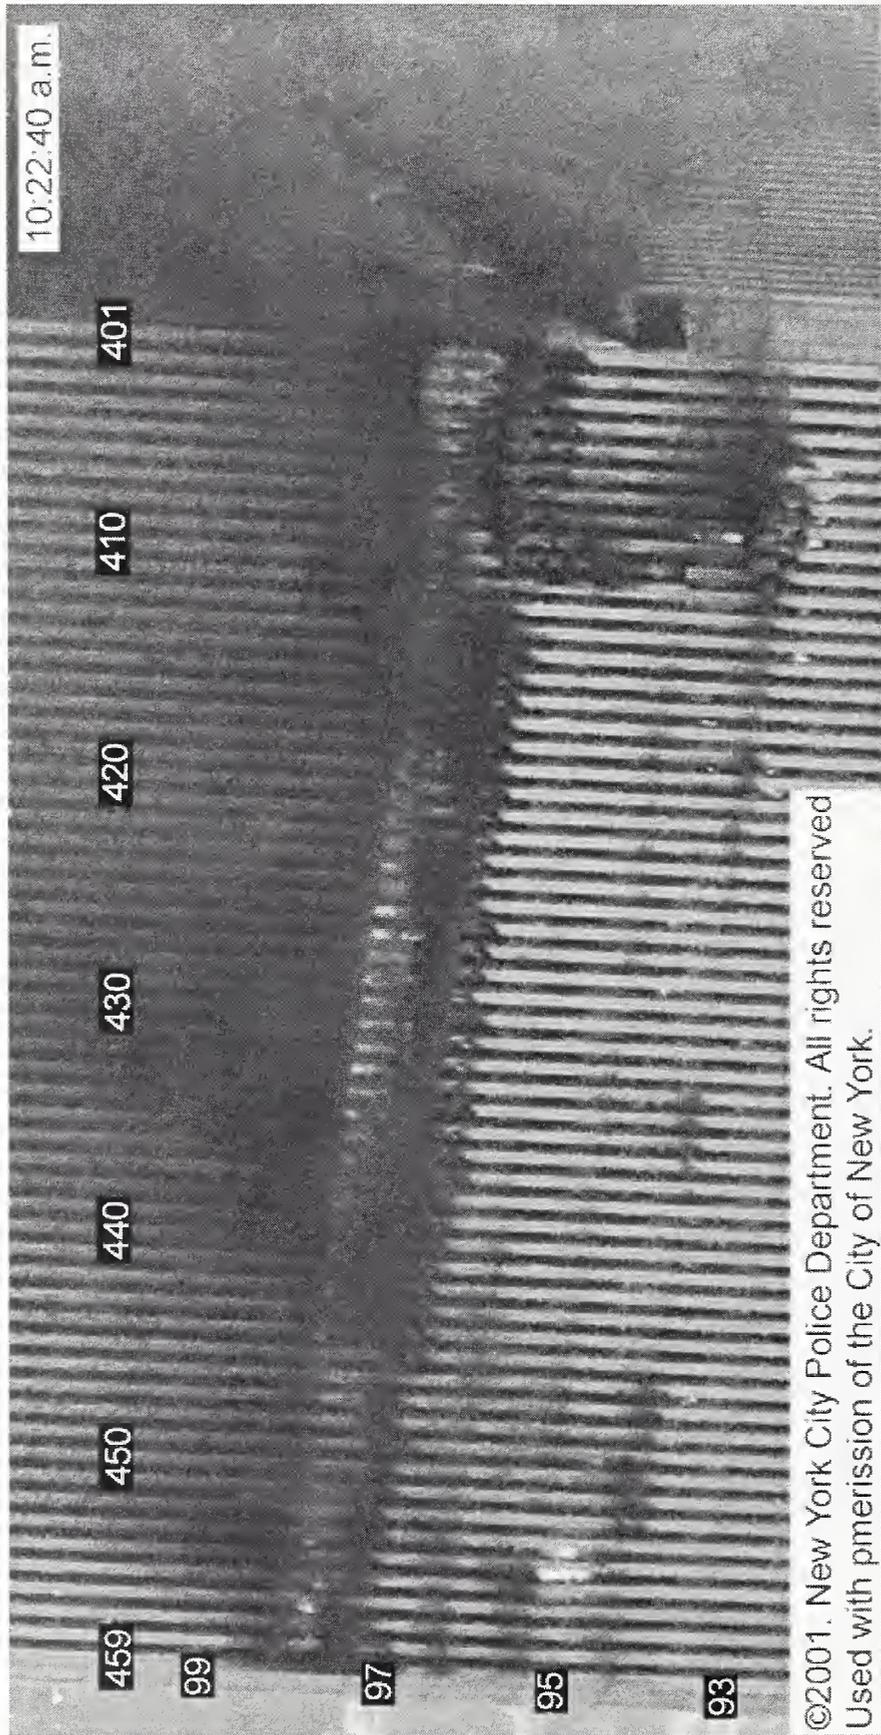
A close-up photograph of the west face taken at 10:22:40 a.m. from a helicopter looking down on the tower is shown in Figure 8–112. Fires are visible on the 94th, 95th, and 98th floors. In general, the fire distributions are consistent with the discussion immediately above.

On the 94th floor fires can be seen at many locations between windows 94-405 and 94-448. Most of the fires are burning at isolated locations near the floor. The only window where flames are protruding out is 94-405. The presence of carets on nearby column covers is consistent with the intense fire seen earlier at windows 94-407 and 94-408. The smoke marks at the tops of the column covers indicate that at many locations only light smoke or no smoke had passed through the open windows. This agrees with earlier observations that the fires burning on the west side of the 94th floor were relatively gentle at most locations. In Figure 8–112 windows 94-438 to 94-441 appear to be open, and flames are visible in windows 94-438 to 94-440. These windows were clearly intact at 9:47:34 a.m. in Figure 8–72. The floor plan layout in Figure B-3 indicates that these four windows were located in a room with walls at columns 94-438 and 94-441. Fire had clearly spread into this room since 9:48 a.m. Many other windows on this floor that had intact glass at the earlier time are also open in Figure 8–112.

Figure 8-112. This cropped photograph was shot from a helicopter at 10:22:40 a.m. and shows the west face of WTC 1 from above. The image has been enhanced by adjusting the intensity levels, and column and floor numbers have been added.

Fires are visible on the 95th floor over most of the length of the west face. At most locations the fires look similar to those on the 94th floor, appearing to burn with low intensities near the floor. Exceptions are the most intense flames located in the room having walls at columns 95-452 and 95-456 (see Figure B-4) and the fire in windows 95-408 to 95-411. The fire on the north side has already been described, while the fire on the south side is located next to a room with walls at columns 95-404 and 95-408. Over most of this floor there are no smoke marks on the column covers despite the wide spread fires. This observation most likely means that the smoke from fires on this side of the 95th floor vented within the building elsewhere.

From the angle from which Figure 8-112 was taken the internal fires on the 98th floor are only visible near the center of the floor and at a few locations on either end. This fire has clearly died down considerably since Figure 8-92 was taken at 10:18:01 a.m. Carets are visible at the tops of the column covers near the two ends, but very little marking is evident elsewhere. This suggests that the only places flames came out of windows were from fires burning inside the corner rooms (see Figure B-7). Consistent with earlier observations, the absence of column cover marks elsewhere indicates that neither fire nor smoke flowed from most 98th floor windows on the west face where fire was present.

There are no indications of fire or open windows on the west side of the 92nd floor or 93rd floor. Apparently fires burning elsewhere on these floors had not yet reached this face.
