**NIST NCSTAR 1-5A
Federal Building and Fire Safety Investigation of
the World Trade Center Disaster**

**Visual Evidence, Damage Estimates,
And Timeline Analysis**

Visual Evidence, Damage Estimates, and Timeline Analysis

September 2005

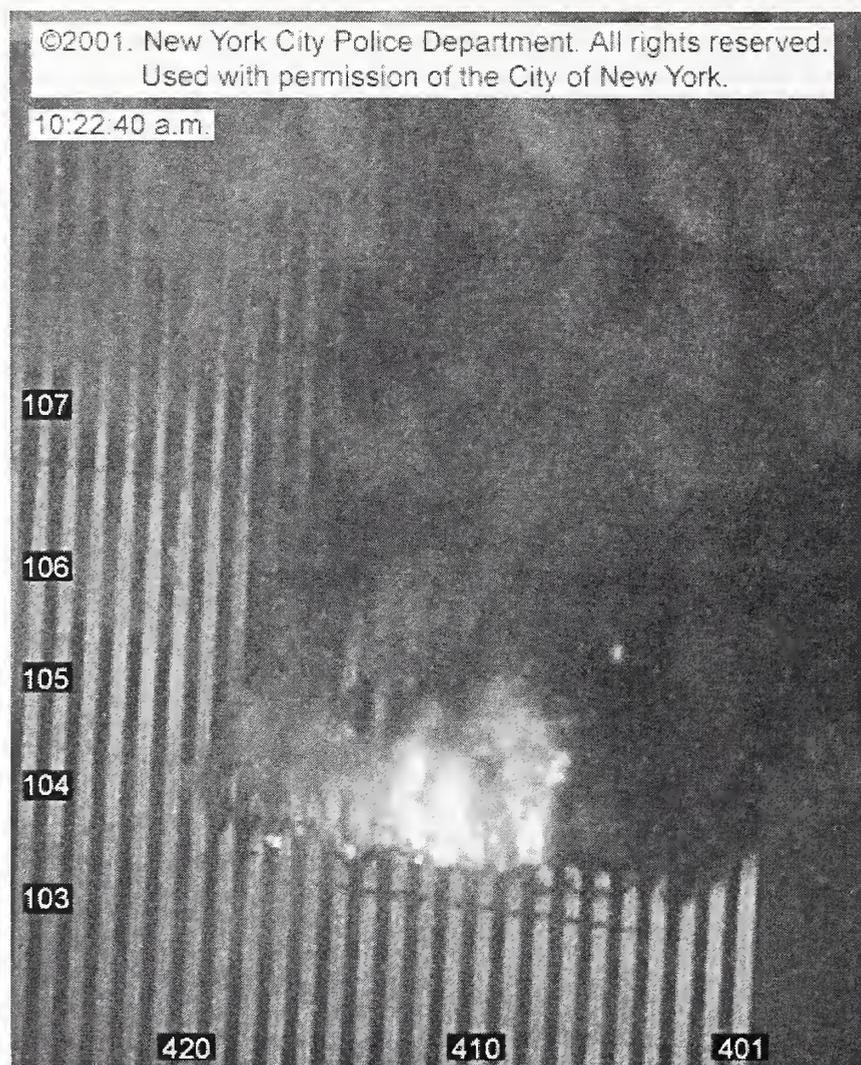
An image of the fires on the 104th floor at 10:22:40 a.m. is shown in Figure 8-113. It was cropped from the same photograph as Figure 8-112. It shows that after first appearing twenty minutes earlier, this fire continues to burn very intensely with long flames extending out of the windows. Visible flames and column cover smoke marks indicate this fire has burned from window 104-403 to window 104-418. Despite the intensity of the fire, it has not spread significantly since its initial growth period, as indicated by comparison with earlier photographs.

Figure 8-113. This cropped photograph shows a view of the west face of WTC 1 shot looking down from a helicopter at 10:22:40 a.m. The image has been enhanced by adjusting the intensity levels, and column and floor numbers have been added.

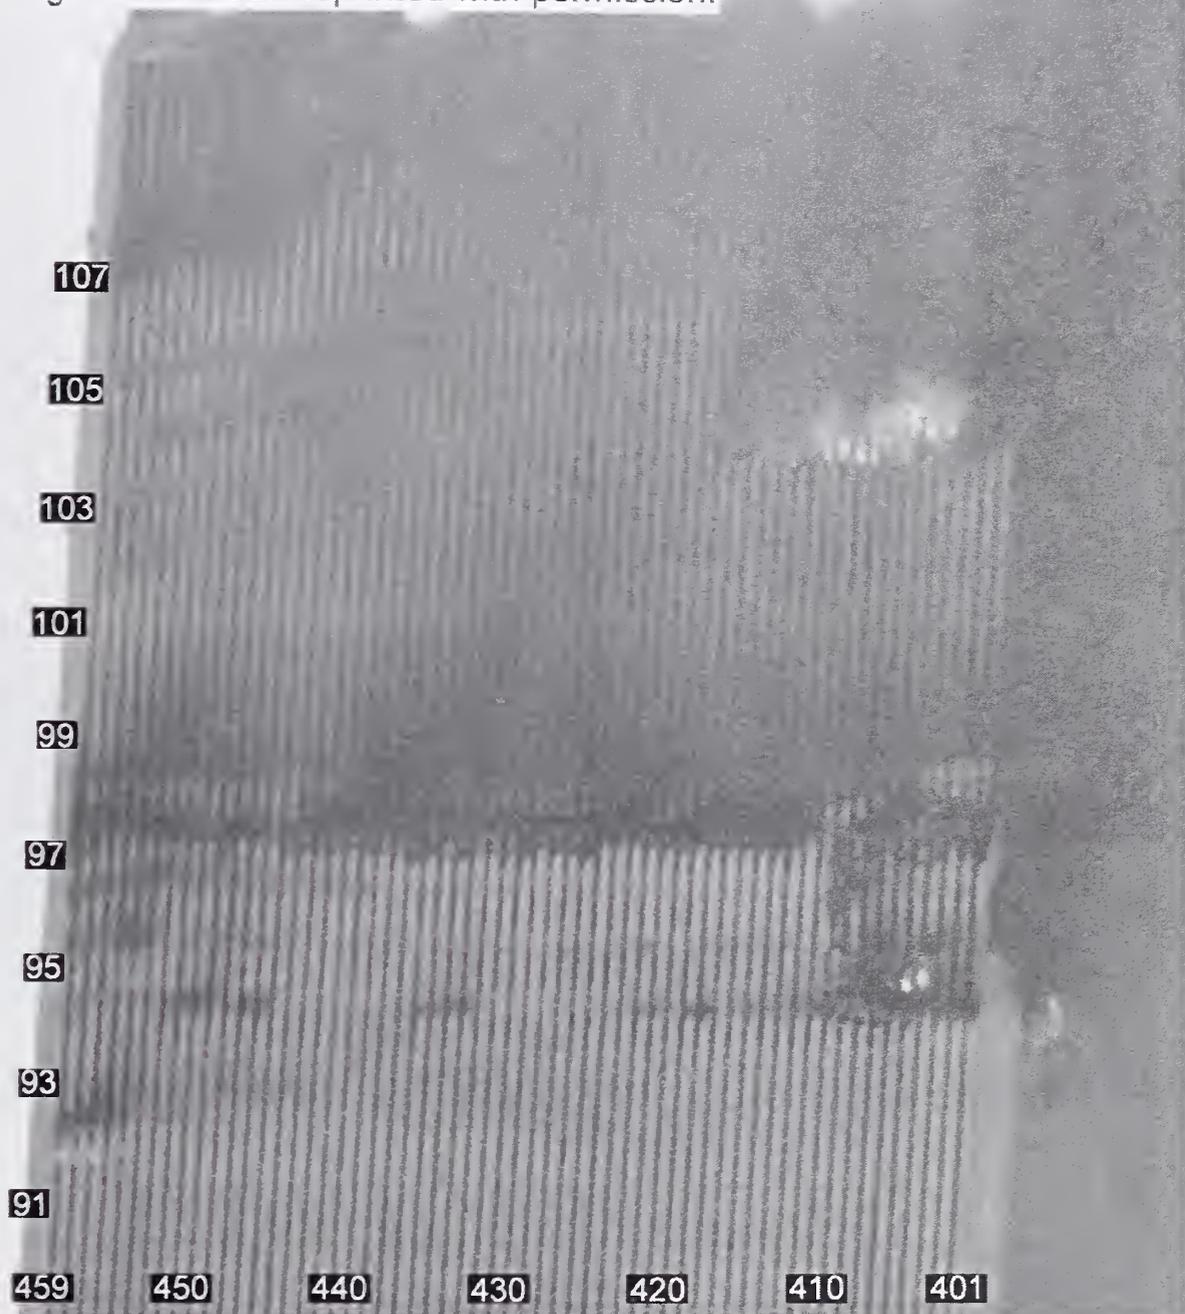
Close-up imagery of the west face over the next several minutes was very limited. Figure 8-114 shows an image of the face recorded at 10:26:54 a.m. that provides sufficient resolution to resolve windows and floors. Fires are visible at several locations on the face. Some changes have taken place since Figure 8-112 was taken at 10:22:40 a.m. Fire has appeared in the two adjacent rooms nearest the northwest corner of the 92nd floor (see Figure B-1), which have walls at columns 92-452 and 92-455 and share an east wall that terminates at column 92-105. Flames are now present in windows 92-454 to 92-458. Videos shot from the northwest and southwest show that heavy smoke first appeared in this area at 10:25:21 a.m. As already discussed, a similar stream of smoke came from window 92-101 on the north face at 10:24:26 a.m. These observations indicate that flashover occurred in these rooms around this time.

Flames are also visible in Figure 8-114 on the 94th floor in windows 94-101 to 94-104 that were not visible in Figure 8-112. This is consistent with the conclusion (discussed above) that flashover occurred in the southwest corner room of this floor (see Figure B-3) around 10:23 a.m. Flames also extend a significant distance from open windows in this room on the south face.

In the earlier photograph (Figure 8-112) a bright flame was evident at window 95-408 on the 95th floor, but windows further to the south appeared to be closed. In Figure 8-114 bright fires can be seen in windows 95-404 and 95-405. This indicates that fire had entered the room along the west face having walls at columns 95-404 and 95-408 (see Figure B-4). Based on this photograph, the windows in the corner room with walls at columns 95-350 and 95-404 may still be closed.

The interior fire near the center of the 98th floor is still visible in Figure 8-114. Flames are also visible in the windows located in the room on the 95th floor that had walls at columns 95-452 and 95-456, but the flames appear to have died down somewhat since 10:22:40 a.m. The flames seen at other locations on the

Figure 8-114. This cropped photograph showing the west face of WTC 1 was taken at 10:26:54 a.m. The image has been enhanced by adjusting the intensity levels, and column and floor numbers have been added.

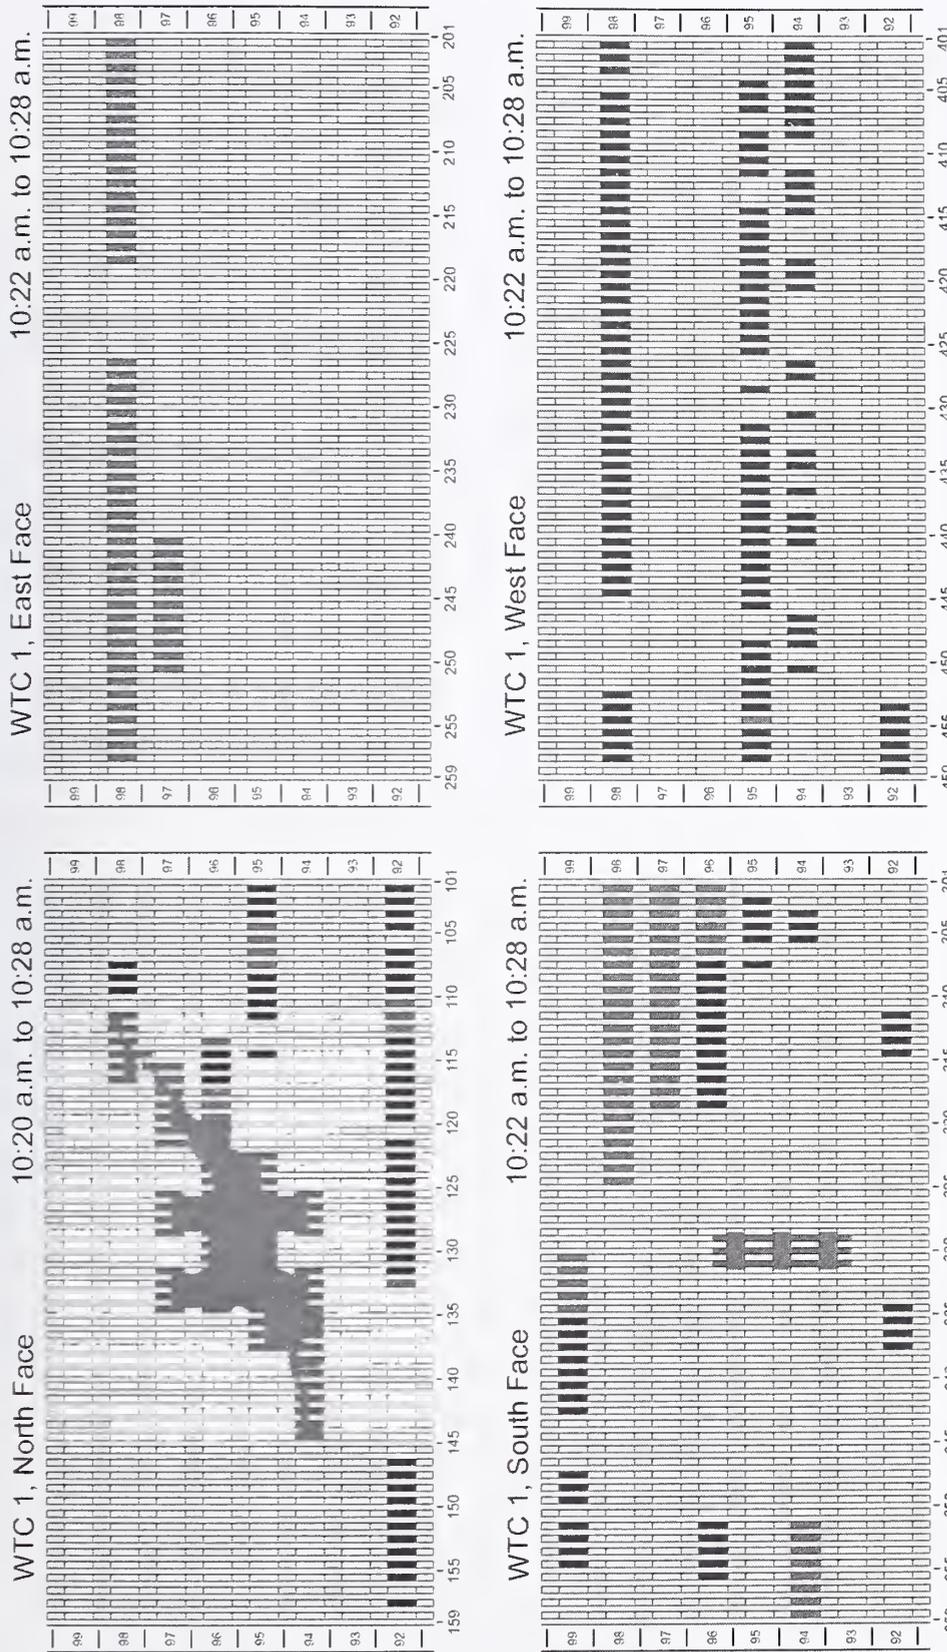
Figure 8-115. Maps of integrated fire observations between 10:20 a.m. and 10:28 a.m. are shown for the four faces of WTC 1. Colors represent the highest intensity fire observed in a window using the color scale defined in Figure 5-1.

With the exceptions of the 92nd floor, where a large fire burning on the north face worked its way around the northwest corner, and the 94th floor, where the fire spreading from the north passed around the southwest corner; only limited fire spread took place on the west face during the period. In general, fires that were burning on the 94th, 95th, and 98th floors earlier, while still widespread, became less intense and were less visible than earlier. A large fire on the west face that grew on the 104th floor shortly after the collapse of WTC 2 (not shown in Figure 8–115) continued to burn intensely throughout the period. Most of the 92nd floor, the exception being at the northern edge, and the 93rd floor appeared to be fire free on the west side when the tower collapsed.

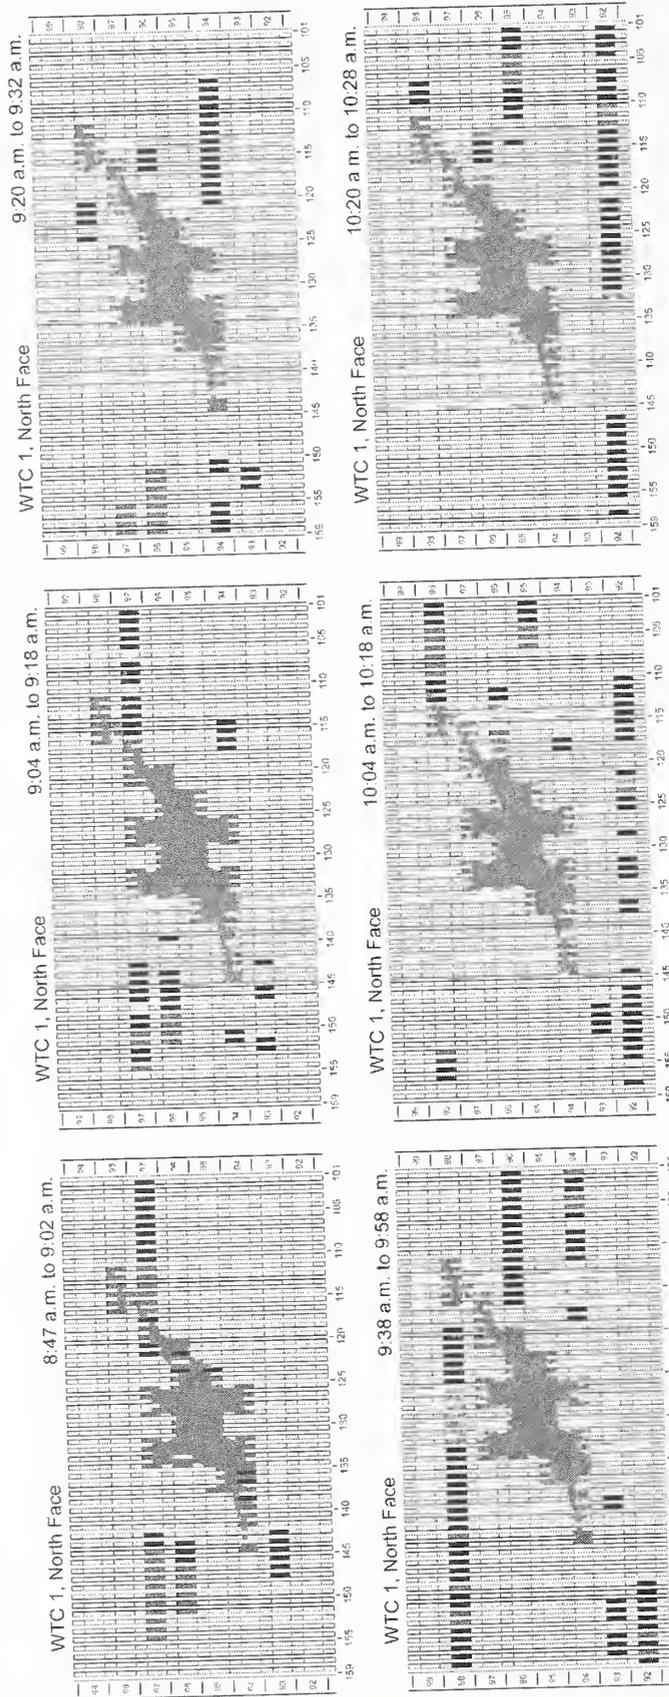
Figure 8-116. Maps of integrated fire intensity data for the north face of WTC 1 are plotted in sequence for the six time periods. Colors represent the highest intensity fire observed in a window using the color scale defined in Figure 5-1.

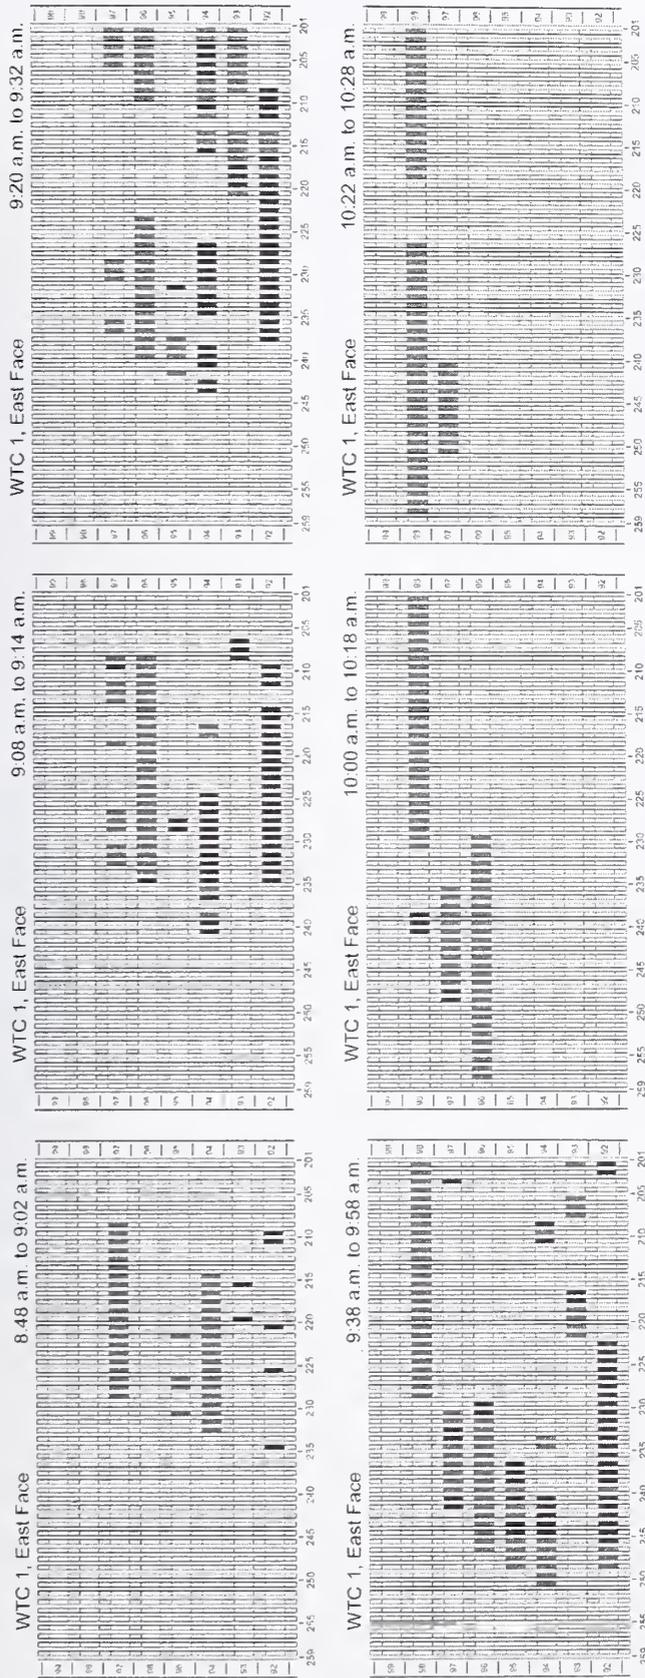
Figure 8-117. Maps of integrated fire intensity data for the east face of WTC 1 are plotted in sequence for the six time periods. Colors represent the highest intensity fire observed in a window using the color scale defined in Figure 5-1.

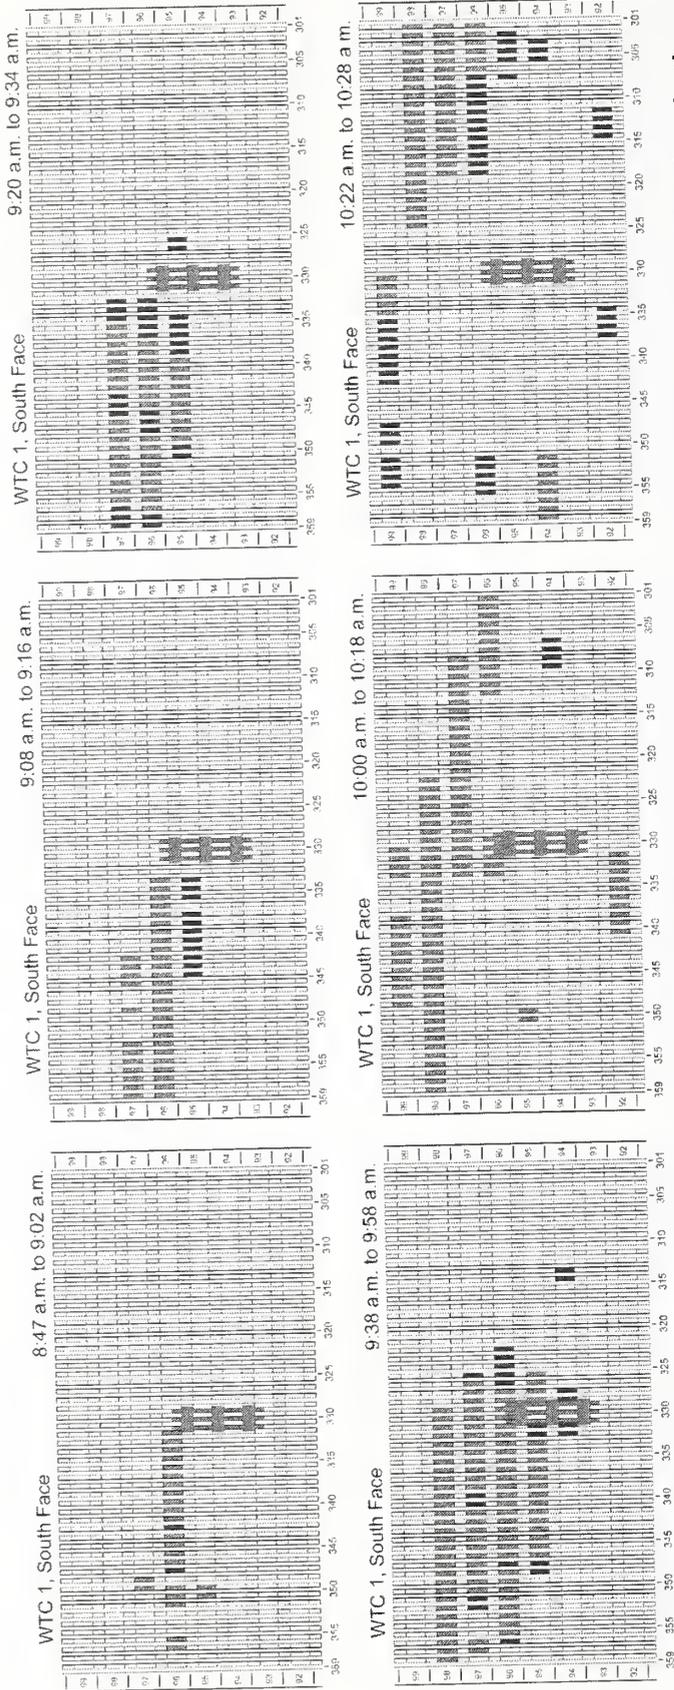
Figure 8-118. Maps of integrated fire intensity data for the south face of WTC 1 are plotted in sequence for the six time periods. Colors represent the highest intensity fire observed in a window using the color scale defined in Figure 5-1.

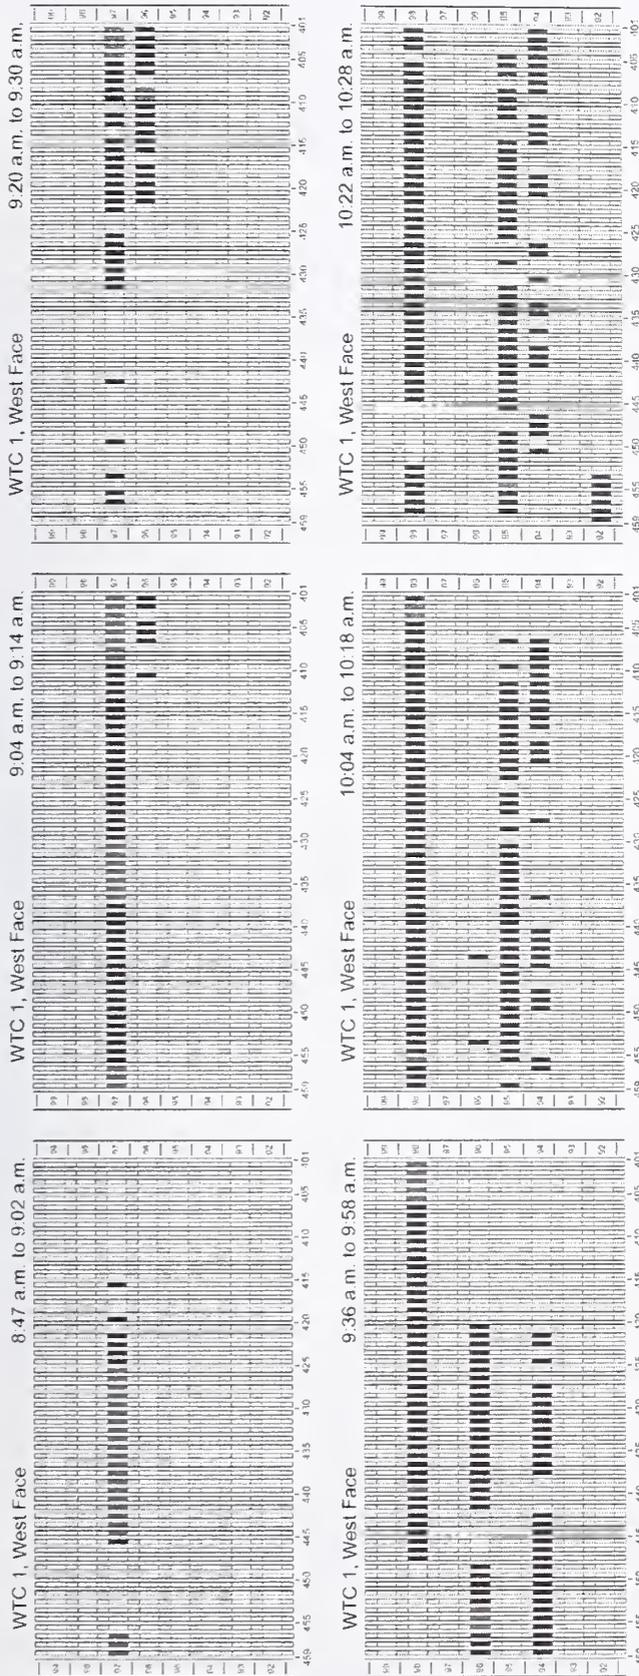
Figure 8-119. Maps of integrated fire intensity data for the west face of WTC 1 are plotted in sequence for the six time periods. Colors represent the highest intensity fire observed in a window using the color scale defined in Figure 5-1.

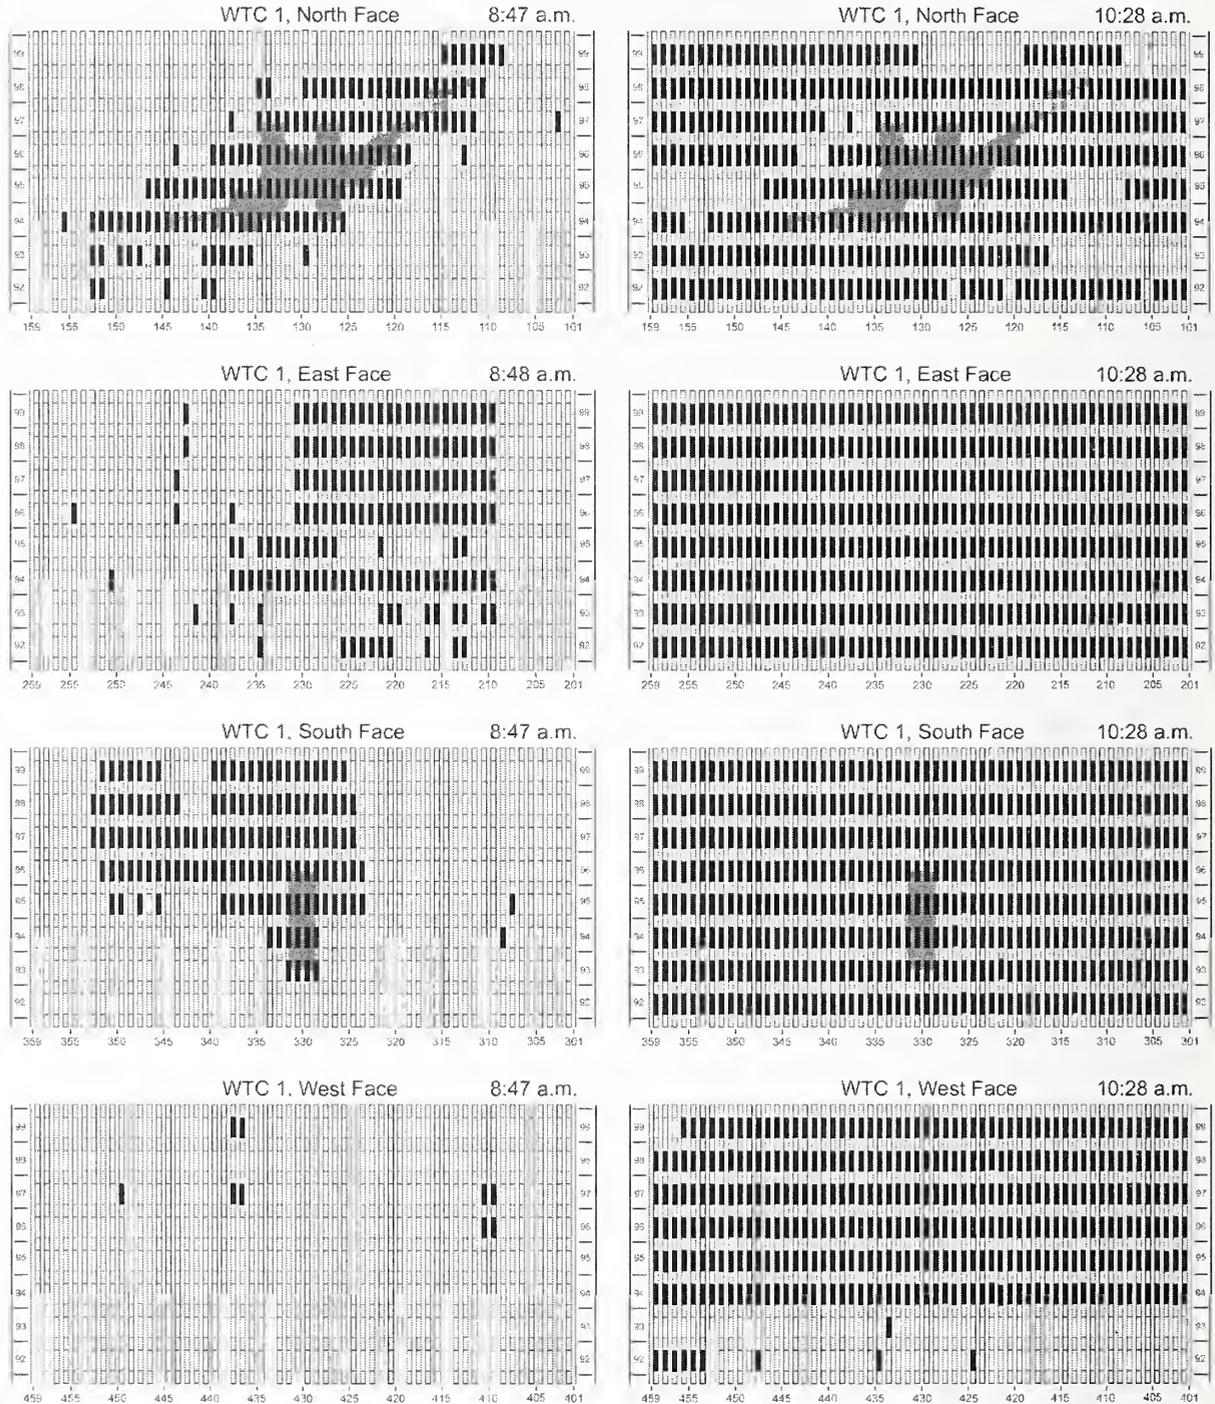
The information shown visually in Figure 8–120 is summarized numerically in Table 8–4 and Table 8–5. These two tables are similar to Table 8–2 and Table 8–3, which were generated using data from shortly after the aircraft impacted WTC 1 and just prior to the collapse of WTC 2. The results indicate that the total number of open windows on these floors increased by roughly 333 windows between 9:59 a.m. and 10:28 a.m. The increase in the number of open windows between the time from shortly after the aircraft struck WTC 1 and the collapse of the tower was approximately 1,048 windows, or a factor of 4.2. This corresponds to an increase in the open area on the façade available to provide air to the fires on these floors of around 12,190 ft².

Figure 8-120. Maps for the 92nd through the 99th floors compare missing windows for the four faces of WTC 1 at two times, immediately following the aircraft impact at 8:46:30 a.m. and just prior to the collapse of WTC 1 at 10:28:22 a.m.

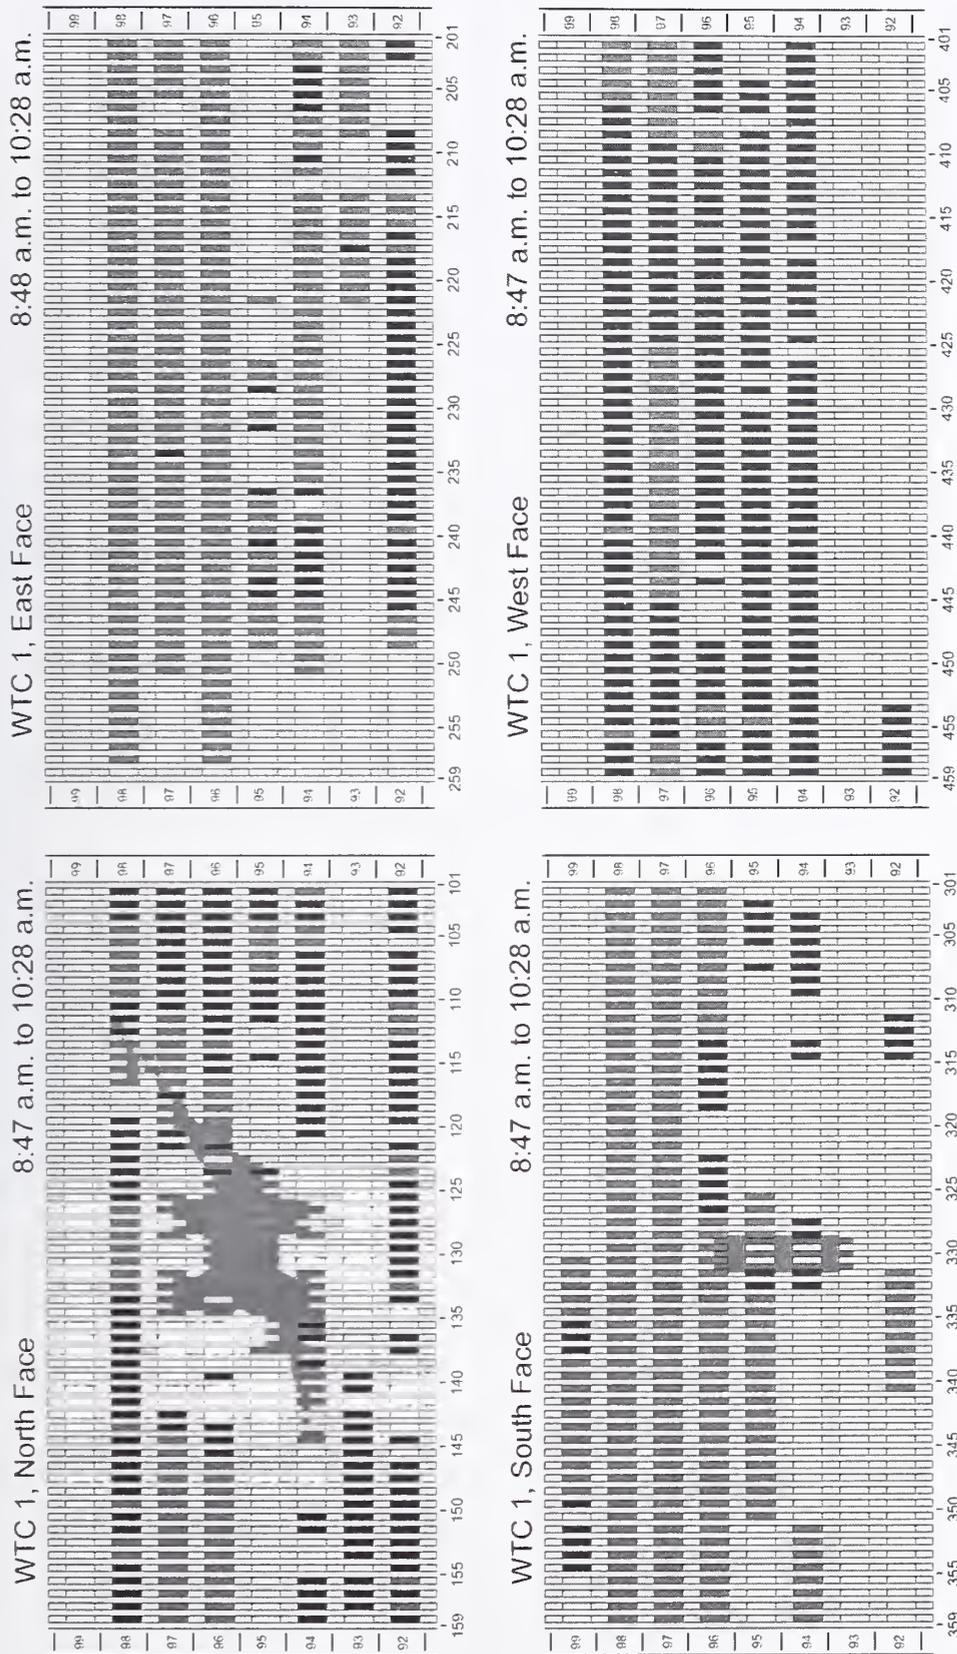
The results in the fire data sheets have been utilized to generate integrated fire data for the entire period between the aircraft impact and the collapse of WTC 1. The results are shown graphically in Figure 8–121 for the four faces of the tower. These maps demonstrate the extensive area of WTC 1 that was subjected to fire. Comparison with Figure 6-19, which shows the fire distribution on the four faces shortly after the aircraft impact, provides a graphic illustration of the amount of fire spread and growth that occurred. The relative numbers of windows in Figure 8–121 where external flames (orange) were observed compared to the total number of windows with observed fire reflects the differences between fire behaviors on the west and north faces as compared to the east and south faces, where external flaming was much more likely.

In contrast to the behavior on the west and north faces, fires burning on the east and south faces often generated heavy amounts of smoke and external flaming at nearby windows. It was common to observe many adjacent open windows with long extended flames. The tops of nearby column covers were often marked with carets. Examples of such fires were observed on the 94th, 96th, 97th, and 98th floors on the east face and on the 95th, 96th, 97th, 98th, and 99th floors on the south face. Exceptions to the general behavior included fires that developed on the 92nd floor on the east face and fires burning on the east side of the south face on the 92nd and 94th floors.

Various explanations for the different fire behaviors were considered. The most plausible is based on the effects of the prevailing wind. On September 11, 2001 the wind was striking WTC 1 from the northwest and then flowing down the north and west faces. This wind created positive pressures at the windows on these faces that tended to resist gas flows out of the tower. On the east and south faces the effect of the wind was the opposite, creating low pressure areas at the windows that tended to pull gases out of the building. The net effect of these pressure forces would be a tendency for gases to flow internally on a floor, if a pathway was available, from the west and north faces to the east and south faces. Such internal flows provide a possible explanation for the observed fire behaviors.

Figure 8-121. Maps of integrated fire observations between 8:47 a.m. and 10:28 a.m. are shown for the four faces of WTC 1. Colors represent the highest intensity fire observed in a window using the color scale defined in Figure 5-1.
