**NYC Department of Education**  
**Building Condition Assessment Survey 2023 - 2024**

Architectural Inspection

**K010**

**Asset:** P.S. 10 - BROOKLYN, 511 7TH AVENUE, New York, 11215

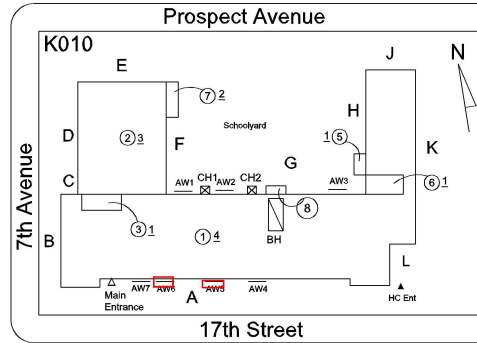
Question	Response
<b>Architectural</b>	
<b>EXTERIOR</b>	Inspected
<b>AREAWAY</b>	Inspected
Instance on AW3-AW7	Inspected
Instance Condition	2 - Between Good and Fair
Instance Quantity	5
Instance Quantity Uom	EACH
Deficiency	AREAWAY WALLS: CRACKS AND SPALLING

10  
S.F.  
REPAIR  
PRIORITY 3  
LEVEL 2

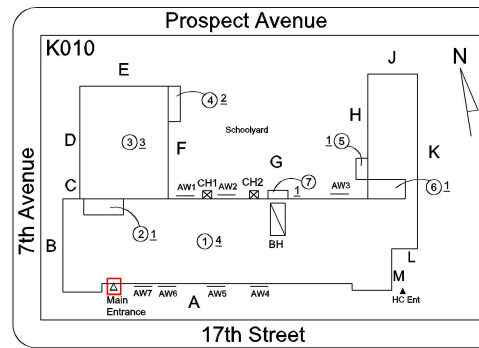
METAL: DETERIORATED DOOR - MAJOR DETERIORATION

1  
EACH  
REPLACE  
PRIORITY 4  
LEVEL 2

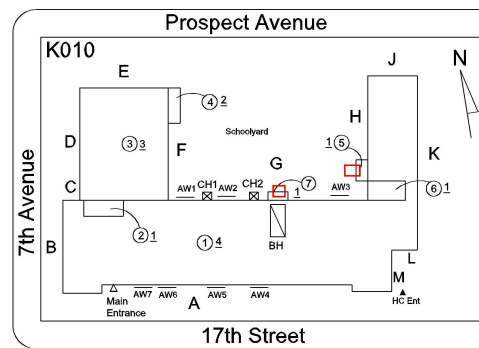
**METAL: DETERIORATED DOOR - MINOR DETERIORATION**

4  
EACH  
MAINTENANCE  
PRIORITY 3  
LEVEL 2

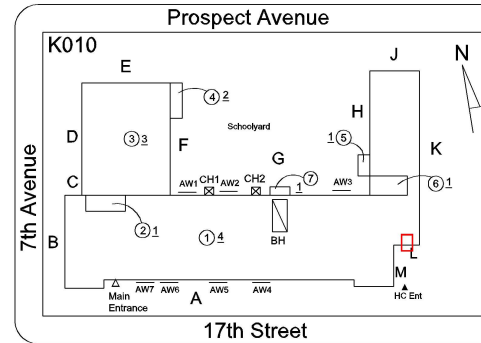
**METAL CLAD: DETERIORATED DOOR - MAJOR DETERIORATION**

REPLACE

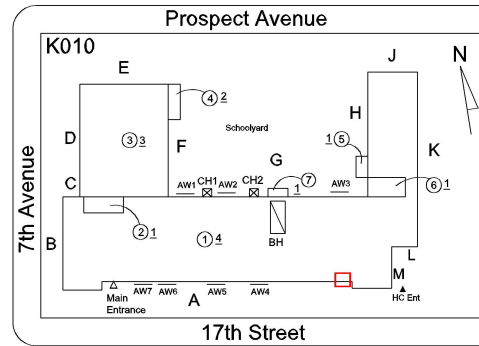
**METAL: DETERIORATED DOOR AND FRAME - MINOR DETERIORATION**

2  
EACH  
MAINTENANCE  
PRIORITY 3  
LEVEL 2

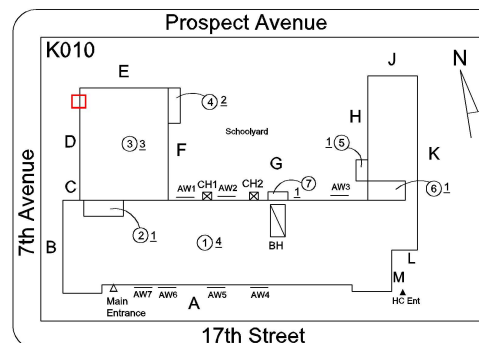
METAL: DENTED, MAJOR RUSTING

10  
S.F.  
REPLACE

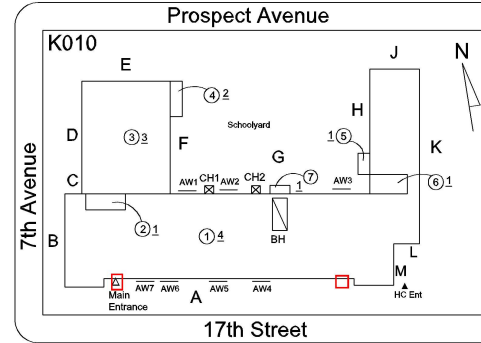
**WOOD: BROKEN GLASS**

10  
 S.F.  
 MAINTENANCE  
 PRIORITY 3  
 LEVEL 2

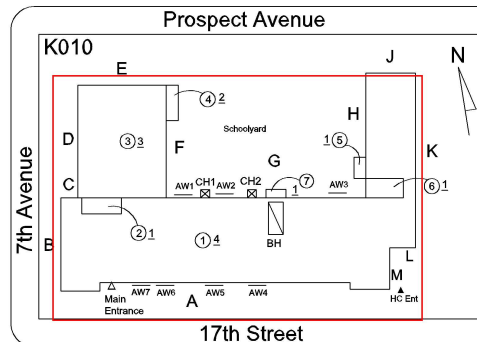
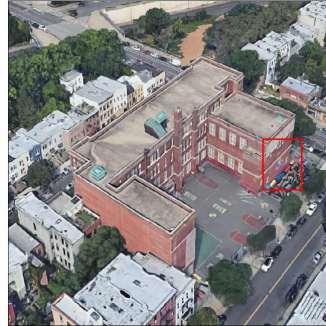
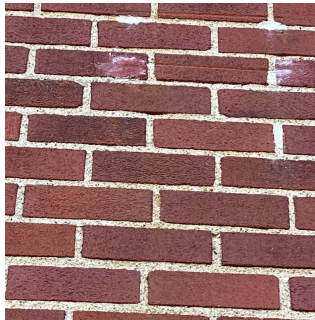
Facade A

Inspected  
3 - Fair  
36,000  
S.F.  
BRICK: DETERIORATED JOINTS

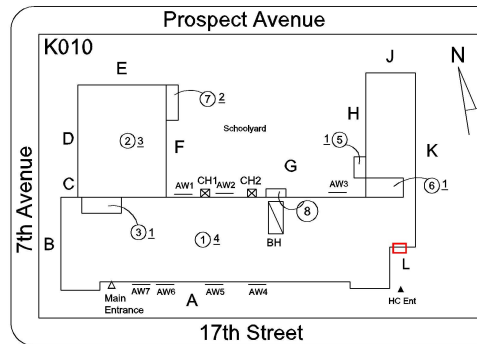
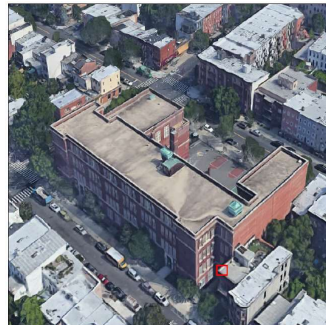
BRICK: DETERIORATED JOINTS

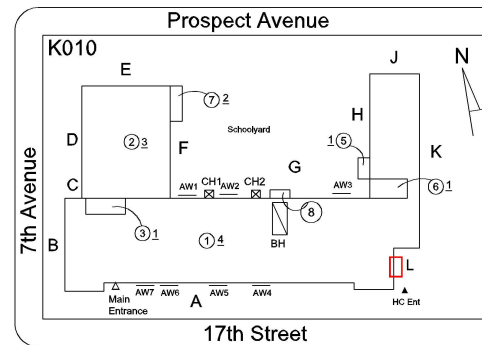
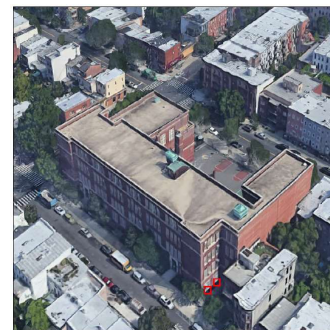
**BRICK: DETERIORATED MASONRY SILLS - MAJOR**

REMOVE AND REPLACE

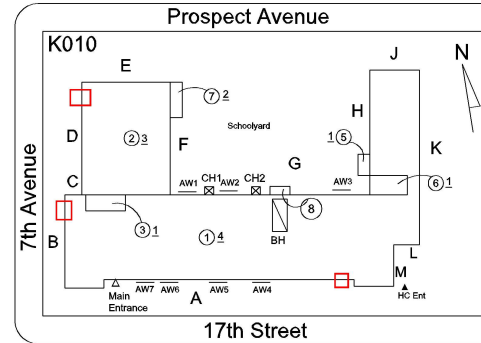
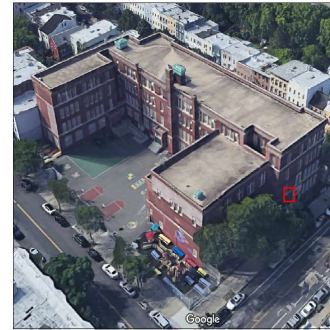
CAST IN PLACE / PRE-CAST CONCRETE: MINOR CRACKS/SPALLING

REPAIR

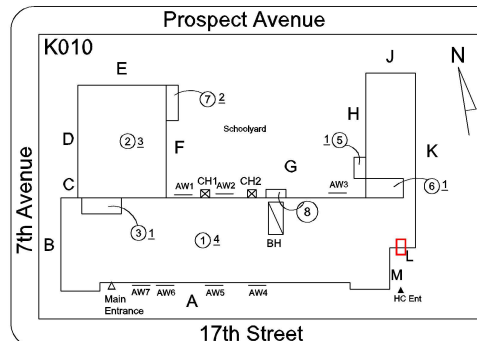
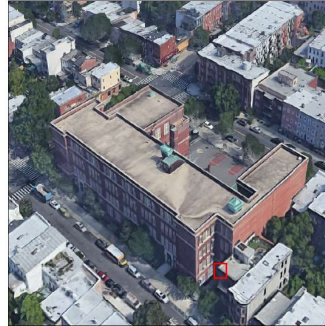
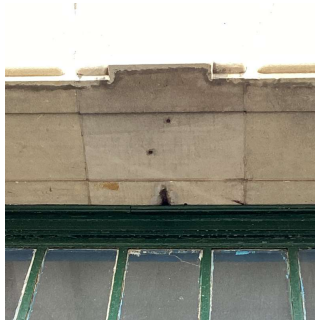
Facade L

CONCRETE: DETERIORATED

REPLACE

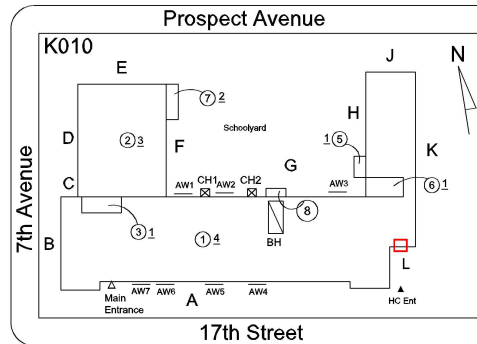
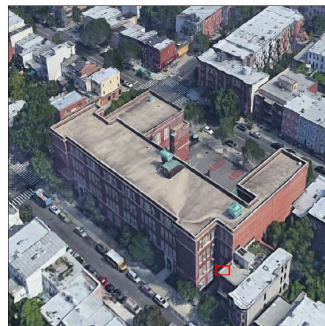
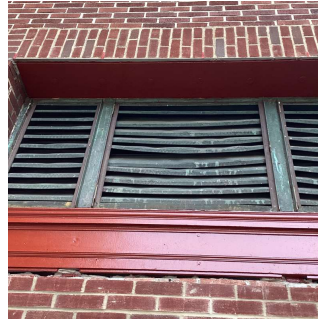
Facade L

BROKEN/ DENTED BLADES

Deficiency Quantity	20
Quantity Uom	S.F.
Potential Action	REPLACE
Urgency of Action	PRIORITY 4
Purpose of Action	LEVEL 2
Deficiency Photo1

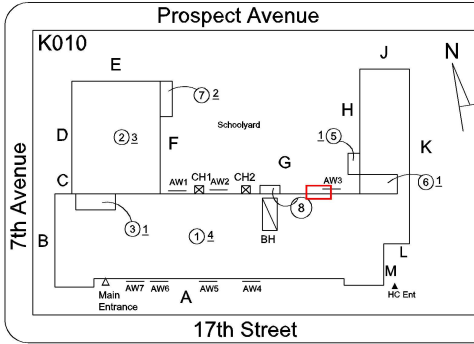
<b>SKYLIGHT/ROOF VENT</b>	
	Inspected
Material Type(s)	Other
Condition	2 - Between Good and Fair
Deficiency	No deficiencies recorded
<b>ROOF/GRAVITY TANK</b>	
	Does not Exist
<b>STAIRS/RAMPS: EXTERIOR</b>	
	Inspected
<b>BUILDING CHEEK/FLANK WALLS</b>	
	Inspected
Condition	4 - Between Fair and Poor
Deficiency	CAST IN PLACE CONCRETE: CRACKS/SPALLING - MAJOR
Roof Plan reference

Deficiency Quantity	20
Quantity Uom	S.F.
Potential Action	REPLACE
Urgency of Action	PRIORITY 4
Purpose of Action	LEVEL 2

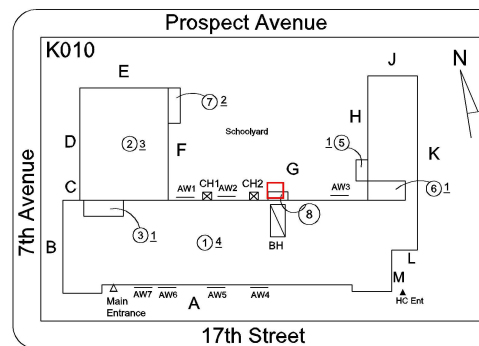
**CONCRETE: CRACKS/SPALLING - MINOR**

10  
S.F.  
REPAIR  
PRIORITY 3  
LEVEL 2

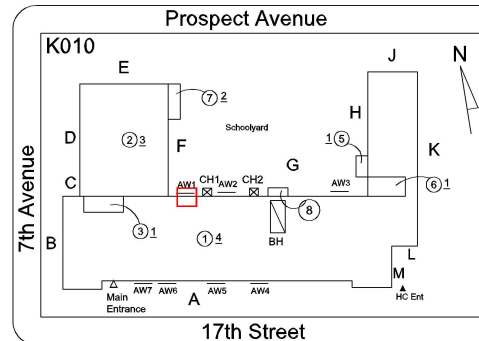
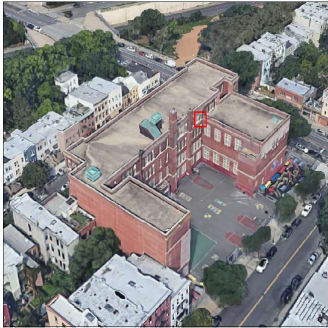
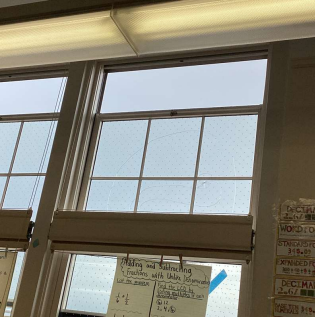
ALUMINUM - DOUBLE HUNG: BROKEN PANE

Deficiency Quantity	30
Quantity Uom	S.F.
Potential Action	MAINTENANCE
Urgency of Action	PRIORITY 3
Purpose of Action	LEVEL 2
Deficiency Photo1

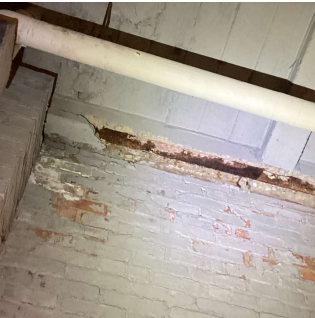
Violations	Facade G - Room 406 No violations recorded.
<b>INTERIOR</b>	Inspected
<b>POOLS</b>	Does not Exist
<b>STRUCTURAL</b>	Inspected
<b>COLUMNS/BEAMS/BEARING WALLS</b>	Inspected
Condition	3 - Fair
Deficiency	STEEL COLUMNS/BEAMS: MAJOR RUSTING
Deficiency Location/Instance	Basement - Oil Tank
Deficiency Quantity	10
Quantity Uom	S.F.
Potential Action	REPLACE
Urgency of Action	PRIORITY 4
Purpose of Action	LEVEL 5
Deficiency Photo1

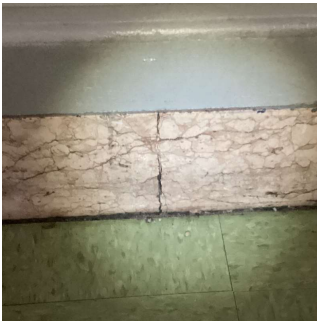
Left side
Violations	No violations recorded.
<b>Stage Curtain Rigging</b>	
	Inspected

Room 156
Violations	No violations recorded.
<b>Sliding-folding Partition</b>	
Instance on 1st Floor (507 Seats)	Does not Exist
<b>Stage</b>	
Instance on 1st Floor (507 Seats)	Inspected
<b>Stage</b>	
Instance on 1st Floor (507 Seats)	Inspected
Condition	3 - Fair
Deficiency	DAMAGED FASCIA
Deficiency Location/Instance	Center, left side
Deficiency Quantity	10
Quantity Uom	S.F.
Potential Action	REPLACE
Urgency of Action	PRIORITY 3
Purpose of Action	LEVEL 2
Deficiency Photo1

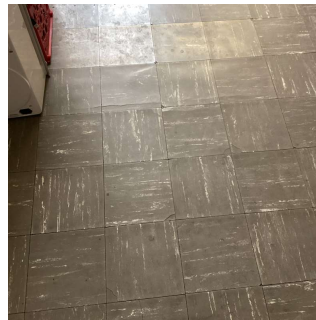
Room 114

VINYL TILES: DETERIORATED SUBSTRATE

REPLACE

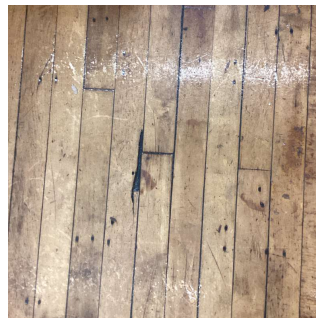
WOOD: DAMAGED/DETERIORATED

REPLACE

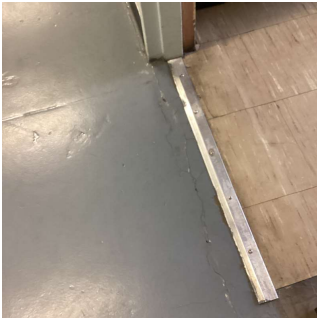
Question	Response
<b>INTERIOR</b>	
<b>CLASSROOMS/CORRIDORS/ADMIN SPACES</b>	
<b>Floor Finish</b>	
Violations	Room 210 No violations recorded.
Deficiency	CONCRETE: CRACKS
Deficiency Location/Instance	Corridor near Room 114, Exit 4, Exit 7
Deficiency Quantity	60
Quantity Uom	S.F.
Potential Action	REPLACE
Urgency of Action	PRIORITY 3
Purpose of Action	LEVEL 2
Deficiency Photo1

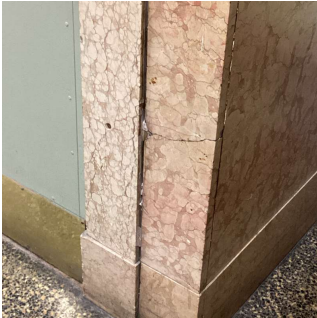
Violations	Corridor near Room 114 No violations recorded.
<b>Walls</b>	Inspected
Condition	2 - Between Good and Fair
Deficiency	STONE: CRACKS/SPALLING
Deficiency Location/Instance	Main Entrance Lobby, Main Entrance Vestibule, Exit 10
Deficiency Quantity	50
Quantity Uom	S.F.
Potential Action	REPLACE
Urgency of Action	PRIORITY 3
Purpose of Action	LEVEL 2
Deficiency Photo1

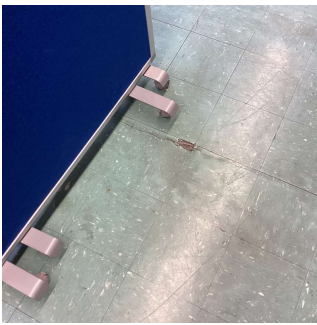
Question	Response
<b>INTERIOR</b>	
<b>GYMNASIUM</b>	
<b>Floor Finish</b>	
Deficiency Photo1

Violations	Room 372B No violations recorded.
<b>Seating</b>	
Instance on 3rd Floor	Does not Exist
<b>Sliding-folding Partition</b>	
Instance on 3rd Floor	Does not Exist
<b>Stage</b>	
Instance on 3rd Floor	Does not Exist
<b>Walls</b>	
Instance on 3rd Floor	Inspected
Condition	2 - Between Good and Fair
Deficiency	SALT GLAZED BRICK: CRACKS/SPALLING
Deficiency Location/Instance	Near Room 372A
Deficiency Quantity	10
Quantity Uom	S.F.
Potential Action	REPLACE
Urgency of Action	PRIORITY 3
Purpose of Action	LEVEL 2
Deficiency Photo1

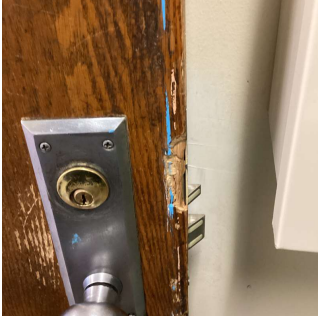
Kitchen Staff Locker Room
Violations	No violations recorded.

Question	Response
<b>INTERIOR</b>	
<b>KITCHEN</b>	
<b>Door(s)</b>	
Purpose of Action	LEVEL 2
Deficiency Photo1

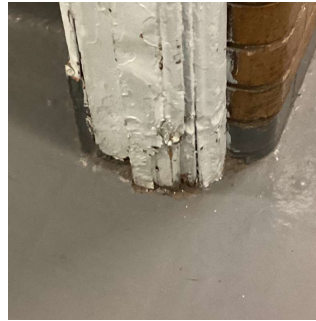
Deficiency	No deficiencies recorded
<b>Door(s)</b>	
Condition	Inspected 2 - Between Good and Fair
Deficiency	METAL: DETERIORATED DOOR AND FRAME
Deficiency Location/Instance	Stair HI/1
Deficiency Quantity	1
Quantity Uom	EACH
Potential Action	MAINTENANCE
Urgency of Action	PRIORITY 3
Purpose of Action	LEVEL 2

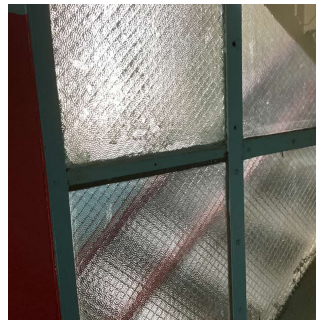
Stair BC/3

METAL FRAME: DAMAGED/DETERIORATED

REPLACE

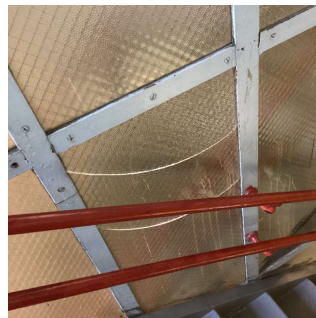
GLASS PANEL: DAMAGED/DETERIORATED

REPLACE

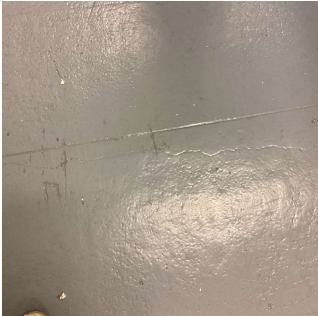
Question	Response
<b>INTERIOR</b>	
<b>STAIRS/RAMPS: INTERIOR</b>	
<b>Partition</b>	Inspected
	Stair HI/2
Violations	No violations recorded.
<b>Railings</b>	Inspected
Condition	2 - Between Good and Fair
Deficiency	No deficiencies recorded
<b>Stairs and Landings</b>	Inspected
Condition	2 - Between Good and Fair
Deficiency	STONE: BROKEN/MISSING
Deficiency Location/Instance	Main Entrance Vestibule
Deficiency Quantity	10
Quantity Uom	S.F.
Potential Action	REPLACE
Urgency of Action	PRIORITY 3
Purpose of Action	LEVEL 2
Deficiency Photo1	 
Violations	Main Entrance Vestibule No violations recorded.
Deficiency	CONCRETE: CRACKS/SPALLING - MAJOR
Deficiency Location/Instance	Gymnasium
Deficiency Quantity	20
Quantity Uom	S.F.
Potential Action	REPLACE
Urgency of Action	PRIORITY 3
Purpose of Action	LEVEL 2
Deficiency Photo1

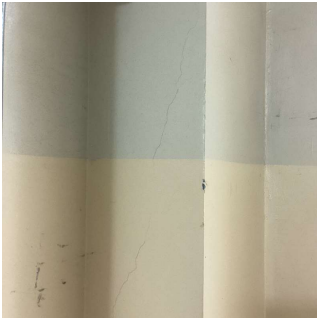
Violations	Gymnasium No violations recorded.
<b>Walls</b>	Inspected
Condition	2 - Between Good and Fair
Deficiency	PLASTER: CRACKS/SPALLING

Deficiency Location/Instance	Stair J/1, BC/1, Gymnasium Exit 10

Question	Response
<b>INTERIOR</b>	
<b>STAIRS/RAMPS: INTERIOR</b>	
<b>Walls</b>	
Deficiency Quantity	60
Quantity Uom	S.F.
Potential Action	REPLACE
Urgency of Action	PRIORITY 3
Purpose of Action	LEVEL 2
Deficiency Photo1

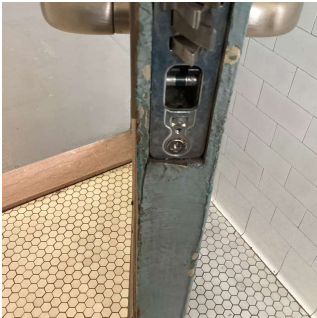
Stair J/1
Violations	No violations recorded.
<b>TOILET ROOMS - STAFF</b>	Inspected
<b>Ceiling</b>	Inspected
Condition	2 - Between Good and Fair
Deficiency	No deficiencies recorded
<b>Door(s)</b>	Inspected
Condition	5 - Poor
Deficiency	WOOD: DETERIORATED DOOR
Deficiency Location/Instance	Room 453, 353
Deficiency Quantity	2
Quantity Uom	EACH
Potential Action	MAINTENANCE
Urgency of Action	PRIORITY 3
Purpose of Action	LEVEL 2
Deficiency Photo1

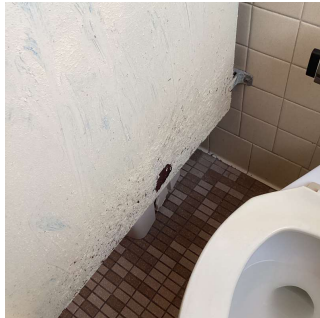
Question	Response
<b>INTERIOR</b>	
<b>TOILET ROOMS - STAFF</b>	
<b>Floor Finish</b>	
Urgency of Action	PRIORITY 3
Purpose of Action	LEVEL 2
Deficiency Photo1	 
Violations	Kitchen Staff Locker Room No violations recorded.
<b>Stalls</b>	
Condition	Inspected 5 - Poor
Deficiency	RUST - MAJOR
Deficiency Location/Instance	Room 353, Kitchen Staff Locker Room
Deficiency Quantity	2
Quantity Uom	EACH
Potential Action	REPLACE
Urgency of Action	PRIORITY 3
Purpose of Action	LEVEL 2
Deficiency Photo1

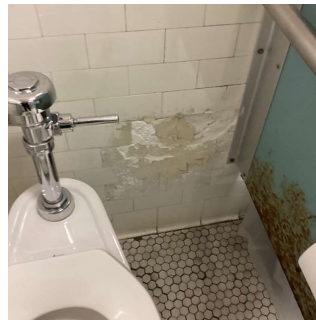
Room 462

RUST - MAJOR

REPLACE

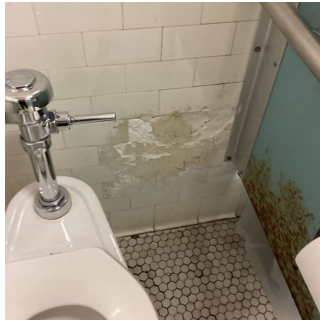
CERAMIC TILE: BROKEN/ MISSING

REPLACE

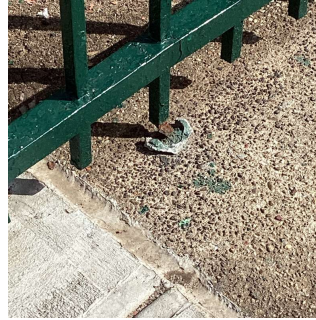
Condition	3 - Fair
Deficiency	WROUGHT IRON: DAMAGED/DETERIORATED
Deficiency Location/Instance	Along 17th Street
Deficiency Quantity	120
Quantity Uom	S.F.
Potential Action	REPLACE
Urgency of Action	PRIORITY 3
Purpose of Action	LEVEL 2

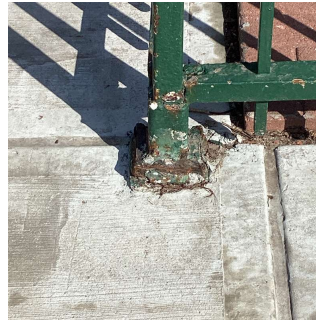
Along 7th Avenue

**WROUGHT IRON: RUST - MAJOR**

REPLACE

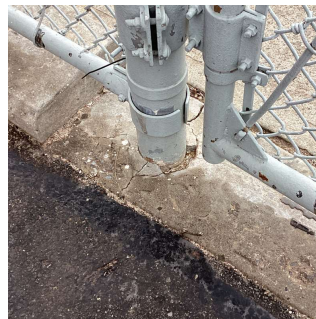
Along 7th Avenue

**CONCRETE CURB: DAMAGED/DETERIORATED**

REPLACE

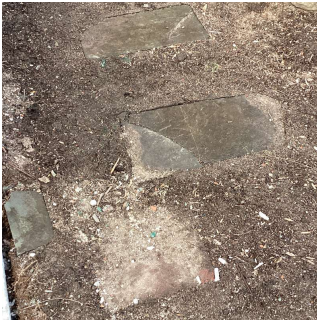
Violations	Along Prospect Avenue No violations recorded.
<b>IRRIGATION SYSTEM</b>	Does not Exist
<b>PAVING</b>	Inspected
<b>Student Non-Use</b>	Inspected
Gravel Exists?	No
<b>Asphalt</b>	Does not Exist
<b>Concrete</b>	Inspected
Condition	2 - Between Good and Fair
Deficiency	No deficiencies recorded
<b>Pavers</b>	Inspected
Condition	2 - Between Good and Fair
Deficiency	DAMAGED/MISSING
Deficiency Location/Instance	Along 7th Avenue, 17th Street
Deficiency Quantity	10
Quantity Uom	S.F.
Potential Action	REPLACE
Urgency of Action	PRIORITY 3
Purpose of Action	LEVEL 2
Deficiency Photo1

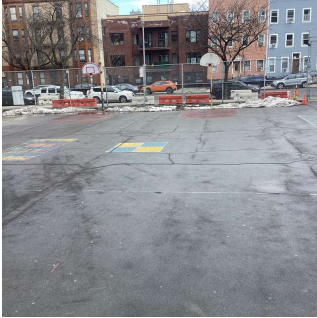
Violations	Along 7th Avenue No violations recorded.
<b>Student Use</b>	Inspected
Gravel Exists?	No
<b>Asphalt</b>	Inspected
Condition	4 - Between Fair and Poor
Deficiency	CRACKS - MAJOR
Deficiency Location/Instance	Schoolyard
Deficiency Quantity	1,200
Quantity Uom	S.F.
Potential Action	REPLACE

Question	Response
<b>SITE</b>	
<b>PAVING</b>	
<b>Student Use</b>	
<b>Asphalt</b>	
Urgency of Action	PRIORITY 3
Purpose of Action	LEVEL 2
Deficiency Photo1

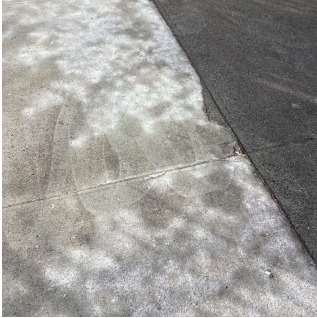
Violations	Schoolyard No violations recorded.
<b>Concrete</b>	Does not Exist
<b>Pavers</b>	Does not Exist
<b>Site Sidewalks &amp; Walkways</b>	Inspected
<b>Asphalt</b>	Does not Exist
<b>Concrete</b>	Inspected
Condition	3 - Fair
Deficiency	DAMAGED/DETERIORATED/MISSING SECTIONS
Deficiency Location/Instance	Along 17th Street
Deficiency Quantity	100
Quantity Uom	S.F.
Potential Action	REPLACE
Urgency of Action	PRIORITY 3
Purpose of Action	LEVEL 2
Deficiency Photo1

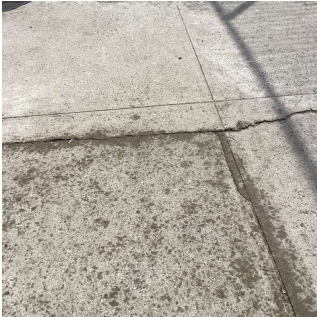
Violations	Along 17th Street No violations recorded.
<b>Pavers</b>	Does not Exist
<b>DOT Sidewalk</b>	Inspected
<b>Asphalt</b>	Does not Exist
<b>Concrete</b>	Inspected
Condition	4 - Between Fair and Poor
Deficiency	DAMAGED/DETERIORATED/MISSING SECTIONS
Deficiency Location/Instance	Along 7th Avenue, Prospect Avenue, 17th Street

Question	Response
<b>SITE</b>	
<b>PAVING</b>	
<b>DOT Sidewalk</b>	
<b>Concrete</b>	
Quantity Uom	S.F.
Potential Action	REPLACE
Urgency of Action	PRIORITY 3
Purpose of Action	LEVEL 2
Deficiency Photo1

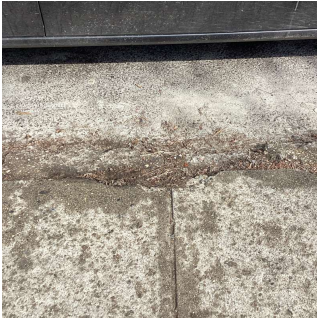
Along Prospect Avenue
Violations	No violations recorded.
Deficiency	DAMAGED CURBS
Deficiency Location/Instance	Along 7th Avenue, Prospect Avenue, 17th Street
Deficiency Quantity	275
Quantity Uom	L.F.
Potential Action	REPLACE
Urgency of Action	PRIORITY 3
Purpose of Action	LEVEL 2
Deficiency Photo1

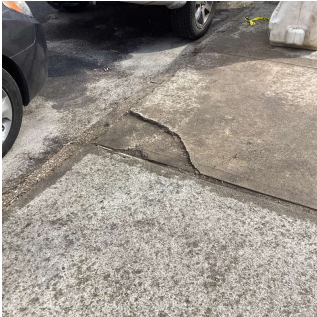
Along Prospect Avenue
Violations	No violations recorded.
Deficiency	HEAVING
Deficiency Location/Instance	Along 7th Avenue, Prospect Avenue, 17th Street
Deficiency Quantity	200
Quantity Uom	S.F.
Potential Action	REPLACE
Urgency of Action	PRIORITY 3
Purpose of Action	LEVEL 2

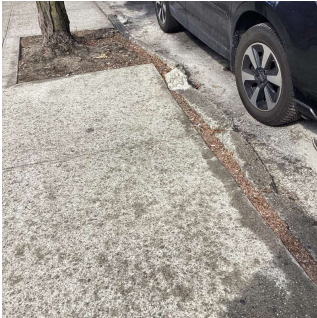
Violations	Along Prospect Avenue No violations recorded.
Deficiency	<b>HEAVING</b>
Deficiency Location/Instance	Along 7th Avenue, Prospect Avenue
Deficiency Quantity	350
Quantity Uom	S.F.
Potential Action	<b>REPLACE</b>
Urgency of Action	<b>PRIORITY 5</b>
Purpose of Action	<b>LEVEL 6</b>
Deficiency Photo1
