**NYC Department of Education**  
**Building Condition Assessment Survey 2023 - 2024**

Architectural Inspection

**Asset:**      **P.S. 12 - BROOKLYN, 430 HOWARD AVE, New York, 11233**

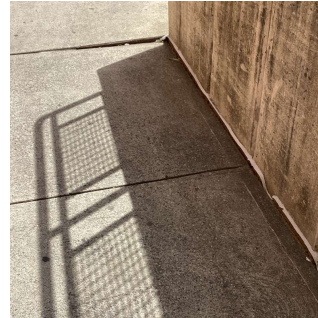
Question	Response
<b>Architectural</b>	
<b>EXTERIOR</b>	Inspected
<b>AREAWAY</b>	Inspected
Instance on AW1 - AW4	Inspected
Instance Condition	3 - Fair
Instance Quantity	4
Instance Quantity Uom	EACH
Deficiency	AREAWAY SLAB: DISPLACED

AREAWAY SLAB: CRACKS AND SPALLING

REPLACE

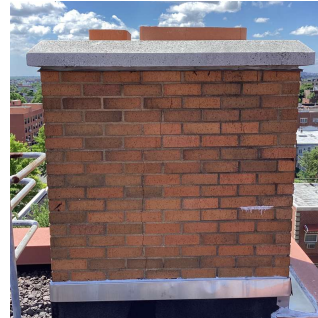
CH1

Violations	AW1 No violations recorded.
<b>AWNINGS AND CANOPIES</b>	Inspected
Condition	2 - Between Good and Fair
Deficiency	No deficiencies recorded
<b>CHIMNEY</b>	Inspected
Material Type(s)	Masonry
Condition	2 - Between Good and Fair
Deficiency	BRICK: MINOR CRACKS AND SPALLING

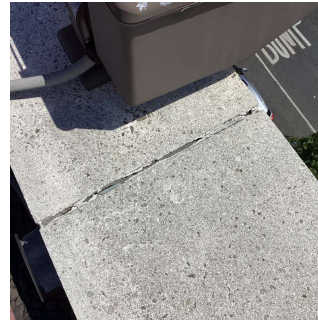
Roof 12 - Facade A

CAST STONE: DETERIORATED TRANSVERSE JOINTS

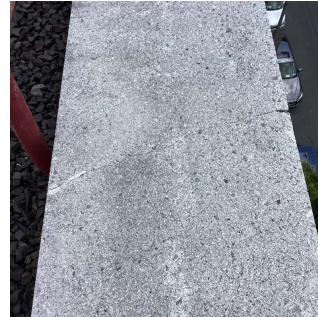
Roof 17 - Facade B

CAST STONE: CRACKED/BROKEN PIECES

REPLACE-IN-KIND

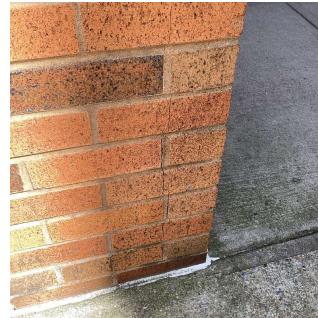
Facade D

BRICK: MINOR CRACKS AND SPALLING

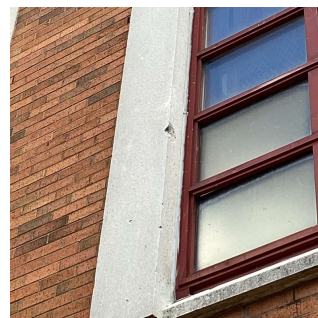
CAST IN PLACE / PRE-CAST CONCRETE: MINOR  
 CRACKS/SPALLING

10  
 S.F.  
 REPAIR  
 PRIORITY 3  
 LEVEL 2

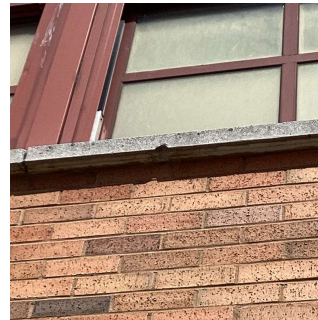
Facade E

BRICK: DETERIORATED MASONRY SILLS - MINOR

REPAIR

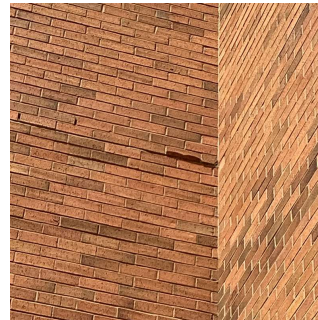
Facade E

BRICK: MAJOR / THRU CRACKS

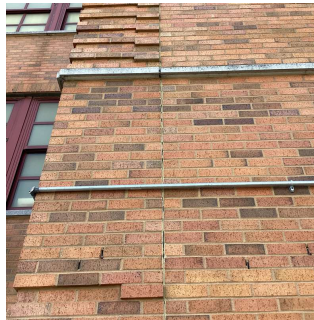
Facade A

BRICK: DETERIORATED CONTROL/EXPANSION JOINTS

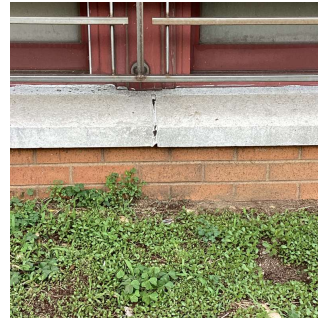
Facade B

BRICK: MASONRY SILLS - DETERIORATED JOINTS

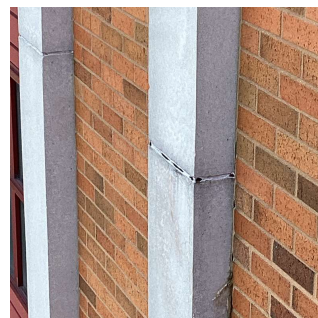
CAST IN PLACE / PRE-CAST CONCRETE: DETERIORATED JOINTS

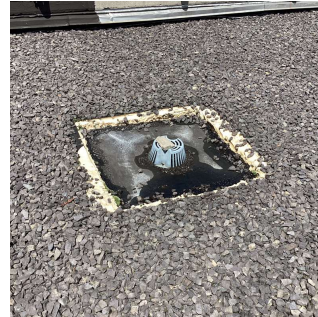
Roof 12

Deficiency

IRMA: ROOFING: MAJOR ACTIVE ROOF LEAKS IN INSTRUCTIONAL SPACE

REPLACE

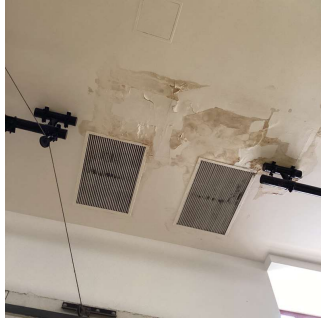
Roof 9 - Gymnasium shown, Roof 4 - Corridor near Room 244, Roof 12 - Room 419, Corridor near Room 419 similar
Violations	No violations recorded.
Instance on Modified Bitumen: Roofs 21 - 22	Inspected
Instance Condition	3 - Fair
Instance Photo

REPLACE ROOFING WITHOUT MAJOR EQUIPMENT REMOVAL

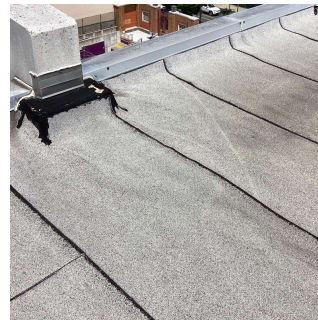
BH3 Roof

80  
S.F.  
REPLACE  
PRIORITY 4  
LEVEL 2

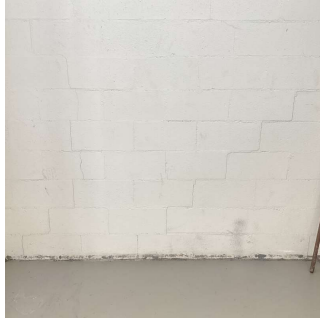
**BULKHEAD/PENTHOUSE WALLS/INTERIOR: CMU  
CRACKS/SPALLING**

100  
S.F.  
REPLACE  
PRIORITY 3  
LEVEL 2

Violations	BH3 No violations recorded.
Deficiency	BULKHEAD/PENTHOUSE ROOF: MAJOR LEAKAGE
Roof Plan reference

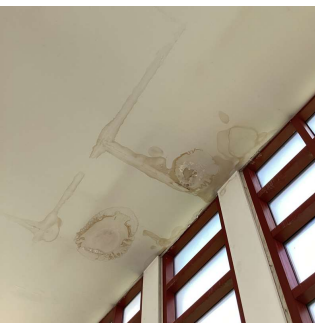
Violations	BH3 No violations recorded.
Deficiency	BULKHEAD/PENTHOUSE CEILING: GYPSUM BOARD DAMAGED/DETERIORATED

Deficiency Quantity	200
Quantity Uom	S.F.
Potential Action	REPLACE
Urgency of Action	PRIORITY 4
Purpose of Action	LEVEL 2
Deficiency Photo1

Violations	BH1 No violations recorded.
<b>CUPOLA/ SPIRES/ TOWERS</b>	Does not Exist
<b>DORMER</b>	Does not Exist
<b>DUNNAGE STEEL</b>	Inspected
Condition	2 - Between Good and Fair
Deficiency	No deficiencies recorded
<b>SKYLIGHT/ROOF VENT</b>	Does not Exist
<b>ROOF/GRAVITY TANK</b>	Does not Exist
<b>STAIRS/RAMPS: EXTERIOR</b>	Does not Exist
<b>WINDOWS</b>	Inspected
Replacement Quantity	10,000
Replacement Uom	S.F.
<b>EXTERIOR GUARDS</b>	Inspected
Condition	2 - Between Good and Fair
Deficiency	No deficiencies recorded
<b>LINTELS</b>	Inspected
Condition	2 - Between Good and Fair
Deficiency	No deficiencies recorded
<b>WINDOWS</b>	Inspected
Material Type(s)	Aluminum

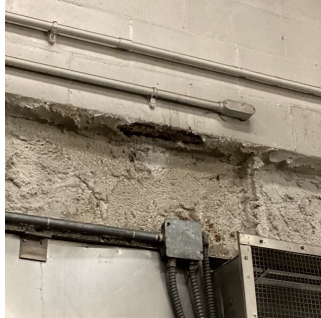
STEEL COLUMNS/BEAMS: DETERIORATED/MISSING  
PLASTER FIREPROOFING

Question	Response
<b>INTERIOR</b>	
<b>STRUCTURAL</b>	
<b>COLUMNS/BEAMS/BEARING WALLS</b>	
Purpose of Action	LEVEL 5
Deficiency Photo1

Boiler Room
Violations	No violations recorded.
Deficiency	STEEL COLUMNS/BEAMS: DETERIORATED/MISSING SPRAY-ON FIREPROOFING
Deficiency Location/Instance	Basement - Water and Gas Meter Room, Oil Tank Room, Sub-Basement - Emergency Generator Room
Deficiency Quantity	30
Quantity Uom	S.F.
Potential Action	REPLACE
Urgency of Action	PRIORITY 3
Purpose of Action	LEVEL 5
Deficiency Photo1

REPLACE

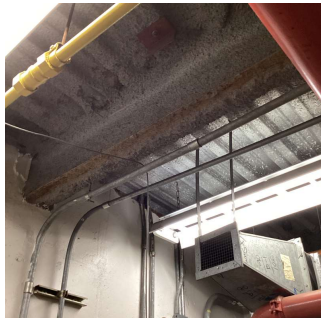
Water and Gas Meter Room
Violations	No violations recorded.
<b>FLOOR STRUCTURE</b>	
	Inspected
Condition	3 - Fair
Deficiency	METAL DECK AND CONCRETE: DETERIORATED
Deficiency Location/Instance	Sub-Basement - Boiler Room
Deficiency Quantity	20
Quantity Uom	S.F.
Potential Action	REPAIR
Urgency of Action	PRIORITY 4
Purpose of Action	LEVEL 5

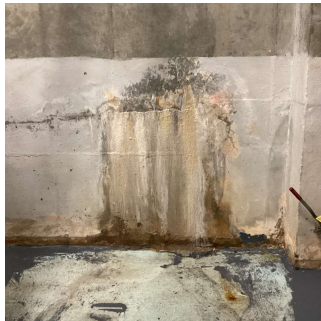
Violations	Auditorium Mechanical Equipment Room No violations recorded.
<b>FOUNDATION WALLS</b>	Inspected
Material Type(s)	Concrete
Condition	4 - Between Fair and Poor
Deficiency	CONCRETE: WATER INFILTRATION IN INSTRUCTIONAL SPACE
Deficiency Location/Instance	Basement - Oil Tank Room, Sub-Basement - Boiler Room, Generator Room
Deficiency Quantity	300
Quantity Uom	S.F.
Potential Action	INSTALL WATERPROOFING
Urgency of Action	PRIORITY 5
Purpose of Action	LEVEL 5

Violations	Oil Tank Room No violations recorded.
<b>ROOF STRUCTURE</b>	Inspected
Condition	3 - Fair
Deficiency	STEEL COLUMNS/BEAMS: DETERIORATED/MISSING SPRAY-ON FIREPROOFING
Deficiency Location/Instance	Roof 5 - Mechanical Equipment Room, Roof 16 - PH2, Roof 21 - Snow Machine Storage Room
Deficiency Quantity	30
Quantity Uom	S.F.
Potential Action	REPLACE
Urgency of Action	PRIORITY 3
Purpose of Action	LEVEL 5
Deficiency Photo1

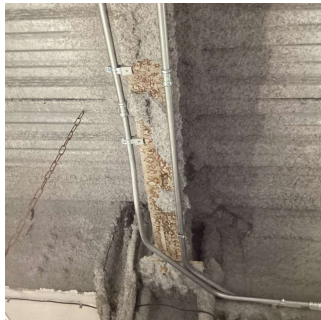
Violations	Roof 5 - Mechanical Equipment Room No violations recorded.
<b>VAULTS-BUNKERS</b>	Does not Exist
<b>AUDITORIUM</b>	Inspected
Instance on 2nd Floor (270 Seats)	Inspected
<b>Ceiling</b>	
Instance on 2nd Floor (270 Seats)	Inspected
Condition	2 - Between Good and Fair
Deficiency	GYPSON BOARD: DAMAGED/DETERIORATED
Deficiency Location/Instance	Right and Left Side Ramp, Over Stage, and HC Lift

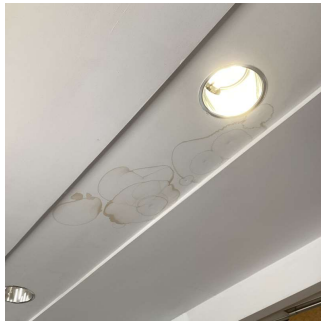
Deficiency Quantity	110
Quantity Uom	S.F.
Potential Action	REPLACE
Urgency of Action	PRIORITY 3
Purpose of Action	LEVEL 2

Violations	Right Side Ramp No violations recorded.
<b>Door(s)</b>	
Instance on 2nd Floor (270 Seats)	Inspected
Condition	3 - Fair
Deficiency	WOOD: DETERIORATED DOOR
Deficiency Location/Instance	Room 229D
Deficiency Quantity	1
Quantity Uom	EACH
Potential Action	MAINTENANCE
Urgency of Action	PRIORITY 3
Purpose of Action	LEVEL 2
Deficiency Photo1

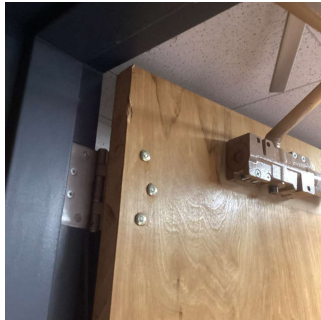
Violations	Room 229D No violations recorded.
<b>Fixed H/C Lift</b>	
Instance on 2nd Floor (270 Seats)	Inspected
Condition	5 - Poor
Deficiency	INOPERABLE
Deficiency Location/Instance	Right Side near Stage
Deficiency Quantity	1
Quantity Uom	EACH
Potential Action	REPLACE
Urgency of Action	PRIORITY 3
Purpose of Action	LEVEL 2
Deficiency Photo1	No photo recorded
Violations	No violations recorded.
<b>Fixed Seating</b>	
Instance on 2nd Floor (270 Seats)	Inspected
Condition	3 - Fair

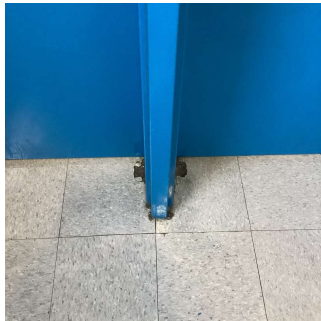
Violations	Seat A/109 No violations recorded.
<b>Floor Finish</b>	
Instance on 2nd Floor (270 Seats)	Inspected
Condition	2 - Between Good and Fair
Deficiency	VINYL TILES: BROKEN/DETERIORATED/MISSING TILES
Deficiency Location/Instance	Right Side, Near Left Side Main Entrance
Deficiency Quantity	20
Quantity Uom	S.F.
Potential Action	REPLACE

Near Left Side Main Entrance
Violations	No violations recorded.
<b>Sliding-folding Partition</b>	
Instance on 2nd Floor (270 Seats)	Does not Exist
<b>Stage</b>	
Instance on 2nd Floor (270 Seats)	Inspected
<b>Stage</b>	Inspected
Instance on 2nd Floor (270 Seats)	Inspected
Condition	2 - Between Good and Fair
Deficiency	DAMAGED FASCIA
Deficiency Location/Instance	Left Side
Deficiency Quantity	10
Quantity Uom	S.F.
Potential Action	REPLACE
Urgency of Action	PRIORITY 3
Purpose of Action	LEVEL 2
Deficiency Photo1

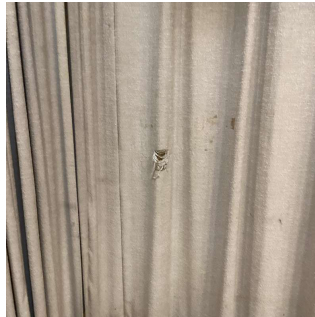
Question	Response
<b>INTERIOR</b>	
<b>AUDITORIUM</b>	
<b>Stage</b>	
<b>Stage</b>	
Deficiency Photo1	 
Center Back	
Violations	No violations recorded.
<b>Stage Curtain Rigging</b>	Inspected
Instance on 2nd Floor (270 Seats)	Inspected
Condition	5 - Poor
Deficiency	DAMAGED/DETERIORATED
Deficiency Location/Instance	Right Side
Deficiency Quantity	1
Quantity Uom	EACH
Potential Action	REPLACE
Urgency of Action	PRIORITY 3
Purpose of Action	LEVEL 2
Deficiency Photo1	 
Right Side	
Violations	No violations recorded.
<b>Stage Curtains</b>	Inspected
Instance on 2nd Floor (270 Seats)	Inspected
Condition	3 - Fair
Deficiency	WORN/DETERIORATED
Deficiency Location/Instance	Right and Left Side
Deficiency Quantity	200
Quantity Uom	S.F.
Potential Action	REPLACE
Urgency of Action	PRIORITY 3
Purpose of Action	LEVEL 2

Right Side
Violations	No violations recorded.
<b>Walls</b>	
Instance on 2nd Floor (270 Seats)	Inspected
Condition	2 - Between Good and Fair
Deficiency	No deficiencies recorded
<b>Window Curtains/Shades/Blinds</b>	
Instance on 2nd Floor (270 Seats)	Inspected
Condition	2 - Between Good and Fair
Deficiency	No deficiencies recorded
<b>CAFETERIA</b>	
Instance on 1st Floor - Staff (500 SF)	Inspected
Instance on 1st Floor - Students	Inspected
<b>Ceiling</b>	
Instance on 1st Floor - Students	Inspected
Condition	3 - Fair
Deficiency	ACOUSTIC TILES: DAMAGED/MISSING
Deficiency Location/Instance	Close to Kitchen, by Main Entrance, next to Servery, Near Exit Door, close to Windows
Deficiency Quantity	200
Quantity Uom	S.F.
Potential Action	REPLACE
Urgency of Action	PRIORITY 3
Purpose of Action	LEVEL 2
Deficiency Photo1

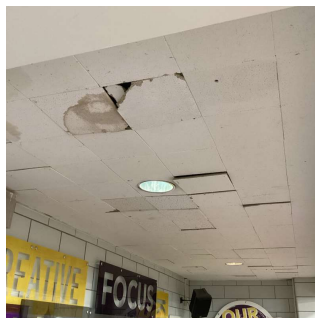
Near Exit Door
Violations	No violations recorded.
Deficiency	GYPSUM BOARD: DAMAGED/DETERIORATED
Deficiency Location/Instance	Near Room 144B, by Windows

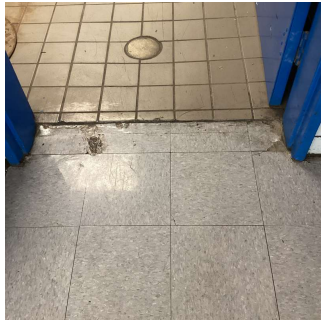
Question	Response
<b>INTERIOR</b>	
<b>CAFETERIA</b>	
<b>Floor Finish</b>	
Instance on 1st Floor - Students	Inspected
Condition	2 - Between Good and Fair
Deficiency	VINYL TILES: BROKEN/DETERIORATED/MISSING TILES
Deficiency Location/Instance	Near Main Entrance, Close to Kitchen
Deficiency Quantity	20
Quantity Uom	S.F.
Potential Action	REPLACE
Urgency of Action	PRIORITY 3
Purpose of Action	LEVEL 2
Deficiency Photo1

Violations	Close to Kitchen No violations recorded.
<b>Sliding-folding Partition</b>	
Instance on 1st Floor - Staff (500 SF)	Does not Exist
Instance on 1st Floor - Students	Does not Exist
<b>Stage</b>	
Instance on 1st Floor - Staff (500 SF)	Does not Exist
Instance on 1st Floor - Students	Does not Exist
<b>Walls</b>	
Instance on 1st Floor - Staff (500 SF)	Inspected
Condition	2 - Between Good and Fair
Deficiency	No deficiencies recorded
Instance on 1st Floor - Students	Inspected
Condition	2 - Between Good and Fair

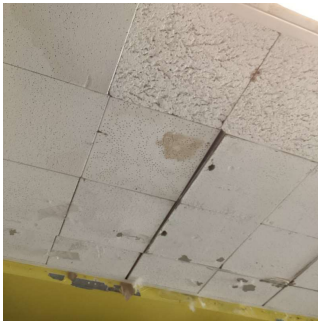
Deficiency	No deficiencies recorded
<b>Window Curtains/Shades/Blinds</b>	
Instance on 1st Floor - Staff (500 SF)	Does not Exist
Instance on 1st Floor - Students	Does not Exist
<b>CLASSROOMS/CORRIDORS/ADMIN SPACES</b>	
<b>Ceiling</b>	
Condition	4 - Between Fair and Poor
Deficiency	ACOUSTIC TILES ON PLASTER: DAMAGED/MISSING - ACTIVE LEAK
Deficiency Location/Instance	Corridor near Room 244
Deficiency Quantity	10
Quantity Uom	S.F.
Potential Action	REPLACE
Urgency of Action	PRIORITY 5
Purpose of Action	LEVEL 2

Corridor near Room 244
Violations	No violations recorded.
Deficiency	GYPSUM BOARD: DAMAGED/DETERIORATED
Deficiency Location/Instance	Main Entrance - Vestibule and Lobby, Corridor near Exit 10
Deficiency Quantity	40
Quantity Uom	S.F.
Potential Action	REPLACE
Urgency of Action	PRIORITY 3
Purpose of Action	LEVEL 2
Deficiency Photo1

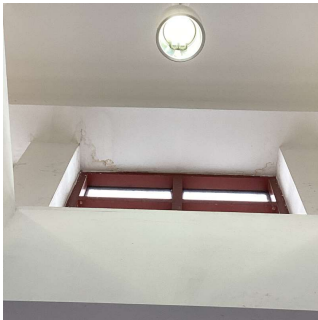
Main Entrance - Vestibule
Violations	No violations recorded.
Deficiency	GYPSUM BOARD: DAMAGED/DETERIORATED - ACTIVE LEAK
Deficiency Location/Instance	Corridor near Rooms 402, 419, Room 419
Deficiency Quantity	70
Quantity Uom	S.F.
Potential Action	REPLACE
Urgency of Action	PRIORITY 5
Purpose of Action	LEVEL 2
Deficiency Photo1

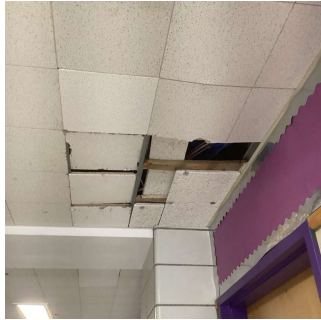
Question	Response
<b>INTERIOR</b>	
<b>CLASSROOMS/CORRIDORS/ADMIN SPACES</b>	
<b>Ceiling</b>	
Violations	No violations recorded.
Deficiency	ACOUSTIC TILES: DAMAGED/MISSING
Deficiency Location/Instance	Main Entrance Lobby, Corridor near Rooms 113, 138, 123, 306 and others
Deficiency Quantity	4,500
Quantity Uom	S.F.
Potential Action	REPLACE
Urgency of Action	PRIORITY 3
Purpose of Action	LEVEL 2
Deficiency Photo1

Corridor near Room 306
Violations	No violations recorded.
<b>Door(s)</b>	
Inspected	Inspected
Condition	4 - Between Fair and Poor
Deficiency	METAL: MISSING DOOR
Deficiency Location/Instance	Room 215
Deficiency Quantity	1
Quantity Uom	EACH
Potential Action	MAINTENANCE
Urgency of Action	PRIORITY 3
Purpose of Action	LEVEL 2
Deficiency Photo1

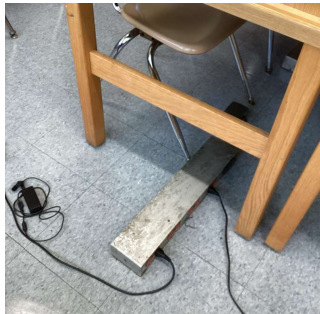
Question	Response
<b>INTERIOR</b>	
<b>CLASSROOMS/CORRIDORS/ADMIN SPACES</b>	
<b>Door(s)</b>	
Deficiency Photo1	 
Violations	Room 414 No violations recorded.
<b>Floor Finish</b>	Inspected
Condition	2 - Between Good and Fair
Deficiency	SHEET VINYL: BROKEN/DETERIORATED
Deficiency Location/Instance	Room 230
Deficiency Quantity	10
Quantity Uom	S.F.
Potential Action	REPLACE
Urgency of Action	PRIORITY 3
Purpose of Action	LEVEL 2
Deficiency Photo1	 
Violations	Room 230 No violations recorded.
Deficiency	VINYL TILES: TRIPPING HAZARD - ELECTRICAL OUTLET
Deficiency Location/Instance	Room 321
Deficiency Quantity	20
Quantity Uom	S.F.
Potential Action	REMOVE
Urgency of Action	PRIORITY 5
Purpose of Action	LEVEL 6
Deficiency Photo1

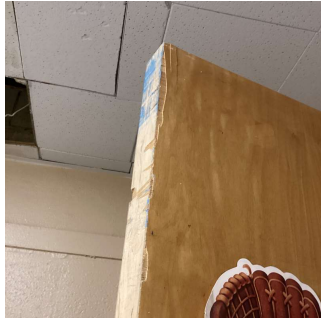
Question	Response
<b>INTERIOR</b>	
<b>GYMNASIUM</b>	
<b>Ceiling</b>	
Violations	No violations recorded.
<b>Door(s)</b>	
Instance on 1st Floor	Inspected
Condition	3 - Fair
Deficiency	WOOD: DETERIORATED DOOR
Deficiency Location/Instance	Office Room
Deficiency Quantity	1
Quantity Uom	EACH
Potential Action	MAINTENANCE
Urgency of Action	PRIORITY 3
Purpose of Action	LEVEL 2
Deficiency Photo1

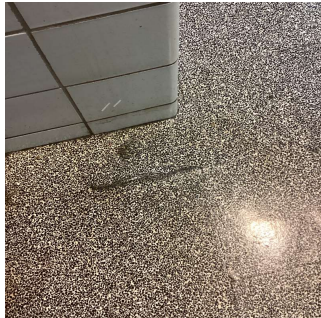
Violations	Office Room No violations recorded.
<b>Fixed Equipment</b>	
Instance on 1st Floor	Inspected
Condition	2 - Between Good and Fair
Deficiency	No deficiencies recorded
<b>Floor Finish</b>	
Instance on 1st Floor	Inspected
Condition	2 - Between Good and Fair
Deficiency	VINYL TILES: DETERIORATED SUBSTRATE
Deficiency Location/Instance	Near Office Room
Deficiency Quantity	10
Quantity Uom	S.F.
Potential Action	REPLACE
Urgency of Action	PRIORITY 3
Purpose of Action	LEVEL 2
Deficiency Photo1

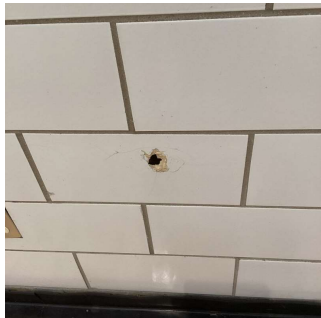
Question	Response
<b>INTERIOR</b>	
<b>GYMNASIUM</b>	
<b>Floor Finish</b>	
Deficiency	VINYL TILES: BROKEN/DETERIORATED/MISSING TILES
Deficiency Location/Instance	Near Main Entrance, by Office Room
Deficiency Quantity	20
Quantity Uom	S.F.
Potential Action	REPLACE
Urgency of Action	PRIORITY 3
Purpose of Action	LEVEL 2
Deficiency Photo1	 
	Near Main Entrance
Violations	No violations recorded.
<b>Seating</b>	
Instance on 1st Floor	Does not Exist
<b>Sliding-folding Partition</b>	
Instance on 1st Floor	Does not Exist
<b>Stage</b>	
Instance on 1st Floor	Does not Exist
<b>Walls</b>	
Instance on 1st Floor	Inspected
Condition	2 - Between Good and Fair
Deficiency	GLAZED BLOCK: CRACKS/SPALLING
Deficiency Location/Instance	Near Right Side Exit
Deficiency Quantity	10
Quantity Uom	S.F.
Potential Action	REPLACE
Urgency of Action	PRIORITY 3
Purpose of Action	LEVEL 2
Deficiency Photo1

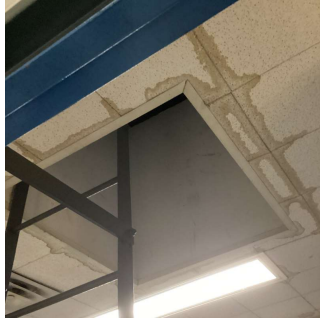
Question	Response
<b>INTERIOR</b>	
<b>INTERIOR DOOR HARDWARE</b>	Inspected
Condition	3 - Fair
Deficiency	No deficiencies recorded
<b>INTERIOR GUARDS</b>	Inspected
Condition	2 - Between Good and Fair
Deficiency	No deficiencies recorded
<b>KITCHEN</b>	Inspected
Instance on 1st Floor	Inspected
<b>Ceiling</b>	
Instance on 1st Floor	Inspected
Condition	4 - Between Fair and Poor
Deficiency	ACOUSTIC TILES: DAMAGED/MISSING
Deficiency Location/Instance	Rooms 127C, 131A, 131C, Exit 7 - Vestibule
Deficiency Quantity	40
Quantity Uom	S.F.
Potential Action	REPLACE
Urgency of Action	PRIORITY 3
Purpose of Action	LEVEL 2
Deficiency Photo1

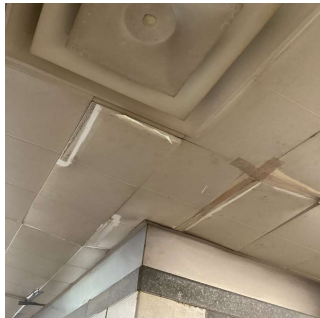
Violations	Exit 7 - Vestibule No violations recorded.
Deficiency	METAL PAN: DAMAGED/MISSING
Deficiency Location/Instance	Preparation Area, by Fridges
Deficiency Quantity	60
Quantity Uom	S.F.
Potential Action	REPLACE
Urgency of Action	PRIORITY 3
Purpose of Action	LEVEL 2
Deficiency Photo1

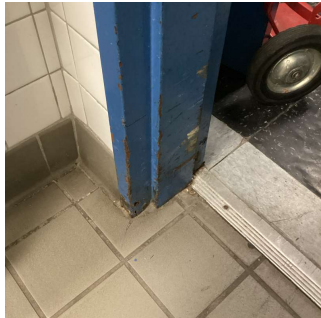
Question	Response
<b>INTERIOR</b>	
<b>KITCHEN</b>	
<b>Door(s)</b>	
Condition	3 - Fair
Deficiency	METAL CLAD WOOD: DETERIORATED DOOR AND FRAME
Deficiency Location/Instance	Near Exit 7 - Vestibule
Deficiency Quantity	1
Quantity Uom	EACH
Potential Action	MAINTENANCE
Urgency of Action	PRIORITY 3
Purpose of Action	LEVEL 2
Deficiency Photo1

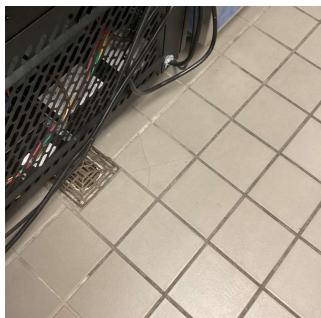
Violations	Near Exit 7 - Vestibule No violations recorded.
<b>Floor Finish</b>	
Instance on 1st Floor	Inspected
Condition	3 - Fair
Deficiency	QUARRY TILE: BROKEN/MISSING TILES
Deficiency Location/Instance	Servery
Deficiency Quantity	10
Quantity Uom	S.F.
Potential Action	REPLACE
Urgency of Action	PRIORITY 3
Purpose of Action	LEVEL 2
Deficiency Photo1

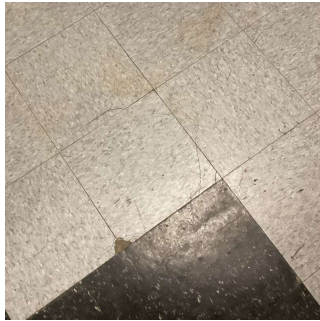
Violations	Servery No violations recorded.
Deficiency	VINYL TILES: BROKEN/DETERIORATED/MISSING TILES
Deficiency Location/Instance	Rooms 131C, 131A, 127C, Exit 7 - Vestibule
Deficiency Quantity	40
Quantity Uom	S.F.
Potential Action	REPLACE

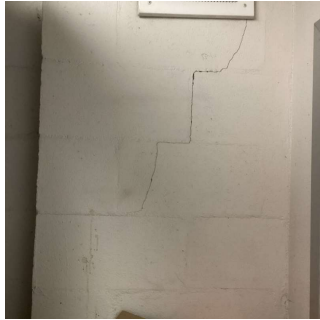
Violations	Exit 7 - Vestibule No violations recorded.
<b>Walls</b>	
Instance on 1st Floor	Inspected
Condition	2 - Between Good and Fair
Deficiency	MASONRY: CRACKS/SPALLING
Deficiency Location/Instance	Room 127C
Deficiency Quantity	20
Quantity Uom	S.F.
Potential Action	REPLACE
Urgency of Action	PRIORITY 3
Purpose of Action	LEVEL 2
Deficiency Photo1

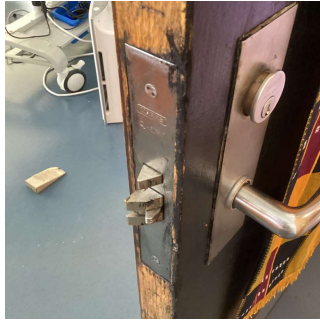
Left Side
Violations	No violations recorded.
<b>Door(s)</b>	
Instance on Room 428	Inspected
Condition	2 - Between Good and Fair
Deficiency	WOOD: DETERIORATED DOOR
Deficiency Location/Instance	Main Entrance
Deficiency Quantity	1
Quantity Uom	EACH
Potential Action	MAINTENANCE
Urgency of Action	PRIORITY 3
Purpose of Action	LEVEL 2
Deficiency Photo1

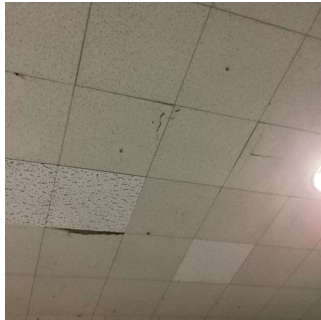
Question	Response
<b>INTERIOR</b>	
<b>STAIRS/RAMPS: INTERIOR</b>	
<b>Ceiling</b>	
Deficiency Photo1	 
Violations	Exit 3 - Vestibule No violations recorded.
Deficiency	ACOUSTIC TILES: DAMAGED/MISSING
Deficiency Location/Instance	Exits 3, 2 - Vestibules
Deficiency Quantity	20
Quantity Uom	S.F.
Potential Action	REPLACE
Urgency of Action	PRIORITY 3
Purpose of Action	LEVEL 2
Deficiency Photo1

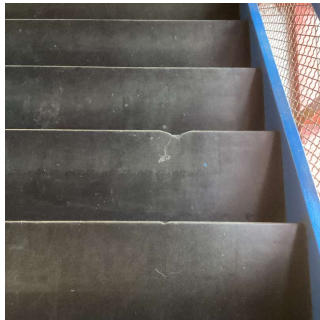
Question	Response
<b>INTERIOR</b>	
<b>STAIRS/RAMPS: INTERIOR</b>	
<b>Stairs and Landings</b>	
Deficiency Photo1	 
Violations	Stair C/2 No violations recorded.
Deficiency	STONE: BROKEN/MISSING
Deficiency Location/Instance	Stair C/2
Deficiency Quantity	10
Quantity Uom	S.F.
Potential Action	REPLACE
Urgency of Action	PRIORITY 3
Purpose of Action	LEVEL 2
Deficiency Photo1

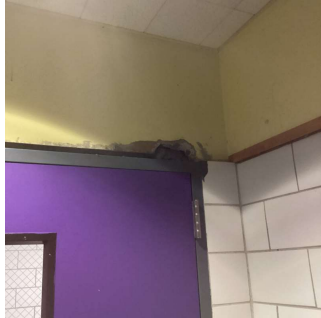
Question	Response
<b>INTERIOR</b>	
<b>STAIRS/RAMPS: INTERIOR</b>	
<b>Walls</b>	Inspected
Condition	2 - Between Good and Fair
Deficiency	PLASTER: CRACKS/SPALLING
Deficiency Location/Instance	Exit 3 - Vestibule
Deficiency Quantity	20
Quantity Uom	S.F.
Potential Action	REPLACE
Urgency of Action	PRIORITY 3
Purpose of Action	LEVEL 2
Deficiency Photo1

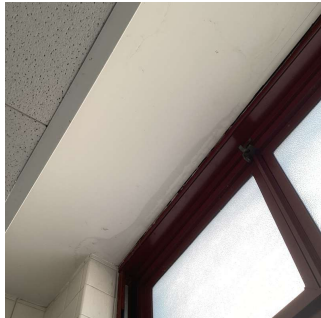
Violations	Exit 3 - Vestibule No violations recorded.
<b>TOILET ROOMS - STAFF</b>	
<b>Ceiling</b>	Inspected
Condition	3 - Fair
Deficiency	GYPSUM BOARD: DAMAGED/DETERIORATED
Deficiency Location/Instance	Room 131D
Deficiency Quantity	10
Quantity Uom	S.F.
Potential Action	REPLACE
Urgency of Action	PRIORITY 3
Purpose of Action	LEVEL 2
Deficiency Photo1

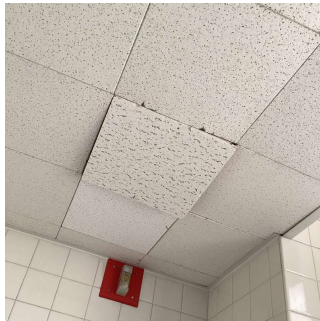
Violations	Room 131D No violations recorded.
Deficiency	ACOUSTIC TILES: DAMAGED/MISSING
Deficiency Location/Instance	Rooms 131D, 222, 324
Deficiency Quantity	30
Quantity Uom	S.F.
Potential Action	REPLACE
Urgency of Action	PRIORITY 3

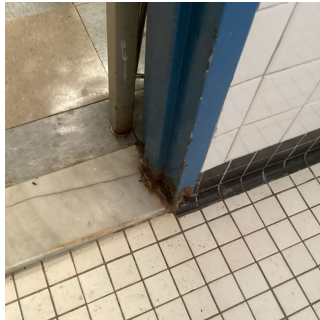
Violations	Room 131D No violations recorded.
<b>Door(s)</b>	Inspected
Condition	5 - Poor
Deficiency	METAL: DETERIORATED DOOR AND FRAME
Deficiency Location/Instance	Room 131D
Deficiency Quantity	1
Quantity Uom	EACH
Potential Action	MAINTENANCE
Urgency of Action	PRIORITY 3
Purpose of Action	LEVEL 2
Deficiency Photo1

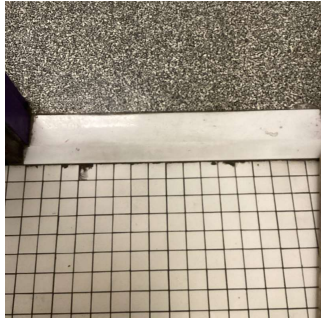
Question	Response
<b>INTERIOR</b>	
<b>TOILET ROOMS - STAFF</b>	
<b>Door(s)</b>	Inspected
	Room 122
Violations	No violations recorded.
<b>Floor Finish</b>	Inspected
Condition	2 - Between Good and Fair
Deficiency	CERAMIC TILE: BROKEN/MISSING TILES
Deficiency Location/Instance	Room 122
Deficiency Quantity	10
Quantity Uom	S.F.
Potential Action	REPLACE
Urgency of Action	PRIORITY 3
Purpose of Action	LEVEL 2
Deficiency Photo1

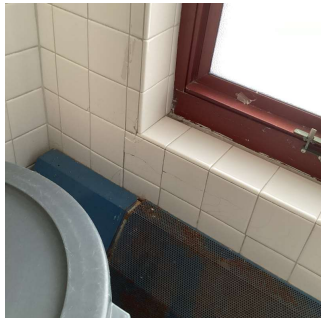
Room 122
Violations	No violations recorded.
<b>Stalls</b>	Does not Exist
<b>Walls</b>	Inspected
Condition	2 - Between Good and Fair
Deficiency	CERAMIC TILE: BROKEN/ MISSING
Deficiency Location/Instance	Room 131D
Deficiency Quantity	10
Quantity Uom	S.F.
Potential Action	REPLACE
Urgency of Action	PRIORITY 3
Purpose of Action	LEVEL 2
Deficiency Photo1

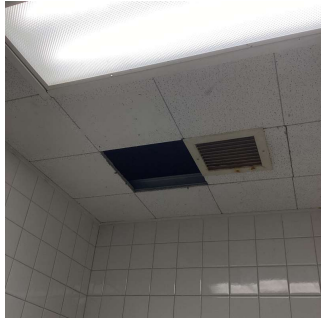
Question	Response
<b>INTERIOR</b>	
<b>TOILET ROOMS - STUDENTS</b>	
<b>Ceiling</b>	
Deficiency	ACOUSTIC TILES: DAMAGED/MISSING
Deficiency Location/Instance	In Room 205
Deficiency Quantity	10
Quantity Uom	S.F.
Potential Action	REPLACE
Urgency of Action	PRIORITY 3
Purpose of Action	LEVEL 2
Deficiency Photo1

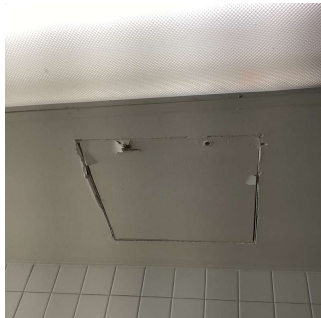
In Room 205
Violations	No violations recorded.
Deficiency	GYPSON BOARD: DAMAGED/DETERIORATED
Deficiency Location/Instance	Rooms 304, 338
Deficiency Quantity	20
Quantity Uom	S.F.
Potential Action	REPLACE
Urgency of Action	PRIORITY 3
Purpose of Action	LEVEL 2
Deficiency Photo1

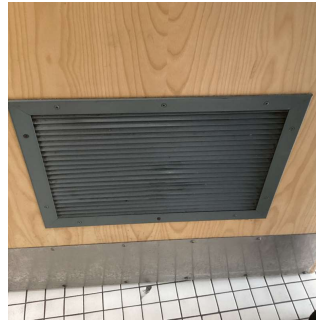
Room 304
Violations	No violations recorded.
<b>Door(s)</b>	Inspected
Condition	5 - Poor
Deficiency	WOOD: DAMAGED LOUVER
Deficiency Location/Instance	Room 338
Deficiency Quantity	1
Quantity Uom	EACH
Potential Action	MAINTENANCE
Urgency of Action	PRIORITY 3
Purpose of Action	LEVEL 2

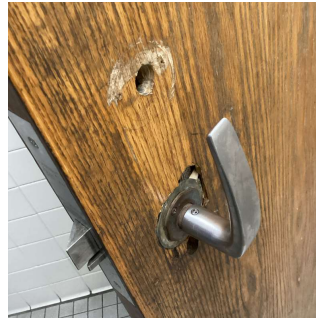
Room 144B

WOOD: DETERIORATED DOOR

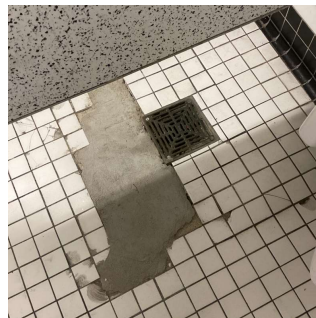
CERAMIC TILE: BROKEN/MISSING TILES

REPLACE

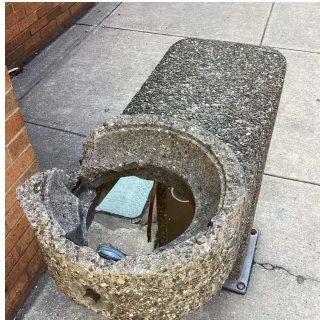
Violations	Near Containerization No violations recorded.
<b>Culverts - Concrete Covering</b>	Does not Exist
<b>Drainage System for Soil</b>	Does not Exist
<b>DRINKING FOUNTAINS</b>	Inspected
Condition	5 - Poor
Deficiency	DAMAGED
Deficiency Location/Instance	Near Exit 3, by Basketball Court
Deficiency Quantity	2
Quantity Uom	EACH
Potential Action	REPLACE
Urgency of Action	PRIORITY 3
Purpose of Action	LEVEL 2
Deficiency Photo1

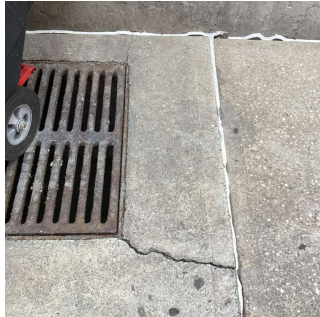
Violations	Near Containerization No violations recorded.
Deficiency	DAMAGED/DETERIORATED/MISSING SECTIONS
Deficiency Location/Instance	Near Containerization, By Exit 7
Deficiency Quantity	50
Quantity Uom	S.F.
Potential Action	REPLACE
Urgency of Action	PRIORITY 3
Purpose of Action	LEVEL 2
Deficiency Photo1

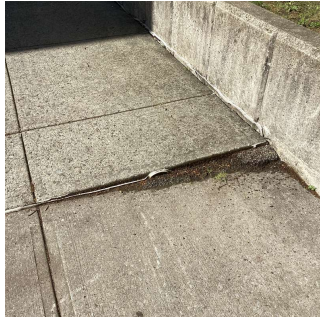
Violations	<p>Near Drinking Fountain by Basketball Court</p> <p>No violations recorded.</p>
<b>Concrete</b>	Inspected
Condition	4 - Between Fair and Poor
Deficiency	HEAVING
Deficiency Location/Instance	Near Playground, by Exits 3, 10
Deficiency Quantity	150
Quantity Uom	S.F.
Potential Action	REPLACE
Urgency of Action	PRIORITY 3
Purpose of Action	LEVEL 2
Deficiency Photo1

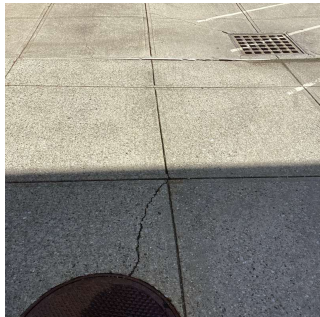
Violations	<p>Near Playground</p> <p>No violations recorded.</p>
Deficiency	DAMAGED/DETERIORATED/MISSING SECTIONS
Deficiency Location/Instance	Near Playground, by Exits 8, 10, close to Drinking Fountain, near Basketball Court and others
Deficiency Quantity	825
Quantity Uom	S.F.
Potential Action	REPLACE
Urgency of Action	PRIORITY 3
Purpose of Action	LEVEL 2

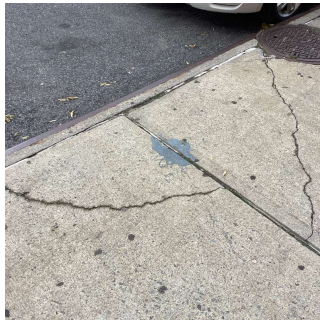
Question	Response
<b>SITE</b>	
<b>PAVING</b>	
<b>DOT Sidewalk</b>	
<b>Concrete</b>	
Violations	53562K012
Deficiency	DAMAGED/DETERIORATED/MISSING SECTIONS
Deficiency Location/Instance	Howard Avenue, Prospect Place, St. Marks Avenue
Deficiency Quantity	1,325
Quantity Uom	S.F.
Potential Action	REPLACE
Urgency of Action	PRIORITY 4
Purpose of Action	LEVEL 4
Deficiency Photo1

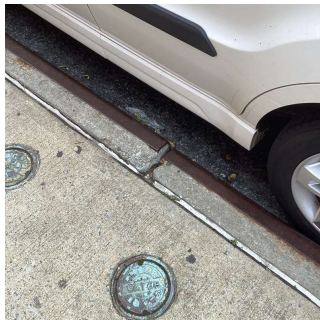
Violations	Howard Avenue 53562K012
Deficiency	DAMAGED CURBS
Deficiency Location/Instance	Howard Avenue, Prospect Place, St. Marks Avenue
Deficiency Quantity	50
Quantity Uom	L.F.
Potential Action	REPLACE
Urgency of Action	PRIORITY 4
Purpose of Action	LEVEL 4
Deficiency Photo1

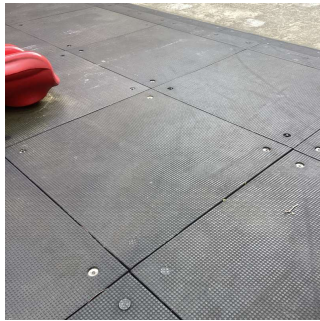
Question	Response
<b>SITE</b>	
<b>PLAYGROUNDS</b>	
<b>Play Equipment</b>	
Instance on South Schoolyard	Inspected
Condition	2 - Between Good and Fair
Deficiency	No deficiencies recorded
<b>Safety Surfacing</b>	
Instance on South Schoolyard	Inspected
Condition	3 - Fair
Deficiency	DETERIORATED/MISSING
Deficiency Location/Instance	Near Slide
Deficiency Quantity	80
Quantity Uom	S.F.
Potential Action	REPLACE
Urgency of Action	PRIORITY 3
Purpose of Action	LEVEL 2
Deficiency Photo1

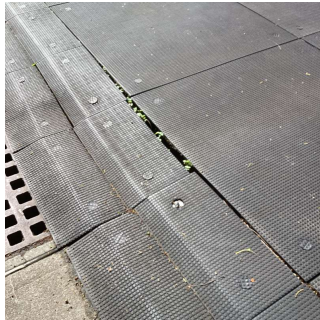
Near Slide
Violations	No violations recorded.
Deficiency	DETERIORATED/MISSING
Deficiency Location/Instance	Near Exit 8, by Drinking Fountain
Deficiency Quantity	20
Quantity Uom	S.F.
Potential Action	MAINTENANCE
Urgency of Action	PRIORITY 3
Purpose of Action	LEVEL 2
Deficiency Photo1

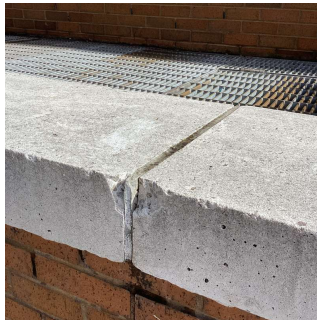
Question	Response
<b>SITE</b>	
<b>RETAINING WALLS</b>	
street/sidewalk?	
Condition	3 - Fair
Deficiency	BRICK: DETERIORATED COPING STONE
Deficiency Location/Instance	Prospect Place, Howard Avenue
Deficiency Quantity	20
Quantity Uom	S.F.
Potential Action	REPLACE
Urgency of Action	PRIORITY 4
Purpose of Action	LEVEL 4
Deficiency Photo1

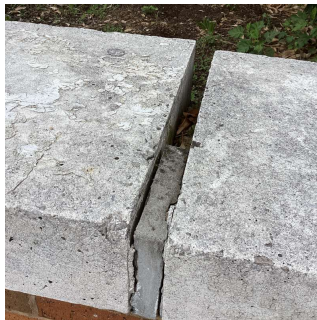
Violations	Prospect Place 35674656L
Deficiency	BRICK: DETERIORATED CONTROL/EXPANSION JOINT
Deficiency Location/Instance	Howard Avenue, Prospect Place
Deficiency Quantity	30
Quantity Uom	L.F.
Potential Action	REPLACE
Urgency of Action	PRIORITY 4
Purpose of Action	LEVEL 4
Deficiency Photo1

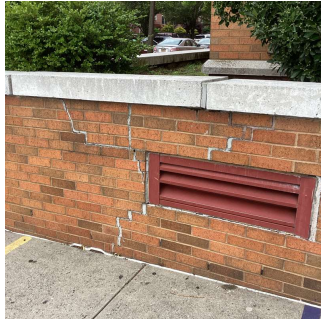
Violations	Howard Avenue 35674656L
Deficiency	BRICK: CRACKS/SPALLING - MAJOR
Deficiency Location/Instance	Howard Avenue
Deficiency Quantity	30
Quantity Uom	S.F.
Potential Action	REPLACE
Urgency of Action	PRIORITY 4
Purpose of Action	LEVEL 4

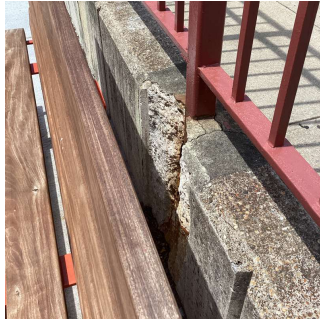
Violations	Howard Avenue 35674656L
Deficiency	CAST IN PLACE CONCRETE: CRACKS/SPALLING - MAJOR
Deficiency Location/Instance	Near Containerization, Prospect Place, Exterior Ramp near Basketball Court, by Basketball Court, Schoolyard and others
Deficiency Quantity	100
Quantity Uom	S.F.
Potential Action	REPLACE
Urgency of Action	PRIORITY 3
Purpose of Action	LEVEL 2
Deficiency Photo1	 
Violations	Schoolyard No violations recorded.
<b>SEATING</b>	Inspected
<b>Benches</b>	Inspected
<b>Concrete</b>	Inspected
Condition	2 - Between Good and Fair
Deficiency	No deficiencies recorded
<b>Metal/Wood/Plastic</b>	Inspected
Condition	2 - Between Good and Fair
Deficiency	No deficiencies recorded
<b>Bleachers</b>	Does not Exist
<b>SITE WALLS (NOT RETAINING WALLS)</b>	Inspected
Condition	3 - Fair
Deficiency	CAST IN PLACE CONCRETE: CRACKS/SPALLING - MAJOR
Deficiency Location/Instance	St. Marks Avenue

Deficiency Quantity	40
Quantity Uom	S.F.
Potential Action	REPLACE
Urgency of Action	PRIORITY 3
Purpose of Action	LEVEL 2

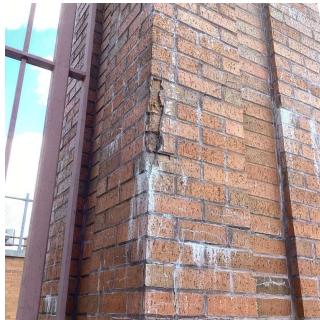
Violations	St. Marks Avenue No violations recorded.
Deficiency	BRICK: CRACKS/SPALLING - MAJOR
Deficiency Location/Instance	Howard Avenue, St. Marks Avenue, Near Basketball Court
Deficiency Quantity	100
Quantity Uom	S.F.
Potential Action	REPLACE
Urgency of Action	PRIORITY 4
Purpose of Action	LEVEL 4
Deficiency Photo1

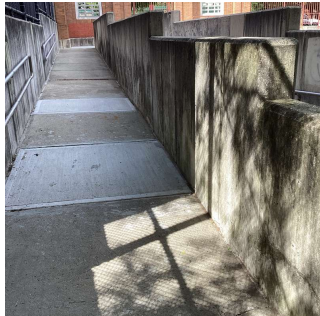
Violations	Near Basketball Court 35674656L
<b>STAIRS/RAMPS: EXTERIOR</b>	Inspected
<b>Railings</b>	Inspected
Condition	3 - Fair
Deficiency	MISSING
Deficiency Location/Instance	Site Ramp near Basketball Court
Deficiency Quantity	15
Quantity Uom	L.F.
Potential Action	REPLACE
Urgency of Action	PRIORITY 5
Purpose of Action	LEVEL 6
Deficiency Photo1

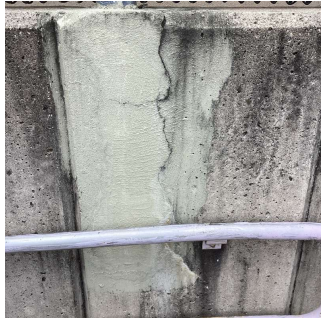
Question	Response
<b>SITE</b>	
<b>STAIRS/RAMPS: EXTERIOR</b>	
<b>Railings</b>	Inspected
	Site Ramp near Basketball Court
Violations	No violations recorded.
<b>Site Cheek/flank Walls</b>	Inspected
Condition	3 - Fair
Deficiency	CAST IN PLACE CONCRETE: CRACKS/SPALLING - MAJOR
Deficiency Location/Instance	Site Ramp near Basketball Court
Deficiency Quantity	50
Quantity Uom	S.F.
Potential Action	REPLACE
Urgency of Action	PRIORITY 3
Purpose of Action	LEVEL 2
Deficiency Photo1

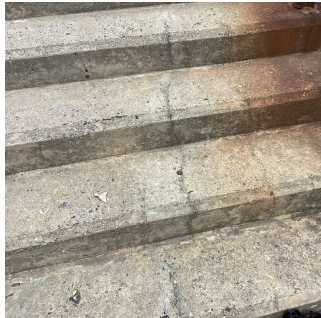
Right Side Stair near Basketball Court

Site Ramp near Basketball Court
Violations	No violations recorded.
<b>Stairs/ramps</b>	Inspected
Condition	3 - Fair
Deficiency	CAST IN PLACE CONCRETE: CRACKS/SPALLING - MAJOR
Deficiency Location/Instance	Right and Left side stair near Basketball Court, Ramp by Basketball Court
Deficiency Quantity	80
Quantity Uom	S.F.
Potential Action	REPLACE
Urgency of Action	PRIORITY 3
Purpose of Action	LEVEL 2
Deficiency Photo1
