**NYC Department of Education**  
**Building Condition Assessment Survey 2023 - 2024**

Architectural Inspection

**Asset:**        **P.S. 13 - BROOKLYN, 557 PENNSYLVANIA AVENUE, New York, 11207**

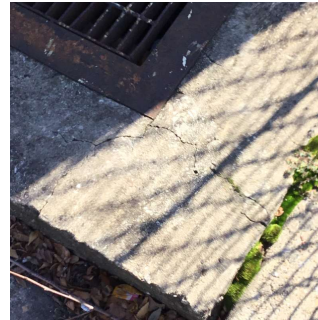
Question	Response
<b>Architectural</b>	
<b>EXTERIOR</b>	Inspected
<b>AREAWAY</b>	Inspected
Instance on AW1	Inspected
Instance Condition	3 - Fair
Instance Quantity	1
Instance Quantity Uom	EACH
Deficiency	AREAWAY WALLS: CRACKS AND SPALLING
Roof Plan reference	K013
Deficiency Quantity	15
Quantity Uom	S.F.
Potential Action	REPAIR
Urgency of Action	PRIORITY 3
Purpose of Action	LEVEL 2

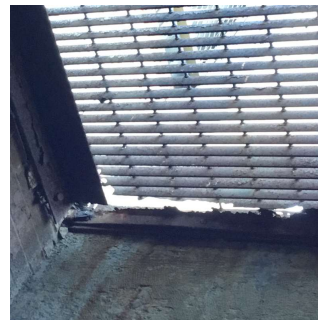
AW1

AREAWAY GRATINGS: MAJOR RUSTING AND / OR BROKEN SUPPORTS

REPLACE

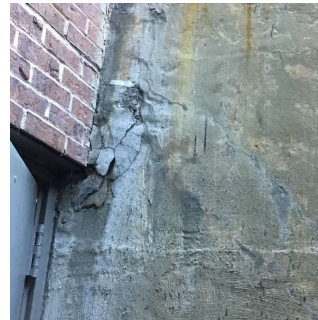
AW1

AREAWAY WALLS: CRACKS AND SPALLING

REPLACE

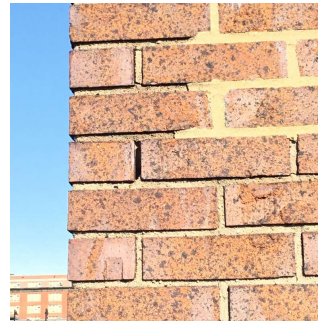
Chimney

AW1
Violations	No violations recorded.
<b>AWNINGS AND CANOPIES</b>	Does not Exist
<b>CHIMNEY</b>	Inspected
Material Type(s)	Masonry
Condition	3 - Fair
Deficiency	BRICK: DETERIORATED JOINTS

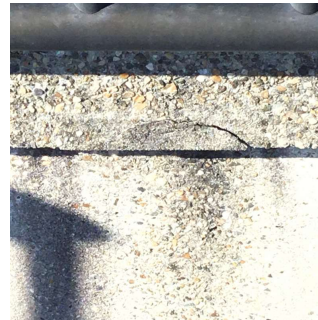
Violations	Roof 1 No violations recorded.
Deficiency	CAST STONE: CRACKED/BROKEN PIECES

REPLACE-IN-KIND

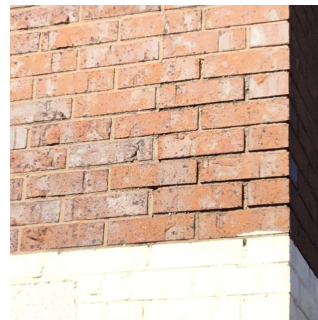
Facade J

Violations	<p>Facade B</p> <p>No violations recorded.</p>
<b>DOOR HARDWARE</b>	Inspected
Condition	3 - Fair
Deficiency	No deficiencies recorded
<b>LINTELS</b>	Inspected
Condition	2 - Between Good and Fair
Deficiency	No deficiencies recorded
<b>TRANSOM/SIDE LIGHT</b>	Inspected
Condition	2 - Between Good and Fair
Deficiency	No deficiencies recorded
<b>EXTERIOR WALLS</b>	Inspected
Material Type(s)	Concrete, Masonry
Replacement Quantity	24,000
Replacement Uom	S.F.
Instance on All Facades	Inspected
Instance Condition	4 - Between Fair and Poor
Instance Quantity	24,000
Instance Quantity Uom	S.F.
Deficiency	BRICK: DETERIORATED JOINTS

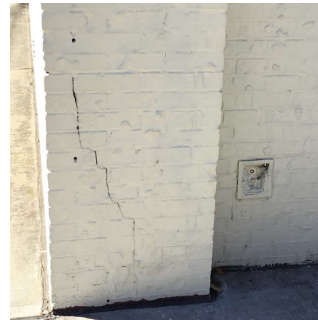
Facade E

BRICK: CRACKS/DISPLACED/SPALLED BRICK AT BUILDING CORNERS

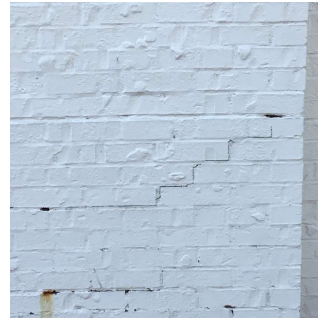
Facade E

BRICK: MINOR CRACKS AND SPALLING

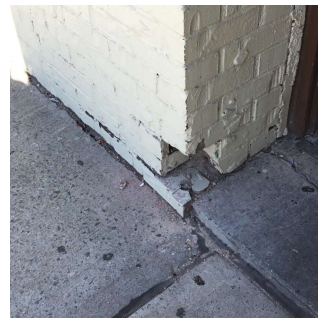
Facade A - Exit 6

BRICK: MAJOR / THRU CRACKS

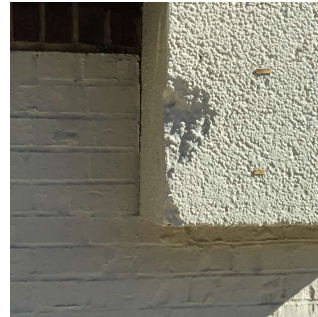
Facade A

CAST IN PLACE / PRE-CAST CONCRETE: MAJOR  
CRACKS/SPALLING

REPLACE

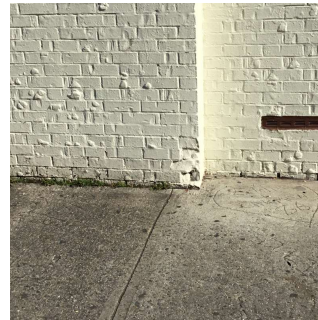
Facade A

BRICK: MAJOR / THRU CRACKS

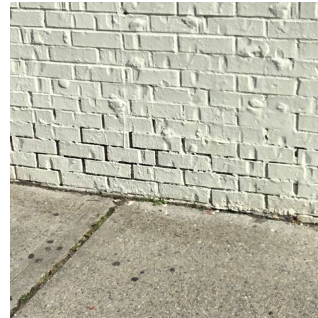
Facade A

BRICK: DETERIORATED JOINTS

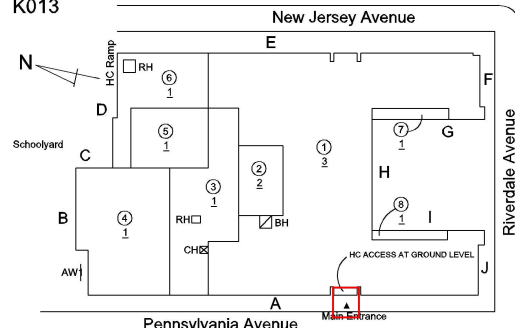
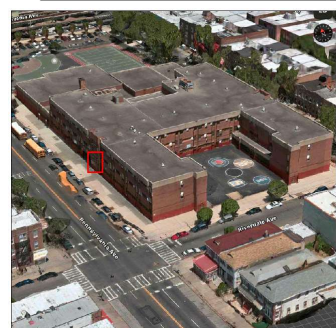
Question	Response
<b>EXTERIOR</b>	
<b>EXTERIOR WALLS</b>	Inspected
Violations	No violations recorded.
<b>EXTERIOR SOFFITS</b>	Inspected
Condition	2 - Between Good and Fair
Deficiency	CONCRETE: MINOR CRACKS/SPALLING
Roof Plan reference	K013

Deficiency Quantity	25
Quantity Uom	S.F.
Potential Action	REPAIR
Urgency of Action	PRIORITY 3
Purpose of Action	LEVEL 2
Deficiency Photo1

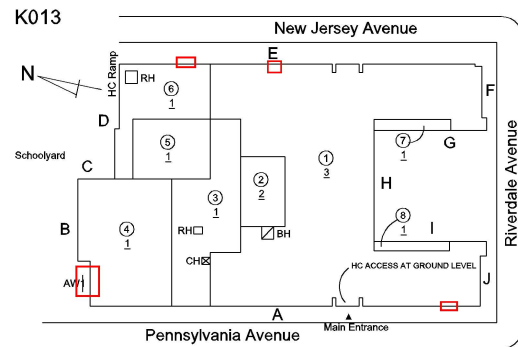
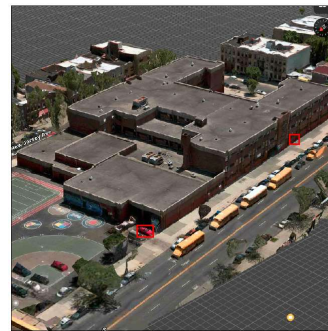
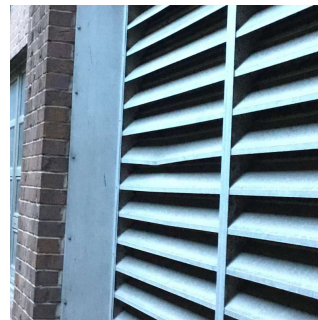
AW1

Facade A
Violations	No violations recorded.
<b>LOADING DOCK</b>	Does not Exist
<b>LOUVER</b>	Inspected
Condition	3 - Fair
Deficiency	BROKEN/ DENTED BLADES

REPLACE

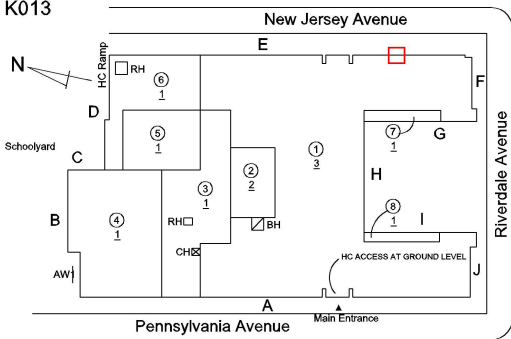
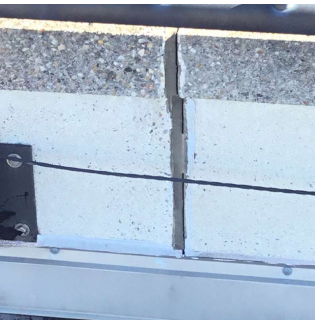
CONCRETE: DETERIORATED CONTROL/EXPANSION JOINT

Deficiency Quantity	10
Quantity Uom	L.F.
Potential Action	MAINTENANCE
Urgency of Action	PRIORITY 3
Purpose of Action	LEVEL 2
Deficiency Photo1

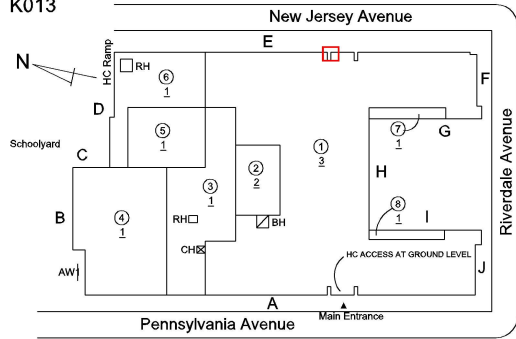
Question	Response
<b>EXTERIOR</b>	
<b>ROOF</b>	
<b>Roofing</b>	
<b>ROOFING</b>	
Instance Photo	 
	Roof 1
Instance Quantity	54,000
Instance Quantity Uom	S.F.
Does the roof have major mechanical equipment sitting on Dunnage Steel less than 18" above the Roofing?	No
Does this roof instance have a Sustainable Roof System?	No
Do solar panels exist on these roofs?	No
Is/Are the roof(s) suitable for Solar Panel installation?	Yes
Installation Year	1974
Source of Installation	Custodial Staff
Deficiency	BUILT-UP: FLASHING: BASE FLASHING DETERIORATED
Roof Plan reference	K013

Deficiency Quantity	10
Quantity Uom	S.F.
Potential Action	REMOVE AND REPLACE
Urgency of Action	PRIORITY 4
Purpose of Action	LEVEL 2
Deficiency Photo1

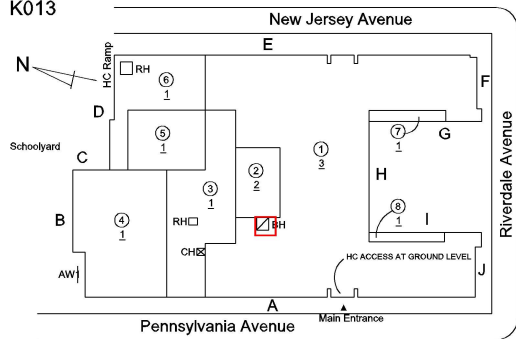
Question	Response
<b>EXTERIOR</b>	
<b>ROOF</b>	
<b>Specialties</b>	
<b>BULKHEAD/PENTHOUSE</b>	
Quantity Uom	S.F.
Potential Action	REPLACE
Urgency of Action	PRIORITY 4
Purpose of Action	LEVEL 2
Deficiency Photo1	 
Violations	BH No violations recorded.
Deficiency	BULKHEAD/PENTHOUSE WALLS/EXTERIOR: DETERIORATED JOINTS
Roof Plan reference	K013

Deficiency Quantity	80
Quantity Uom	S.F.
Potential Action	REPOINT
Urgency of Action	PRIORITY 3
Purpose of Action	LEVEL 2
Deficiency Photo1	 
Violations	BH No violations recorded.
<b>CUPOLA/ SPIRES/ TOWERS</b>	Does not Exist
<b>DORMER</b>	Does not Exist
<b>DUNNAGE STEEL</b>	Inspected

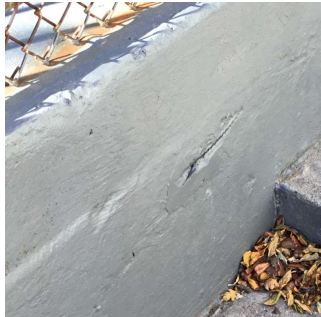
Question	Response
<b>EXTERIOR</b>	
<b>ROOF</b>	Inspected
<b>Specialties</b>	
<b>DUNNAGE STEEL</b>	Inspected
Condition	2 - Between Good and Fair
Deficiency	No deficiencies recorded
<b>SKYLIGHT/ROOF VENT</b>	Does not Exist
<b>ROOF/GRAVITY TANK</b>	Does not Exist
<b>STAIRS/RAMPS: EXTERIOR</b>	Inspected
<b>BUILDING CHEEK/FLANK WALLS</b>	Inspected
Condition	3 - Fair
Deficiency	CAST IN PLACE CONCRETE: CRACKS/SPALLING - MINOR
Roof Plan reference	K013
Deficiency Quantity	15
Quantity Uom	S.F.
Potential Action	REPAIR
Urgency of Action	PRIORITY 3
Purpose of Action	LEVEL 2
Deficiency Photo1

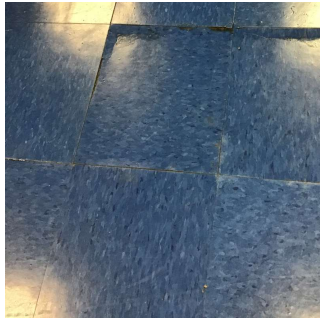
Question	Response
<b>INTERIOR</b>	
<b>AUDITORIUM</b>	
<b>Floor Finish</b>	
Purpose of Action	LEVEL 4
Deficiency Photo1

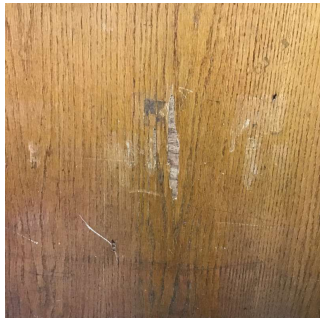
Near Exit
Violations	35671829R
<b>Sliding-folding Partition</b>	
Instance on 1st Floor (259 seats)	Inspected
Condition	3 - Fair
Deficiency	MOVABLE PANELS: DAMAGED
Deficiency Location/Instance	Near Entrance
Deficiency Quantity	80
Quantity Uom	S.F.
Potential Action	REPLACE
Urgency of Action	PRIORITY 3
Purpose of Action	LEVEL 2
Deficiency Photo1

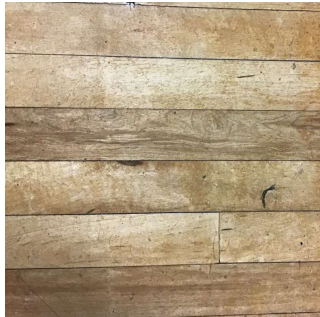
Near Entrance
Violations	No violations recorded.
<b>Stage</b>	
Instance on 1st Floor (259 seats)	Inspected
<b>Stage</b>	
Instance on 1st Floor (259 seats)	Inspected
Condition	3 - Fair
Deficiency	DAMAGED FLOOR
Deficiency Location/Instance	Near center
Deficiency Quantity	10
Quantity Uom	S.F.
Potential Action	REPLACE
Urgency of Action	PRIORITY 3
Purpose of Action	LEVEL 2

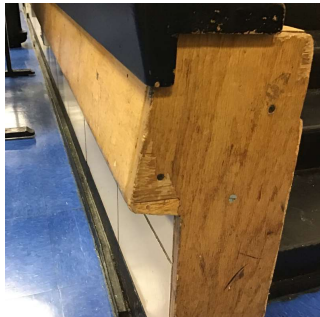
Violations	Near center No violations recorded.
Deficiency	DAMAGED FASCIA
Deficiency Location/Instance	Left side
Deficiency Quantity	10
Quantity Uom	S.F.
Potential Action	REPLACE
Urgency of Action	PRIORITY 3
Purpose of Action	LEVEL 2
Deficiency Photo1

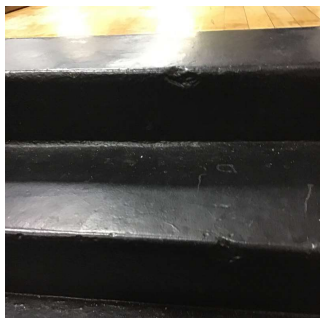
Violations	Left side No violations recorded.
Deficiency	DAMAGED STEPS
Deficiency Location/Instance	Left side
Deficiency Quantity	15
Quantity Uom	S.F.
Potential Action	REPLACE
Urgency of Action	PRIORITY 3
Purpose of Action	LEVEL 2
Deficiency Photo1

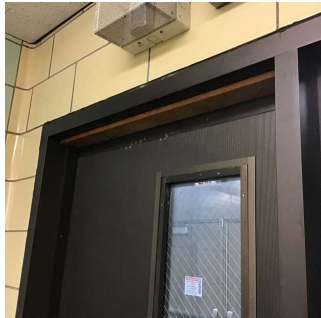
Question	Response
<b>INTERIOR</b>	
<b>CLASSROOMS/CORRIDORS/ADMIN SPACES</b>	
<b>Door(s)</b>	
	Near room 341
Violations	No violations recorded.
Deficiency	METAL: DETERIORATED DOOR AND FRAME
Deficiency Location/Instance	Corridor near Exit 6
Deficiency Quantity	2
Quantity Uom	EACH
Potential Action	MAINTENANCE
Urgency of Action	PRIORITY 3
Purpose of Action	LEVEL 2
Deficiency Photo1

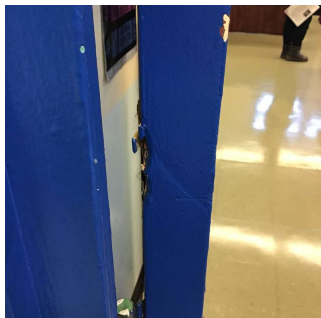
Corridor near Exit 6
Violations	No violations recorded.
Deficiency	WOOD: DETERIORATED DOOR
Deficiency Location/Instance	Room 249, 226
Deficiency Quantity	2
Quantity Uom	EACH
Potential Action	MAINTENANCE
Urgency of Action	PRIORITY 3
Purpose of Action	LEVEL 2
Deficiency Photo1

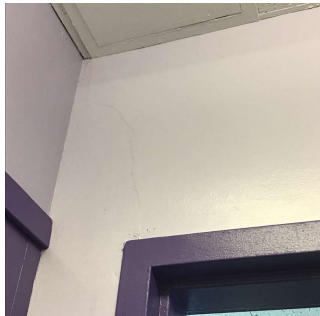
Violations	Room 352 No violations recorded.
<b>Walls</b>	Inspected
Condition	2 - Between Good and Fair
Deficiency	PLASTER: CRACKS/SPALLING
Deficiency Location/Instance	Corridor near Room 302, Room 352
Deficiency Quantity	10
Quantity Uom	S.F.
Potential Action	REPLACE
Urgency of Action	PRIORITY 3
Purpose of Action	LEVEL 2
Deficiency Photo1

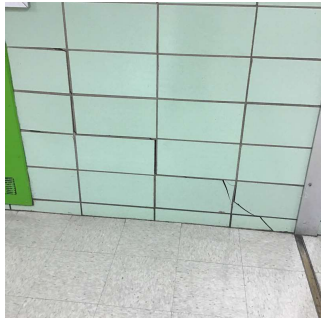
Question	Response
<b>INTERIOR</b>	
<b>CLASSROOMS/CORRIDORS/ADMIN SPACES</b>	
<b>Walls</b>	
Violations	Corridor near Room 302 No violations recorded.
Deficiency	GLAZED BLOCK: CRACKS/SPALLING
Deficiency Location/Instance	Corridor near Room 230, 227, 226, 104, Exit 6, and others
Deficiency Quantity	40
Quantity Uom	S.F.
Potential Action	REPLACE
Urgency of Action	PRIORITY 3
Purpose of Action	LEVEL 2
Deficiency Photo1

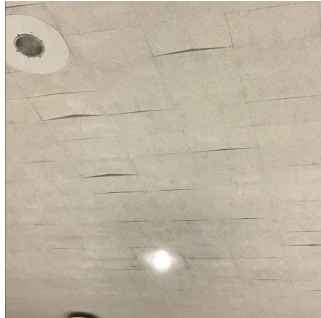
Violations	Corridor near Room 104 No violations recorded.
<b>Specialties</b>	Does not Exist
<b>GYMNASIUM</b>	
Instance on 1st Floor	Inspected
<b>Ceiling</b>	
Instance on 1st Floor	Inspected
Condition	3 - Fair
Deficiency	METAL PAN: DAMAGED/MISSING
Deficiency Location/Instance	Near center, left side, right side
Deficiency Quantity	160
Quantity Uom	S.F.
Potential Action	REPLACE
Urgency of Action	PRIORITY 3
Purpose of Action	LEVEL 2
Deficiency Photo1

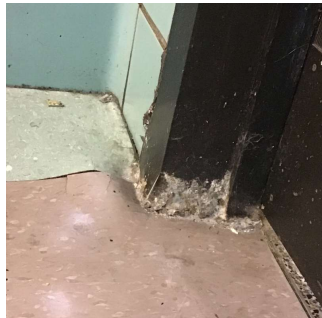
Question	Response
<b>INTERIOR</b>	
<b>SCIENCE PREP ROOM</b>	
Alternative use	Yes
<b>Fixed Equipment</b>	
Instance on Room 325	Inspected
Condition	2 - Between Good and Fair
Deficiency	No deficiencies recorded
<b>SHOWER ROOM</b>	
	Does not Exist
<b>STAIRS/RAMPS: INTERIOR</b>	
Do Letter Stair Signs Exist?	Inspected
	Partially
<b>Ceiling</b>	
	Inspected
Condition	2 - Between Good and Fair
Deficiency	No deficiencies recorded
<b>Door(s)</b>	
	Inspected
Condition	4 - Between Fair and Poor
Deficiency	METAL: DETERIORATED DOOR AND FRAME
Deficiency Location/Instance	Stair D/1
Deficiency Quantity	2
Quantity Uom	EACH
Potential Action	MAINTENANCE
Urgency of Action	PRIORITY 3
Purpose of Action	LEVEL 2
Deficiency Photo1

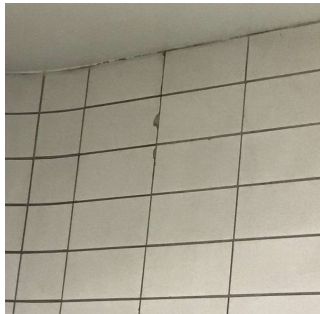
Violations	Stair 1/3 No violations recorded.
<b>Walls</b>	<b>Inspected</b>
Condition	2 - Between Good and Fair
Deficiency	GLAZED BLOCK: CRACKS/SPALLING
Deficiency Location/Instance	Stair 1/3, 1/1, B/3,2, D/2, and others
Deficiency Quantity	40
Quantity Uom	S.F.
Potential Action	REPLACE
Urgency of Action	PRIORITY 3
Purpose of Action	LEVEL 2
Deficiency Photo1

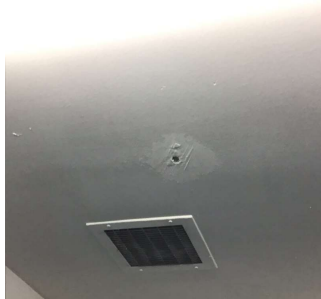
Question	Response
<b>INTERIOR</b>	
<b>TOILET ROOMS - STUDENTS</b>	
<b>Ceiling</b>	
Urgency of Action	PRIORITY 3
Purpose of Action	LEVEL 2
Deficiency Photo1

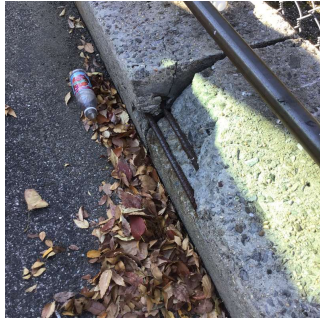
Question	Response
<b>SITE</b>	
<b>FENCES</b>	
Deficiency Location/Instance	Schoolyard
Deficiency Quantity	10
Quantity Uom	S.F.
Potential Action	REPLACE
Urgency of Action	PRIORITY 5
Purpose of Action	LEVEL 6
Deficiency Photo1

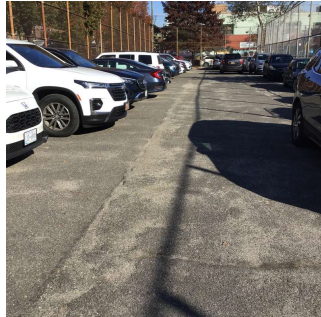
Violations	Schoolyard No violations recorded.
<b>Deficiency</b>	<b>CHAIN LINK: RUST - MAJOR</b>
Deficiency Location/Instance	South East Schoolyard, Along New Jersey Avenue, Livonia Avenue
Deficiency Quantity	4,000
Quantity Uom	S.F.
Potential Action	REPLACE
Urgency of Action	PRIORITY 3
Purpose of Action	LEVEL 2
Deficiency Photo1	 
Violations	Along Livonia Avenue No violations recorded.
<b>IRRIGATION SYSTEM</b>	Does not Exist
<b>PAVING</b>	Inspected
<b>Student Non-Use</b>	Inspected
Gravel Exists?	No
<b>Asphalt</b>	Inspected
Condition	4 - Between Fair and Poor
<b>Deficiency</b>	<b>CRACKS - MAJOR</b>
Deficiency Location/Instance	Parking Area
Deficiency Quantity	900
Quantity Uom	S.F.
Potential Action	REPLACE

Urgency of Action	PRIORITY 3
Purpose of Action	LEVEL 2

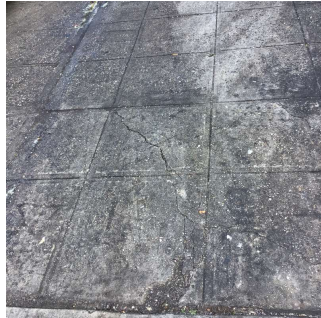
Violations	Parking Area No violations recorded.
<b>Concrete</b>	Inspected
Condition	3 - Fair
Deficiency	CRACKS - MAJOR
Deficiency Location/Instance	Near entrance to Containerization
Deficiency Quantity	75
Quantity Uom	S.F.
Potential Action	REPLACE
Urgency of Action	PRIORITY 3
Purpose of Action	LEVEL 2
Deficiency Photo1

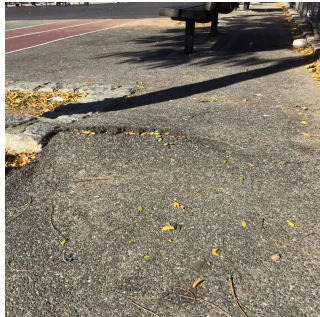
Violations	Near entrance to Containerization No violations recorded.
<b>Pavers</b>	Does not Exist
<b>Student Use</b>	Inspected
Gravel Exists?	No
<b>Asphalt</b>	Inspected
Condition	4 - Between Fair and Poor
Deficiency	HEAVING
Deficiency Location/Instance	Schoolyard
Deficiency Quantity	10
Quantity Uom	S.F.
Potential Action	REPLACE
Urgency of Action	PRIORITY 5
Purpose of Action	LEVEL 6

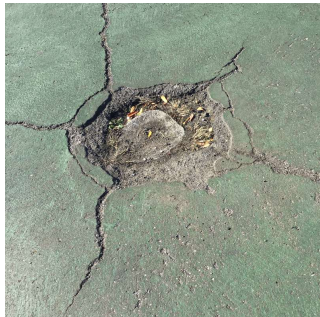
Violations	Schoolyard No violations recorded.
Deficiency	POTHLES
Deficiency Location/Instance	Schoolyard
Deficiency Quantity	10
Quantity Uom	S.F.
Potential Action	REPAIR
Urgency of Action	PRIORITY 5
Purpose of Action	LEVEL 6
Deficiency Photo1

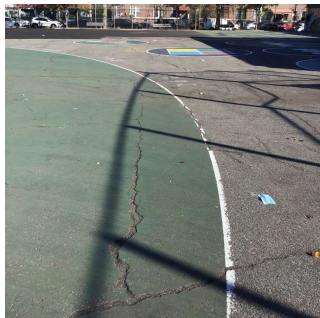
Violations	Schoolyard No violations recorded.
Deficiency	CRACKS - MAJOR
Deficiency Location/Instance	North Schoolyard, south Playground
Deficiency Quantity	4,000
Quantity Uom	S.F.
Potential Action	REPLACE
Urgency of Action	PRIORITY 3
Purpose of Action	LEVEL 2
Deficiency Photo1

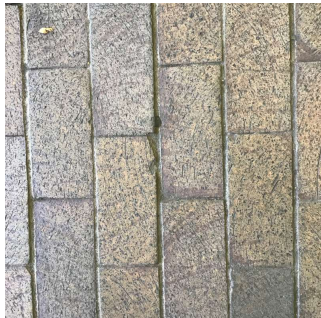
Violations	Along Pennsylvania Avenue No violations recorded.
<b>Pavers</b>	Inspected
Condition	2 - Between Good and Fair
Deficiency	DAMAGED/MISSING
Deficiency Location/Instance	Along Pennsylvania Avenue
Deficiency Quantity	10
Quantity Uom	S.F.
Potential Action	REPLACE
Urgency of Action	PRIORITY 3
Purpose of Action	LEVEL 2

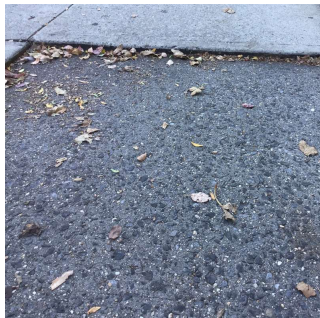
Question	Response
<b>SITE</b>	
<b>PAVING</b>	
<b>Site Sidewalks &amp; Walkways</b>	Inspected
<b>Pavers</b>	Inspected
Violations	No violations recorded.
<b>DOT Sidewalk</b>	Inspected
<b>Asphalt</b>	Does not Exist
<b>Concrete</b>	Inspected
Condition	4 - Between Fair and Poor
Deficiency	HEAVING
Deficiency Location/Instance	Along Pennsylvania Avenue, New Jersey Avenue
Deficiency Quantity	100
Quantity Uom	S.F.
Potential Action	REPLACE
Urgency of Action	PRIORITY 3
Purpose of Action	LEVEL 2
Deficiency Photo1

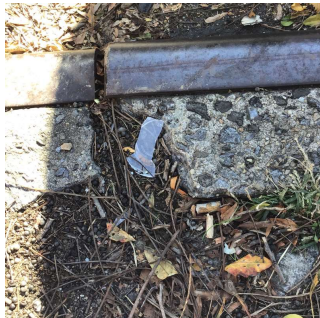
Violations	Along New Jersey Avenue No violations recorded.
Deficiency	DAMAGED CURBS
Deficiency Location/Instance	Along Pennsylvania Avenue, Riverdale Avenue, New Jersey Avenue, Livonia Avenue
Deficiency Quantity	250
Quantity Uom	L.F.
Potential Action	REPLACE
Urgency of Action	PRIORITY 3
Purpose of Action	LEVEL 2
Deficiency Photo1

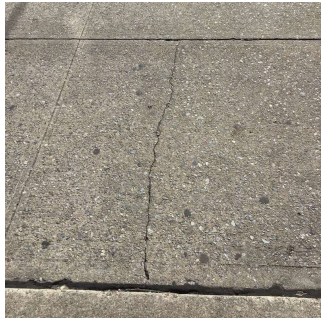
Violations	Along Riverdale Avenue No violations recorded.
Deficiency	DAMAGED/DETERIORATED/MISSING SECTIONS

Deficiency Location/Instance	Along Pennsylvania Avenue, Riverdale Avenue, New Jersey Avenue, Livonia Avenue
Deficiency Quantity	1,075

Question	Response
<b>SITE</b>	
<b>PAVING</b>	
<b>DOT Sidewalk</b>	Inspected
<b>Concrete</b>	Inspected
Quantity Uom	S.F.
Potential Action	REPLACE
Urgency of Action	PRIORITY 3
Purpose of Action	LEVEL 2
Deficiency Photo1

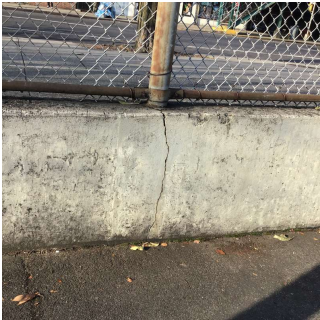
<b>RETAINING WALLS</b>	Inspected
Are there any Retaining Walls 6' OR higher facing public street/sidewalk?	No
Condition	3 - Fair
Deficiency	CAST IN PLACE CONCRETE: CRACKS/SPALLING - MAJOR
Deficiency Location/Instance	Schoolyard, Parking Lot
Deficiency Quantity	50
Quantity Uom	S.F.
Potential Action	REPLACE
Urgency of Action	PRIORITY 3
Purpose of Action	LEVEL 2

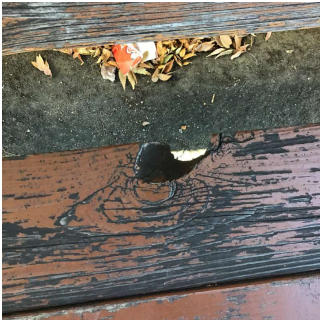
Violations	Schoolyard No violations recorded.
<b>SEATING</b>	Inspected
<b>Benches</b>	Inspected
<b>Concrete</b>	Does not Exist
<b>Metal/Wood/Plastic</b>	Inspected
Condition	5 - Poor
Deficiency	DAMAGED/DETERIORATED
Deficiency Location/Instance	Schoolyard
Deficiency Quantity	3
Quantity Uom	EACH
Potential Action	REPLACE
Urgency of Action	PRIORITY 3
Purpose of Action	LEVEL 2
Deficiency Photo1
